SUMMARY
1234 Main St. Kansas City MO 64151
Buyer Name
06/10/2018 9:00AM

Eddie Cosler
Internachi Certified Professional Home
Inspector
Homeology Inspections LLC
816-506-0831
eddie@homeologyinspections.com

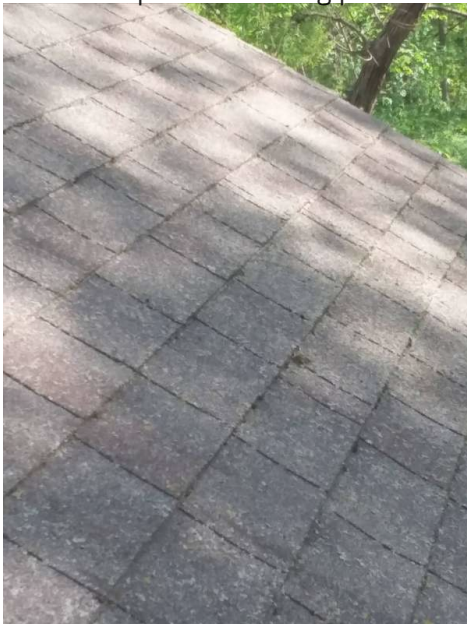
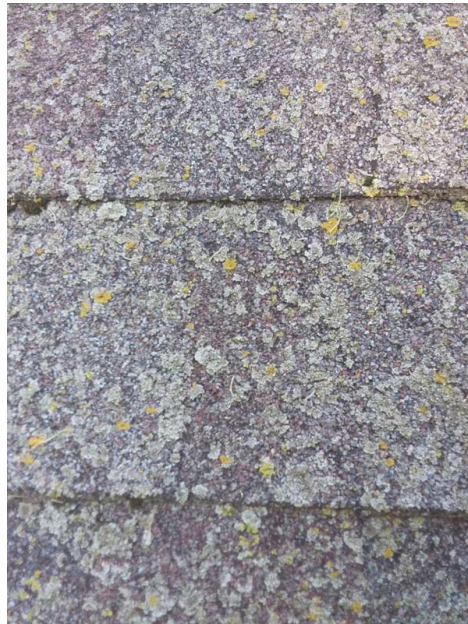
Above garages front

2.1.1 Coverings

LICHEN (ALGAE) GROWTH

At the time of inspection the roof appeared to have substantial Lichen growth. Lichens are composite organisms consisting of a fungus and a photosynthetic partner, such as green or blue-green algae. Lichens bond tightly to the roof, and when they're removed from asphalt shingles, they may take granules with them.

Contact a qualified roofing professional.

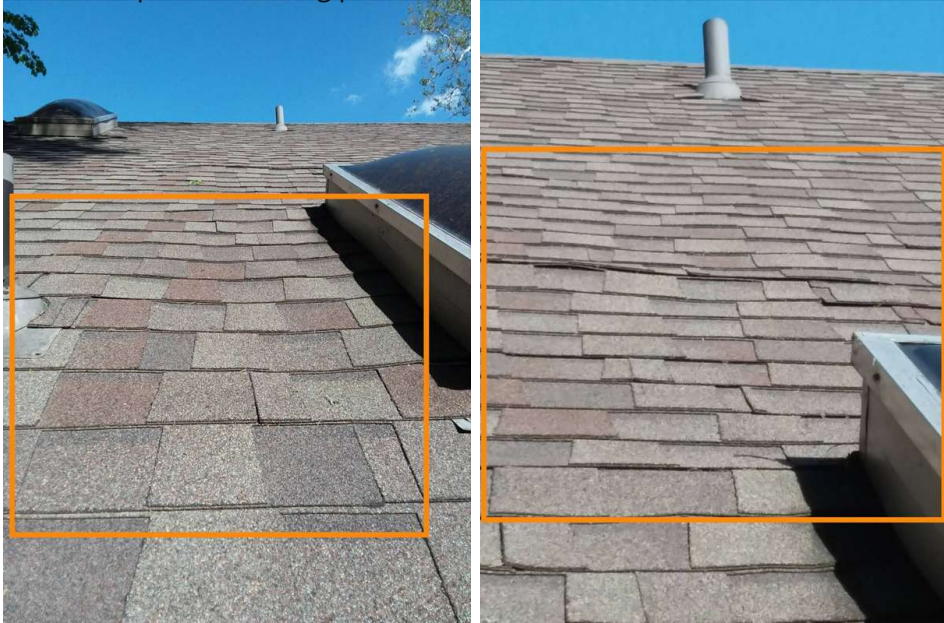
2.1.2 Coverings

WAVY SHINGLES

At the time of inspection one or more areas of the roof shingles appeared to be wavy. Recommend further evaluation by qualified roofing contractor.

Contact a qualified roofing professional.

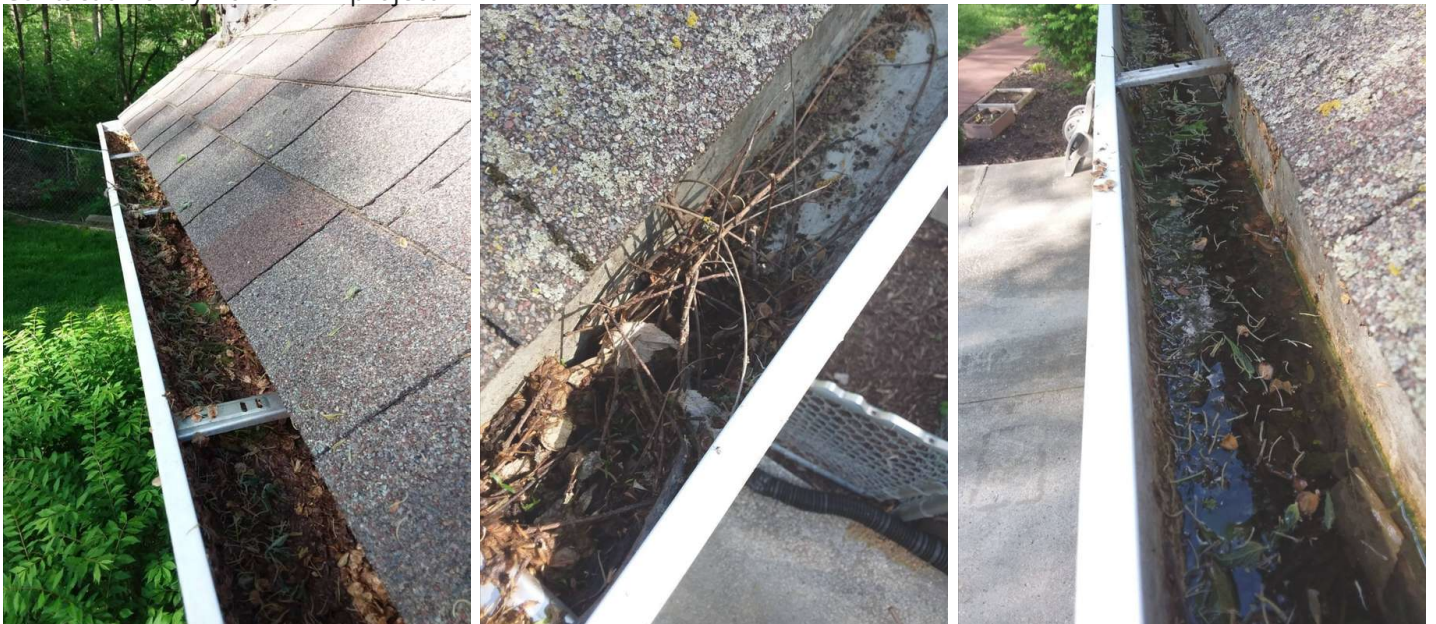
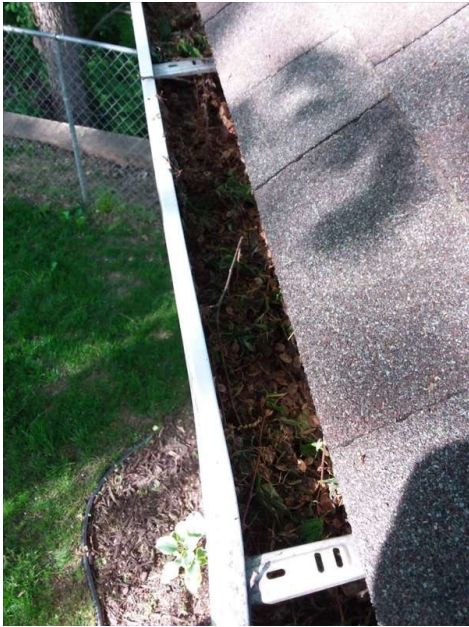
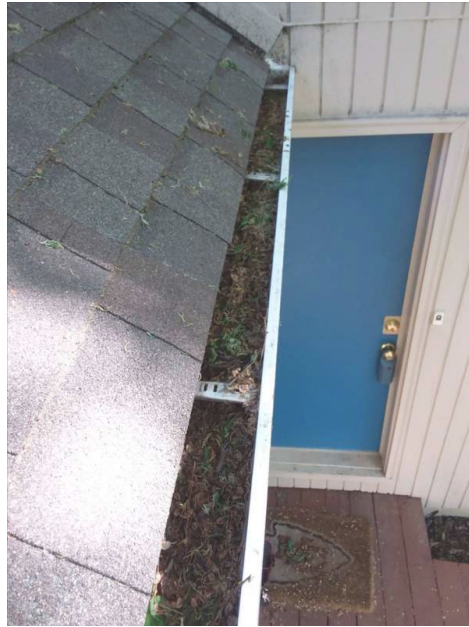
2.3.1 Roof Drainage Systems

DEBRIS

Debris has accumulated in the gutters. Recommend cleaning to facilitate water flow.

Contact a handyman or DIY project

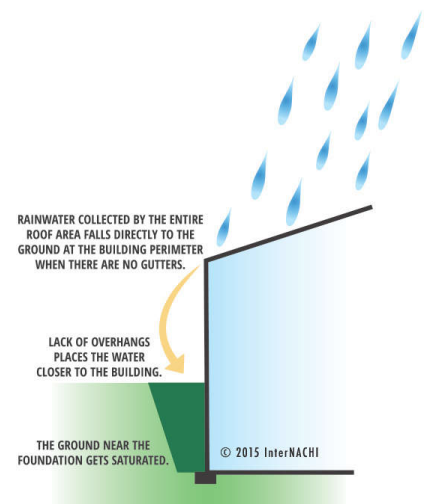
2.3.3 Roof Drainage Systems

GUTTERS MISSING

There are no gutters present on the structure. Gutters are recommended because they collect rain water from the roof and direct it away from the building.

Recommendation
Contact a qualified handyman.

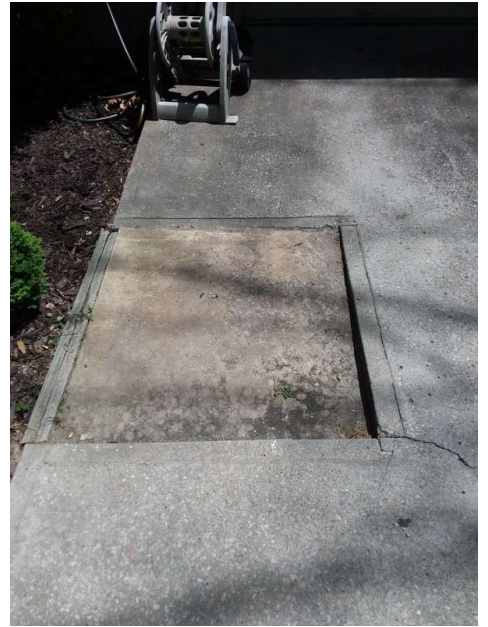
3.1.1 Driveways

CONCRETE PATCH

Drive has an area that was filled in at some point and has created a tripping hazard. Recommend leveling with the rest of the drive way to eliminate tripping hazard.

Recommendation
Contact a handyman or DIY project

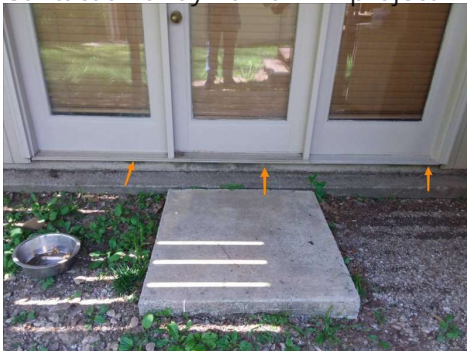
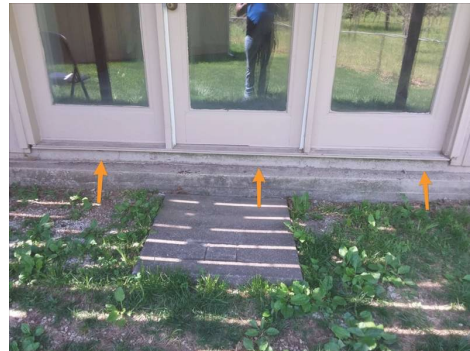
Lower level back door

3.7.2 Exterior Doors

THRESHOLD NEEDS SUPPORT

One or more exterior doors had thresholds that were not supported. This can lead to the deterioration and functionality of this part of the door. Recommend adding support to the entire threshold. This should be a DIY/Handyman issue.

Contact a handyman or DIY project

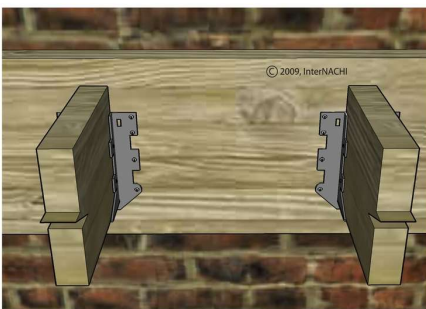
Joist Hanger/ Ledger Connections

3.9.5 Decks, Balconies, Porches & Steps

JOIST HANGERS/FASTENERS

Joist hanger(s) and or deck fasteners are missing or improperly installed. This could cause the deck structure to fail. Recommend that joist hangers be properly installed by qualified contractor.

Contact a qualified deck contractor.

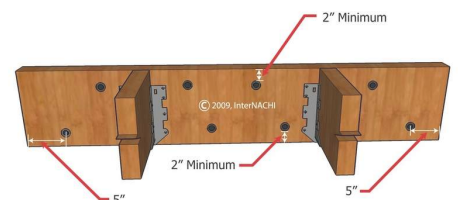
Ledger Fasteners

3.9.6 Decks, Balconies, Porches & Steps

LEDGER BOARD IMPROPERLY INSTALLED

The ledger board is not properly attached to the building. This can cause the deck to pull away from the building and possibly collapse. Recommend that the deck and/or ledger board be properly attached by qualified contractor.

Contact a qualified deck contractor.

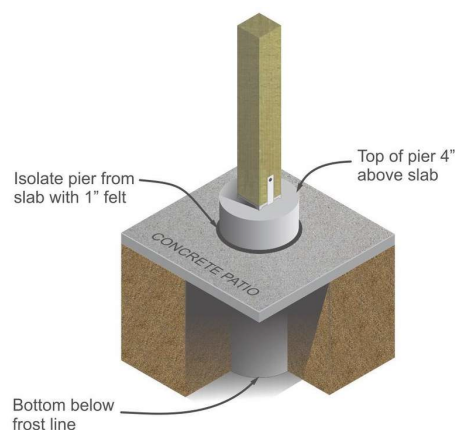
DECK POST IN CONTACT WITH GROUND AND OR CONCRETE

At the time of inspection one or more of the deck posts were in contact with the soil and or concrete. this allows water to saturate the wood posts and cause deterioration and wood rot. This condition can lead to a major structural issues and can lead to deck failure. Recommend further evaluation by qualified deck contractor.

Contact a qualified deck contractor.

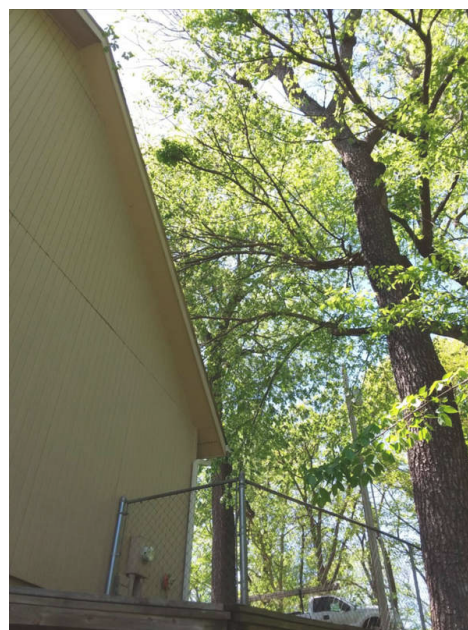
TREE OVERHANG

Trees observed overhanging the roof. This can cause damage to the roof and prevent proper drainage. Recommend a qualified tree service trim to allow for proper drainage.

Contact a qualified tree service company.

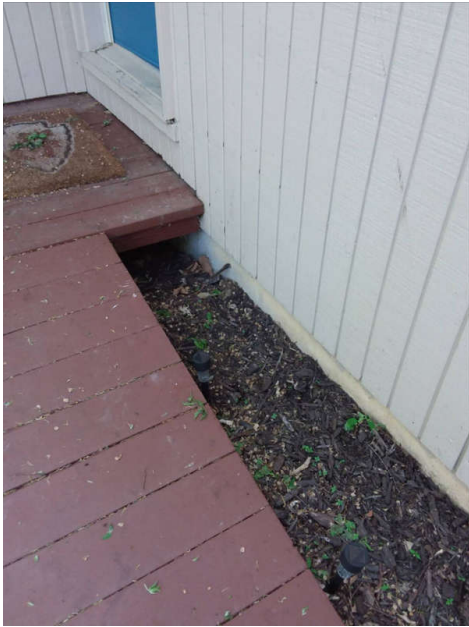
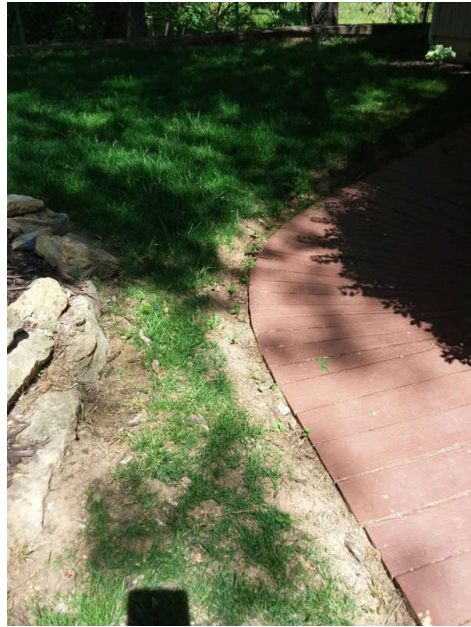
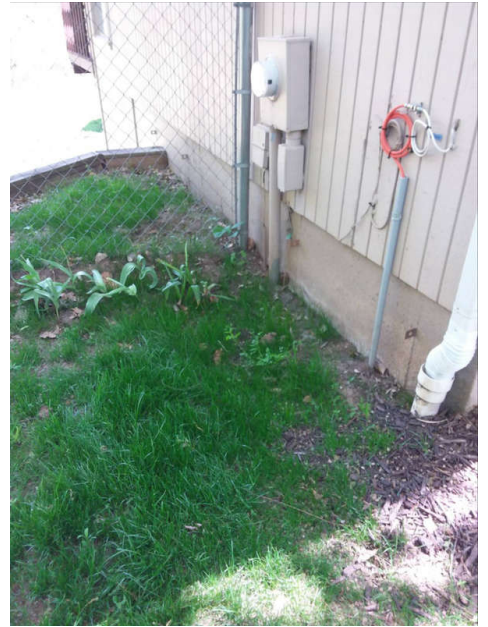
Left of front door

NEGATIVE GRADING

Grading is sloping towards the home in some areas. This could lead to water intrusion and foundation issues. Recommend qualified landscaper or foundation contractor regrade so water flows away from home.

Contact a qualified landscaping contractor

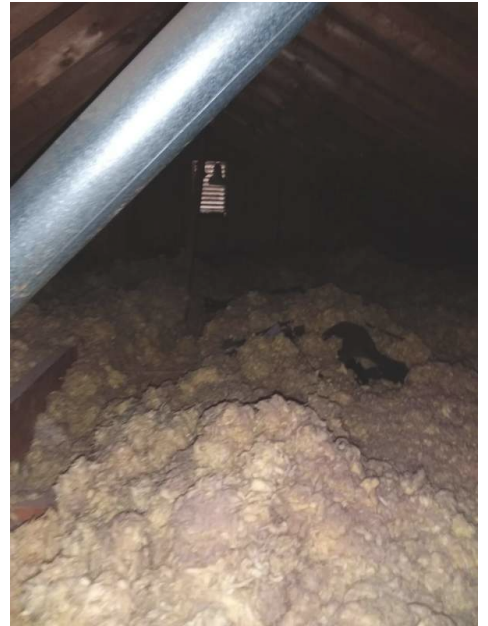
INSUFFICIENT INSULATION

Insulation depth was inadequate. To maximize savings on heating and cooling costs, insulation levels should comply with local energy codes. Recommend a qualified attic insulation contractor install additional insulation.

Contact a qualified insulation contractor.

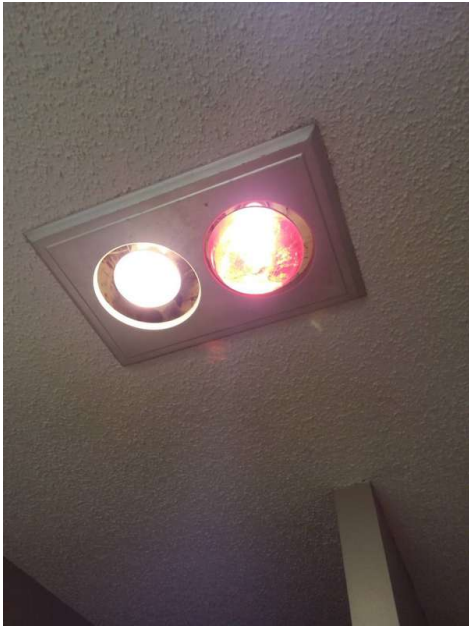
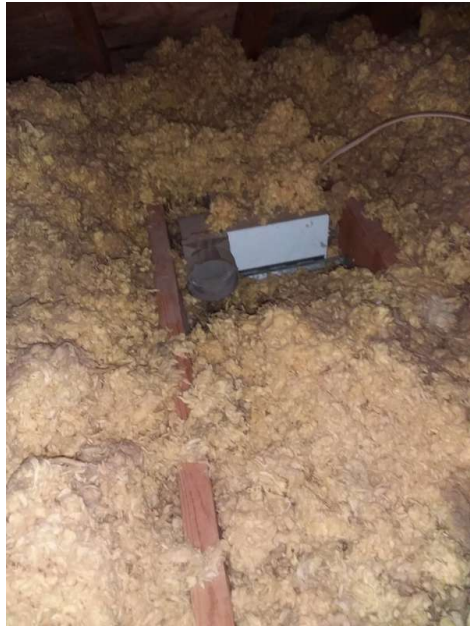
BATHROOM VENTS INTO ATTIC

Bathroom fan vents into the attic, which can cause moisture and mold. Recommend a qualified HVAC or Roofing contractor properly install exhaust fan to terminate to the exterior.

Contact a qualified HVAC professional.

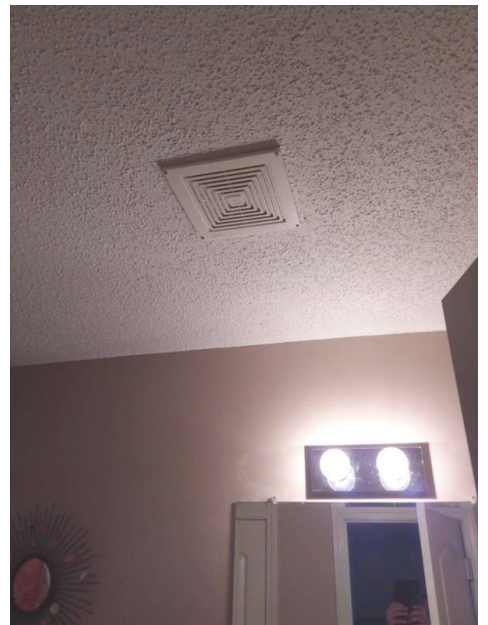
Main floor bath

APPEARS TO VENT INTO CEILING

Bathroom fan appears to vent into the ceiling, which can cause moisture and mold. Recommend a qualified HVAC or Roofing contractor property install exhaust fan to terminate to the exterior.

Contact a qualified professional.

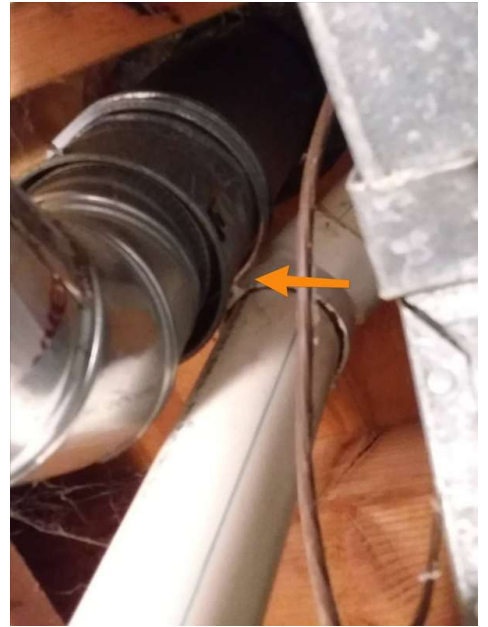
FLUE CLEARANCE

Improper clearance between combustible material and flue pipe. Type "B" vent pipes need a minimum clearance from combustible materials of at least 1 inch. Could pose potential risk of fire. Recommend evaluation by qualified HVAC contractor.

Contact a qualified HVAC professional.

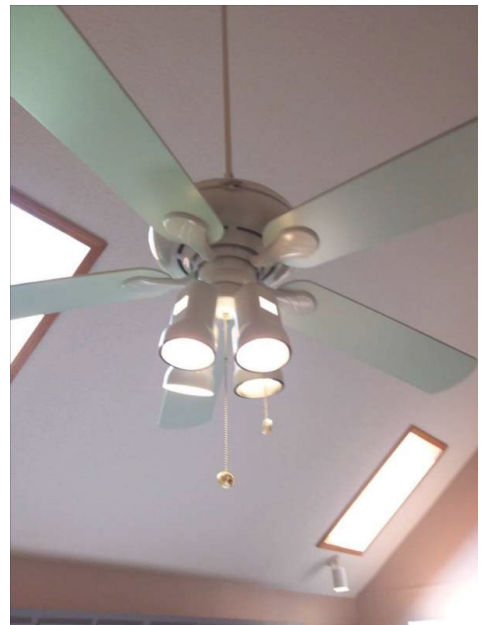
Kitchen

INOPERABLE

The Fan was inoperable at time of inspection. Recommend further evaluation by a qualified electrician.

Contact a qualified electrical contractor.

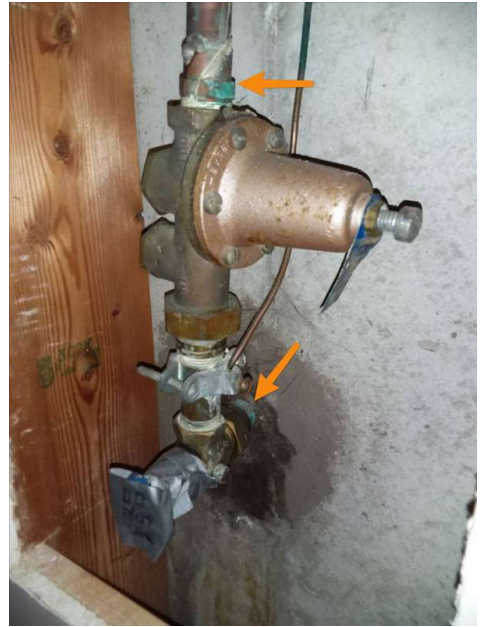
CORROSION

Water main shut-off shows signs of corrosion. Recommend a qualified plumber evaluate.

Contact a qualified plumbing contractor.

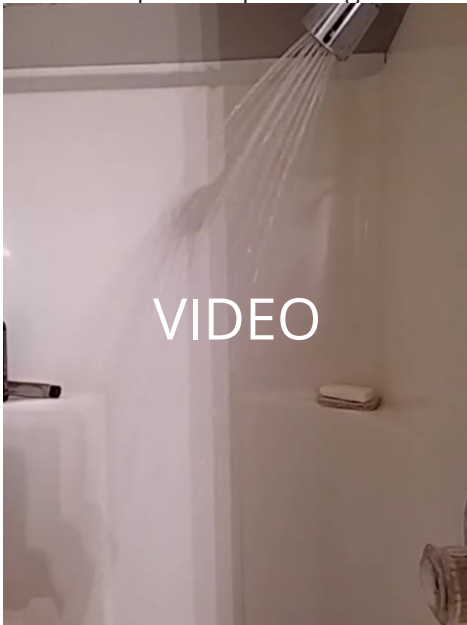
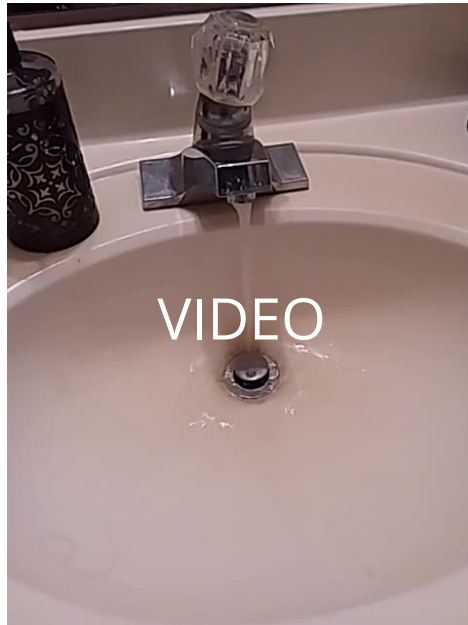
BASEMENT SHOWER

INADEQUATE FLOW

Plumbing fixture exhibited insufficient flow. The Inspector recommends that before the expiration of your Inspection Objection Deadline you consult with a qualified contractor to discuss options and costs for correction.

Contact a qualified plumbing contractor.

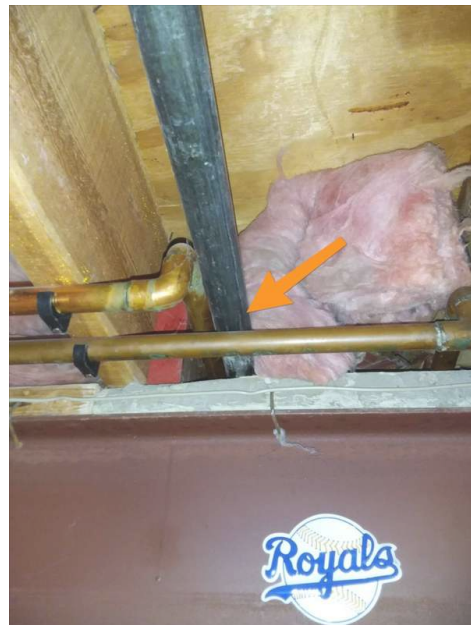
Above furnace room Basement

DISSIMILAR METALS IN CONTACT

Metal water distribution pipes in contact with each other were made of different types of metal. Dissimilar metals in contact with each other in the presence of sufficient moisture can cause metal to deteriorate due to galvanic corrosion. The Inspector recommends installation of dielectric unions wherever necessary by a qualified plumbing contractor.

Contact a qualified plumbing contractor.

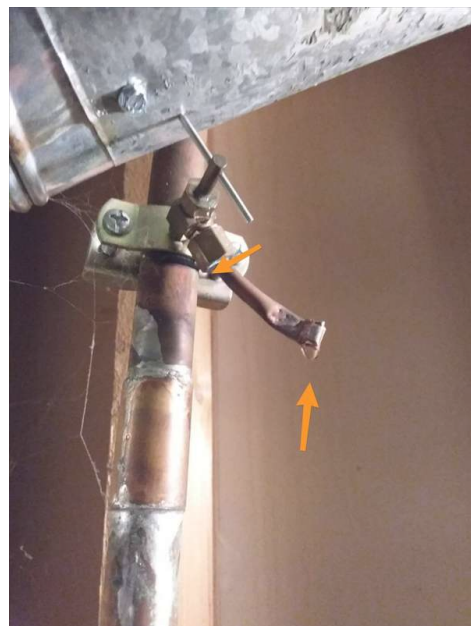
Above water heater

ACTIVE LEAK

At the time of the inspection one or more areas of the plumbing supply pipes was actively leaking. Recommend further evaluation by qualified plumbing contractor.

Contact a qualified plumbing contractor.

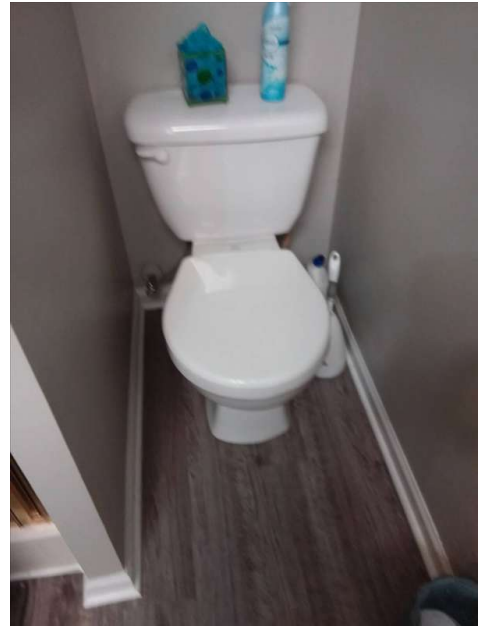
THIRD FLOOR

LOOSE TOILET

At the time of inspection one or more toilets were physically loose. This can lead to significant leaks and water damage if not addressed. Recommend further evaluations by qualified plumbing contractor.

Contact a qualified plumbing contractor.

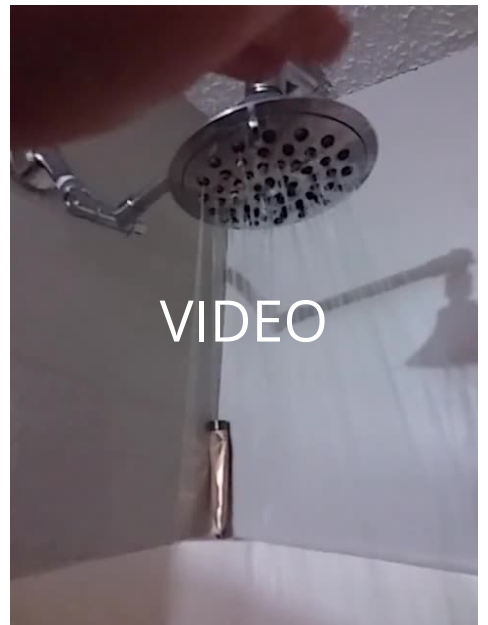
THIRD FLOOR BATH

SHOWER HEAD LEAKS WHEN MANIPULATED

At the time of inspection one or more shower heads leaked when adjusted. Recommend replacement to avoid possible water damage. This should be a handyman/DIY issue

Contact a handyman or DIY project

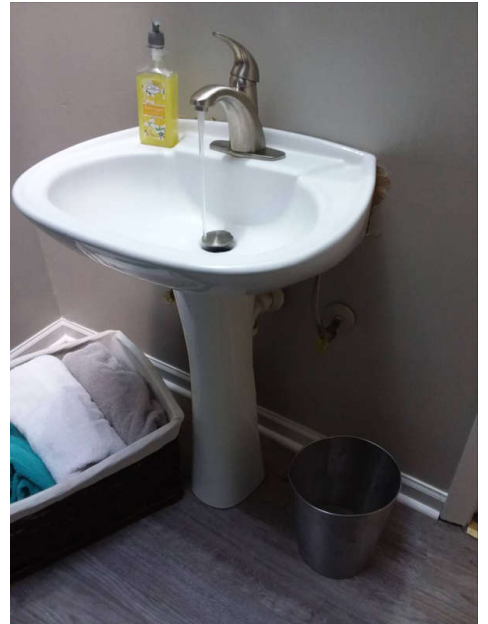
Third floor bath

LOOSE SINK

At time of inspection one or more of the bathroom sinks were loose. Recommend attachment to avoid damage and leaks.

Contact a handyman or DIY project

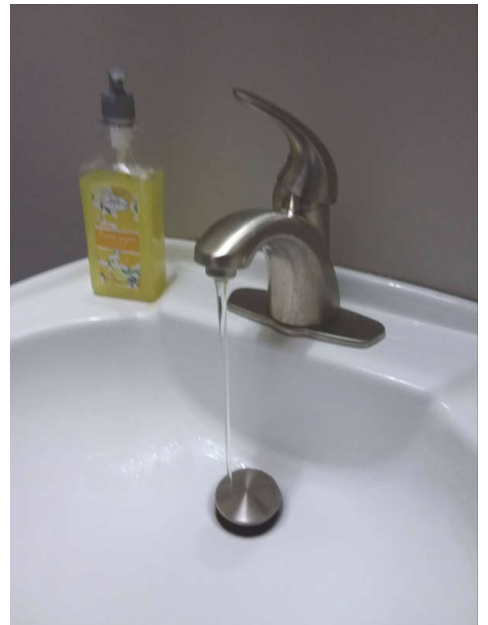
Third floor bath

LOW HOT WATER FLOW

At the time of inspection the hot water flow at one or more of the bathroom sinks appeared to be weak. Recommend further evaluation by qualified plumbing contractor.

Contact a qualified plumbing contractor.

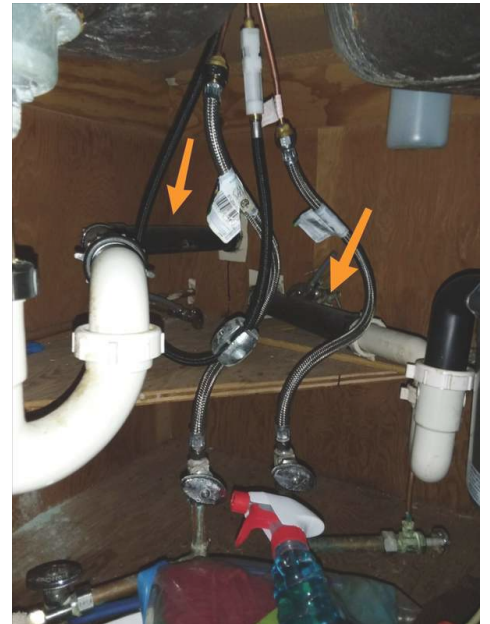
Kitchen

IMPROPER SLOPE

Waste pipes were improperly sloped. This condition may result in improper drainage, pipe blockage or damage. The Inspector recommends correction by a qualified plumbing contractor.

Contact a qualified plumbing contractor.

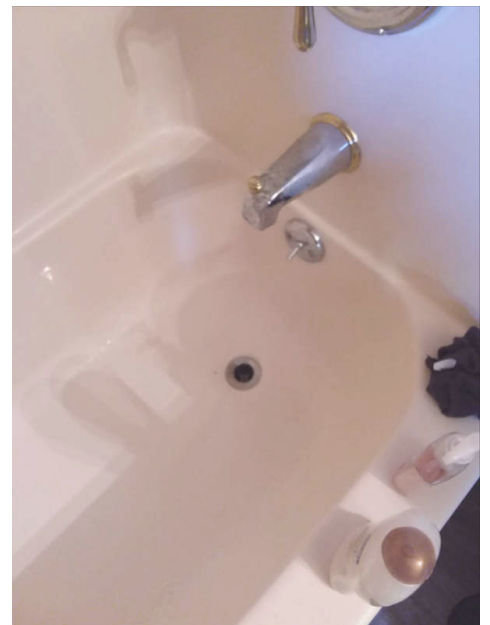
Main floor bath

MISSING TUB STOPPER

Contact a qualified professional.

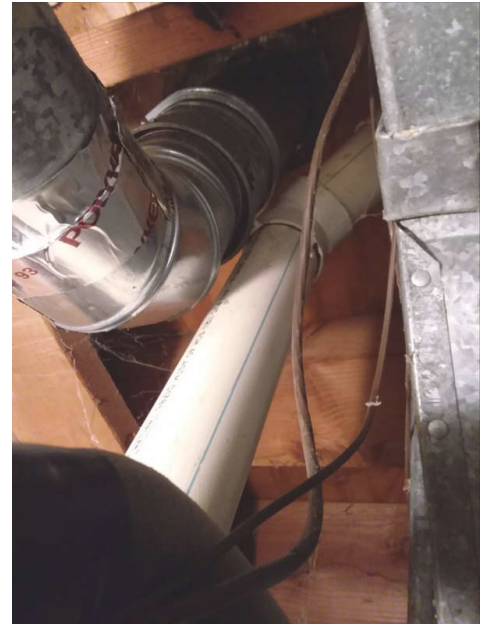
FLUE- INADEQUATE CLEARANCE FROM COMBUSTIBLES

The exhaust flue for this gas-fired water heater had inadequate clearance from combustibles. This type of exhaust flue requires 1-inch clearance from combustible materials. This condition is a potential fire hazard and should be corrected by a qualified contractor.

Contact a qualified plumbing contractor.

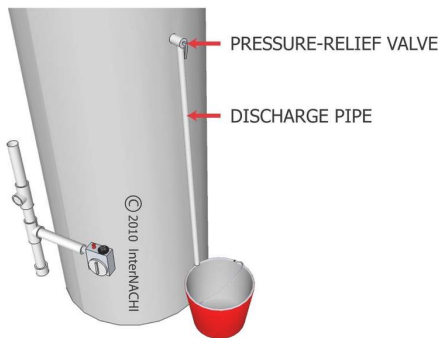
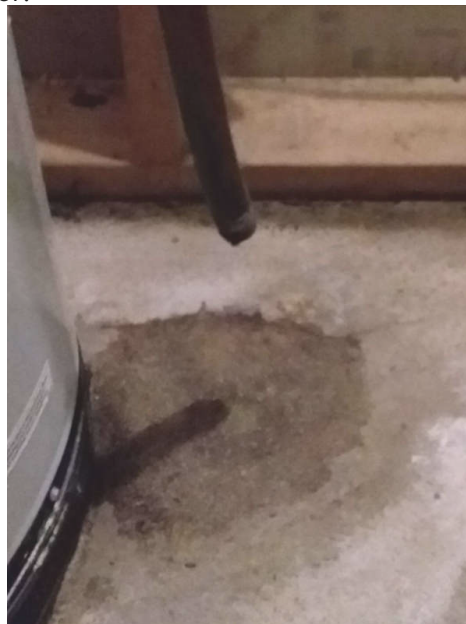
DISCHARGE PIPE ON TPR VALVE

TPR VALVE LEAKING

Temperature/pressure-relief or TPR valves are safety devices installed on water heating appliances, such as boilers and domestic water supply heaters. TPRs are designed to automatically release water in the event that pressure or temperature in the water tank exceeds safe levels. A leaky TPR valve is an indication that it needs to be replaced. Faulty TPR valves have the potential to become a safety hazard. Recommend repair/replacement by qualified Plumbing contractor.

Contact a qualified plumbing contractor.

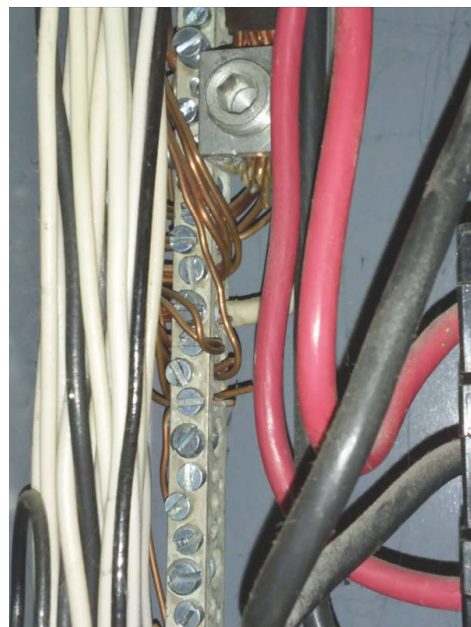
DOUBLE TAPS

Double-Tapping is when there are two or more conductors terminating under one screw/lug that was only meant for one conductor. This can lead to arcing and overheating of the conductors. Recommend evaluation by qualified electrician.

Contact a qualified electrical contractor.

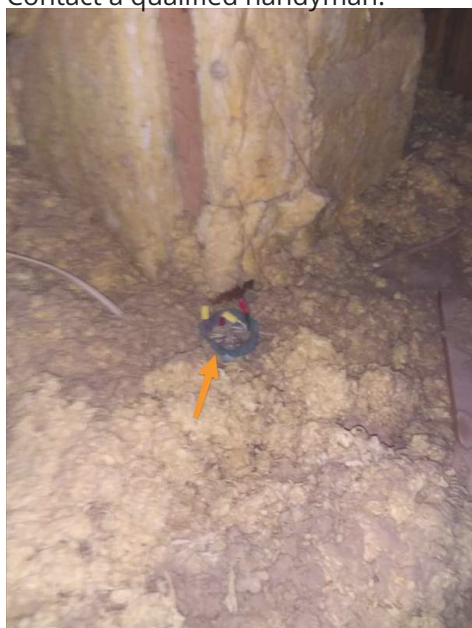
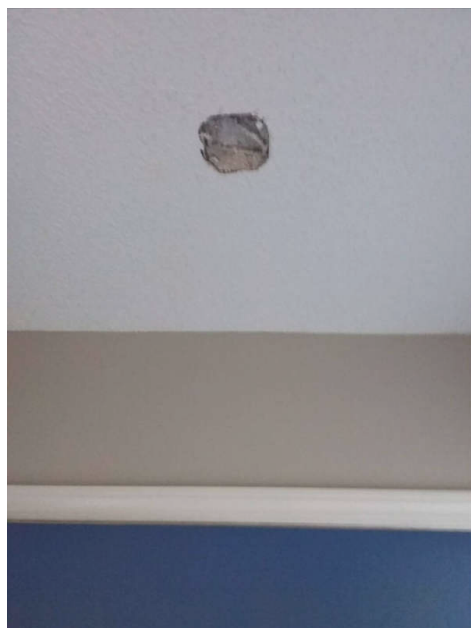
Attic

OPEN JUNCTION BOX

At the time of inspection, one or more electrical junction box covers were missing. This poses a risk of electrical shock and potential fire hazard. Recommend boxes be permanently covered. This should be a handyman issue, if not recommend repair be made by qualified electrician.

Contact a qualified handyman.

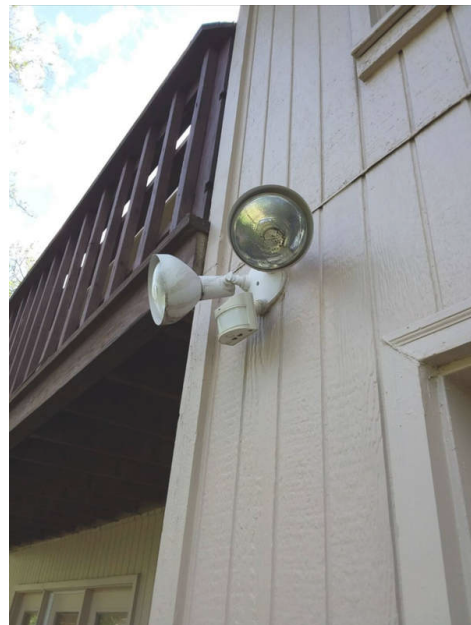
LIGHT INOPERABLE

Light fixture did not respond to the switch. The bulb may need to be replaced or there may be a problem with the switch, wiring or light fixture. *If bulb replacement does not correct the issue*, this condition may represent a potential fire hazard and the Inspector recommends that an evaluation and any necessary repairs be performed by a qualified electrical contractor.

Contact a handyman or DIY project

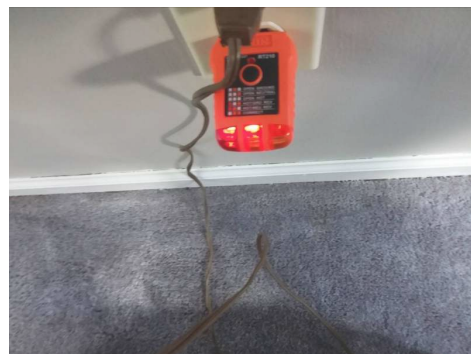
Main living room

HOT-NEUTRAL REVERSED RECEPTACLE

An electrical receptacle had hot and neutral wires reversed. This condition should be corrected by a qualified electrical contractor

Contact a qualified electrical contractor.

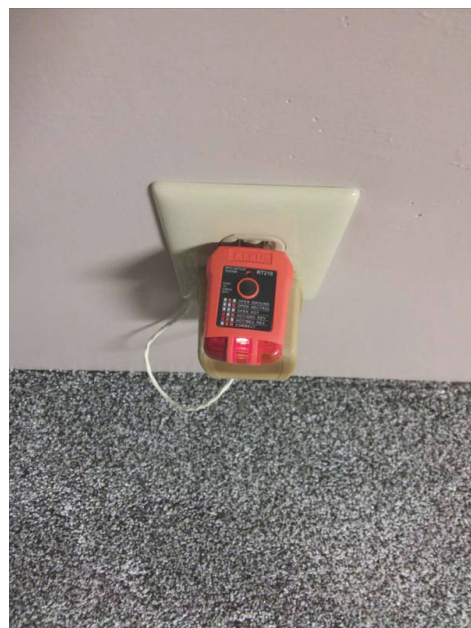
Basement office

OPEN GROUND RECEPTACLE(S)

An electrical receptacle had an open ground. Other receptacles in the home were grounded. This receptacle should have a functional equipment grounding conductor installed by qualified electrical contractor.

Contact a qualified electrical contractor.

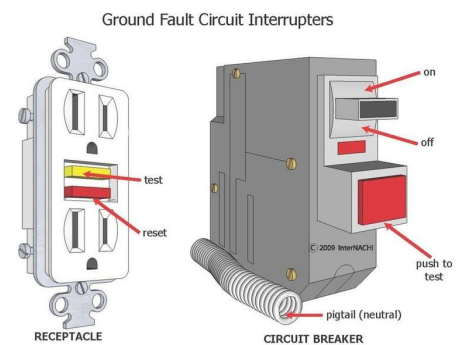
NO GFCI PROTECTION INSTALLED

No ground fault circuit interrupter (GFCI) protection of home electrical receptacles was provided in the home at the time of inspection. Although GFCI protection may not have been required at the time the home was built, for safety reasons, the Inspector recommends that electrical receptacles located in basements, crawlspaces, garages, the home exterior, and interior receptacles located within 6 feet of a plumbing fixture be provided with ground fault circuit interrupter (GFCI) protection in good working order to avoid potential electric shock or electrocution hazards. This can be achieved relatively inexpensively by:

1. Replacing an individual standard receptacle with a GFCI receptacle.
2. Replacing the electrical circuit receptacle located closest to the overcurrent protection device (usually a breaker) with a GFCI receptacle.
3. Replacing the breaker currently protecting the electrical circuit that contains the receptacles of concern with a GFCI breaker.

Contact a qualified electrical contractor.

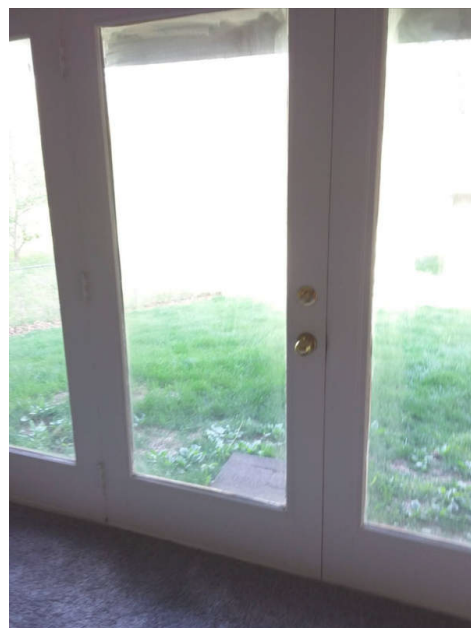
Basement

DOOR STICKS

Door sticks and is tough to open. Recommend sanding down offending sides.

Recommendation
Contact a qualified handyman.

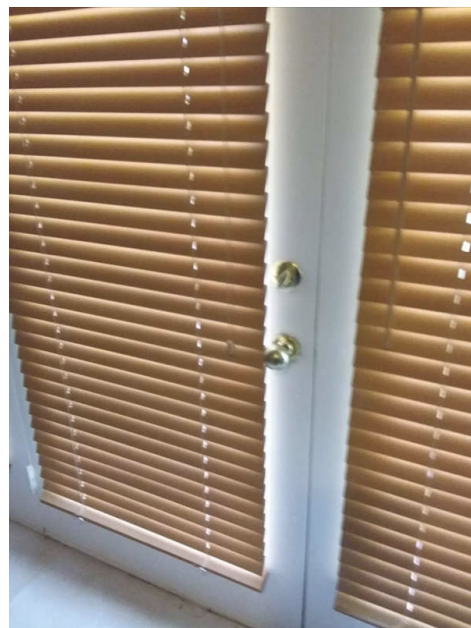
Basement bedroom

DOOR HARDWARE- MINOR DAMAGE/DETERIORATION

Door hardware in the home exhibited general minor damage or deterioration.

Recommendation
Recommend monitoring.

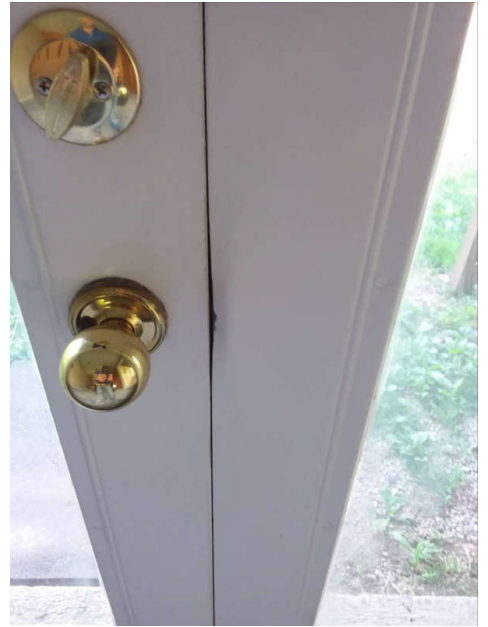
Basement

LIGHT DAMAGE/DETERIORATION

Doors exhibited general light damage or deterioration.

Recommendation
Recommend monitoring.

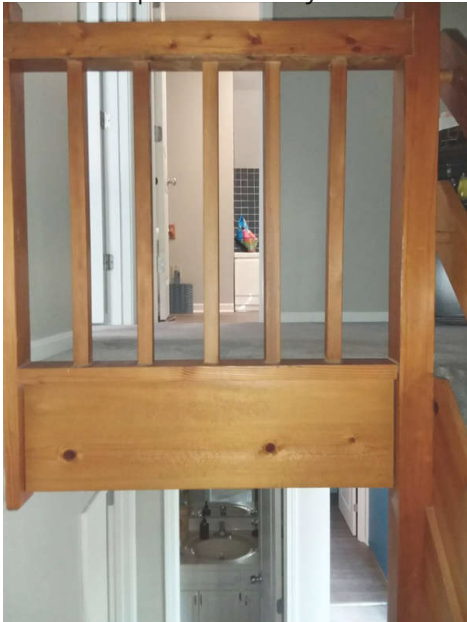
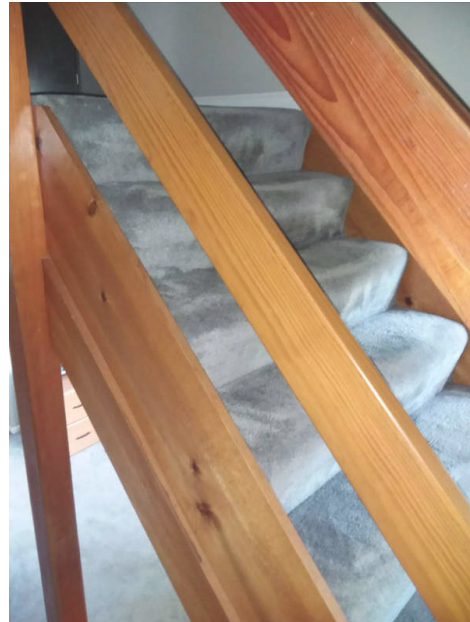
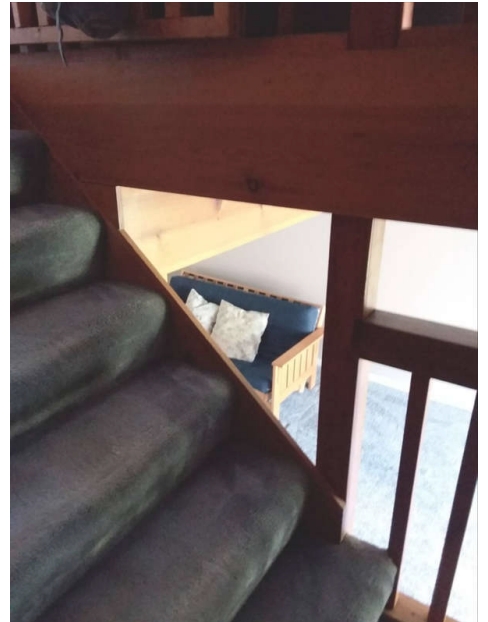
BALUSTER SPACES TOO WIDE

The baluster space is not up to modern safety standards. The space between balusters should not allow passage of a 4 3/8-inch sphere for child safety. Recommend a qualified handyman or original installer repair and bring up to code.

Recommendation
Contact a qualified handyman.

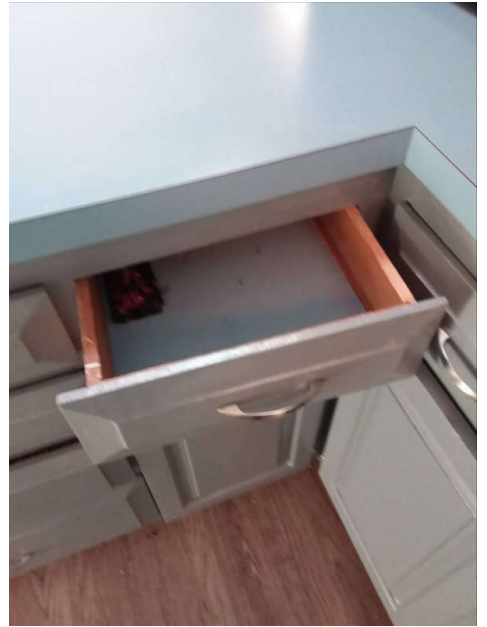
DRAWER- BROKEN SLIDE

Cabinet drawer(s) had broken glides. Potential Handyman or DIY project.

Recommendation
Contact a handyman or DIY project

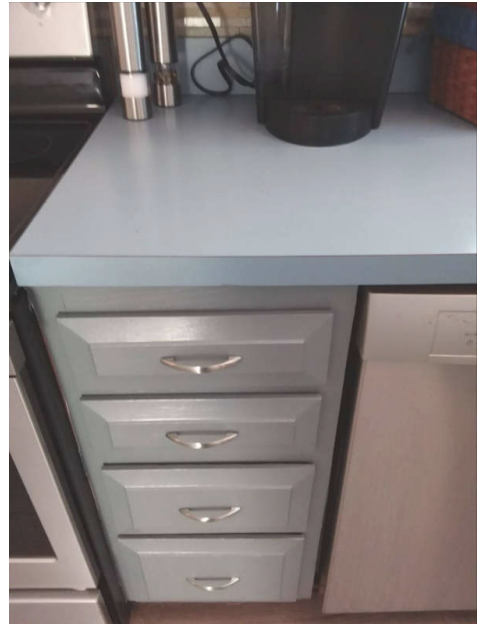
10.9.2 Countertops & Cabinets
COUNTERTOP NOT SECURED

Kitchen countertop appeared insecure. Recommend qualified countertop contractor evaluate and secure countertop properly.

Recommendation
Contact a qualified countertop contractor.

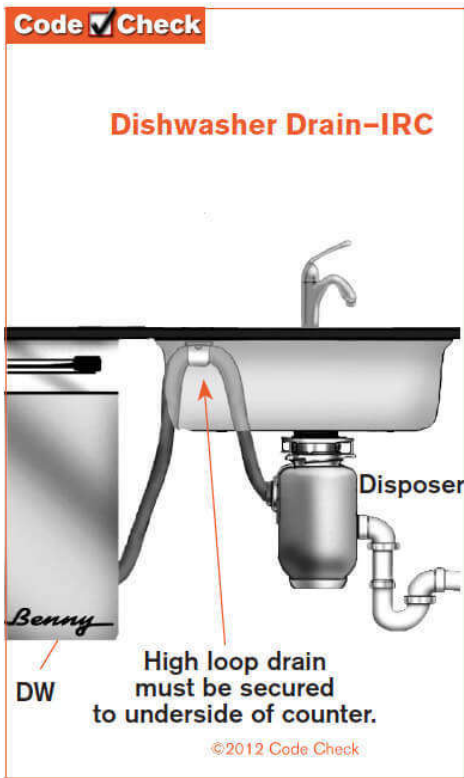
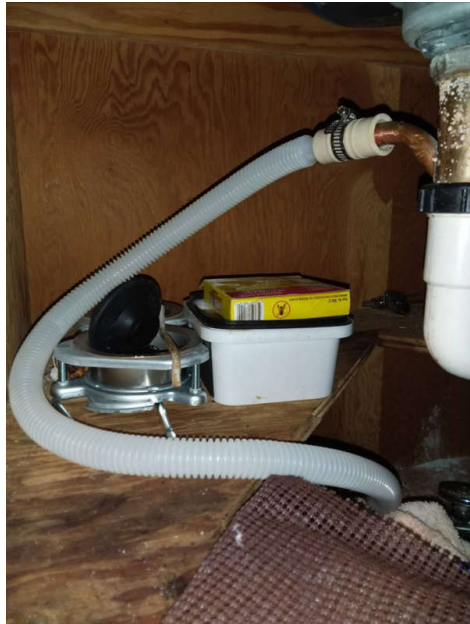
11.1.1 Dishwasher
NO HIGH LOOP

The dishwasher drain line was not installed with a "**high loop**". The drain hose must have the **high loop** from the floor to prevent back-flow of water into the **dishwasher** or water siphoning out during operation. The Inspector recommends drain line to be installed in this manner.

Recommendation
Contact a handyman or DIY project

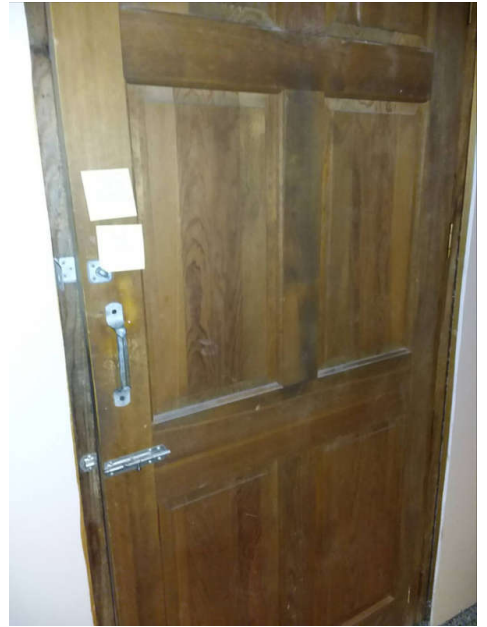
Basement

DOOR DOES NOT MEET SEPARATION REQUIREMENTS

Door separating garage and home does not meet safety standards. Doors in firewalls must be at least 1 3/8-inch thick, metal/steel, or a 20-minute fire-rated door.

Contact a qualified door repair/installation contractor.

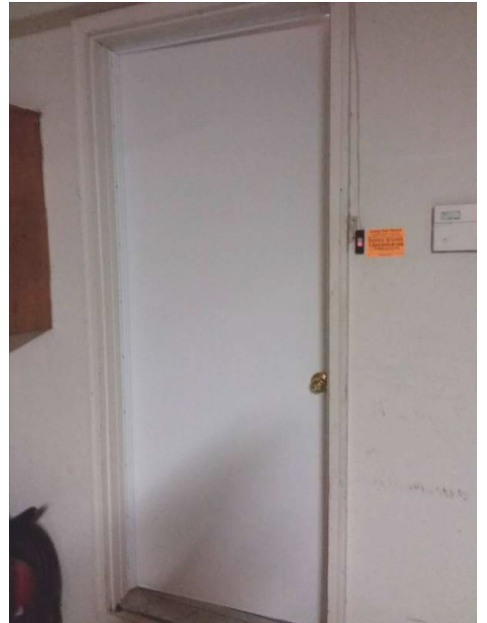
Man level garage

NOT SELF-CLOSING

Door from garage to home should have self-closing hinges to help prevent spread of a fire to living space. Recommend a qualified contractor install self-closing hinges.

Contact a qualified door repair/installation contractor.
