SUMMARY
1234 Main St. Mountain Grove MO
65711
Buyer Name
03/01/2019 9:00AM

Erek Boatright
Certification no. 18238
Boatright Home Inspections, LLC
4172596733
boatrighthomeinspections@gmail.com

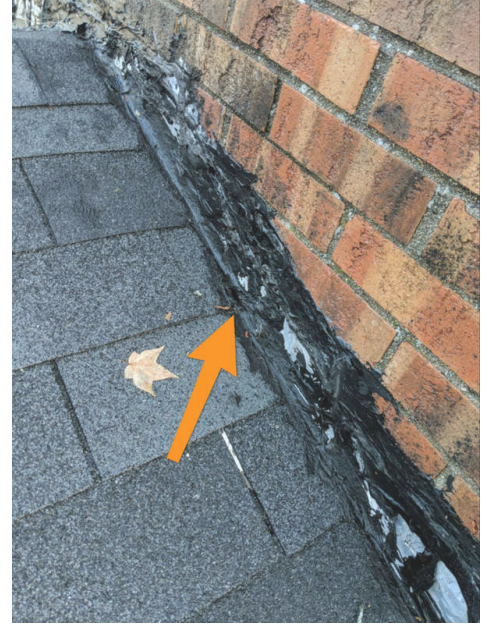
2.3.1 Flashings

WORN

Flashings showed signs of wear and tear. This is normal for a roof of this age. Recommend monitoring.

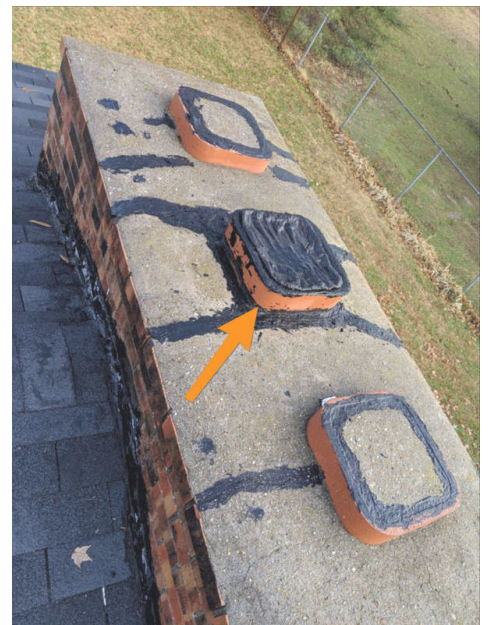
2.4.1 Skylights, Chimneys & Roof Penetrations

CHIMNEY COVERED UP

Chimney appeared to be covered up and no longer in use. Recommend being checked it by a qualified chimney contractor.

Recommendation
Contact a qualified professional.

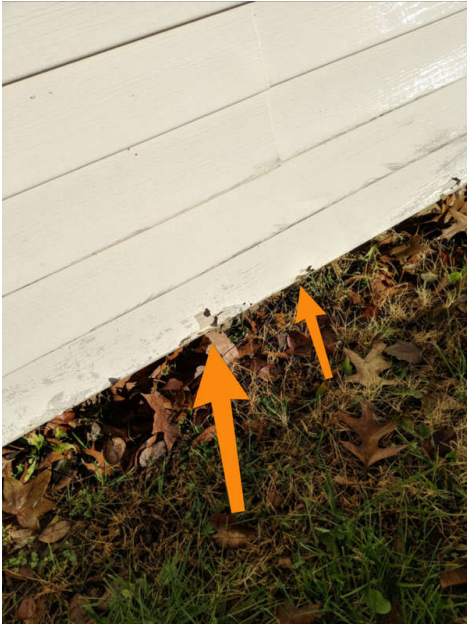
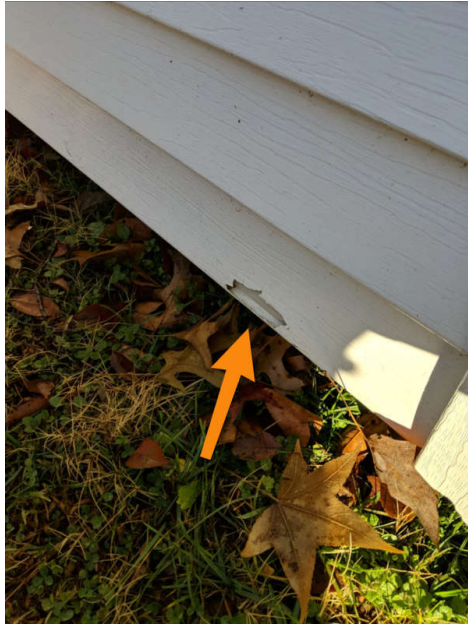
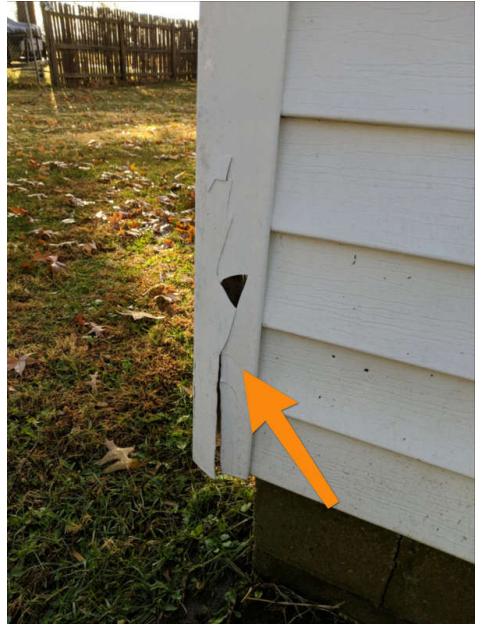
3.1.1 Siding, Flashing & Trim

VINYL SIDING BROKEN

Vinyl siding has broken sections. Recommend further evaluation by a qualified contractor

Recommendation
Contact a qualified professional.

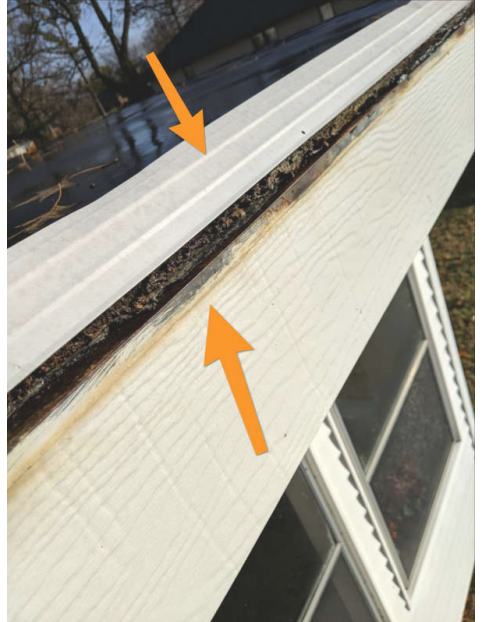
3.4.1 Eaves, Soffits & Fascia

FASCIA - DAMAGED

One or more sections of the fascia are damaged. Recommend qualified roofer evaluate & repair.

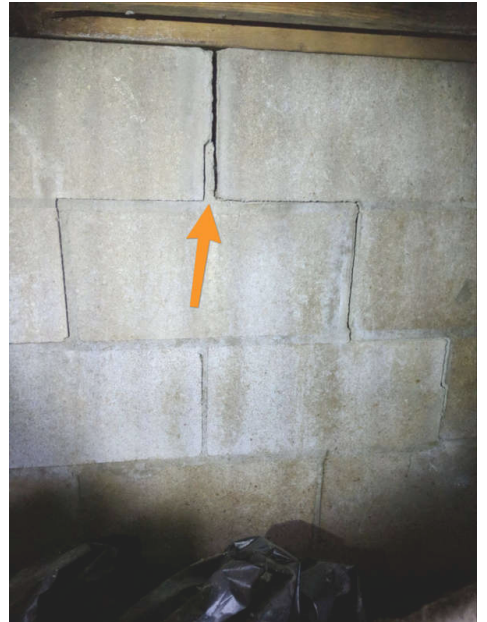
4.1.1 Foundation, Basement & Crawlspace

FOUNDATION CRACKS - MINOR

Minor cracking was noted at the foundation. This is common as concrete ages and shrinkage surface cracks are normal. Recommend monitoring for more serious shifting/displacement.

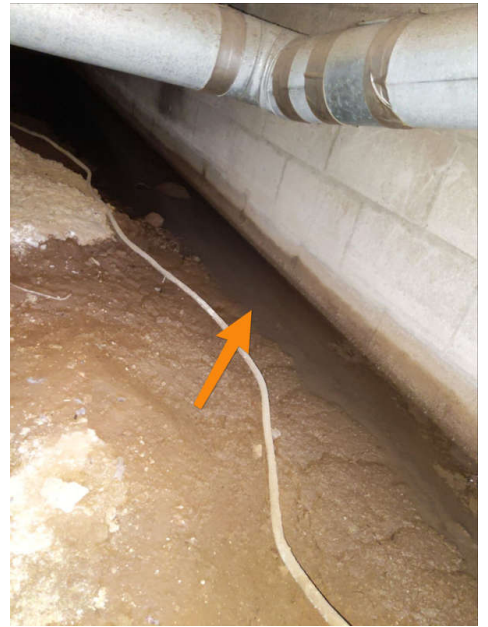
4.1.2 Foundation, Basement & Crawlspace

HIGH MOISTURE LEVELS

High levels of moisture were noted in areas of the crawlspace. Recommend monitoring and finding source of moisture intrusion to prevent damage to structure.

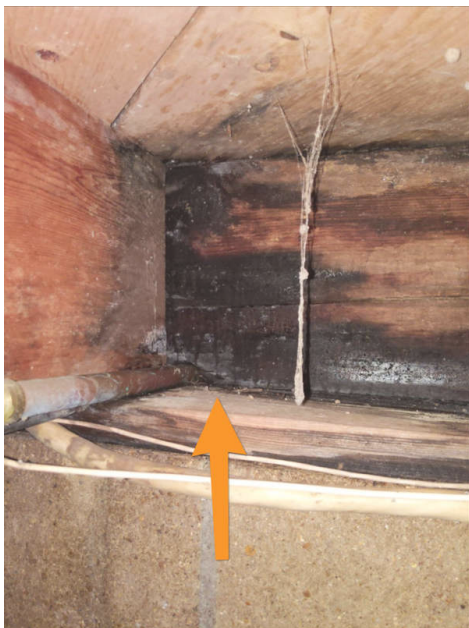
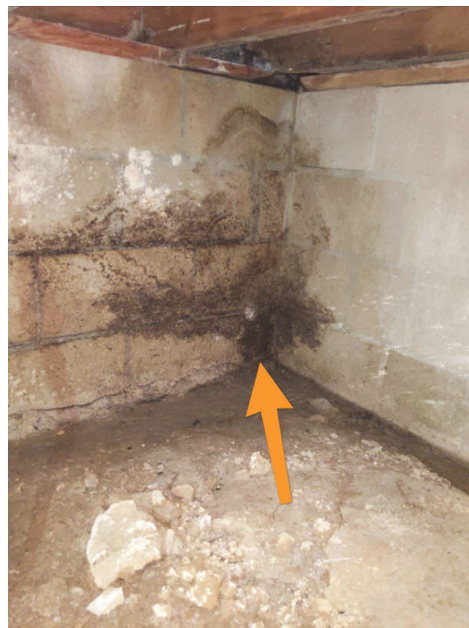
4.1.3 Foundation, Basement & Crawlspace

DISCOLORATION

Discoloration was observed in crawlspace. Had the possibility of being mold. Recommend further evaluation by a mold remediation professional

Recommendation

Contact a qualified professional.

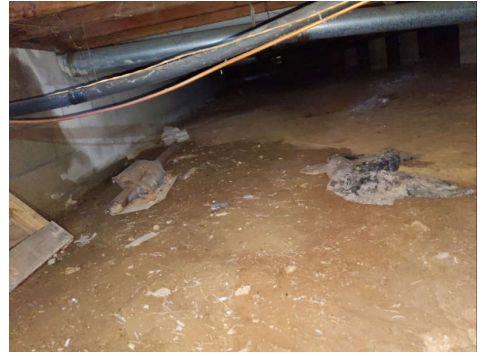
5.2.1 Vapor Retarders

NO VAPOR BARRIER

There is no vapor barrier beneath the flooring. This can result in unwanted moisture.

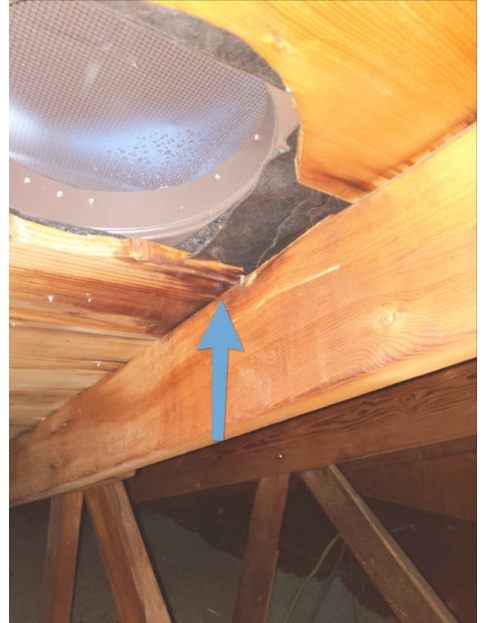
5.3.1 Ventilation

ROOF VENT LEAKING

Leaking around roof vent above garage area. Recommend further evaluation and repair by qualified roofer.

Recommendation

Contact a qualified professional.

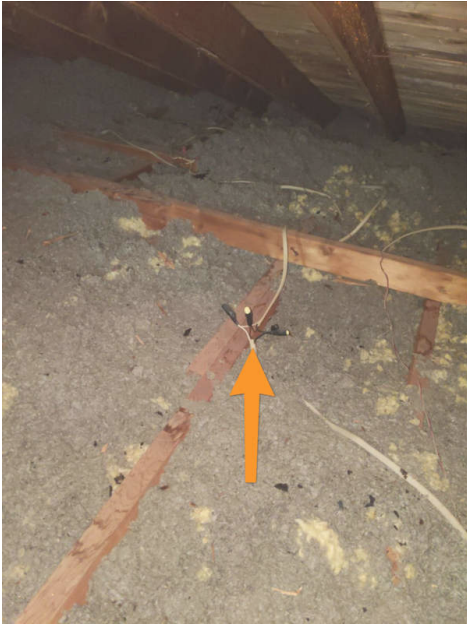
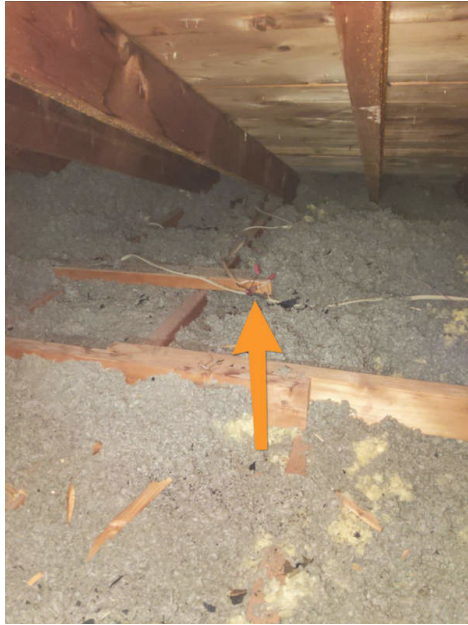
6.3.1 Branch Circuit Conductors, Overcurrent Devices and Compatibility of Their Amperage & Voltage

EXPOSED ENDS & SPLICES

ATTIC, KITCHEN

All wire connections & charged wires with exposed ends and splices should be covered in junction boxes for safety. Recommend a qualified electrician correct.

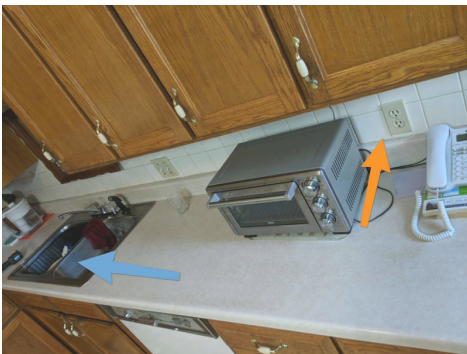
6.6.1 GFCI & AFCI

NO GFCI PROTECTION INSTALLED

No GFCI protection present in one or more locations. Recommend licensed electrician upgrade by installing ground fault receptacles in all locations.

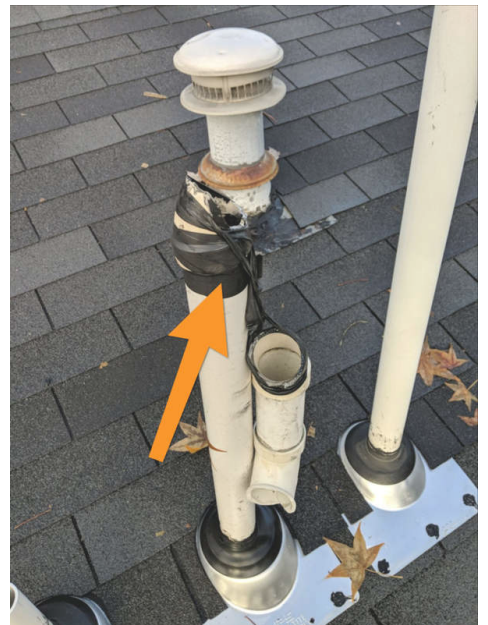
8.3.1 Vents, Flues & Chimneys

FURNACE FLUE BROKEN

Furnace fresh air intake pipe broken at elbow. Recommend replacing by qualified HVAC technician.

Recommendation

Contact a qualified professional.

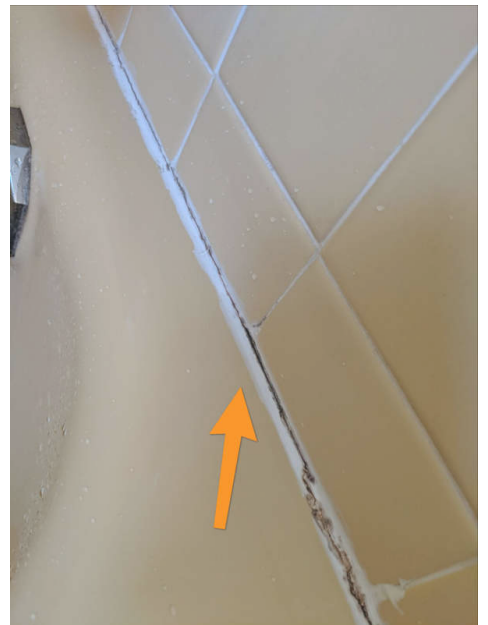
9.1.2 Fixtures / Faucets

CAULK FAILING

Caulking around tubing failing. Recommend repair by a qualified handy man.

Recommendation

Contact a qualified professional.

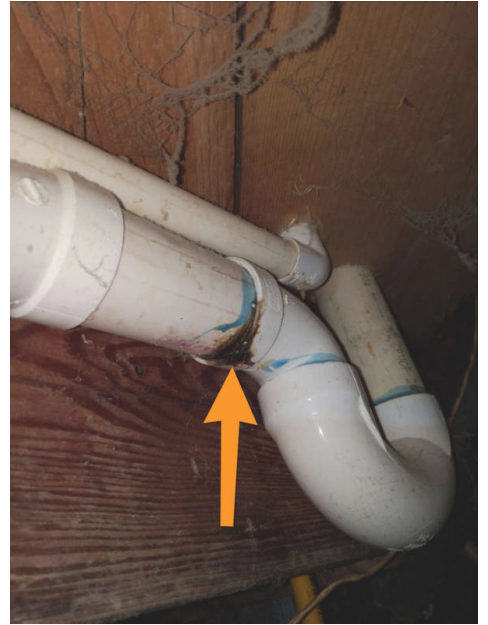
9.2.2 Drain, Waste, & Vent Systems

DRAIN LEAKING

Observed drain for washing machine leaking. Recommend repair by a qualified plumber.

Recommendation
Contact a qualified professional.

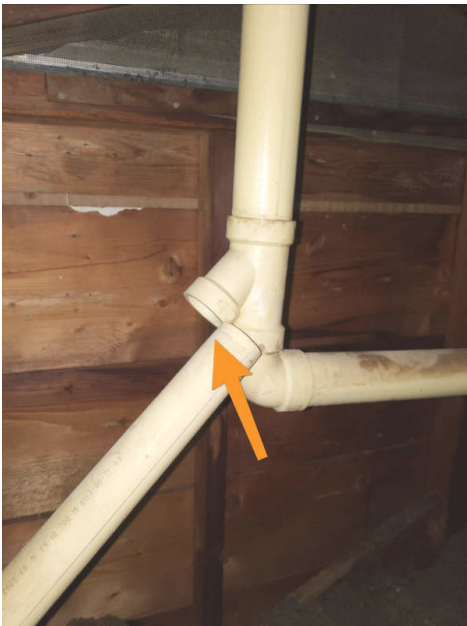
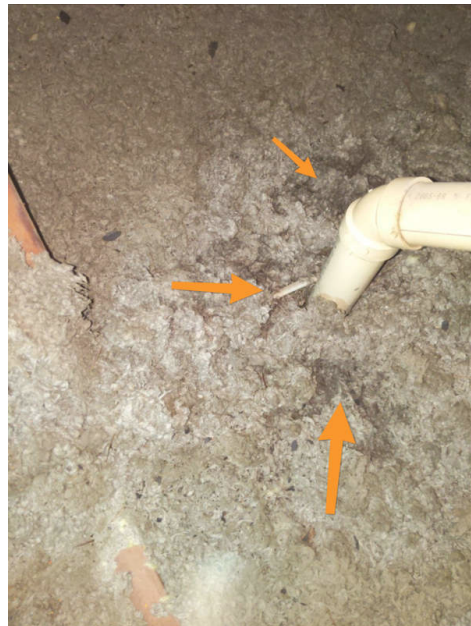
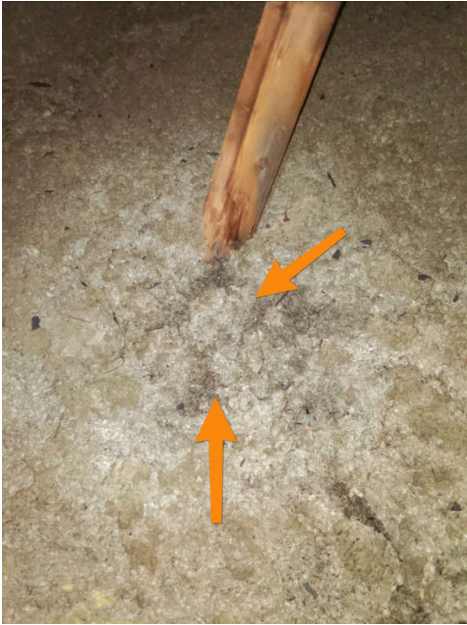
9.2.3 Drain, Waste, & Vent Systems
VENT LINE DISCONNECTED

Vent line in Attic was disconnected. Visible signs of water around insulation in that area. Recommend repair by a qualified plumber and water intrusion be further evaluated by a qualified roofer.

Recommendation
Contact a qualified professional.

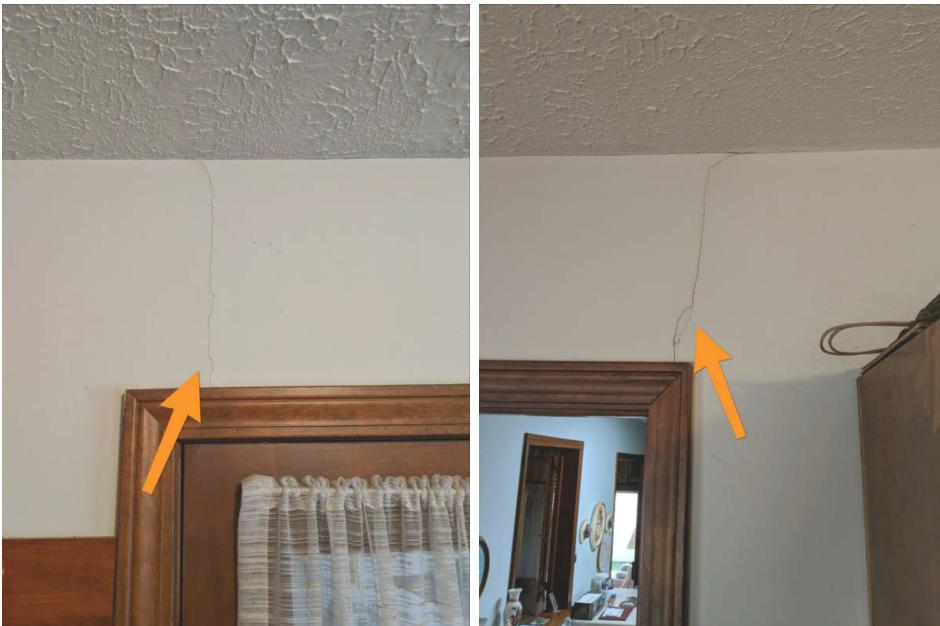
10.1.1 Walls

MINOR CORNER CRACKS

Minor cracks at the corners of doors and windows in walls. Appeared to be the result of long-term settling. Some settling is not unusual in a home of this age and these cracks are not a structural concern.

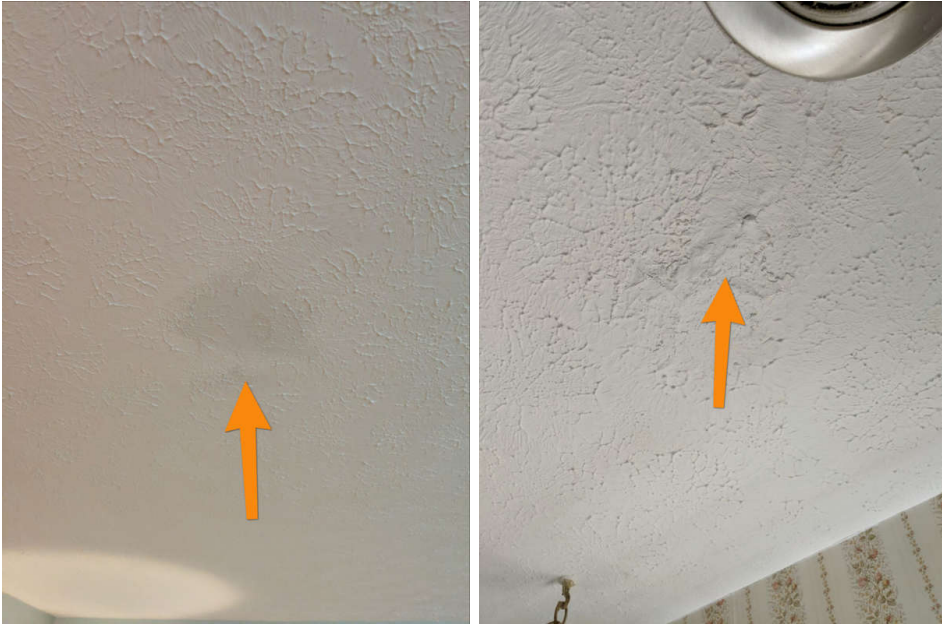
10.2.1 Ceilings

WATER PRESENT

Ceiling had signs of water spots in one or more areas. Recommend further evaluation by a qualified contractor.

Recommendation
Contact a qualified professional.

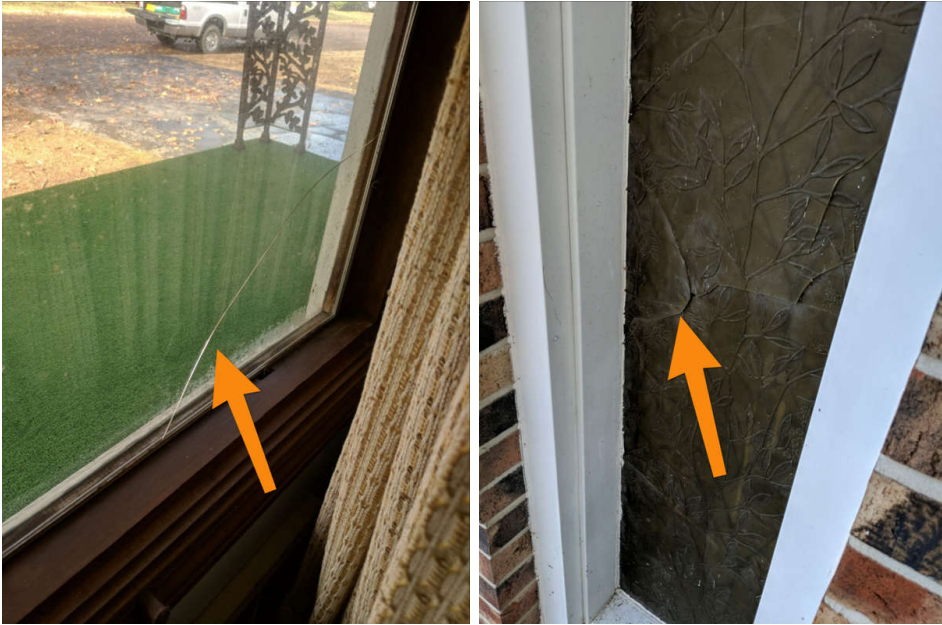
10.7.1 Windows

BROKEN GLASS

LIVING ROOM, GARAGE

One or more Windows had broken glass. Recommend repair by a qualified window contractor.

Recommendation

Contact a qualified professional.

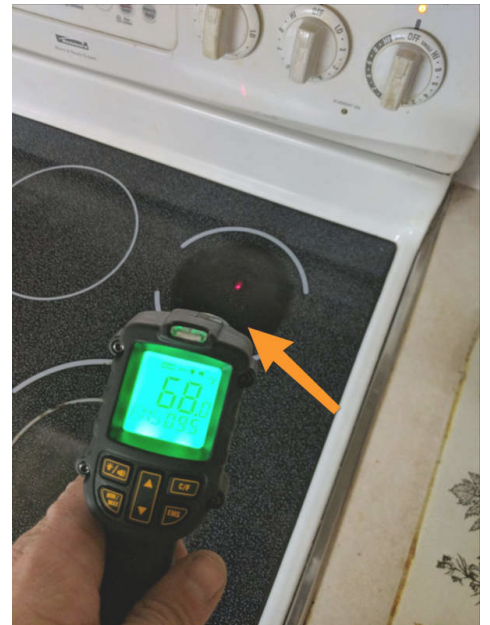
11.3.1 Range/Oven/Cooktop

PARTIALLY INOPERABLE

Range cooktop has one burner not working at time of inspection. Recommend checking with owner and confirming.

Recommendation

Contact a qualified professional.

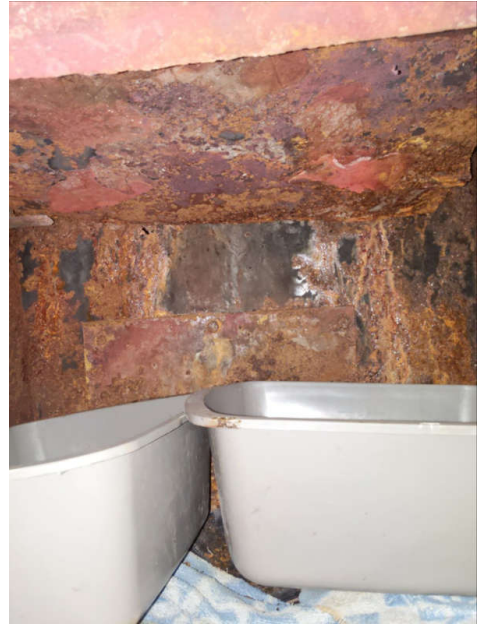
12.1.1 Fireplaces, Stoves & Inserts

RUSTY FIRE BOX

Firebox had a lot of rust buildup and signs of age. Recommend further evaluation by a chimney and fireplace contractor before use.

Recommendation

Contact a qualified professional.
