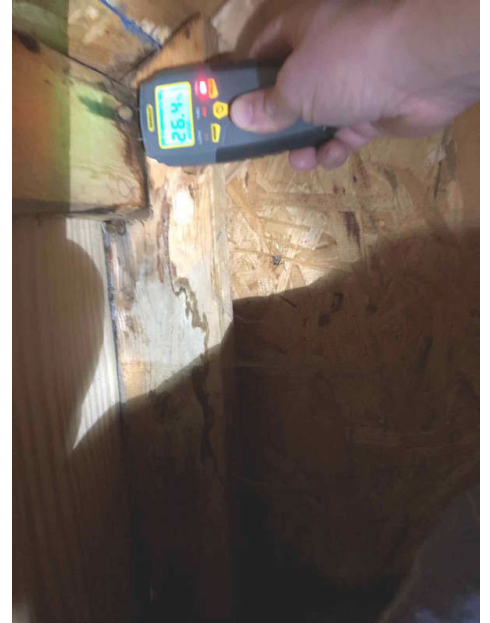
East Garage Attic-near access

WATER STAINING

Water staining on the roof decking. This could be due to a flashing deficiency above this area. Recommend qualified roofing professional for evaluation and repair.

Recommendation
Contact a qualified roofing professional.

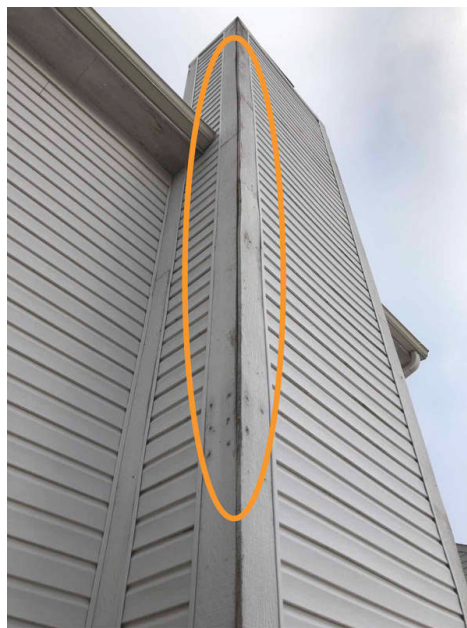
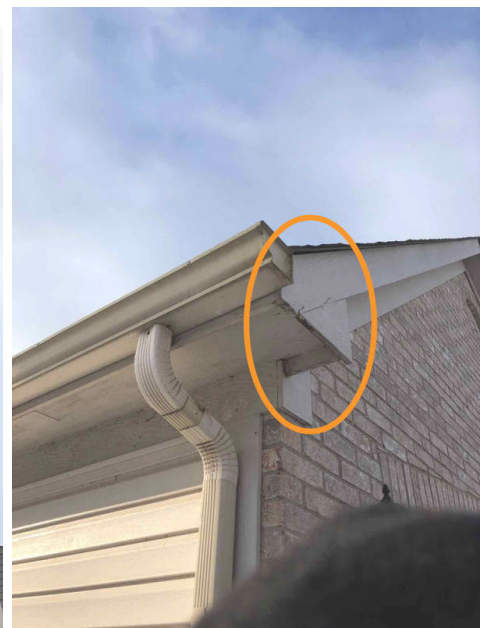
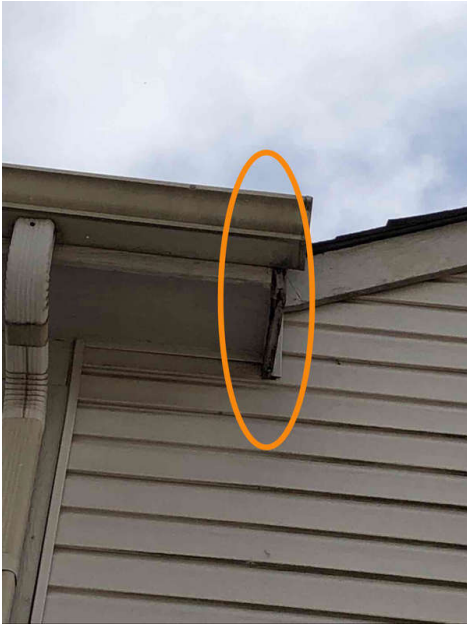
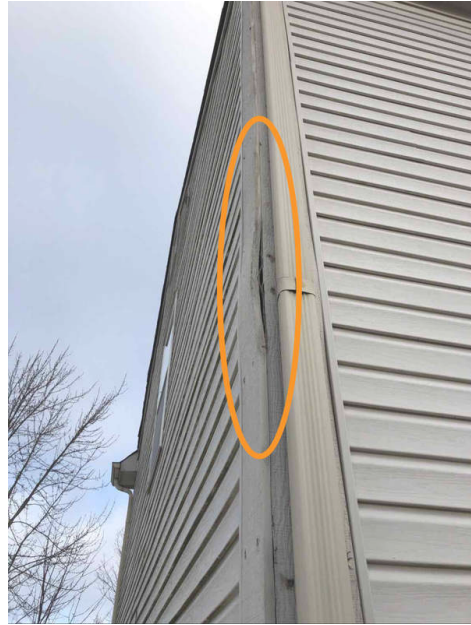
WATER DAMAGE

Water damage was noted in a few places. Recommend qualified professional for repair of affected areas.

Recommendation
Contact a qualified professional.

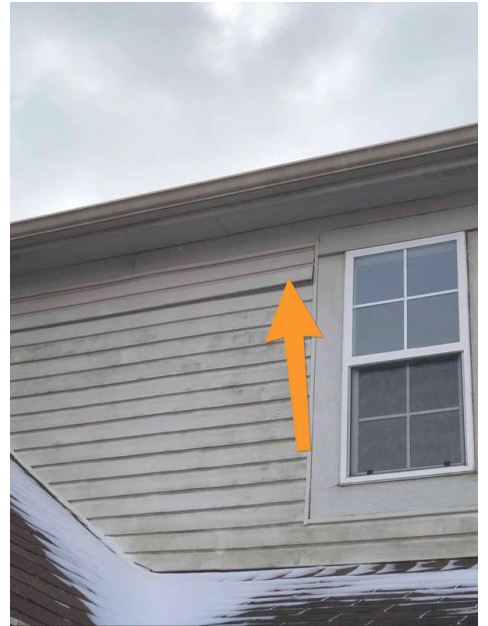
North 2nd Floor

VINYL-LOOSE

Loose vinyl siding will allow water and insects to infiltrate and will also allow the wind to cause damage.

Contact a qualified professional.

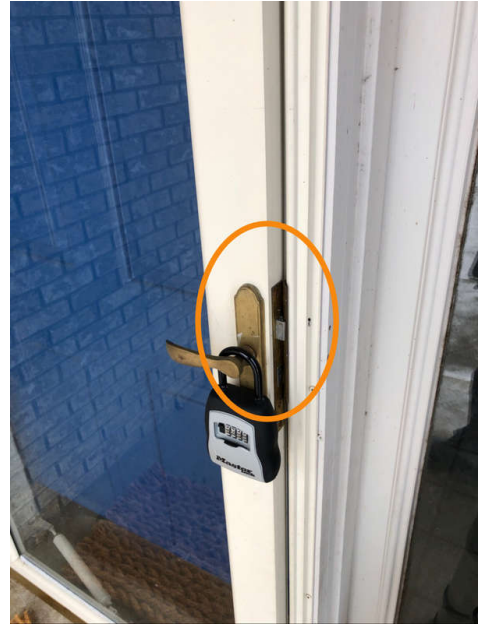
Storm door

DOOR DOES NOT CLOSE OR LATCH

Door does not close or latch properly. Recommend qualified handyman adjust strike plate and/or lock.

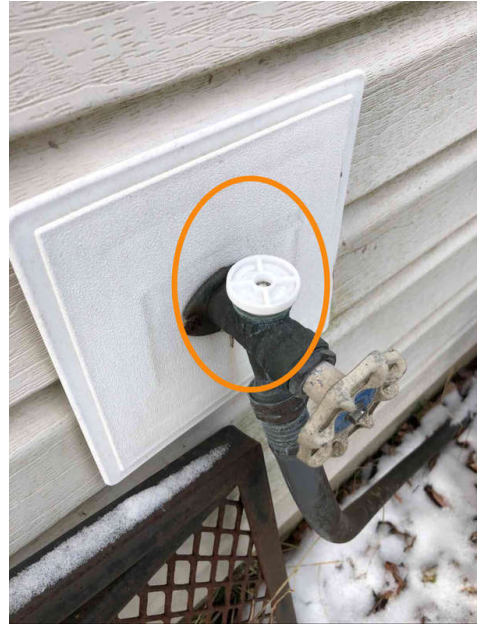
East

**FAUCET- DAMAGED/MISSING
HARDWARE**

Exterior faucet had damaged or missing hardware that could effect performance. Recommend qualified plumber for repair.

Contact a qualified plumbing contractor.

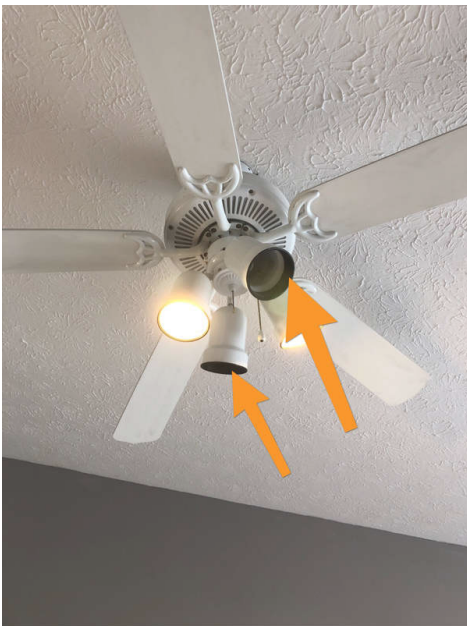
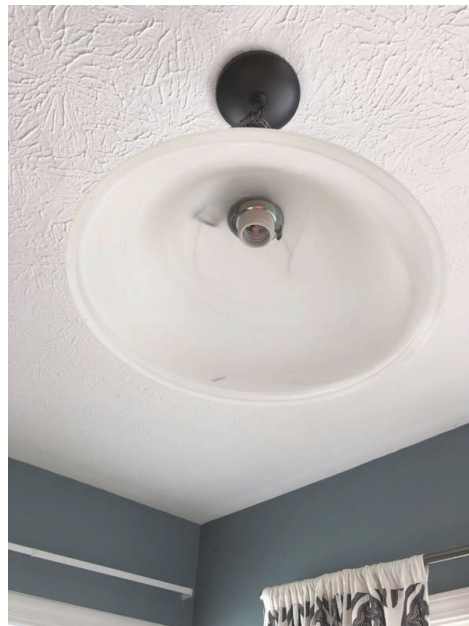
MISSING BULB

One or more bulbs were missing. Recommend handyman for replacement and then testing to ensure proper operation.

Contact a qualified professional.

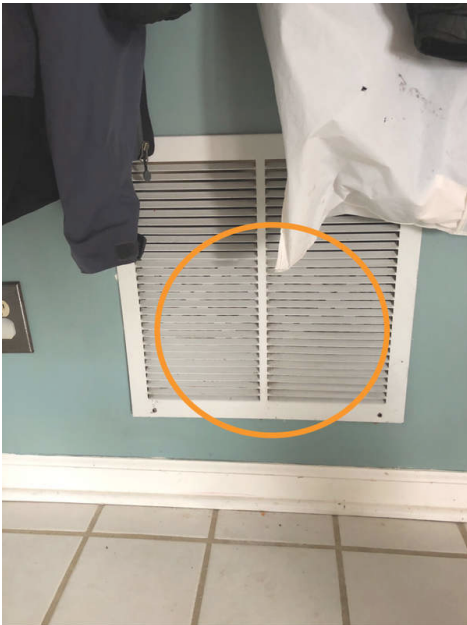
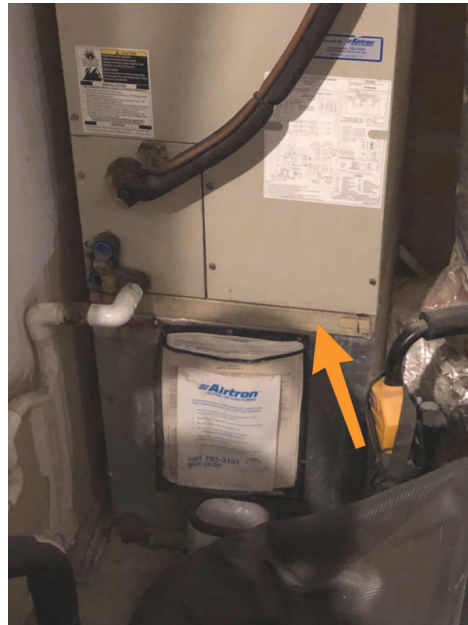
7.1.2 Heating Equipment **FILTER-INADEQUATE**

Only one filter is present. The air from the second return duct is not filtered. This is allowing dirty air to enter the air handler. A filter needs to be added to the second return or a filter placed in the air handler itself. Recommend qualified handyman for repair.

One 16x16 filter 1st Floor

No filter

Recommendation
Contact a handyman or DIY project

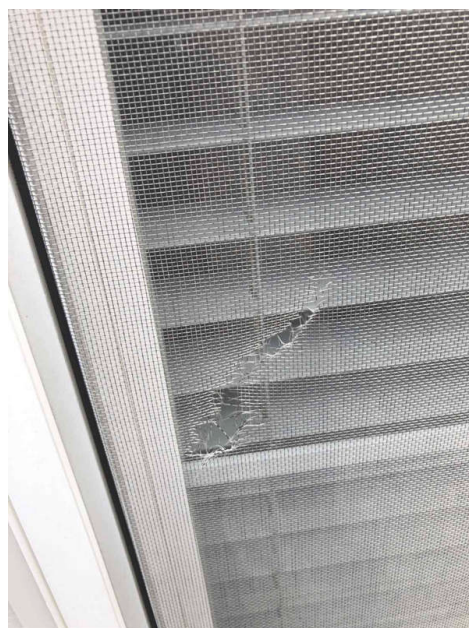
SCREEN- DAMAGED

One or more screen(s) are damaged. Recommend repairing or replacing affected screens.

Recommendation
Contact a qualified professional.

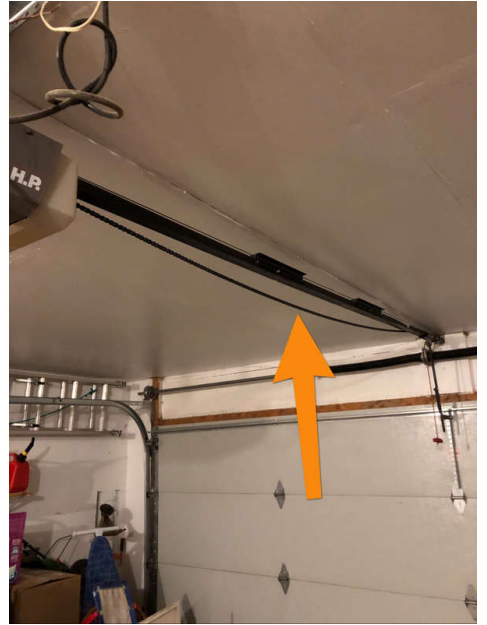
CHAIN ADJUSTMENT

Chain was loose and needs adjusting. Recommend qualified garage door repairman to adjust the chain.

Loose chain

Recommendation
Contact a qualified garage door contractor.

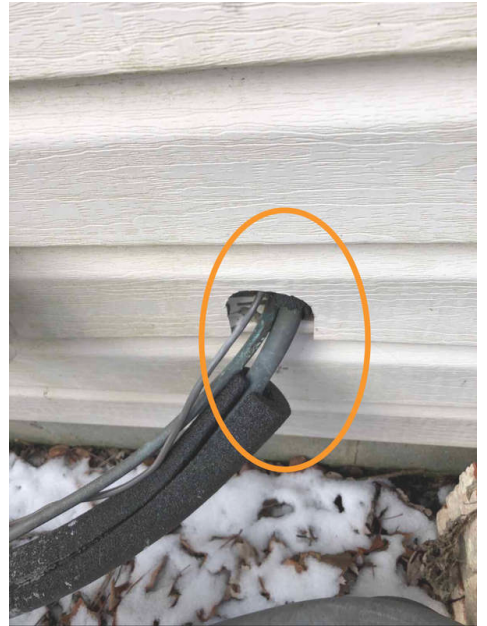
INSULATION MISSING OR DAMAGED

Missing or damaged insulation on refrigerant line can cause energy loss and condensation.

Missing insulation

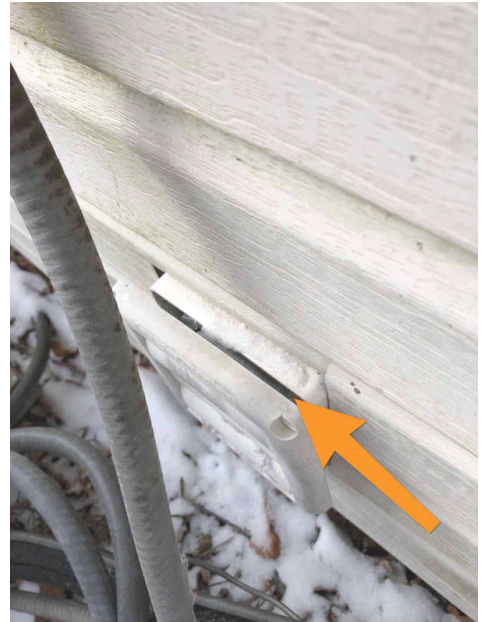
Dryer vent- East

COVER-LOOSE

Vent cover is loose. This can lead to insects and varmint intrusion. Recommend qualified handyman for repair.

Recommendation
Contact a qualified professional.
