2.1.1 Coverings

DAMAGED (GENERAL)

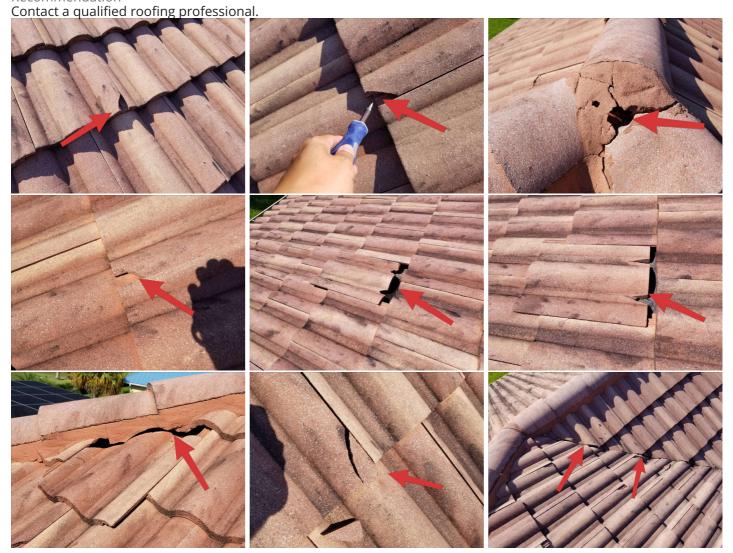
Roof coverings showed moderate damage. Recommend a qualified roofing professional evaluate and repair.

Numerous broken or chipped tiles

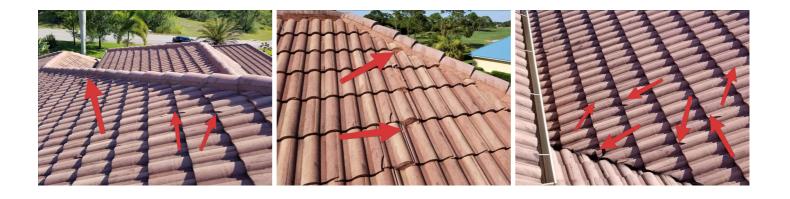
2.1.2 Coverings

PONDING

Observed ponding in one or more areas of roof. Ponding can lead to accelerated erosion and deterioration. Recommend a qualified roofing contractor evaluate and repair.

Repair appears to have been made to previous leak from location near front door.

Recommendation

Contact a qualified roofing professional.
