This Summary Report is meant to organize any **Moderate Recommendations** and **Significant and/or Safety Concerns** into a shorter, straight to-the-point format. The Summary version is not the entire report and should not be considered exclusive. The Summary listed items are considered by the inspector as inoperative, not operating properly or as intended, health and/or safety concerns, warranting further investigation by a specialist, or warranting continued observation by others. Not all findings listed in the Full Report are listed in the Summary. This section is provided as a courtesy and cannot be considered a substitute for reading the entire report.

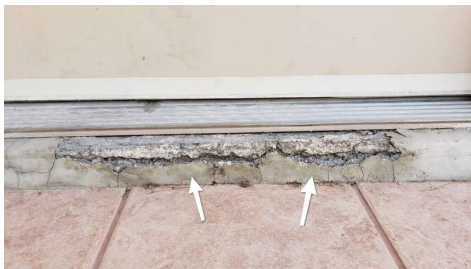
#### **AGED AND DETERIORATED AREAS**

Aged and deteriorated areas noted at one or more locations. Recommend a qualified professional evaluate.

Recommendation  
Contact a qualified professional.

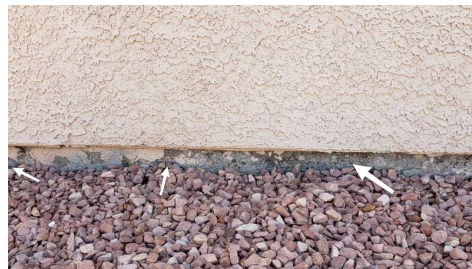
Garge - Right Side

### 2.1.1 Foundation, Floor (Structural)

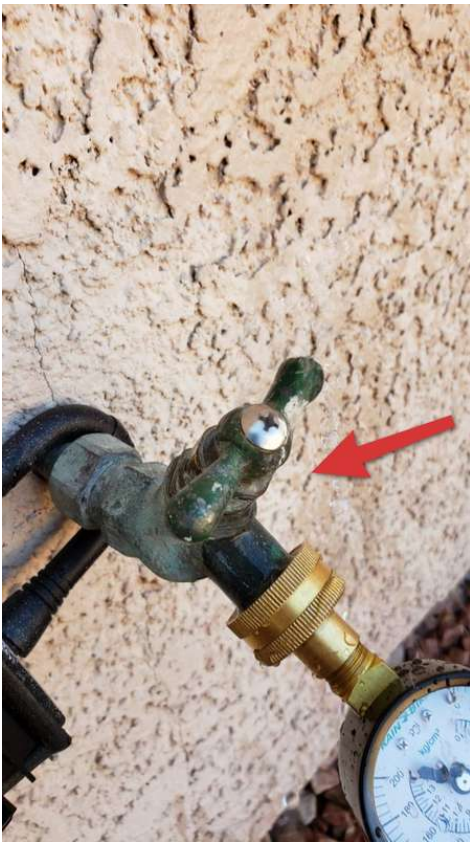
#### **HOSE BIBB LEAK**

One or more hose bibs leaked when tested. When hose bibs leak while turned on, it may be due to worn "packing" around the stem or a defective backflow prevention device if present. Recommend that a qualified plumber repair as necessary.

Recommendation  
Contact a qualified plumbing contractor.

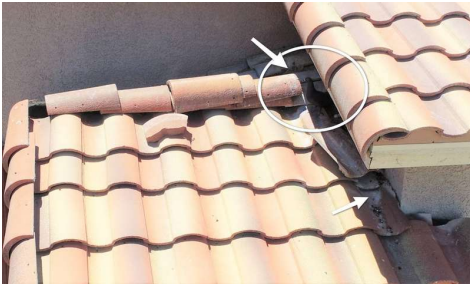
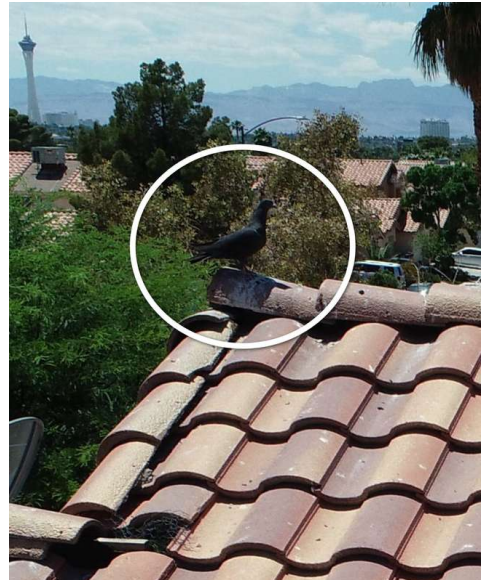
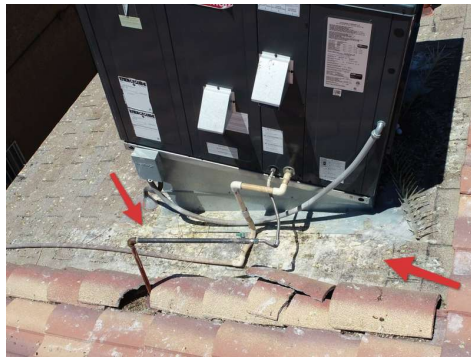
## PIGEONS PRESENCE

There was evidence of pigeon gathering and droppings on the roof, windows trim and eaves. Recommend further review by a pest control person.

Contact a qualified pest control specialist.

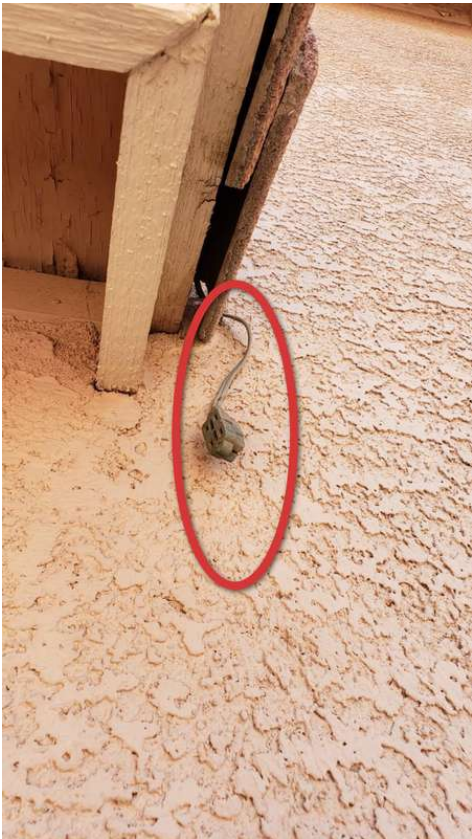
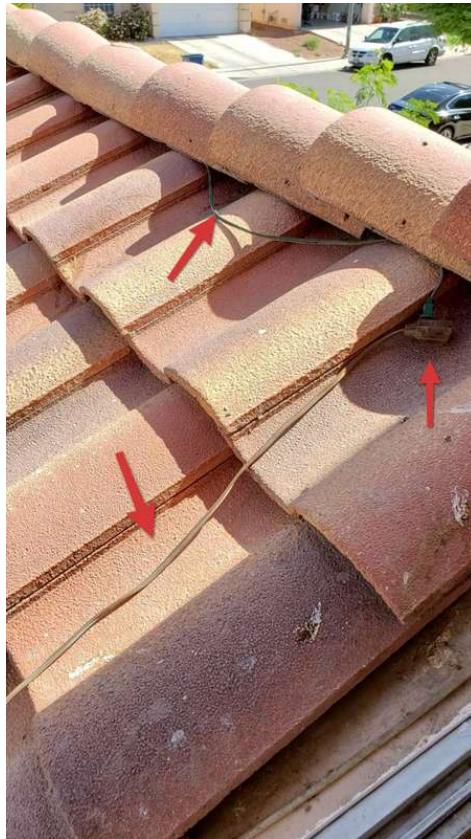
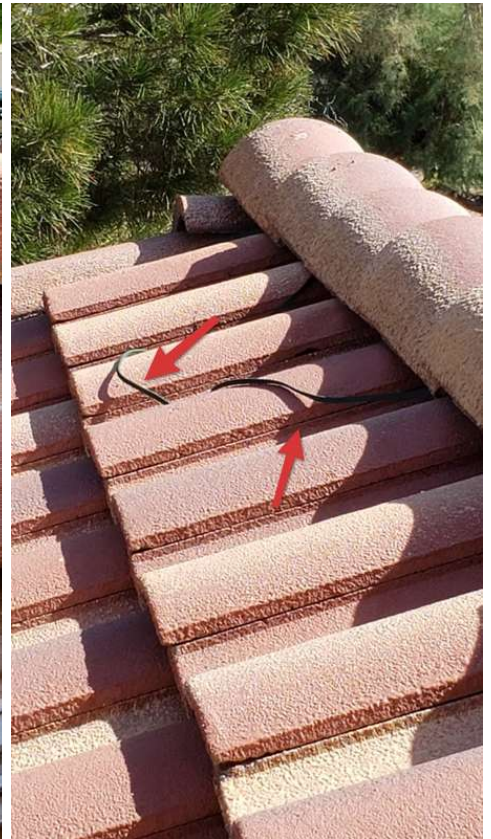
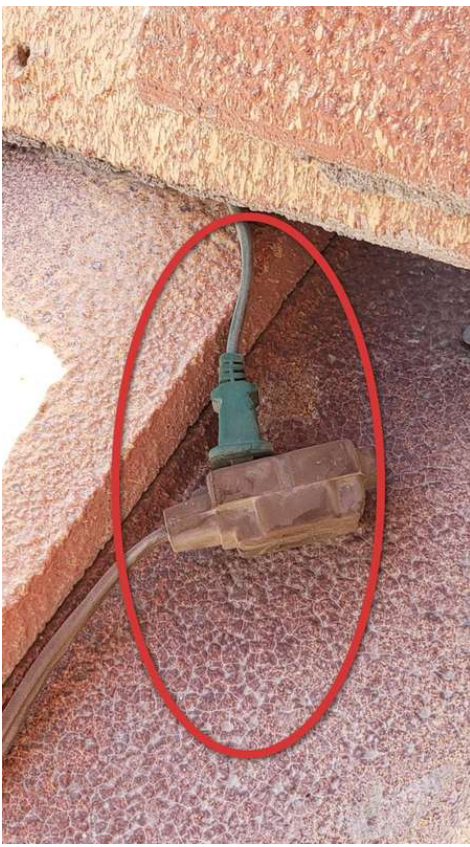
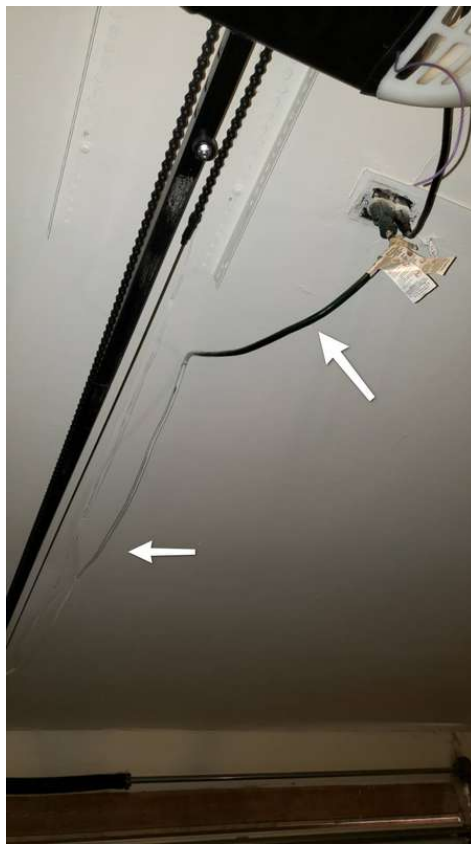
**EXTENSION CORD WIRING**

Extension cords seen used on the exterior of the home, this is not permitted by code standards. Recommend removing by a licensed electrician.

Recommendation  
Contact a qualified electrical contractor.

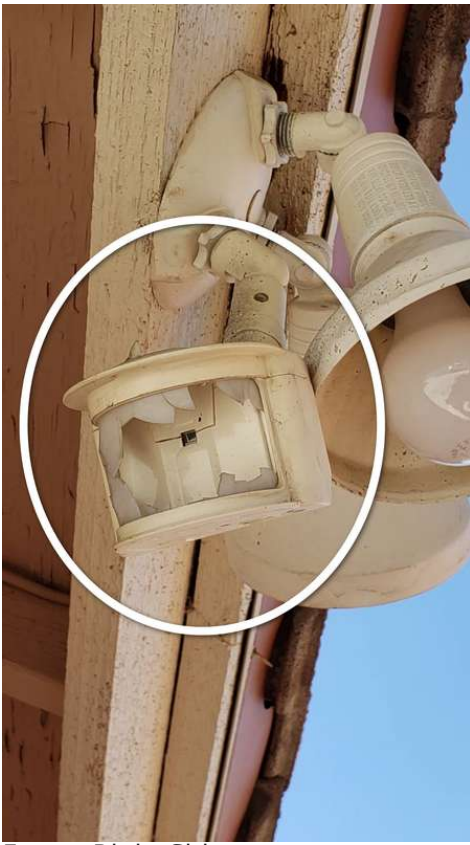
## **LIGHT FIXTURE DAMAGED / DETERIORATED**

One or more light fixtures are damaged and/or deteriorated. A qualified electrician should evaluate and repair or replace where necessary.

Recommendation  
Contact a qualified professional.

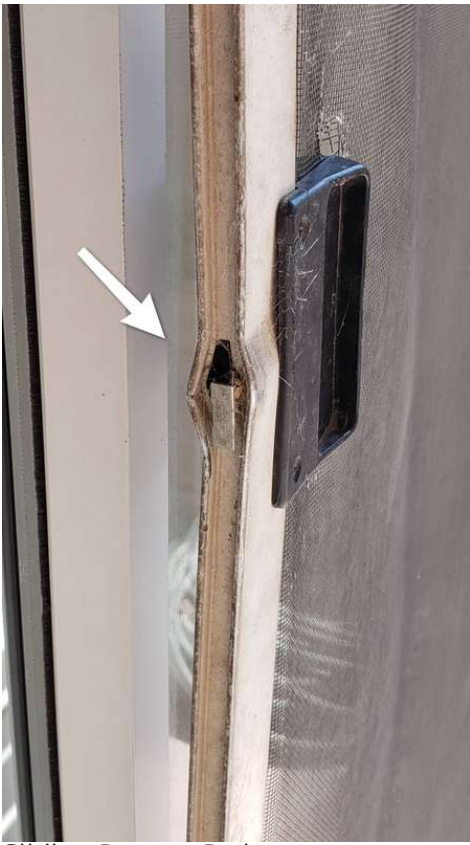
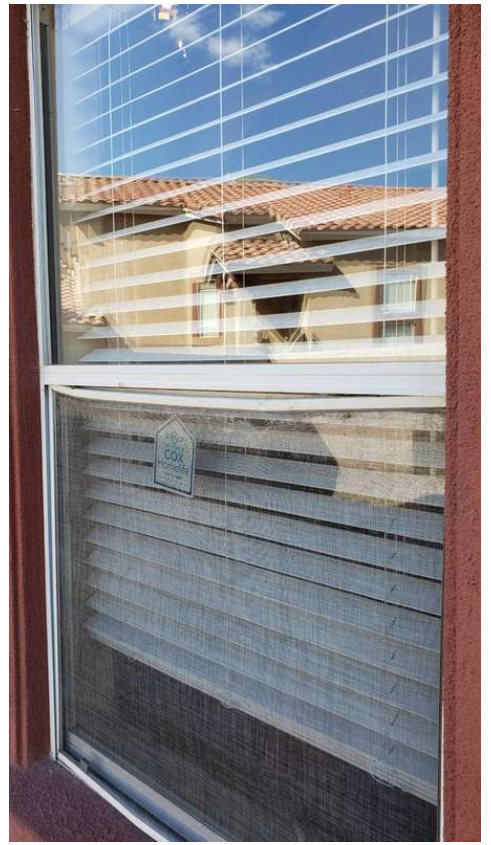
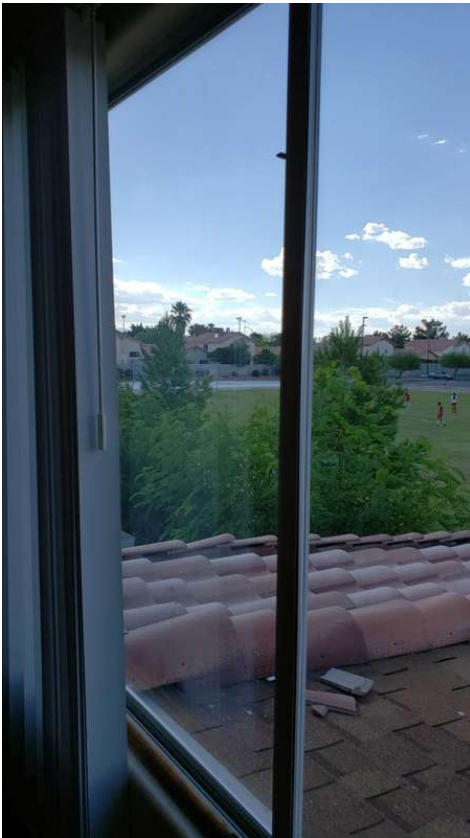
#### **SCREENS MISSING OR DAMAGED**

Screens were missing or damaged from one or more windows or doors. These windows may not provide ventilation during months when insects are active. On second story windows, these are also deterrents to keep small children from falling out of open windows during cooler temperatures. Recommend installing or repairing screens as necessary

Contact a qualified window repair/installation contractor.

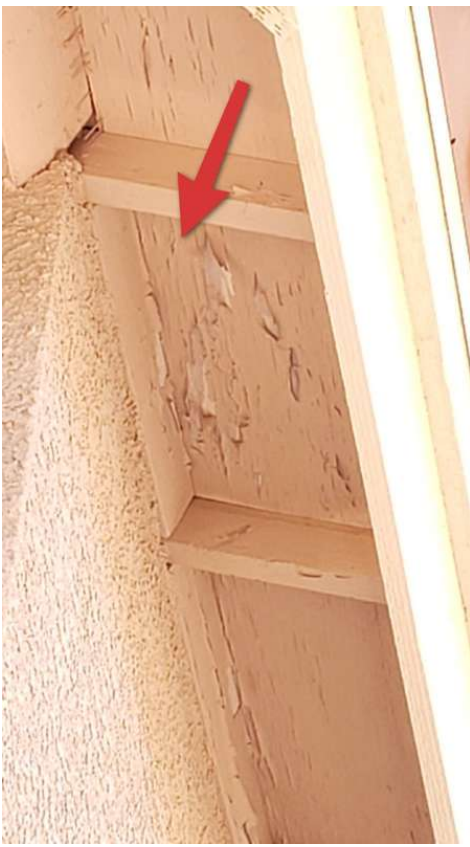
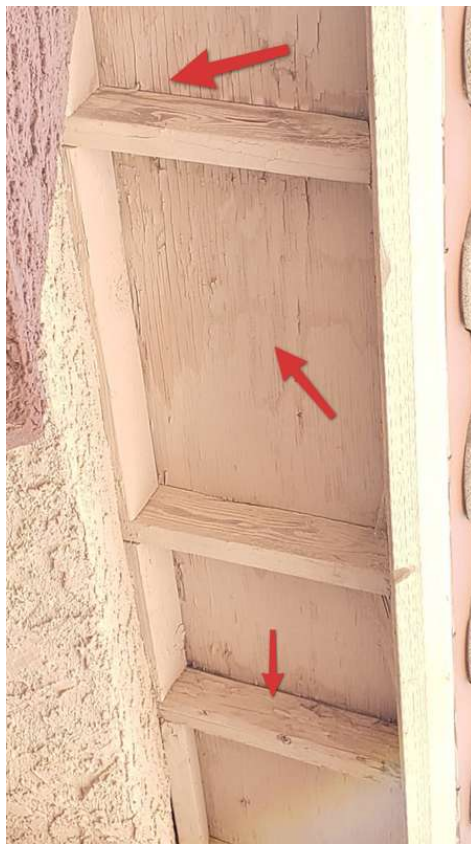
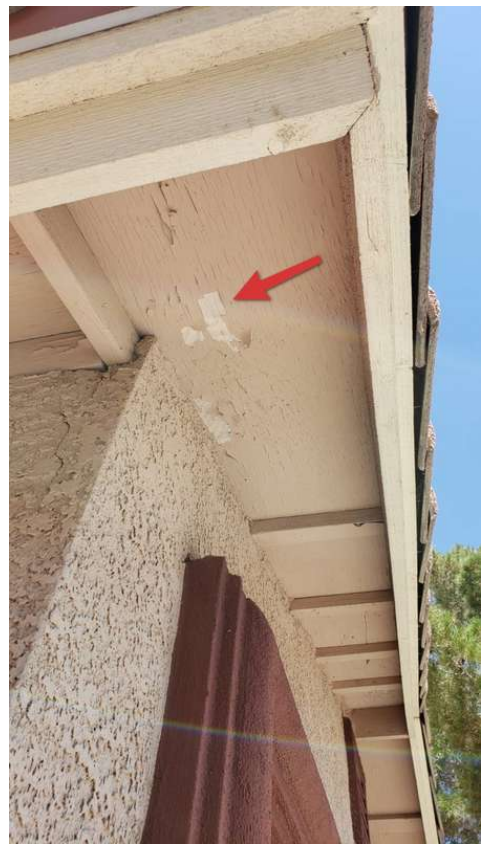
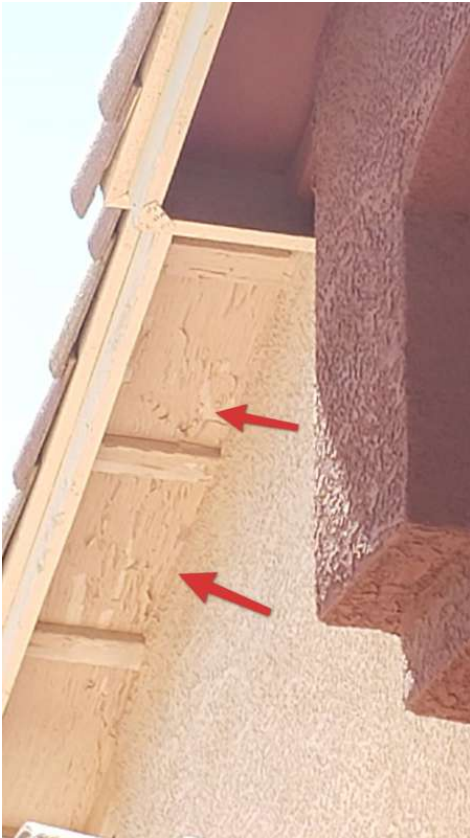
#### **EAVE ROOF SHEATHING DETERIORATED**

Eave roof sheathing at one or more areas was deteriorated and peeling paint was noted. Recommend repairs be made by a qualified contractor.

Contact a qualified general contractor.

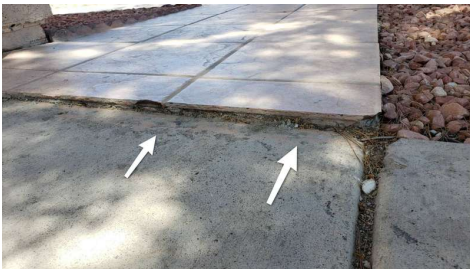
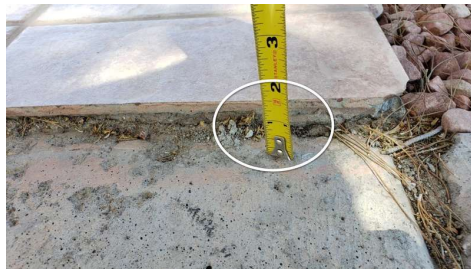
FRONT

#### **RAISED SIDEWALK**

Due to the installation of tiles, the sidewalk/walkway was raised creating a trip hazard in noted areas. Recommend repair.

Recommendation  
Contact a qualified professional.

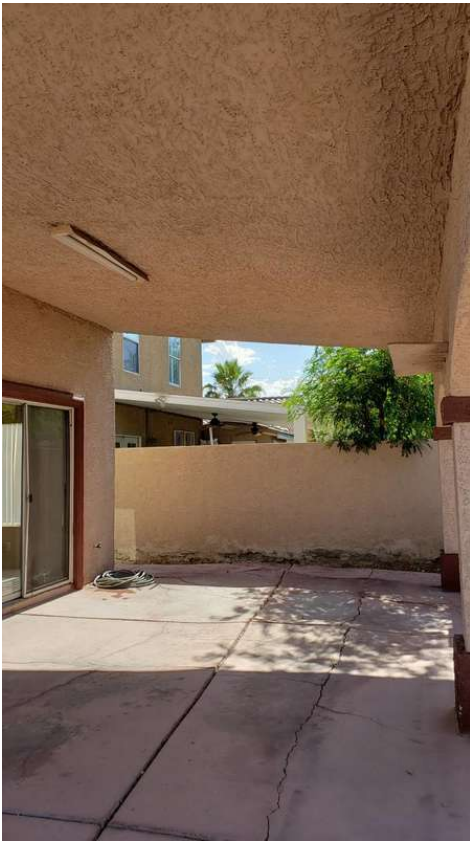
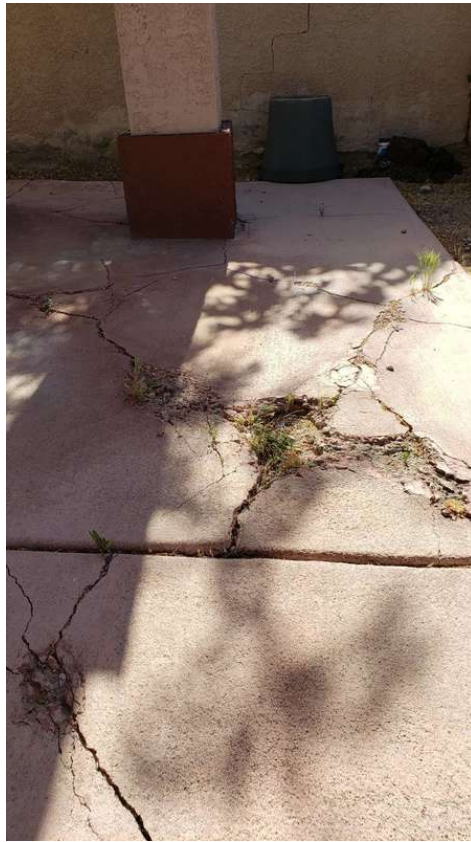
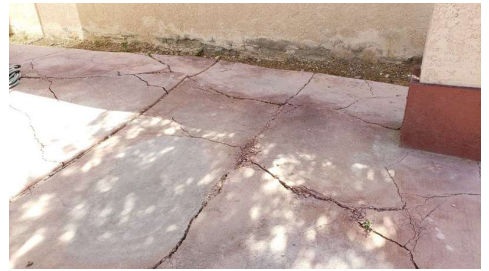
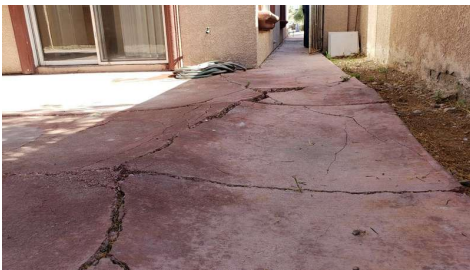
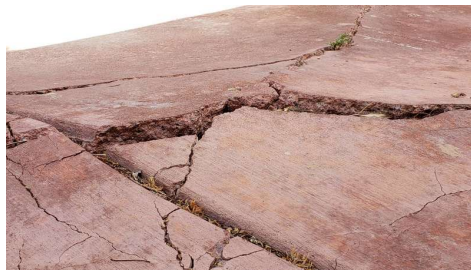
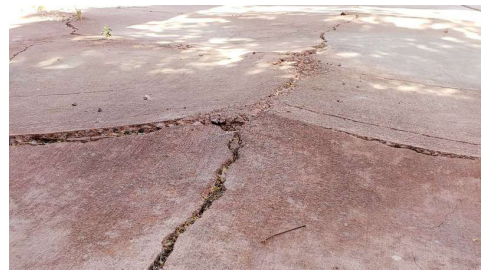
**PATIO CONCRETE - DETERIORATED - REPLACE SLAB**

The patio was undermined in one or more areas, where the soil has eroded out from beneath the patio. Significant cracks and/or damage has occurred, where one or more patio sections need replacing. Recommend that a qualified contractor replace all damaged sections as necessary.

Contact a qualified concrete contractor.

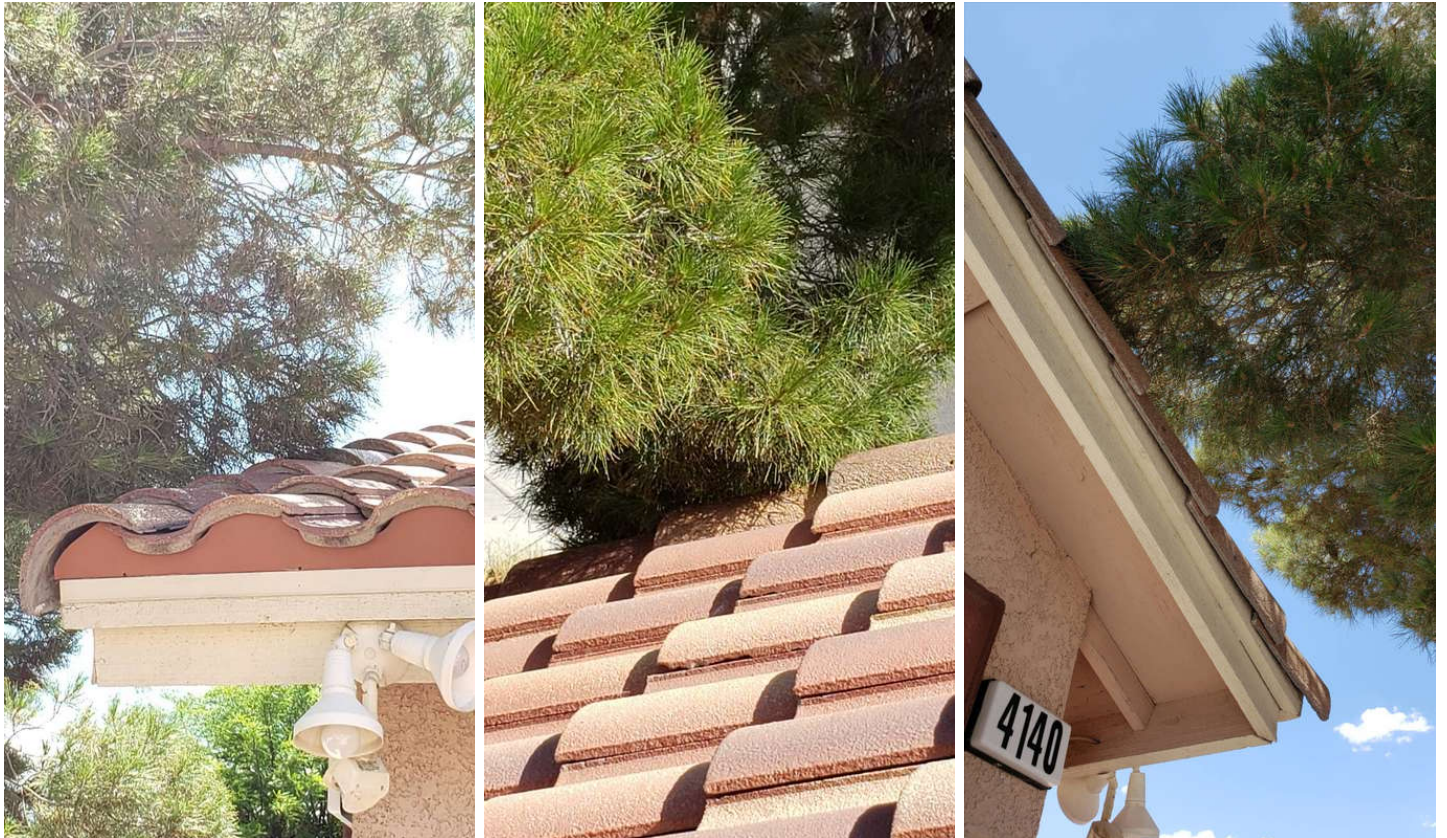
**TREE BRANCHES - OVERHANG THE ROOF**

Tree branches were in contact with the roof or were touching the structure at one or more locations. Damage to the building or the roof can occur, especially during high winds, or may have already occurred (see other comments in this report if applicable). Recommend that a qualified tree service contractor or certified arborist prune back the tree as necessary to prevent damage to the roof and to the building exterior.

Contact a qualified tree service company.

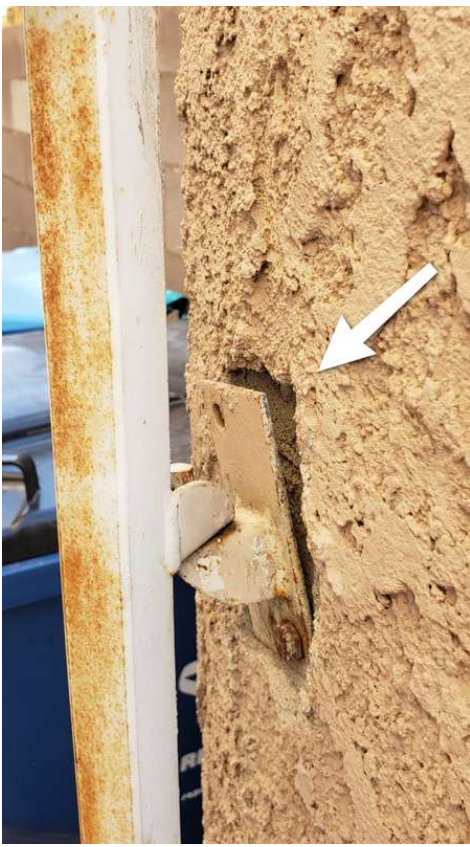
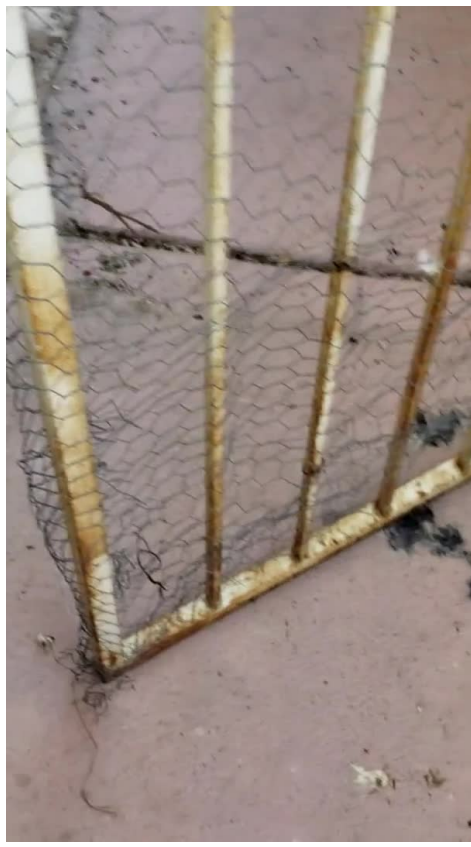
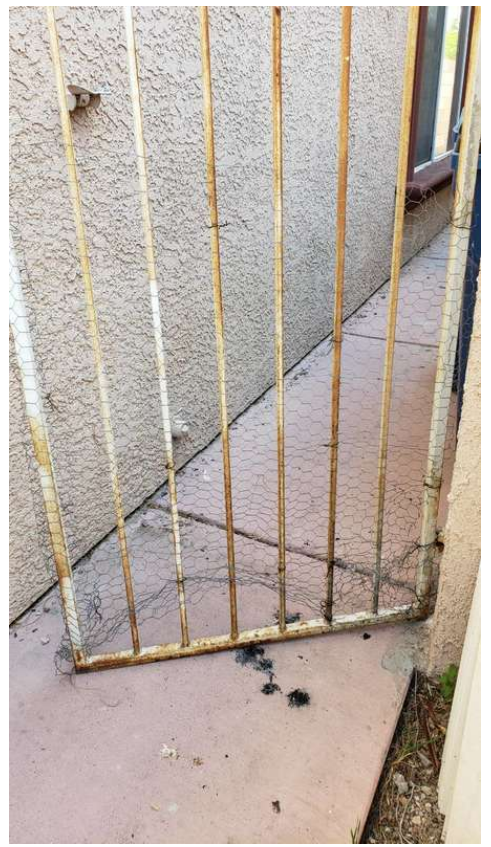
**GATE REPAIR**

One or more gates are damaged and/or deteriorated. A qualified contractor should evaluate and replace or make repairs as necessary.

Contact a qualified fencing contractor

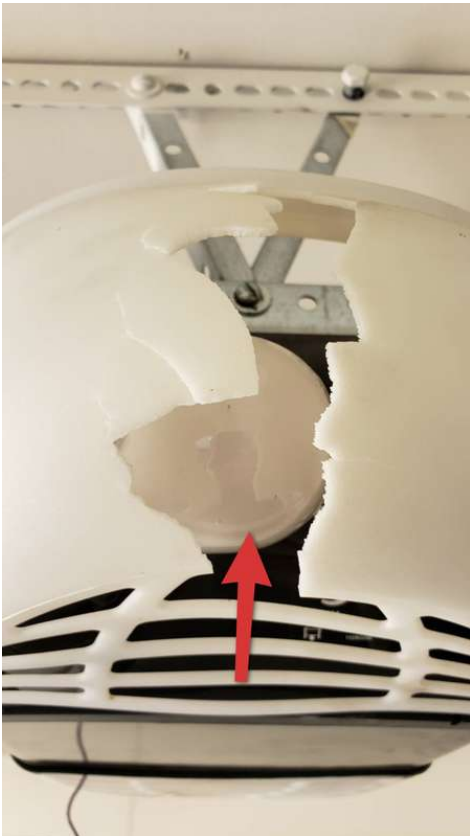
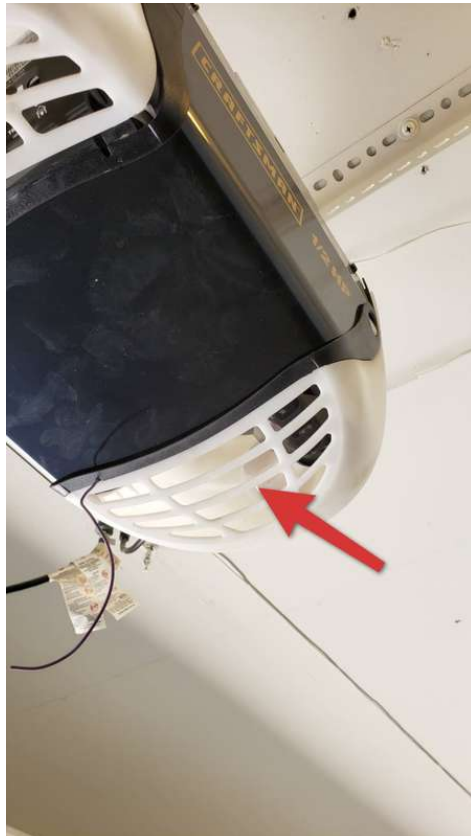
### **BURNED-OUT LIGHTBULBS**

Bulbs at the garage opener were burned-out. These lights couldn't be fully evaluated. If replacement bulbs are inoperable, then recommend that a qualified electrician evaluate, repair or replace as necessary.

Recommendation  
Contact a qualified electrical contractor.

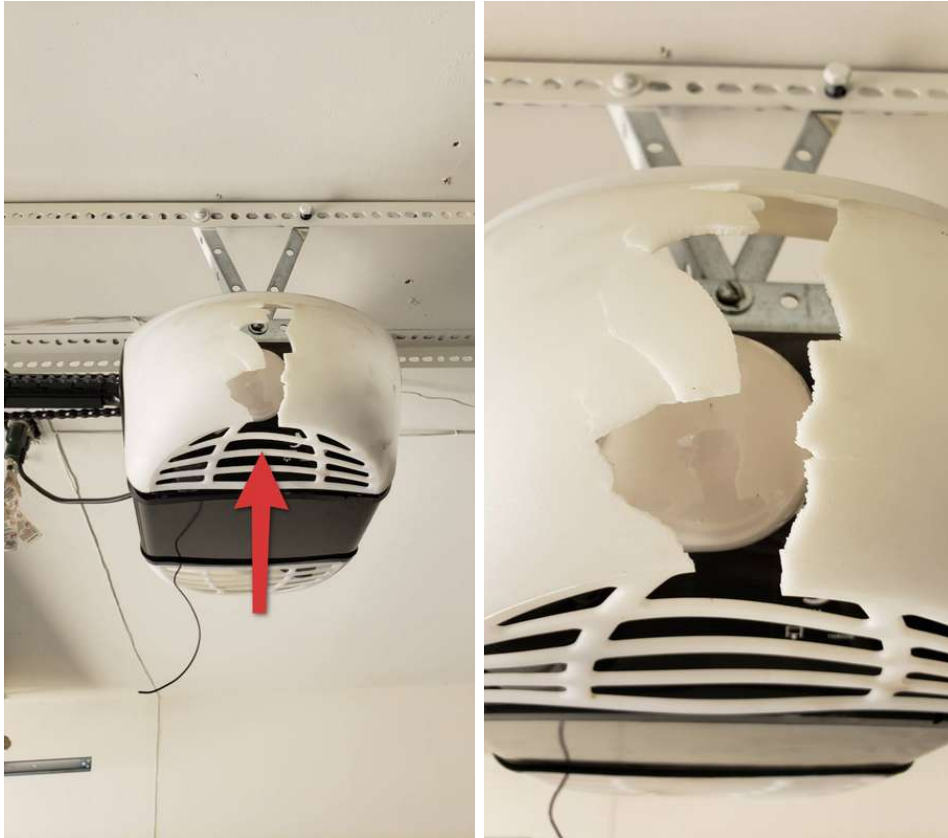
GARAGE

### **LIGHT COVER DAMAGED**

The garage opener light cover was damaged. Recommend that a qualified professional replace as necessary.

Contact a qualified electrical contractor.

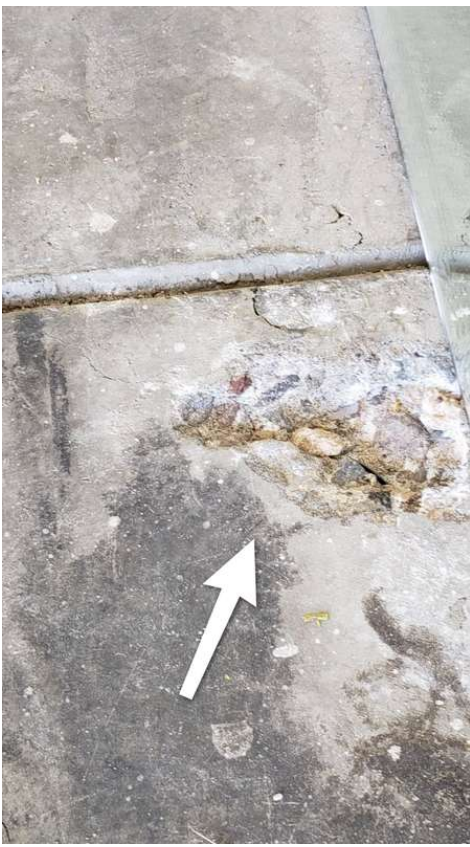
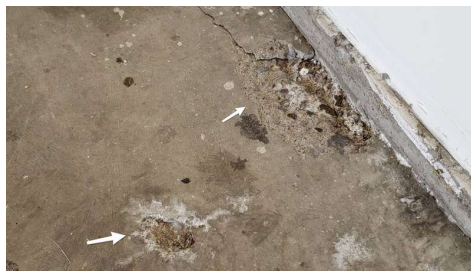
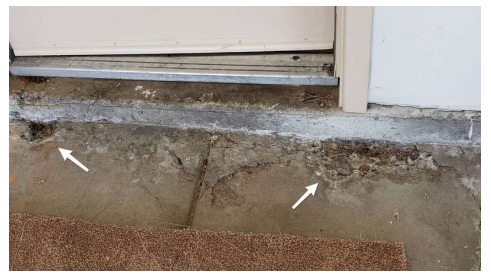
GARAGE

### **CRACKS / SETTLEMENT / HEAVING**

Significant cracks, heaving or settlement were found in one or more sections of the garage concrete slab. Uneven surfaces can also pose a trip hazard. Recommend that a qualified contractor repair concrete slab floors where necessary.

Contact a qualified professional.

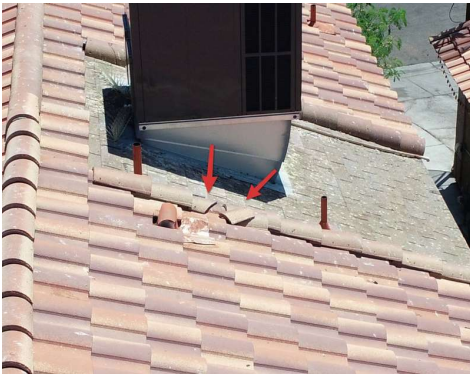
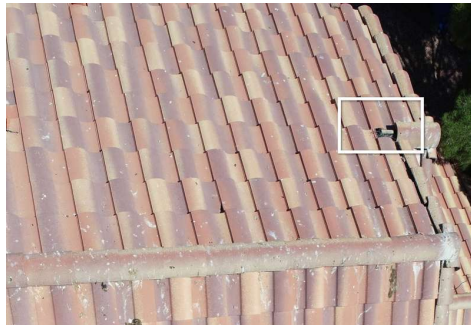
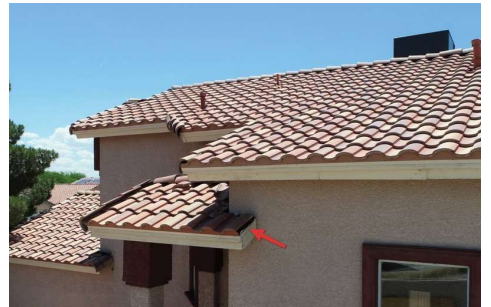
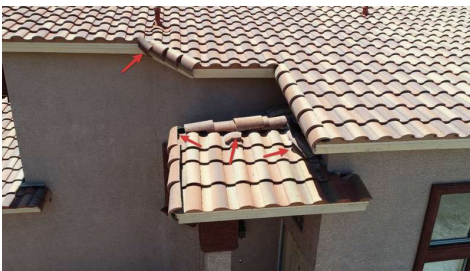
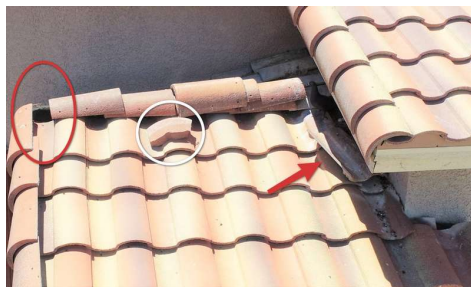
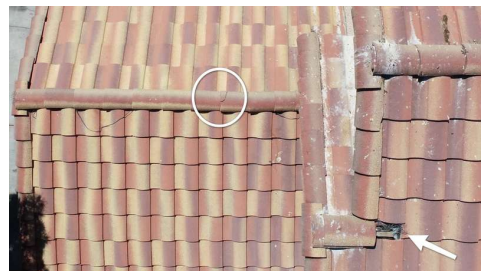
## **ROOF TILES CRACKED, BROKEN, LOOSE OR MISSING**

Roof tiles were cracked, broken, missing or loose. Leaks may occur as a result. This is a conducive condition for wood-destroying organisms. Recommend that a qualified person replace tiles or make repairs as necessary.

Contact a qualified roofing professional.

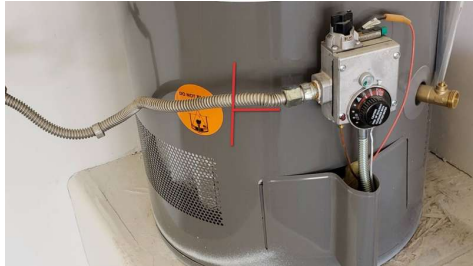
## MISSING SEDIMENT TRAP

No sediment trap was present for one or more appliances gas lines. Sediment traps are a T and are placed to prevent moisture and tiny debris in the gas system from entering the combustion chamber prolonging the life of the appliance. Recommend a plumber add a sediment trap per standard building practices.

Contact a qualified plumbing contractor.

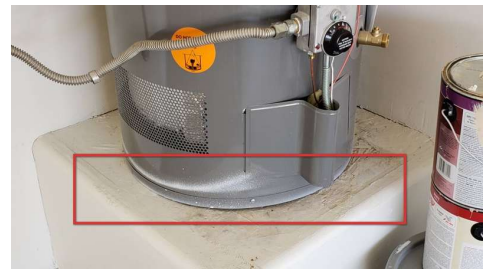
## NO DRAIN PAN INSTALLED

No catch pan was installed below the water heater. Consider having a qualified contractor install a catch pan per standard building practices.

Contact a qualified plumbing contractor.

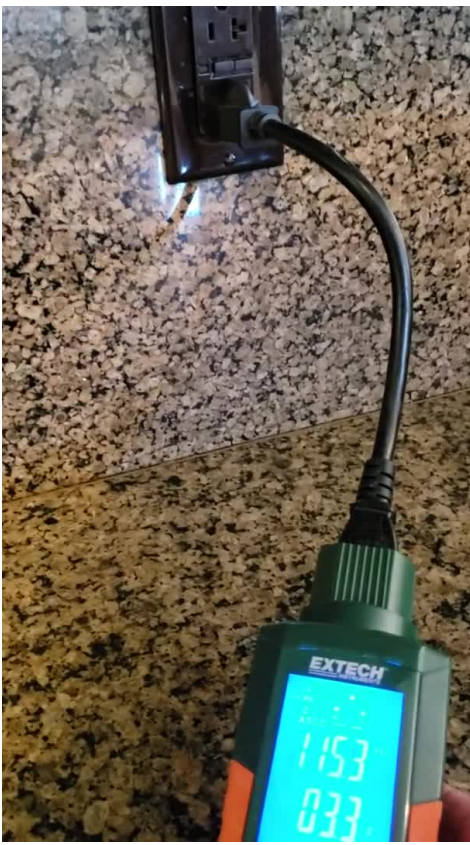
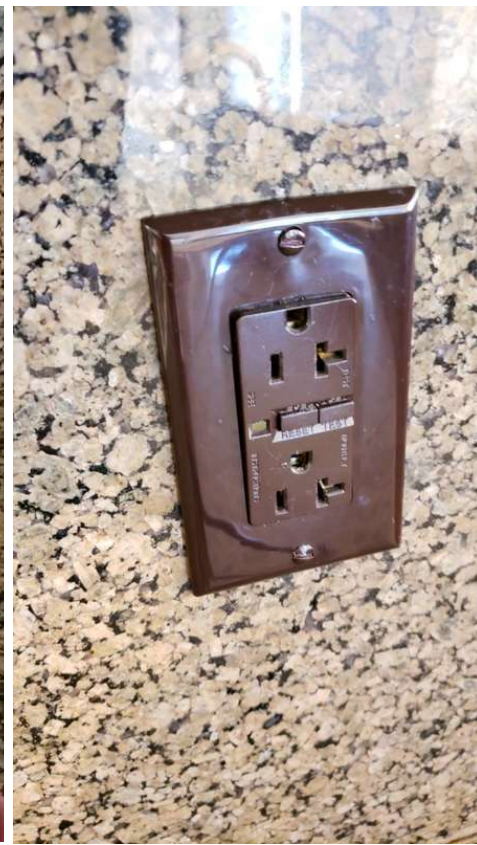
KITCHEN

## GFCI ISSUES - WOULDN'T TRIP

One or more ground fault circuit interrupter (GFCI) receptacles (outlets) were not functioning properly (would not trip). Recommend replacement by a qualified licensed electrical contractor.

Contact a qualified electrical contractor.

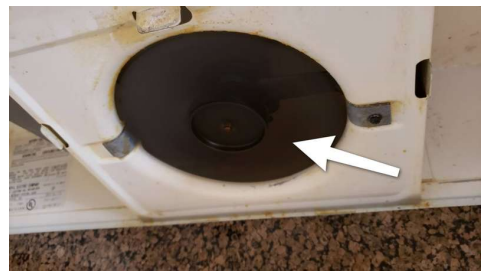
#### **GREASE FILTER MISSING**

The hood grease filter was missing. Recommend replace filter as necessary.

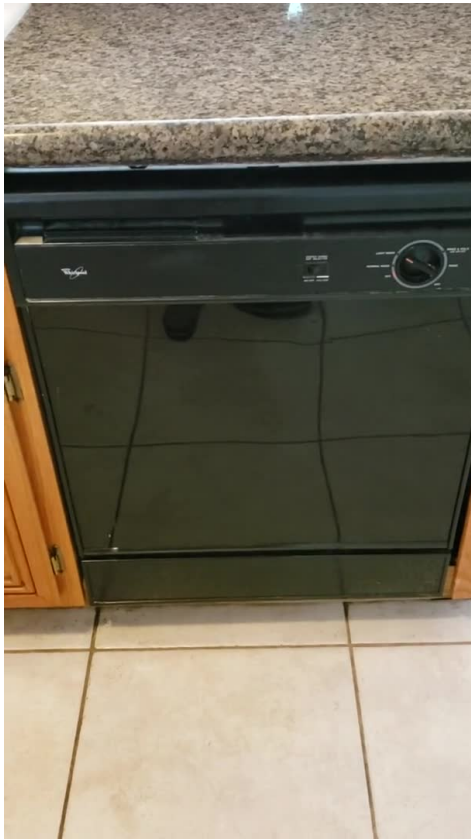
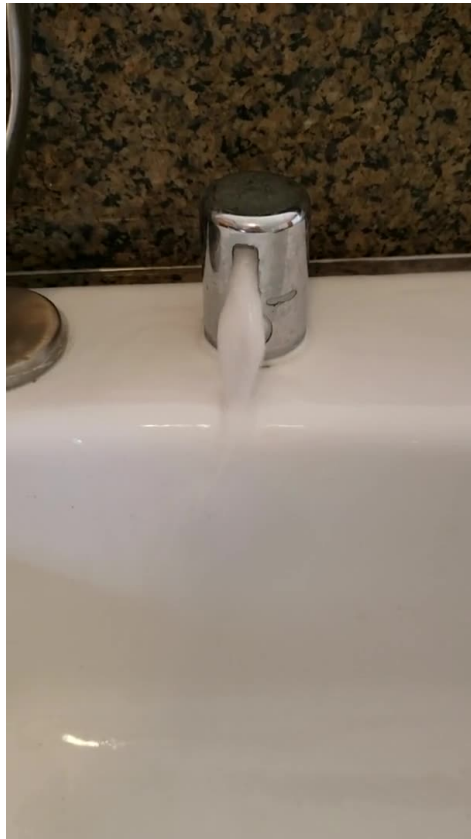
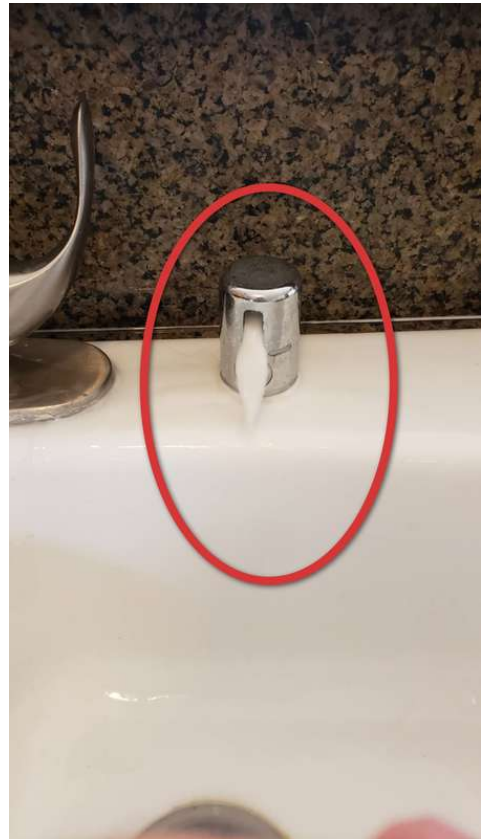
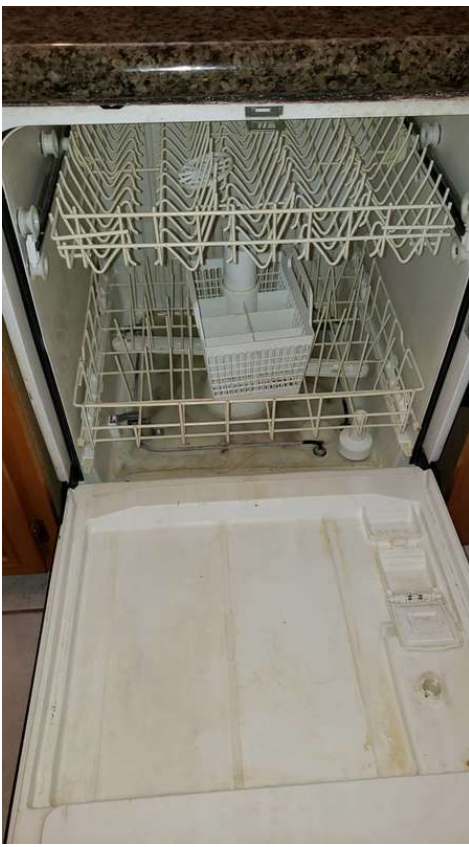
**LEAKS AT COUNTER - AIR GAP**

The dishwasher was tested and it was found to be leaking at the countertop air gap connection. The test was terminated as soon as the leaks were discovered to prevent additional water leaks or damage. Recommend that a qualified professional evaluate and make repairs as necessary.

Recommendation  
Contact a qualified professional.

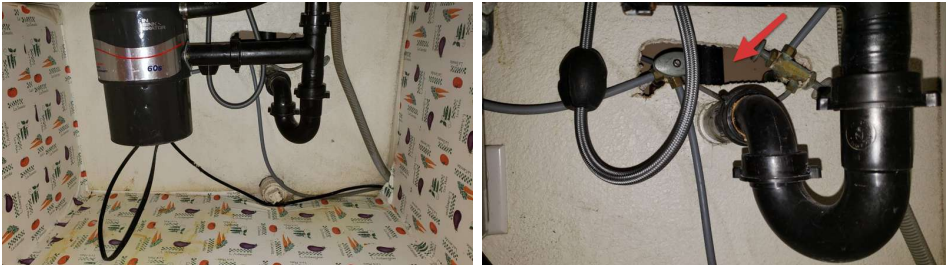
### **WALL DAMAGE UNDER SINK**

The wall under the sink is damaged. Recent repairs may have been performed. Recommend asking the owner about this. Services of a licensed professional are also recommended to patch the wall.

Contact a qualified professional.

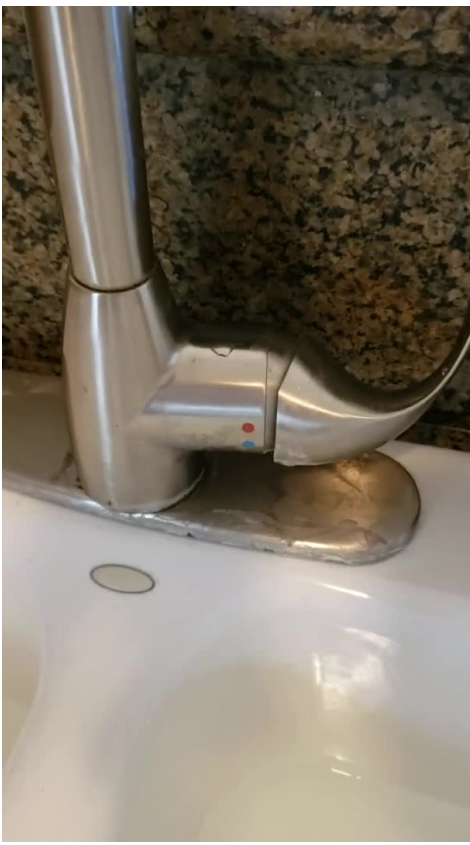
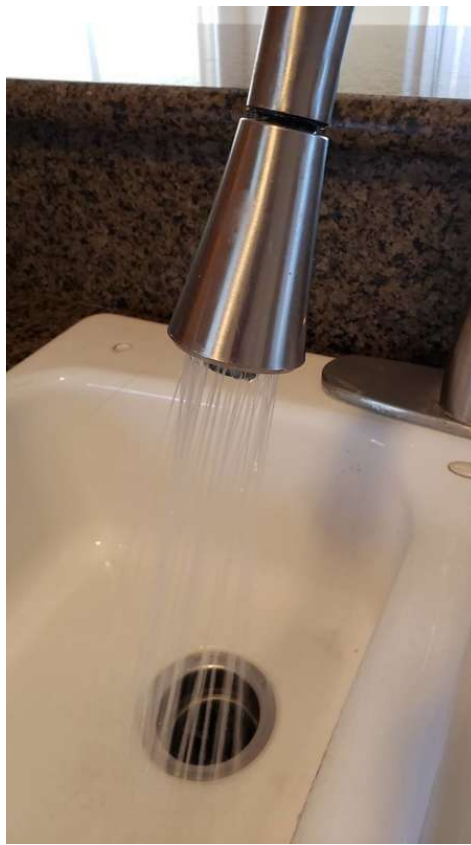
### **FAUCET LOOSE AT THE BASE**

The sink faucet is loose at the base. Hard water/mineral build up is preventing the spout from turning. Recommend that a qualified person repair or replace as necessary.

Contact a qualified plumbing contractor.

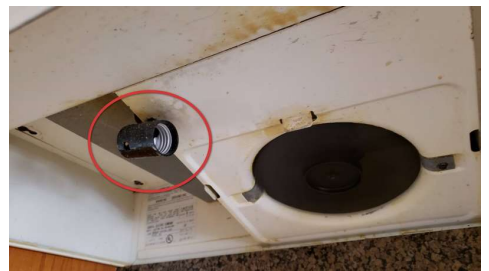
HOOD

**LIGHT BULBS MISSING**

One or more light bulbs were missing and could not be fully evaluated. Bulbs may simply need to be installed. Repairs or replacement may be necessary.

Contact a qualified professional.

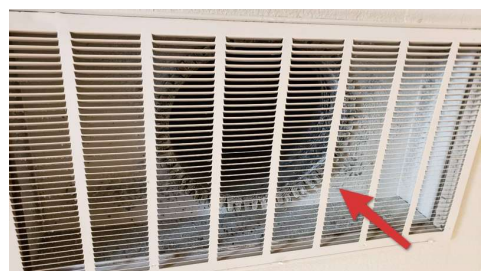
**FILTERS MISSING**

Air filters for the heating and/or cooling system were missing where they should have been installed. The indoor air quality will be reduced as a result. Recommend installing good quality filters at intended locations. Filters should be sized correctly to minimize air gaps. Many types of filters are available. Recommend installing pleated filters or better rather than the cheapest disposable kind.

Recommendation  
Recommended DIY Project

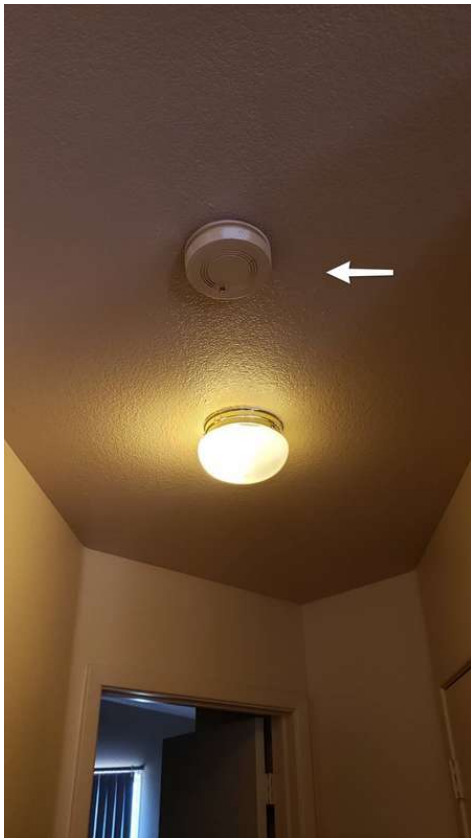
### **SMOKE ALARMS INOPERABLE**

Smoke alarms were inoperable at one or more locations. Smoke alarms should be replaced as necessary and installed per standard building practices (e.g. in hallways leading to bedrooms, in each bedroom, on each floor). We recommend installing photoelectric type smoke alarms.

Recommendation  
Contact a handyman or DIY project

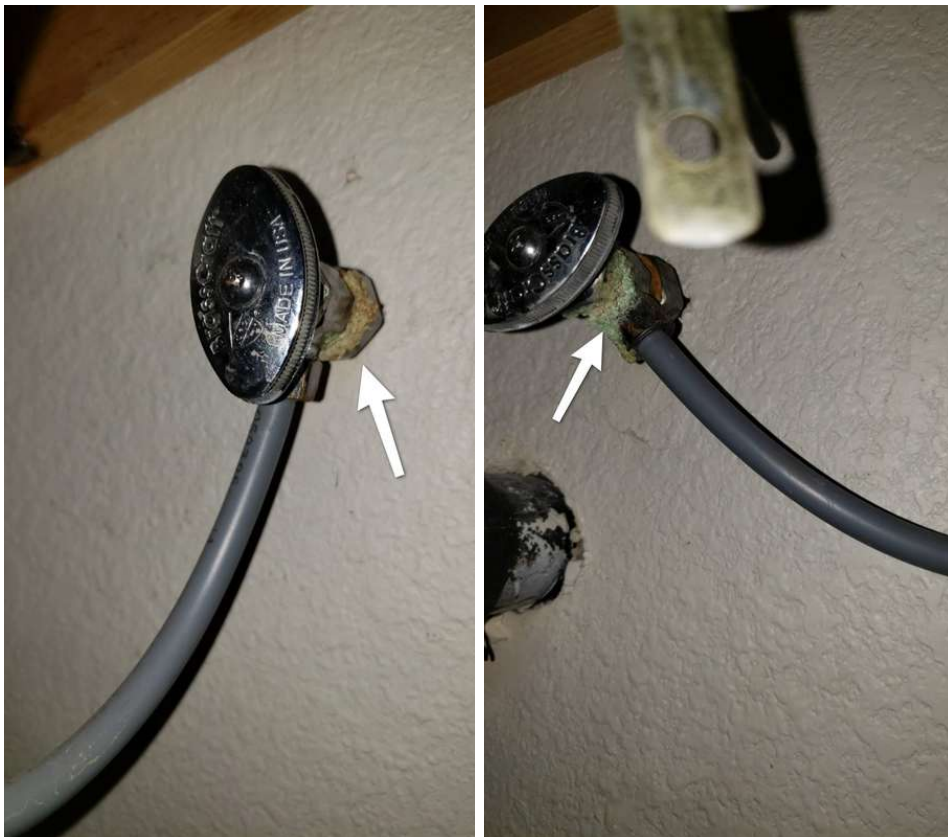
BATHROOM - 1ST FLOOR

## **CORROSION ON FITTINGS/LINES**

Corrosion was found on fittings and/or water supply lines for the bathroom sink. Leaks may occur. A qualified plumbing contractor should evaluate and repair as necessary.

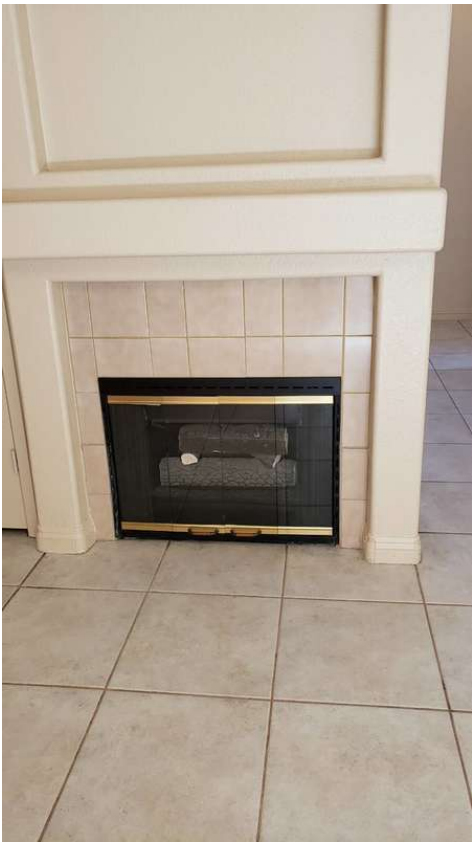
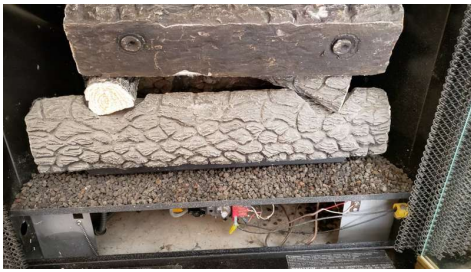
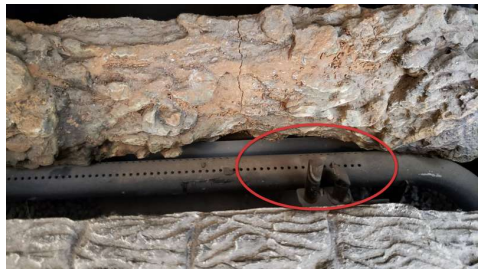
**GAS FIREPLACE - PILOT OFF**

One or more gas fireplaces did not respond to normal controls (e.g. on/off switch, thermostat, remote control) and were not fully evaluated as a result. The pilot light or gas supply may have been turned off, or some other condition may have prevented operation. The inspector only operates normal controls and does not light pilot lights or operate gas shut-off valves. Consult with the property owner, review all documentation for such gas appliances, and become familiar with the lighting procedure. If necessary, a qualified specialist should assist in lighting such appliances, and make any needed repairs.

Contact a qualified fireplace contractor.
