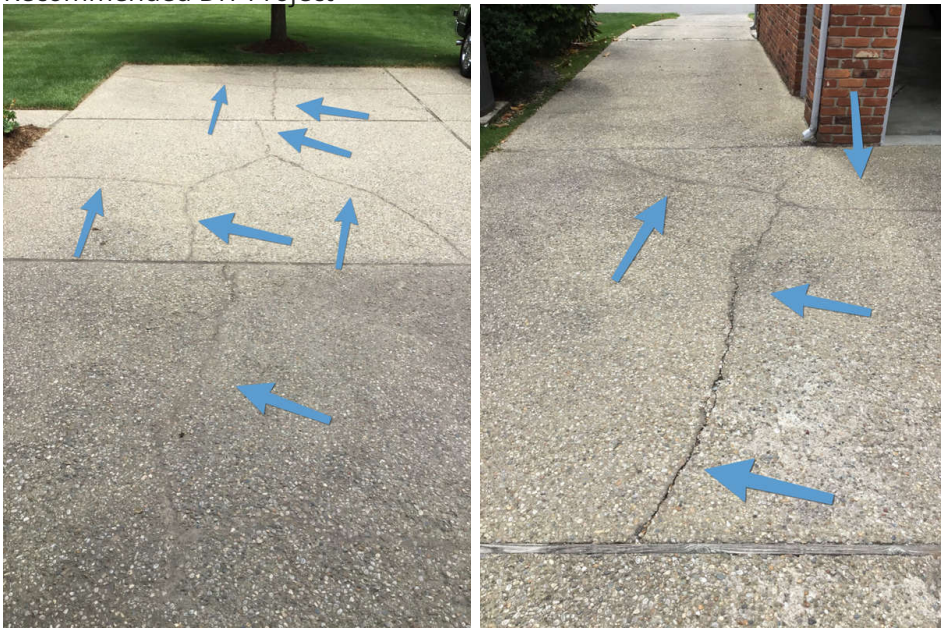
DRIVEWAY CRACKING - MINOR

Minor cosmetic cracks observed, which may indicate movement in the soil. Recommend monitor and/or patch/seal cracks.

Recommendation

Recommended DIY Project

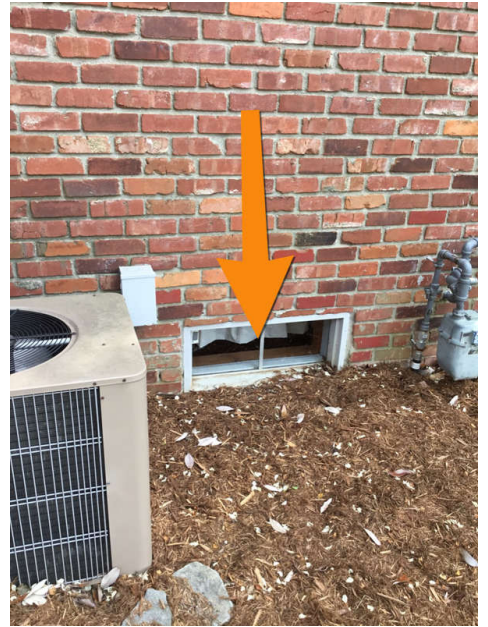
North

RECOMMEND INSTALLING WINDOW WELLS

Recommend installing window wells.

Contact a qualified professional.

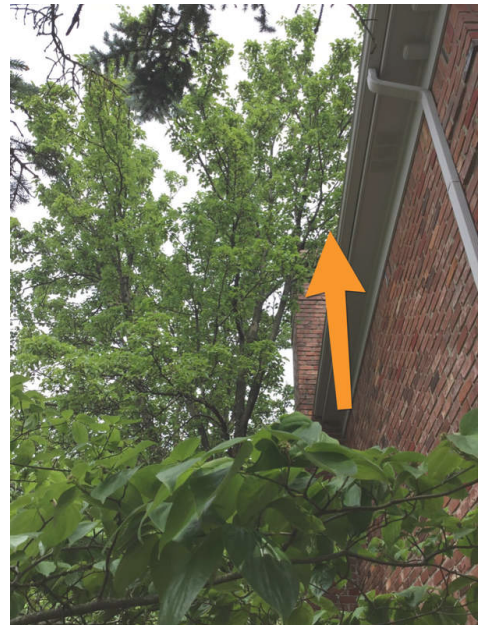
North

TREE OVERHANG

Trees observed overhanging the roof. This can cause damage to the roof and prevent proper drainage. Recommend a qualified tree service trim to allow for proper drainage.

Contact a qualified tree service company.

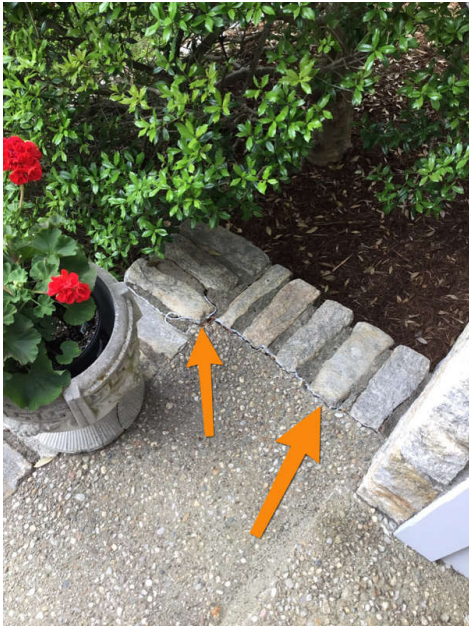
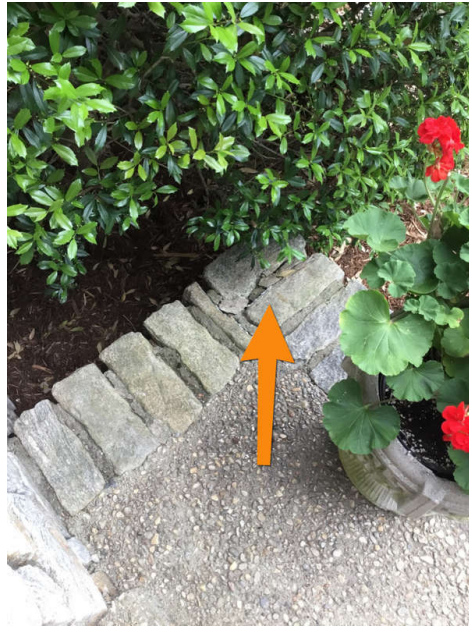
STEP/STOOP- CRACKED/DAMAGED

Step/Stoop is cracked/damaged. Recommend repair and monitoring.

Contact a qualified concrete contractor.

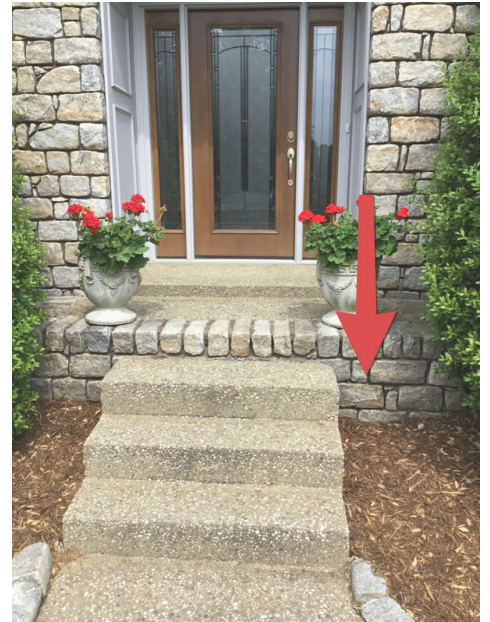
HANDRAIL MISSING

Recommend installing handrails on stairs with more than 4 steps to platform. This is a potential safety hazard

Contact a qualified professional.

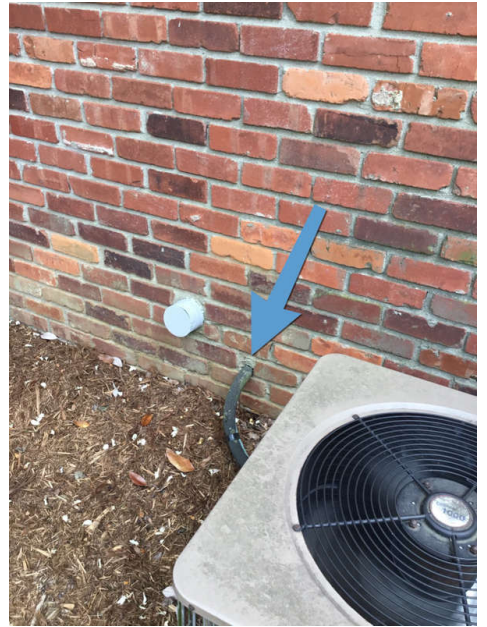
North

CAULK UTILITY PENETRATIONS

Recommend caulking at utility penetrations in siding.

Recommended DIY Project

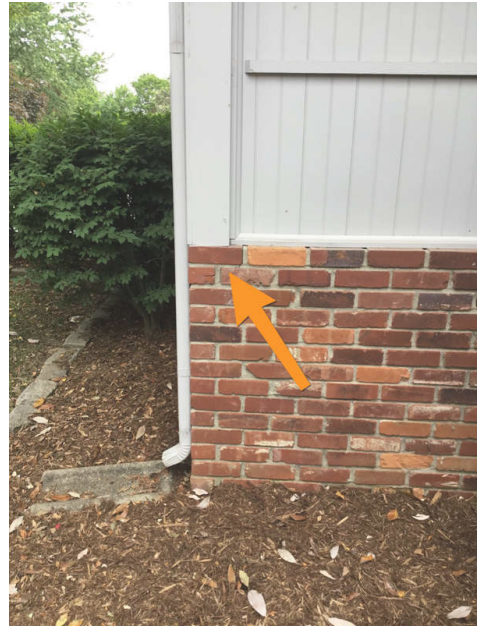
North

2.4.2 Siding, Flashing & Trim
CRACKING - MINOR

Siding showed cracking in one or more places. Recommend repair and tuck pointing maintenance of mortar.

Contact a qualified masonry professional.

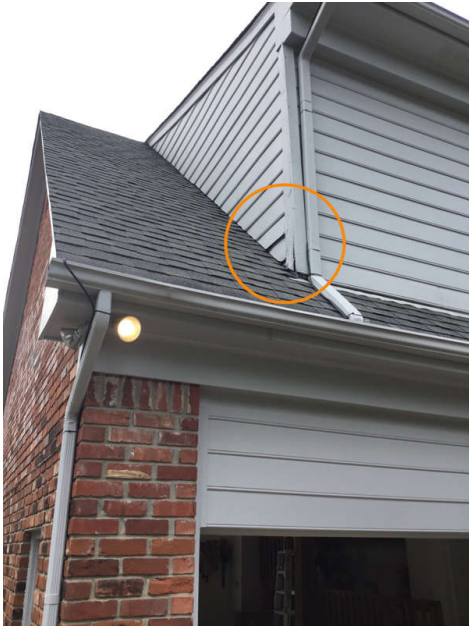
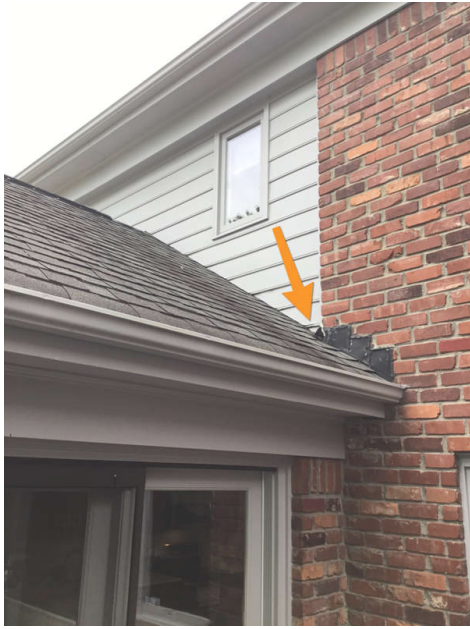
East

2.4.3 Siding, Flashing & Trim
SIDING DAMAGE - MINOR

Siding showed signs of minor damage. Recommend repairing/monitoring any damaged areas that may allow moisture intrusion.

Contact a qualified siding specialist.

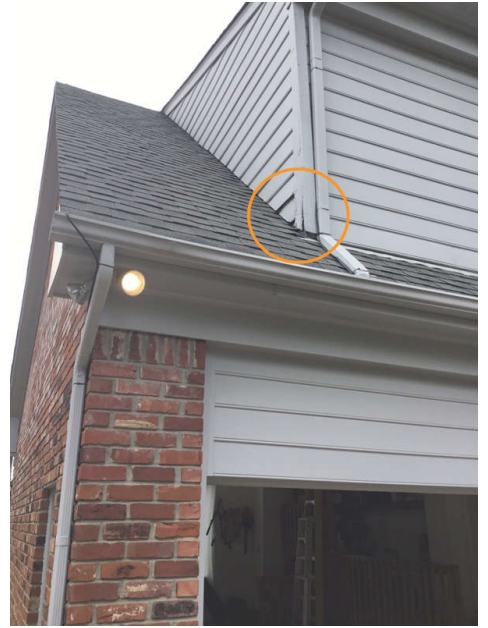
East

TRIM DAMAGED

Exterior trim is visibly damaged. Recommend repair/replacement of damaged sections

Contact a qualified carpenter.

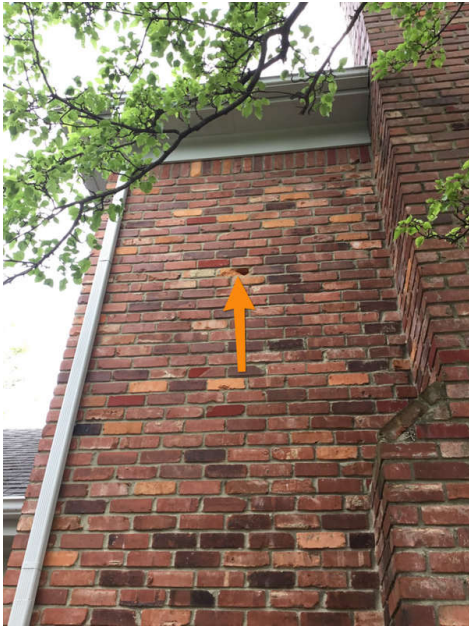
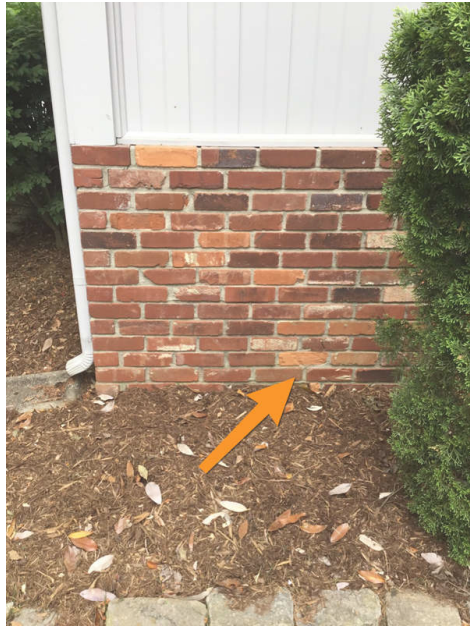
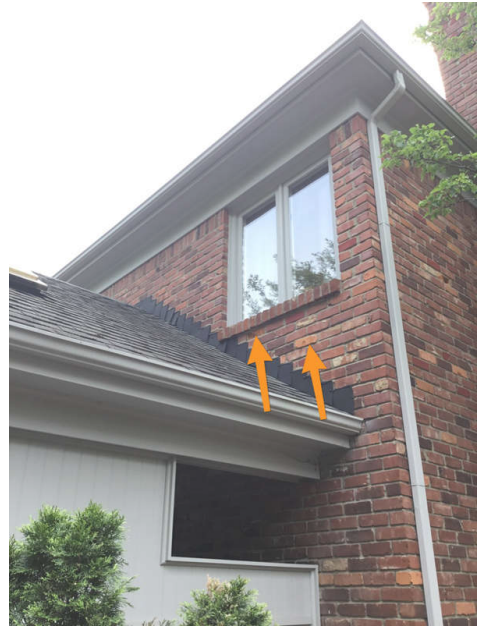
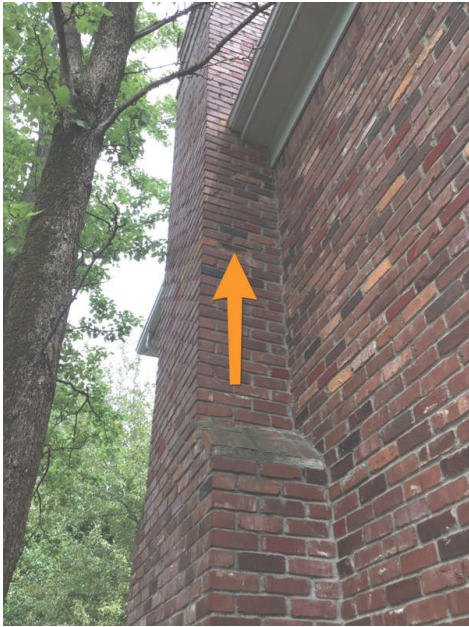
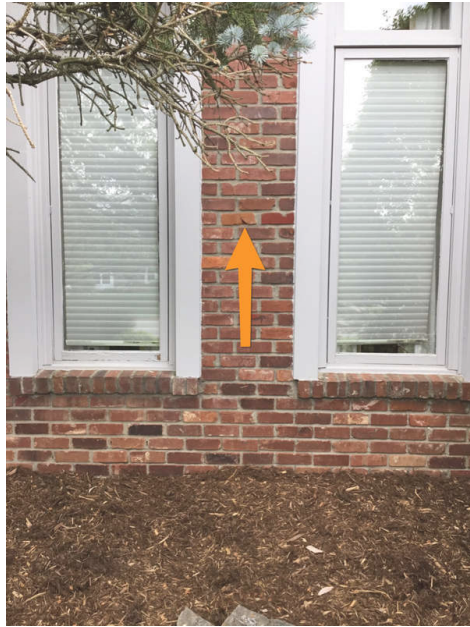
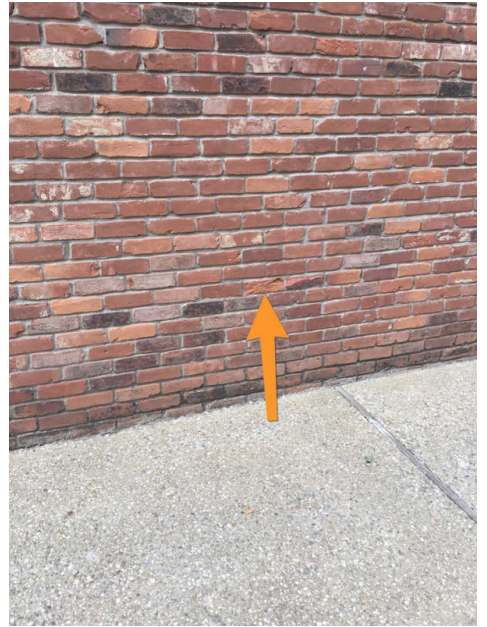
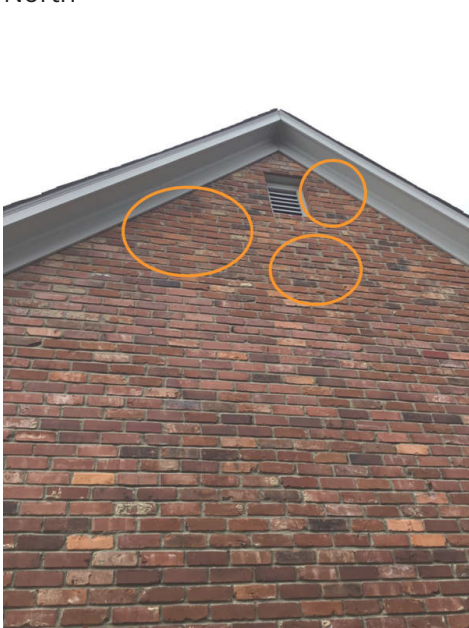
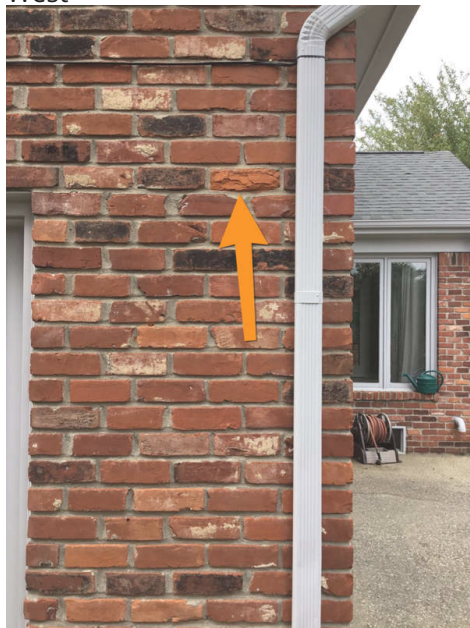
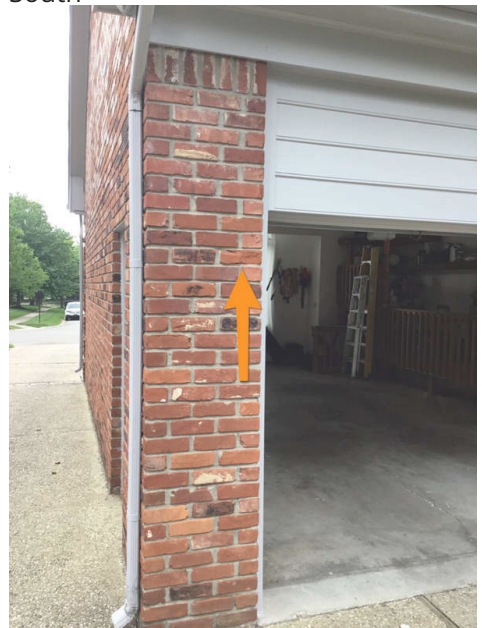
PUMPKIN BRICK

Pumpkin brick was noted on exterior siding. This is old brick of bad quality and is known to deteriorate. Recommend masonry contractor evaluate and repair/replace damaged bricks

Contact a qualified masonry professional.

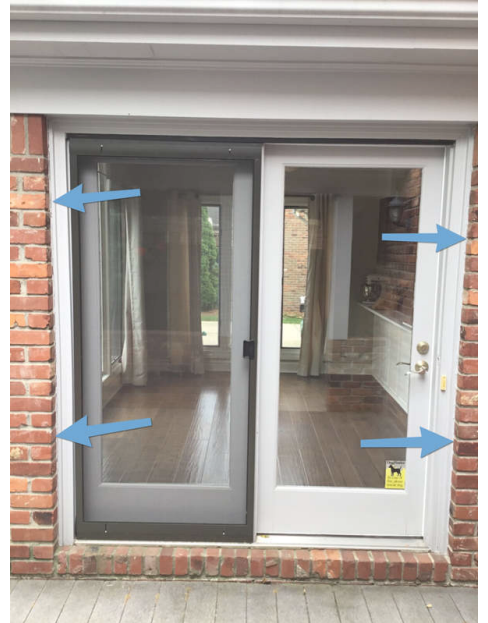
East

EXTERIOR DOOR- CAULKING MAINTENANCE

Recommend caulking around exterior door(s) where caulking is cracked/separated/missing.

Contact a qualified painter.

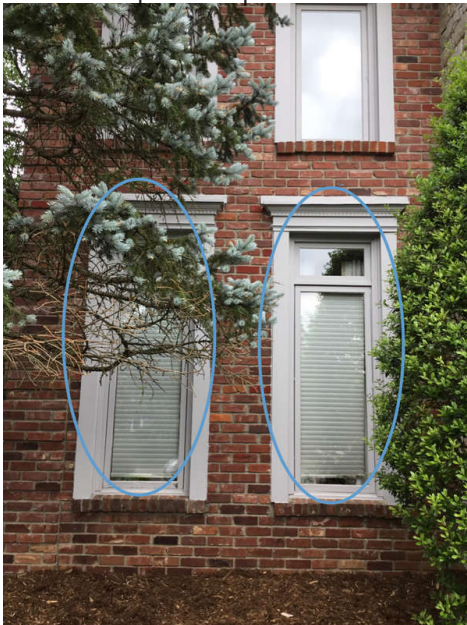
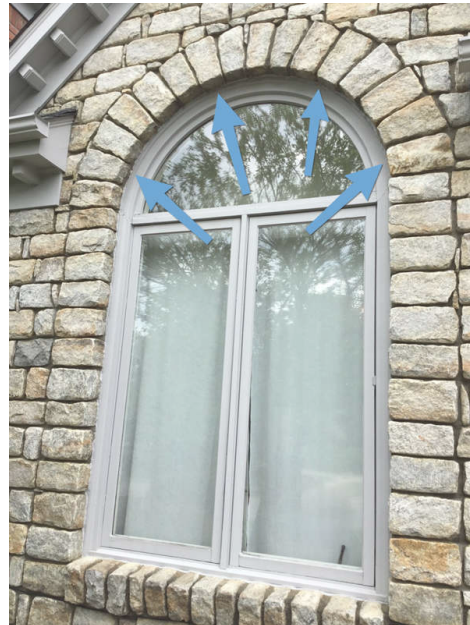
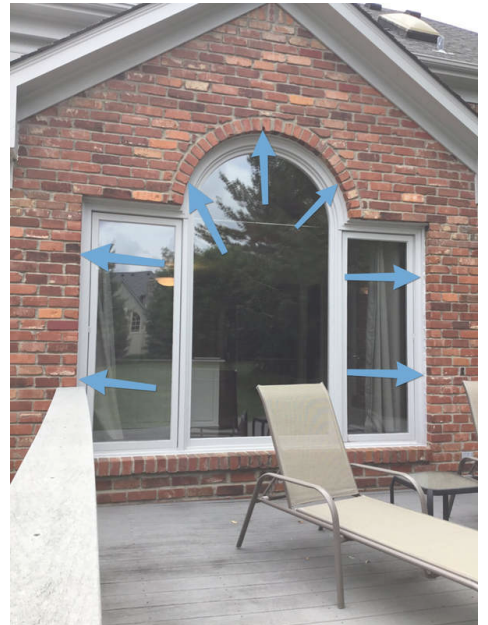
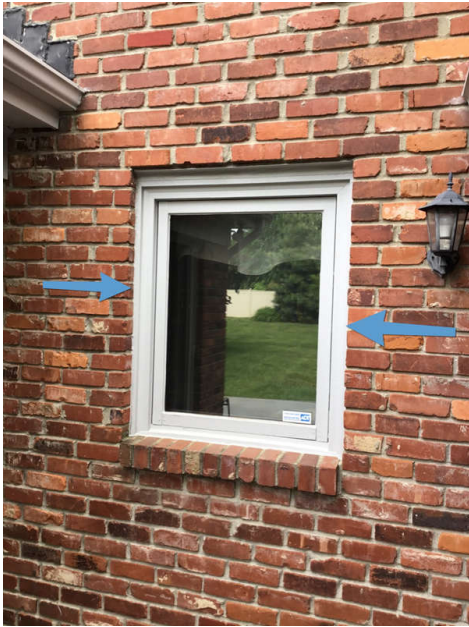
EXTERIOR WINDOWS- CAULKING MAINTENANCE

Exterior window caulking is cracked/separated/missing. Recommend caulking maintenance around windows/window trim

Contact a qualified painter.

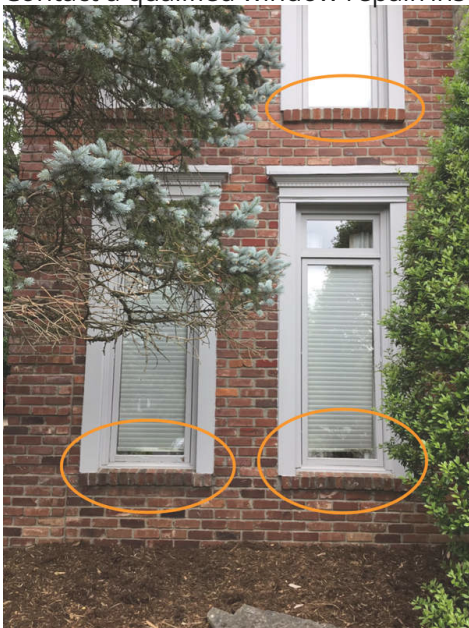
West

WINDOW FRAME DAMAGED

Window frame is damaged. Recommend repair/replacement of damaged frame(s).

Contact a qualified window repair/installation contractor.

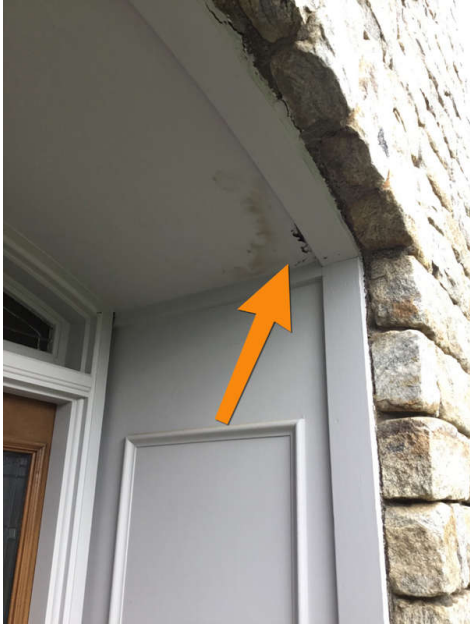
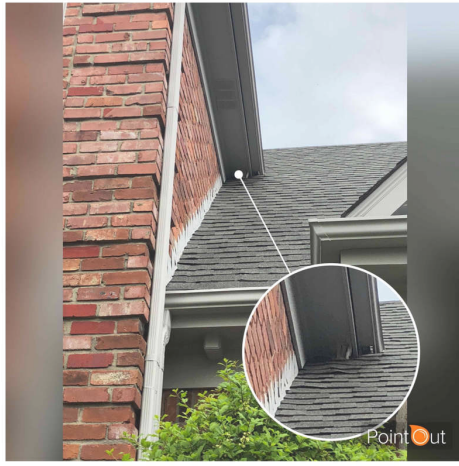
West

SOFFIT/EAVES - DAMAGED

One or more sections of the soffit/eaves are damaged. Recommend qualified roofer evaluate & repair.

Contact a qualified roofing professional.

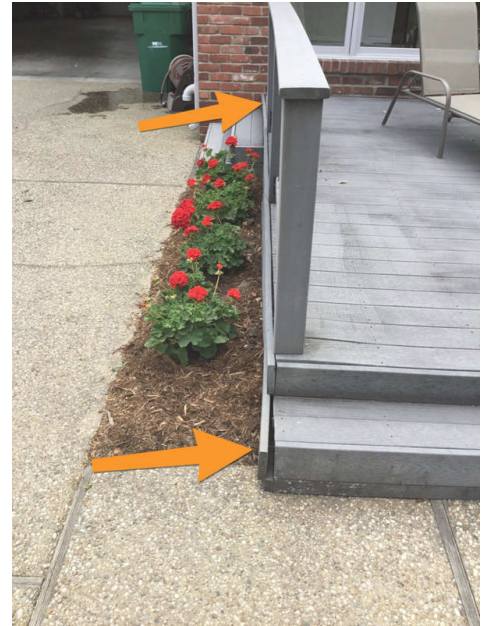
DECK - LOOSE BOARDS

One or more deck boards were observed to be loose. Recommend they be refastened.

Contact a qualified deck contractor.

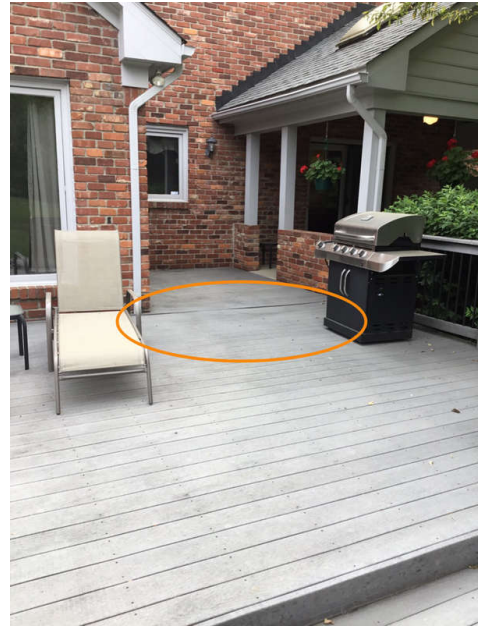
DECK - UNSTABLE SUPPORT

One of more areas of the deck support appears unstable. This could cause a safety hazard and further deterioration of the deck. Recommend qualified deck contractor evaluate and repair.

Contact a qualified roofing professional.

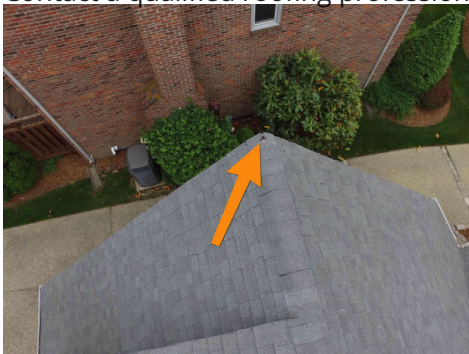
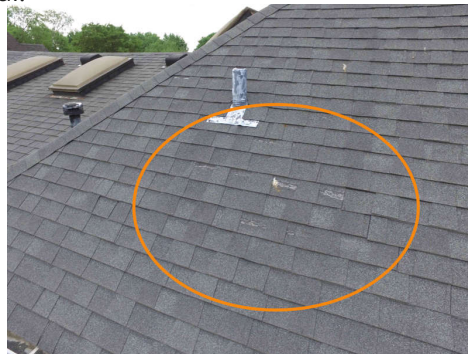
DAMAGED COVERINGS

Roof coverings exhibited general damage that could affect performance. Recommend a qualified roofer evaluate and repair.

Contact a qualified roofing professional.

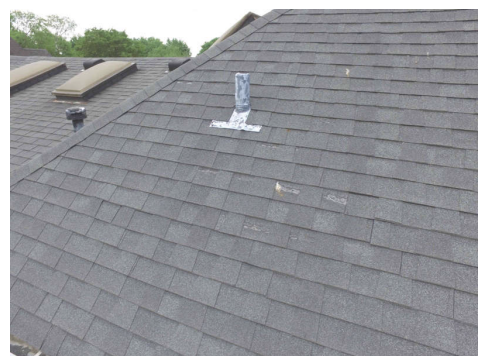
GRANULES MISSING/EXPOSED FELT

Asphalt shingles have missing granules/exposed felt. Recommend a roofing professional evaluate and repair as needed.

Contact a qualified roofing professional.

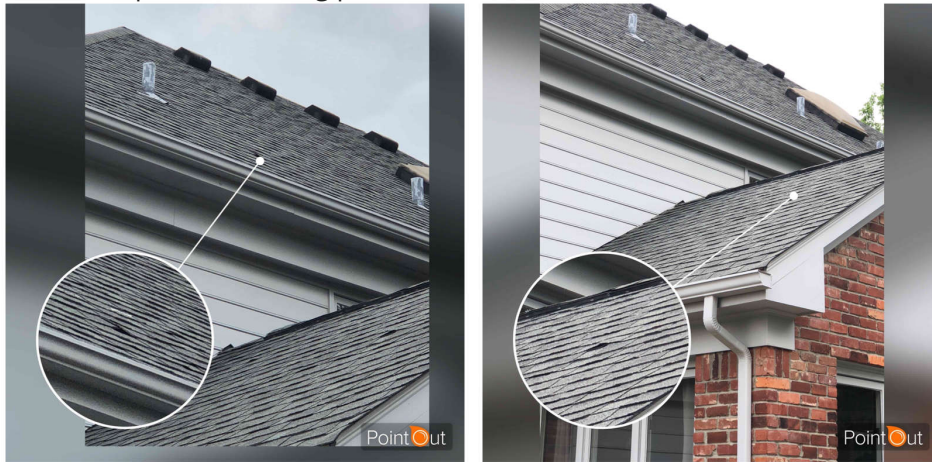
NAIL POPS

Visible nail pops in roof coverings. Recommend roofing professional evaluate and repair.

Contact a qualified roofing professional.

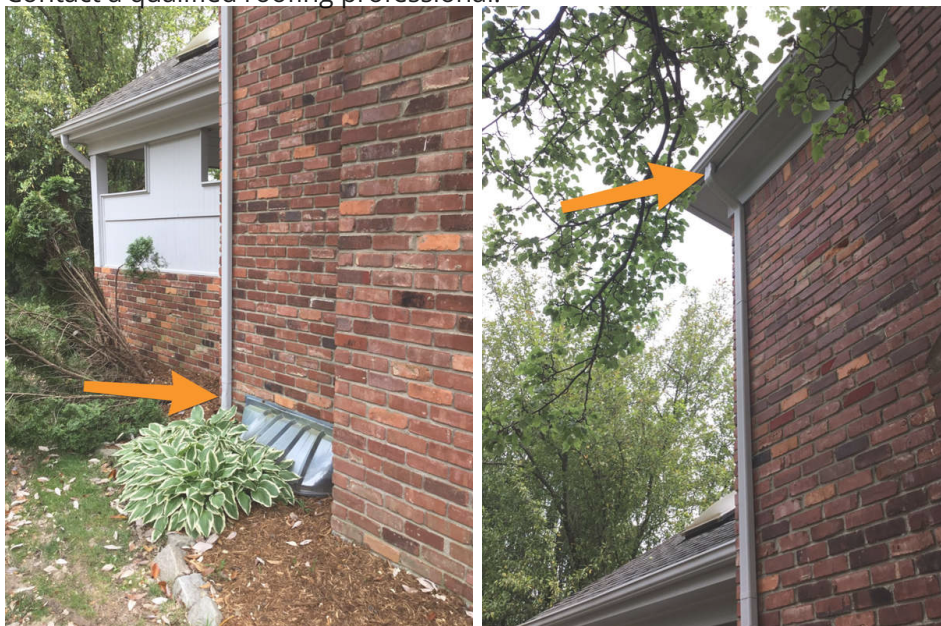
North

DOWNSPOUT DAMAGED

Downspouts were damaged. This can result in excessive moisture in the soil at the foundation, which can lead to foundation/structural movement. Recommend a qualified contractor evaluate and repair.

Contact a qualified roofing professional.

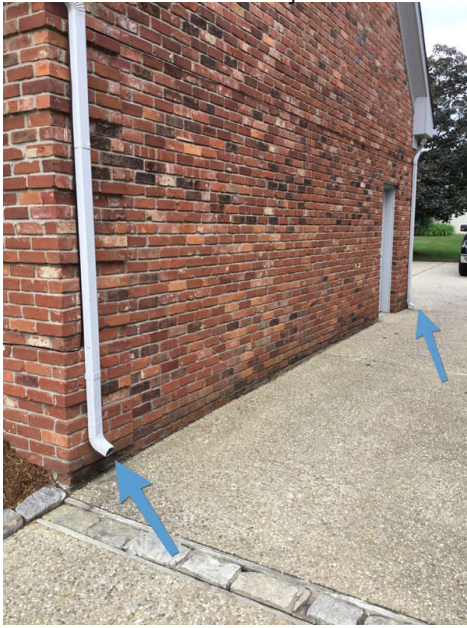
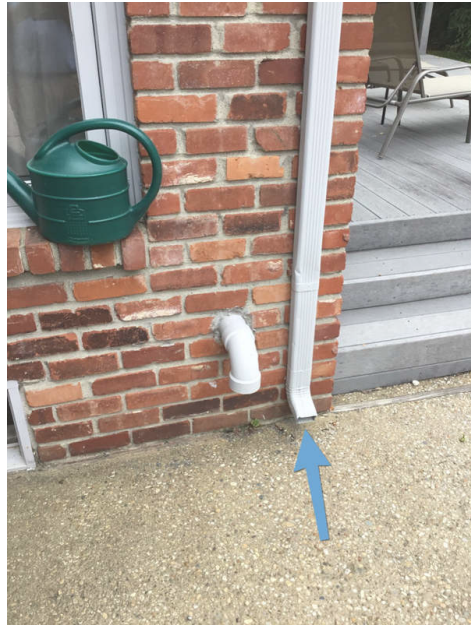
DOWNSPOUTS DRAIN NEAR HOUSE

One or more downspouts drain too close to the home's foundation. This can result in excessive moisture in the soil at the foundation, which can lead to foundation/structural movement. Recommend a qualified contractor adjust downspout extensions to drain at least 6 feet from the foundation.

Recommendation
Recommended DIY Project

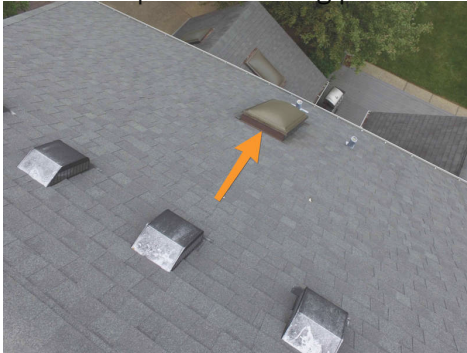
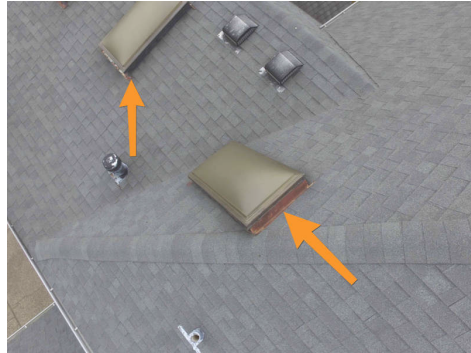
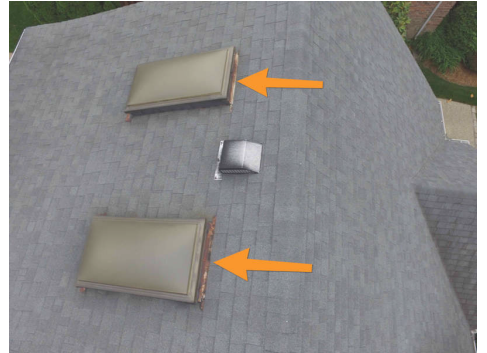
CORRODED - MINOR

Roof flashing showed signs of corrosion, but are still in working condition. Flashing should be evaluated and monitored to prevent severe corrosion leading to moisture intrusion.

Contact a qualified roofing professional.

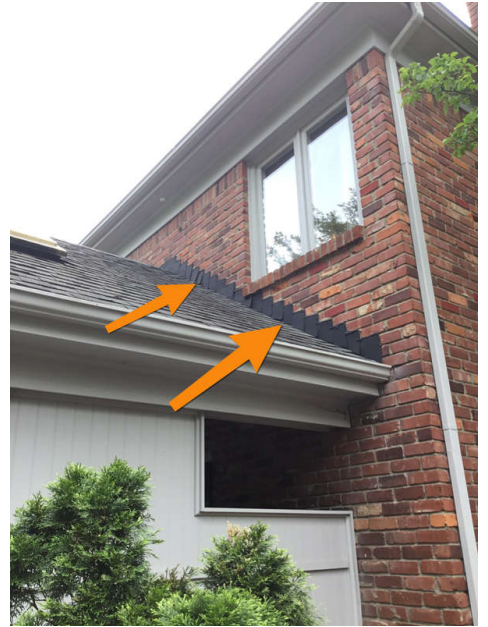
East

LOOSE/SEPARATED

Flashings observed to be loose or separated, which can lead to water intrusion and/or mold. Recommend a qualified roofing contractor repair.

Contact a qualified roofing professional.

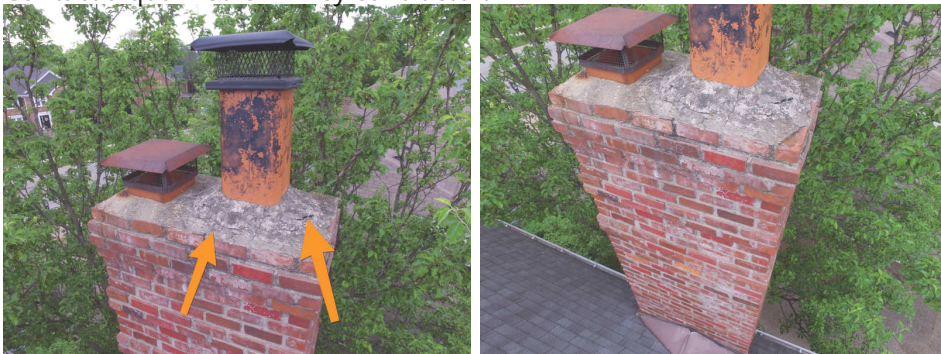
CHIMNEY CAP CRACKED

Chimney cap was visibly cracked. Recommend repair

Contact a qualified chimney contractor.

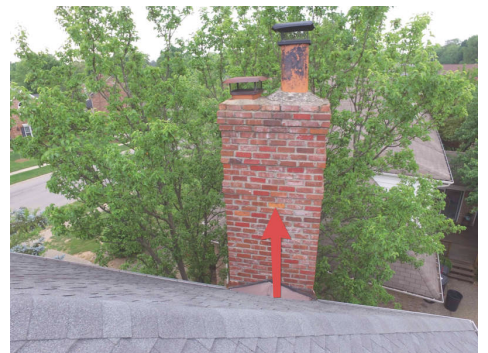
FLAKING/SPALLING BRICK

Chimney has visible flaking/spalling brick. Damaged/loose bricks present a potential safety hazard. Recommend repair.

Contact a qualified masonry professional.

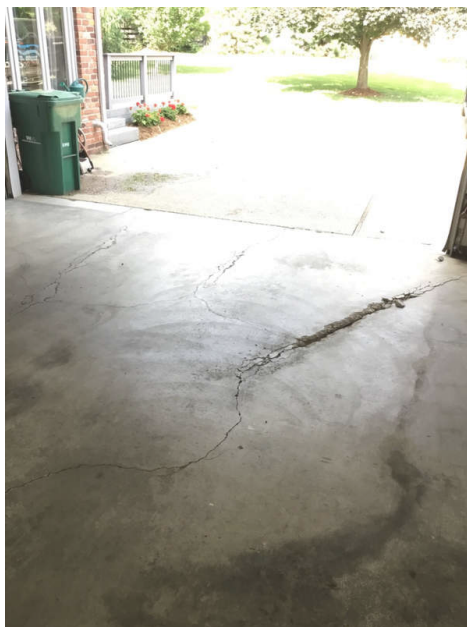
LARGE CRACKS/DAMAGE

Garage floor has large cracks and damage. Recommend concrete contractor evaluate and repair to preserve concrete slab

Contact a qualified concrete contractor.

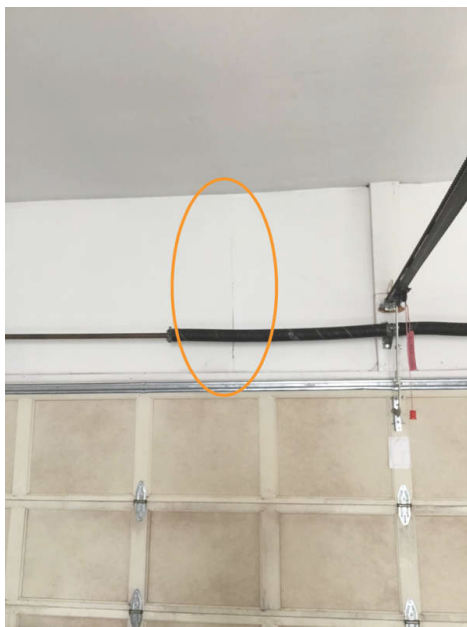
TYPICAL CRACKS/DAMAGE

Garage walls were noted as having typical cracks/damage. Recommend repair of cracked/damaged drywall

Contact a qualified drywall contractor.

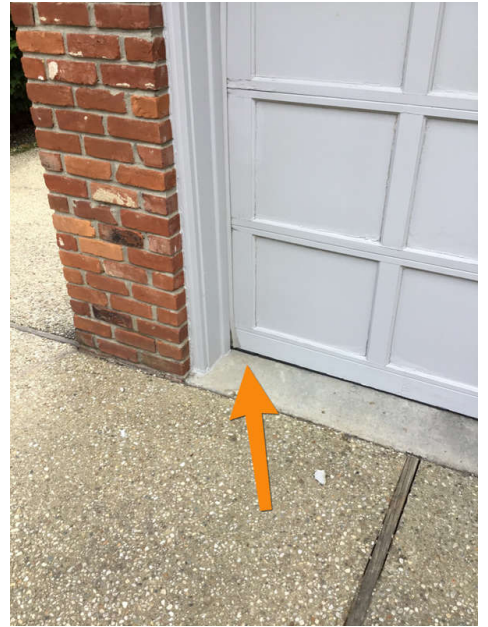
WEATHER STRIPPING DAMAGED

Overhead garage door weather stripping was noted as damaged. Recommend repair/replacement of damaged sections

Contact a qualified garage door contractor.

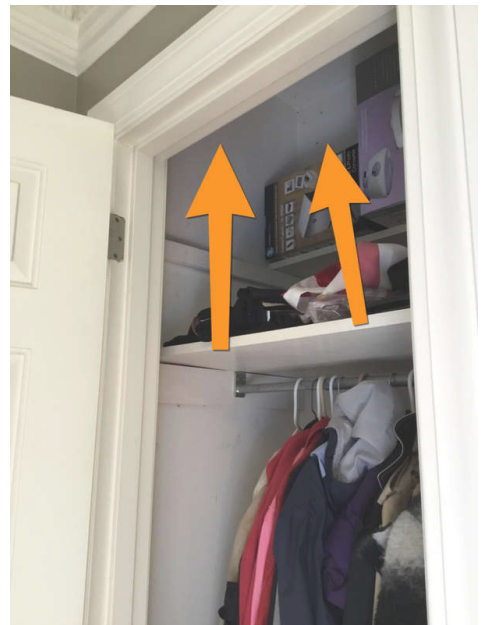
Foyer

WOOD DESTROYING INSECT DAMAGE

Wood Destroying Insect Damage apparent. Recommend further evaluation for damages and repair as needed

Contact a qualified general contractor.

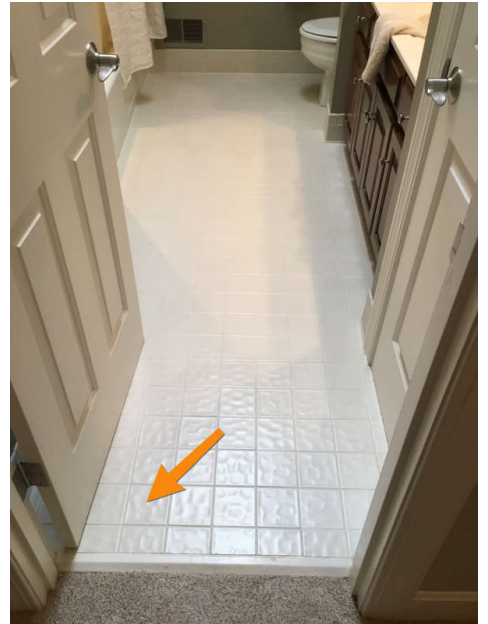
2nd Floor Bathroom

TILES CRACKED/DAMAGED

Floor tiles are visibly cracked/damaged. Recommend tile contractor repair/replace damaged tiles.

Contact a qualified tile contractor

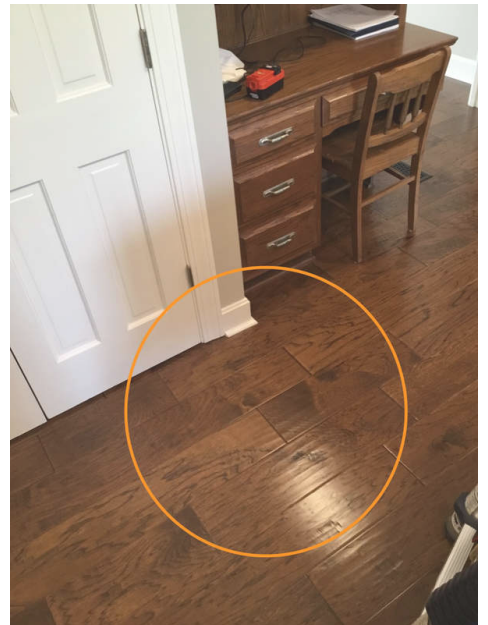
Kitchen

SOFT/BOUNCY FLOORS

Soft/Bouncy Floors were noted at time of inspection. Recommend flooring contractor evaluate and repair

Contact a qualified flooring contractor

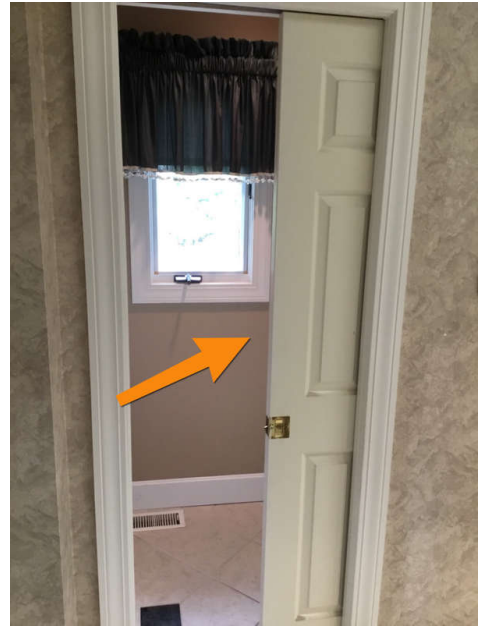
Master Bathroom

DOOR DOESN'T LATCH

Door doesn't latch properly. Recommend handyman repair to ensure proper operation

Contact a qualified handyman.

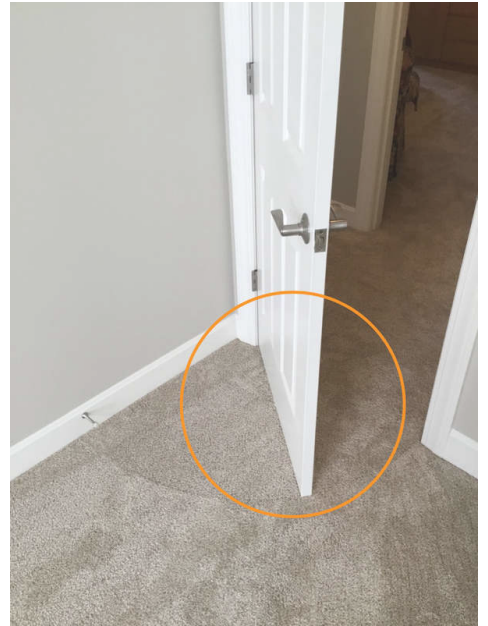
Left Bedroom

DOOR DRAGGING CARPET

Door(s) is dragging carpet when operated. Recommend adjusting to ensure proper operation.

Contact a qualified door repair/installation contractor.

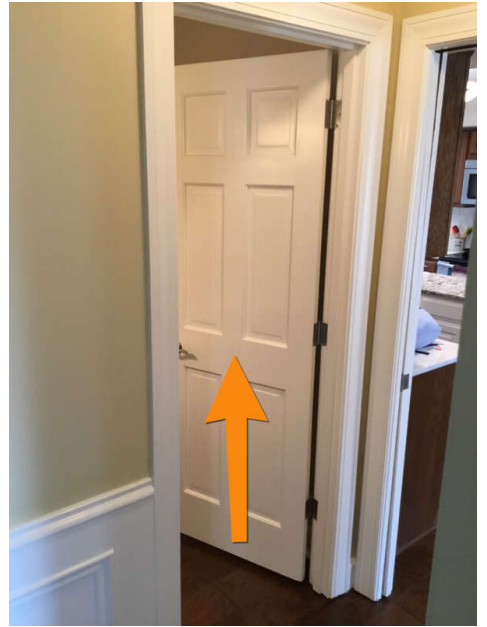
DOOR WARPED/TWISTED

Door is noticeably Warped/Twisted. Recommend repair/replacement as needed

Contact a qualified door repair/installation contractor.

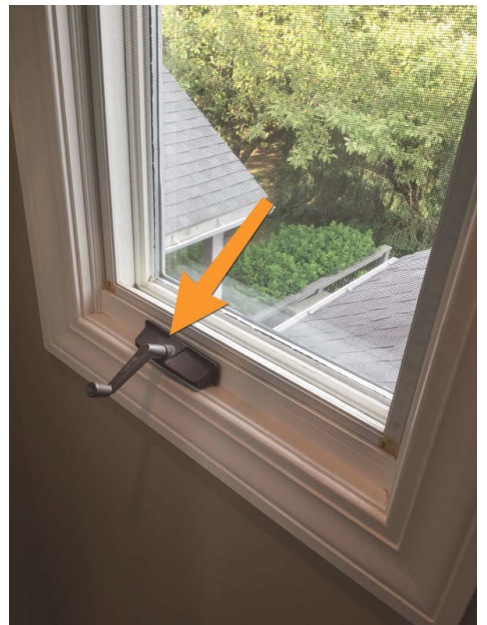
DAMAGED/MISSING HARDWARE

Some windows have damaged/missing hardware. Recommend repairing to ensure proper operation.

Contact a qualified window repair/installation contractor.

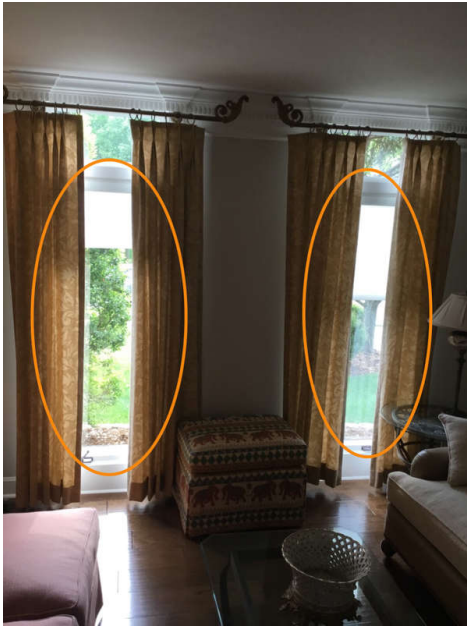
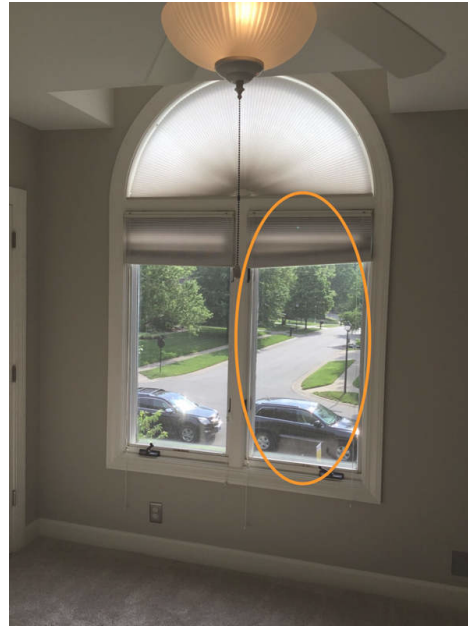
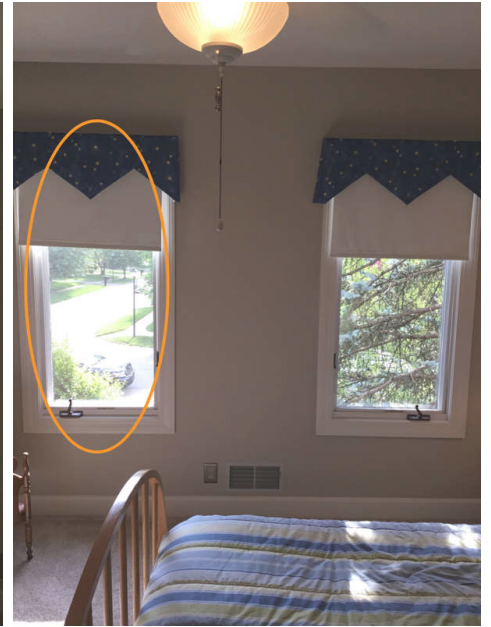
WINDOW WONT OPEN

Window will not open under normal operating procedures. Recommemd repair.

Contact a qualified window repair/installation contractor.

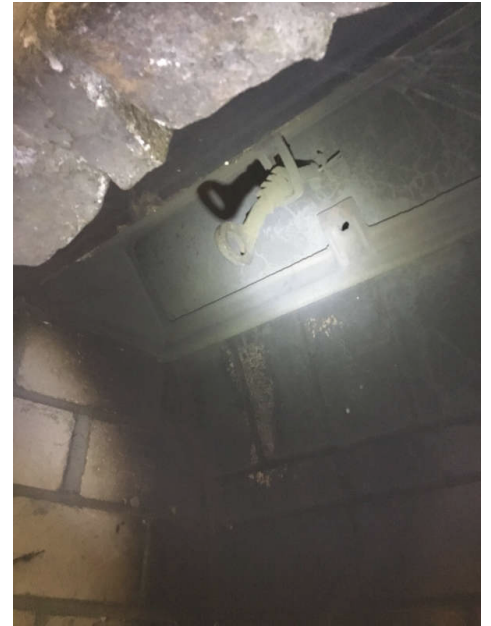
CHIMNEY LINER DIRTY

Chimney liner had layer of creosote dust, so underlying structure couldn't be inspected for cracks. Recommend qualified chimney sweep company inspect and/or clean.

Contact a qualified chimney contractor.

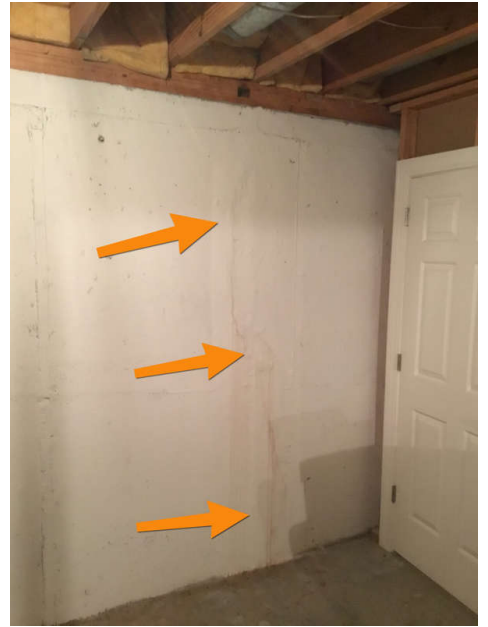
INTERIOR FOUNDATION CRACKS - MINOR

Minor cracking was noted at the foundation. This is common as concrete ages and shrinkage surface cracks are normal. Recommend repairing/sealing cracks and monitoring for more serious shifting/displacement.

Contact a foundation contractor.

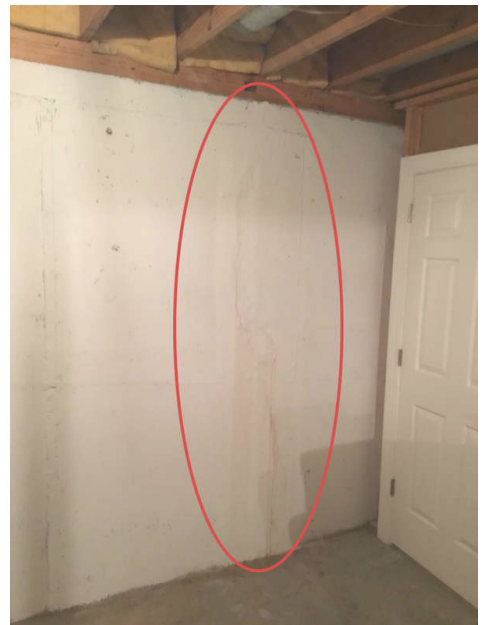
WATER INTRUSION

Water intrusion was evident in the basement/crawlspace. This can compromise the basement/crawlspace and could cause damage. Recommend a qualified contractor identify the source of moisture and remedy.

Contact a foundation contractor.

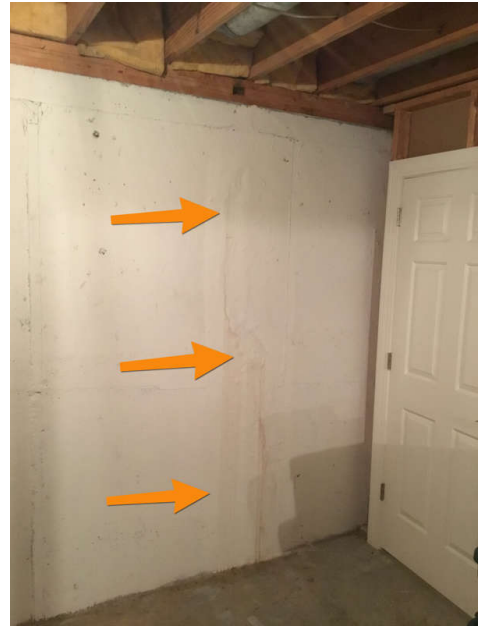
REPAIRED/WATERPROOFED FOUNDATION CRACKS

Visible Repaired/Waterproofed Foundation Cracks were noted at time of inspection. Recommend obtaining any warranty information from owner and monitoring

Contact a qualified professional.

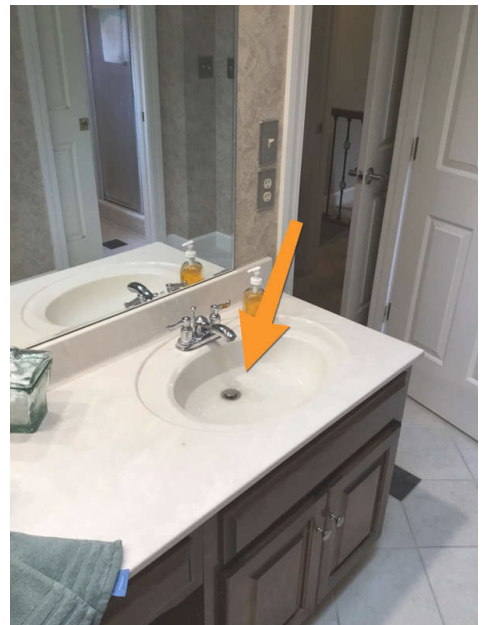
Master Bathroom

POOR/SLOW DRAINAGE

Poor/slow drainage was observed at time of inspection. Recommend a qualified plumber evaluate and repair.

Contact a qualified plumbing contractor.

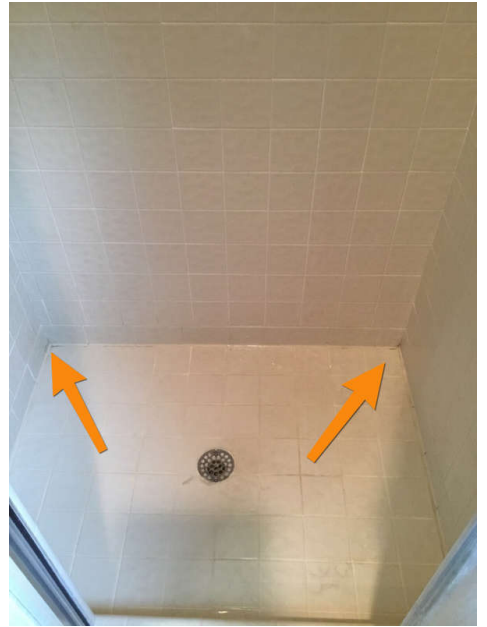
Master Bathroom

CAULK/GROUT SHOWER SURROUND

Recommend caulking/grouting shower surround where caulk/grout is cracked/separated/missing. This will help prevent moisture damages from occurring.

Contact a qualified professional.

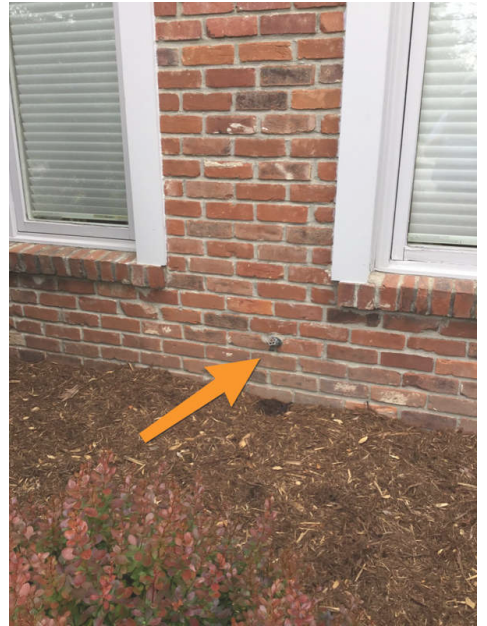
West

HOSE BIB LEAKING/DRIPPING

Hose bib is leaking/dripping. Recommend plumber evaluate and repair

Contact a qualified plumbing contractor.

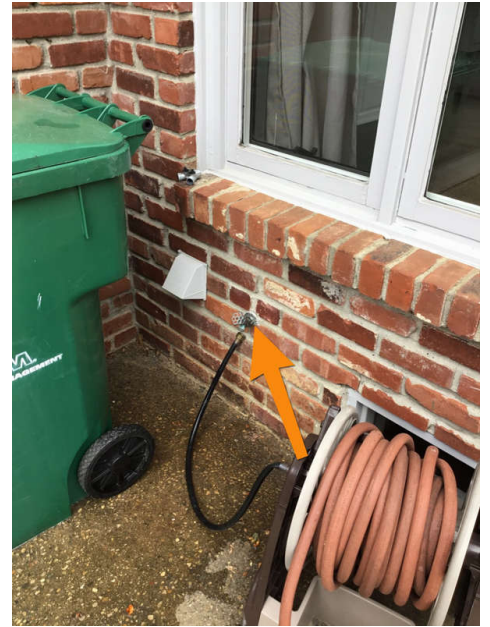
East

SECURE HOSE BIB

Hose bib is not properly secured to exterior of home. Recommend anchoring hose bib to home.

Recommended DIY Project

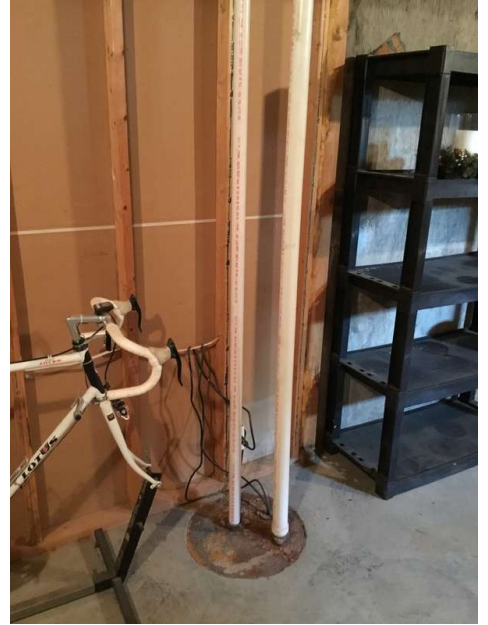
INSTALL CHECK VALVE

Recommend installing check valve on sump pump discharge line

Contact a qualified plumbing contractor.

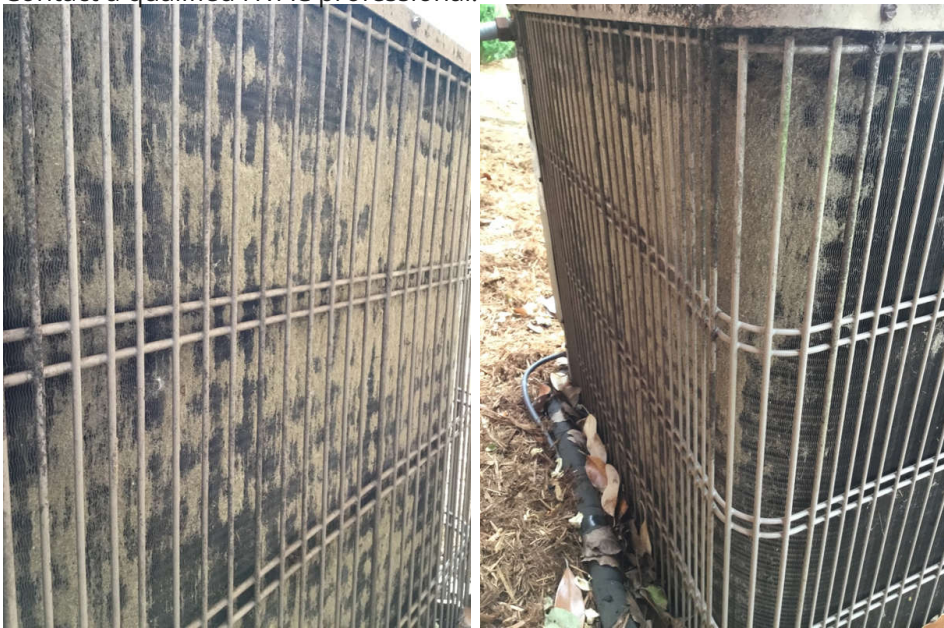
13.1.1 Cooling Equipment
AIR FLOW RESTRICTED

Air flow to the air conditioner condenser was restricted. This may result in inefficient operation. Recommend cleaning dirt and/or debris from unit.

Recommendation
Contact a qualified HVAC professional.

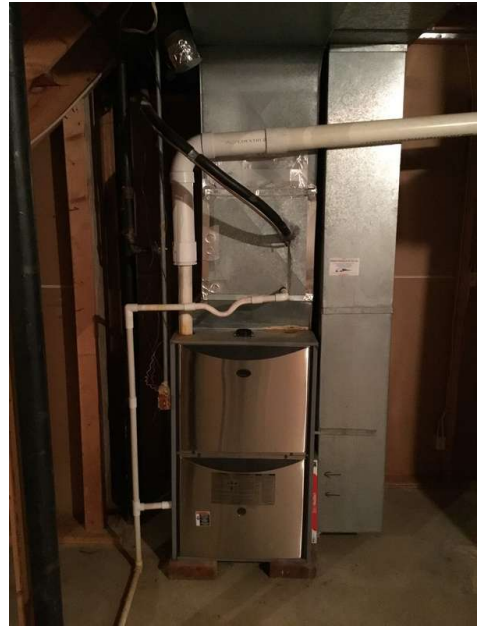
13.1.2 Cooling Equipment
FAILED TO PRODUCE COLD AIR

The air conditioner was functional but did not produce cold air. Recommend licensed HVAC contractor evaluate.

Recommendation
Contact a qualified HVAC professional.

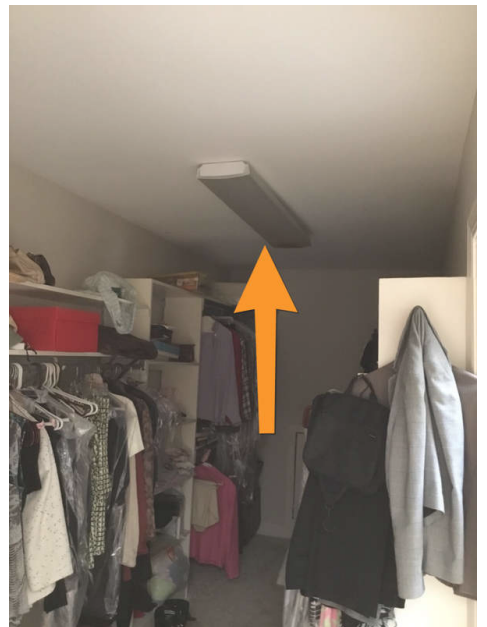
Master Bedroom

LIGHT INOPERABLE

One or more lights are not operating. New light bulb possibly needed.

Contact a qualified electrical contractor.
