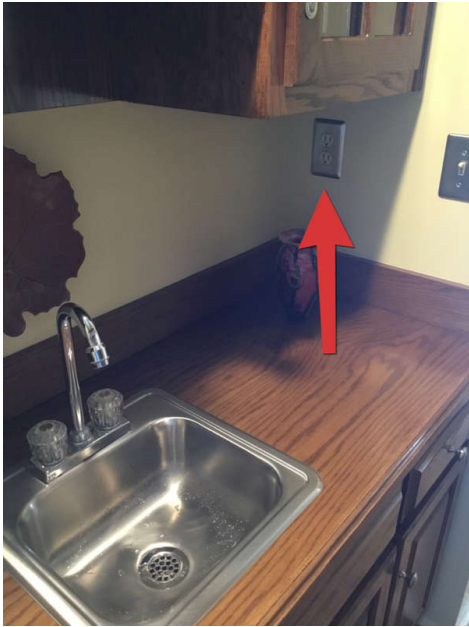
Living Room

NO GFCI PROTECTION INSTALLED

No GFCI protection present in noted locations. Recommend licensed electrician upgrade by installing ground fault receptacles in all noted locations.

Contact a qualified electrical contractor.

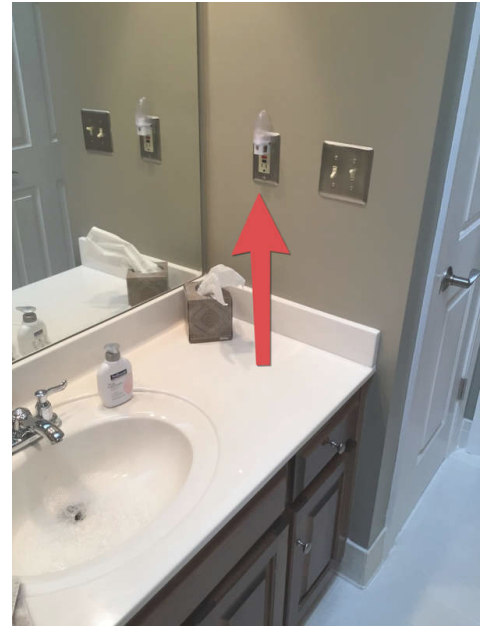
2nd Floor Bathroom

OUTLET(S) WON'T TRIP

One or more outlets won't "trip" when tested. Recommend a qualified electrician evaluate and repair.

Contact a qualified electrical contractor.
