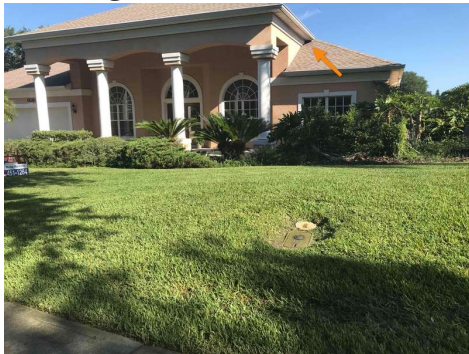
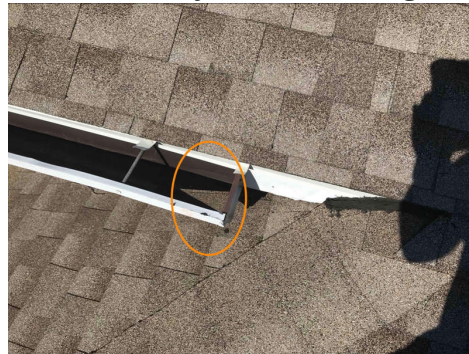
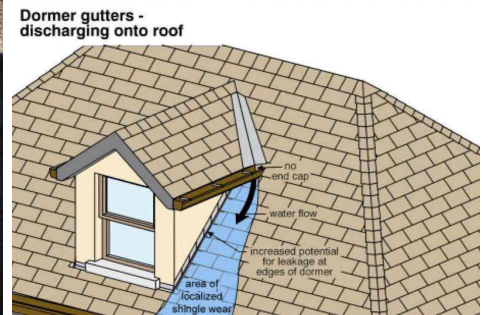
2.3.1 Gutters/drains

**GUTTER DRAINS ON ROOF**

One or more downspouts terminated above a roof surface, and rainwater from the downspouts washes over the roof surface below. This is a common configuration, but in some cases large quantities of rainwater can damage shingles by removing granules and reduce the life of the roof surface. Consider installing extensions to route the rainwater directly to the closest gutter below to prevent such damage.

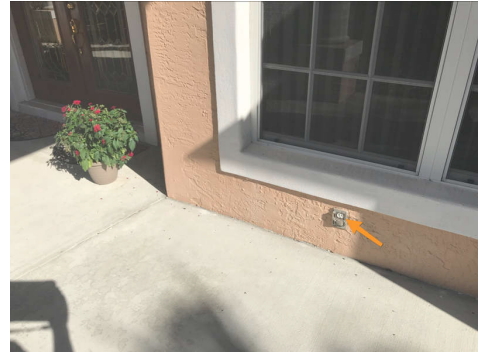
3.3.1 Electrical

**WATERPROOF COVER DAMAGED**

Waterproof cover(s) over one or more electric receptacles are damaged or broken. This is a safety hazard due to the risk of shock and fire. Damaged covers should be replaced where necessary.

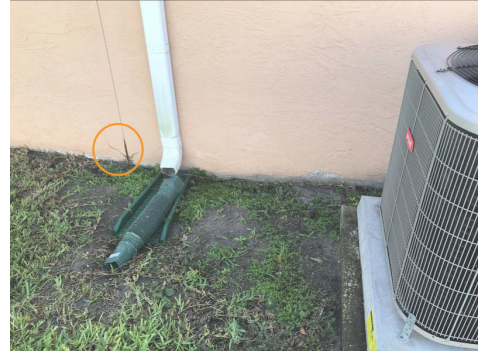
3.8.1 Wall Structure & Coverings

**STUCCO-CORNER RUST**

Metal corner bead used for stucco was corroded at one or more locations.

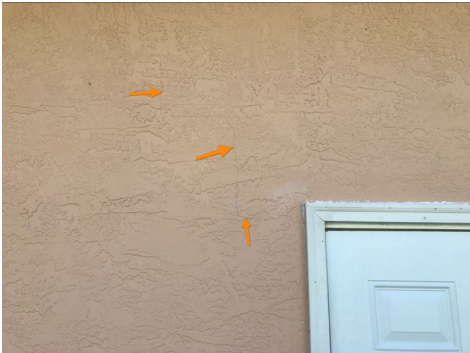
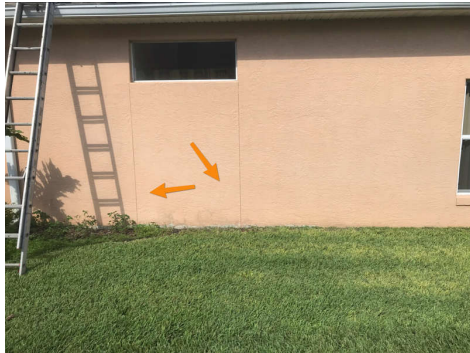
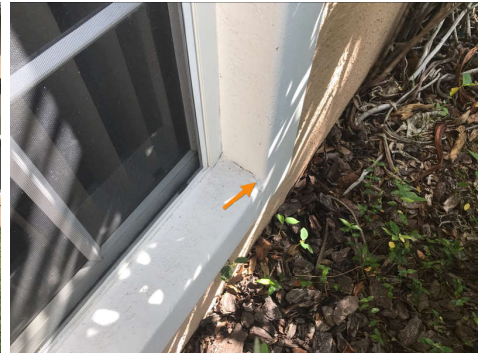
3.8.2 Wall Structure & Coverings

**CRACKING-MINOR**

One or more minor cracks were found in the wall areas. It is unknown the age of these cracks. At the time of inspection nothing out of the ordinary of normalized cracking was noticed. Recommend caulking and painting these areas, along with monitoring for future movement/widening. Cracks over framing can allow moisture penetration behind wall areas and can potentially damage sheathing/framing. Note that areas concealed behind walls are not able to be evaluated without invasive testing and cannot be evaluated.

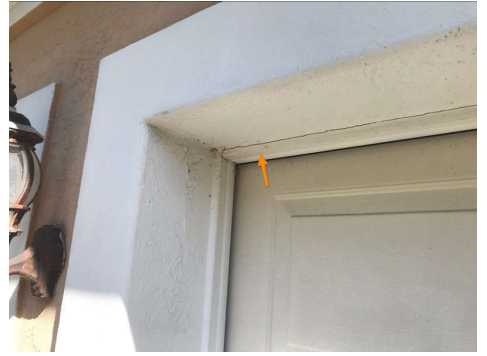
3.8.3 Wall Structure & Coverings

**SIDING/TRIM ISSUES**

Sections of siding and/or trim were *deteriorated / loose / split / warped / missing / damaged / substandard / rotten*. Recommend that a qualified person repair, replace or install siding or trim as necessary.

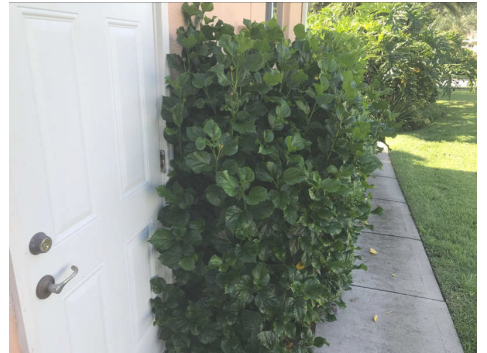
### 3.9.1 Vegetation and Grading **VEGETATION**

Vegetation such as trees, shrubs and/or vines was in contact with or close to the building exterior. Vegetation can serve as a pathway for wood-destroying insects and can retain moisture against the exterior after it rains. This is a conducive condition for wood-destroying organisms. Recommend pruning, moving or removing vegetation as necessary to maintain at least 6 inches of space between it and the building exterior. A 1-foot clearance is better.

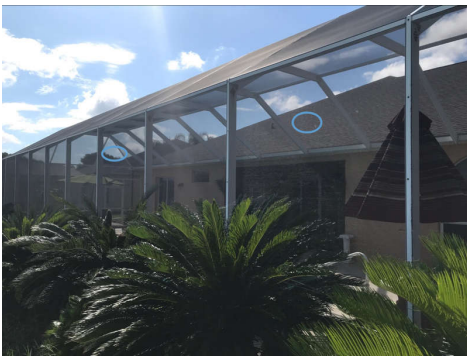
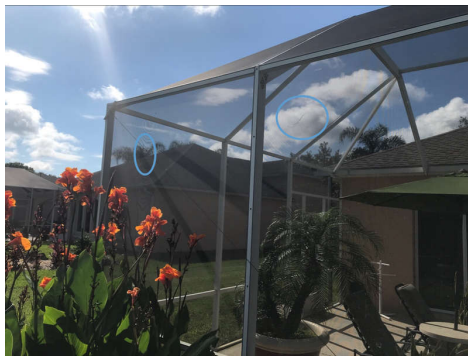
### 3.12.1 Screen Enclosure **SCREEN ENCLOSURE SCREEN TORN/PATCHED**

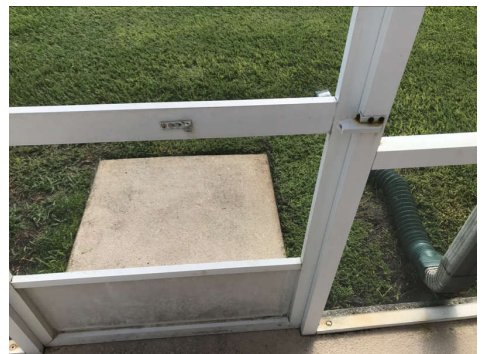
### 3.12.2 Screen Enclosure **SCREEN DOOR CLOSURE**

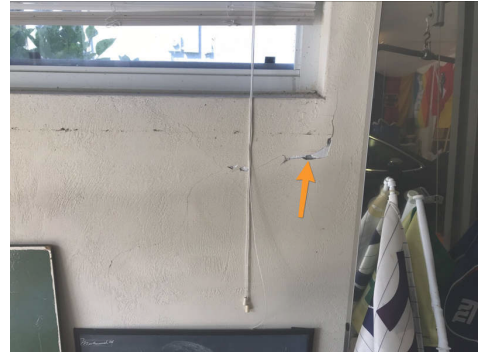
4.1.1 Floors, walls, Ceiling

### CEILING/WALL DAMAGE

There is damage to the ceiling/wall. This can allow gases and fumes to enter the homes living spaces. These areas should be properly finished.

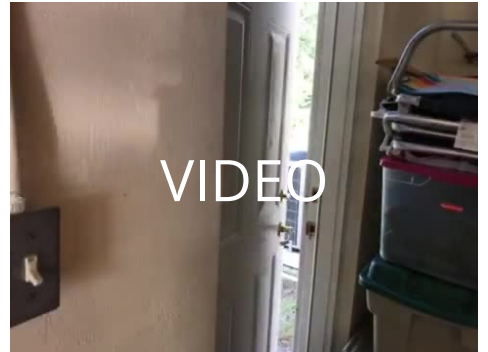
4.2.1 Doors/Windows

### EXTERIOR DOOR DIFFICULT

One or more exterior doors were difficult or sticking. Recommend that a qualified person repair as necessary.

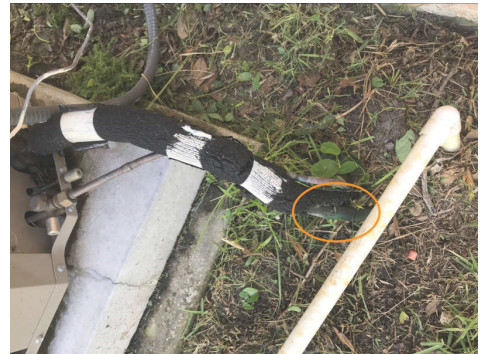
5.2.1 Condensing Unit

### LINE INSULATION

Insulation for the outside condensing unit's refrigerant lines is damaged, deteriorated and/or missing in one or more areas. This may result in reduced efficiency and increased energy costs. A qualified heating and cooling contractor should replace insulation as necessary.

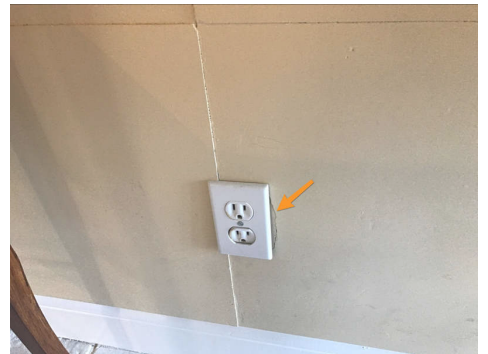
8.3.1 Branch Circuit

### RECEPTACLE DAMAGE

One or more receptacles were broken or damaged. This is a potential shock or fire hazard. Recommend that a qualified electrician replace such receptacles as necessary.

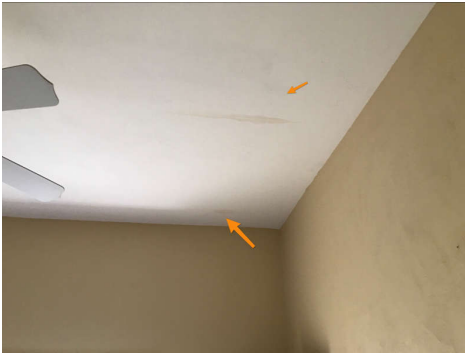
10.2.1 Floors, Walls, Ceilings

### CEILING-DRY STAINS

Stains were found in one or more ceiling areas. However, no elevated levels of moisture were found. The stain(s) may be due to past roof and/or plumbing leaks. Recommend asking the property owner(s) about this, and monitoring the stained area(s) in the future, especially after heavy or prolonged rain. If elevated moisture is found in the future, a qualified contractor should evaluate and repair as necessary.

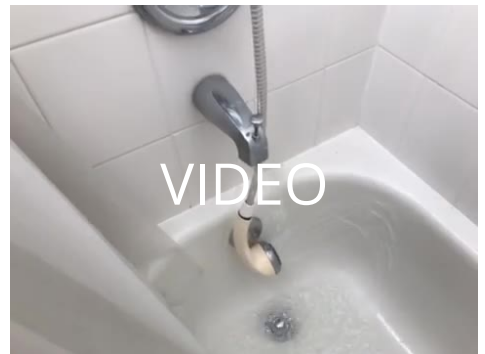
### 15.8.1 Bathub

#### MIXING VALVE

The mixing valve in one or bathrooms is not properly operating. The mixing valve allows the hot and cold water to mix so the temperature can be controlled by any person. The mixing valve is not properly mixing hot and cold water at the valve. There is only hot or cold water coming out of the mixing valve. It is recommended to have a Certified Plumbing Contractor make the necessary repairs.

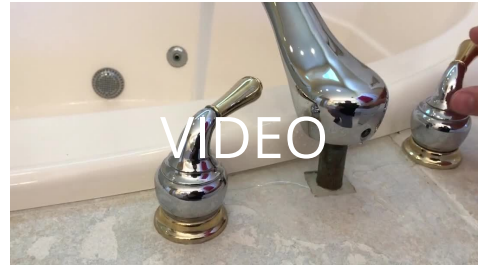
17.8.1 Bathub

**FAUCET LEAKS ON**

One or more faucets leak by handle(s) or at their base when turned on. A qualified plumber should evaluate and repair as necessary.

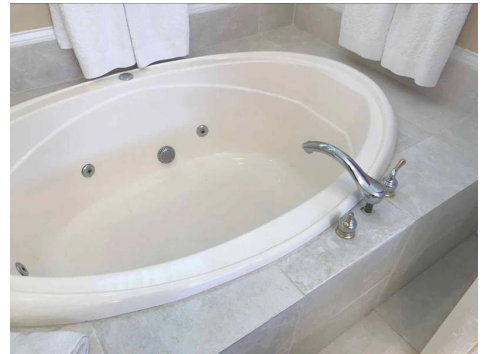
17.8.2 Bathub

**JETTED TUB INOPERABLE**

The jetted tub was inoperable. The tub should be evaluated and repaired as needed.

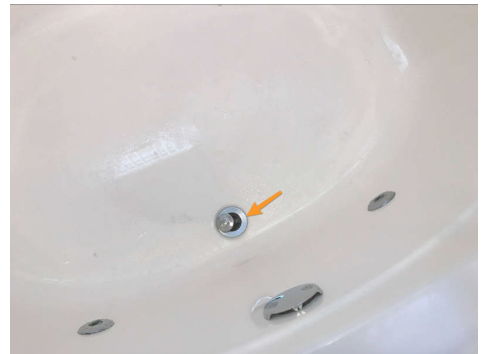
17.8.3 Bathub

**STOPPER ISSUE**

The bath tub stopper mechanisms are missing, or need adjustment or repair. Stopper mechanisms should be installed where missing and/or repairs should be made so sink stoppers open and close easily.

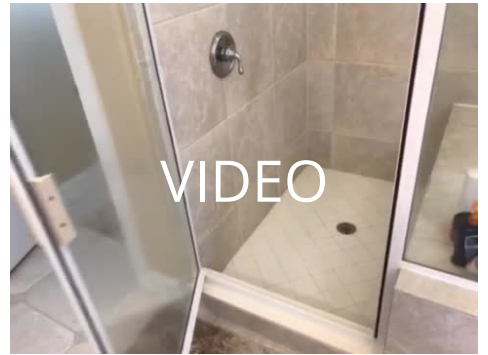
17.9.1 Shower

**SHOWER DOOR**

The shower door does not properly close on the rail. The shower door should be repaired or replaced to prevent damage to the door.

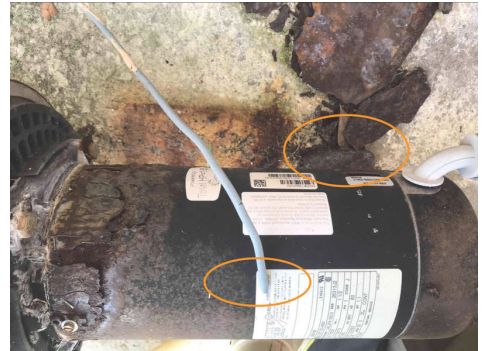
### 21.1.1 Pool Equipment

#### **BONDING**

The bonding wire is missing or not properly connected to the pool circulation pump and or other pool equipment. It is highly recommended to have the wire properly installed for safety.

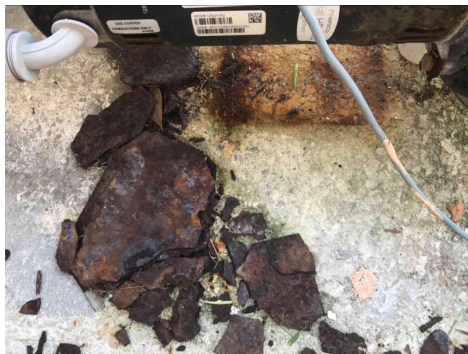
### 21.1.2 Pool Equipment

#### **EQUIPMENT EVALUATION**

Because of the age and condition of the equipment, It is recommended that the pool pump and filter system be evaluated. It's also advised to seek guidance for the proper operation and maintance of the pool equipment as many systems differ.

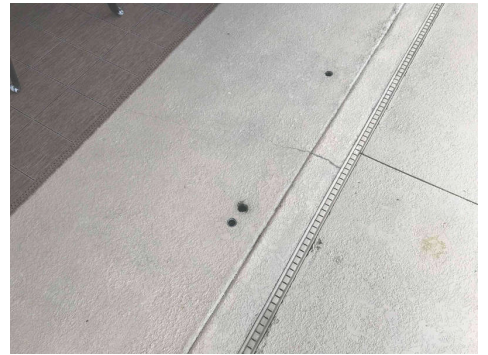
21.4.1 Pool and decking

**DECK CRACKING MINOR**

The pool deck has some minor deck cracking. It does not appear to be structural at this time, but it is recommended to monitor the area(s) in concern in the future.
