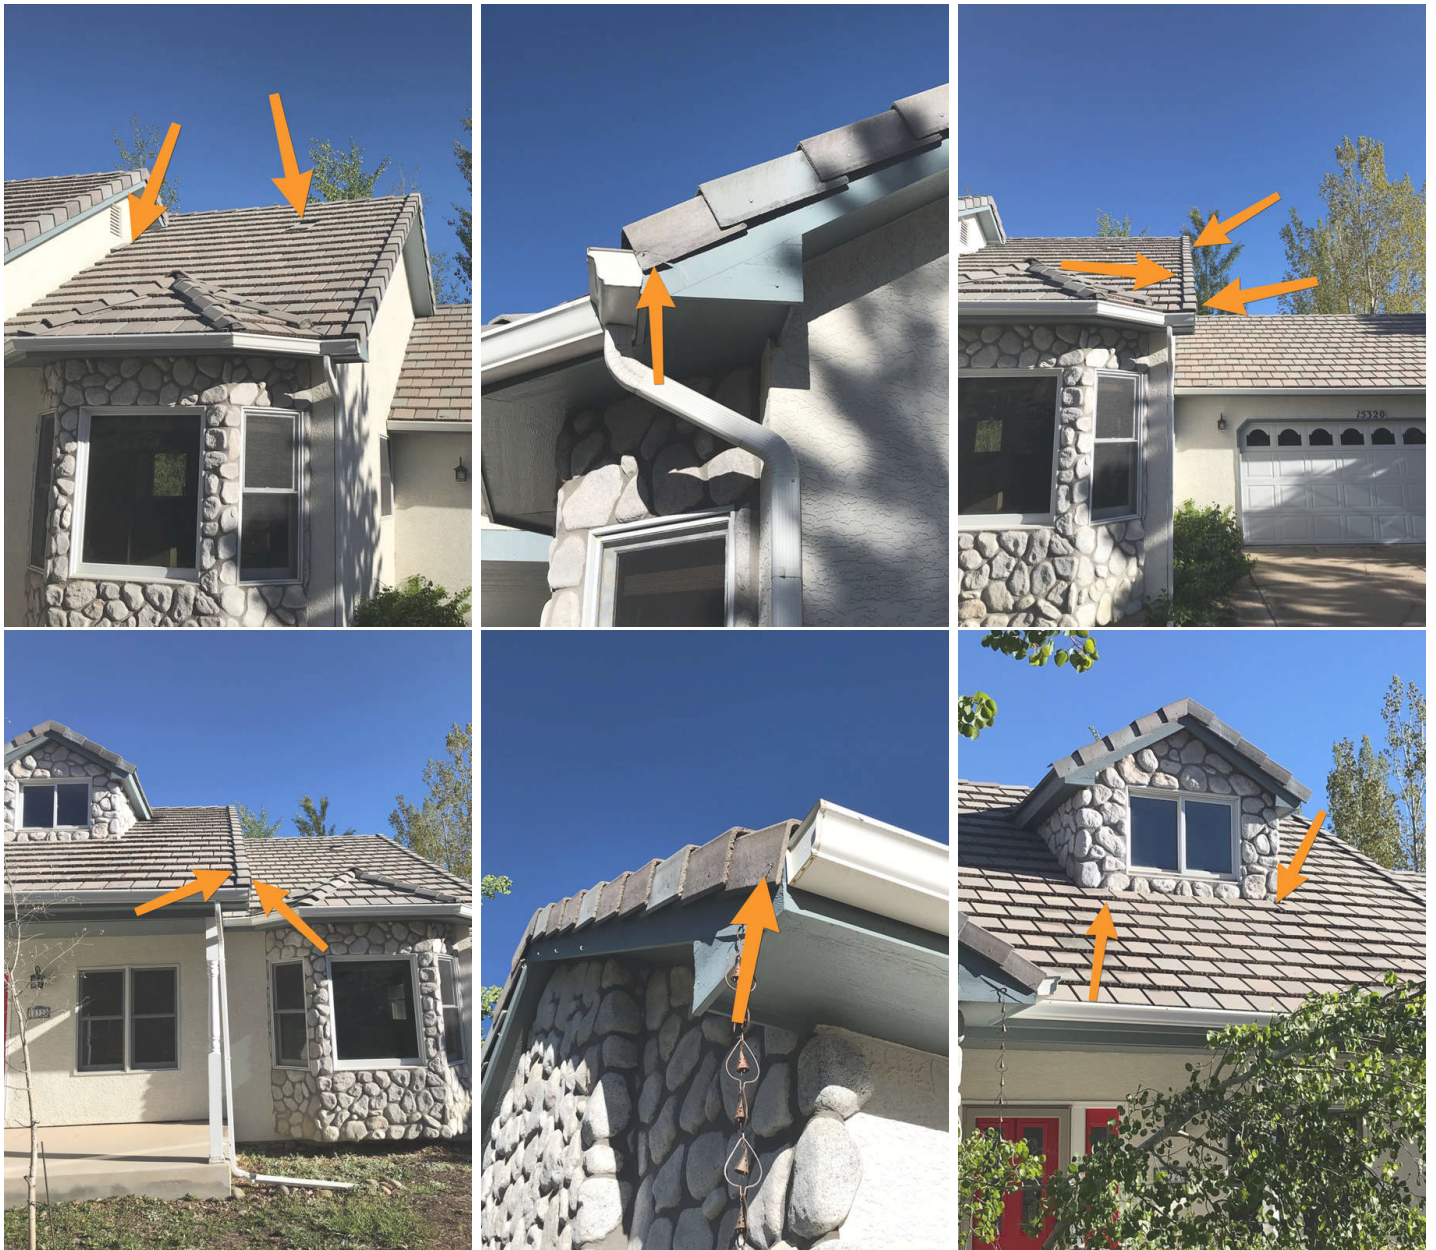
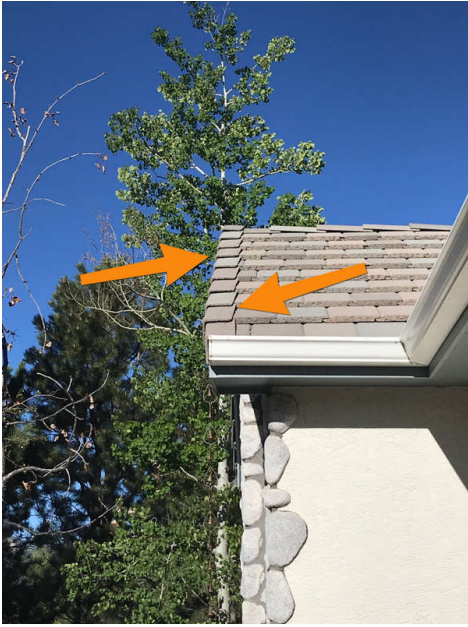
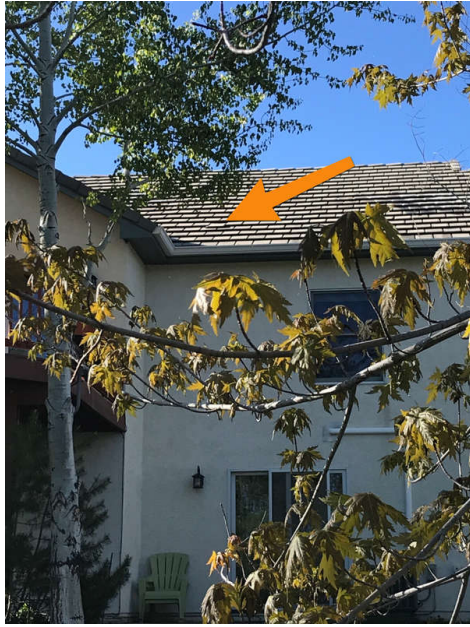
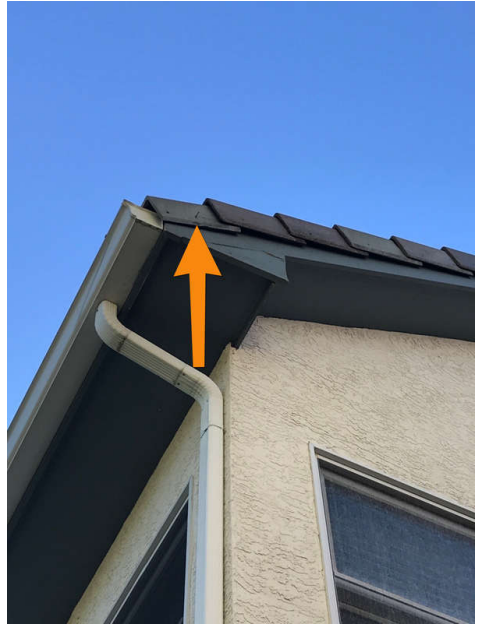
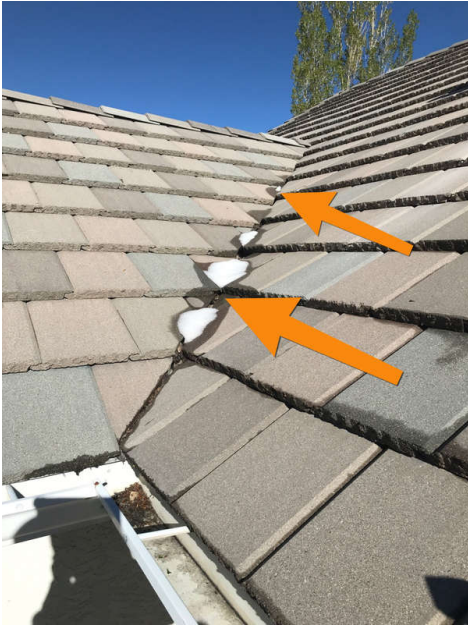
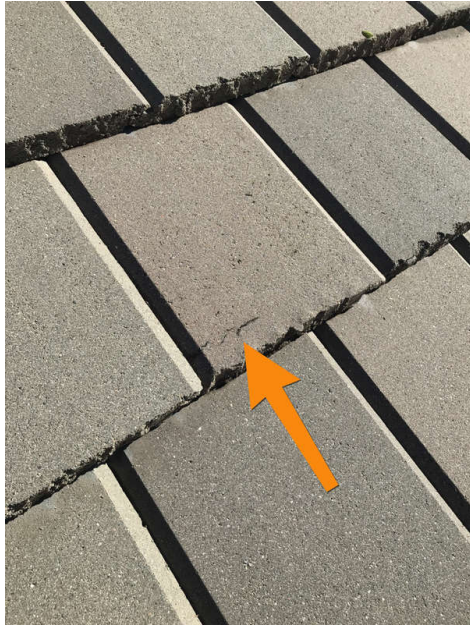
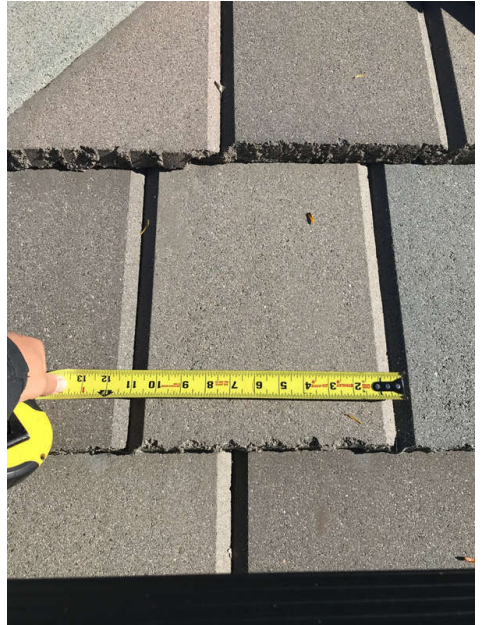
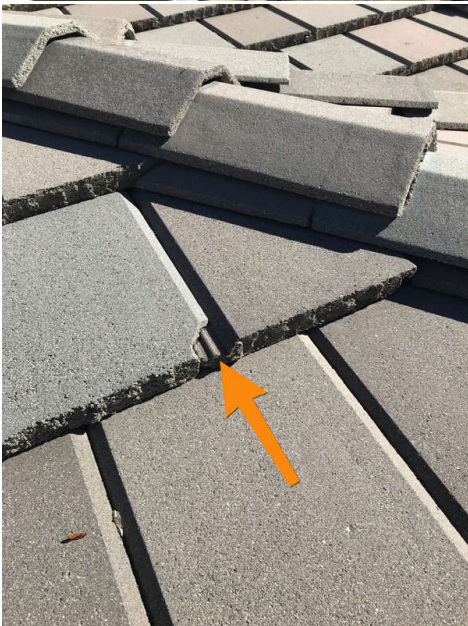
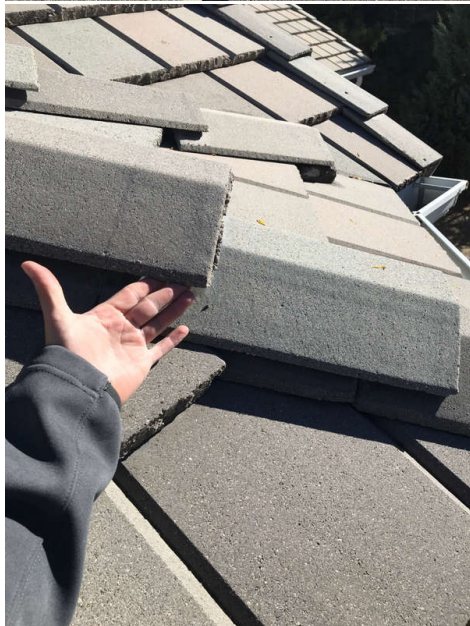
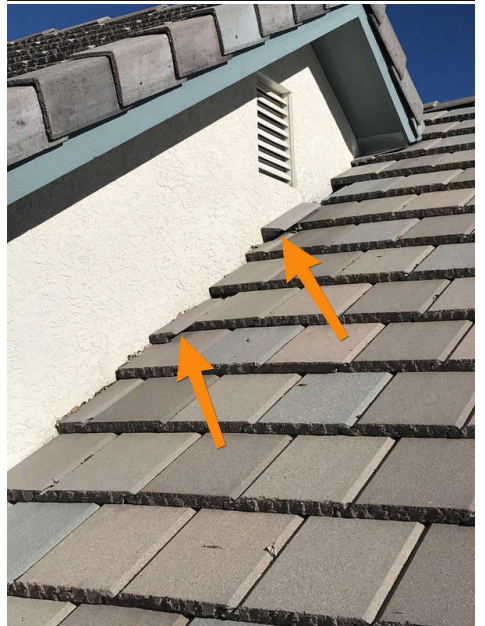
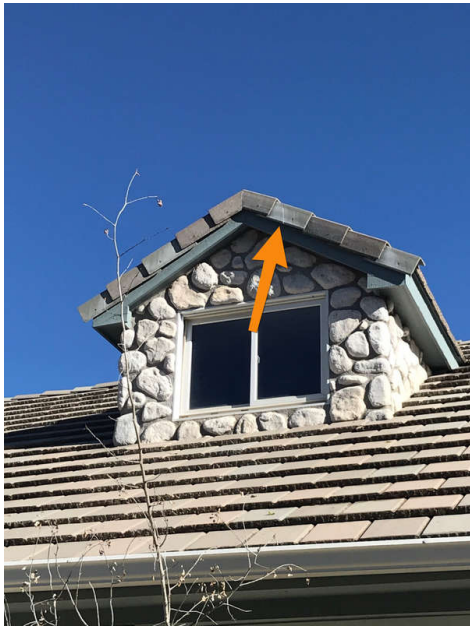
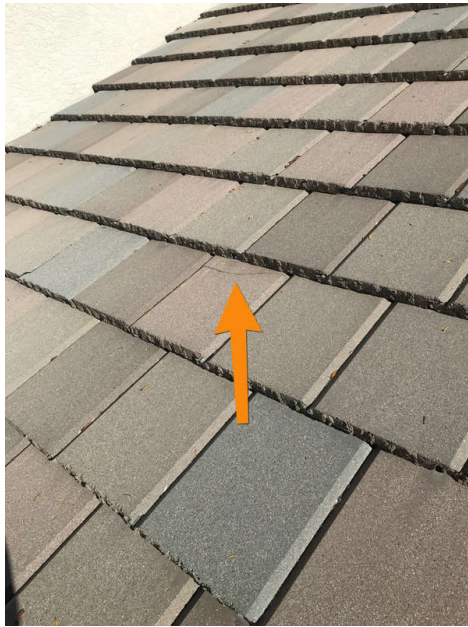
2.1.1 Coverings

**ROOF DAMAGE**

Inspector notes cement roof tiles slipping out of place in numerous areas around house both on front and back. Cracked/broken tiles noted on both the rake and the surface of the roof. Nail heads are backing out at rake and multiple rakes are uneven and show signs of movement. Roof valleys should be cut and opened to prevent buildup of debris and proper water flow. Additionally these tiles appear to be the older 12" size that is no longer manufactured and difficult to find replacements. Inspector recommends further evaluation by roofing professional. If the same size, style, and color of roof tile cannot be sourced consider roof covering replacement.

Recommend Repair

Recommendation  
Contact a qualified roofing professional.

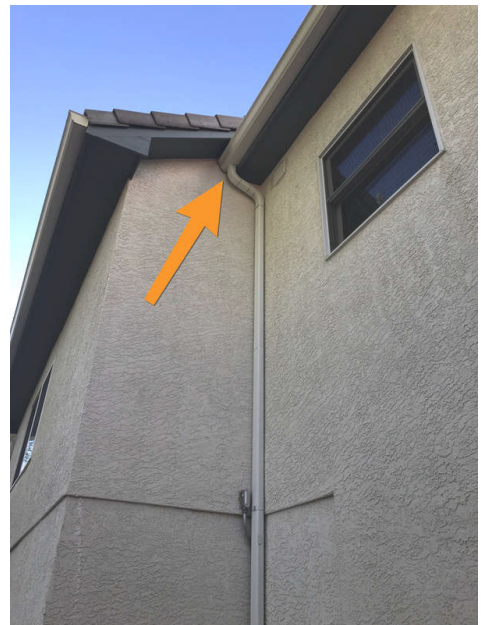
### 2.2.3 Roof Drainage Systems

#### **DOWN SPOUTS ARE TOO SMALL**

Down spouts appear to be undersized for the size of the gutters. Recommend further evaluation for replacement by roofing professional.

Contact a qualified roofing professional.

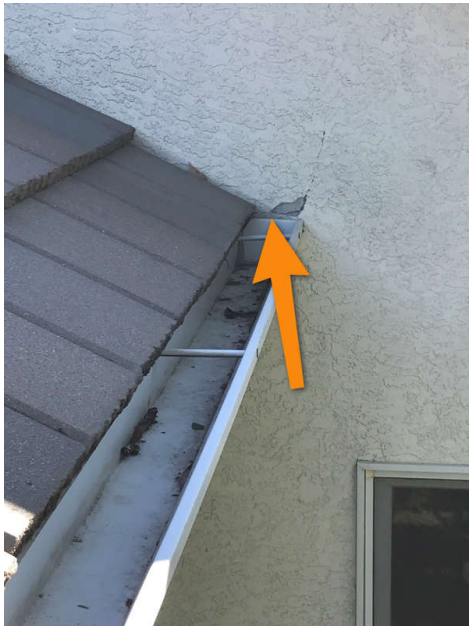
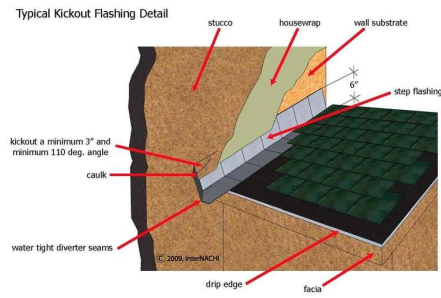
### 2.3.1 Flashings

#### **FLASHING MISSING**

ALL WHERE REQUIRED

Kick out flashing was missing or inadequate at time of inspection in one or more areas. Kick out flashing provide protection against moisture intrusion. Recommend a qualified roofing contractor evaluate and repair.

Contact a qualified roofing professional.

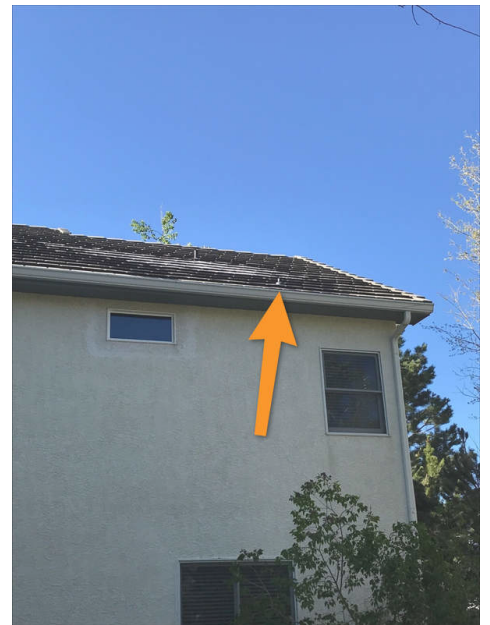
2.4.1 Skylights, Chimneys & Other Roof Penetrations

**VENT STACK TOO SHORT**

It is of the inspectors opinion the vent stacks are too short. They should be 6" minimum or 6" higher than snow accumulation for the geographic area. Recommend further evaluation by qualified roofing professional.

Recommendation  
Contact a qualified professional.

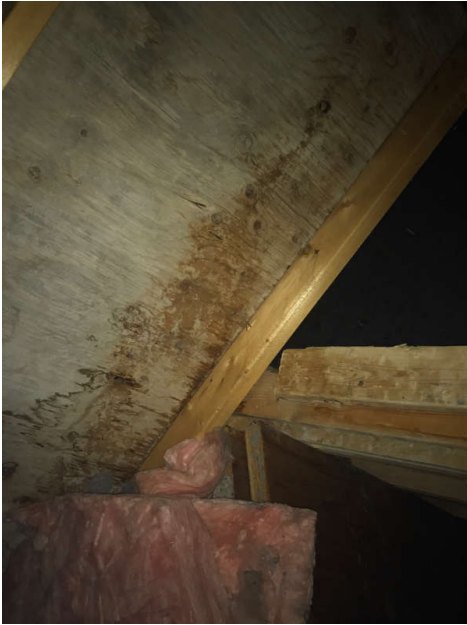
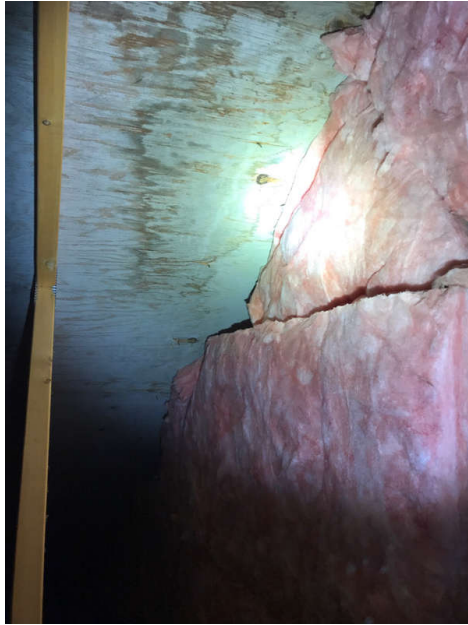
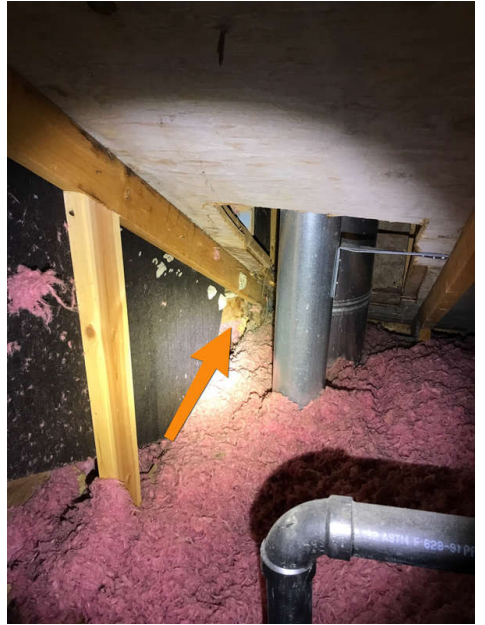
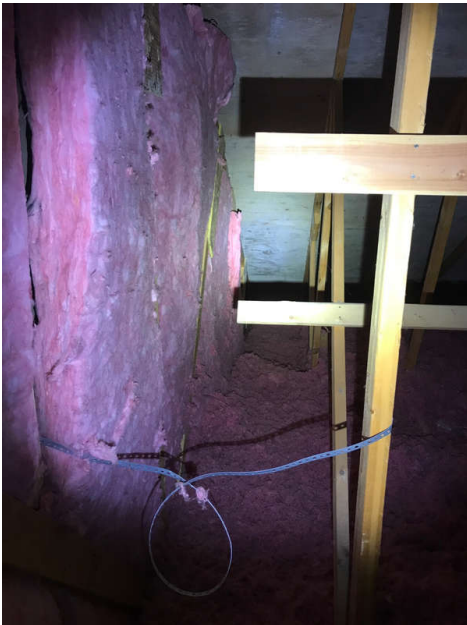
4.5.1 Ceiling Structure

**EVIDENCE OF WATER INTRUSION**

Roofing structure showed signs of water intrusion, which could lead to more serious structural damage. This does not appear to be an active roof leak and there was no sign of moisture at time of inspection. Recommend a qualified contractor identify source or moisture and remedy.

Recommendation  
Contact a qualified roofing professional.

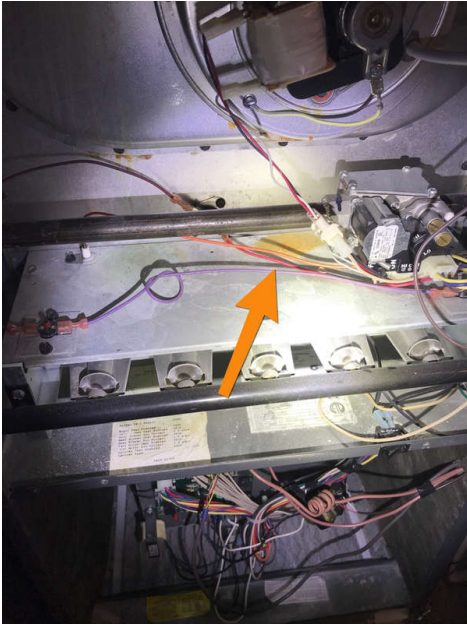
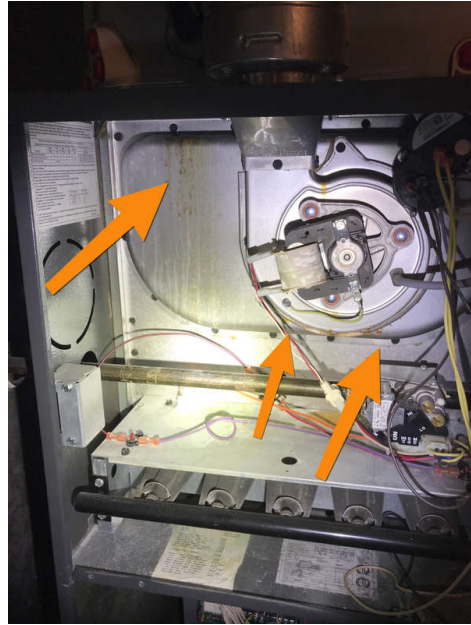
### 5.1.1 Equipment **CORROSION**

Furnace had evidence of corrosion or previous water infiltration in one or more areas. This could be the result of a leak, which the source would need to be identified. Recommend a HVAC contractor evaluate and repair.

Recommendation  
Contact a qualified HVAC professional.

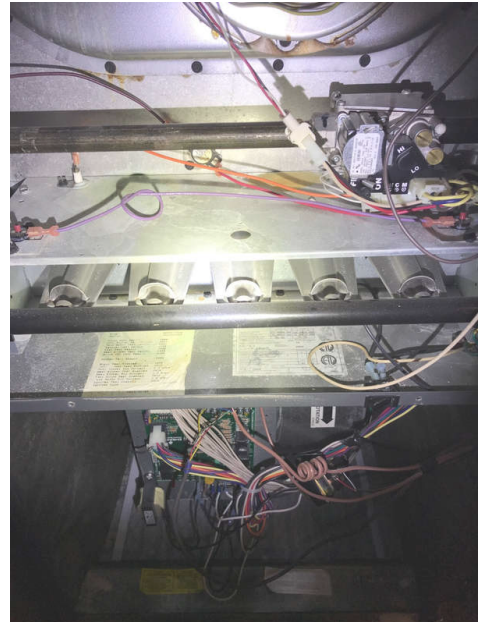
5.1.2 Equipment

**NEEDS SERVICING/CLEANING**

Furnace and AC should be cleaned and serviced annually. Recommend a qualified HVAC contractor clean, service and certify both the furnace and AC Unit.

Contact a qualified HVAC professional.

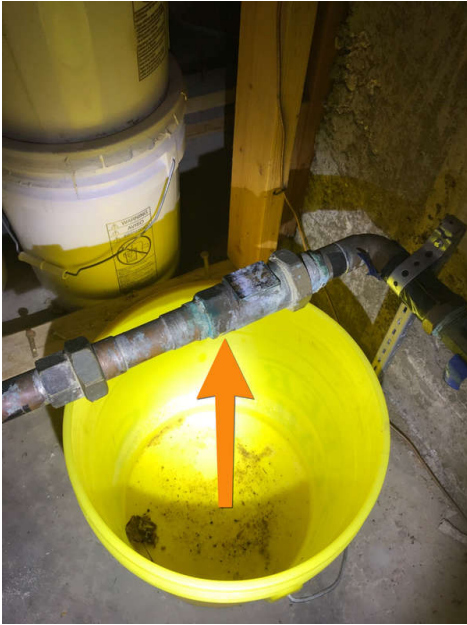
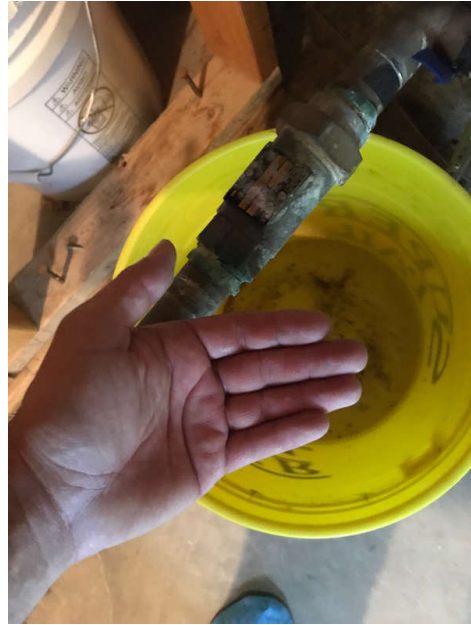
7.1.1 Main Water Shut-off Device

**ACTIVE WATER LEAK**

BASEMENT UTILITY ROOM

Active water leak at water meter and main water shutoff. Recommend repair by licensed plumber.

Contact a qualified plumbing contractor.

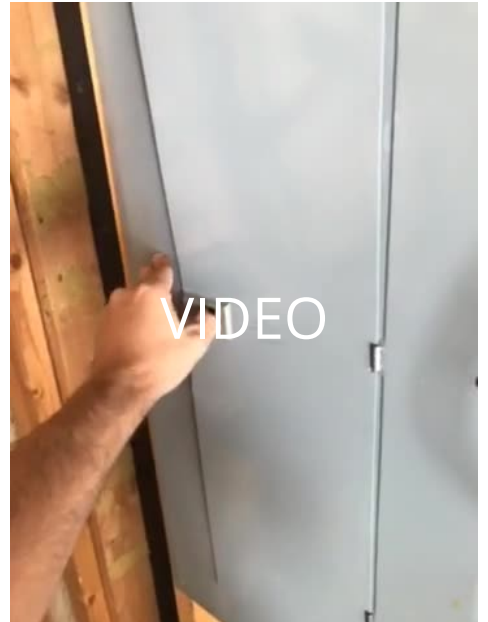
8.2.1 Main & Subpanels, Service & Grounding,  
Main Overcurrent Device

**DOOR STICKS**

GARAGE

Electrical Dead Front Cover Door sticks when trying to open. Recommend having door repaired or replaced for ease of access in case emergency shutdown of electricity is required.

Contact a qualified electrical contractor.

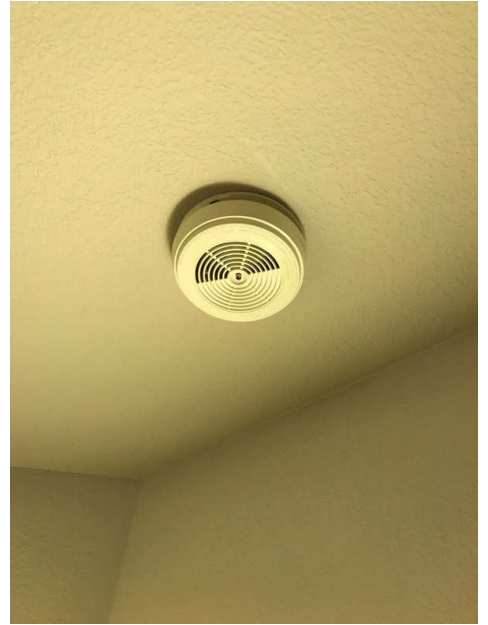
8.6.1 Smoke Detectors

**PAST LIFE EXPECTANCY**

ALL DETECTORS

Fire detectors should be replaced every 10 years. Detectors appears to be past its life cycle expectancy. Recommend replacing.

Contact a handyman or DIY project

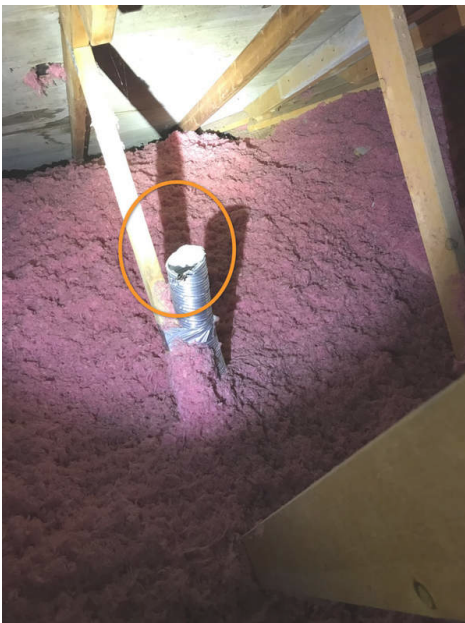
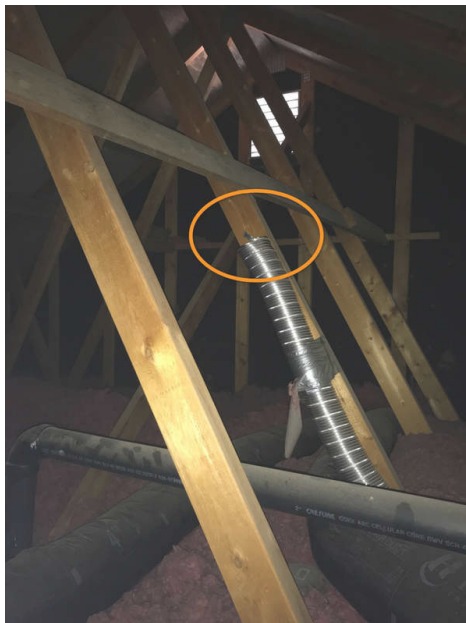
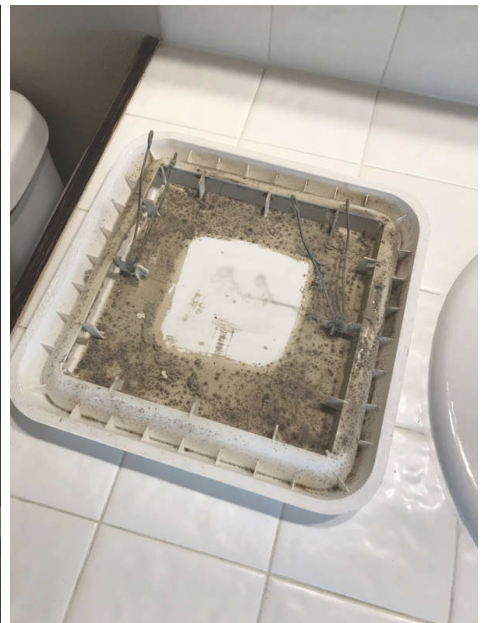
### 9.3.1 Exhaust Systems

#### **BATHROOM VENTS INTO ATTIC**

Bathroom fan vents into the attic, which can cause moisture and mold. Recommend a qualified attic contractor properly install exhaust fan to terminate to the exterior or near a roof vent. Possible mold found on vent cover. Consider air quality testing in attic space to ensure there is no mold contamination.

Contact a qualified HVAC professional.

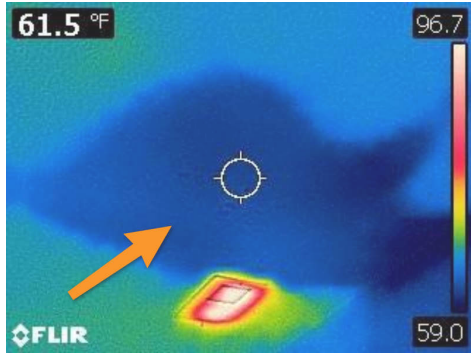
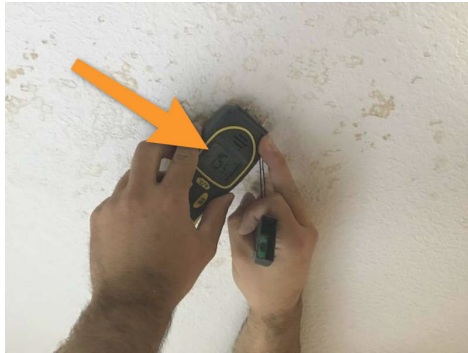
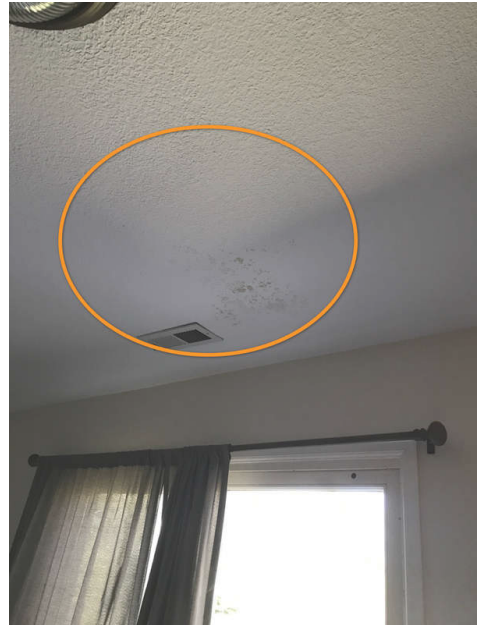
10.5.1 Ceilings

**ACTIVE WATER LEAK IN CEILING**

BASEMENT FAMILY ROOM

Evidence of an active water leak in the basement ceiling. There is water staining, variation in temperature change on IR, and high levels of moisture (15%) noted on moisture detector. Recommend further evaluation and repair by licensed plumber and drywall contractor to identify source, repair leak, mitigate any mold growth, and repair ceiling.

Contact a qualified professional.

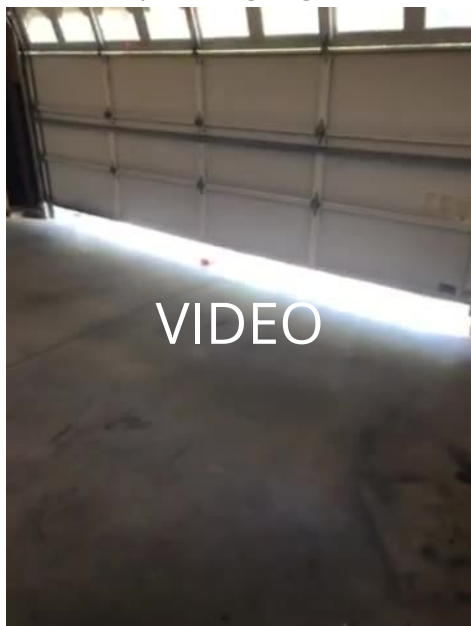
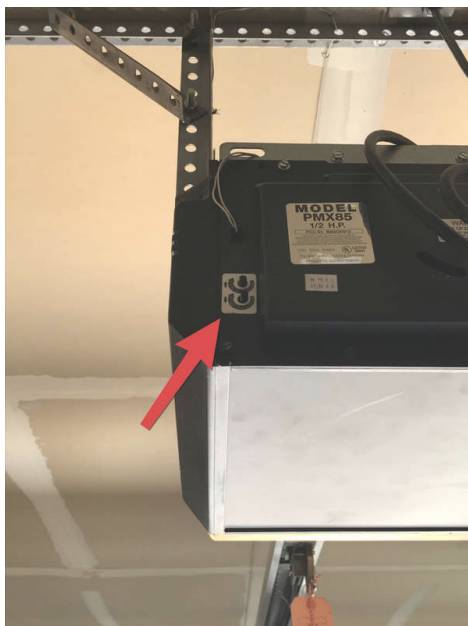
12.5.1 Garage Door Opener

**MISSING SAFETY FEATURES ON GARAGE DOOR**

Garage door did not reverse when 1 1/2 block is placed under it during closing. This is a required safety feature. Recommend repair by garage door contractor.

Contact a qualified garage door contractor.

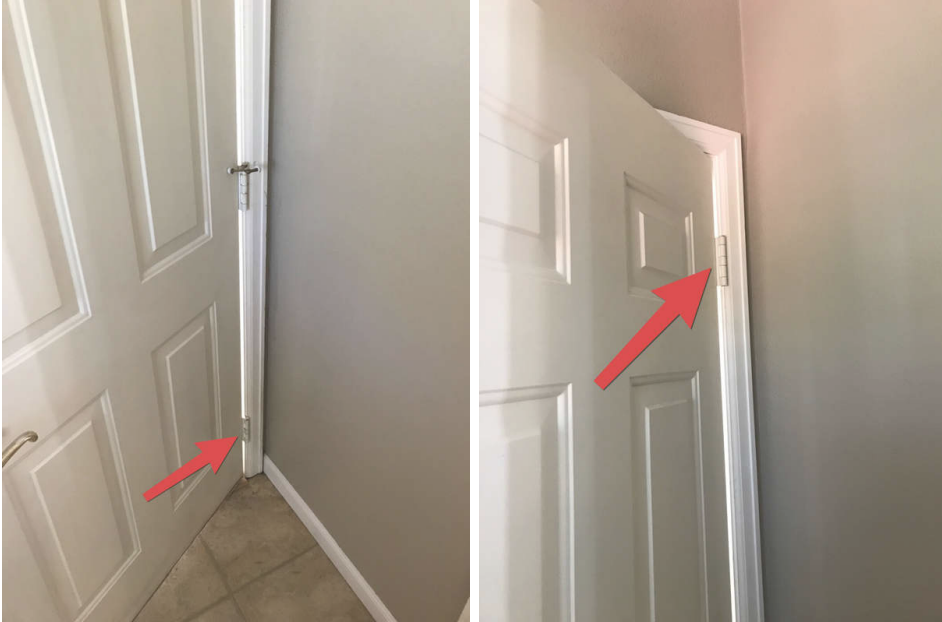
12.6.1 Occupant Door (From garage to inside of home)

**NOT SELF-CLOSING**

Door from garage to home should have self-closing hinges to help prevent spread of a fire to living space. Recommend a qualified contractor install self-closing hinges.

Contact a qualified door repair/installation contractor.
