## SUMMARY

1234 Main St. Dover TN 37058

Donnie Gerken III  
InterNACHI Certified Home Inspector  
On Target Home Inspections, LLC  
9313055533  
ontargethomeinspector@gmail.com

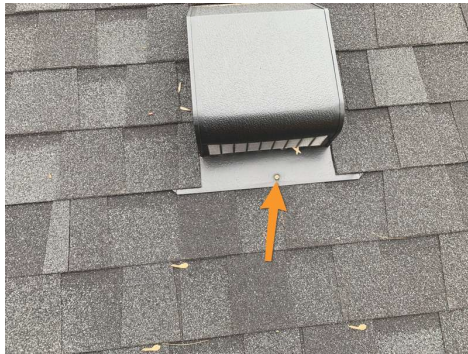
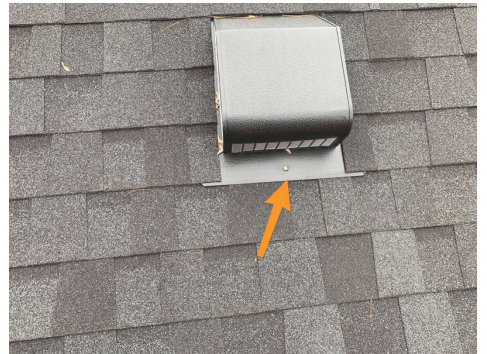
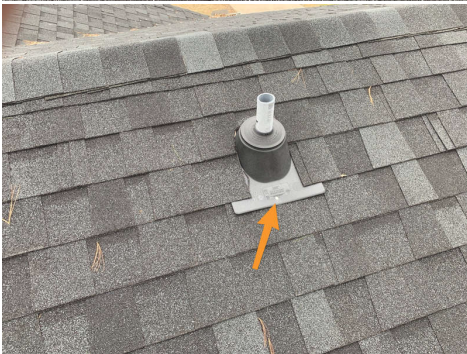
### 2.1.1 Coverings

#### EXPOSED NAIL HEADS

Exposed nailheads on flashing and shingles will allow water penetration into the roof decking. Recommend a qualified roofing contractor to inspect and repair.

Contact a qualified roofing professional.

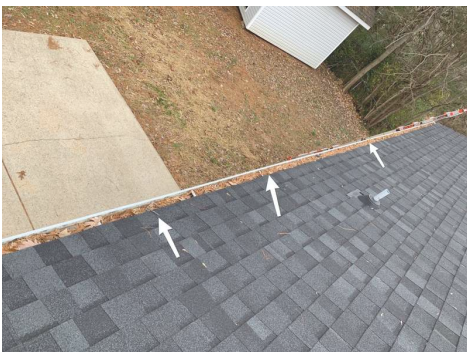
### 2.2.1 Roof Drainage Systems

#### DEBRIS

Debris has accumulated in the gutters. Recommend cleaning to facilitate water flow.

Contact a handyman or DIY project

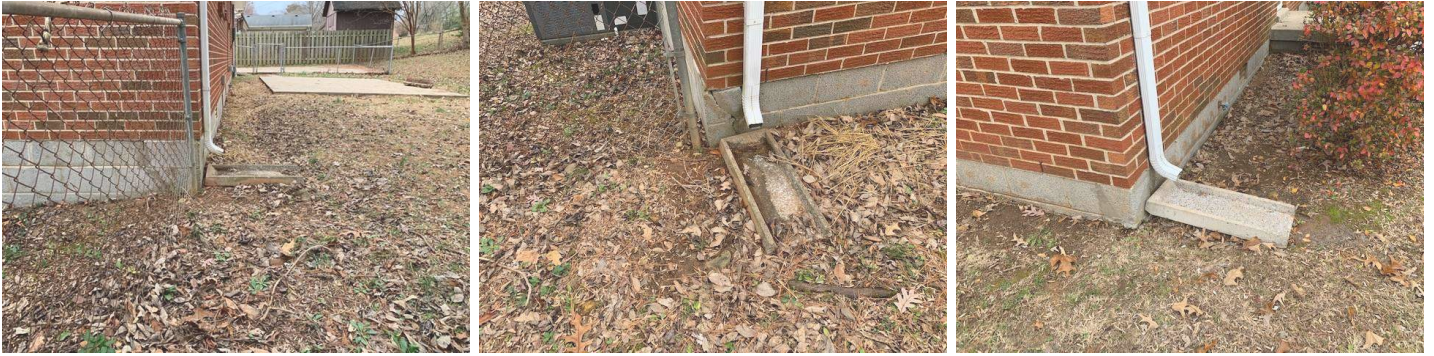
### 2.2.2 Roof Drainage Systems

## DOWNSPOUTS DRAIN NEAR HOUSE

### WEST AND EAST WALLS

One or more downspouts drain too close to the home's foundation. This can result in excessive moisture in the soil at the foundation, which can lead to foundation/structural movement. Recommend a qualified contractor adjust downspout extensions to drain at least 6 feet from the foundation.

Contact a qualified gutter contractor

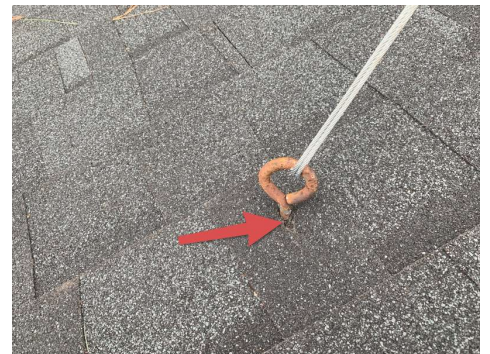
### 2.4.1 Skylights, Chimneys & Other Roof Penetrations

## ANCHOR BOLT PENETRATION

The eyebolt anchor penetration point for the weather head is not sealed. This will allow moisture penetration into the roof and should be corrected.

Contact a qualified roofing professional.

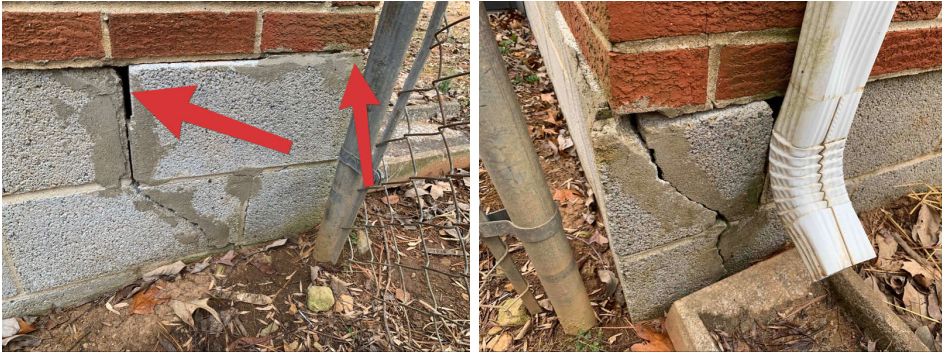
### 3.3.1 Foundation

## FOUNDATION CRACKS - MAJOR

Severe cracking noted at the foundation. This is typically consistent with soil movement and could lead to serious damage to structural components, foundation and/or slabs. Recommend a structural engineer evaluate and provide a report on course of action and remedy.

Contact a qualified structural engineer.

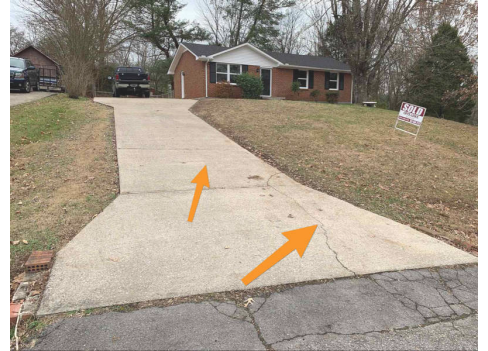
### 3.6.1 Walkways, Patios & Driveways

#### **DRIVEWAY CRACKING - MINOR**

Minor cosmetic cracks observed, which may indicate movement in the soil. Recommend monitor and/or have concrete contractor patch/seal.

Contact a qualified concrete contractor.

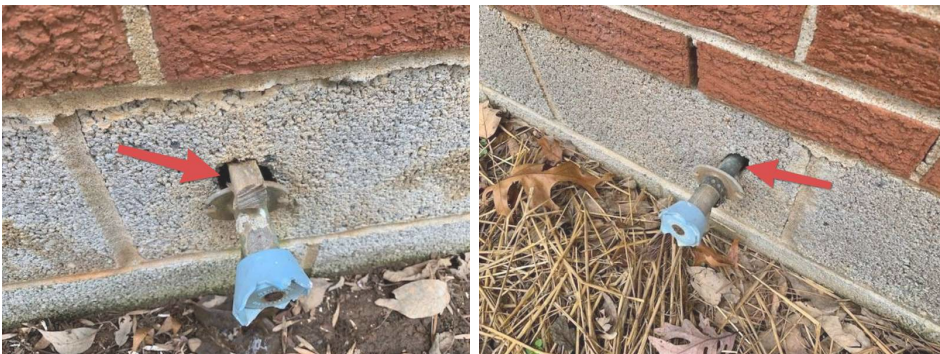
### 3.9.1 Hose Bibs

#### **POOR OR INSUFFICIENT CAULKING**

WEST AND EAST EXTERIOR WALLS

Hose bibs in both the front and backyard did not have any weather sealant caulking around the fixtures. This can allow for moisture penetration into the foundation wall that can cause deterioration the structure. Recommend sealing around the fixture to prevent moisture intrusion. Also recommend inspection of the interior foundation wall by a qualified contractor.

Contact a foundation contractor.

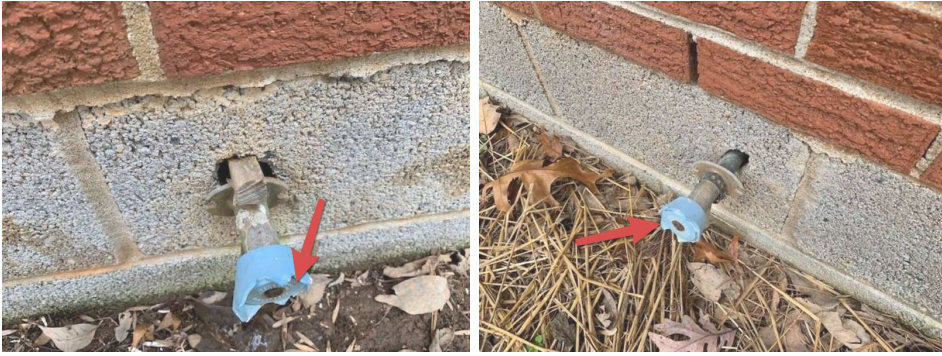
### 3.9.2 Hose Bibs

#### **BROKEN OR DAMAGED HOSE BIB HANDLES**

WEST AND EAST WALLS

The hose bib handles on both the front and backyard hose bibs are broken. This can become a safety issue to the user when turning broken handles. Recommend replacement of broken hose bib handles by a qualified contractor.

Recommendation  
Contact a qualified plumbing contractor.

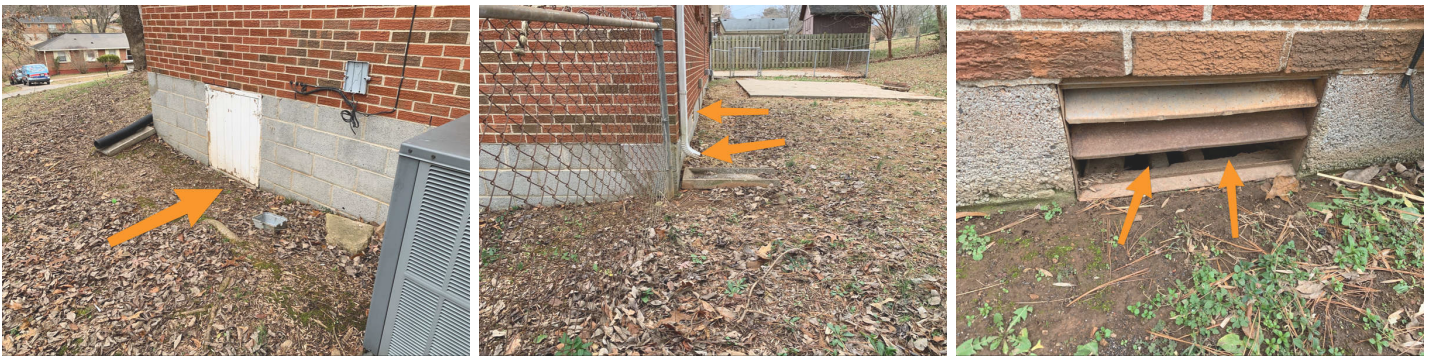
### 3.11.1 Vegetation, Grading, Drainage & Retaining Walls

#### **NEGATIVE GRADING**

NORTHWEST AND NORTH SIDE OF HOUSE

Grading is sloping towards the home in some areas. This could lead to water intrusion and foundation issues. Recommend qualified landscaper or foundation contractor regrade so water flows away from home.

Recommendation  
Contact a qualified grading contractor.

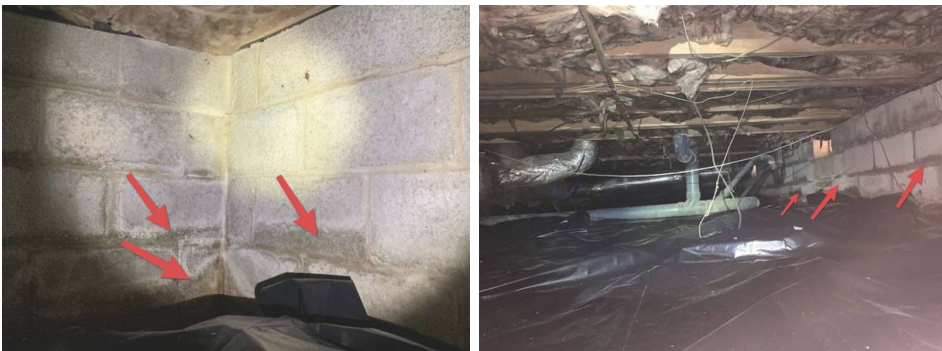
### 4.6.1 Wall Structure

#### **EVIDENCE OF WATER INTRUSION**

CRAWLSPACE

Wall structure showed signs of water intrusion, which could lead to more serious structural damage. Recommend a qualified contractor identify source or moisture and remedy.

Recommendation  
Contact a qualified structural engineer.

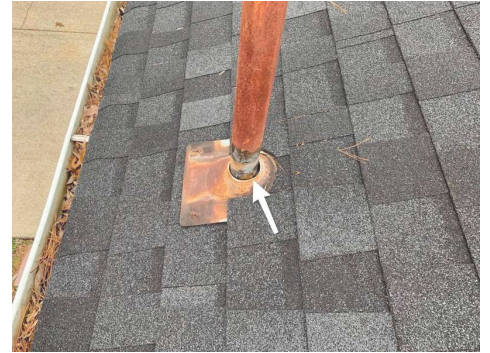
5.1.1 Service Entrance Conductors

**MAST WEATHER BOOT MISSING**

The weather head mast on the roof is missing the weather boot at the base of the mast where it penetrates the roof. This should be corrected to prevent water infiltration into the roof decking.

Contact a qualified professional.

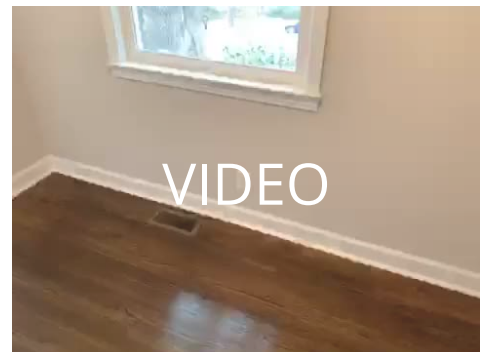
9.8.1 GFCI & AFCI

**NO GFCI PROTECTION INSTALLED**

BEDROOM 3

No GFCI protection present in all locations. Recommend licensed electrician upgrade by installing ground fault receptacles in all locations.

Recommendation  
Contact a qualified electrical contractor.

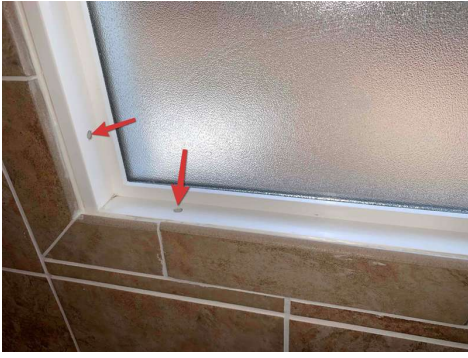
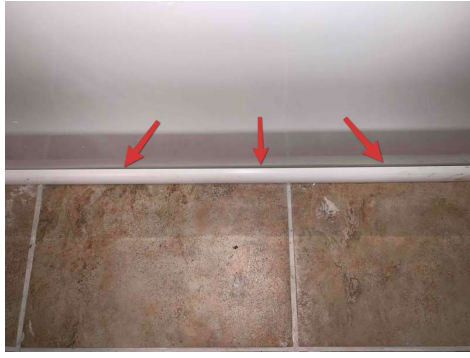
10.2.1 Shower

## **INSUFFICIENT CAULKING**

### SHOWER

There is insufficient caulking at the tub fixture and the outer edges of the tub down the the floor. Moisture can penetrate these areas with insufficient caulking causing damage to the underlying areas.

Contact a handyman or DIY project

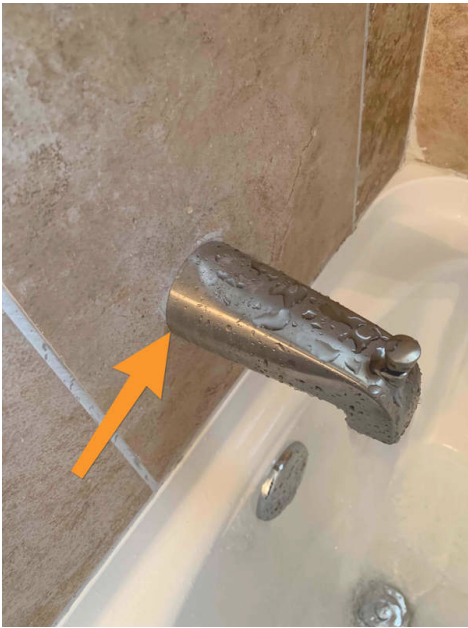
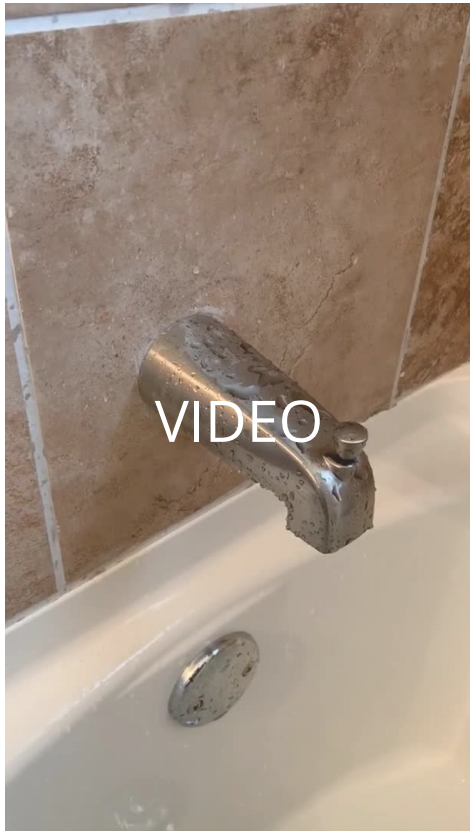
10.2.2 Shower  
**TUB FIXTURE**  
BATHROOM

Tub fixture is loose and should have a caulked seal around it to prevent moisture intrusion into the wall.

Recommendation  
Recommended DIY Project

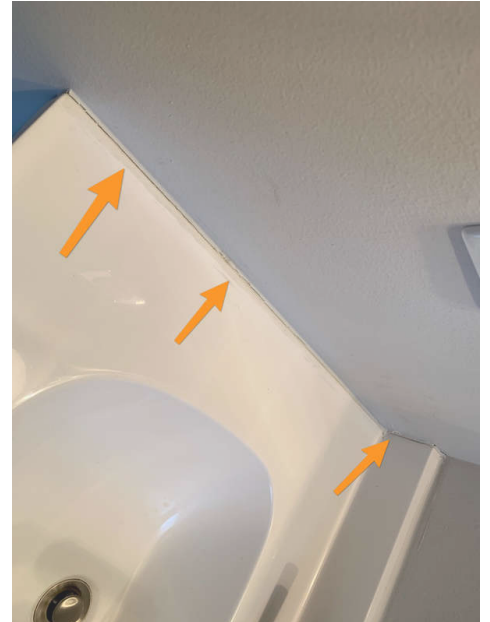
10.7.1 Bathroom Sink

**POOR/MISSING CAULK**

BATHROOM SINK

Bathroom countertop was missing sufficient caulk/sealant at the wall. This can lead to water damage. Recommend adding sealant at sides and corners where counters touch walls.

Recommended DIY Project

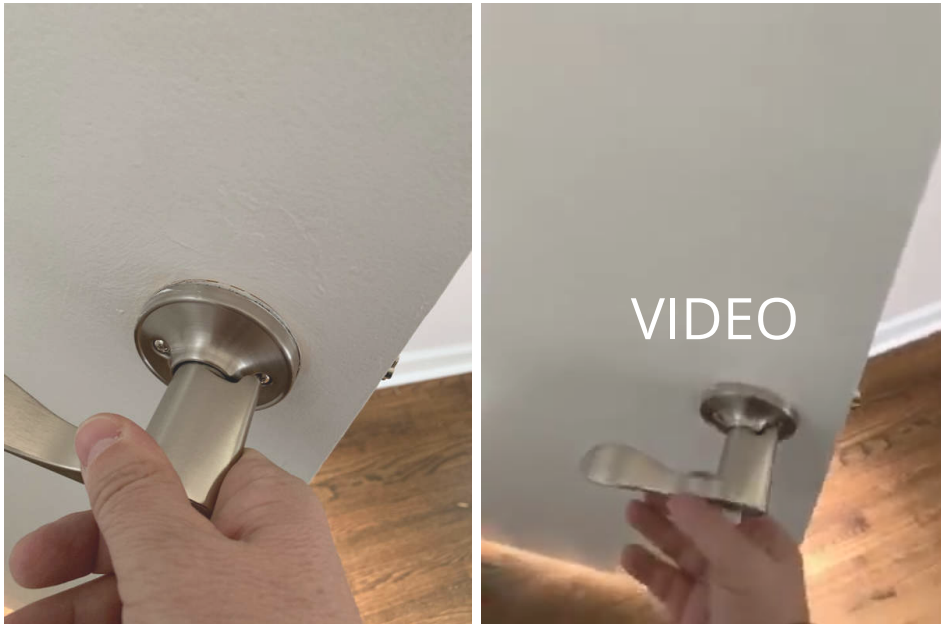
11.1.1 Doors

**LOOSE DOORKNOB/HANDLE**

LIVING ROOM

The front door knob/handle is loose. This should be corrected to prevent premature wear of the doorknob parts and prevent the door knob from not working properly.

Contact a handyman or DIY project

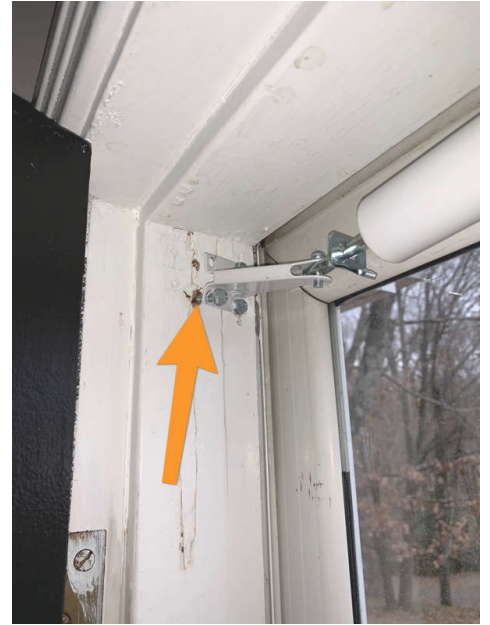
11.1.2 Doors

**LOOSE STORM DOOR CLOSER**

LIVING ROOM

Storm door closer is loose and does not allow the door to close completely. The anchor has pulled loose and is bent. It should be repaired.

Recommendation  
Contact a handyman or DIY project

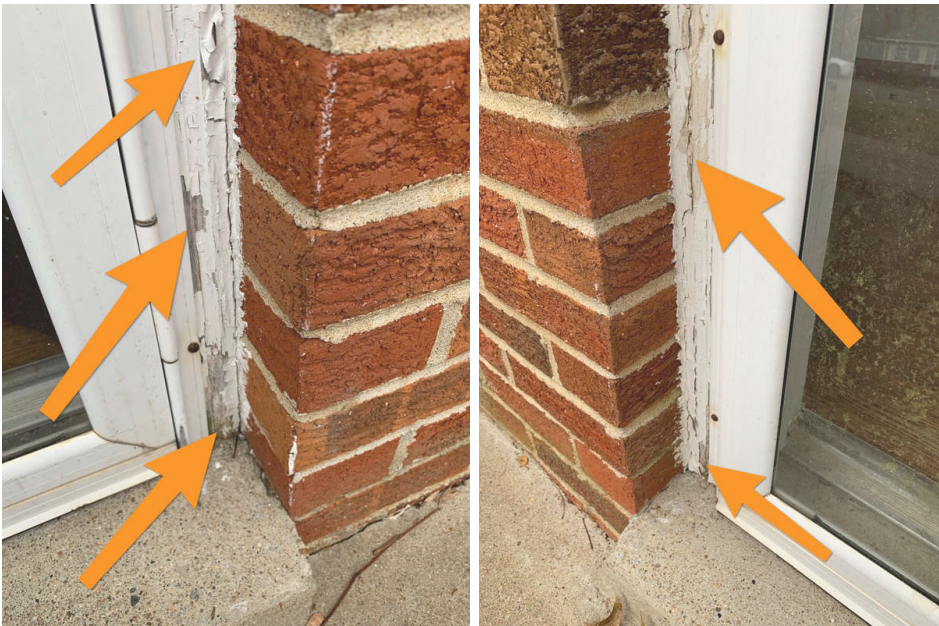
### 11.1.3 Doors

#### **PAINT CHIPPING AT EXTERIOR DOOR FRAME**

Chipped paint at the exterior door frame allows moisture penetration into the frame that cause cause further damage to the frame. This should be corrected to prevent water damage to the frame.

Recommendation  
Contact a handyman or DIY project

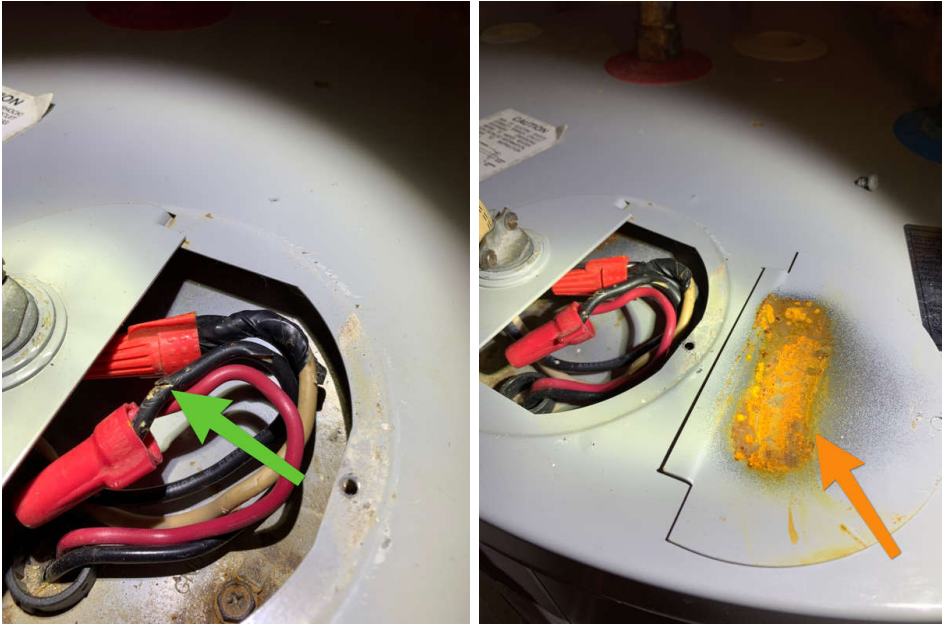
### 12.2.1 Hot Water Systems, Controls, Flues & Vents

#### **DAMAGE TO WIRE SHEATHING**

Damage to the electrical feed wire insulation can cause an arc within the electrical connection box on the water heater. This can cause electrical shock or a fire. This should be repaired immediately by a qualified contractor.

Recommendation  
Contact a qualified electrical contractor.
