SUMMARY

1234 Main St. Pittsburg CA 94565

Douglas McKinney
NACHI Certified
4 Par Home Inspections
925/759-0945
4parinspections@comcast.net

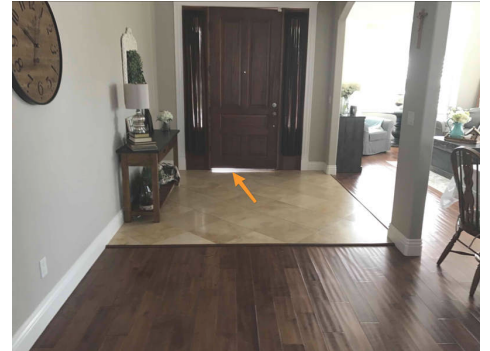
FRONT DOOR

4.2.1 Exterior Doors

Door is out of square causing uneven gaps at top and bottom.

Contact a qualified door repair/installation contractor.

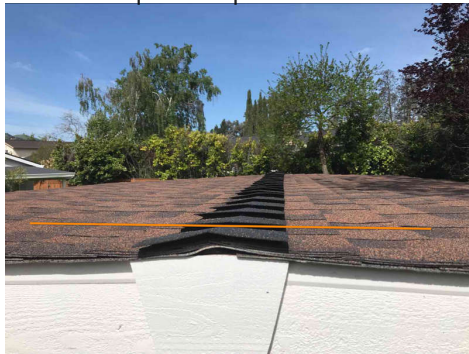
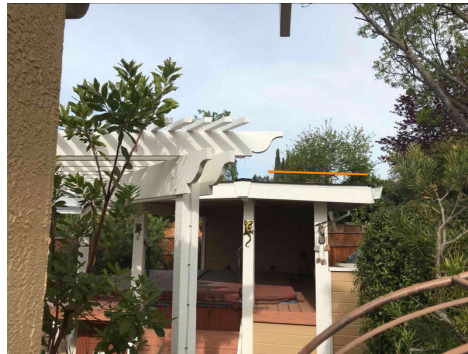
COVERED HOT TUB

4.4.1 Decks, Balconies, Porches & Steps

Roof is asphalt shingles on a 1:12 sloped roof and wont shed water properly. Needs to be a built up roof designated for a flat roof.

Contact a qualified professional.

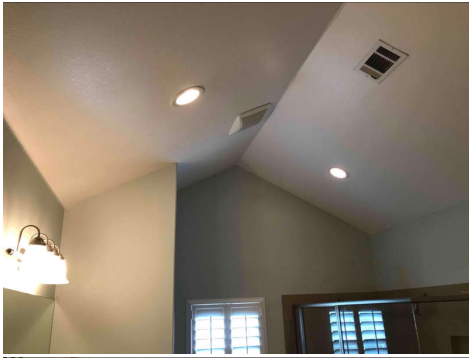
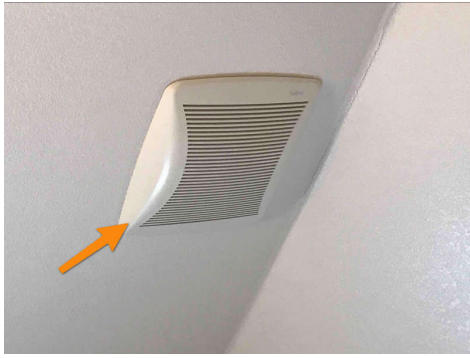
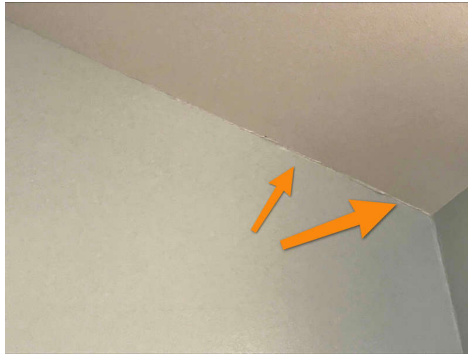
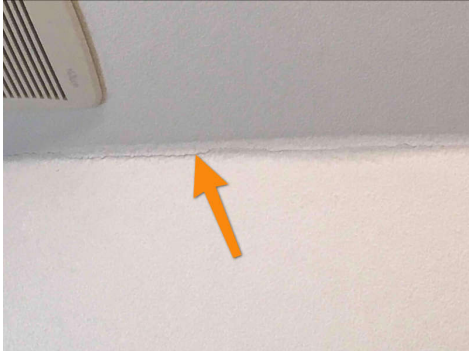
EXHAUST FAN

10.4.1 Exhaust Systems

Fan in master bathroom needs to be upgraded. There is moisture damage to walls

Contact a qualified electrical contractor.

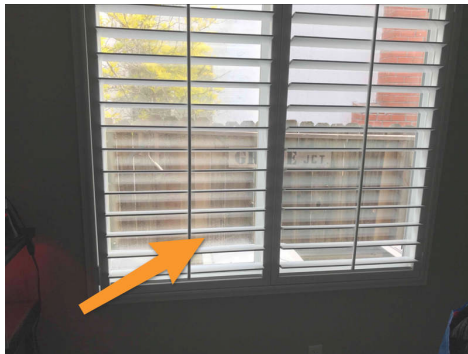
#1 BEDROOM WINDOW ON RIGHT

11.2.1 Windows

Window seal is broken in bedroom #1 allowing for moisture between panes.

Contact a qualified window repair/installation contractor.
