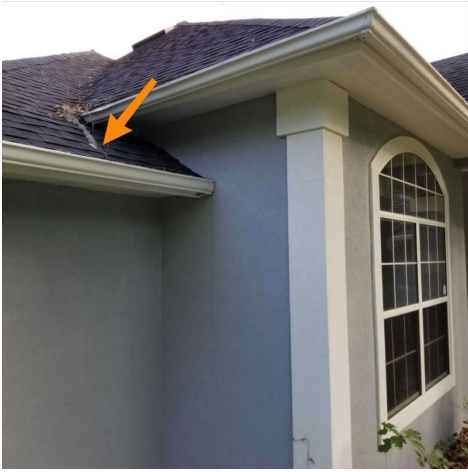
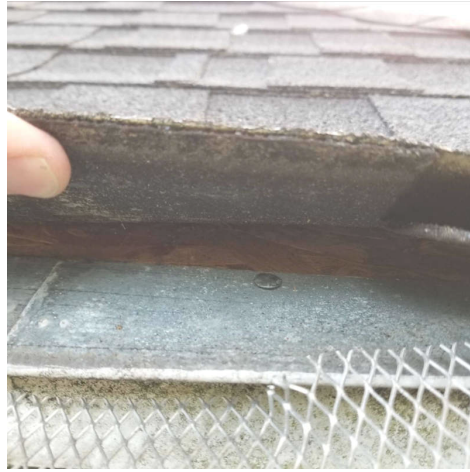
Front

NO FELT PAPER/UNDERLAYMENT

Roofing underlayment was not properly installed and will allow any water that gets underneath the shingles to penetrate directly into the roof sheathing. A roofer should properly install underlayment to prevent leaks.

Contact a qualified roofing professional.

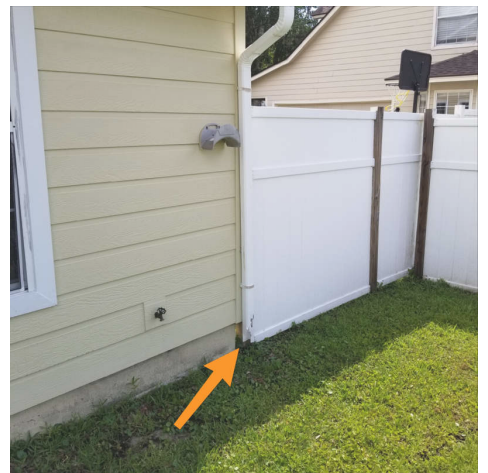
Back Left Corner

DOWNSPOUTS DRAIN NEAR HOUSE

One or more downspouts drain too close to the home's foundation. This can result in excessive moisture in the soil at the foundation, which can lead to foundation/structural movement. Recommend a qualified contractor adjust downspout extensions to drain at least 6 feet from the foundation.

Contact a qualified roofing professional.

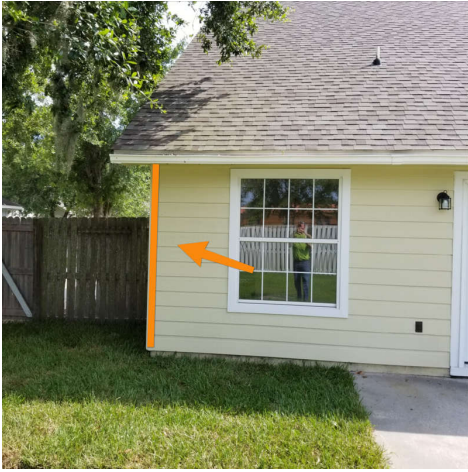
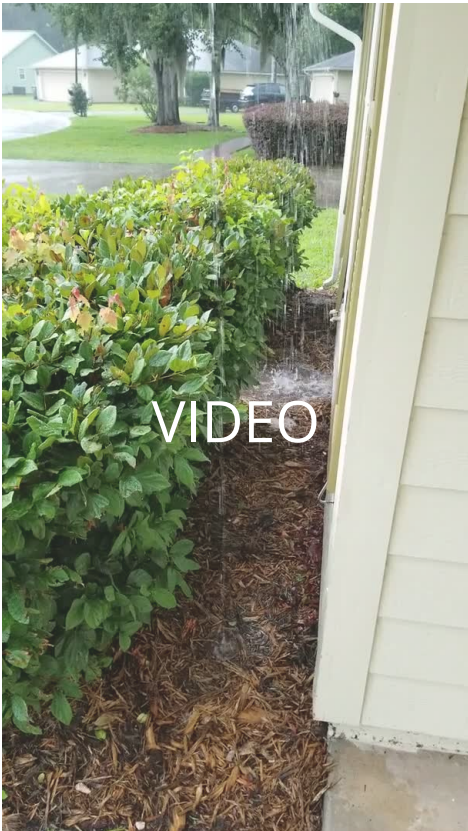
DOWNSPOUTS MISSING

Home was missing downspouts in one or more areas. This can result in excessive moisture in the soil at the foundation, which can lead to foundation/structural movement. Recommend a qualified contractor install downspout extensions that drain at least 6 feet from the foundation. **Only 1 downspout was installed on each of the gutters (front/back) the gutters will drain better if an additional downspout is installed.**

Contact a qualified roofing professional.

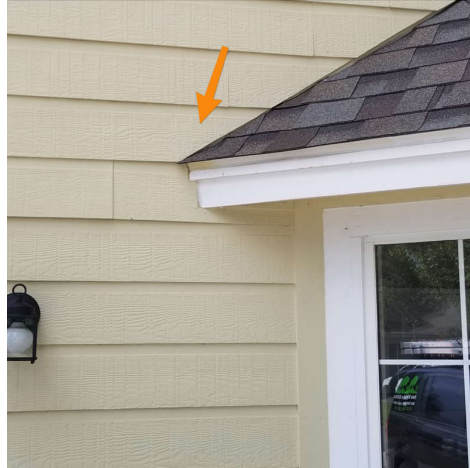
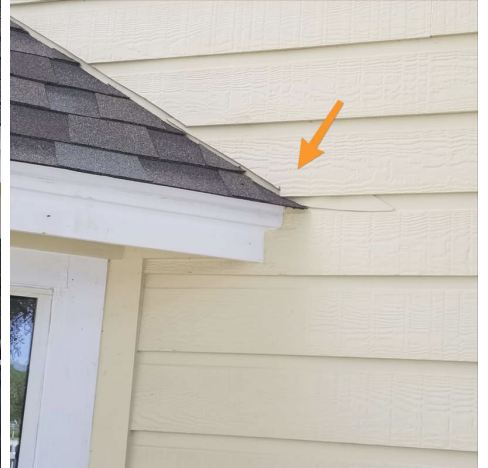
KICK OUT FLASHING MISSING

Missing kick out flashing was observed. Kick out diverts water away from the wall and into the gutter. Inadequately flashed roofs can allow water to enter the wall causing sever water damage. Recommend a qualified professional evaluate and properly install a kick out flashing.

Recommendation
Contact a qualified roofing professional.

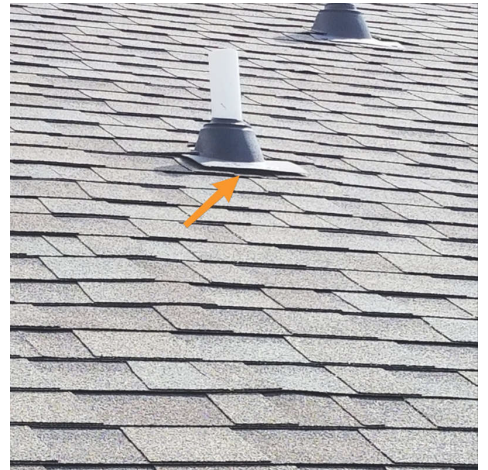
Back

VENT BOOT

A vent boot was lifted and should be attached to the roof with sealant to prevent leaks and wind uplift.

Recommendation
Contact a qualified roofing professional.

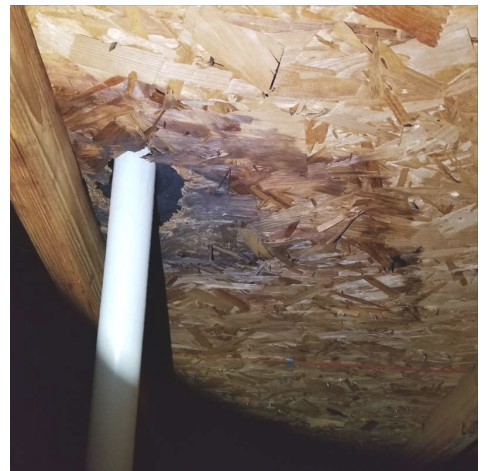
SHEATHING DAMAGE

A vent boot has deteriorated and is no longer functional. Water damage has occurred at the base of the boot. Recommend replacing the boot immediately to prevent further damage.

Recommendation
Contact a qualified roofing professional.

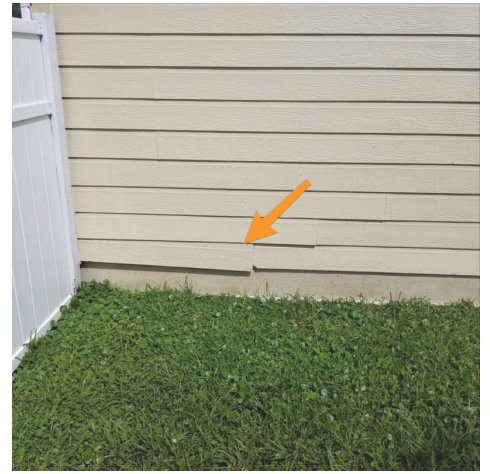
Left

SIDING - LOOSE OR MISSING

One or more siding boards were loose, which could result in moisture intrusion. Recommend a qualified siding contractor secure and fasten.

Contact a qualified siding specialist.

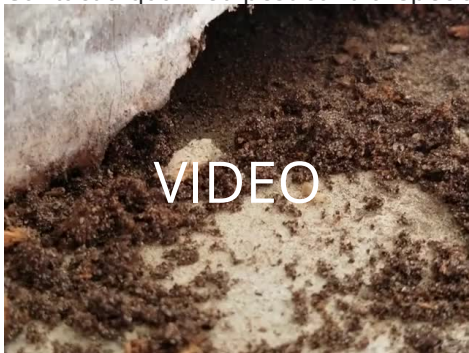
Garage

PESTS

At the time of the inspection pests were observed. Recommend contacting a pest control specialist.

Contact a qualified pest control specialist.

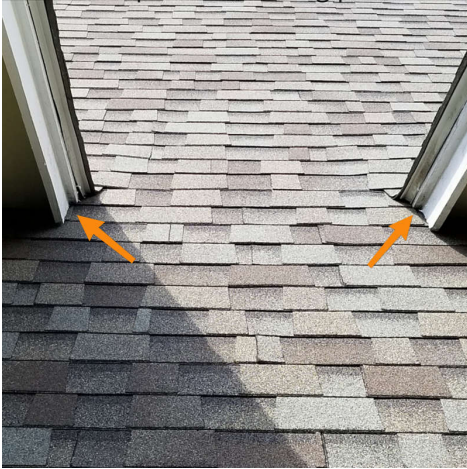
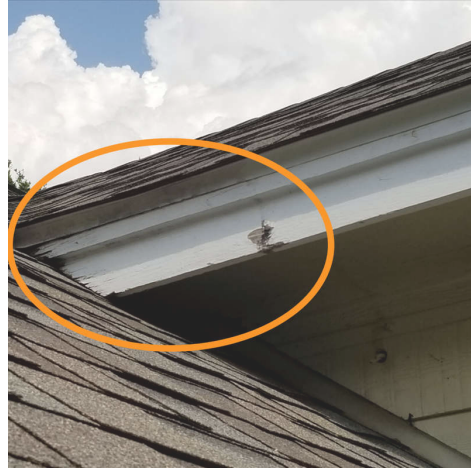
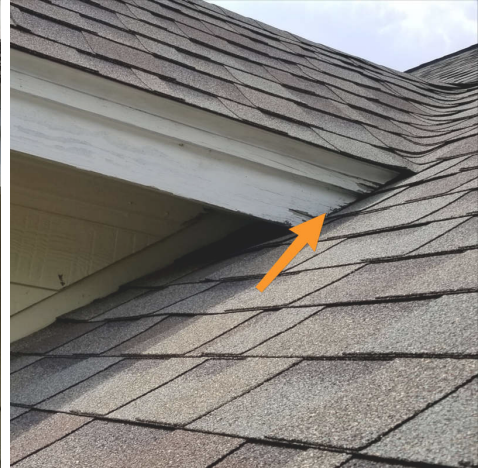
FASCIA - DAMAGED

One or more sections of the fascia are damaged. Recommend qualified roofer evaluate & repair.

Contact a qualified roofing professional.

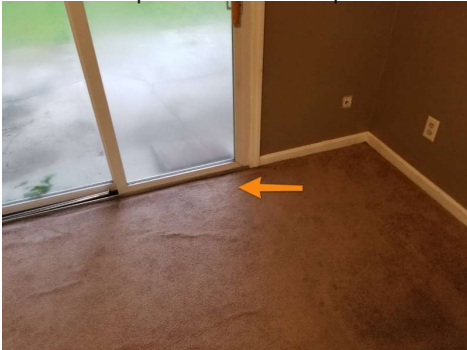
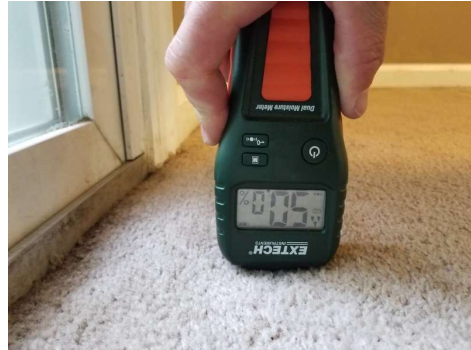
DOOR SILL/TRIM

At the time of inspection moisture was detected inside the sliding glass door. Recommend further evaluation and repair as needed.

Contact a qualified door repair/installation contractor.

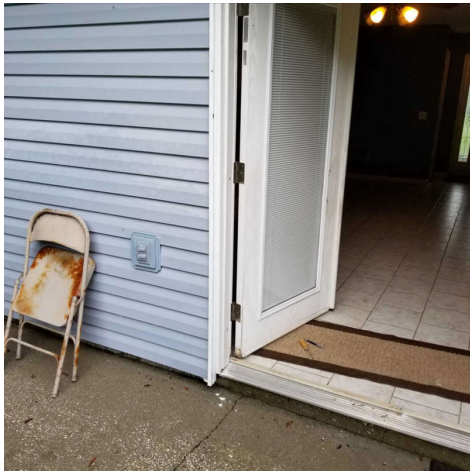
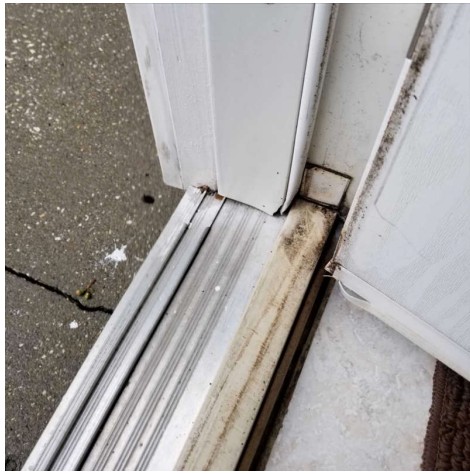
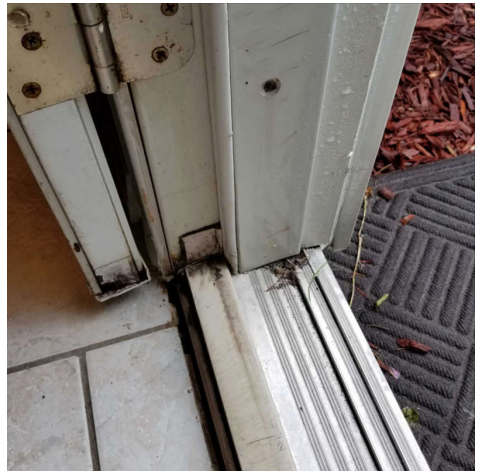
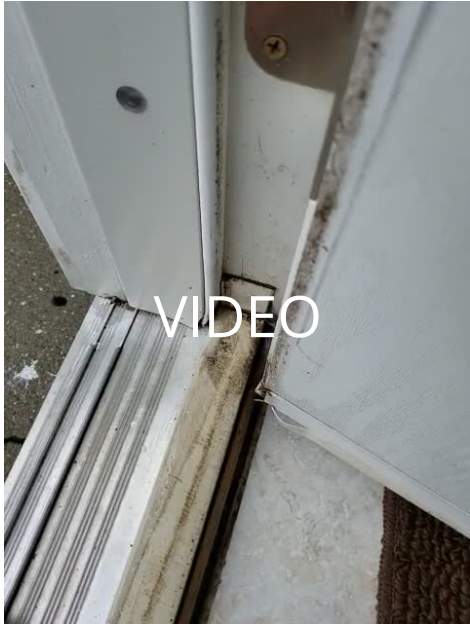
THRESHOLD LOOSE

Door threshold is not sealed to the slab and has come loose from the jambs. Water was seeping under the threshold at the time of inspection. Recommend installing gutters to channel water away from the door and properly repairing or replacing the jamb and threshold.

Contact a qualified door repair/installation contractor.

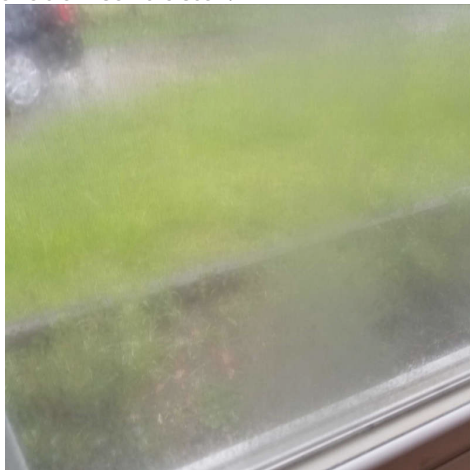
Left Bedroom

SEAL FAILURE

A window appeared to have a failed seal and should be replaced.

Recommendation
Contact a qualified window repair/installation contractor.

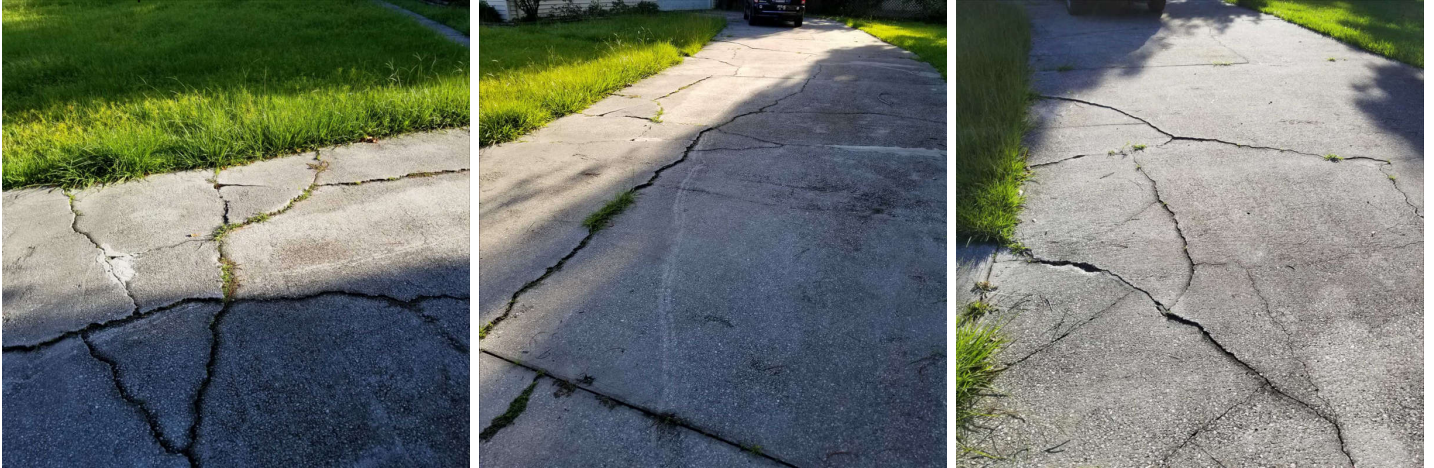
DRIVEWAY CRACKING/DAMAGE

Cracks, holes, settlement, heaving and/or deterioration were found in the driveway. Recommend that qualified contractor repair as necessary.

Contact a qualified concrete contractor.

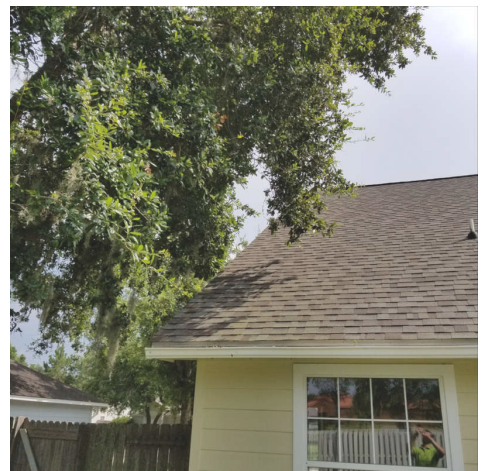
Right Back

TREE OVERHANG

Trees were overhanging the roof which can cause damage to the roof and prevent proper drainage from falling debris. Recommend a qualified tree service trim trees away from the home.

Contact a qualified tree service company.

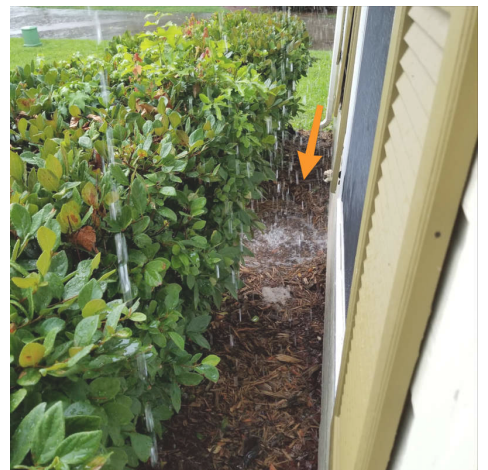
Front

GROUND EROSION

Soil erosion has occurred around the foundation of the home. Erosion can cause ruts and/or negative grading that will hold water increasing the moisture around the homes foundation and can also breed insects if the water does not dry quickly. Recommend correcting the source causing the erosion and filling in the eroded areas with soil, sloping the ground away from the home. **Caused by the gutter not draining properly.**

Contact a qualified professional.

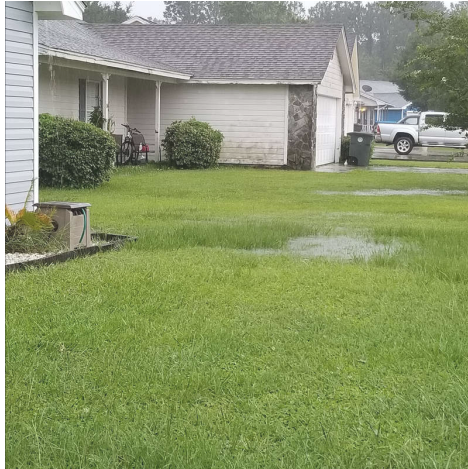
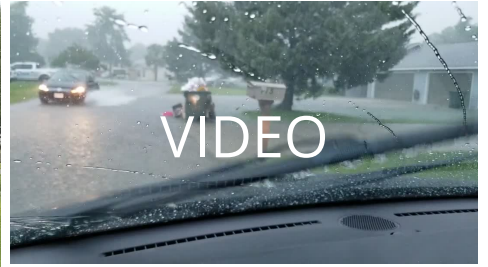
SITE DRAINAGE

At the time of inspection site grading and drainage was inadequate. Recommend further evaluation.

Recommendation
Contact a qualified professional.

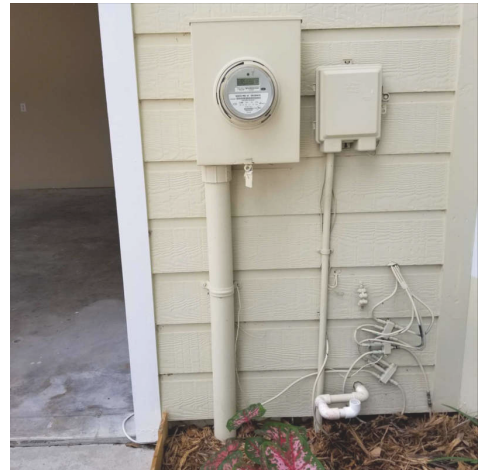
Right

5.1.1 Service Entrance Conductors GROUNDING NOT PRESENT

I did not observe an electrical grounding rod at the electrical meter. Electrical grounding systems divert potentially dangerous electrical currents by providing a path between a buildings service box and the earth. Lightning and static electricity are the most common sources of dangerous or damaging charges that can be dissipated through a grounding system. I would recommend contacting a qualified electrician to further evaluate and repair.

Recommendation
Contact a qualified electrical contractor.

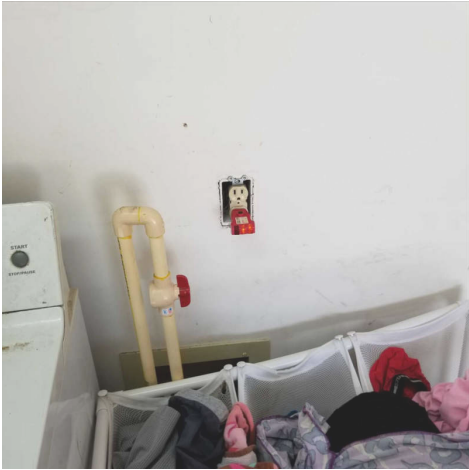
COVER PLATES MISSING

One or more receptacles are missing a cover plate. This causes short and shock risk. Recommend installation of cover plates.

Recommendation
Contact a qualified electrical contractor.

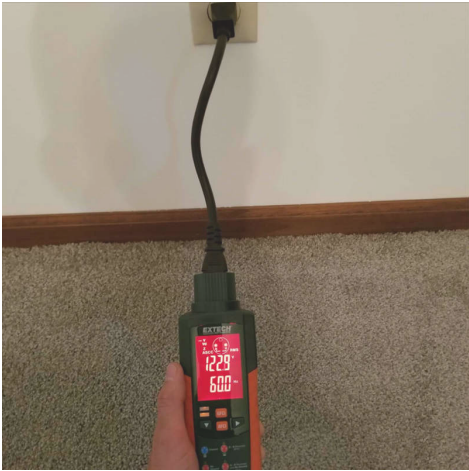
RECEPTACLE - OPEN GROUND

An electrical receptacle had an open ground. Other receptacles in the home were grounded. This receptacle should have a functional equipment grounding conductor installed by qualified electrical contractor.

Recommendation
Contact a qualified electrical contractor.

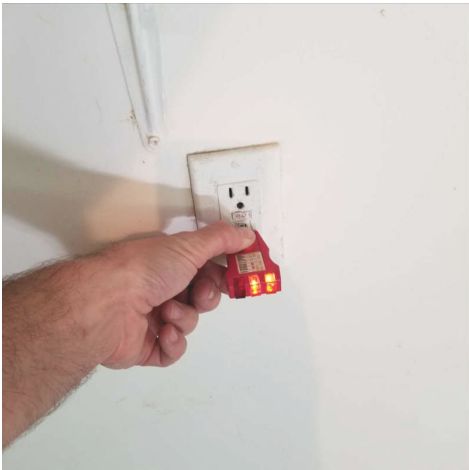
Garage

GFCI FAILURE

Observed a ground fault circuit interrupter (GFCI) electrical receptacle did not respond to testing, did not re-set, was slow to re-set or made a buzzing sound when re-set. The Inspector recommends replacement of the receptacle to ensure that it works correctly when required. All work should be performed by a qualified contractor.

Recommendation
Contact a qualified electrical contractor.

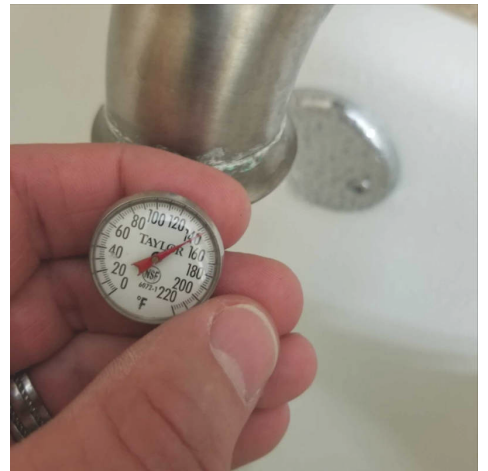
WATER TEMPERATURE/SCALDING

Water temperature exceeded 120 degrees which can scald. Recommend reducing water temperature at the water heater or adjust tempering valves at fixtures if installed, if not it is recommended that anti-scald fixtures are installed.

Contact a qualified plumbing contractor.

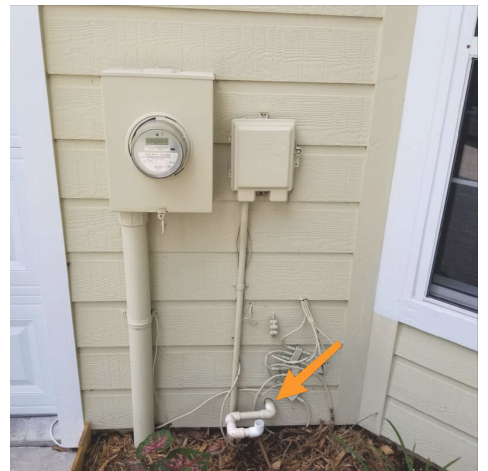
Right

CONDENSATE DRAINING TOO CLOSE TO HOUSE

The condensate was draining too close to the house. Drains should be moved away from the home. Constant water drainage can increase the chances of moisture wicking into the foundation and walls and it attracts pests.

Contact a qualified professional.

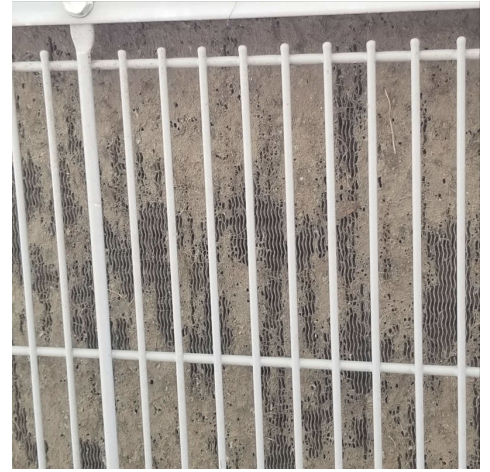
Right

COIL DIRTY

The coil on the condenser unit was dirty and needs to be cleaned to operate efficiently. Recommend an HVAC technician clean the coil to optimize performance.

Recommendation
Contact a qualified HVAC professional.

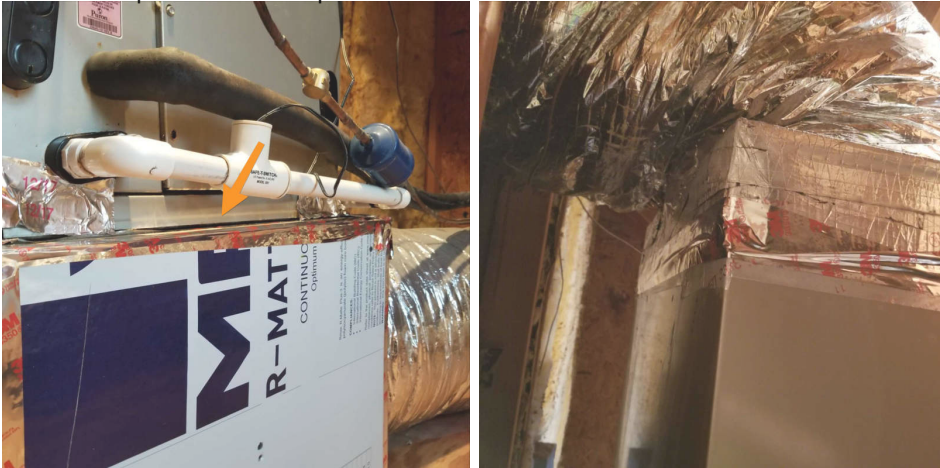
DUCT WORK - CONNECTION

The air handler duct work needs to be properly sealed, air was leaking at the supply and return sides. Recommend and HVAC contractor properly seal the duct work at the air handler.

Recommendation
Contact a qualified HVAC professional.

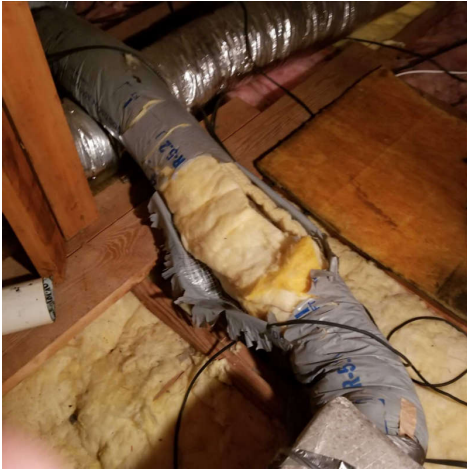
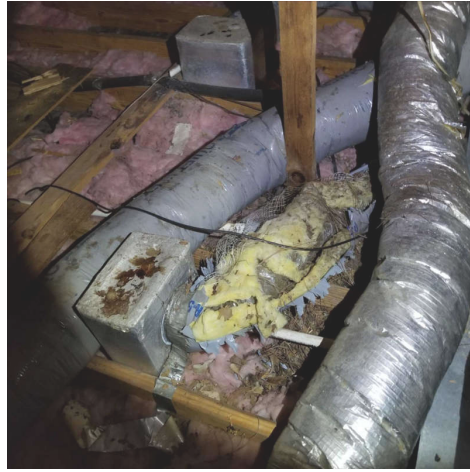
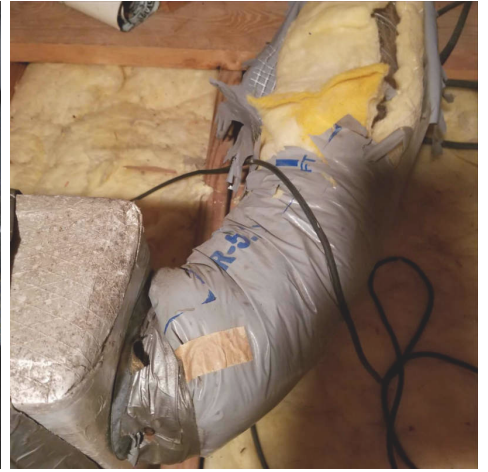
DUCTS DETERIORATED

Deteriorated ducts were observed. Recommend licensed HVAC contractor repair or replace.

Recommendation
Contact a qualified HVAC professional.

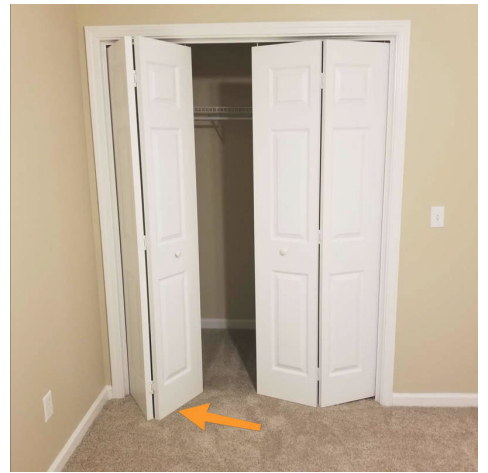
2nd Floor Bedroom

DOOR ADJUSTMENT

A door did not close properly, adjustment is required. Was dragging on the carpet.

Contact a handyman or DIY project

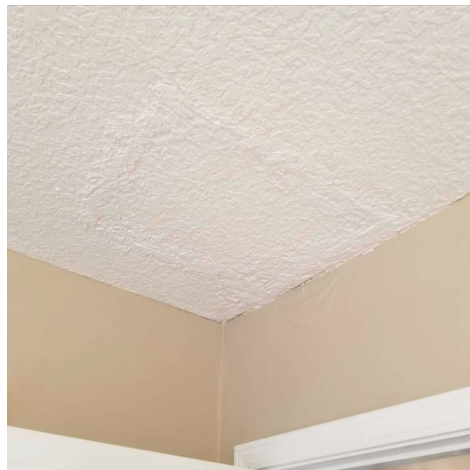
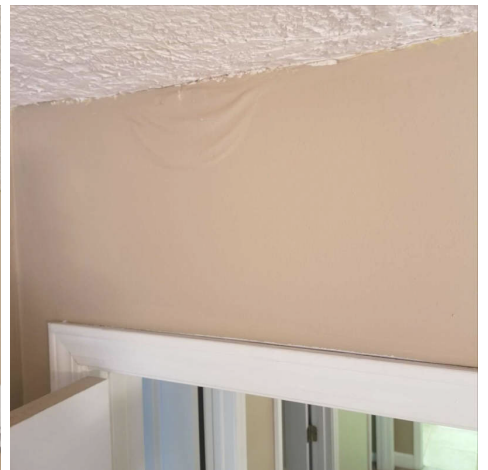
WATER - DAMAGE

Water damage was observed from what appears to be a past water leak. No moisture was detected at the time of the inspection. Recommend a painter repair and paint. Monitor for future leaks.

Contact a qualified professional.

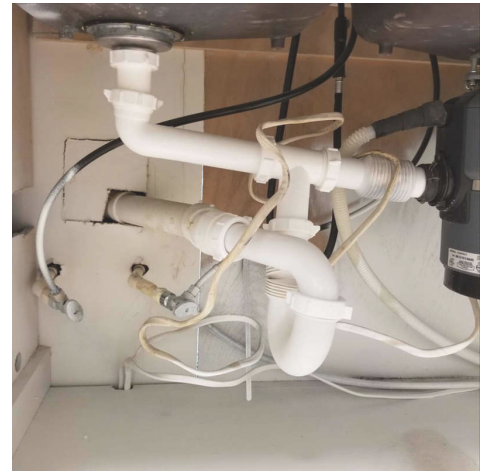
DRAIN SLOPE

The drain had an up hill slope that will restrict or prevent water from draining properly. Recommend a plumber properly install the drain.

Contact a qualified plumbing contractor.

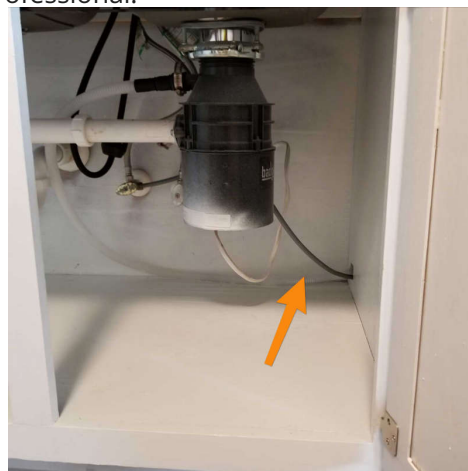
NO HIGH LOOP

The dishwasher installed without a high loop in the drain line. It is required by most jurisdictions and manufacturers that the dishwashers drain line be installed with a high loop. This prevents the dirty water that is being drained in the sink from inadvertently getting pulled back into the dishwasher or even siphoned back into the water system. Recommend an appliance repair technician properly install the drain line.

Contact a qualified appliance repair professional.

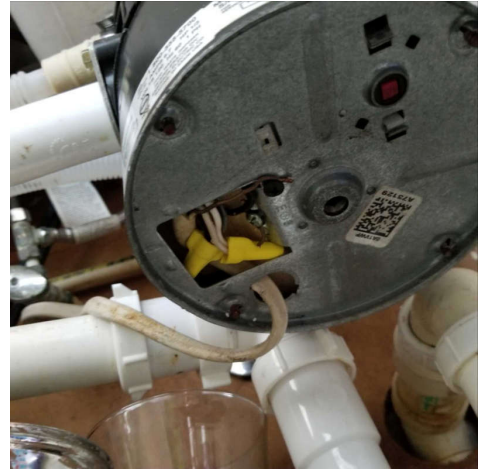
WIRE CLAMP MISSING

The wire clamp that connects the romex to the motor housing was not installed. Recommend installing the wire clamp to prevent the wire from inadvertently being pulled out and to prevent electrical shock and fire.

Contact a qualified electrical contractor.

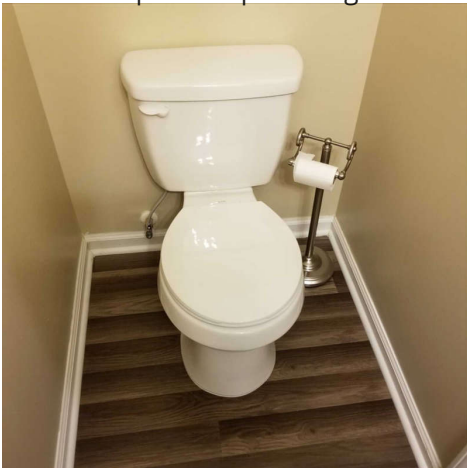
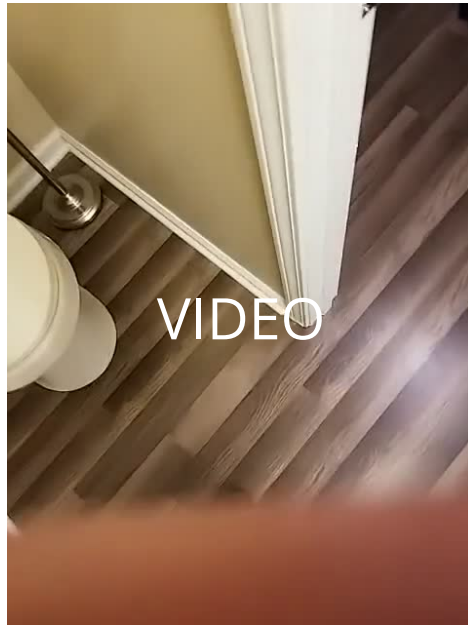
LOOSE AT BASE

Observed a loose toilet fixture. The toilet fixture should be tighten to prevent movement, caution should be taken not to over tighten. Replacing the wax ring may be necessary to prevent leaking.

Contact a qualified plumbing contractor.

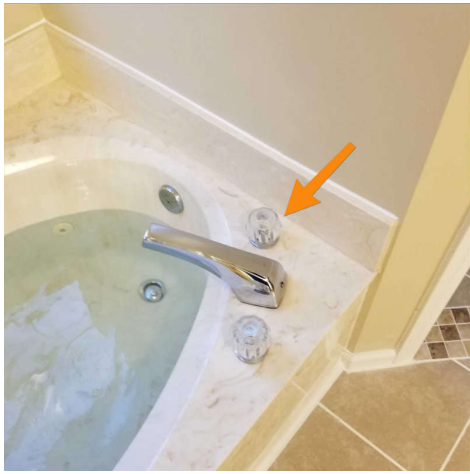
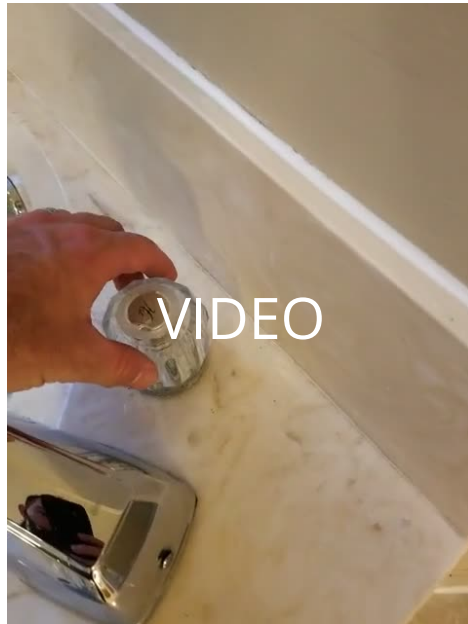
FIXTURE LOOSE

A fixture was loose and should be properly fastened. There is not an access panel to maintain the fixtures.

Contact a qualified plumbing contractor.

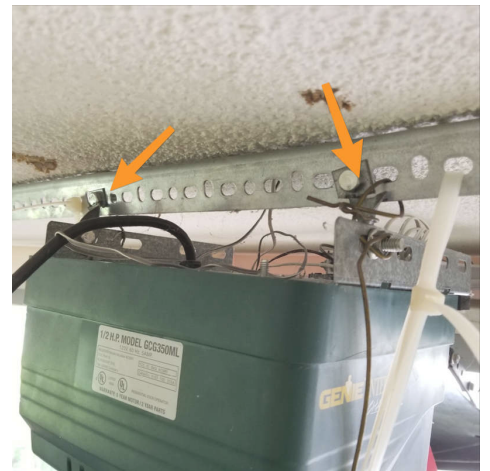
14.5.1 Garage Door Opener **INADEQUATE MOUNTING**

Garage door opener needs to be securely mounted with adequate brackets to prevent movement and falling hazard.

Contact a qualified garage door contractor.

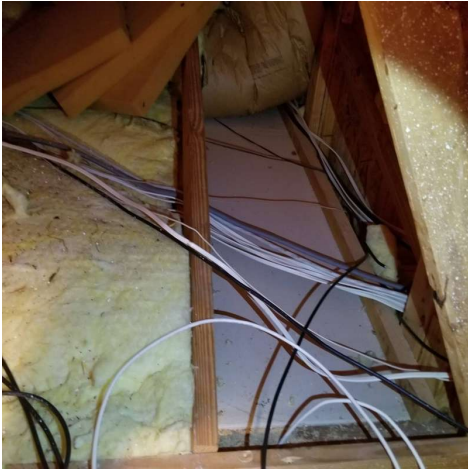
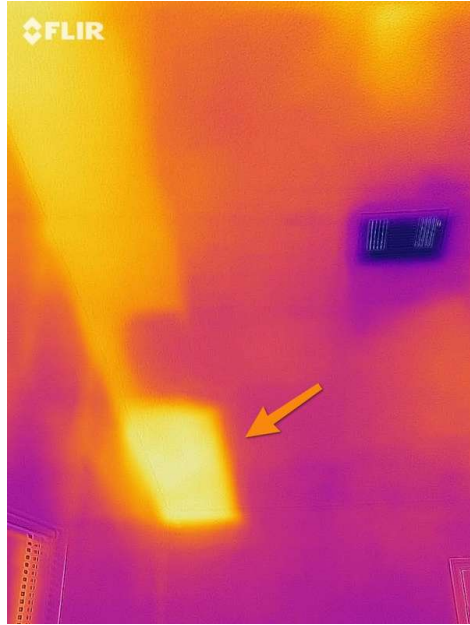
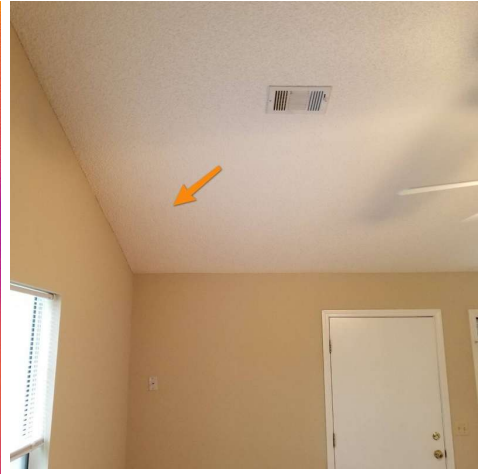
15.1.1 Attic Insulation **MISSING INSULATION**

Areas in the attic were missing insulation which will make heating and cooling difficult and costly. It can also cause moisture that can lead to mold growth.

Contact a qualified insulation contractor.
