SUMMARY
 1234 Main St. Lake Elmo MN 55042
 Buyer Name
 06/17/2018 9:00AM

Randy Erickson
 InterNachi Certified Professional
 Inspector
 Sky Blue Inspections, LLC
 651-675-8895
 randy@skyblueinspects.com

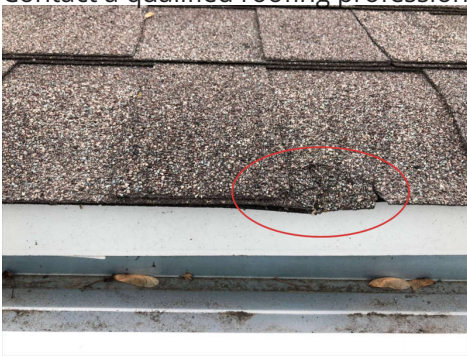
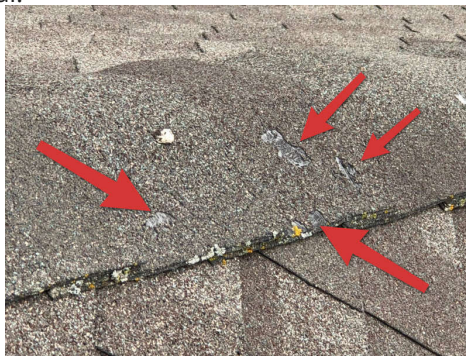
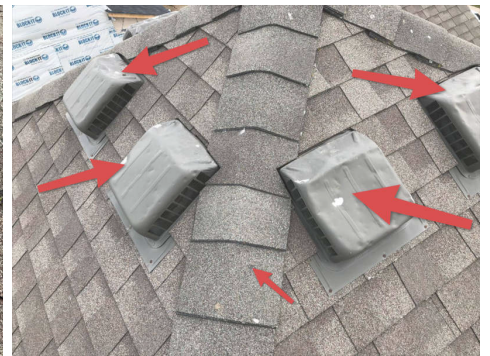
2.1.1 Coverings

Roof coverings showed moderate damage in several locations. This damage may significantly shorten the roof's service life and allow for moisture intrusion. Recommend a qualified roofing professional evaluate and repair as needed. Repair could have significant costs.

Fiberglass mat exposed by damage.

Contact a qualified roofing professional.

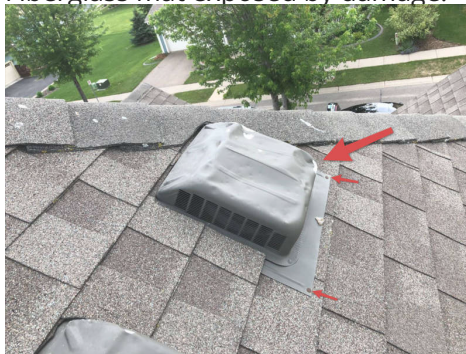
Damaged Vent and no Calk to seal the nail heads.

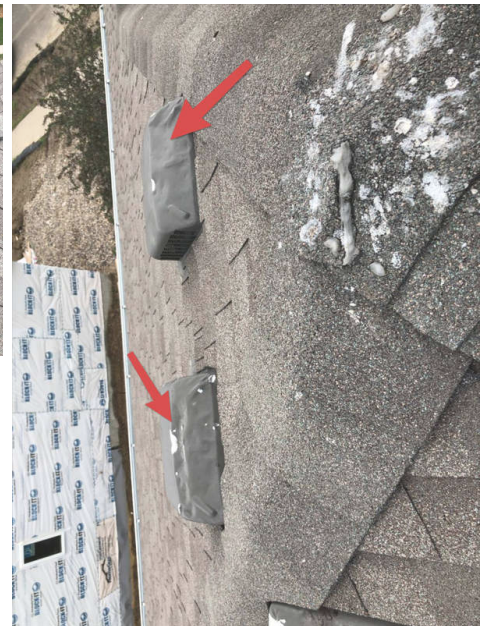
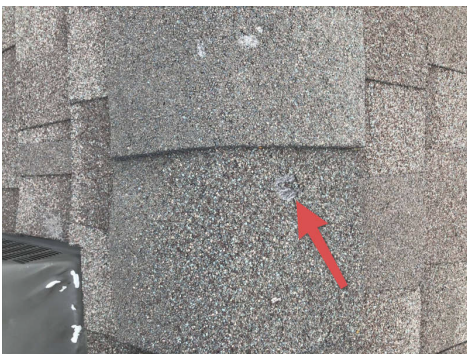
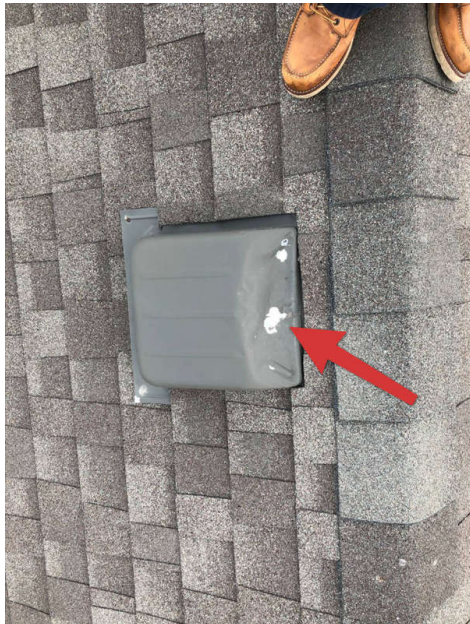
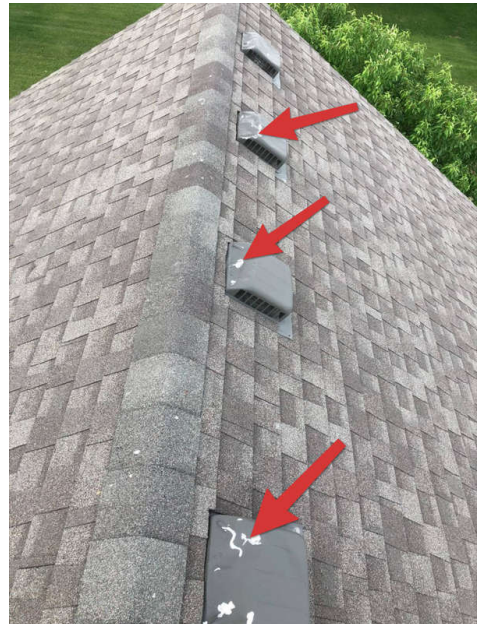
Damage on the vents.

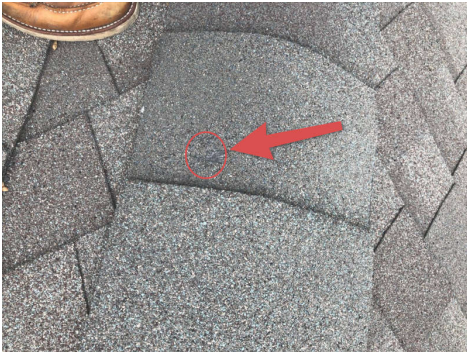
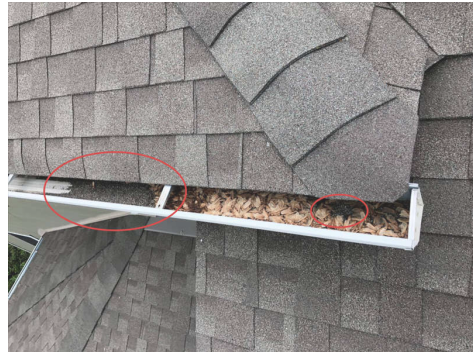
Significant aggregate washed off the shingles.

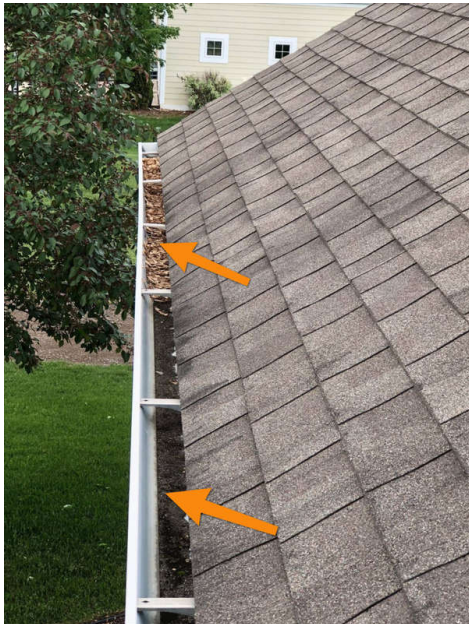
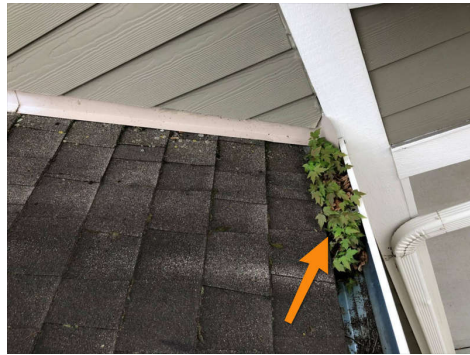
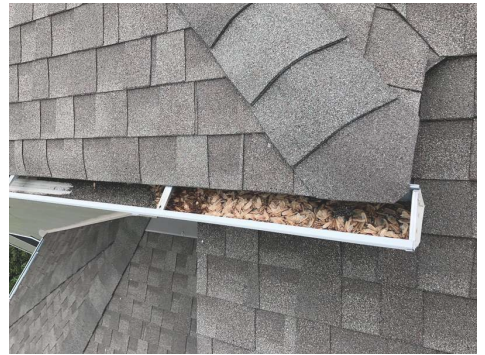
2.2.1 Roof Drainage Systems

Debris has accumulated in the gutters. This can block the normal flow of rain water. Recommend cleaning by a qualified handyman or knowledgeable Home Owner.

Above the Garage

Recommendation
Recommended DIY Project

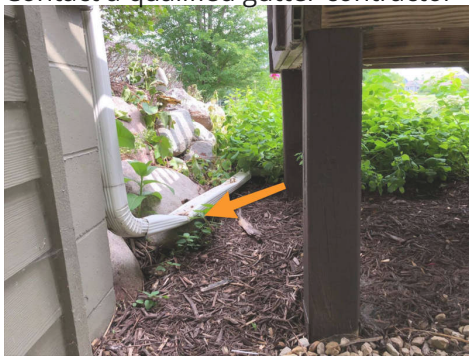
2.2.2 Roof Drainage Systems

Downspout extensions were damaged. This can result in excessive moisture in the soil at the foundation, which can lead to foundation/structural movement. Recommend a qualified gutter contractor or experienced homeowner evaluate and repair. Recommend that extensions carry water 4-6 feet from the house.

Repair

Contact a qualified gutter contractor

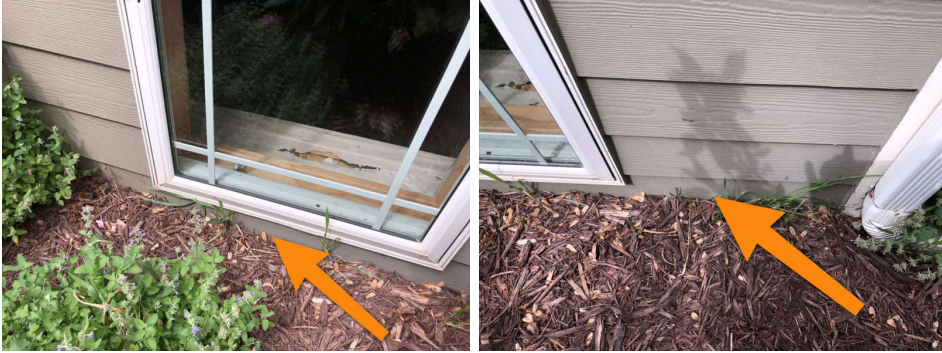
3.1.1 Siding, Flashing & Trim

Inadequate clearance between siding and ground. Recommend a minimum ground clearance between bottom of siding and ground of 4". Siding in contact with the ground, mulch or soil is a serious concern because that condition can provide direct access for wood destroying insects and promote moisture damage.. Recommend correction by a Landscape contractor.

Contact a qualified landscaping contractor

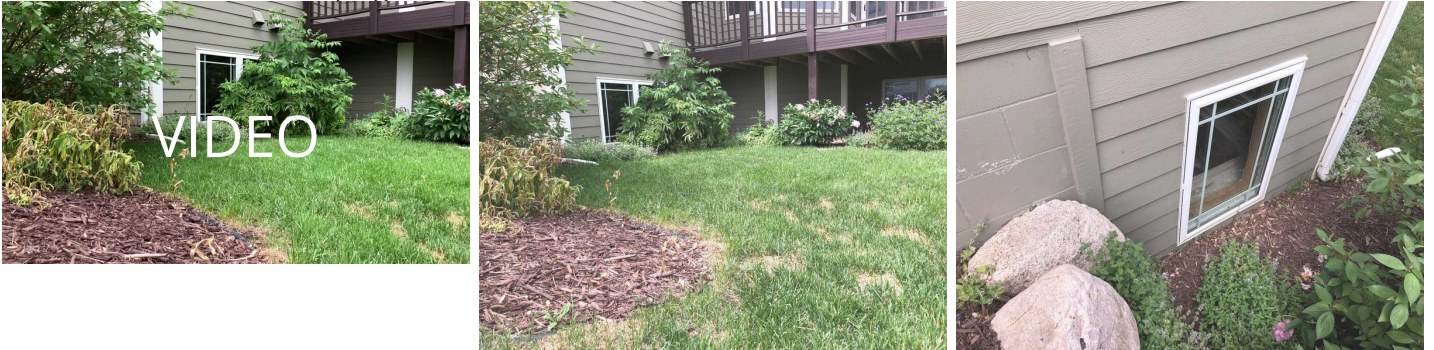
3.6.1 Vegetation, Grading, Drainage & Retaining Walls

Grading is sloping towards the home or flat in some areas. This could lead to water intrusion and foundation issues. Recommend qualified landscaper or foundation contractor evaluate and regrade so water flows away from home.

Contact a qualified landscaping contractor

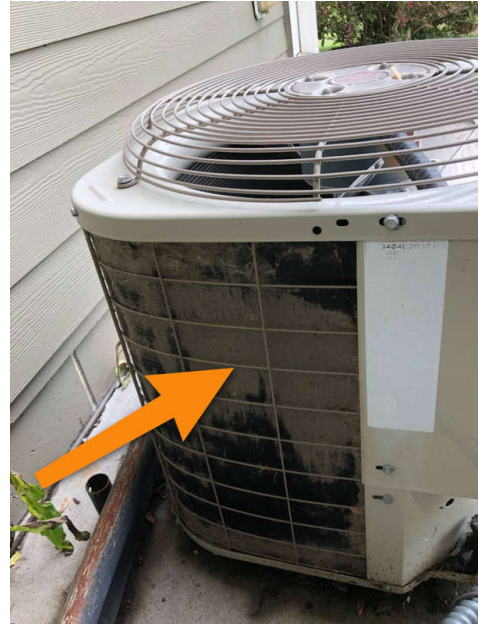
6.1.1 Cooling Equipment

Air Conditioning Unit is Dirty. This may reduce efficiency. Recommend cleaning by the home owner.

Recommended DIY Project

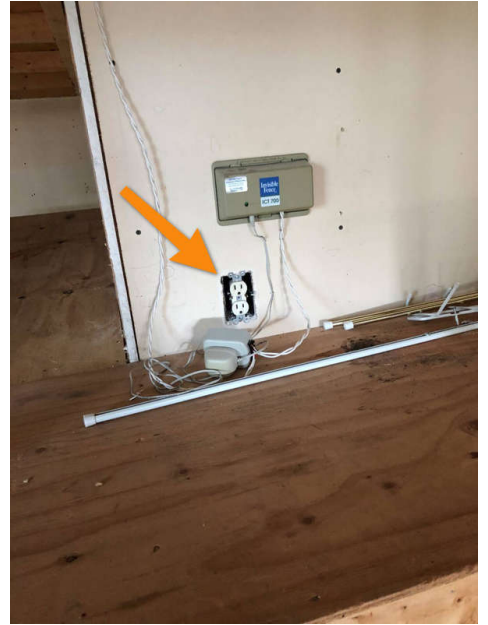
8.4.1 Lighting Fixtures, Switches & Receptacles

One receptacle is missing a cover plate. This causes short and shock risk. Recommend installation of plates.

Recommended DIY Project

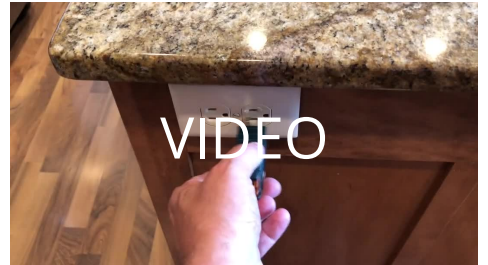
8.4.2 Lighting Fixtures, Switches & Receptacles

One receptacle is loose in it's box. This causes short and shock risk. Recommend correction by a qualified professional..

Contact a qualified professional.

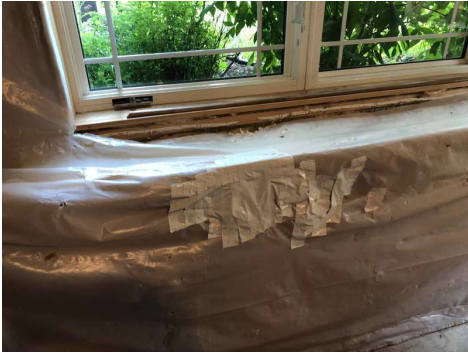
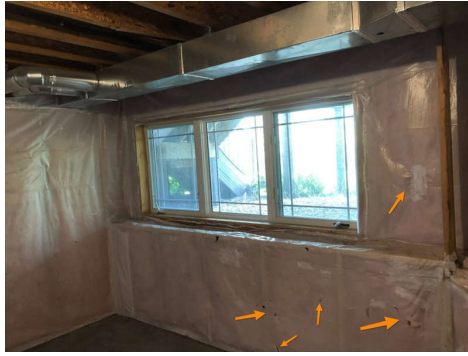
9.2.1 Vapor Retarders (Crawlspace or Basement)

Vapor barrier is damaged (Holes & Tears) in one or more areas. Moisture can easily enter the wall and may cause condensation problems on the basement wall. Recommend insulation contractor repair or replace.

Contact a qualified insulation contractor.

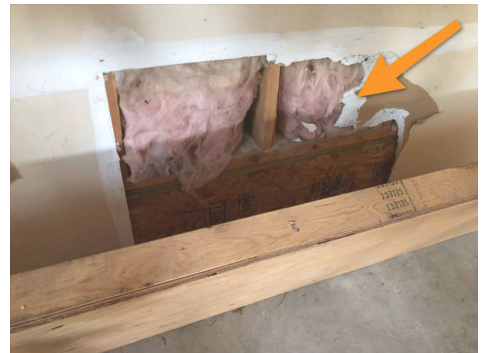
12.3.1 Walls & Firewalls

Garage wall had damaged drywall. Compromises the Firewall. Recommend drywall contractor repair.

Drywall Missing

Contact a qualified drywall contractor.
