This **Summary Report** is meant to organize any **Moderate Recommendations** and **Significant and/or Safety Concerns** into a shorter, straight to-the-point format. It does not, however, include **Minor/Maintenance/Monitor** issues or Informational data that can be found in the Full Report.

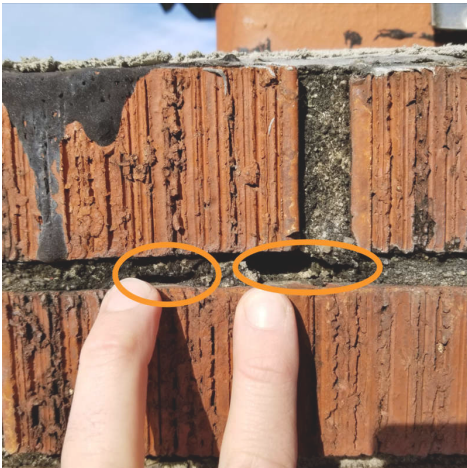
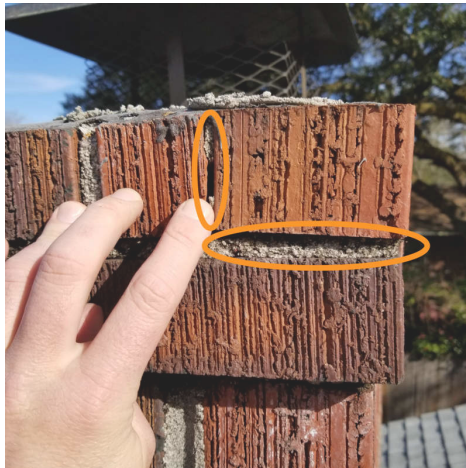
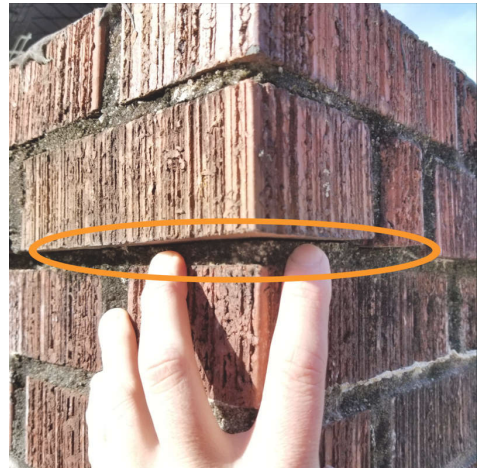
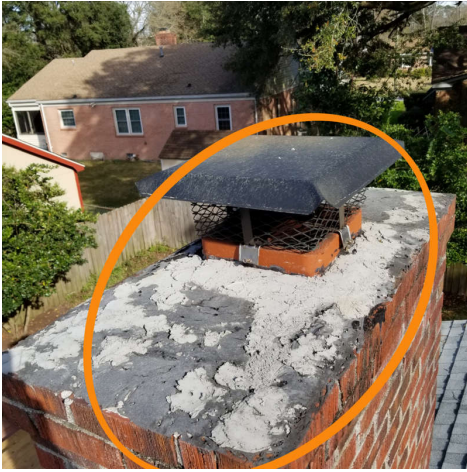
2.3.1 Chimney

REPOINT MORTAR

The masonry chimney's mortar is deteriorated and should be repaired to prevent further, significant deterioration. Recommend having a qualified chimney service contractor or mason evaluate chimney and repair as necessary. This will likely require repointing the mortar.

Contact a qualified chimney contractor.

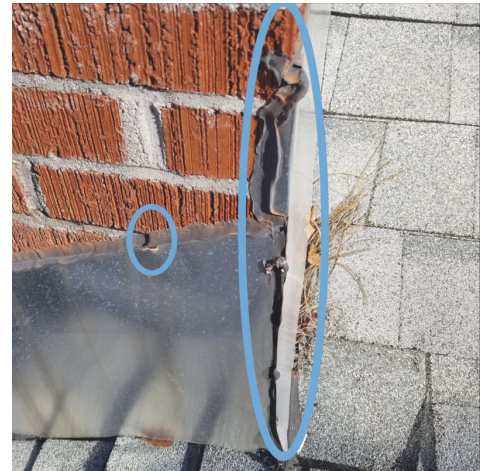
2.3.2 Chimney

NEEDS SEALANT

Some of the roofing cement has deteriorated. Recommend applying a roofing sealant to the exposed areas so as water intrusion does not occur.

Chimney flashing

Contact a qualified professional.

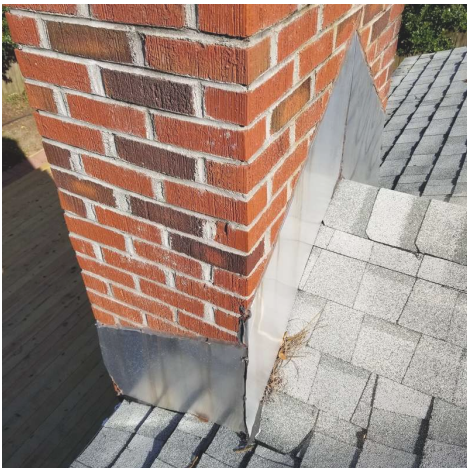
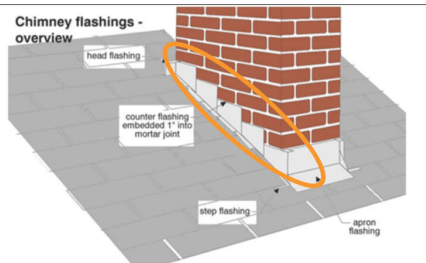
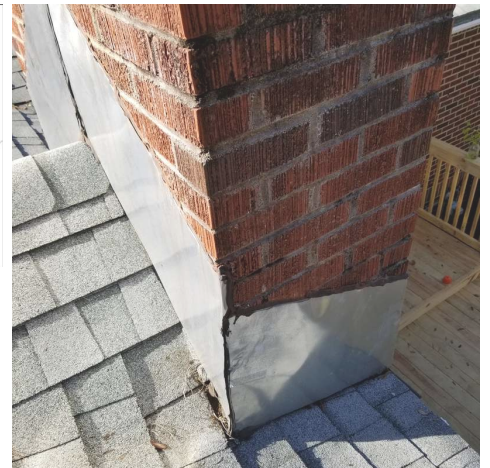
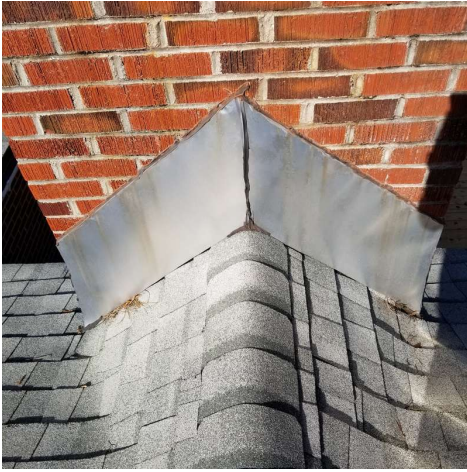
2.6.1 Flashing / Vents

IMPROPER FLASHING - METAL COVERINGS

Inspector could not confirm if counter flashing was installed 1 inch into mortar joints under the newest flashing. Improper metal roof flashing was installed which could allow for water intrusion to attic space. Recommend correction by installing proper metal roof approved vent flashing with boots.

Contact a qualified roofing professional.

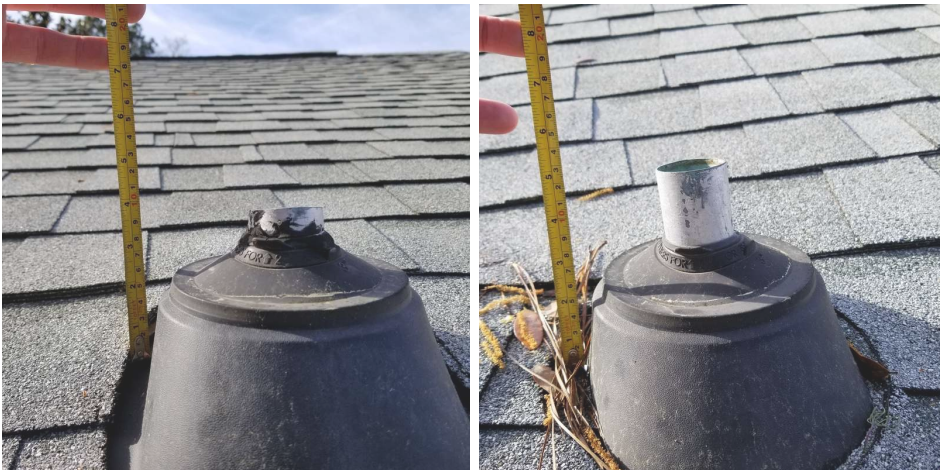
2.6.2 Flashing / Vents

PLUMBING VENT TOO LOW

One or more plumbing vent pipes terminated less than 6 inches above the roof surface below. Debris can block vent pipe openings with such short pipes. Blocked vent pipes can cause sewer gases to enter living spaces. Recommend that a qualified person repair per standard building practices. For example, by extending pipe(s) to terminate at least 6 inches above the roof surface.

Contact a qualified roofing professional.

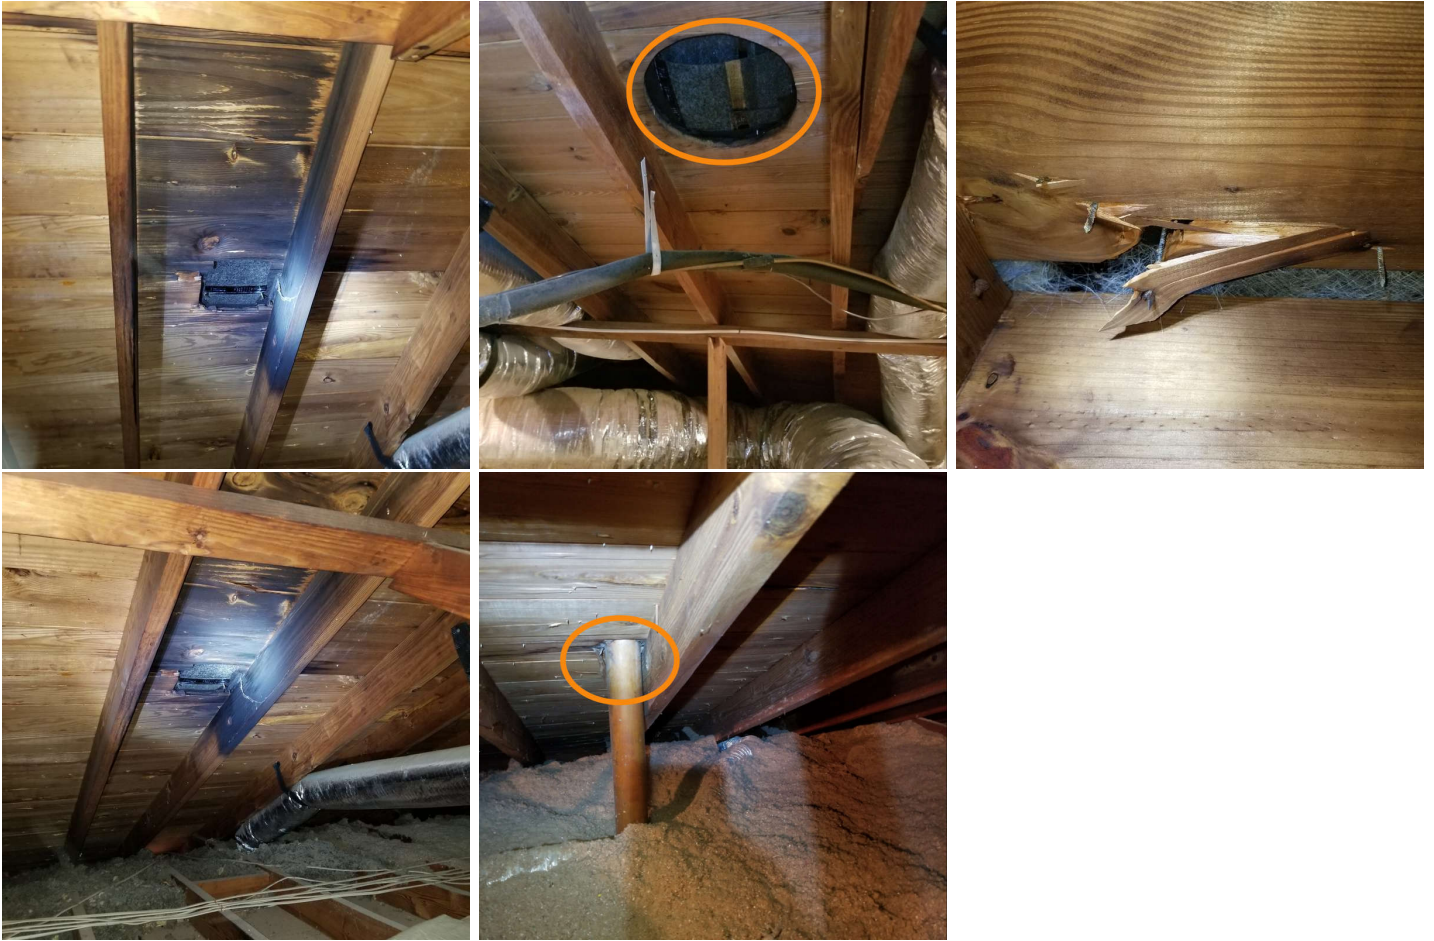
3.2.1 Roof Sheathing

DAMAGED SHEATHING

The roof had areas of visible damage to the roof sheathing at the time of the inspection. All damaged areas should be repaired for safety reasons, and to prevent potential damage from moisture intrusion to the home materials, the roof structure and to prevent development of microbial growth such as mold. You should consult with a qualified roofing contractor to gain an idea of options and costs for repair. Old plumbing vent holes, where you see roof under layment, should be repaired. As in roof decking should be installed underneath.

Contact a qualified professional.

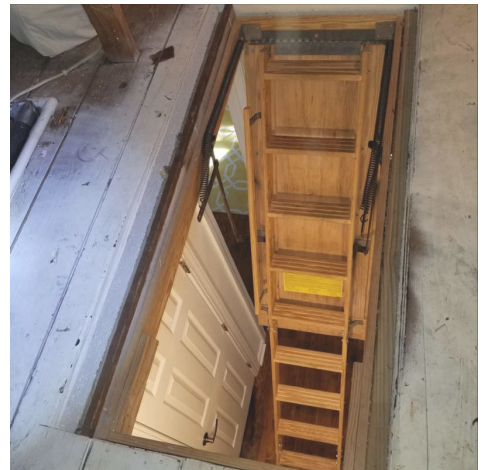
3.4.1 Attic Hatch

UNINSULATED PULL-DOWN

Pull-down stairs are installed for the attic access. No insulation is installed above the stairs and no weatherstripping is installed around the hatch perimeter. To reduce air leakage, recommend installing weatherstripping and an insulated hatch cover.

Interior air leaking into the attic results in heating and cooling losses, increased energy costs, and a possible increase in moisture levels in the attic due condensation forming on the underside of the roof sheathing during cold weather.

Contact a qualified handyman.

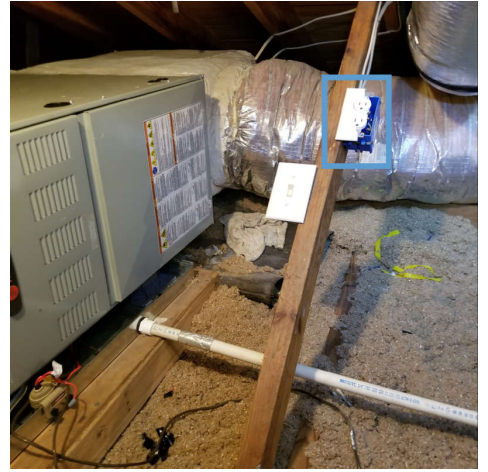
3.5.1 Electrical

COVER PLATE BROKEN

Cover plate is broken at one or more electric boxes, such as for receptacles, switches and/or junction boxes. They are intended to contain fire and prevent electric shock from exposed wires. Cover plates should be replaced where necessary.

Recommended DIY Project

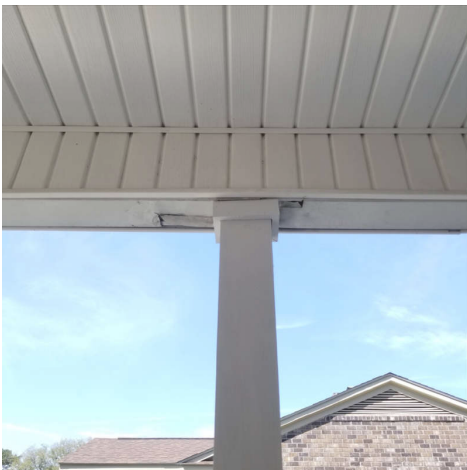
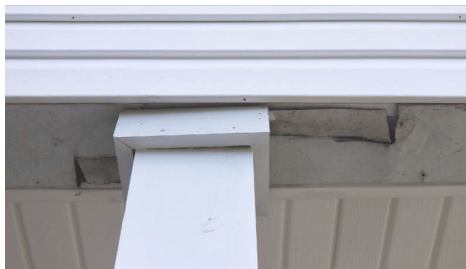
4.1.1 General

CARPORT POSTS DAMAGED

One or more carport and/or porch support posts were damaged. Recommend qualified contractor repair.

Contact a qualified general contractor.

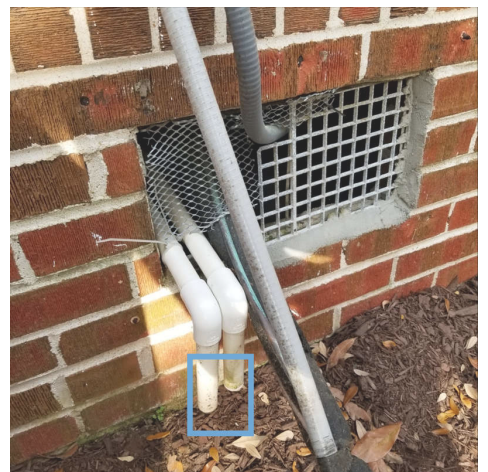
4.2.1 Exterior issues

A/C DRAIN TO CLOSE TO HOME

It is recommended to have the evaporator drain for the air handler directed away from the house. The drain is too close the exterior wall and allows moisture at the wall/footing areas. Recommend to have at least 12" from exterior wall.

Contact a qualified HVAC professional.

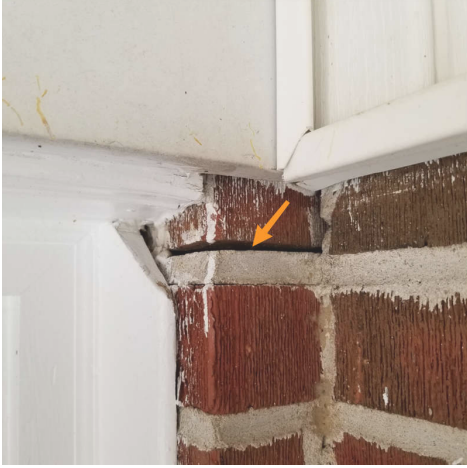
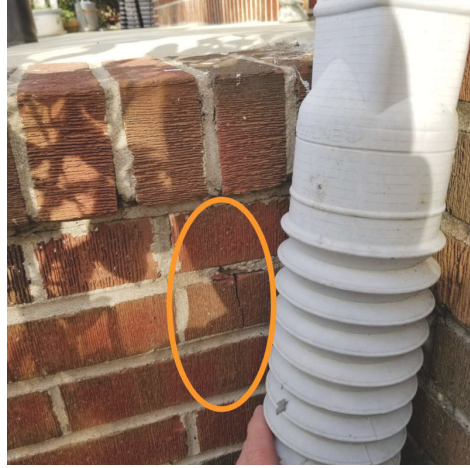
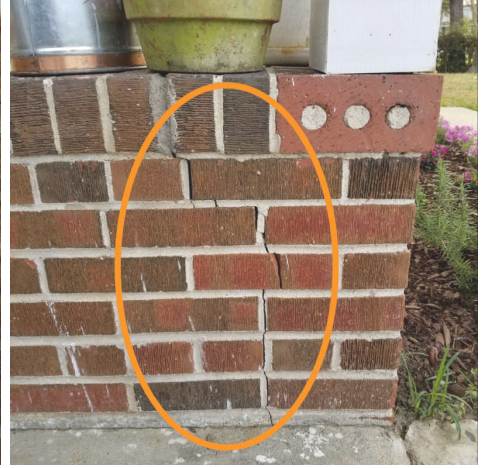
4.2.2 Exterior issues

BRICK - CRACKS, DETERIORATION

The masonry (brick) was deteriorated or damaged in some areas. Where cracks or openings are exposed, water can enter the wall structure causing mold, fungal growth and structural damage. This is a conducive condition for wood-destroying organisms. Recommend that a qualified contractor repair as necessary. For example, by repointing mortar, or sealing with epoxy, or replacing broken or missing masonry.

Top right. Front door

Front porch

Recommendation
Contact a qualified professional.

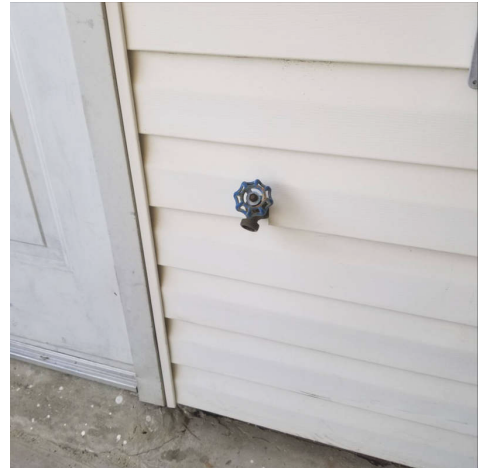
4.2.3 Exterior issues

FAUCET HANDLE ISSUE

hose faucet handle was inoperable / broken. Recommend that a qualified person replace handles or make repairs as necessary.

Recommendation
Contact a qualified professional.

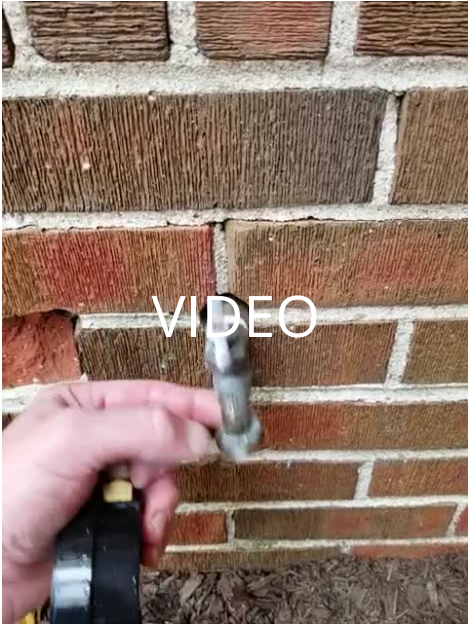
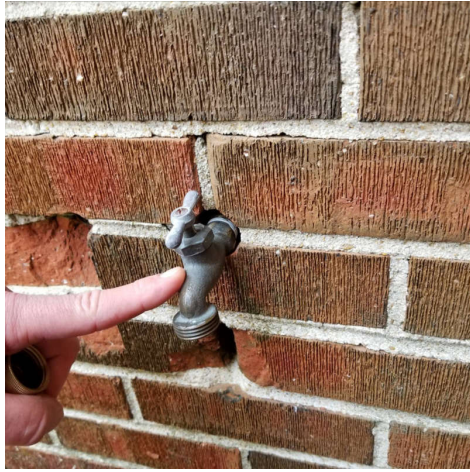
4.2.4 Exterior issues

LOOSE HOSE BIBB

One or more hose bibs weren't anchored securely to the structure's exterior. Water supply pipes can be stressed when hose bibs are turned on and off and when hoses are pulled. Leaks may occur as a result. Recommend that a qualified person install fasteners per standard building practices.

Recommendation
Contact a qualified professional.

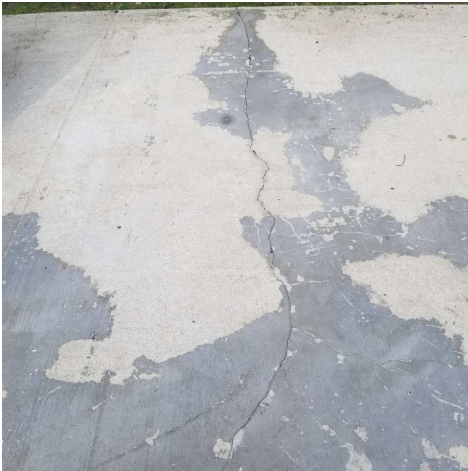
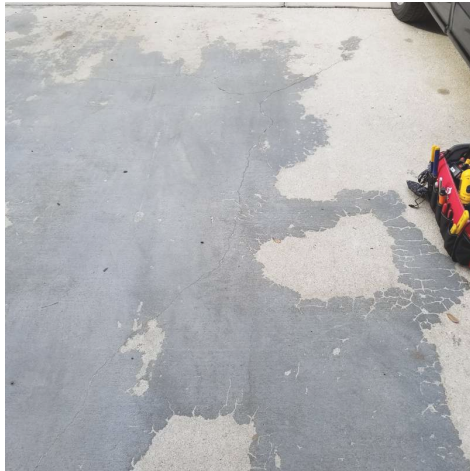
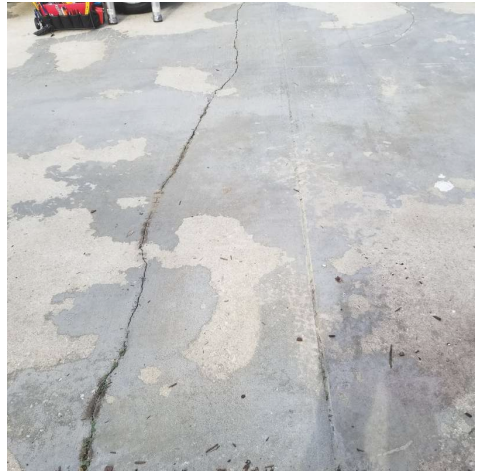
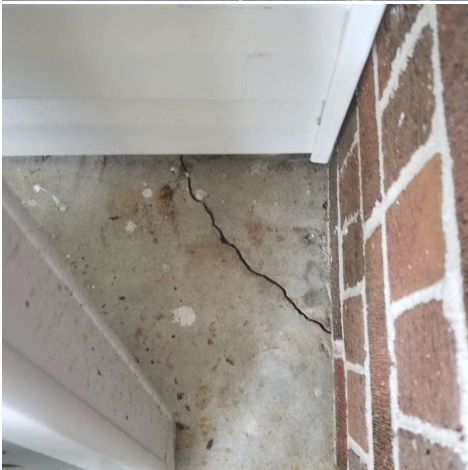
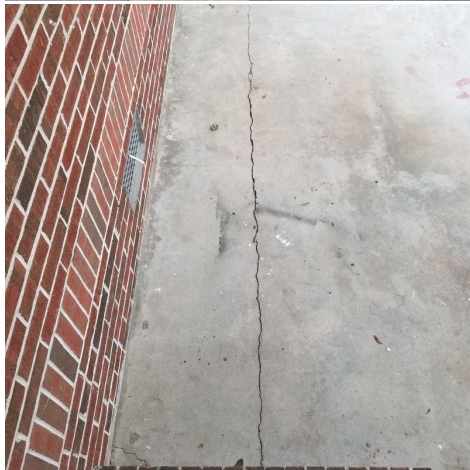
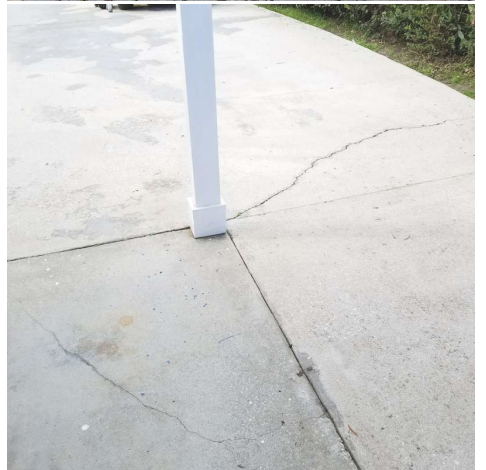
4.3.1 Driveway, Walkway, Patio

MINOR DRIVEWAY DAMAGE

Minor deterioration (e.g. cracks, holes, settlement, heaving) was found in the driveway, but no trip hazards were found. The client may wish to have repairs made for cosmetic reasons.

Contact a qualified professional.

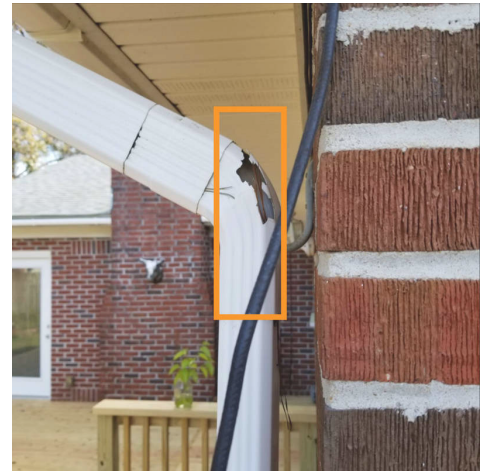
4.7.1 Gutters and Flashing

DAMAGED DOWNSPOUT

Sections of downspouts are damaged. This can result in water accumulating around the structure's foundation, or crawlspace if they exist. Accumulated water is a conducive condition to wood destroying insects and organisms, and may also cause the foundation to settle over time. A licensed contractor should replace or repair downspouts where necessary. A damaged downspout may not allow water to flow freely.

Contact a qualified professional.

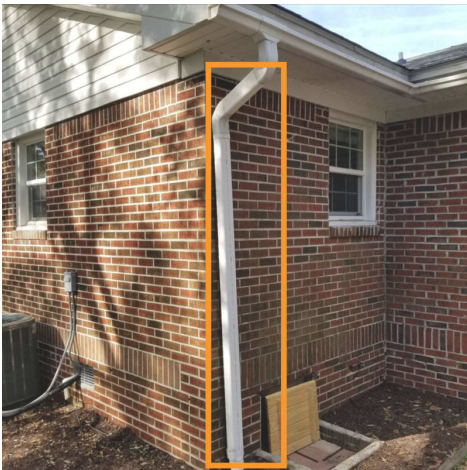
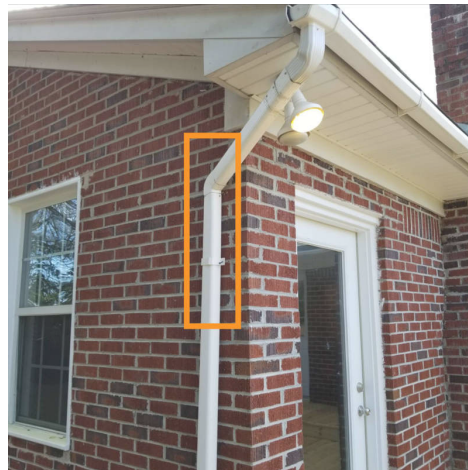
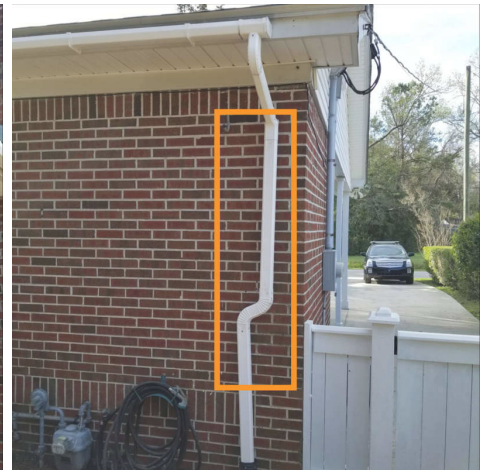
4.7.2 Gutters and Flashing

DOWNSPOUT LOOSE

One or more downspouts or elbows were loose or detached. Rainwater can come in contact with the building exterior or accumulate around the foundation as a result. This is a conducive condition for wood-destroying organisms. Recommend that a qualified person repair as necessary.

Contact a qualified professional.

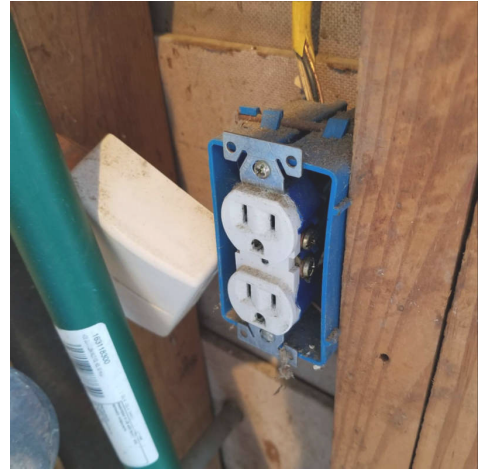
4.9.1 Electrical

COVER PLATE ISSUES

One *cover plate* was *missing*. This is a potential shock and/or fire hazard. Recommend that a qualified professional repair as necessary.

Utility room

Contact a handyman or DIY project

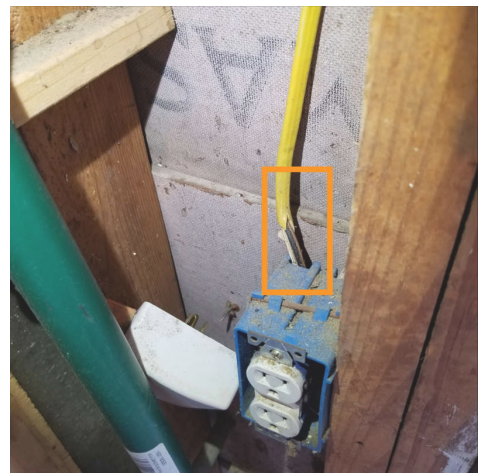
4.9.2 Electrical

EXPOSED WIRES

One or more sections of outdoor wiring were exposed and *subject to damage*. This is a potential shock hazard. Recommend that a qualified electrician repair per standard building practices. For example, by installing conduit, re-routing wires or replacing wiring.

Utility room

Contact a qualified professional.

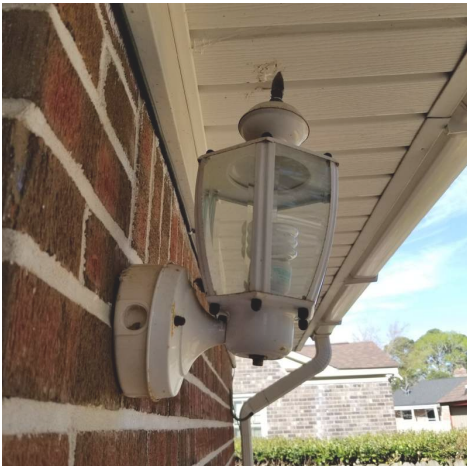
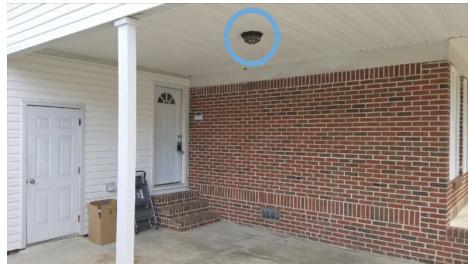
4.9.3 Electrical

LIGHT INOPERABLE

One or more light fixtures appear to be inoperable. Recommend further evaluation by replacing bulb(s) and/or consulting with the property owner(s). Repairs or replacement of the light fixture(s) by a qualified electrician may be necessary.

Contact a handyman or DIY project

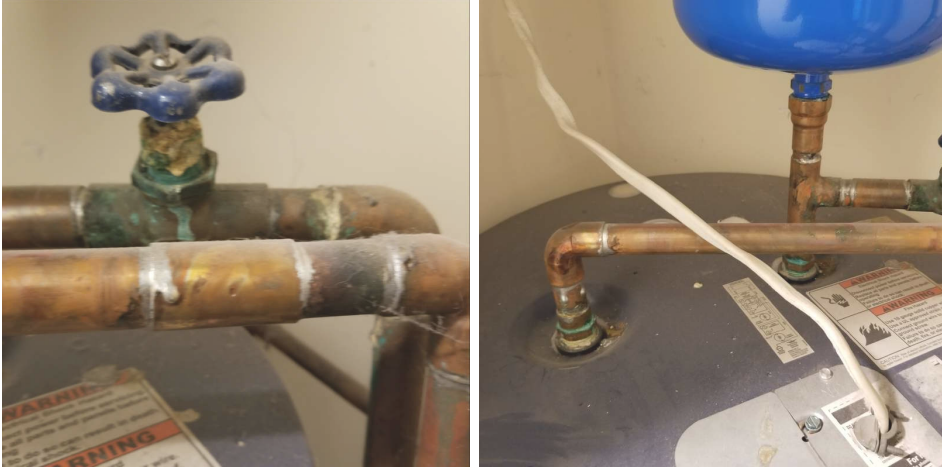
5.1.1 Water Heater

CORROSION ON FITTING/LINES

Corrosion was found on fittings and/or water supply lines for the water heater. Leaks may exist. A qualified plumbing contractor should evaluate and repair as necessary.

Monitor these areas.

Recommendation
Recommend monitoring.

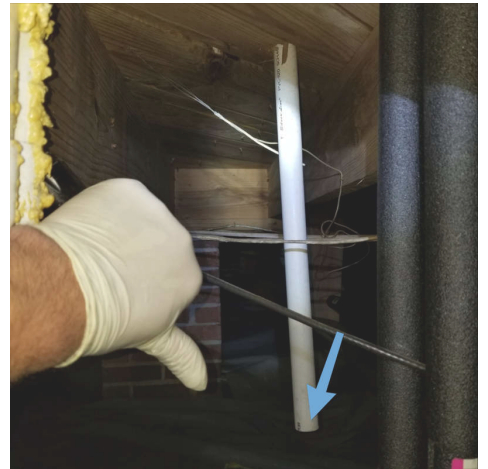
5.1.2 Water Heater

TPR DRAIN IN CRAWLSPACE

The temperature-pressure relief valve drain line is routed so as to empty into the crawl space. Water may accumulate in the crawl space if the valve develops a leak. A qualified plumber should re-route the drain line so as to drain outside.

Recommendation
Contact a qualified professional.

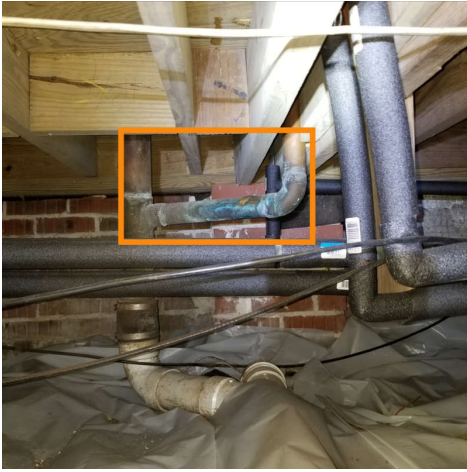
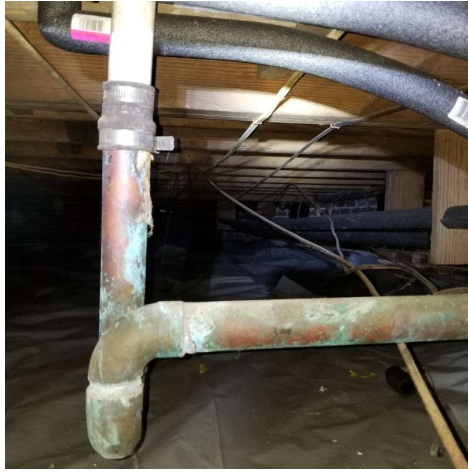
6.3.1 Drain and Waste

SIGNIFICANT CORROSION

Significant corrosion was found on drain or waste fittings/pipes. This is an indication of past leaks, or that leaks are likely to occur in the future. A licensed plumber should evaluate the line and repair as needed.

At the least, monitor the plumbing lines of home throughout the years ahead.

Recommendation
Contact a qualified plumbing contractor.

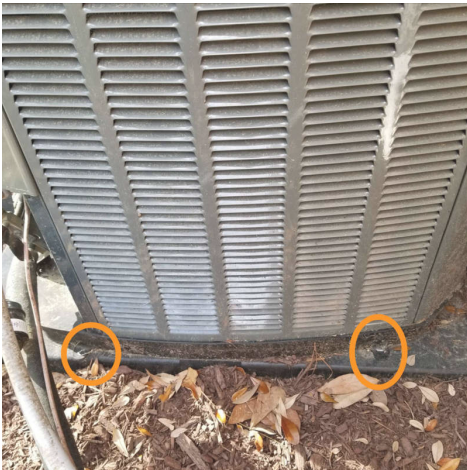
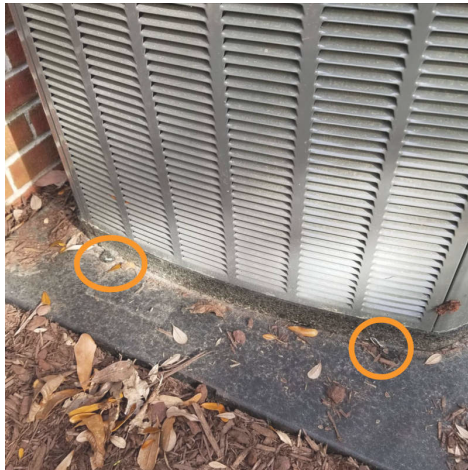
8.2.1 Condensing Unit

DETERIORATED ANCHORS

One of the anchors that secure the condensing unit are deteriorated. The proper anchor need to be installed to prevent the condensing unit from move, this can cause damage to the refrigeration line and electric.

Contact a qualified professional.

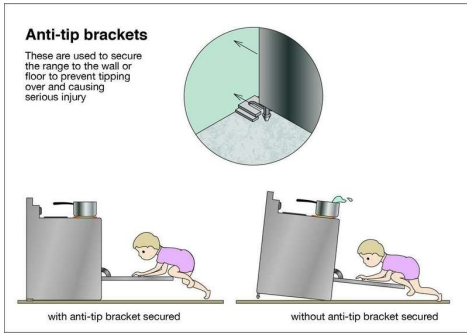
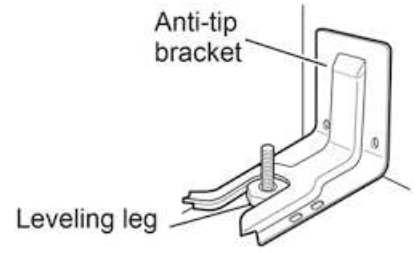
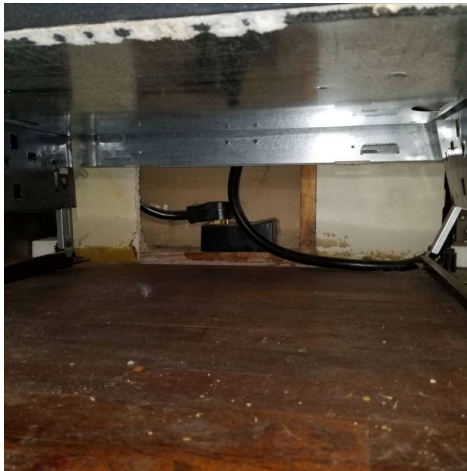
9.2.1 Range-Cooktop-Oven

NO ANTI-TIP

The range can tip forward, and no anti-tip bracket appears to be installed. This is a safety hazard since the range may tip forward when weight is applied to the open door, such as when a small child climbs on it, or if heavy objects are dropped on it. Anti-tip brackets have been sold with all free standing ranges since 1985. An anti-tip bracket should be installed to eliminate this safety hazard. For more information, visit <https://www.nachi.org/anti-tip.htm>

Contact a qualified appliance repair professional.

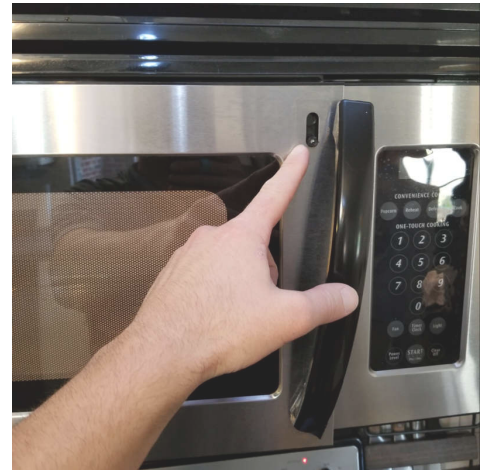
9.3.1 Microwave
HANDLE BROKEN

The microwaves handle is damaged. Recommend a qualified professional make corrections.

Recommendation
 Contact a qualified professional.

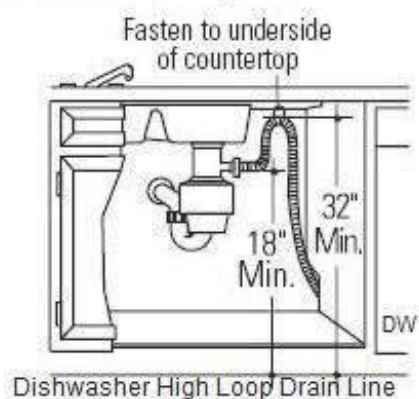
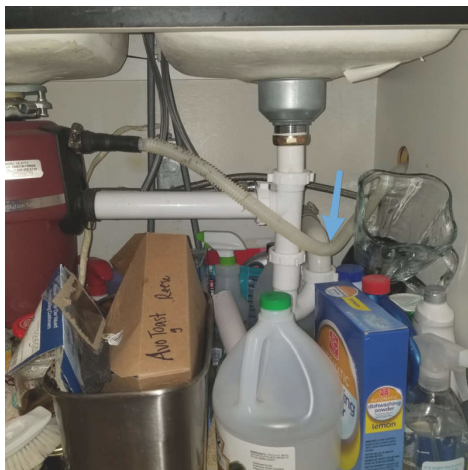
9.6.1 Dishwasher
DISHWASHER NO HIGH LOOP

The dishwasher drain line is not configured with a "high loop" or "air gap". A high loop is created by routing the drain line up to the bottom surface of the countertop above, and securely fastening it to that surface. It is meant to prevent water from siphoning out of the dishwasher, and to prevent water from the sink drain or food disposal from entering the dishwasher. Some dishwashers have a built-in high loop where one is not required to be configured in the drain line. The clients should try to determine if a high loop is required for this brand and model of dishwasher (review installation instructions, etc.). If one is required, or it cannot be determined if one is not required, then a qualified contractor should install a high loop as per standard building practices.

Also, no "air gap" is installed. Air gaps are another device meant to prevent water from the sink drain or food disposal from entering the dishwasher. These are required in some municipalities for new construction and when remodeling. The client(s) should consult with a qualified contractor to determine if an air gap should be installed.

Contact a qualified appliance repair professional.

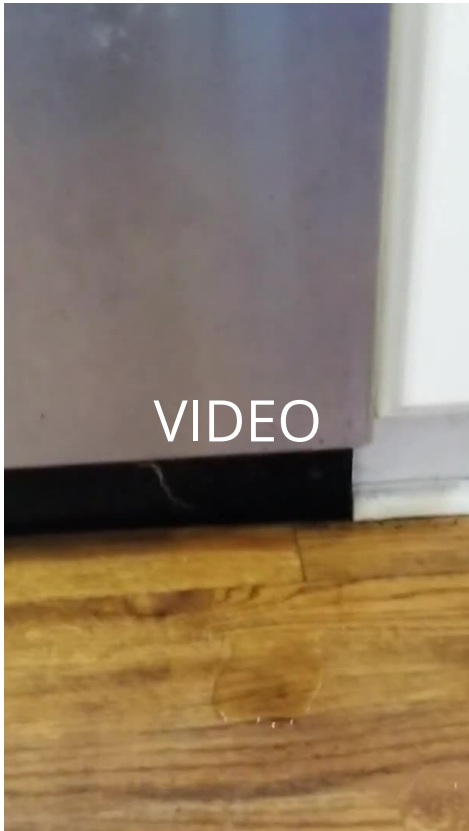
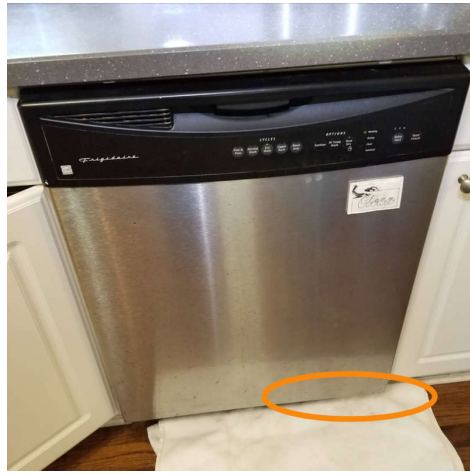
9.6.2 Dishwasher

DISHWASHER WATER BELOW

Water was found beneath the dishwasher, indicating an active leak. A qualified plumber or appliance technician should evaluate and repair as necessary.

Contact a qualified appliance repair professional.

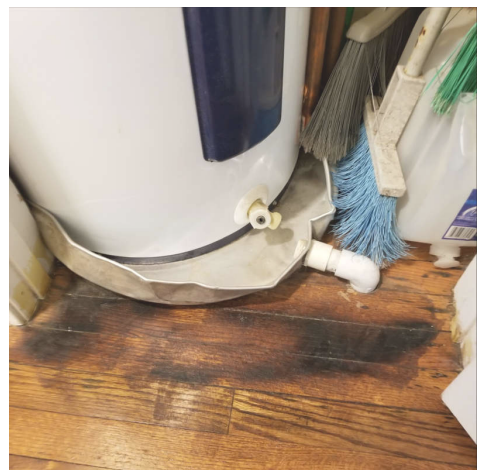
11.3.1 Floors, Walls, Ceilings

FLOORS-REFINISH WOOD

Wood flooring is damaged from what appears a past leak.

Recommend having a qualified contractor evaluate and refinish wood flooring as necessary.

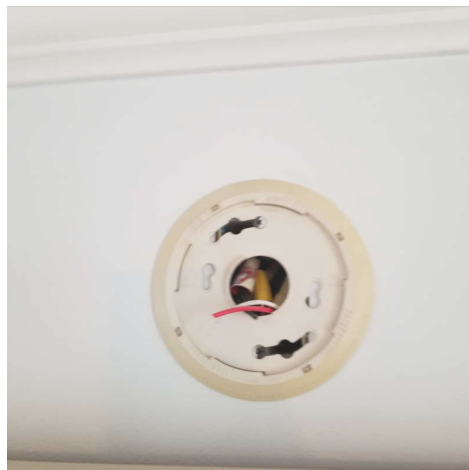
11.4.1 Smoke and CO alarms

SMOKE ALARMS MISSING

Smoke alarms were missing from one or more bedrooms / from one or more hallways leading to bedrooms. Smoke alarms should be installed as necessary so a functioning alarm exists in each hallway leading to bedrooms, in each bedroom, on each level and in any attached garage.

Living Room

Recommendation
Contact a qualified handyman.

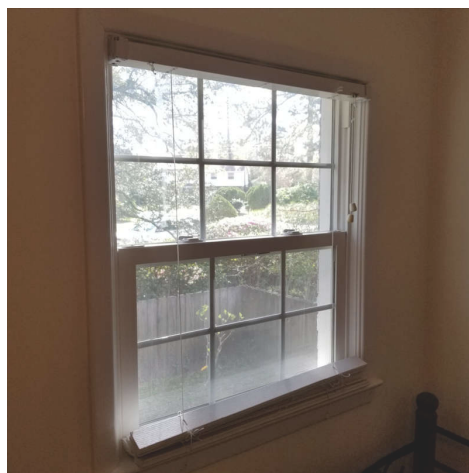
11.6.1 Windows and Door

BLINDS

One or more blinds were damaged or not working properly.

Bedroom

Recommendation
Contact a qualified professional.

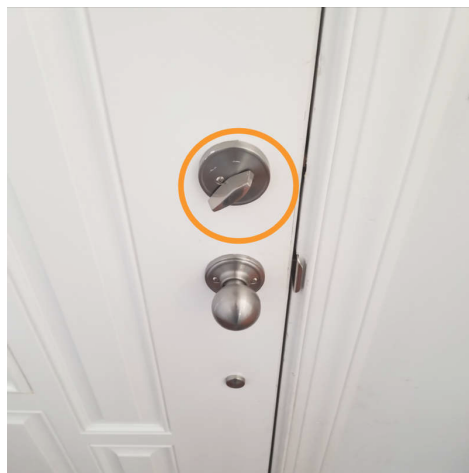
11.6.2 Windows and Door

LOCKSET/DEADBOLT-INOP/DIFFICULT

Door lock / deadbolt mechanisms are difficult to operate. A qualified contractor should evaluate and repair as necessary.

Front door

Recommendation
Contact a qualified handyman.

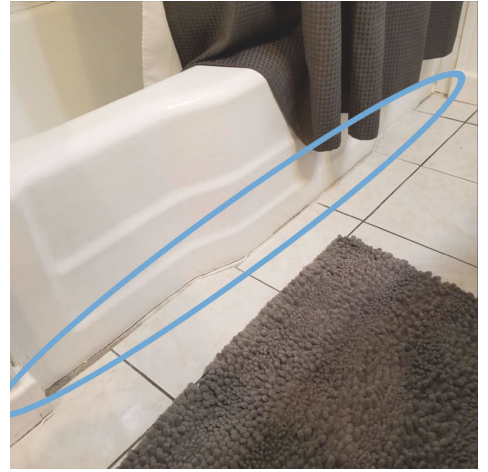
12.1.1 Bathub

CAULK AT FLOOR

Caulk is missing or deteriorated along the base of one or more bathtubs, where flooring meets the tub. It should be replaced where deteriorated and/or applied where missing to prevent water intrusion and damage to the floor structure.

Hallway Bathroom

Recommendation
Recommended DIY Project

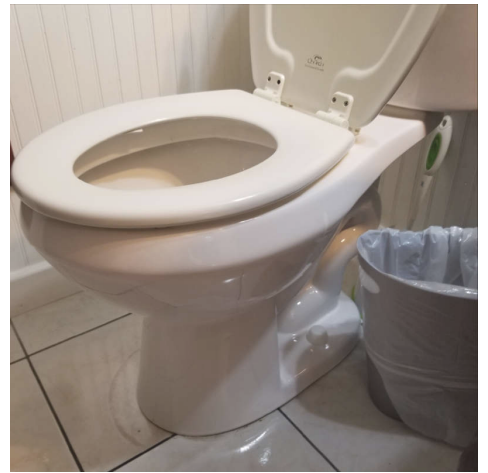
12.8.1 Toilets

LOOSE

One or more toilets are loose. A qualified contractor should remove the toilet(s) for further evaluation and repairs if necessary. A new wax ring should be installed and toilet(s) should be securely anchored to the floor to prevent movement and leaking.

Bathroom

Recommendation
Contact a qualified professional.

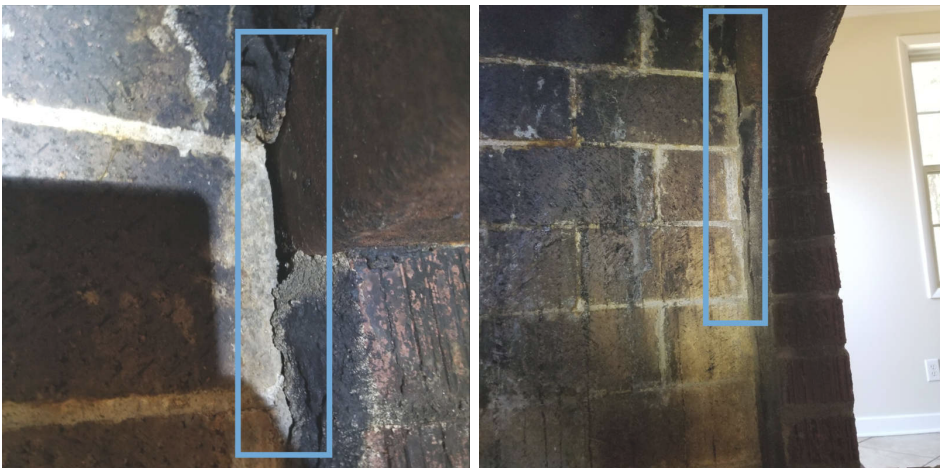
14.4.1 Liner, Firebricks, Panels

GAPS IN HEARTH OF FIREPLACE

Small cracks, pitting and/or deterioration were found in some fireplace firebrick. The clients should monitor the condition of the firebricks in the fireplace's firebox in the future. If significant deterioration occurs or if bricks become loose, then a qualified chimney service contractor should evaluate and make repairs as necessary. These areas should be repointed.

Recommendation
Contact a qualified professional.

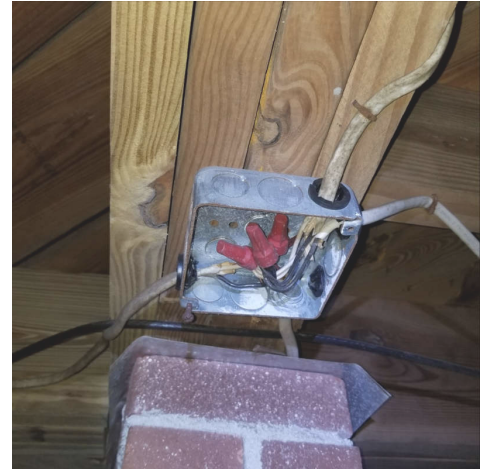
16.2.1 Plumbing-Electrical
COVER PLATE MISSING

There are open junction boxes in the crawlspace. The proper cover needs to be installed to prevent damage to the wires or possible un-contained sparking.

Contact a qualified electrical contractor.

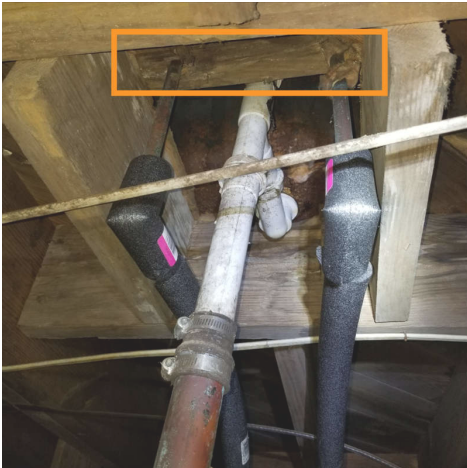
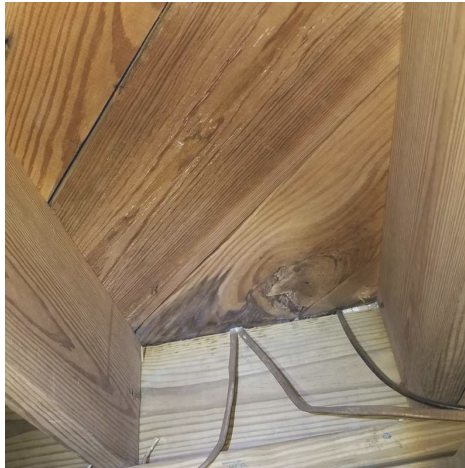
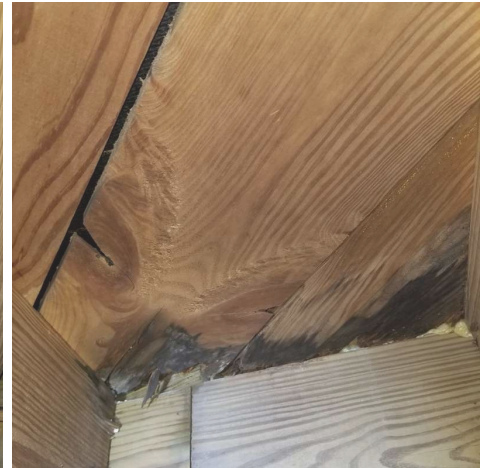
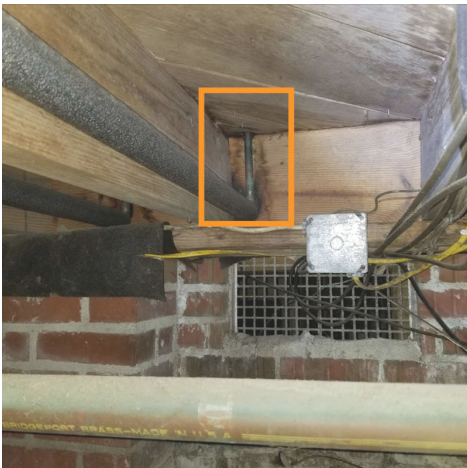
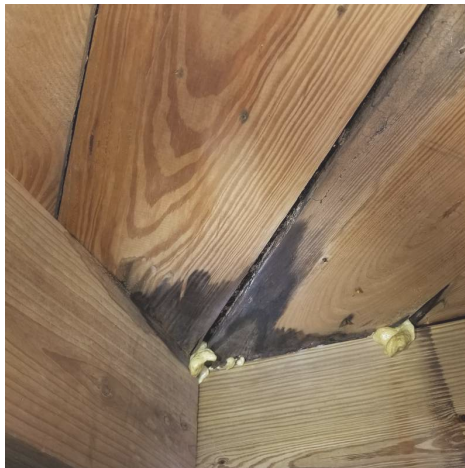
16.3.1 Substructure
DETERIORATED WOOD.

CRAWLSPACE

Fungal rot was found at one or more *joists / sections of floor sheathing*. Some past water strains. The wood is dry. No elevated levels of moisture at these areas. Recommend that a qualified contractor evaluate and repair as necessary. All rotten wood should be repaired or replaced.

Contact a qualified professional.
