SUMMARY

1234 Main St. Naches WA 98937

Ryan Franke
Lic. No. 809

Integrity Inspection Services LLC
509-961-2863
ryan@inspectwithintegrity.com

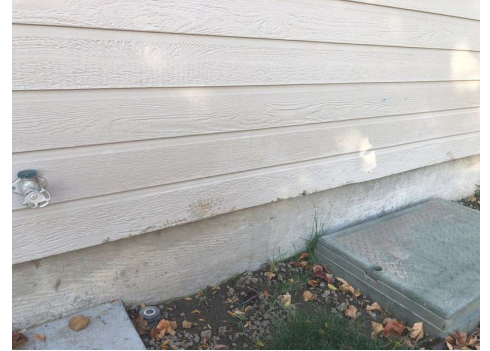
3.1.1 Siding, Flashing & Trim

MINOR DAMAGE

BACK EXTERIOR

Some minor damage/deterioration noted at exterior siding and/or trim. Probable past moisture from garden spigot. Recommend maintaining paint/seal to prevent further compromise due to moisture.

Contact a handyman or DIY project

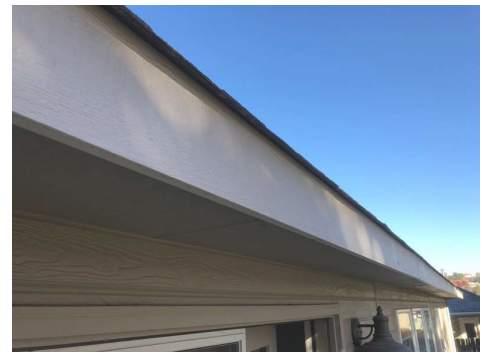
4.4.1 Flashings

DRIP-EDGE FLASHING NOT INSTALLED

Drip-edge flashing protects roof eaves, soffits and fascia from possible moisture penetration and potential damage resulting from moisture. Some areas of home did not have a proper drip-edge flashing installed. Home may benefit from a proper drip-edge flashing installed at roof eaves. Recommend a qualified professional further evaluate and repair.

Contact a qualified roofing professional.

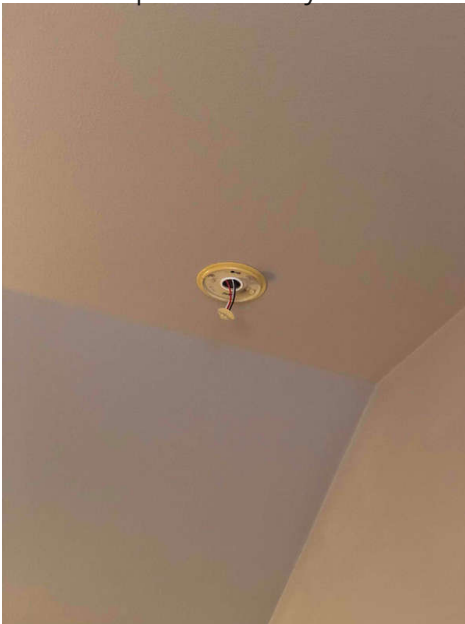
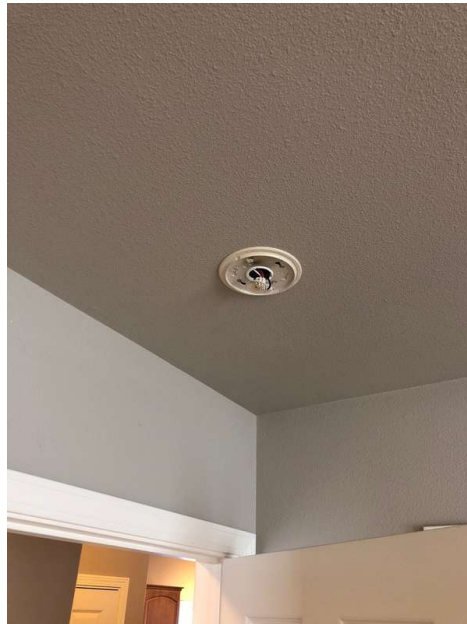
5.1.2 Safety Equipment

SMOKE DETECTORS MISSING

KITCHEN, MASTER BEDROOM, HALL

Inspector was unable to confirm installed Smoke Detectors in all required/recommended locations. Safety Hazard. Recommend repair or replace as needed.

Recommendation
Contact a qualified handyman.

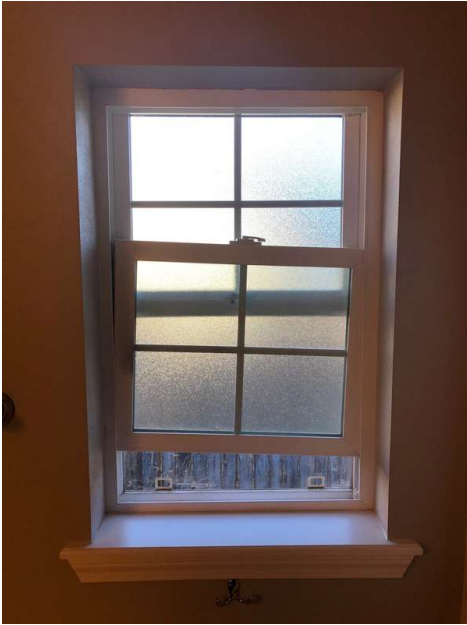
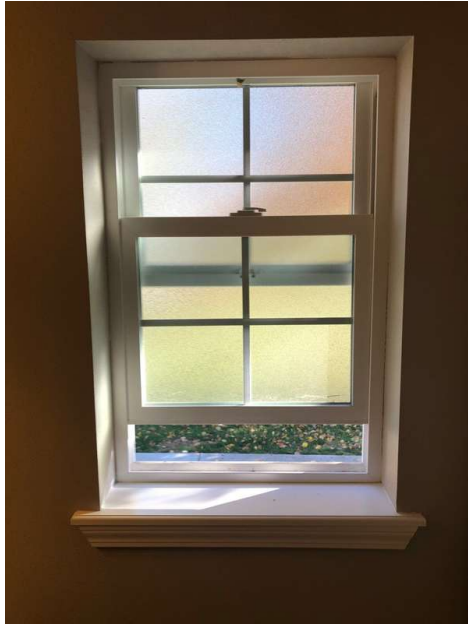
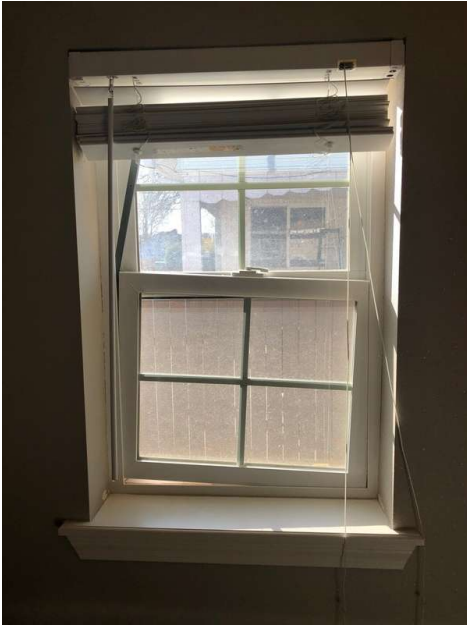
5.5.1 Windows

SINGLE-HUNG WINDOWS

HALL BATHROOM, MASTER BATHROOM, LAUNDRY ROOM

Some single hung windows not operating smoothly/properly and may be in need of adjustment or repair.

Recommendation
Contact a qualified window repair/installation contractor.

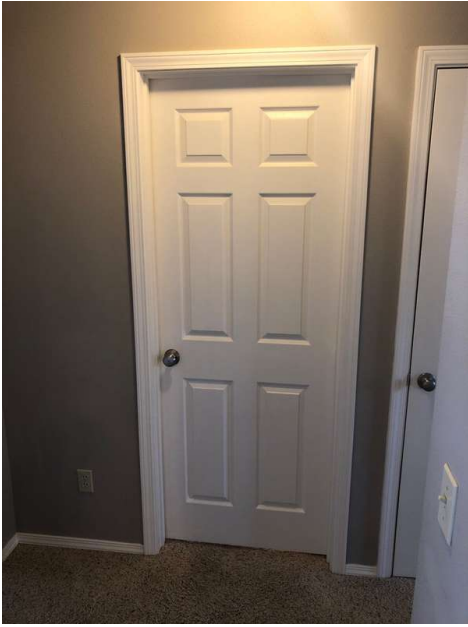
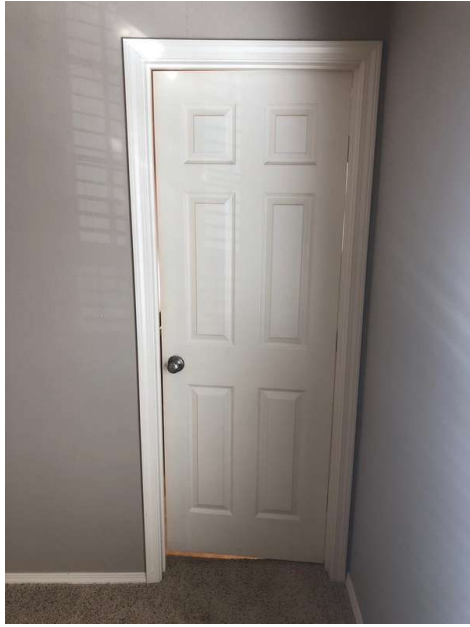
5.6.1 Doors

DOOR IN NEED OF ADJUSTMENT

HALL BATHROOM, MASTER BATHROOM, LAUNDRY ROOM

One or more interior doors stick/rub or do not latch smoothly/properly and may be in need of adjustment or repair.

Contact a qualified door repair/installation contractor.

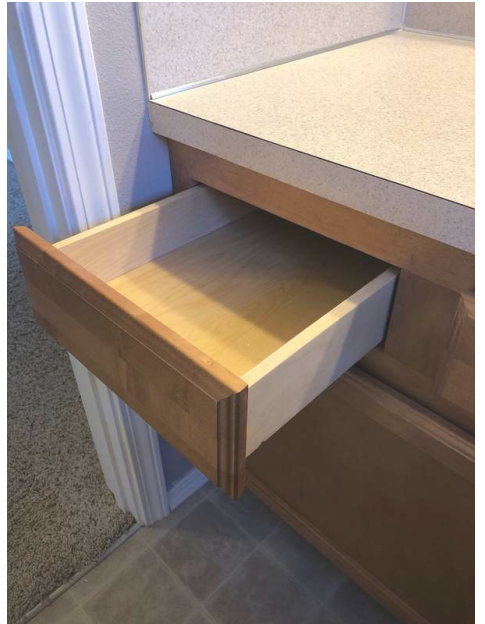
5.10.1 Cabinets & Countertops
ADJUST CABINET HARDWARE
HALL BATHROOM

Some cabinet hardware was not operating smoothly/properly and may be in need of adjustment or repair.

Recommendation
Contact a handyman or DIY project

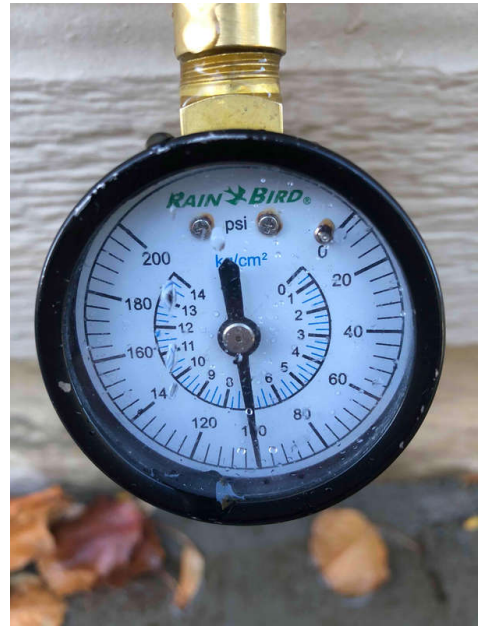
8.1.1 Supply Plumbing
HIGH WATER PRESSURE

High water pressure may put unneeded stress/strain on your plumbing system (pipes and fixtures). The generally recommended safe water pressure for residential application is 60-80 P.S.I. Recommend adjusting water pressure at Pressure Reducing Valve (or install a proper Pressure Reducing Valve if needed). Here is a helpful [article](#) on Water Reducing Valves.

Recommendation
Contact a qualified plumbing contractor.

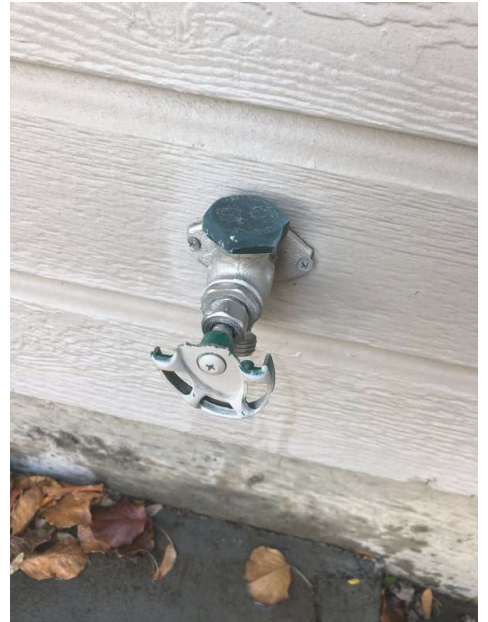
8.2.3 Fixtures & Faucets

SPIGOT HANDLE DAMAGED

BACK EXTERIOR

Garden spigot/hose-bib handle damaged.

Contact a qualified professional.

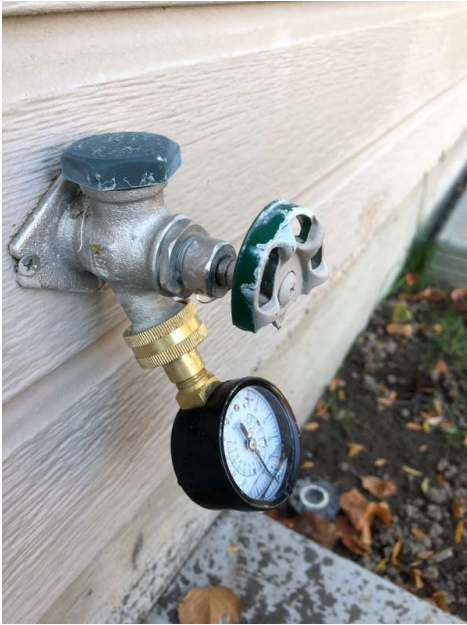
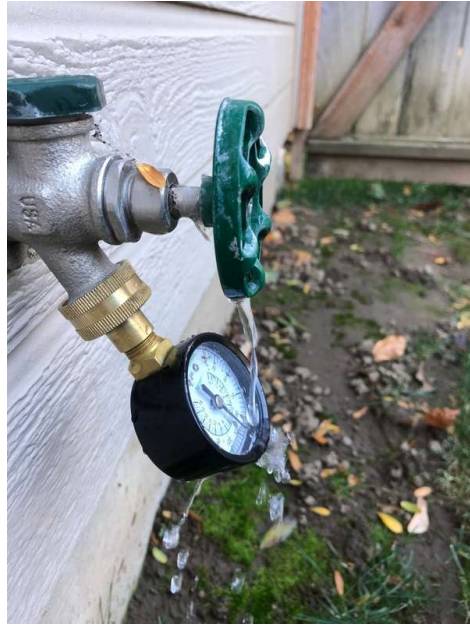
8.2.4 Fixtures & Faucets

SPIGOT LEAKING

Leak noted at exterior garden spigot/s. Recommend repair or replace as needed.

Contact a qualified handyman.

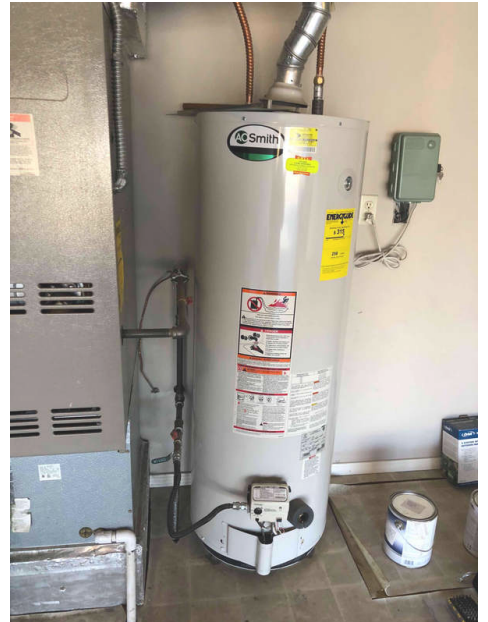
9.3.1 Safety Features

SEISMIC STRAPPING NOT INSTALLED OR IMPROPER

Modern safety standards requires seismic strapping at top and bottom thirds of installed Hot Water Tanks. See this helpful [link](#) for approved strapping and anchoring techniques. Recommend repair.

Contact a qualified handyman.

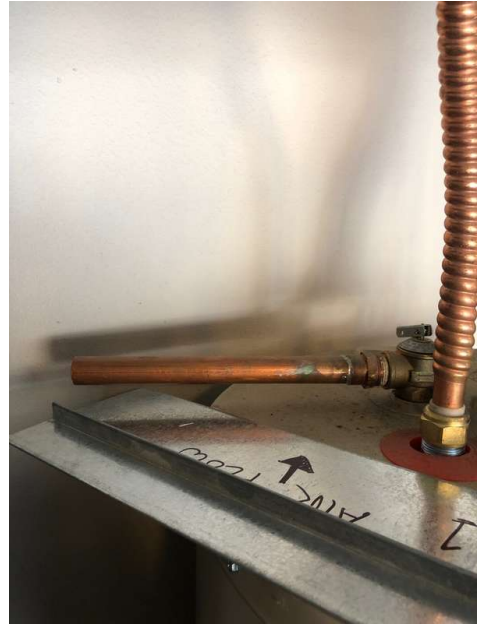
9.3.2 Safety Features

TPRV DISCHARGE PIPE MISSING/IMPROPER

Temperature Pressure Relief Valve discharge piping missing or improper. A proper discharge pipe of approved, rigid, high temp material must be installed and terminate within 24" to 8" of floor, or waste drain with a visual air gap to prevent possible back-flow. Discharge pipe must **not reduce in size** or be connected to any other discharge piping. No point of discharge pipe may be tapped, T-ed, threaded or exposed to freezing temperature. Recommend repair or replace as needed.

Contact a qualified appliance repair professional.

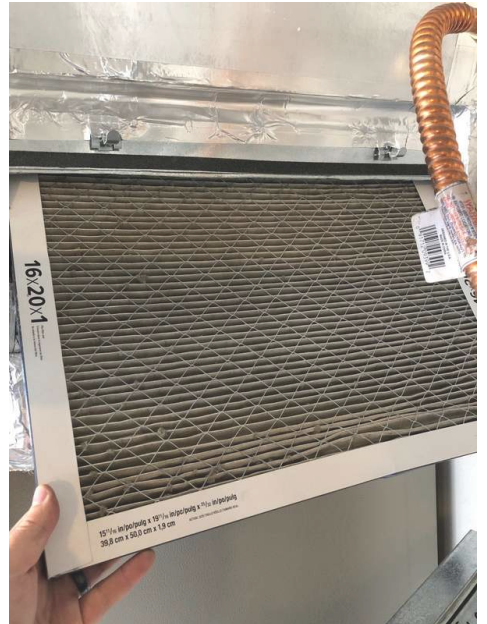
10.1.1 Heating Equipment **FILTER REQUIRES REPLACEMENT**

The furnace filter appears to be beyond its expected lifespan. A dirty Furnace Filter may cause excessive wear and undue maintenance to HVAC system. Recommend replacement.

Recommendation
Contact a handyman or DIY project

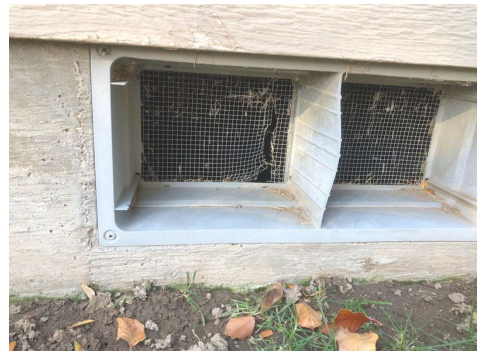
13.3.1 Crawlspace

FOUNDATION VENT/S COMPROMISED

Damaged, loose or missing foundation vent screen/s. Condition conducive to pest intrusion at crawlspace. Recommend repair or replace as needed.

Contact a qualified handyman.

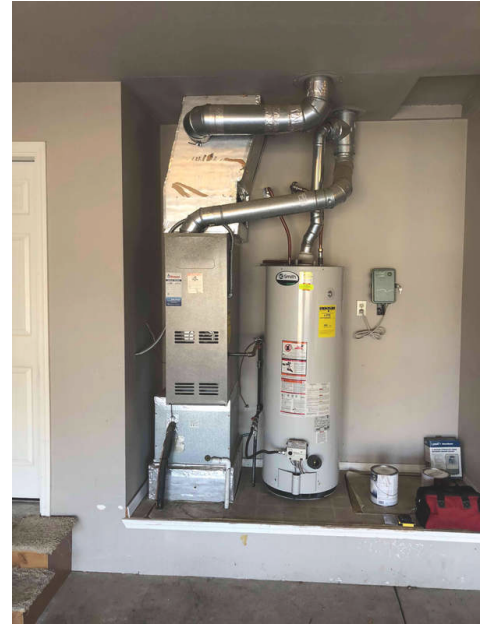
14.5.1 Safety Features

BULKHEAD

A bulkhead/barrier must be present/installed when gas appliances are located inline with the drive-path (back wall) of garage. In case of emergency the bulkhead is designed to protect gas appliances from impact and a potential safety hazard. Recommend qualified professional further evaluate and repair or replace as needed.

Contact a qualified professional.
