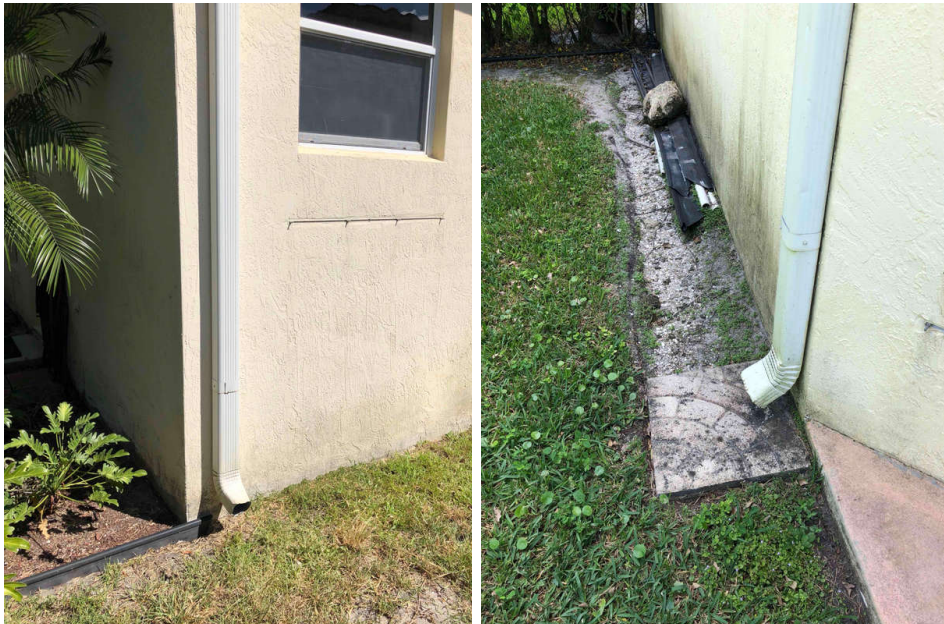
3.4.1 Roof Drainage Systems

DOWNSPOUTS DRAIN NEAR HOUSE

ALL AROUND HOUSE

One or more downspouts drain too close to the home's foundation. This can result in excessive moisture in the soil at the foundation, which can lead to foundation/structural movement. Recommend a qualified contractor adjust downspout extensions to drain at least 6 feet from the foundation.

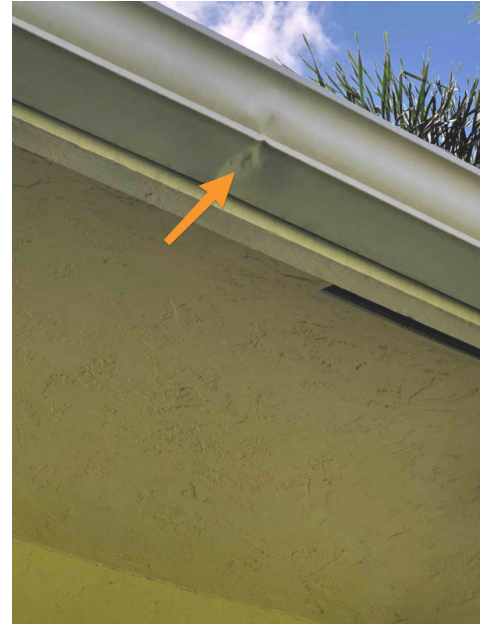
3.4.2 Roof Drainage Systems

GUTTER DAMAGED

WESTSIDE/BACKYARD

Gutters were damaged. This can result in excessive moisture in the soil at the foundation, which can lead to foundation/structural movement. Recommend a qualified contractor evaluate and repair.

Recommendation
Contact a qualified professional.

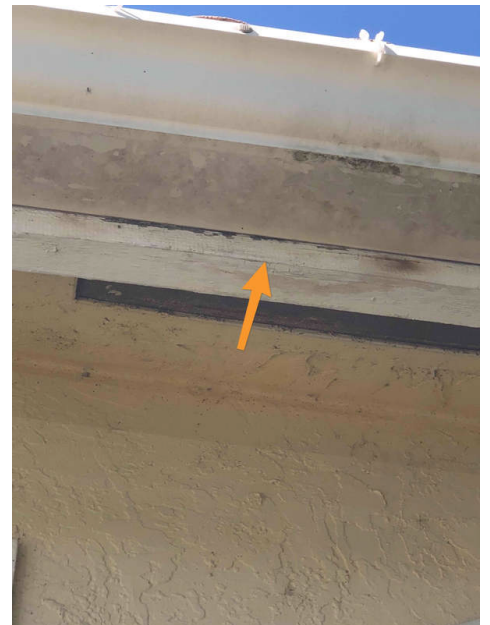
4.1.1 Eaves, Soffits & Fascia **FASCIA - WET STAINS**

ALL AROUND HOUSE

Stains were found at one or more fascia boards. The stains appeared to be from a gutter leak and roof joint due to dripping water, high moisture content, etc. This is a conducive condition for wood-destroying organisms. Recommend that a qualified contractor evaluate and repair as necessary. For example, by repairing the roof surface or flashing or installing drip-edge flashing.

Recommendation
Contact a qualified roofing professional.

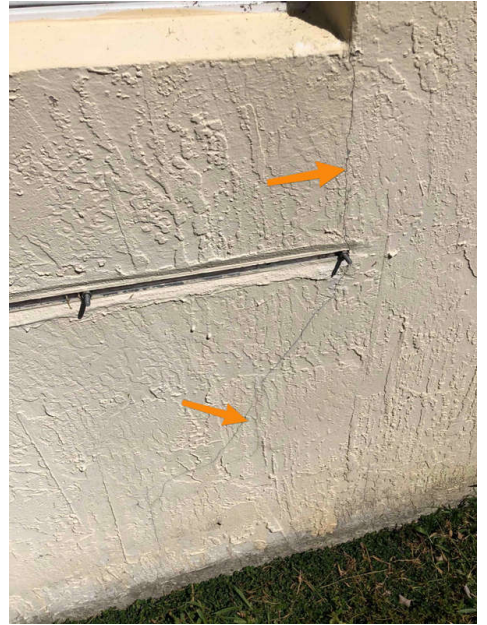
4.2.1 Exterior Walls

HAIRLINE STUCCO CRACKING

SOUTHSIDE AROUND WINDOWS

One or more minor hairline cracks were found in the stucco or wall areas. It is unknown the age of these cracks. At the time of inspection nothing out of the ordinary of normalized cracking was noticed. Recommend caulking and painting these areas, along with monitoring for future movement/widening. Stucco cracks over framing can allow moisture penetration behind wall areas and can potentially damage sheathing/framing. Note that areas concealed behind walls are not able to be evaluated without invasive testing and cannot be evaluated.

Recommendation
Contact a stucco repair contractor

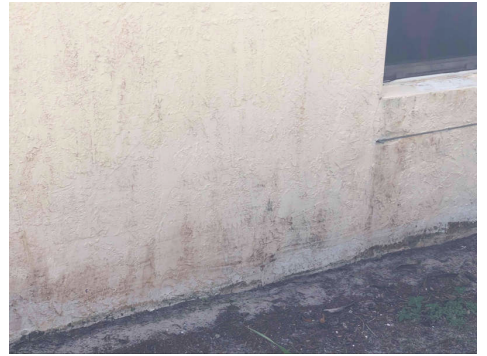
4.2.2 Exterior Walls **MILDEW/ALGAE**

There are signs of algae and/or mildew on the siding. This is a cosmetic issue and is not uncommon especially on shaded portions of the home. Recommend that said areas be washed or cleaned on a regular basis.

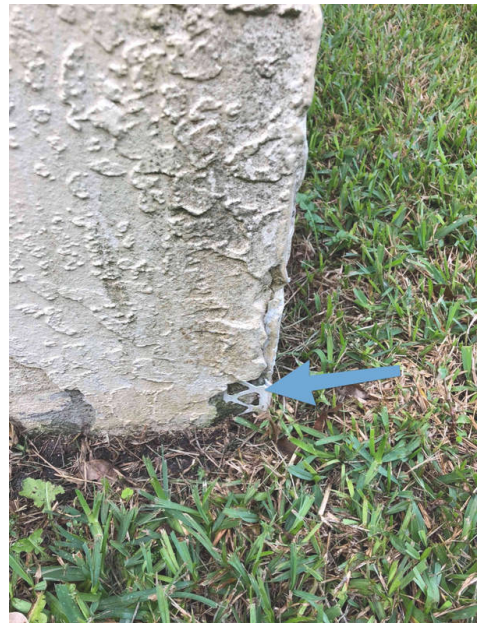
4.2.3 Exterior Walls **REPAIR STUCCO**

NORTHWEST SIDE BACKYARD

Cracks, deterioration and/or damage were found in one or more areas of the exterior stucco finish. In damp climates, moisture can enter cracks or damaged areas and further deteriorate the stucco. Also the wall behind the stucco can become damaged from moisture. Note that areas behind the stucco are inaccessible and excluded from this inspection. Recommend that a qualified contractor repair or replace stucco as necessary.

Recommendation
Contact a stucco repair contractor

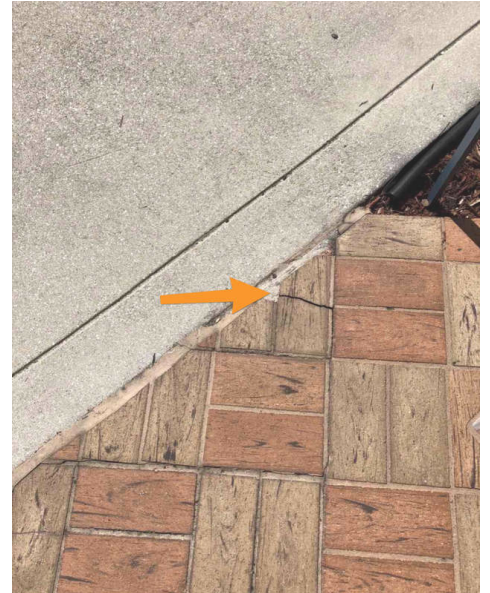
4.5.1 Driveway, Walkway, Patio

CRACKED TILE-SIDEWALK/PATIO

WERE DRIVEWAY MEETS WALKWAY

One or more of the sidewalk or patio tiles are chipped or cracked. Any paver with a deficiency should be replaced by a certified contractor to help prevent future deterioration.

Contact a qualified professional.

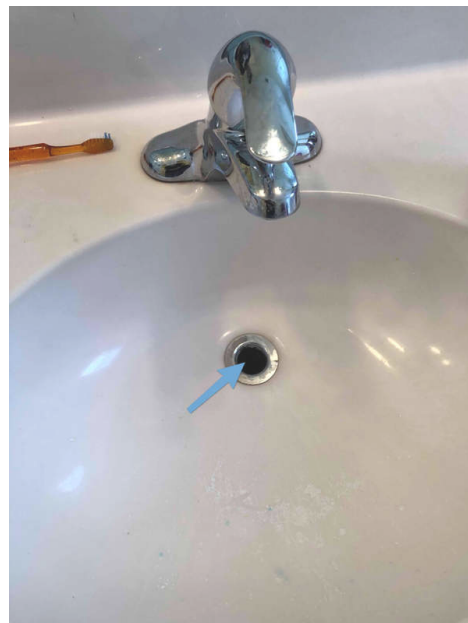
11.4.1 Sink/countertop

STOPPER ISSUE

GUEST BATHROOM

One or more sink stopper(s) mechanisms are missing, or need adjustment or repair. Stopper mechanisms should be installed where

missing and/or repairs should be made so sink stoppers open and close easily.

Recommended DIY Project

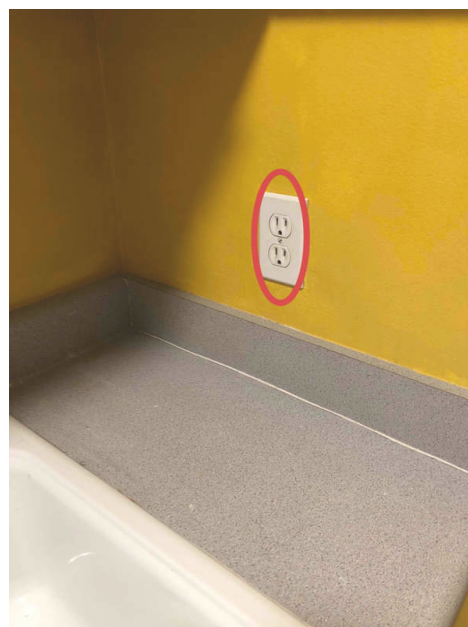
13.3.1 Electrical

NO GFCI BY SINK

The receptacle by the laundry sink that is not GFCI protected. It is recommended to have this receptacle switched to a GFCI for protection, to help prevent possibility of electrical shock.

Contact a qualified electrical contractor.
