## SUMMARY

1234 Main St. Portland OR 97267

Josh Berry  
OCHI 2080 CCB 216996 Veteran  
Owned and Operated  
NEW DAY HOME SERVICES  
503-914-8504  
[josh@newdayhomeservices.com](mailto:josh@newdayhomeservices.com)

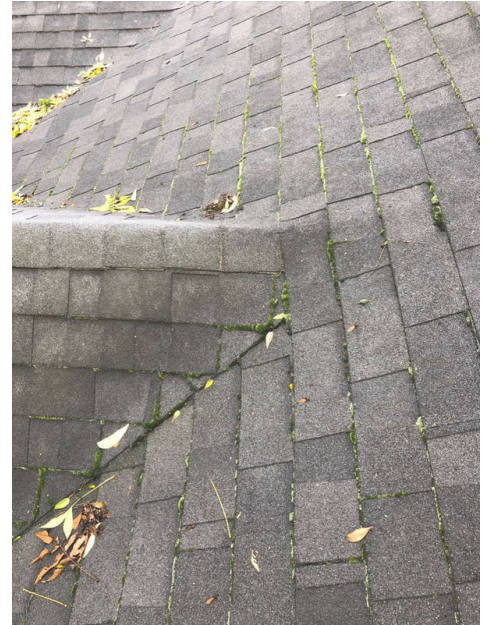
### 2.1.1 Coverings

#### MOSS

Areas of moss on north side of roof. Recommend regular maintenance and pressure washing to extend life of roof shingles

Recommendation  
Contact a qualified professional.

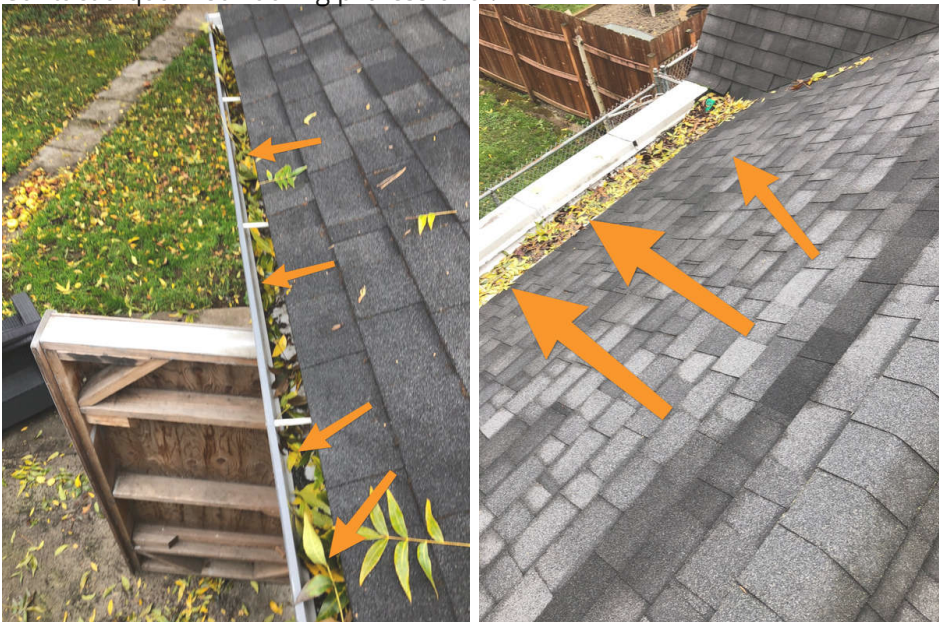
### 2.2.1 Roof Drainage Systems

#### DEBRIS

Debris has accumulated in the gutters. Recommend cleaning to facilitate water flow.

Recommendation  
Contact a qualified roofing professional.

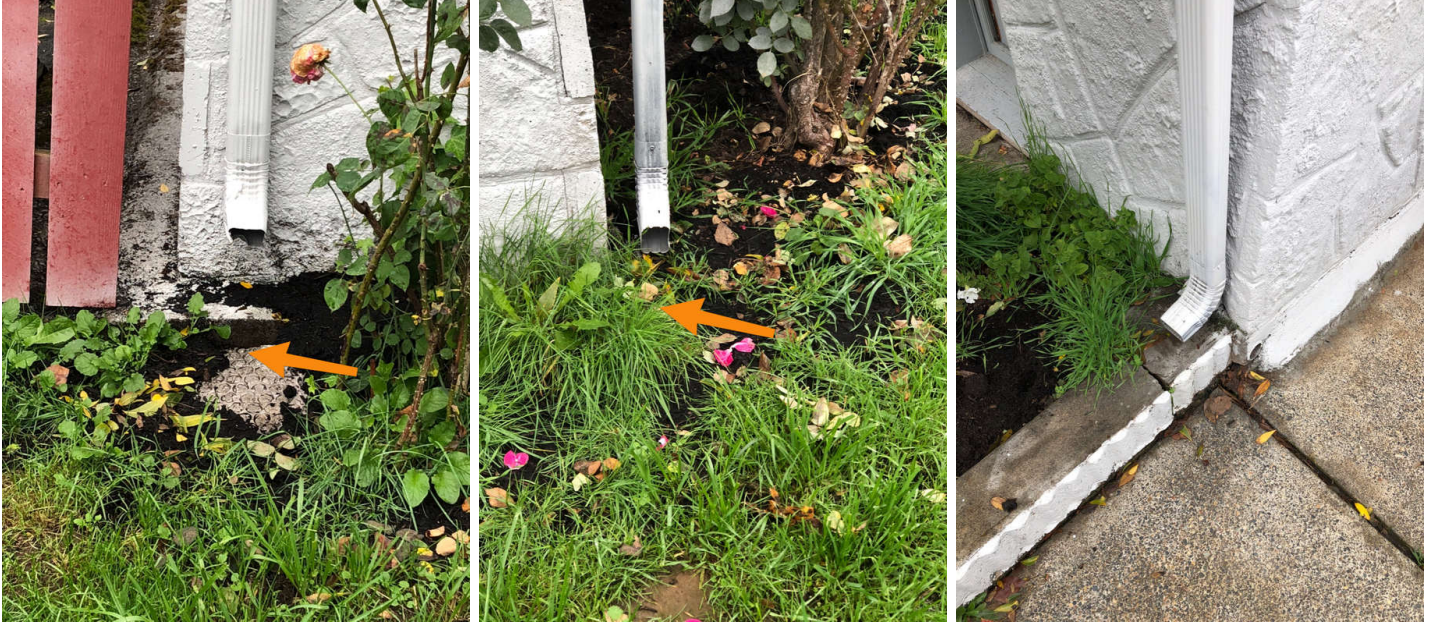
## 2.2.2 Roof Drainage Systems

### DOWNSPOUTS DRAIN NEAR HOUSE

One or more downspouts drain too close to the home's foundation. This can result in excessive moisture in the soil at the foundation, which can lead to foundation/structural movement. Recommend a qualified contractor adjust downspout extensions to drain at least 6 feet from the foundation.

Recommendation

Contact a qualified roofing professional.

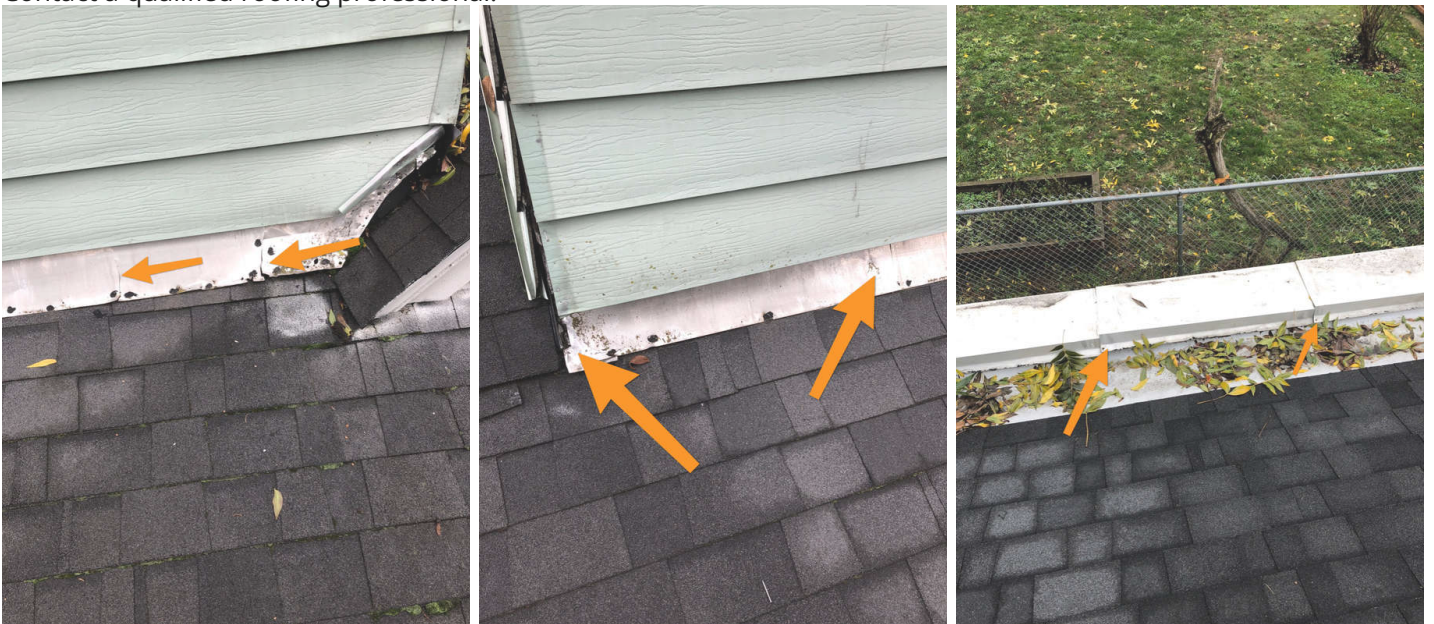
## 2.3.1 Flashings

### FLASHING DAMAGED

Flashing damaged. Recommend repair or replace to prevent moisture issues

Recommendation

Contact a qualified roofing professional.

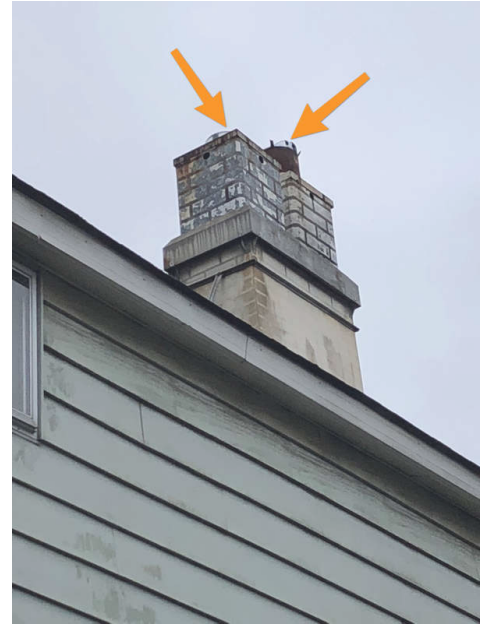
2.4.1 Skylights, Chimneys & Other Roof Penetrations

**CHIMNEY CAP MISSING**

No chimney cap was observed. This is important to protect from moisture intrusion and protect the chimney. Recommend a qualified roofer or chimney expert install.

Recommendation

Contact a qualified roofing professional.

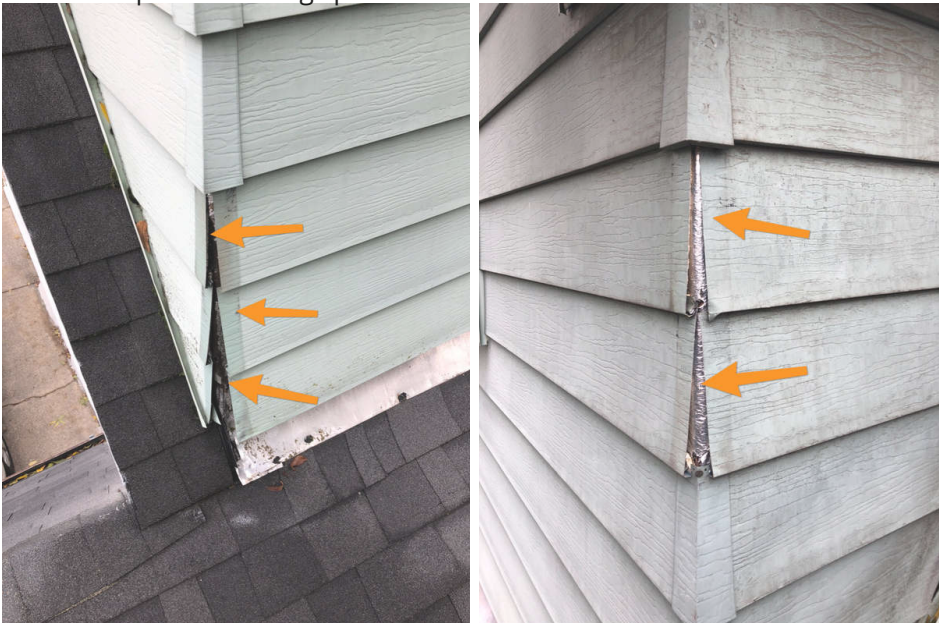
3.1.1 Siding, Flashing & Trim

**POSSIBLE POINT OF MOISTURE INTRUSION**

Possible point of moisture intrusion. Needs repair to prevent moisture intrusion

Recommendation

Contact a qualified siding specialist.

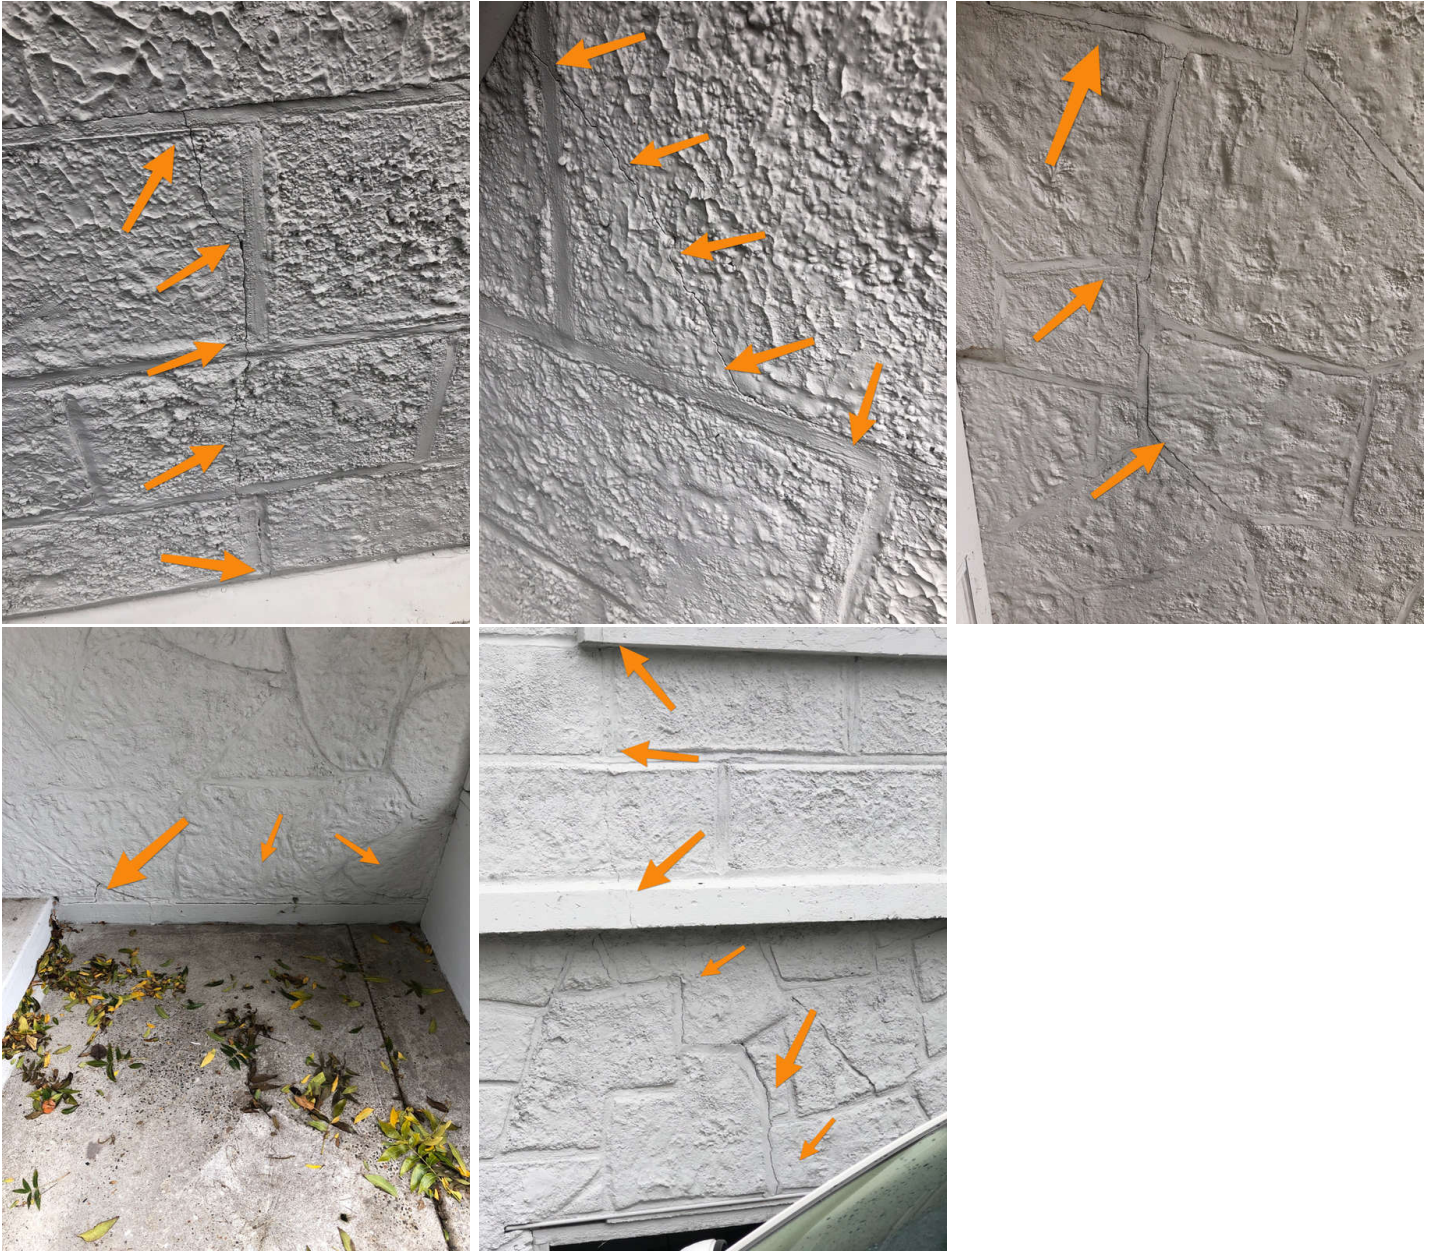
3.1.2 Siding, Flashing & Trim

**BLOCKS AND OR MORTAR CRACKING**

Blocks and or mortar cracking May lead to moisture intrusion or structural issues if not repaired.

Recommendation

Contact a qualified professional.

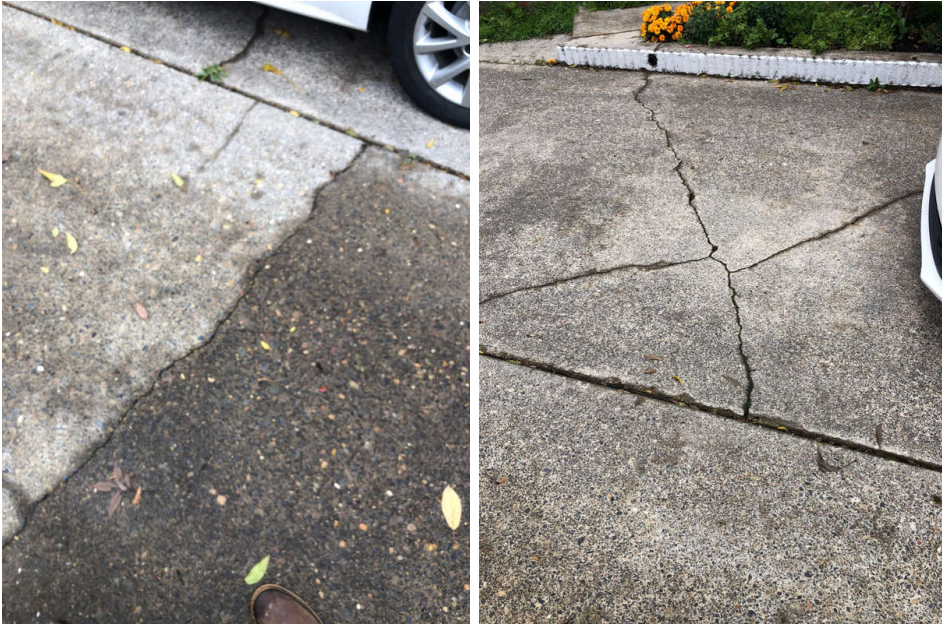
3.3.1 Walkways, Patios & Driveways

**DRIVEWAY CRACKING - MINOR**

Minor cosmetic cracks observed, which may indicate movement in the soil. Recommend monitor and/or have concrete contractor patch/seal.

Recommendation

Contact a qualified concrete contractor.

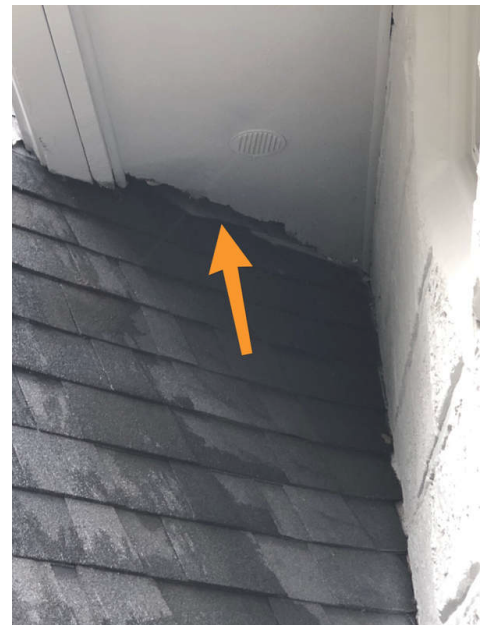
### 3.5.1 Eaves, Soffits & Fascia

#### **SOFFIT DAMAGE OR ROTTING**

The soffit is Damaged or rotting in one or more locations

Recommendation

Contact a qualified siding specialist.

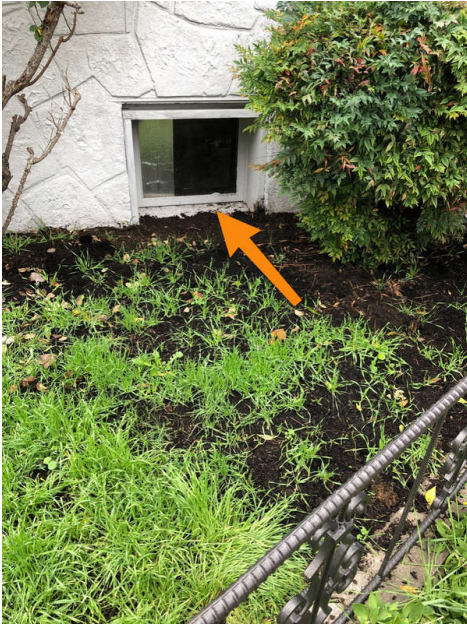
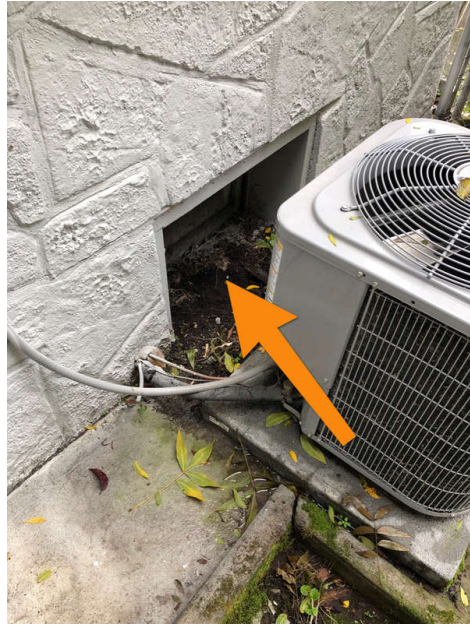
### 3.6.1 Vegetation, Grading, Drainage & Retaining Walls

#### **NEGATIVE GRADING**

Grading is sloping towards the home in some areas. This could lead to water intrusion and foundation issues. Recommend qualified landscaper or foundation contractor regrade so water flows away from home.

Recommendation

Contact a qualified landscaping contractor

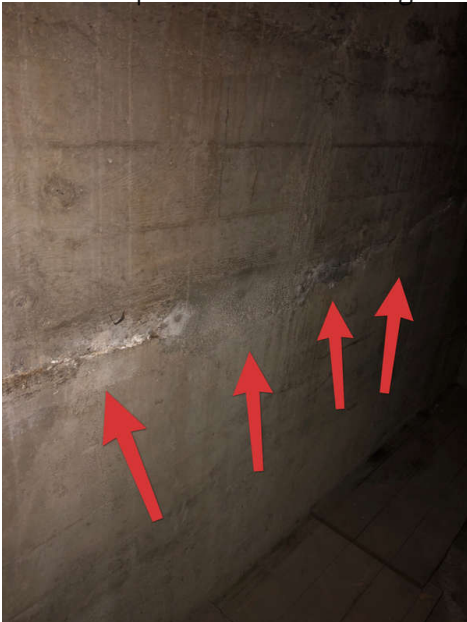
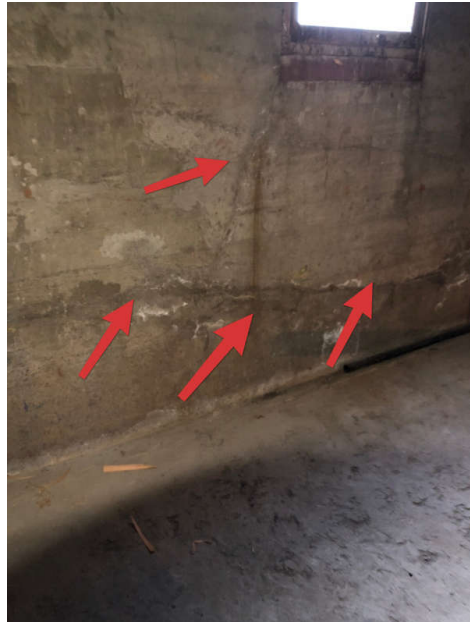
#### 4.1.1 Foundation

### FOUNDATION CRACKS - MAJOR

Severe cracking noted at the foundation. This is typically consistent with soil movement and could lead to serious damage to structural components, foundation and/or slabs. Recommend a structural engineer evaluate and provide a report on course of action and remedy.

#### Recommendation

Contact a qualified structural engineer.

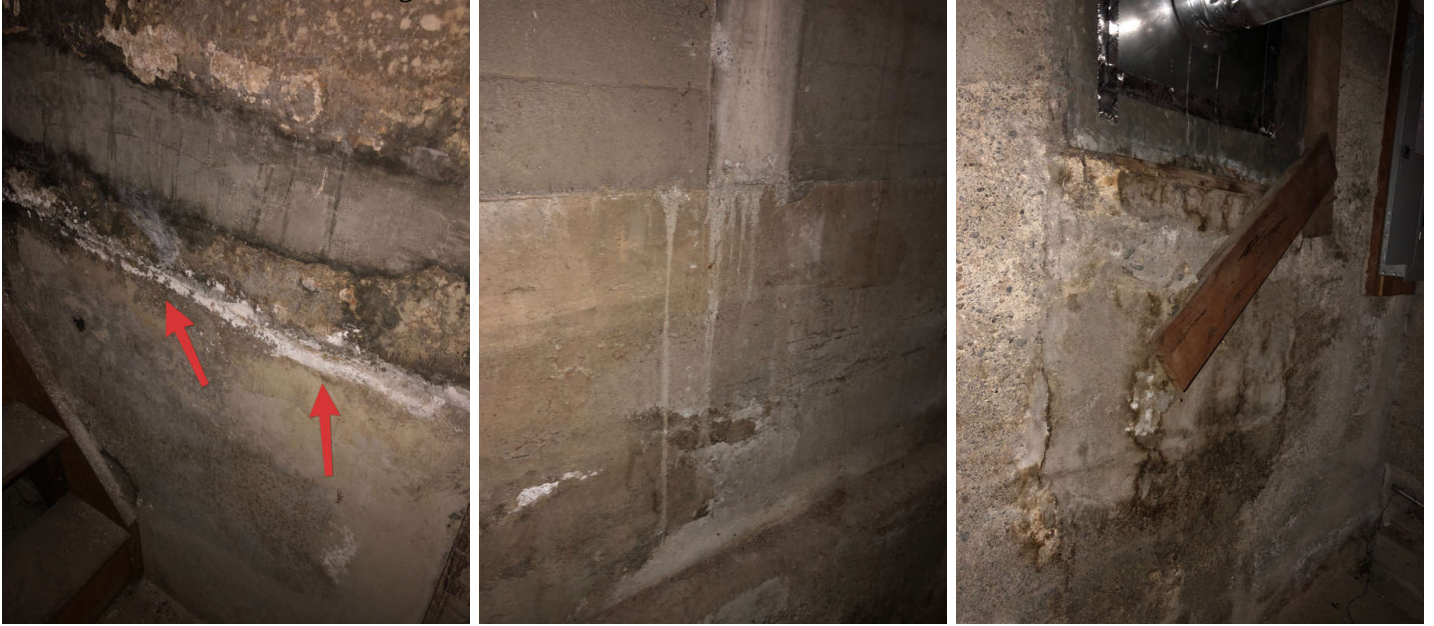
#### 4.1.2 Foundation

### WATER INTRUSION

Water intrusion was evident on the surface of the floor slab or in the basement/crawlspace. This can compromise the soil's ability to stabilize the structure and could cause damage. Recommend a qualified contractor identify the source of moisture and remedy.

Recommendation  
Contact a qualified structural engineer.

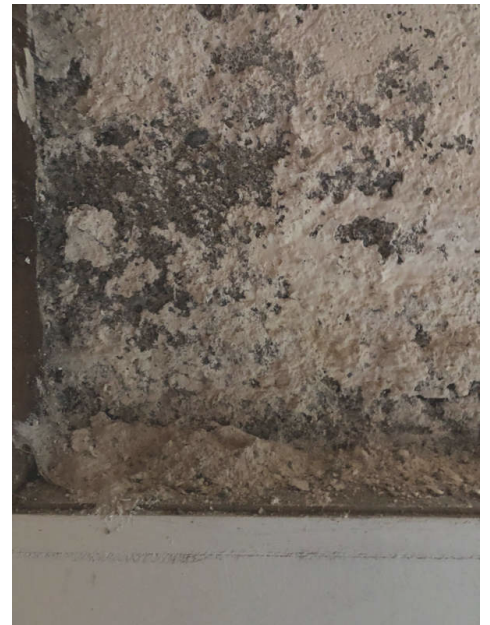
#### 4.2.1 Basements & Crawlspace

##### **EFFLORESCENCE**

Efflorescence noted on the crawlspace surface. This is a white, powdery deposit that is consistent with moisture intrusion. This can compromise the soil's ability to support the home structure and/or lead to mold growth. Recommend a qualified contractor identify source of moisture and correct.

Recommendation  
Contact a qualified professional.

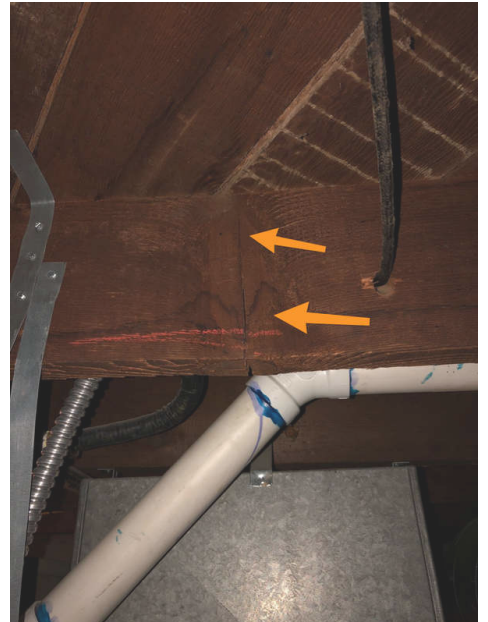
#### 4.3.2 Floor Structure

### **JOISTS NEED REPAIR**

One or more floor joists were damaged or improperly installed. This can cause damage to the structural integrity of the home. Recommend a qualified structural engineer evaluate and advise on how to correct.

Recommendation

Contact a qualified structural engineer.

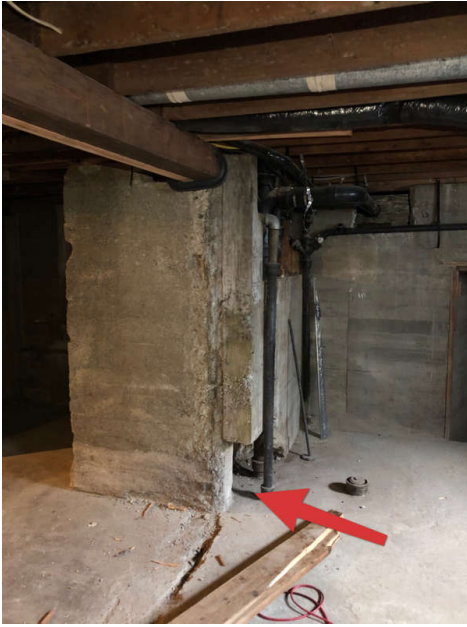
#### 4.4.1 Wall Structure

### **EVIDENCE OF STRUCTURAL DAMAGE**

Evidence of structural damage was found in the wall structure. Recommend a structural engineer evaluate and advise on how to repair.

Recommendation

Contact a qualified structural engineer.

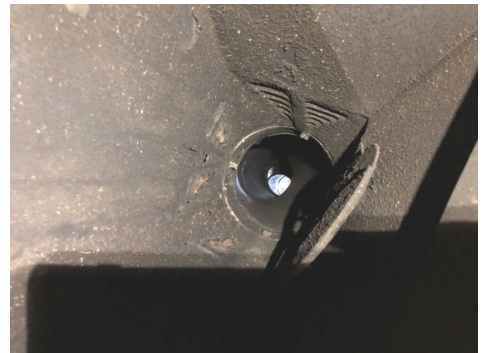
5.4.1 Vents, Flues & Chimneys

**CHIMNEY NEEDS CLEANING BEFORE USE**

Recommendation

Contact a qualified professional.

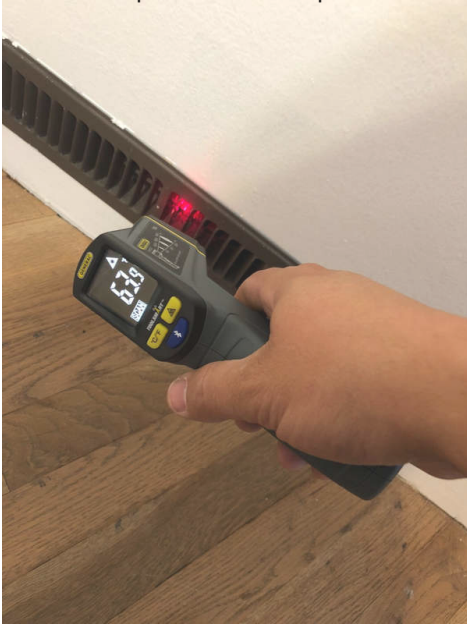
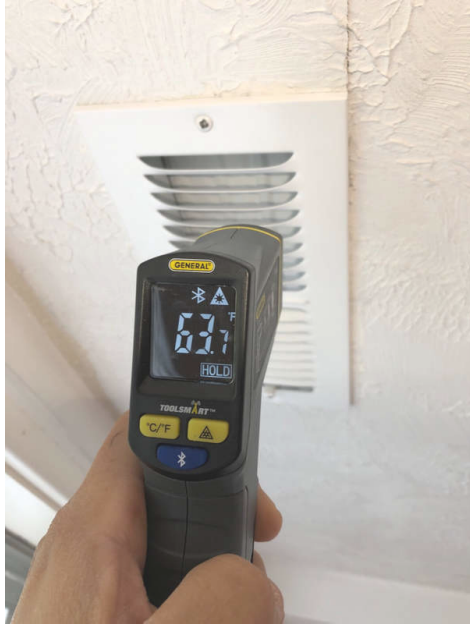
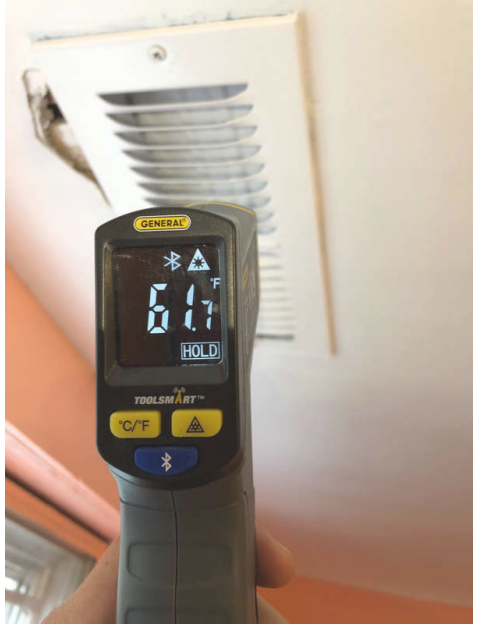
5.5.2 Presence of Installed Heat Source in Each Room

**HEAT SOURCE MISSING IN ONE OR MORE ROOMS OF THE HOUSE**

Heat source missing in one or more rooms of the house.

Basement bathroom, basement laundry room, and upstairs rooms

**NO FORCED AIR HEAT COMING FROM UPSTAIRS BEDROOM VENTS**

Recommendation

Contact a qualified HVAC professional.

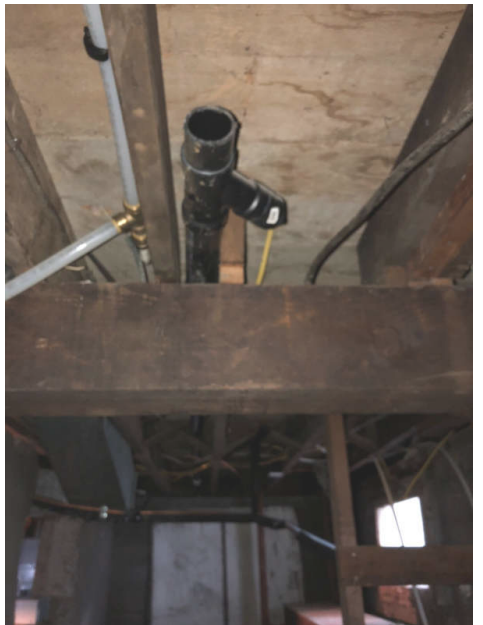
7.2.1 Drain, Waste, & Vent Systems

**OPEN PIPE**

Open pipe That looks like it goes to nowhere, but should be removed if not in use

Recommendation

Contact a qualified professional.

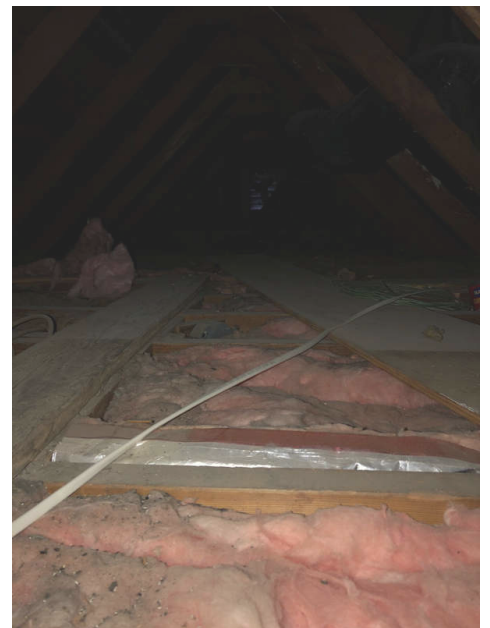
9.1.1 Attic Insulation

**INSUFFICIENT INSULATION**

Insulation depth was inadequate. Recommend a qualified attic insulation contractor install additional insulation.

Recommendation

Contact a qualified insulation contractor.

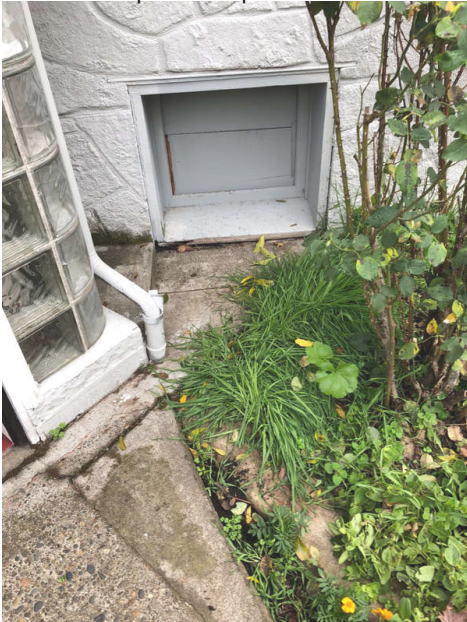
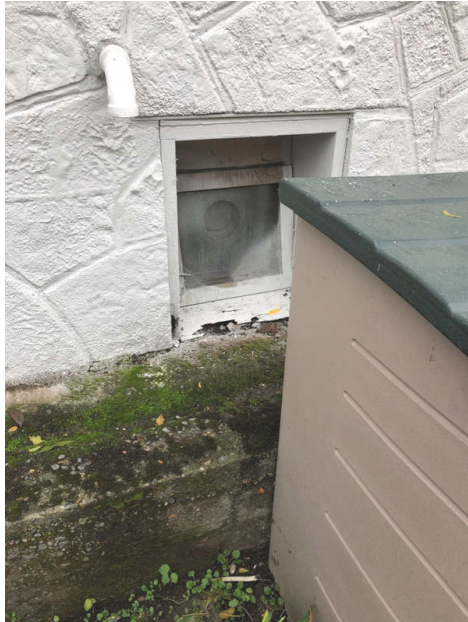
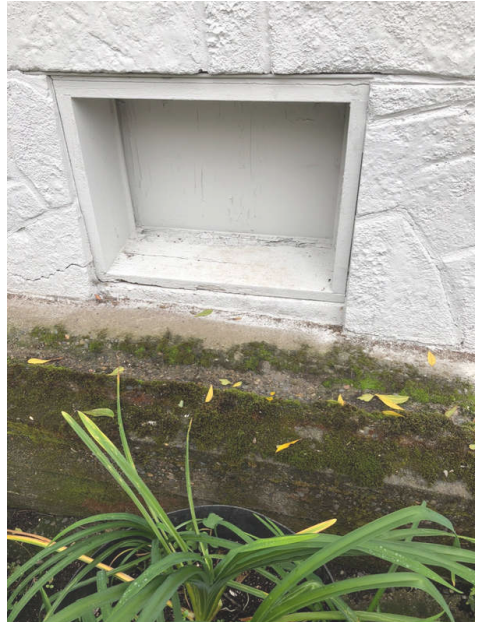
10.2.3 Windows

**MISSING WINDOW**

Recommendation

Contact a qualified professional.

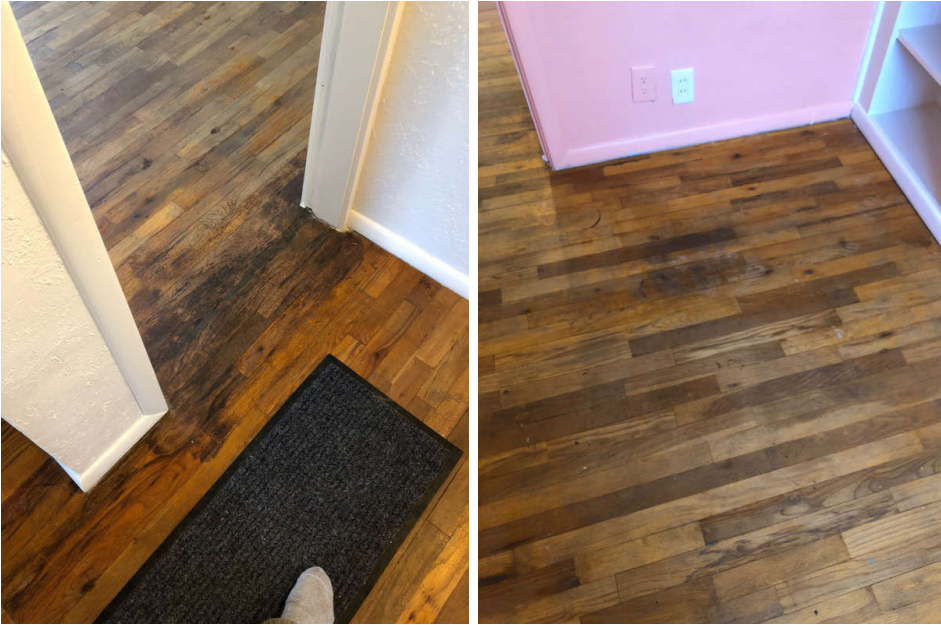
10.3.1 Floors

**MODERATE WEAR**

Floors in the home exhibited moderate surface wear along major paths of travel. Recommend a qualified flooring contractor evaluate for possible re-finish.

Recommendation

Contact a qualified flooring contractor

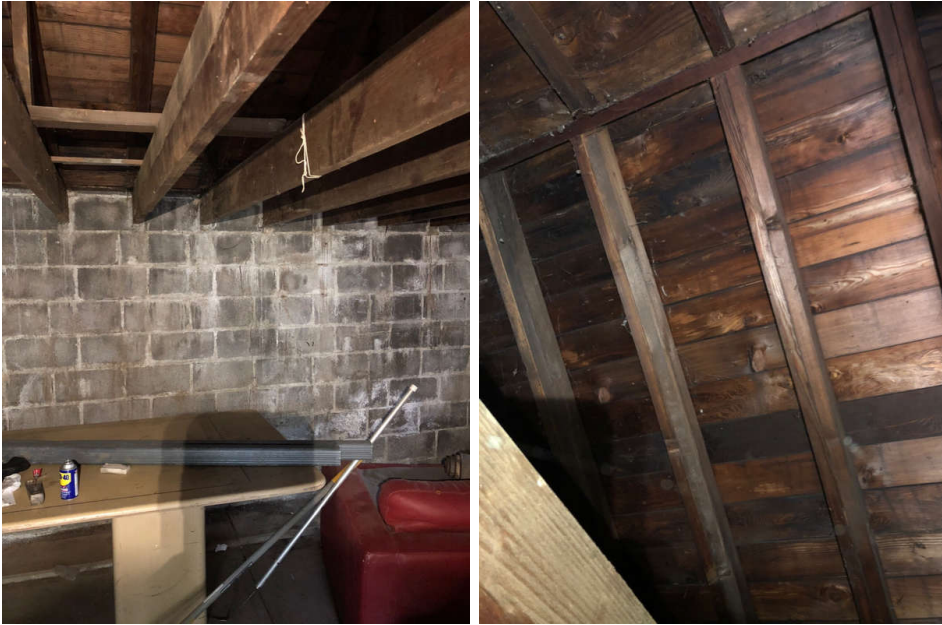
### 12.1.1 Ceiling

#### **MOISTURE INTRUSION**

Garage ceiling shows signs of moisture intrusion. To prevent further damage or growth of mold, I recommend a qualified contractor evaluate the source of moisture intrusion.

Recommendation

Contact a qualified professional.

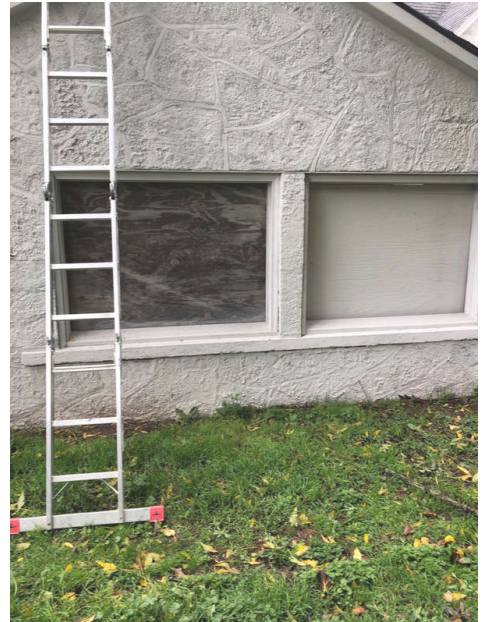
### 12.3.1 Walls & Firewalls

#### **WINDOWS MISSING**

Recommendation

Contact a qualified professional.
