11.6.1 Hot Water Systems

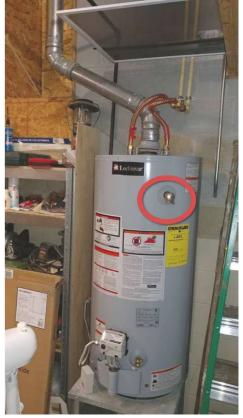
BASEMENT

TPR DISCHARGE PIPE NOT INSTALLED

Safety The temperature / pressure relief (TPR) discharge pipe was not installed. If the valve were to activate while a person was nearby, that person could be badly burned. The Inspector recommends that a properly-configured TPR discharge pipe be installed.

Recommendation Recommended DIY Project
