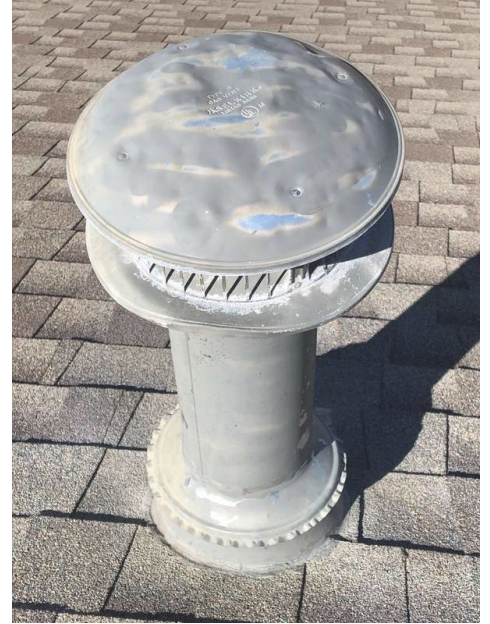
2.4.1 Skylights, Chimneys & Other Roof Penetrations

MINOR DAMAGE

Minor damage to one or more vents was observed. Possible hail damage. Recommend monitoring.

Recommendation
Contact a qualified professional.

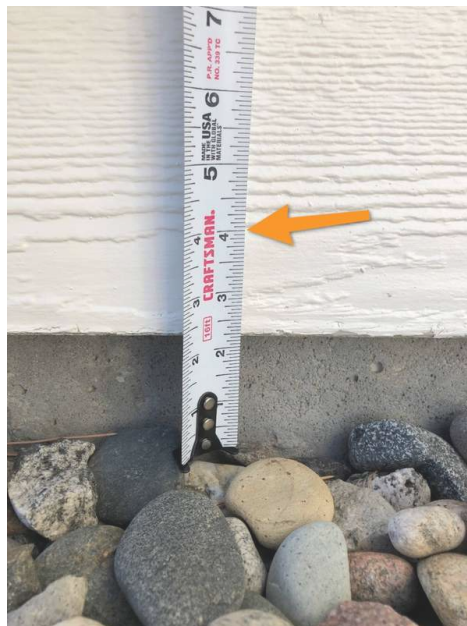
3.1.2 Siding, Flashing & Trim
GROUND CLEARANCE

Inadequate clearance between siding and ground. Recommend a minimum ground clearance between bottom of siding and ground of 4". Siding in contact with the ground or soil can lead to deterioration of the siding material caused by moisture and/or wood destroying organisms.

Recommendation
Contact a qualified siding specialist.

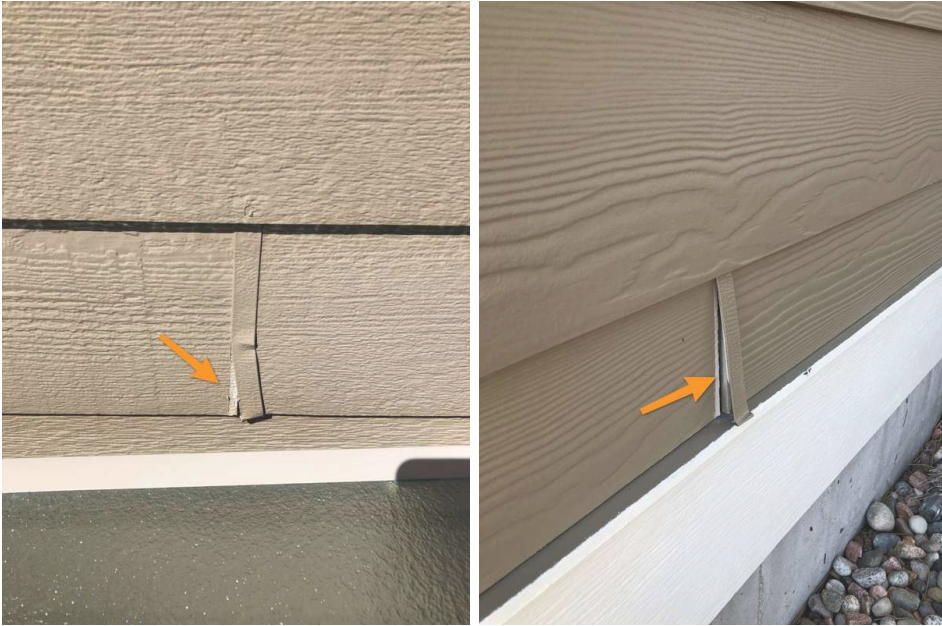
3.1.3 Siding, Flashing & Trim

LOOSE SIDING BRACKETS

One or more siding brackets are loose. This could lead to moisture intrusion and further deterioration of the siding material. Recommend repair or replacement of the brackets.

Contact a qualified siding specialist.

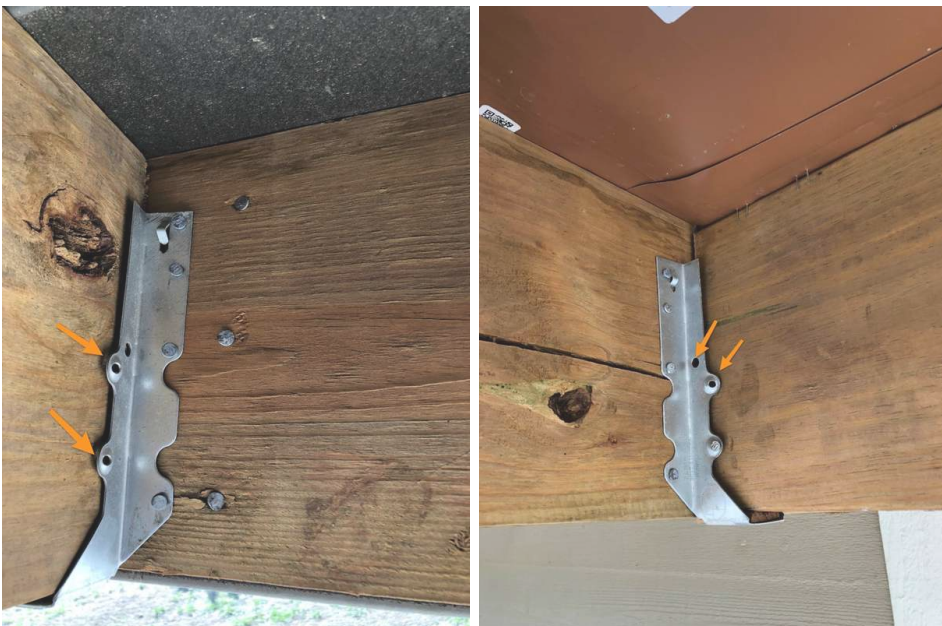
3.4.1 Decks, Balconies, Porches & Steps

JOIST HANGERS

Multiple nails are missing on Joist hanger(s). Recommend further review by a qualified deck contractor.

Contact a qualified deck contractor.

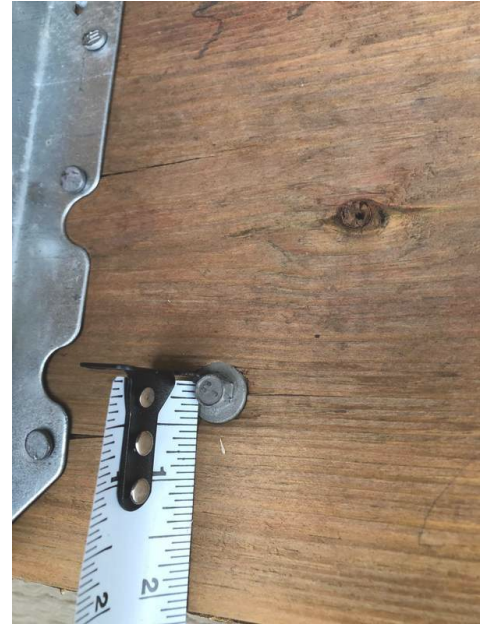
3.4.2 Decks, Balconies, Porches & Steps

LEDGER BOARD IMPROPERLY INSTALLED

Insufficiently sized ledger screws. The ledger screws should be 1/2 inch diameter. Recommend further review by a qualified deck contractor. ONE EXCEPTION, "Simpson Strong-Tie Strong-Drive Sds Ledger Deck Screws" are acceptable at 1/4 inch diameter.

Contact a qualified deck contractor.

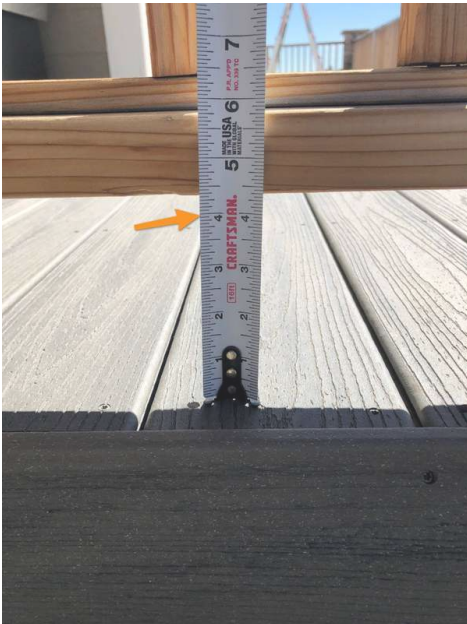
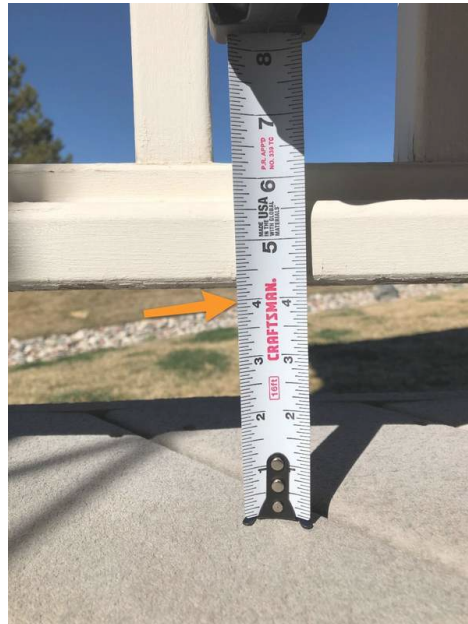
3.4.3 Decks, Balconies, Porches & Steps

RAILING UNSAFE

There is an unsafe opening in the railing. The spacing on the rail should not exceed 4". An opening greater than 4" is a serious safety hazard especially for children as their head or other body part can become trapped.

Contact a qualified deck contractor.

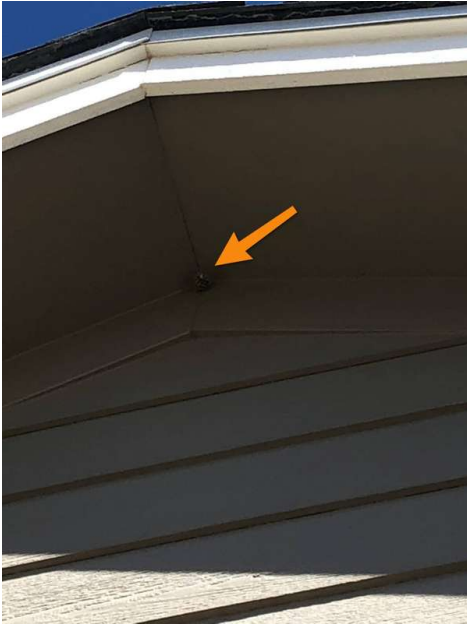
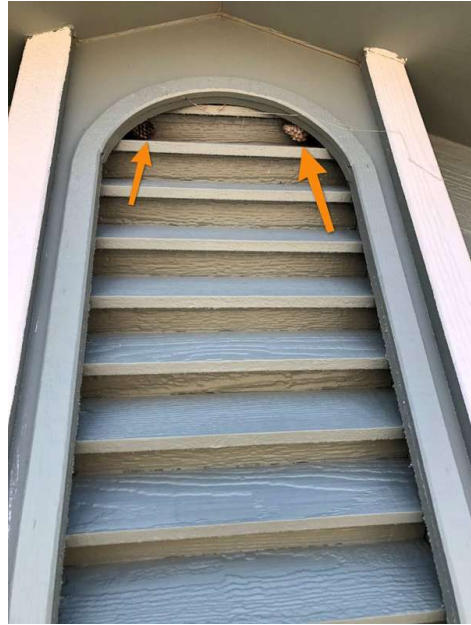
3.5.1 Eaves, Soffits & Fascia

WASPS NEST

Wasp nests were visible under the soffits. Recommend a qualified exterminator evaluate and remove.

Contact a qualified pest control specialist.

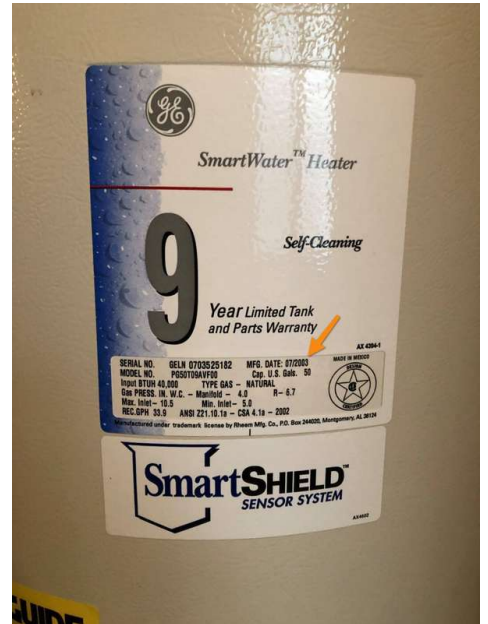
7.4.1 Hot Water Systems, Controls, Flues & Vents

BEYOND EXPECTED SERVICE LIFE

Water heater is beyond its expected service life. Recommend further evaluation by a licensed plumbing contractor.

Contact a qualified plumbing contractor.

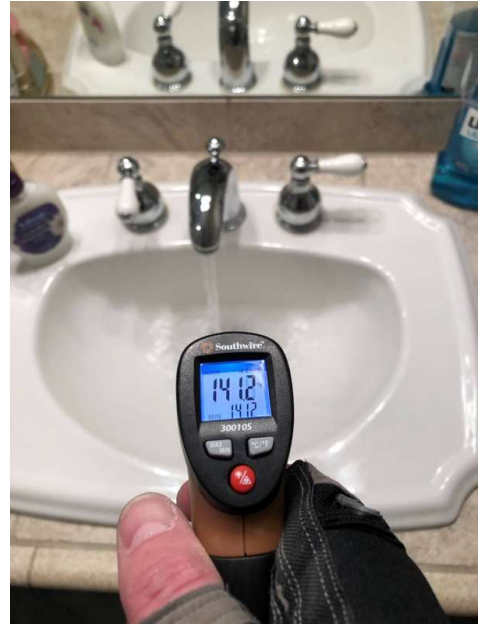
7.4.3 Hot Water Systems, Controls, Flues & Vents

HIGH WATER TEMPERATURE

Water temperature measured higher than the recommended 125 degrees Fahrenheit. Recommend lowering temperature.

Contact a qualified plumbing contractor.

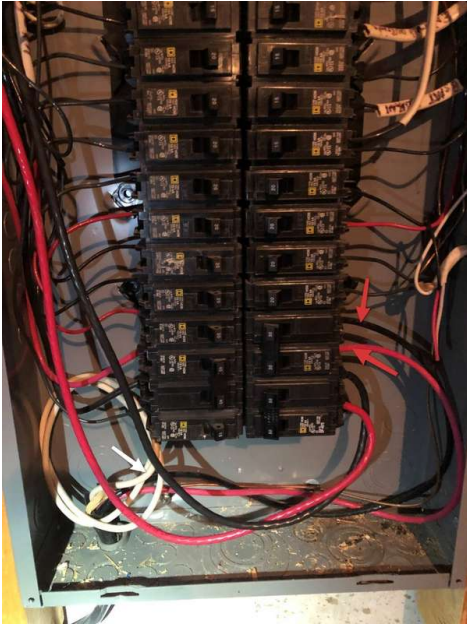
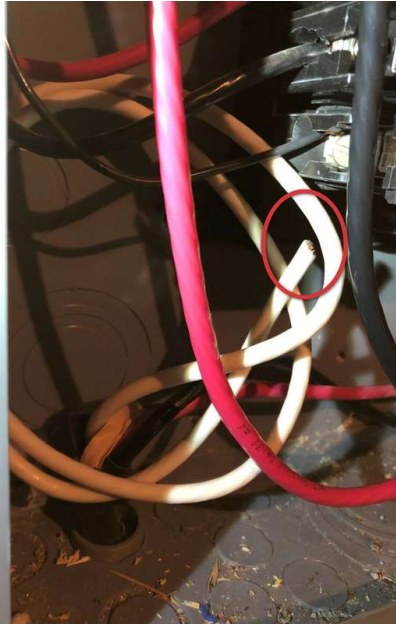
8.3.1 Branch Wiring Circuits, Breakers & Fuses

IMPROPER WIRING

A/C UNIT, MAIN SERVICE PANEL

Neutral branch circuit wire appears loose and not properly connected inside the main service panel. Recommend further review by a licensed electrical contractor.

Contact a qualified electrical contractor.

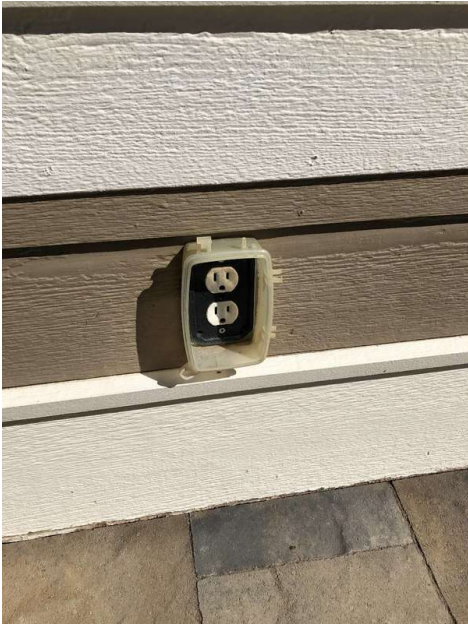
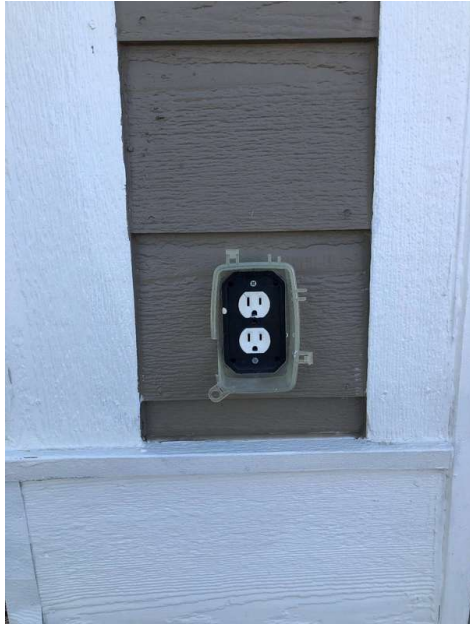
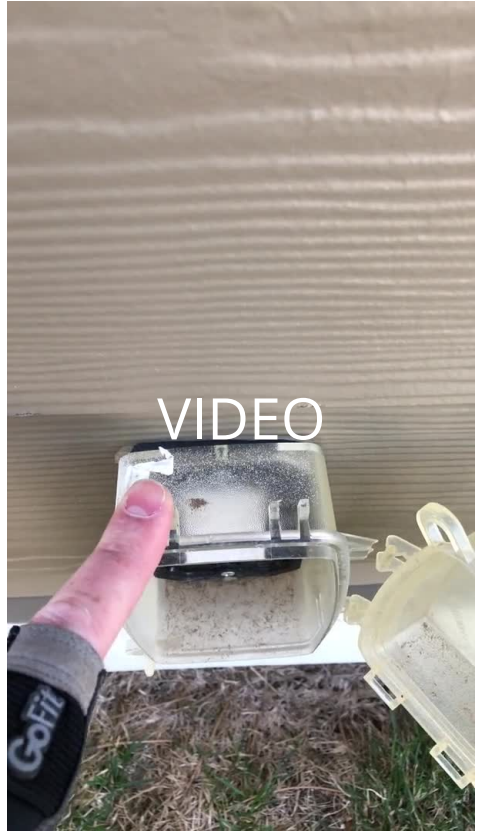
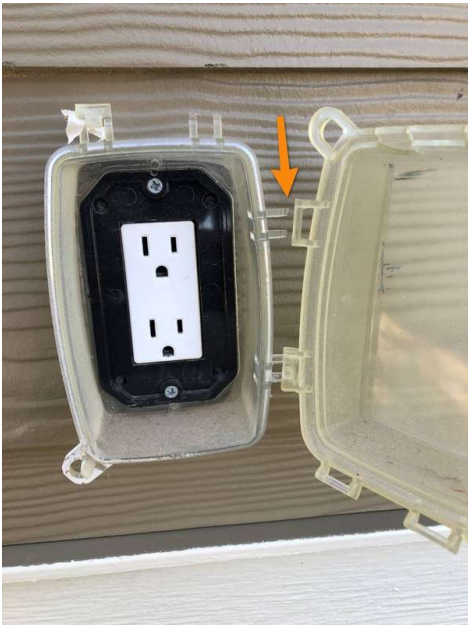
8.4.2 Lighting Fixtures, Switches & Receptacles

BROKEN/MISSING WEATHER PROOF COVER ON EXTERIOR OUTLETS

EXTERIOR

One or more exterior outlets are missing or have broken weather proof covers. Recommend review and replacement by a licensed electrical contractor.

Contact a qualified electrical contractor.

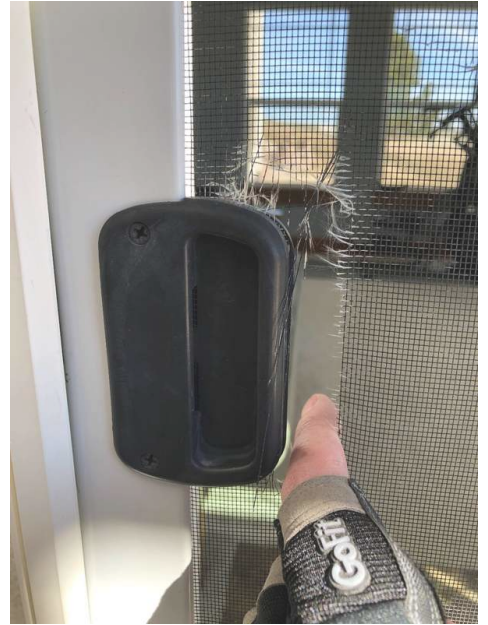
11.1.1 Doors

TORN SCREEN

Screen is torn on exterior sliding door. Recommend replacement.

Recommendation
Contact a qualified professional.

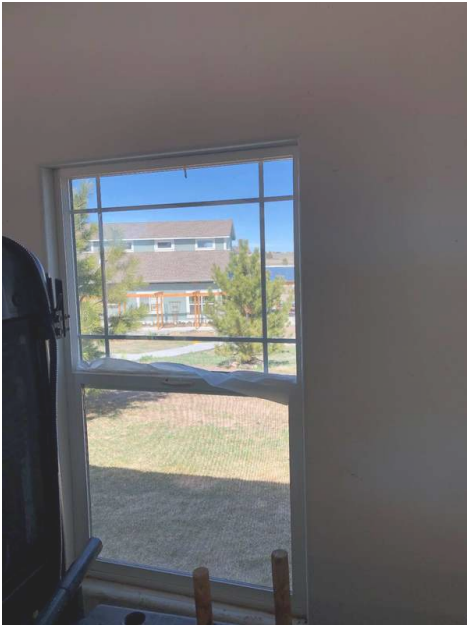
Garage

DAMAGED

One or more windows appears to have general damage. Recommend a window professional repair or if necessary replace the windows in question.

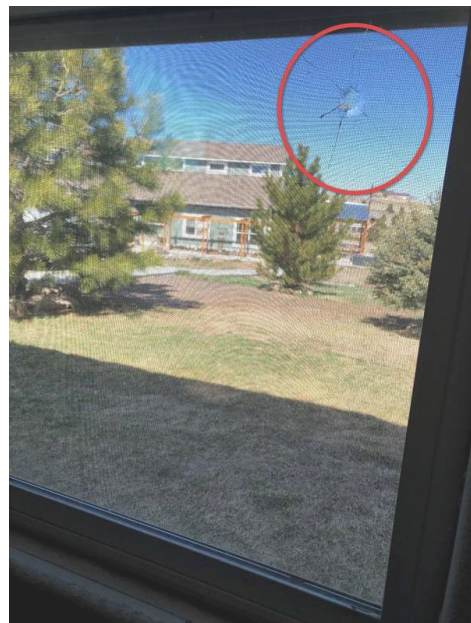
11.2.2 Windows

BROKEN GLASS

GARAGE

Window glass is broken. This is a safety hazard. Recommend immediate replacement by a qualified window repair and installation contractor.

Recommendation
Contact a qualified window repair/installation contractor.

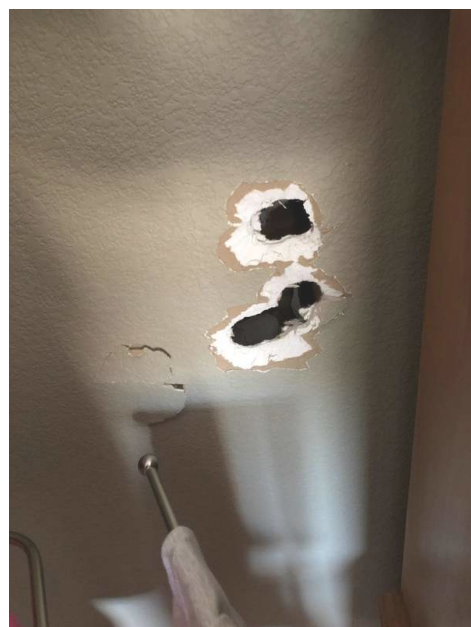
11.4.1 Walls

HOLES

MASTER BEDROOM

One or more holes were found in the interior walls. Recommend repair by a qualified drywall contractor.

Recommendation
Contact a qualified drywall contractor.
