SUMMARY
1234 Main St. Colorado Springs
Colorado 80920
Buyer Name
03/08/2019 9:00AM

Kevin Miller
InterNACHI Certified Home Inspector
PremierOne Home Inspections
(719) 217-9594

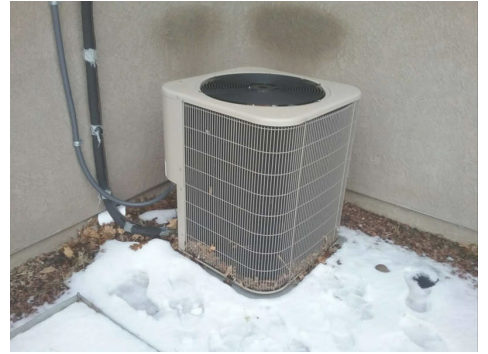
4.1.1 Cooling Equipment

UNIT NOT TESTED

The A/C unit was not tested due to low outdoor temperature. This may cause damage to the unit. As checking the unit out visually i could hear a clicking noise. The AC condenser unit was not in the on position. Recommend a qualified technician to evaluate AC.

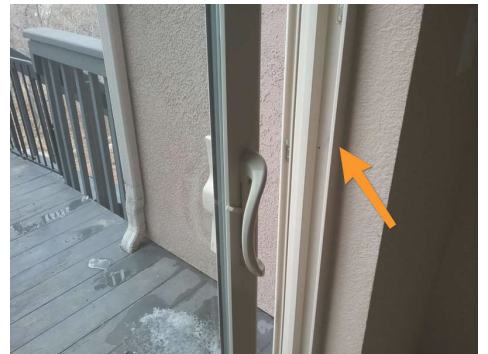
8.3.1 Doors

DOOR DOESN'T LATCH

BASEMENT SLIDING GLASS DOOR.

Door does not latch properly. Recommend installing a catch latch for sliding glass door lock.

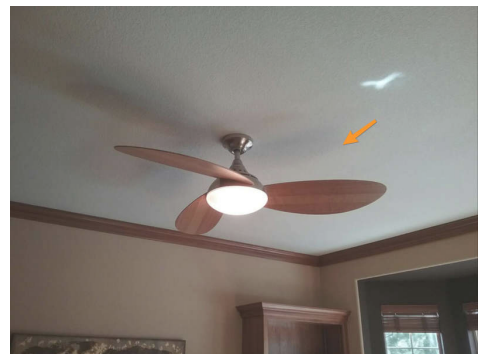
8.5.1 Lighting Fixtures, Switches & Receptacles

FAN/LIGHT

OFFICE

Locate fan controller for fan in office and test fan for proper operation.

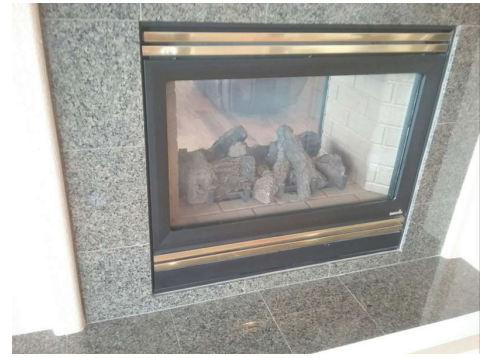
9.1.1 Vents, Flues & Chimneys (Interior)

FIREPLACE

MAIN LEVEL FIREPLACE

Wall switch not operating fireplace at all times. Repairs are needed.

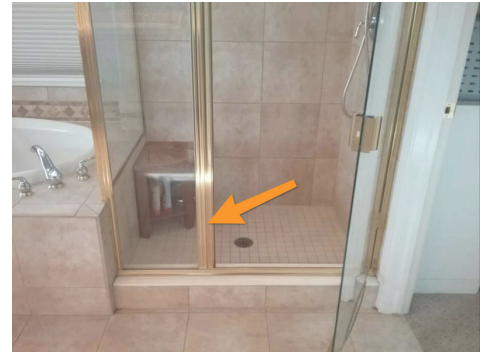
10.7.1 Bathtubs & Showers

SHOWER

MASTER BATHROOM

Glass door stop needs re securing to frame by a qualified person. Magnetic side is very loose.

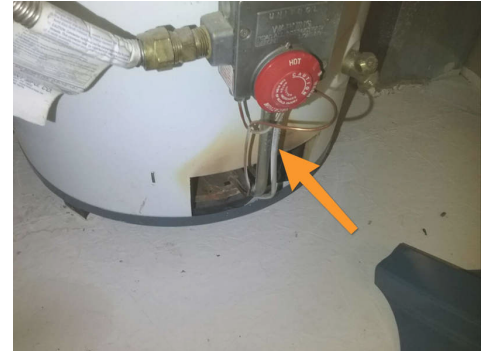
13.4.3 Hot Water Systems, Controls, Flues & Vents

IRREGULAR FLAME

WATER HEATER

Water heater flame is irregular. Recommend qualified plumber evaluate & repair.

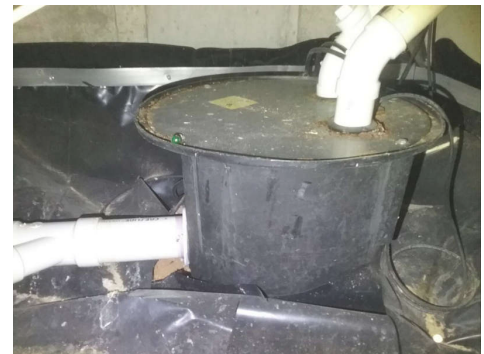
13.5.1 Sump Pump

EJECTOR PUMP

CRAWLSPACE

Ejector pump for basement bathrooms.

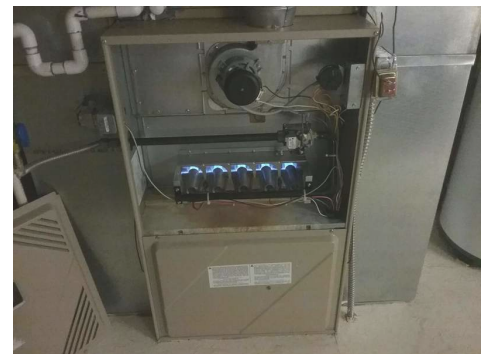
14.1.1 Equipment

SERVICING/CLEANING

Recommend having both furnaces serviced and cleaned by a qualified HVAC specialist prior to close of escrow. NACHI guidelines strongly recommend further evaluation by a licensed HVAC technician to determine if any cracks are present in the heat exchanger, that may or may not be visible, for safety considerations. The furnace should be cleaned and serviced annually.
