## SUMMARY 1234 Main St.College Station TX 77845 Buyer Name

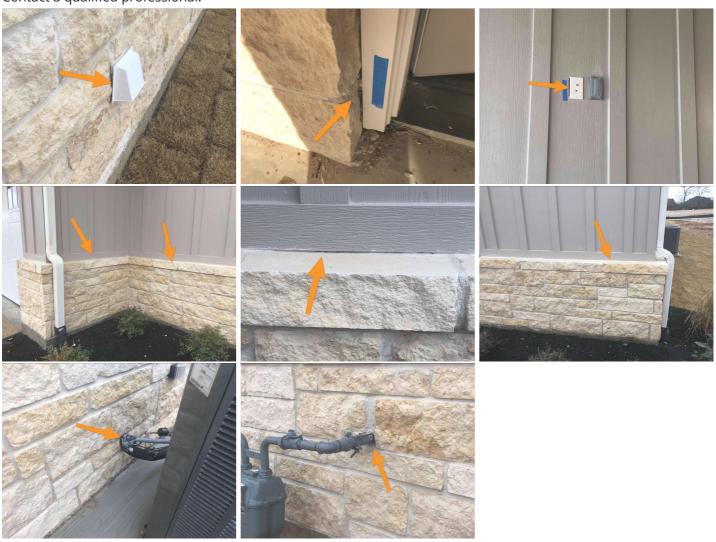
2.5.3 E. Walls (Interior and Exterior)

## **GAPS AT EXTERIOR WALL**

Seal all gaps at joints and utility penetrations to prevent moisture and pest intrusion.

Recommendation Contact a qualified professional.

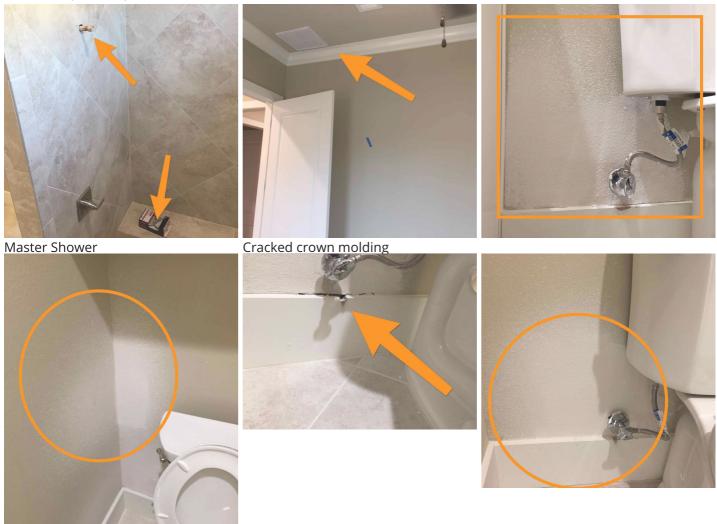
## 2.5.5 E. Walls (Interior and Exterior)

## INTERIOR UNFINISHED WORK /COSMETIC REPAIRS

Unfinished work, painting and cosmetic repairs or touch ups are needed.

Recommendation Contact a qualified professional.

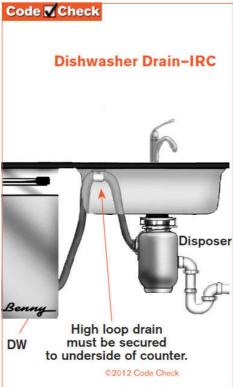
6.1.1 A. Dishwashers

## **NO AIR GAP**

The dishwasher discharge (drain) line needs to be elevated above the inlet to disposal or drain pipe so that it has an air gap to prevent debris and gray water from draining down line from disposal or drain pipe and back into dishwasher.

Recommended DIY Project
