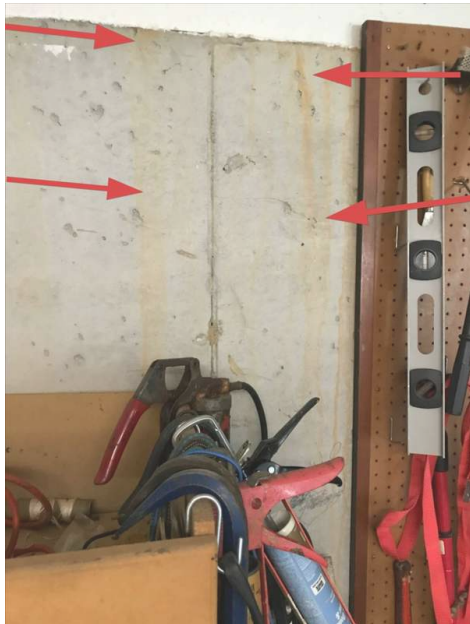
Moisture stains were observed along the east wall of the garage, at the time of inspection the wall/floor was dry. Recommend a qualified contractor identify the source of moisture and remedy.

Moisture stains along the east foundation wall of the garage.

Recommendation
Contact a qualified general contractor.

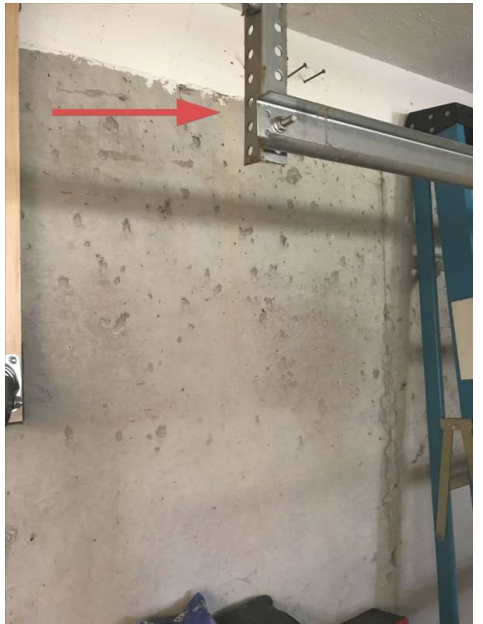
Moisture stains along the east foundation wall of the garage.

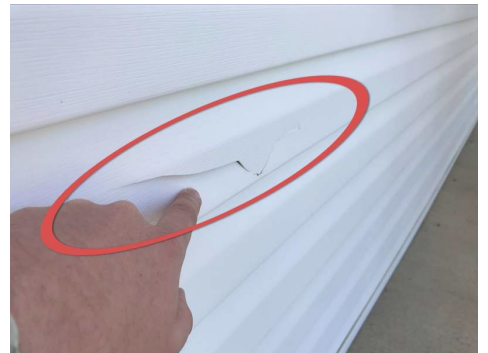
Minor crack is vinyl siding. Recommend repair or replace to prevent moisture intrusion.

Minor crack is vinyl siding on front porch. Recommend repair or replace to prevent moisture intrusion.

Recommendation
Contact a handyman or DIY project

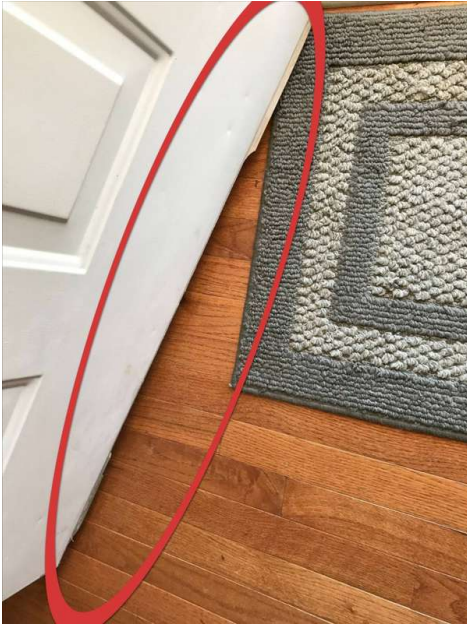
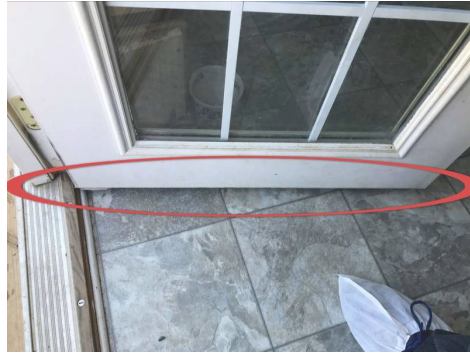
The bottom weatherstripping on the front and both rear doors leading to the inside need weatherstripping replaced. This can result in energy loss and moisture intrusion. Recommend installation of standard weatherstripping.

Front door. Damaged weatherstripping along bottom of door.

Recommendation
Contact a handyman or DIY project

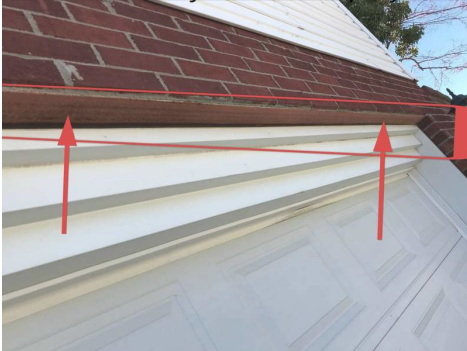
The lintel above the garage and the man door into the garage need to be painted to prevent rust. If these lintels rust they will expand causing issues with the brick veneer.

Metal lintel needs to be painted to prevent rust.

Contact a handyman or DIY project

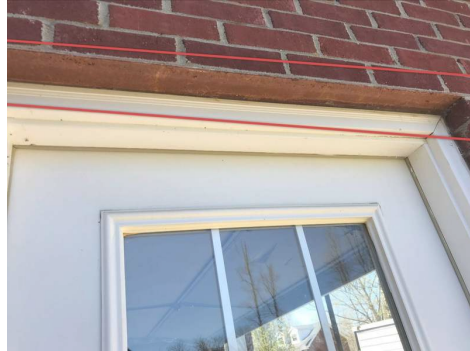
Metal lintel needs to be painted to prevent rust.

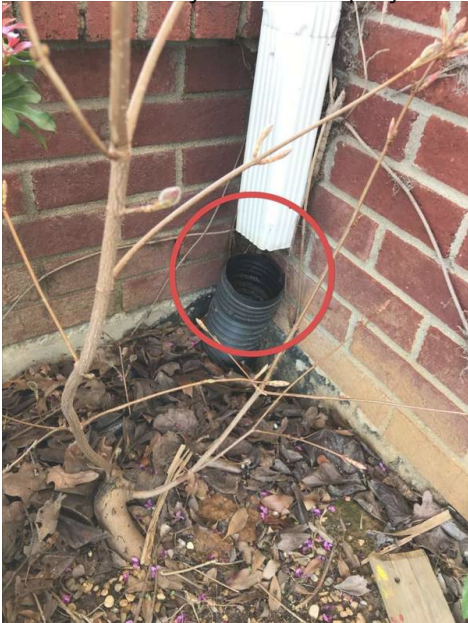
Several of the downspouts are disconnected from their drain. Extensions should be installed so that water flows from the downspout to the drain pipe.

Recommend extending the downspout into the drain pipe.

Contact a handyman or DIY project

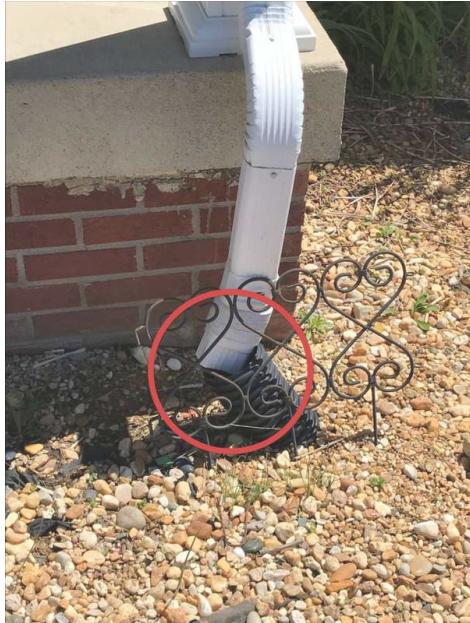
Recommend extending the downspout into the drain pipe.

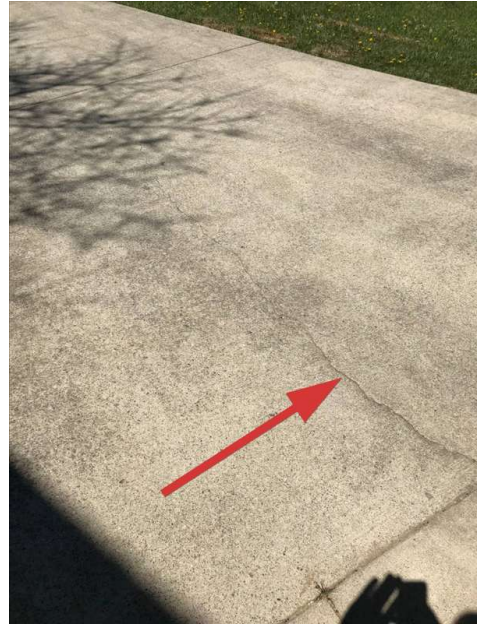
Minor cosmetic cracks observed, which may indicate movement in the soil. Recommend monitor and/or have driveway contractor patch/seal.

Minor driveway crack.

Contact a qualified driveway contractor.

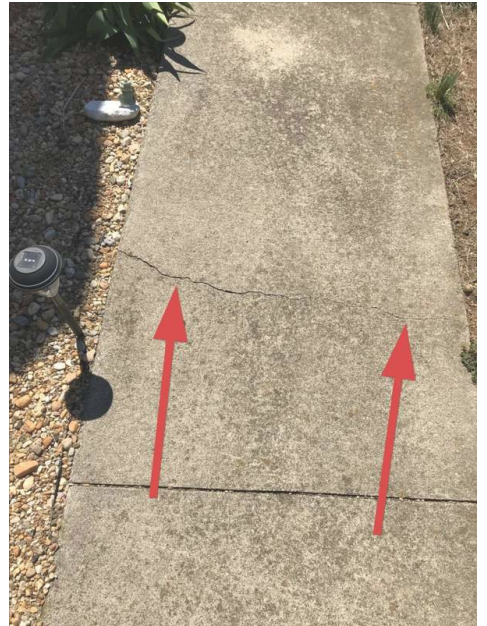
Minor cosmetic cracks observed. Recommend monitor and/or patch/seal.

Minor walkway crack.

Recommended DIY Project

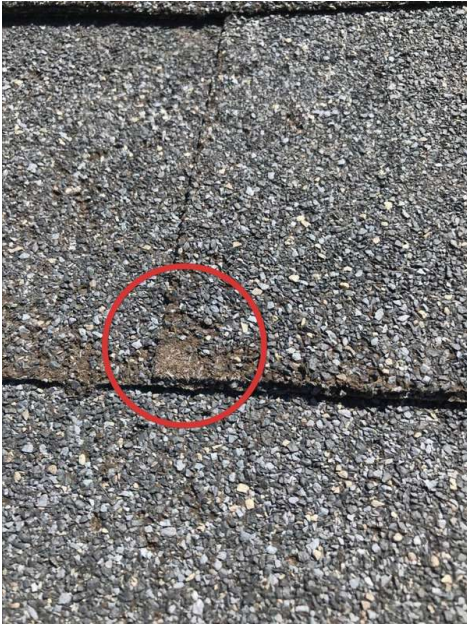
I observed several shingles with granule loss and found granules in the gutters. It is unknown the exact age of the roof, however the shingles appear to be nearing the end of their useful life. I recommend a qualified roofer evaluate the roof to determine the need to repair or replace.

Damaged shingles.

Contact a qualified roofing professional.

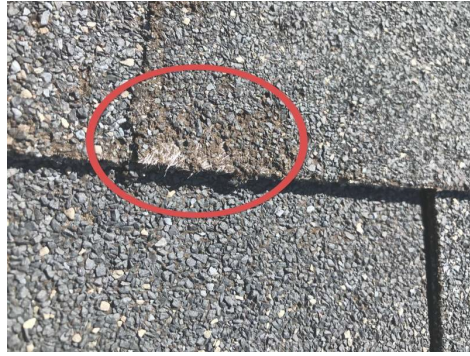
Damaged shingles.

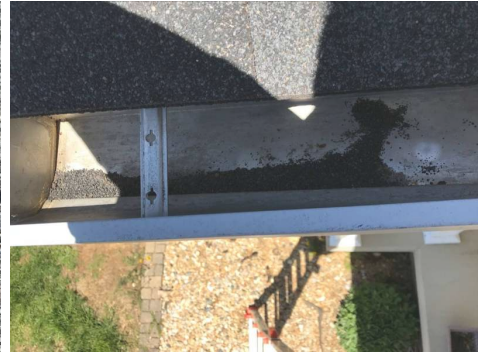
Granules.

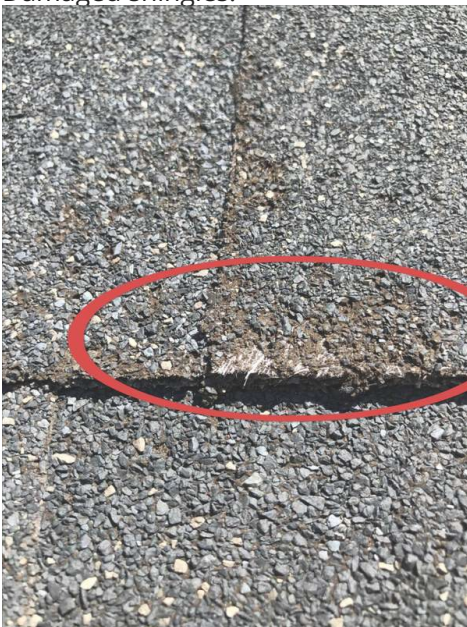
Damaged shingles.

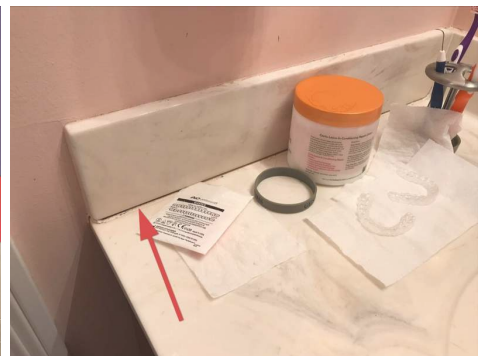
The caulk around all showers and bathroom sinks has expired and should be replaced to prevent water intrusion behind fixtures and walls.

Upstairs bathroom, caulk needed to prevent water intrusion.

Contact a handyman or DIY project

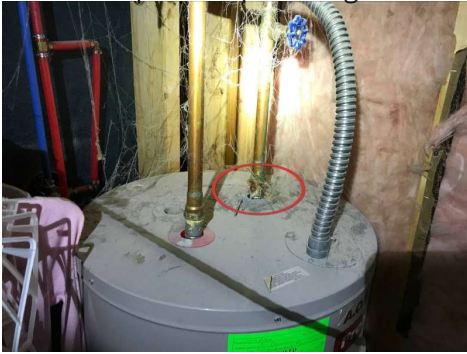
The copper pipe from the water heater is corroded. Recommend a

Corrosion.

Contact a qualified plumbing contractor.

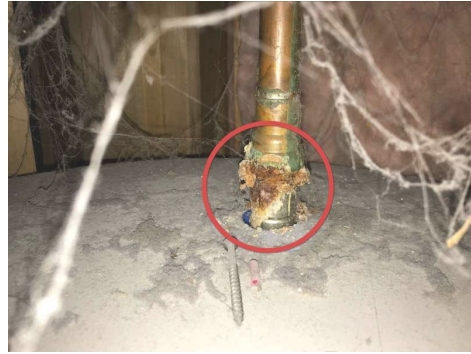
Corrosion.

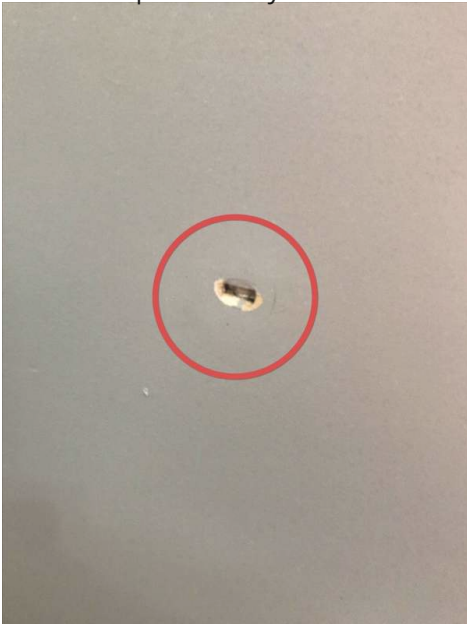
Wall had damage from doorknob. Recommend a qualified handyman or drywall contractor repair.

Doorknob hole, living room front door.

Contact a qualified drywall contractor.

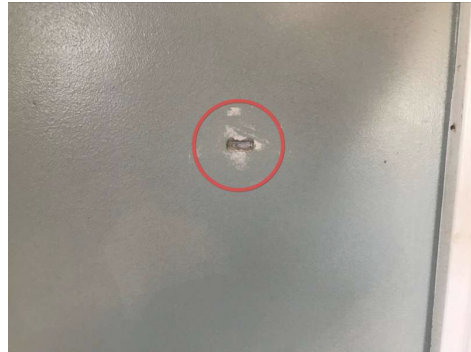
Doorknob hole, kitchen basement door.

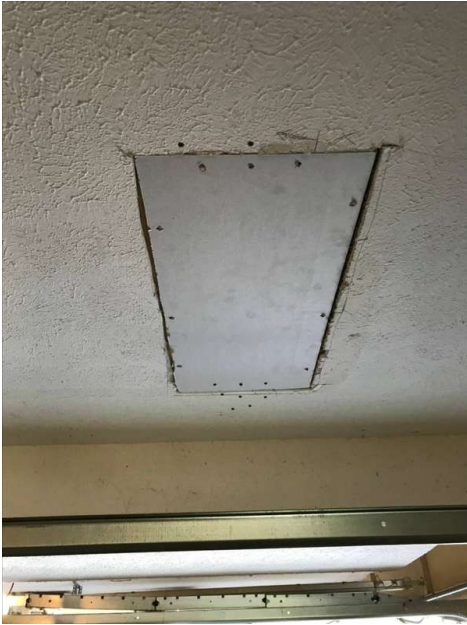
There are two spots in the garage that have been poorly repaired. There appeared to be water stains next to the patch, but the stains were not active when tested with moisture meter. I recommend properly patching/sealing these areas to prevent air/insect intrusion.

Area in garage needs to be properly patched.

Recommendation
Contact a handyman or DIY project

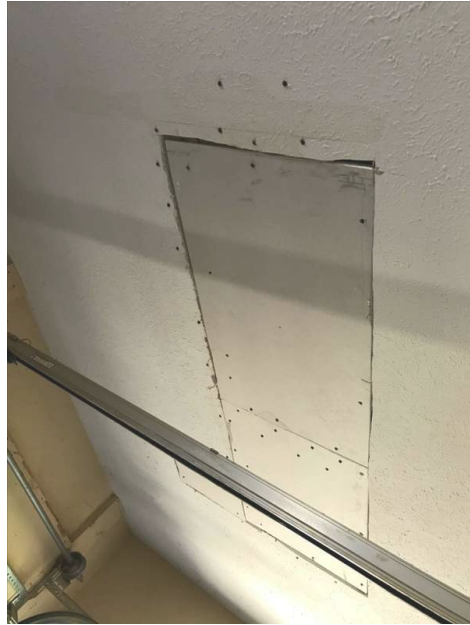
Area in garage needs to be properly patched.
