General Information: Overview

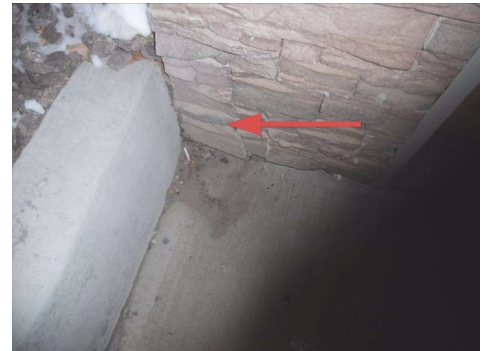
3.1.1 Siding, Flashing & Trim

CRACKING - MINOR

OUTSIDE GARAGE CORNER WALL

Loose siding observed. This is a result of temperature changes, and typical as homes with stucco age. Recommend monitoring.

Recommendation
Recommended DIY Project

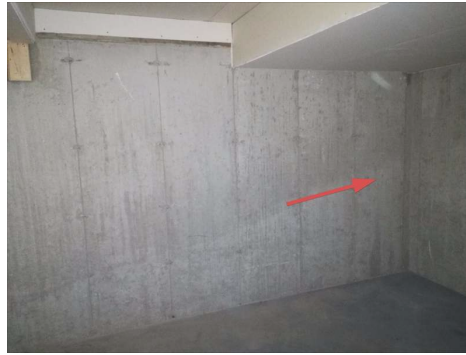
4.4.1 Wall Structure

CRACKS - MINOR

BASEMENT/GARAGE

Minor cracking was observed in the wall structure. This is common in homes. Recommend monitoring.

Cracks are not visible in thermal images, which is cosmetic repair, recommended. Basement

Recommendation
Contact a qualified professional.

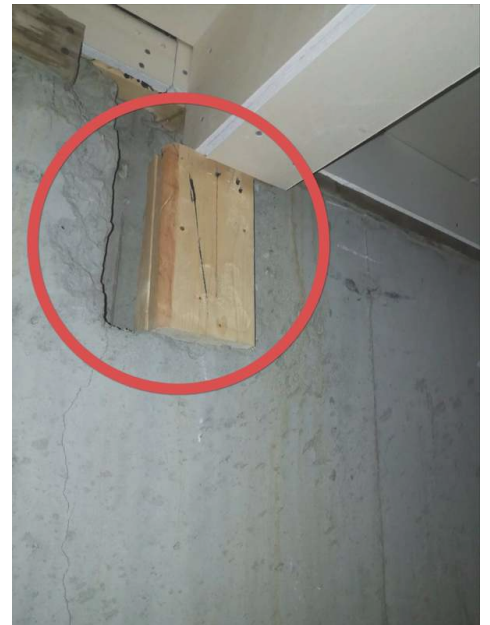
4.5.1 Ceiling Structure

EVIDENCE OF STRUCTURAL DAMAGE

IMMEDIATE/SAFETY ITEM

Evidence of structural repair was found in the ceiling structure. Recommend a structural engineer evaluate repair.

Contact a qualified structural engineer.

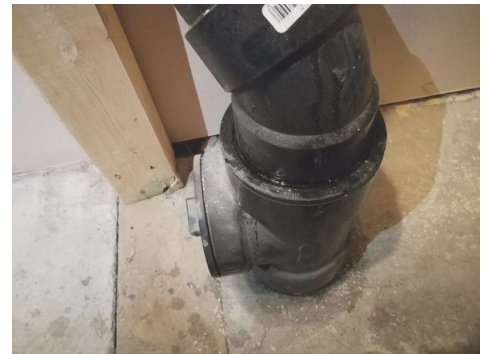
6.2.1 Drain, Waste, & Vent Systems **IMPROPER CONNECTION**

BASEMENT

loose connection and leak observed at a drain, waste pipe. Recommend a qualified plumber evaluate and repair.

Contact a qualified plumbing contractor.

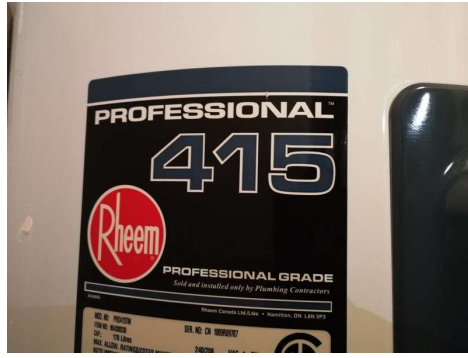
6.4.2 Hot Water Systems, Controls, Flues & Vents **NOT OPERATIONAL**

6.4.1 Hot Water Systems, Controls, Flues & Vents **WATER STAINS - LEAKAGE**

BASEMENT

Water stains were observed beneath water heater, indicating a past or present leak. Recommend further evaluation and repair by a qualified plumber.

Couldn't determine power source for operation, Recommend Contacting seller/condo management for its operational.

Contact a qualified plumbing contractor.

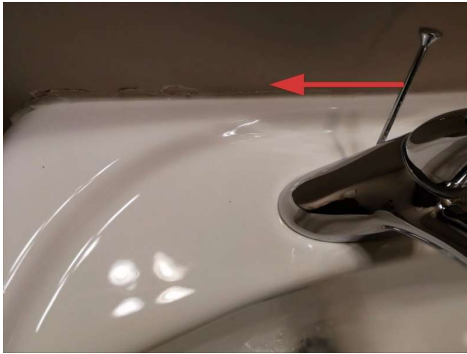
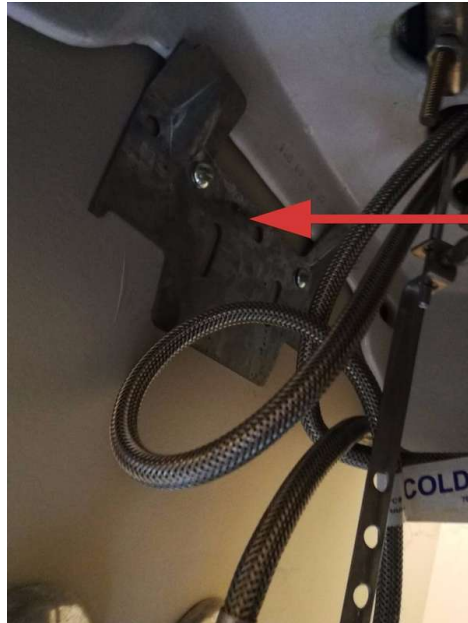
6.6.1 Bathroom Fixture

SINK

MAIN FLOOR HALF BATHROOM

Loose fitting observed at Mainfloor Haf bathroom, Recommend Repair by qualified Professional.

IMMEDIATE/SAFETY ITEM

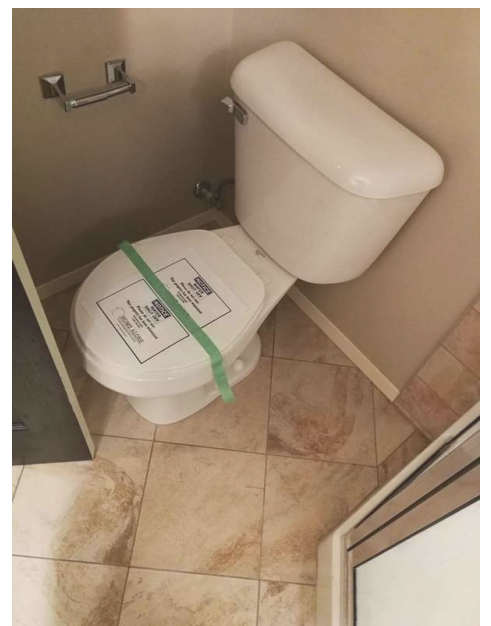
6.6.2 Bathroom Fixture

TOILET

2ND FLOOR ENSUITE BATHROOM

Loose fitting observed, Recommend Repair by qualified Professional.

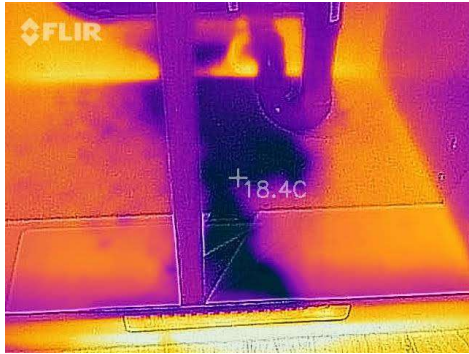
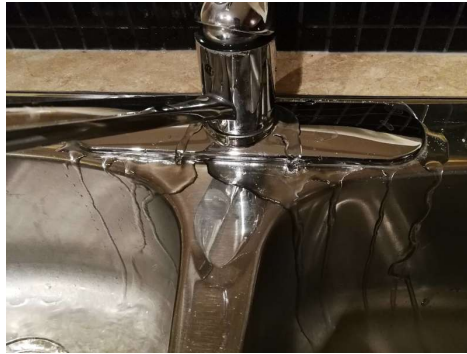
6.7.1 Kitchen Fixture

SINK

MAIN FLOOR KITCHEN

Observed leak while operating kitchen Faucet, Recommend Repair by qualified professional.

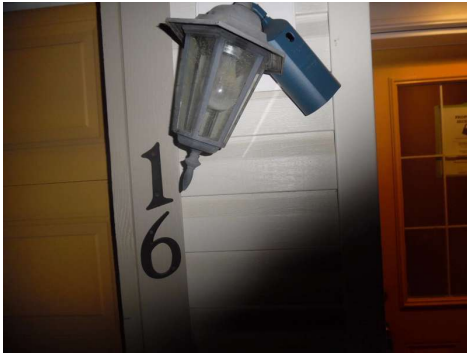
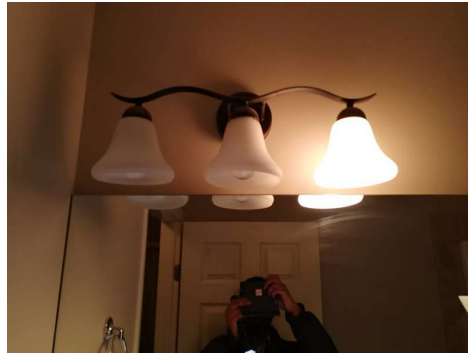
7.4.1 Lighting Fixtures, Switches & Receptacles

LIGHT INOPERABLE

EXTERIOR, LIVING ROOM, 2ND FLOOR

One or more lights are not operating. New light bulb possibly needed.

Contact a qualified electrical contractor.

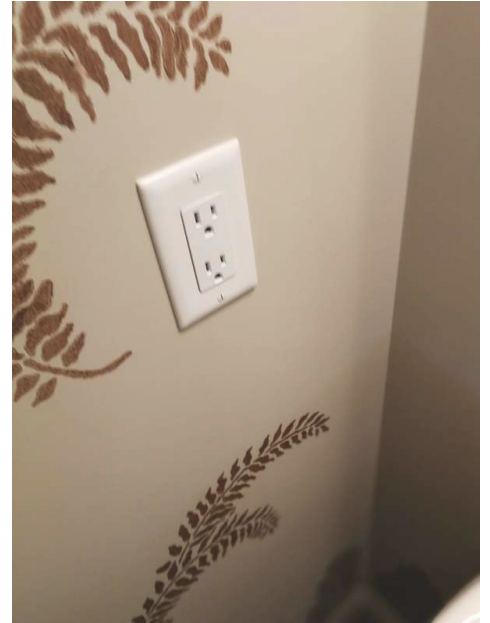
7.5.1 GFCI & AFCI

NO GFCI PROTECTION INSTALLED

MAIN FLOOR HALF BATHROOM

No GFCI protection present in all locations. Recommend licensed electrician upgrade by installing ground fault receptacles in all locations.

IMMEDIATE/SAFETY ITEM

Contact a qualified electrical contractor.

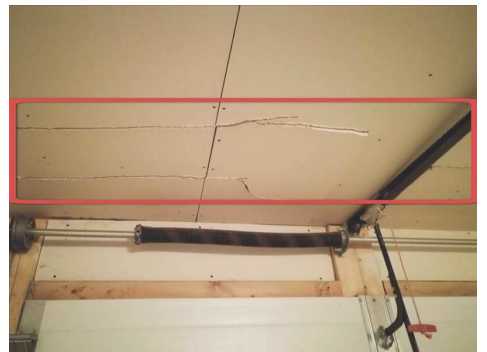
11.1.1 Ceiling

DAMAGED

Garage ceiling was damaged. Recommend qualified contractor evaluate and repair.

Contact a qualified professional.

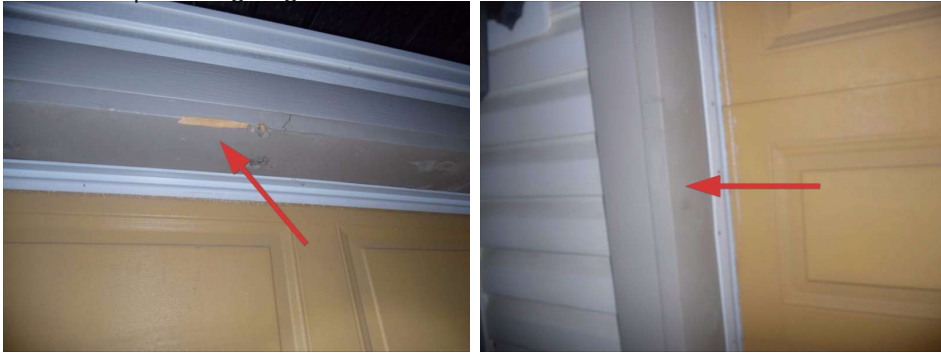
DAMAGE GARAGE TRIM

IMMEDIATE/SAFETY ITEM

GARAGE

Observed Garage door' trim damage and missing cover plate to protect from deterioration.

Contact a qualified garage door contractor.
