SUMMARY
1234 Main St.CHARLESTON sc 29412
Buyer Name
07/14/2018 9:00AM

Preston Clark
InterNACHI Certified Home Inspector
Clark Inspections LLC
843-580-4116
preston@spclarkinspections.com

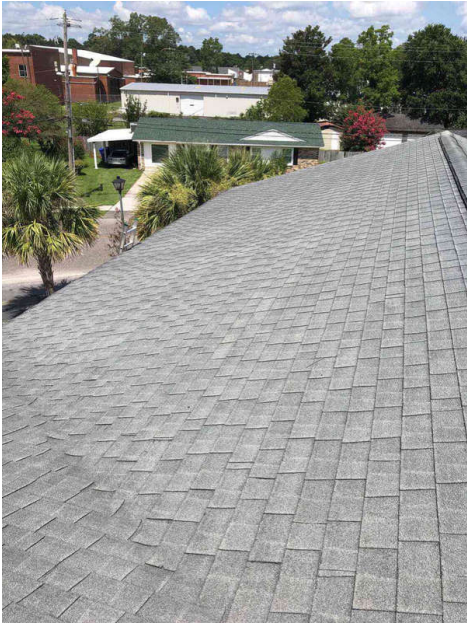
2.2.1 Roof Coverings

WORN SHINGLES

Damaged and/or missing areas of the roof covering was noted at the time of the inspection. Roof covering should be evaluated and areas repaired and/or replaced by a licensed qualified roofing contractor to avoid damage to the underlying home structure from moisture intrusion.

Roof overview. Color fade shows signs of age

Contact a qualified roofing professional.

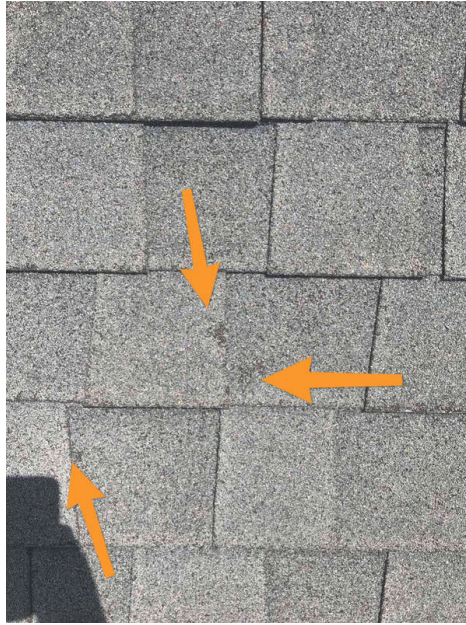
Small blisters and granule loss.

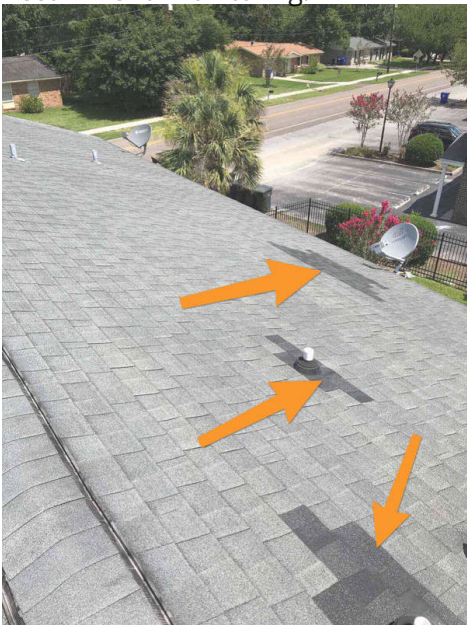
2.2.2 Roof Coverings

The roof covering of this home showed signs of previous repair. This is for your information, ask sellers for more information concerning repairs.

Prior repairs

Recommendation
Recommend monitoring.

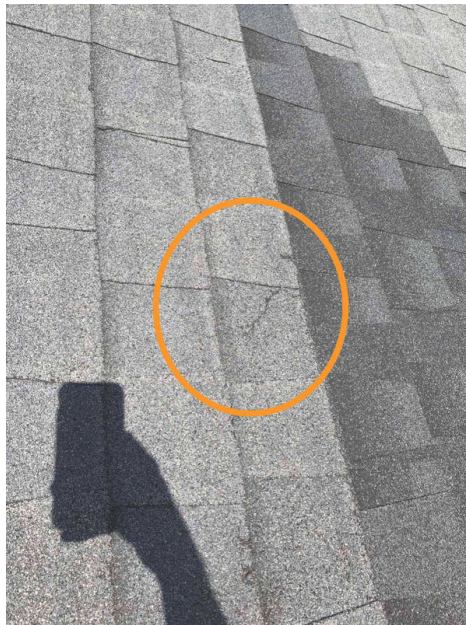
Shingles cracked from repair

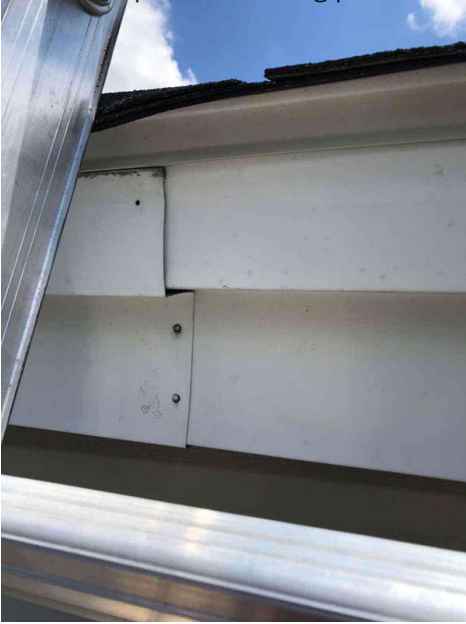
2.5.1 Flashings

One or more of the roof flashing(s) were not properly fastened or secured at the time of the inspection. The flashing should be evaluated and be properly secured with the fasteners sealed. This condition can lead to water intrusion and/or mold. Recommend a qualified roofing contractor repair.

Loose Fascia

Recommendation
Contact a qualified roofing professional.

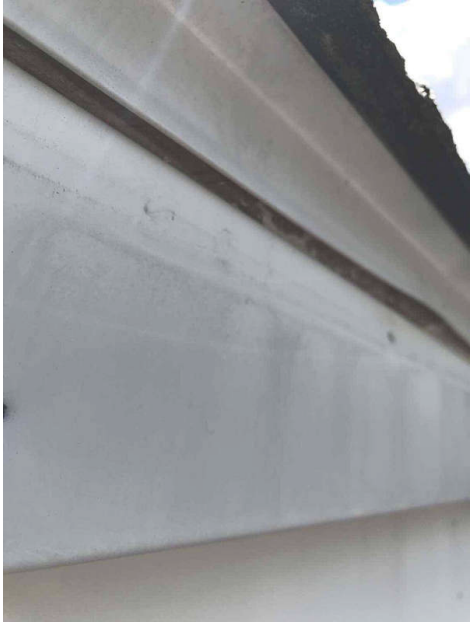
Exposed wood under drip edge

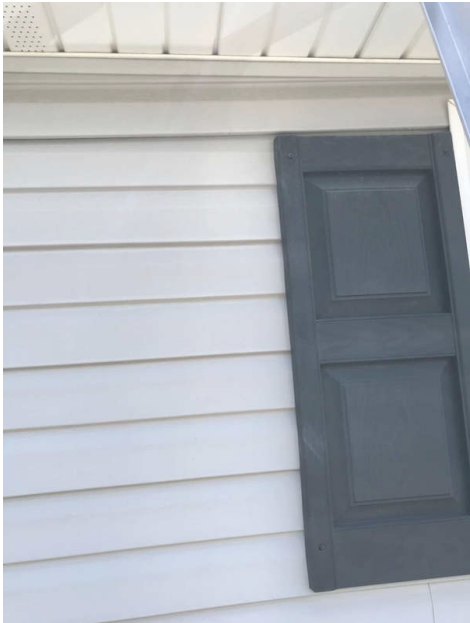
3.2.1 Wall Cladding

LOOSE OR SAGGING

Areas of loose or sagging siding covering exterior walls was visible at the time of inspection. These areas should be repaired to prevent damage to the siding and to help prevent moisture intrusion of the wall assembly.

Recommendation
Contact a qualified professional.

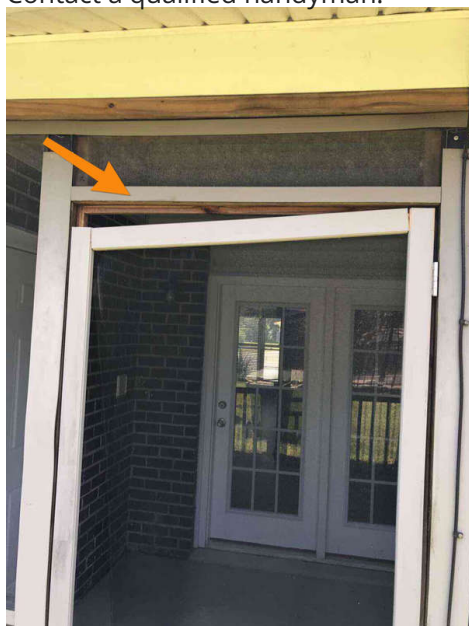
3.5.1 Screen/Storm Door(s)

Back door on screened in porch is not framed properly and there are large gaps. Recommend repair or consulting a handyman

Wood Screen Door on Back Patio showed signs of damage

Recommendation
Contact a qualified handyman.

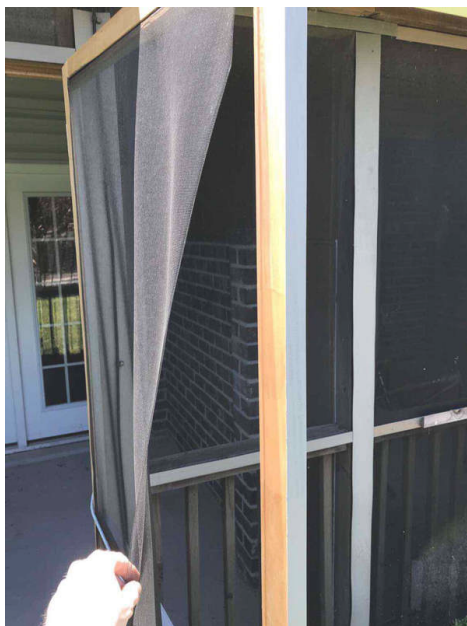
Screen Wooden Door on Back Patio

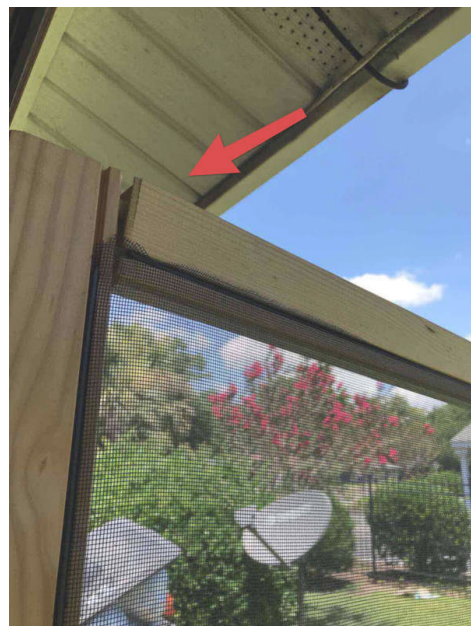
Screen Porch Door Damage

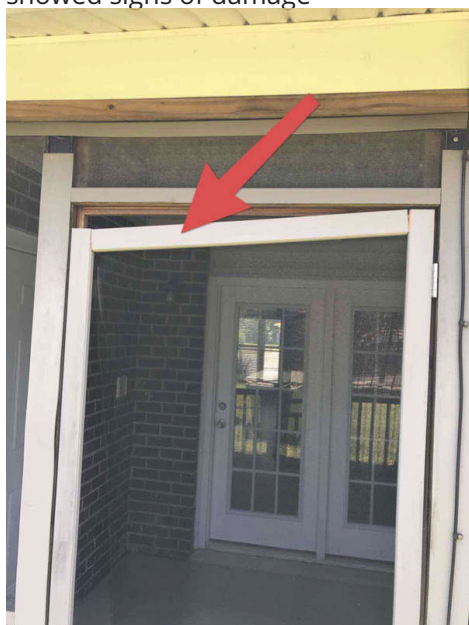
Screen Porch Door had Large Gaps and was not sized properly

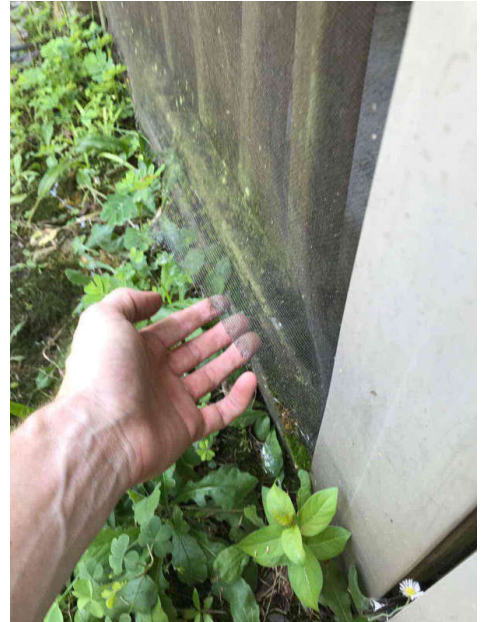
3.5.2 Screen/Storm Door(s)

Back Patio Porch Screen Showed Minor Damage along the base.
Recommend repair at your disclosure.

Damage along Bottom Edge of Screen on Porch

Recommendation
Contact a handyman or DIY project

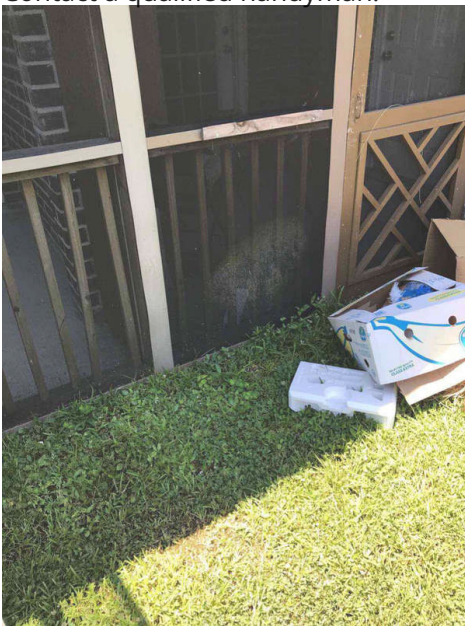
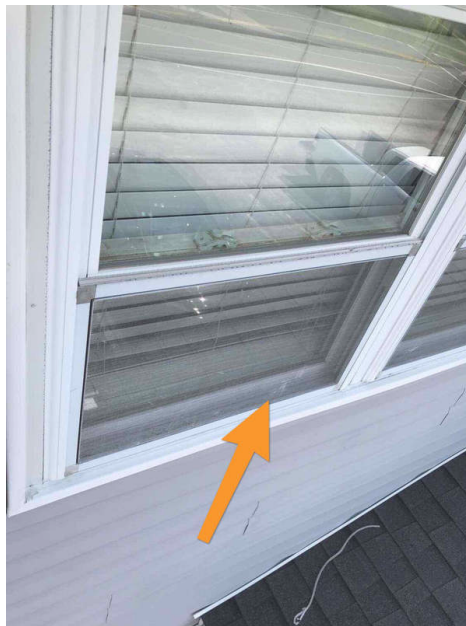
3.5.3 Screen/Storm Door(s)

SCREENS DAMAGED/WORN

Window Screen showed minor holes from wear

Contact a qualified handyman.

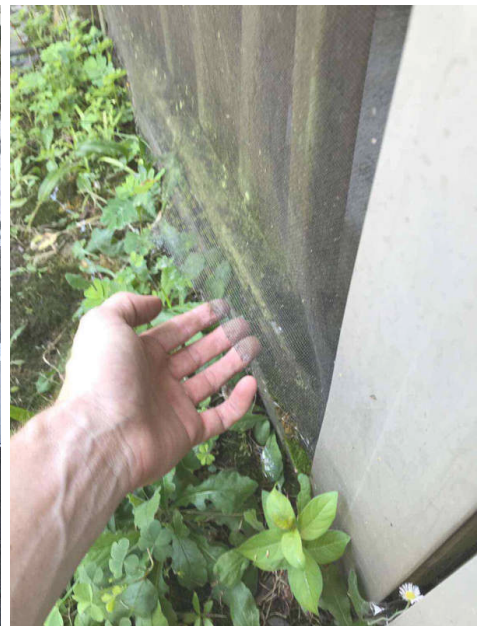
Back Porch Screen was Loose

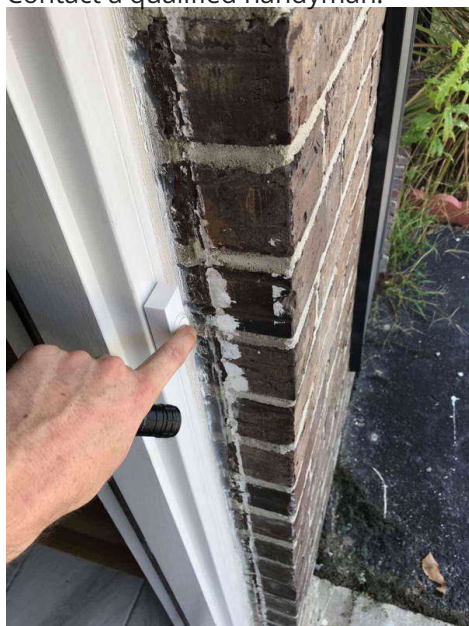
3.7.1 Door Bell

The doorbell did not operate when tested. Recommend checking the door bell button, chime & transformer & replace or repair as needed.

Door Bell did not work properly.

Recommendation
Contact a qualified handyman.

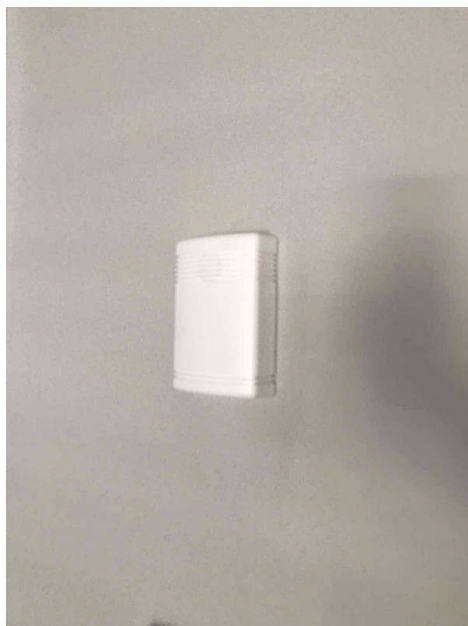
Door Bell Chime in Living Room

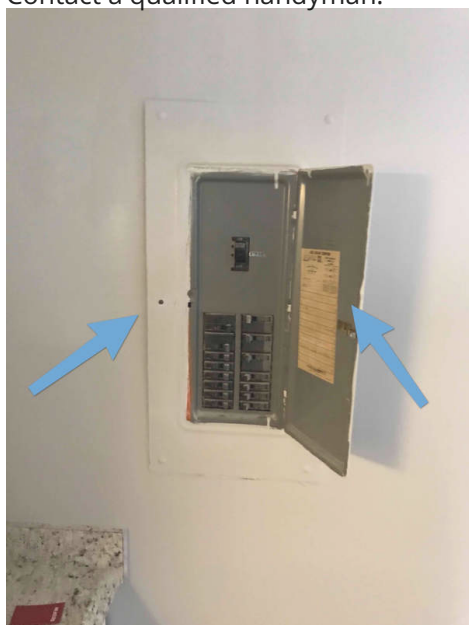
5.3.1 Main, Service & Grounding, Main Overcurrent Device

Panel cover screws were noted at the time of inspection. Replacement recommended.

Panel Screws Missing on both Sides

Recommendation
Contact a qualified handyman.

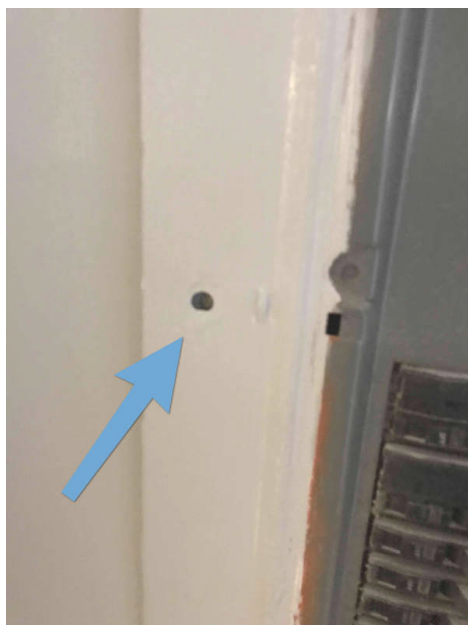
Missing Screws

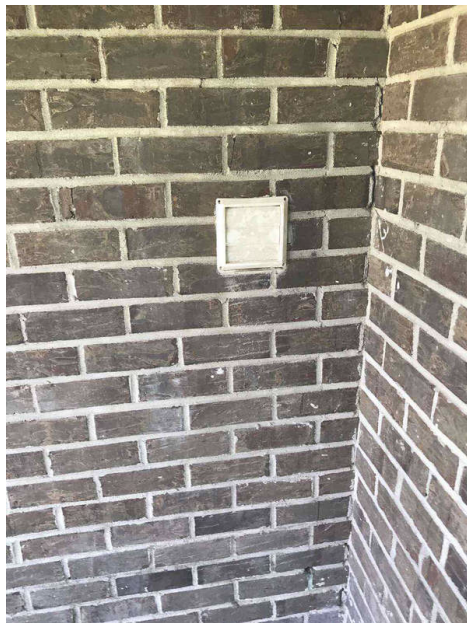
7.4.1
Dryer
Vent
and Cover

TERMINATION WITHIN 3 FT. OF AN OPENING

A dryer duct terminated within 3 feet of an opening to the living space such as a door or window. This is not a standard position. It also vented to the back porch which is a screened area and not enclosed. This is not standard but it is considered to be an outside position.

Most likely the placement will not bother your living conditions but making a note of it.

Dryer vent

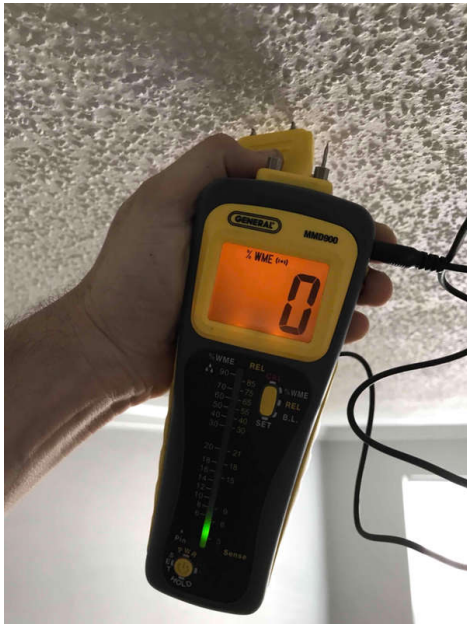
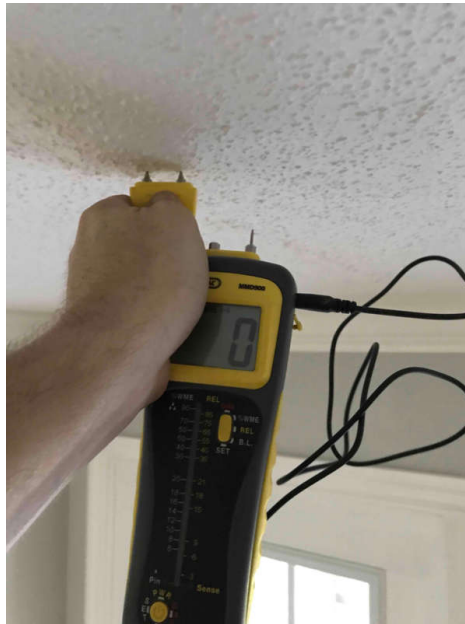
10.1.1 Ceilings

HAIRLINE CRACKS (COSMETIC)

One or more areas of the ceiling had several hairline cracks (cosmetic) or bubbles . This damage is cosmetic but if you want to repair it I recommend hiring a handyman unless you have experience with drywall work.

I checked the areas with a moisture meter and they were dry.

Kitchen ceiling

You could outline the area with a pencil and see if it grows.

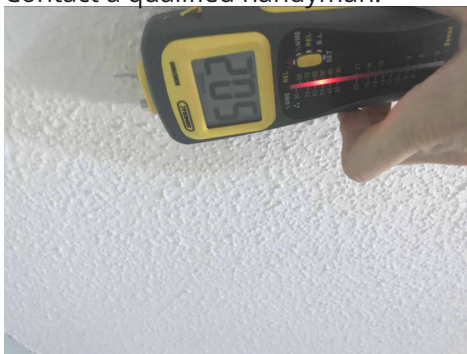
10.1.2 Ceilings

In the upstairs back elevation bedroom the ceiling had a water stain that showed signs of moisture with palm reader, but with pins it did not show much moisture. The thermal camera showed an anomalie where the stain was. The stain could have come from the rains recently or before the roof was repaired. I recommend asking the seller about this area or having a handyman inspect for leaks. It may be beneficial to view a copy of the master deed to see who is responsible for the roof.

Palm readers are not reliable like a pin as it is a type of signal that varies and could be picling up outside moisture.

Palm Reader Showed Moisture

Recommendation
Contact a qualified handyman.

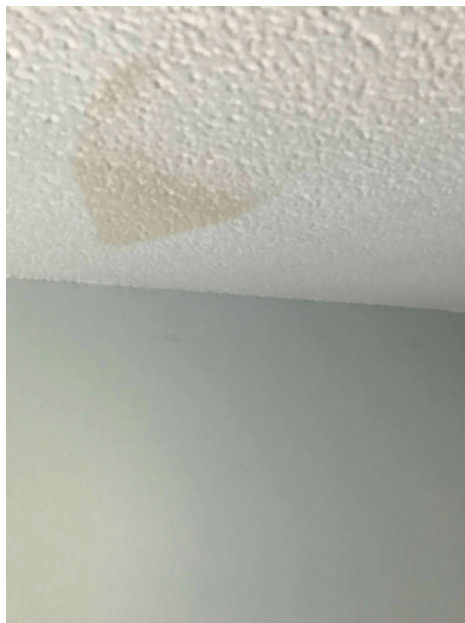
Stain

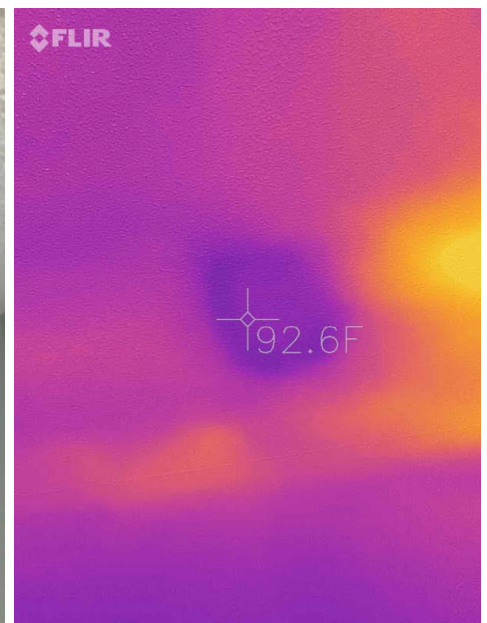
Thermal Image

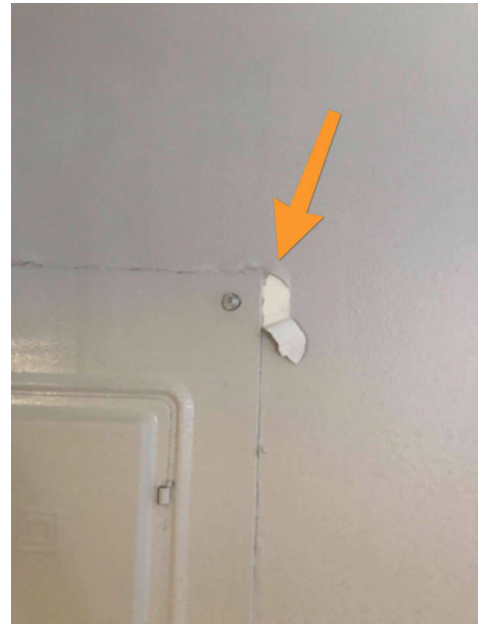
PAINT CRACKING

paint chipped from control panel area because it was painted over which is not standard. Control panel should be able to be deattaches.

Paint chiped

Recommendation
Contact a qualified painter.

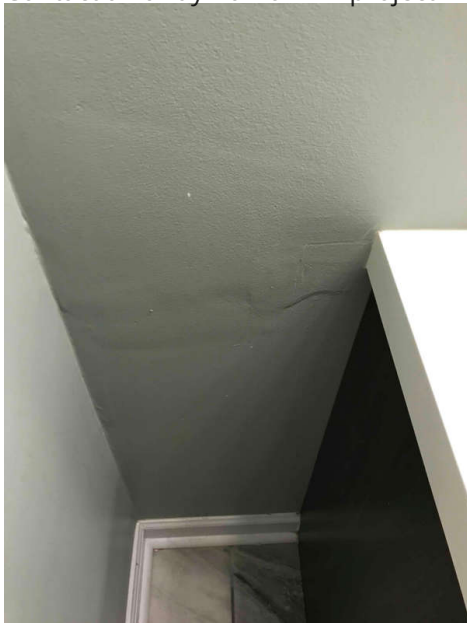
POOR PATCHING

Sub-standard drywall patching observed at time of inspection. If you know how to patch and paint I recommend DIY or you can hire a drywall install.

Overview of patch

Recommendation
Contact a handyman or DIY project

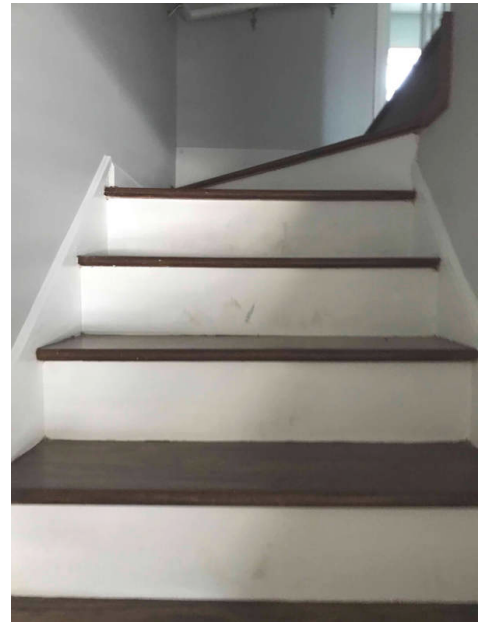
Stairway showed minor stains from shoes

Minor stains

Recommendation
Recommended DIY Project

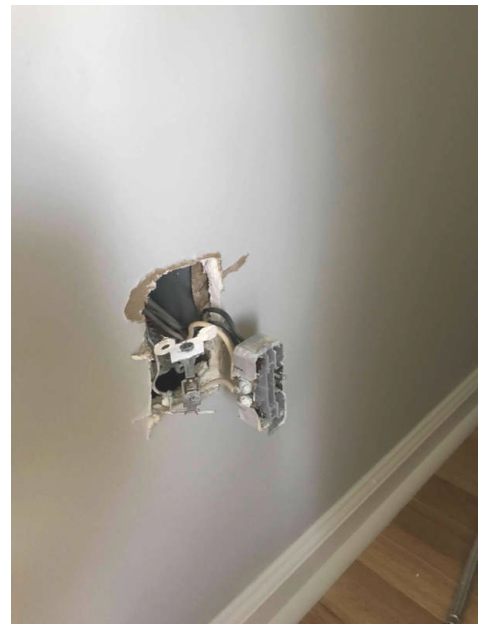
10.6.1 Outlet Observations

DAMAGED OUTLET

One or more electrical outlets were damaged, electrical outlets should be replaced by a qualified electrical contractor.

Behind the fridge

Contact a qualified professional.

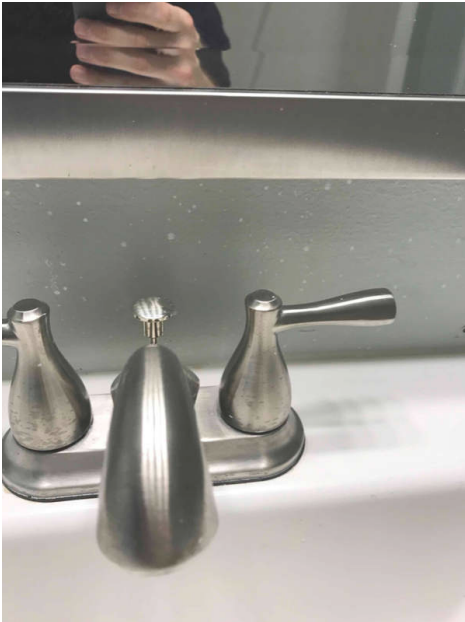
Water spray from faucet not having water control device at tip

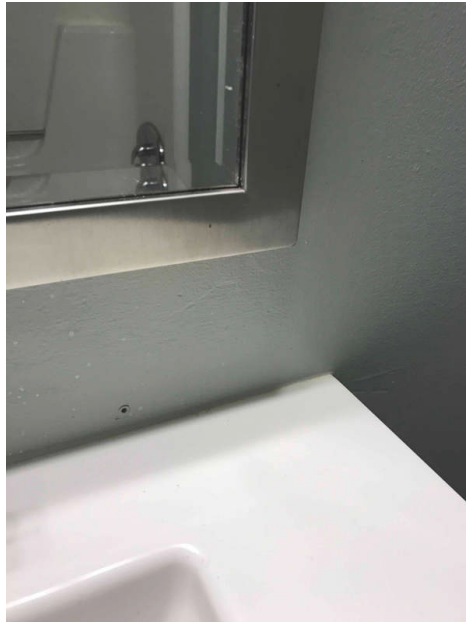
Upstairs faucet was missing a screen at the tip. Recommend replaciement.

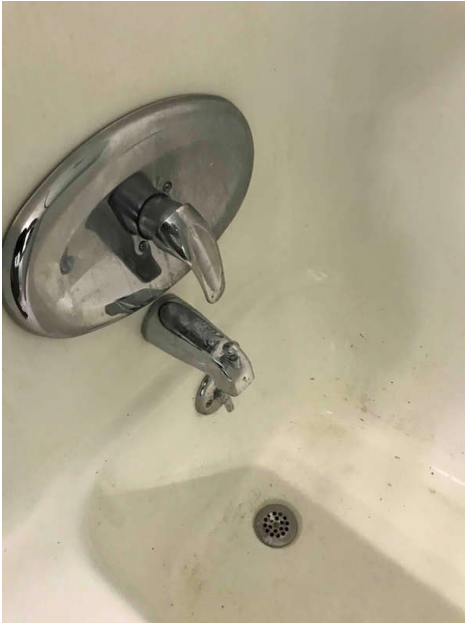
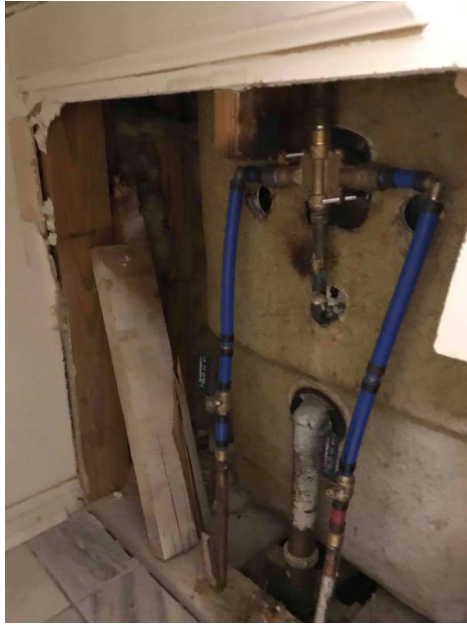
10.12.1 Bathtub Observations

UNPROFESSIONAL REPAIR

Upstairs tub had a cover plate that was not original and the cut out behind it was loose

Contact a qualified professional.

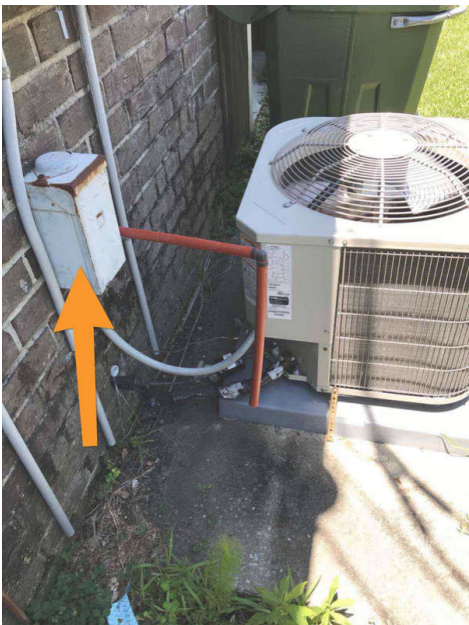
13.1.1

CORROSION TO PANEL

The exterior electrical disconnect/shut off box was rusted and not opened. Unable to verify fuse size.

Contact a qualified professional.
