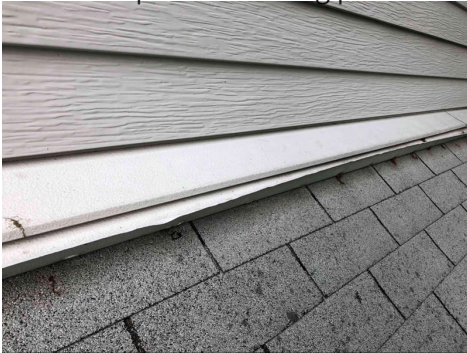
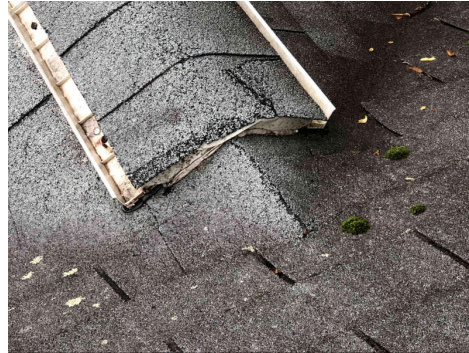
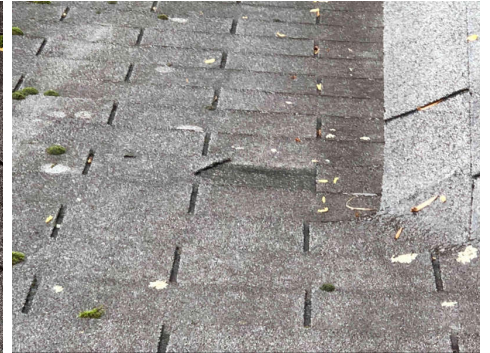
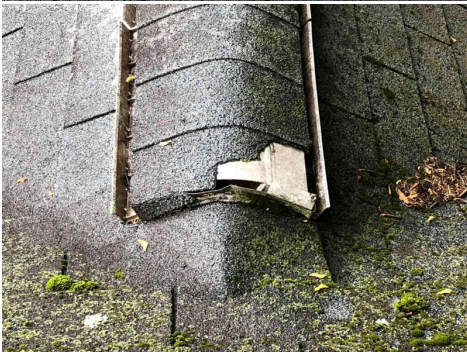
2.1.1 Roof Covering

END OF USEFUL LIFE

The roof appears to be at or near the end of its useful lifespan. You should budget to replace it soon.

Contact a qualified roofing professional.

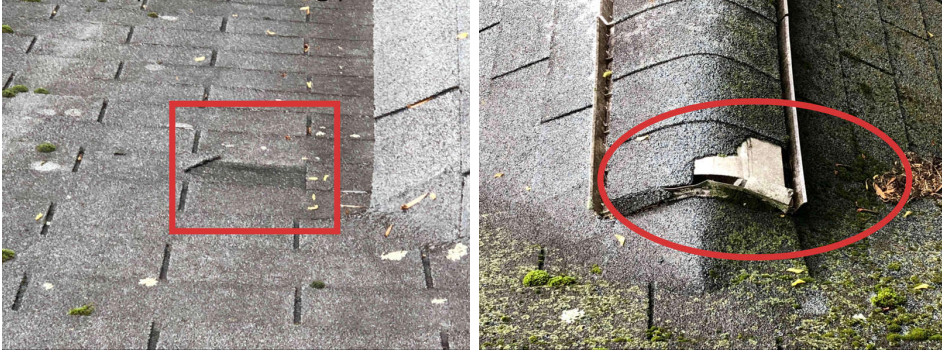
2.1.2 Roof Covering

LOOSE BLOWN-OFF SHINGLES

There are loose or blown-off shingles that should be repaired to prevent leakage.

Contact a qualified roofing professional.

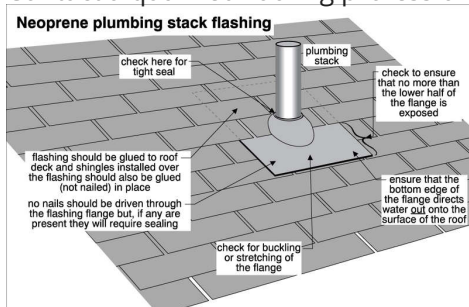
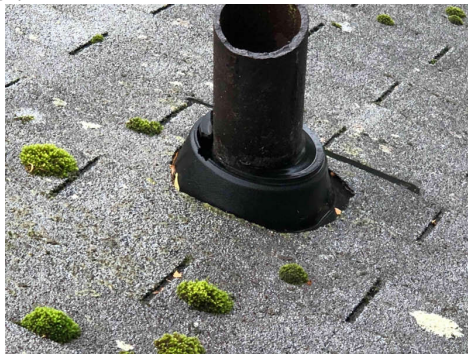
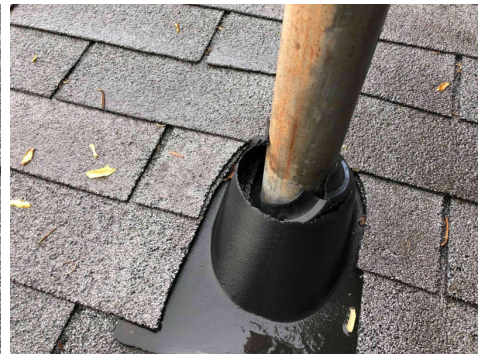
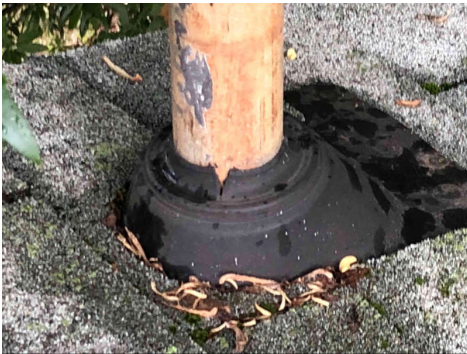
2.2.1 Flashing / Penetrations

DETERIORATED BOOTS

There are one or more old boots at the plumbing vents that are deteriorated and should be replaced as part of regular maintenance to prevent leakage.

Contact a qualified roofing professional.

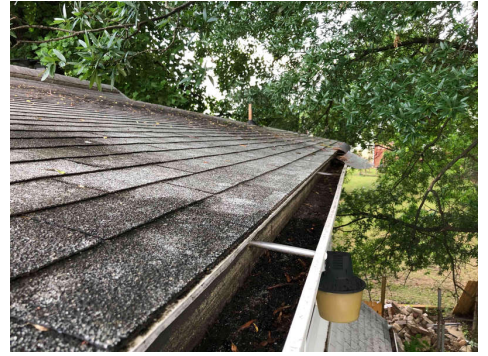
2.3.1 Drainage System

DEBRIS IN RAIN GUTTERS

Rain gutters need to be cleaned out to prevent overflowing and possible leakage into the home or basement.

Contact a qualified professional.

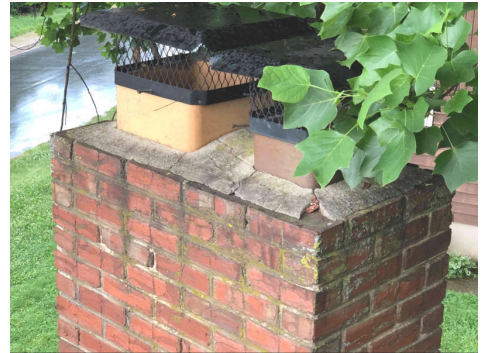
2.4.1 Chimney and Flue Condition
SEVERELY DETERIORATED CROWN

The chimney crown should be replaced to prevent water damage to the chimney chase.

Recommendation
Contact a qualified chimney contractor.

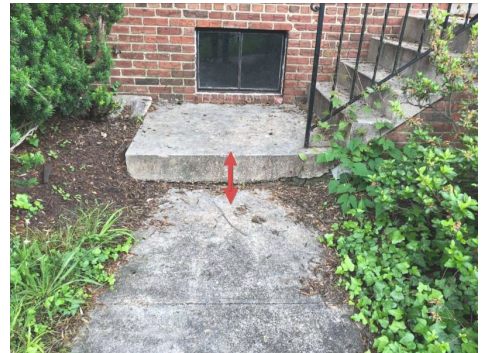
3.1.2 Driveway / Sidewalk / Patio
WALKWAY SETTLED STEP TOO HIGH
FRONT WALKWAY

The walkway has settled leaving a step too high. This may be a trip/fall hazard and should be corrected.

Recommendation
Contact a qualified concrete contractor.

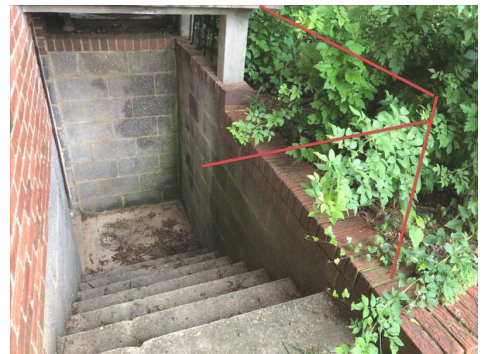
3.2.1 Steps / Porch / Deck
HANDRAIL MISSING
REAR BASEMENT STAIRWAY

This stairway is missing a graspable handrail. Falls are more likely to happen on stairways and a handrail is needed for safe use.

Recommendation
Contact a qualified carpenter.

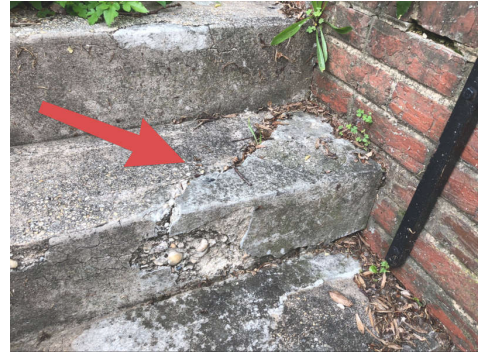
3.2.3 Steps / Porch / Deck

SEVERELY DETERIORATED CONCRETE STAIRWAY

Portions of the concrete stairway are severely deteriorated. This condition may worsen and become unsafe if not corrected.

The cracked section of concrete is starting to come loose

Contact a qualified concrete contractor.

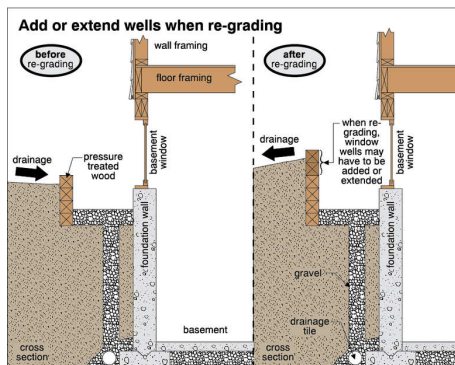
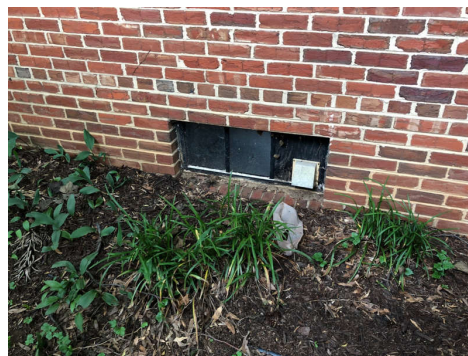
3.3.2 Doors / Windows

POOR WINDOW CLEARANCE TO SOIL

There is insufficient clearance to the soil at one or more windows. This condition may allow water into the structure. The addition of window wells may be a possible solution.

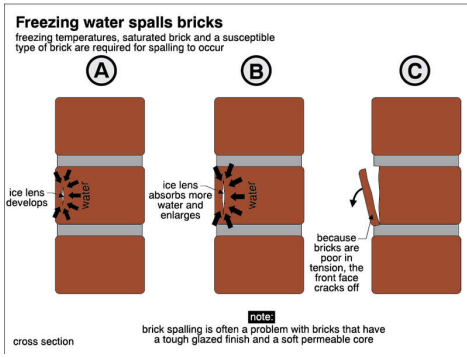
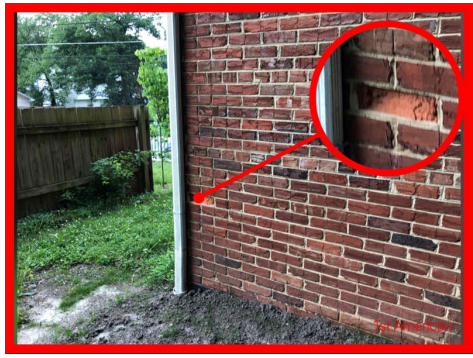
3.4.2 Siding / Trim / Flashing

ISOLATED BRICK FLAKING

There are flaking or scaling bricks that should be repaired to prevent further deterioration and more expensive repairs.

Contact a qualified masonry professional.

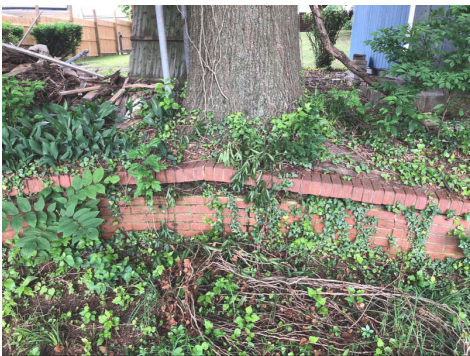
3.6.1 Fence / Retaining Wall Condition
WALL DAMAGED BY TREE

A large tree was in close proximity to the stone retaining wall and appears to have caused movement and damage. This is likely to continue as long as the tree is present and may result in failure of the retaining wall.

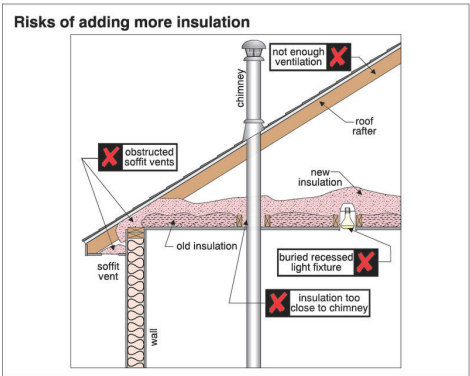
4.2.1 Insulation Condition
INADEQUATE INSULATION IN ATTIC

The insulation of the attic is insufficient by modern standards. This condition will cause higher than necessary heating and cooling costs.

Recommendation
Contact a qualified insulation contractor.

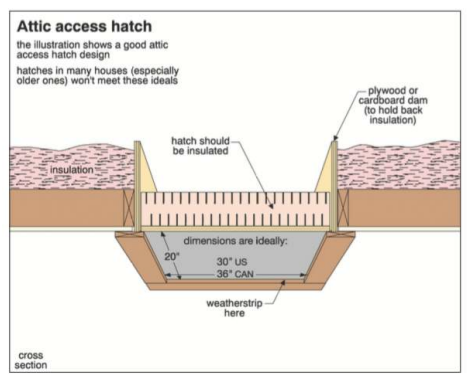
4.2.2 Insulation Condition
NO HATCH INSULATION

Insulation is missing at the attic hatch. This will result in energy loss and higher heating and cooling bills.

Recommendation
Contact a qualified insulation contractor.

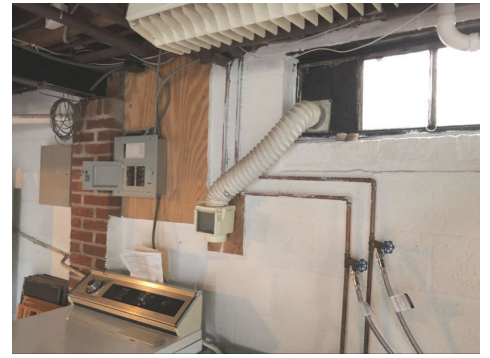
4.3.1 Ventilation / Exhaust Fans

REPLACE DRYER VENT DUCT

The plastic dryer vent duct should be replaced with a metal duct. The dryer vent is disconnected and the warm, moist air is discharged into the basement.

Contact a handyman or DIY project

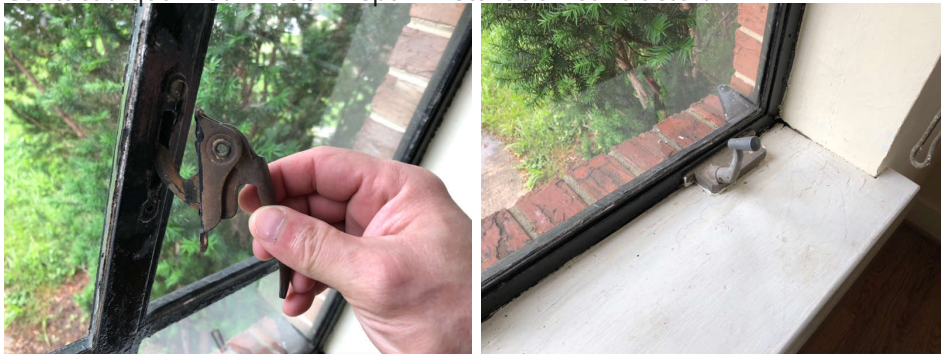
6.2.1 Windows / Doors / Closets

DAMAGED WINDOW HARDWARE

Window hardware is damage and should be repaired to function properly. The affected windows would not latch properly and leaves the home unsecured against unauthorized entry.

Contact a qualified window repair/installation contractor.

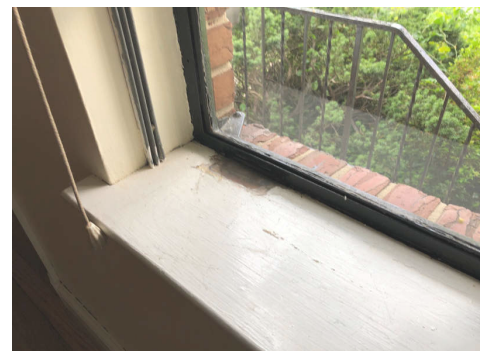
6.2.3 Windows / Doors / Closets

WINDOW HARDWARE IS MISSING

Window hardware is missing and the window is not working properly.

Contact a qualified window repair/installation contractor.

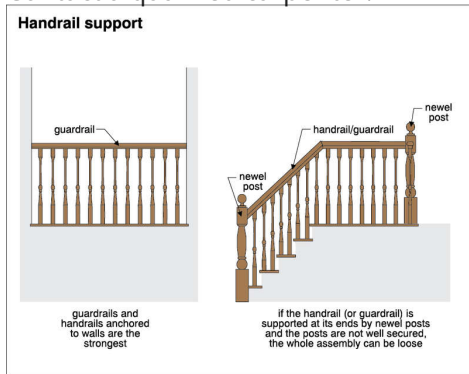
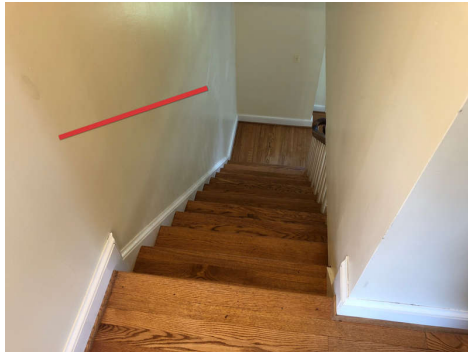
6.4.1 Stairways / Railings

MISSING HANDRAIL

The handrail is missing at one or more stairways. This condition may be unsafe.

Contact a qualified carpenter.

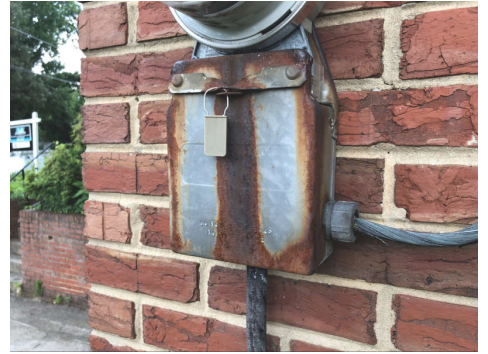
8.2.1 Service Entry / Service Rating

SEVERE CORROSION METER BOX

There is severe corrosion to the electric meter box. This condition will worsen if not corrected and may allow water into the structure or create a potentially unsafe condition.

Recommendation
Contact a qualified painter.

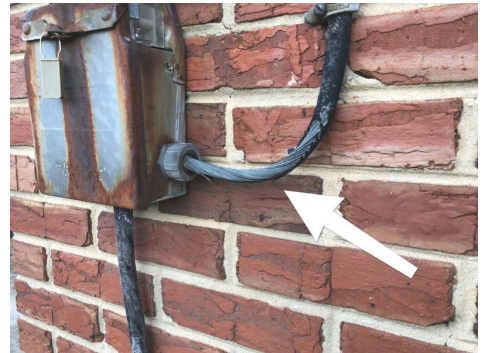
8.2.2 Service Entry / Service Rating

SHEATHING DETERIORATED

The main service conductor sheathing was severely deteriorated at the time of inspection. This condition may lead to deterioration of the conductor insulation and possibly electrocution.

Recommendation
Contact a qualified electrical contractor.

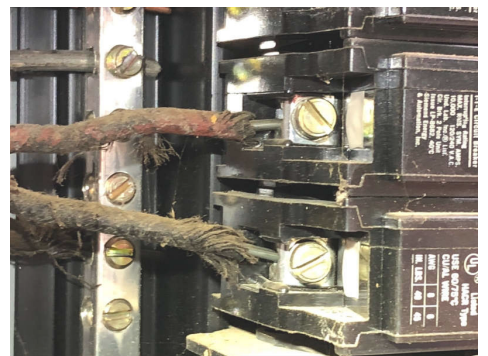
8.3.1 Service Panel / Main Disconnect

ALUMINUM WIRING HAZARDS

Single-strand aluminum wiring was observed in the main panel. Between approximately 1965 and 1973 aluminum wiring was sometimes substituted for copper branch circuit wiring in residential electrical systems. Neglected connections in outlets, switches and light fixtures containing aluminum wiring become increasingly dangerous as time passes. Poor connections cause wiring to overheat, creating a potential fire hazard. In addition to creating a potential fire hazard, the presence of aluminum wiring may have an effect on your insurance policy. You should ask your insurance agent whether the presence of aluminum wiring is a problem that requires changes to your policy language in order to ensure that your house is covered. Here are the reasons aluminum wiring connections deteriorate: Thermal expansion and contraction: Even more than copper, aluminum expands and contracts with changes in temperature. Over time, this will cause connections to loosen. When wires are poorly connected they overheat, which creates a potential fire hazard. Vibration: Electrical current vibrates as it passes through wiring. This vibration is more extreme in aluminum than it is in copper and as time passes, it can cause connections to loosen. Again, when wires are poorly connected they overheat, which creates a potential fire hazard. Oxidation: Exposure to oxygen in the air causes deterioration to the outer surface of wire. This process is called oxidation. Aluminum wire is more easily oxidized than copper wire and as time passes, this process can cause problems with connections. Again, when wires are poorly connected they overheat, which creates a potential fire hazard. Galvanic corrosion: When two different kinds of metal are connected to each other a very low-voltage electrical current is created which causes corrosion. Corrosion causes poor connections. More information is available at this comprehensive website. <http://www.inspect-ny.com/aluminum/aluminum.htm> Options for Correction The wiring should be evaluated by a qualified electrician. This means an electrician experienced in evaluating and correcting aluminum wiring problems. Not all electrical contractors qualify.

1. At a minimum, all connections should be checked and an anti-oxidant paste applied as needed.
2. Aluminum wire can be spliced to copper wire at the connections using approved wire nuts (called "pig-tailing", not recommended by the US Consumer Product Safety Commission.)
3. Copalum crimps can be installed. Although this is the safest option, Copalum Crimps are expensive.
4. AlumiConn Connector.
5. Complete home re-wire. Costs will vary. Consult with a qualified electrical contractor.

Contact a qualified electrical contractor.

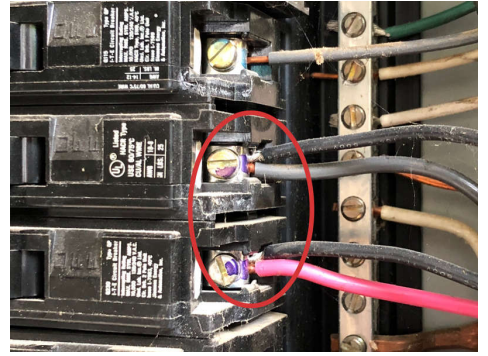
8.3.2 Service Panel / Main Disconnect

DOUBLE TAPPED BREAKER

There is one or more double tapped breaker in the main service panel. A breaker should only serve one circuit.

Contact a qualified electrical contractor.

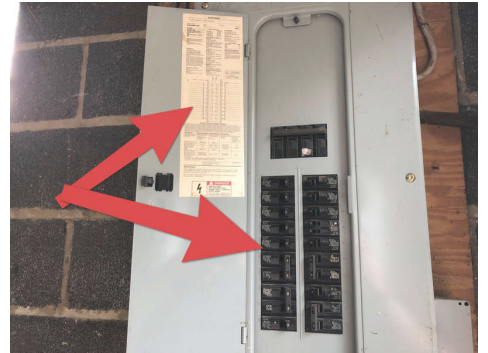
8.3.3 Service Panel / Main Disconnect

LABEL BREAKERS

Every circuit breaker in the electrical panel should be labeled to indicate what it serves so that power can be turned off in a hurry.

Contact a qualified electrical contractor.

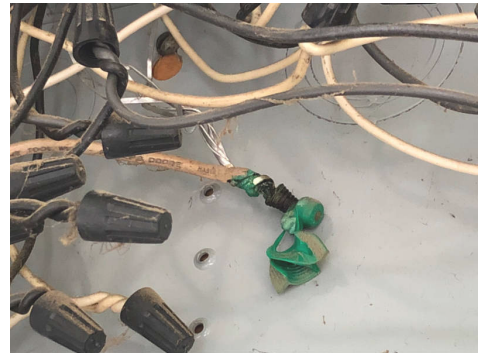
8.3.4 Service Panel / Main Disconnect

TWIST-ON WIRE CONNECTOR NEEDED

The twist-on wire connector (wire nut) is missing or deteriorated and needs to be replaced.

Contact a qualified electrical contractor.

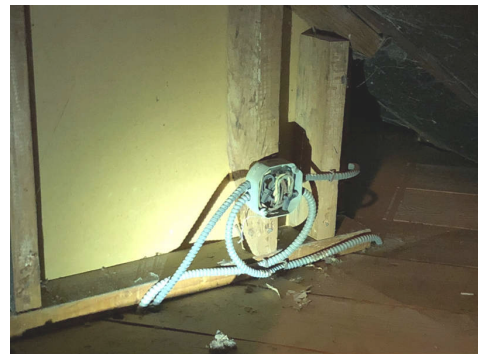
8.4.1 Wiring / Grounding / Junction Boxes

OPEN JUNCTION BOXES

There are open junction boxes which should be covered to prevent accidental electrocution.

Contact a qualified electrical contractor.

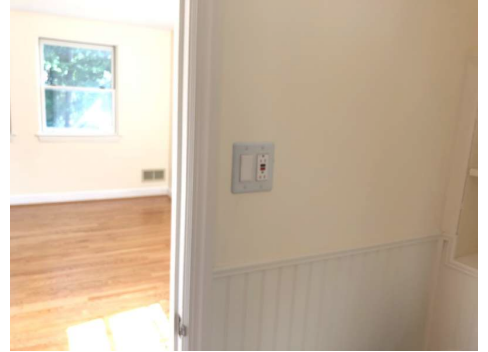
8.5.2 Outlets / Lights / Ceiling Fans

LOOSE ELECTRICAL OUTLET

There are one or more loose electrical outlets.

Contact a qualified electrical contractor.

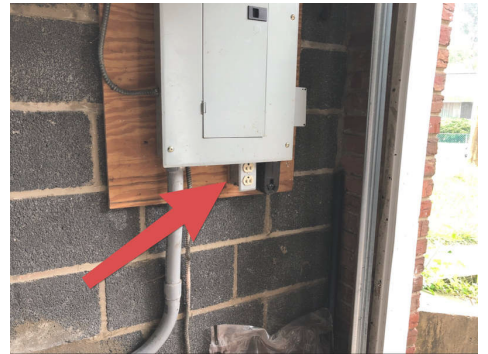
8.5.3 Outlets / Lights / Ceiling Fans

GARAGE NOT GFCI PROTECTED

There are one of more electrical outlets in the garage which are not GFCI protected. This is an important safety feature that should be present in potentially wet locations.

Contact a qualified electrical contractor.

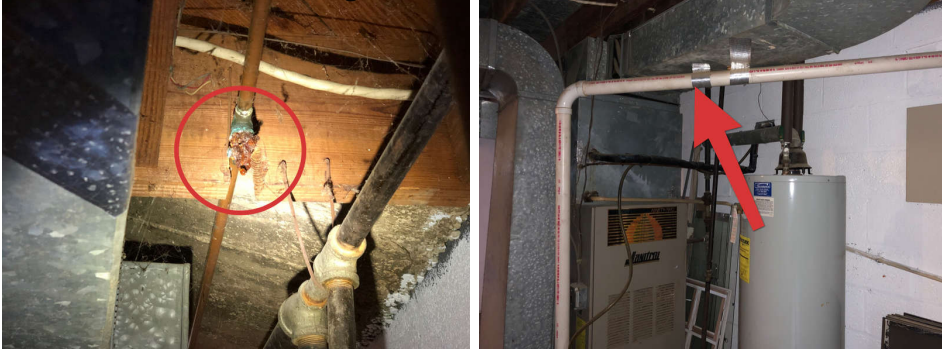
10.1.1 Water Supply Piping / Shutoff

ACTIVE LEAK ABOVE WATER HEATER

There is an active leak above the water heater next to the furnace.

Contact a qualified plumbing contractor.

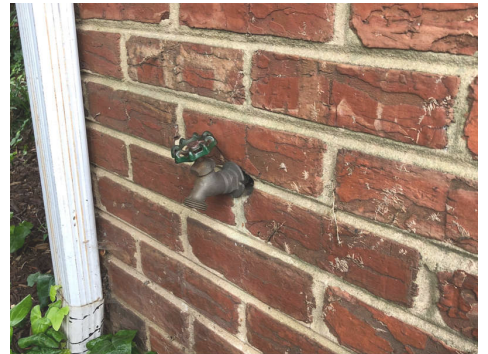
10.3.1 Faucets / Sinks / Toilets

LOOSE EXTERIOR FAUCET

This exterior faucet is loose and should be secured to prevent damage to the plumbing pipes and leakage.

Contact a qualified plumbing contractor.

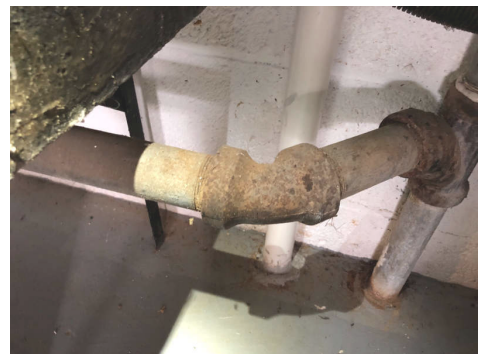
10.4.2 Drain, Waste and Vent Piping

GALVANIZED CORRODED

Galvanized drain/waste pipes are corroded. This condition may worsen and cause leakage, water damage and possibly mold growth if not corrected. Your Inspector recommends: A qualified plumbing contractor evaluates the corroded galvanized steel drain/waste pipes and makes any necessary repairs.

Contact a qualified plumbing contractor.

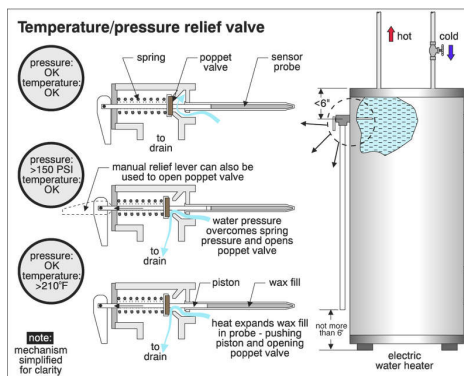
10.5.1 Water Heating

NO TPR DISCHARGE PIPE

A temperature pressure relief valve (TPR) should have a discharge pipe that extends to within 6 inches of the floor to prevent scalding if the valve discharges overheated water.

Contact a qualified plumbing contractor.
