SUMMARY
1234 Main St. Mountain Grove MO
65711
Buyer Name
01/06/2019 9:00AM

Erek Boatright
Certification no. 18238
Boatright Home Inspections, LLC
4172596733
boatrighthomeinspections@gmail.com

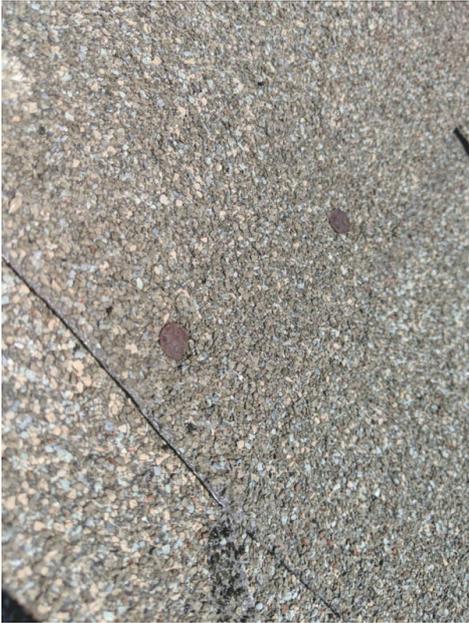
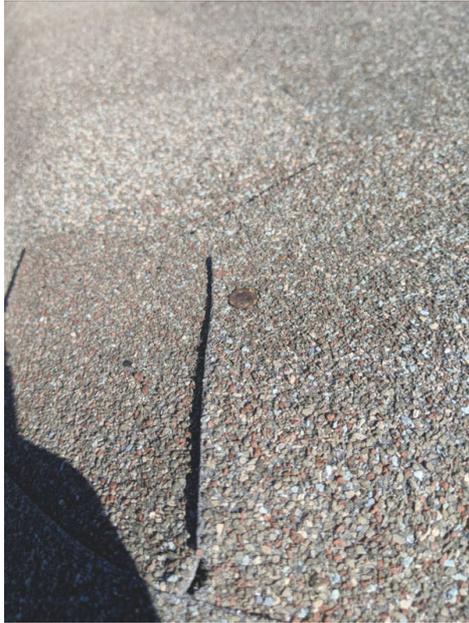
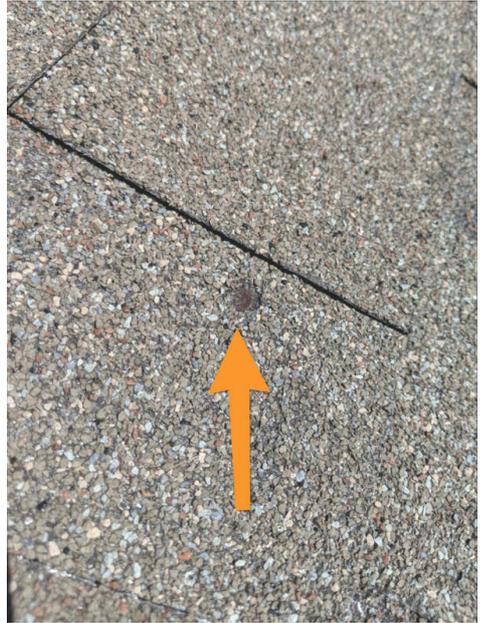
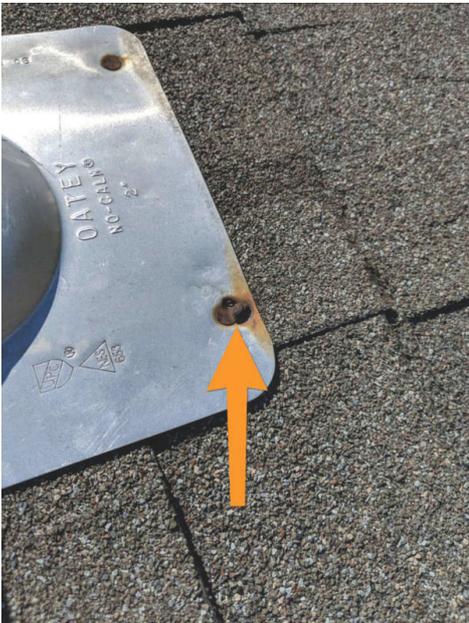
2.1.1 Coverings

EXPOSED NAILS

Under-driven or exposed nails were found in one or more roof coverings. Recommend a qualified roofer evaluate and correct.

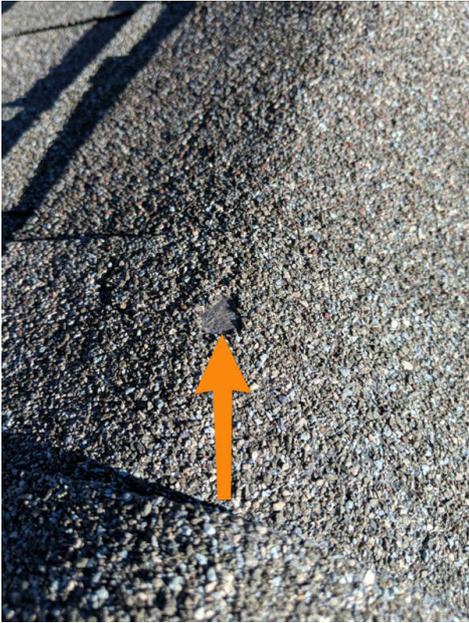
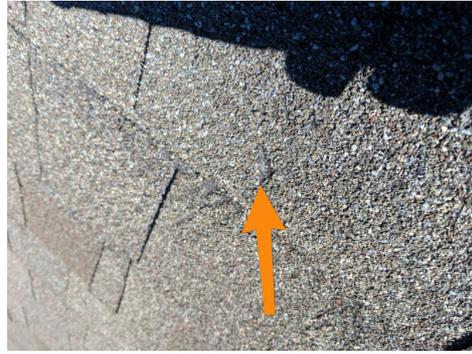
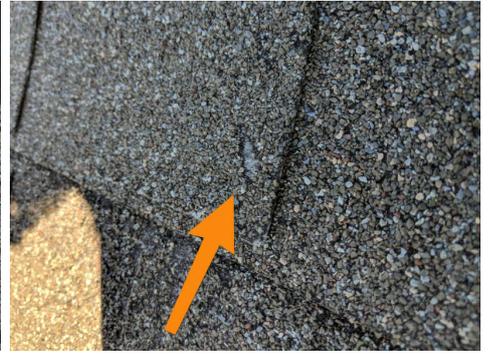
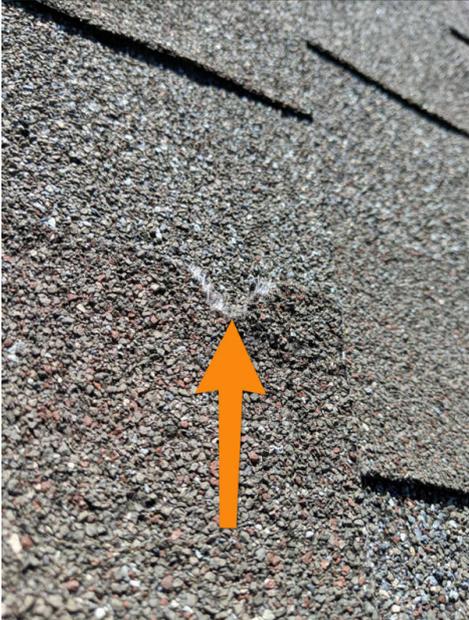
2.1.2 Coverings

TILES CRACKED/BROKEN

Roof had cracked/broken tiles. Recommend a qualified roof contractor repair or replace to prevent moisture intrusion and/or mold.

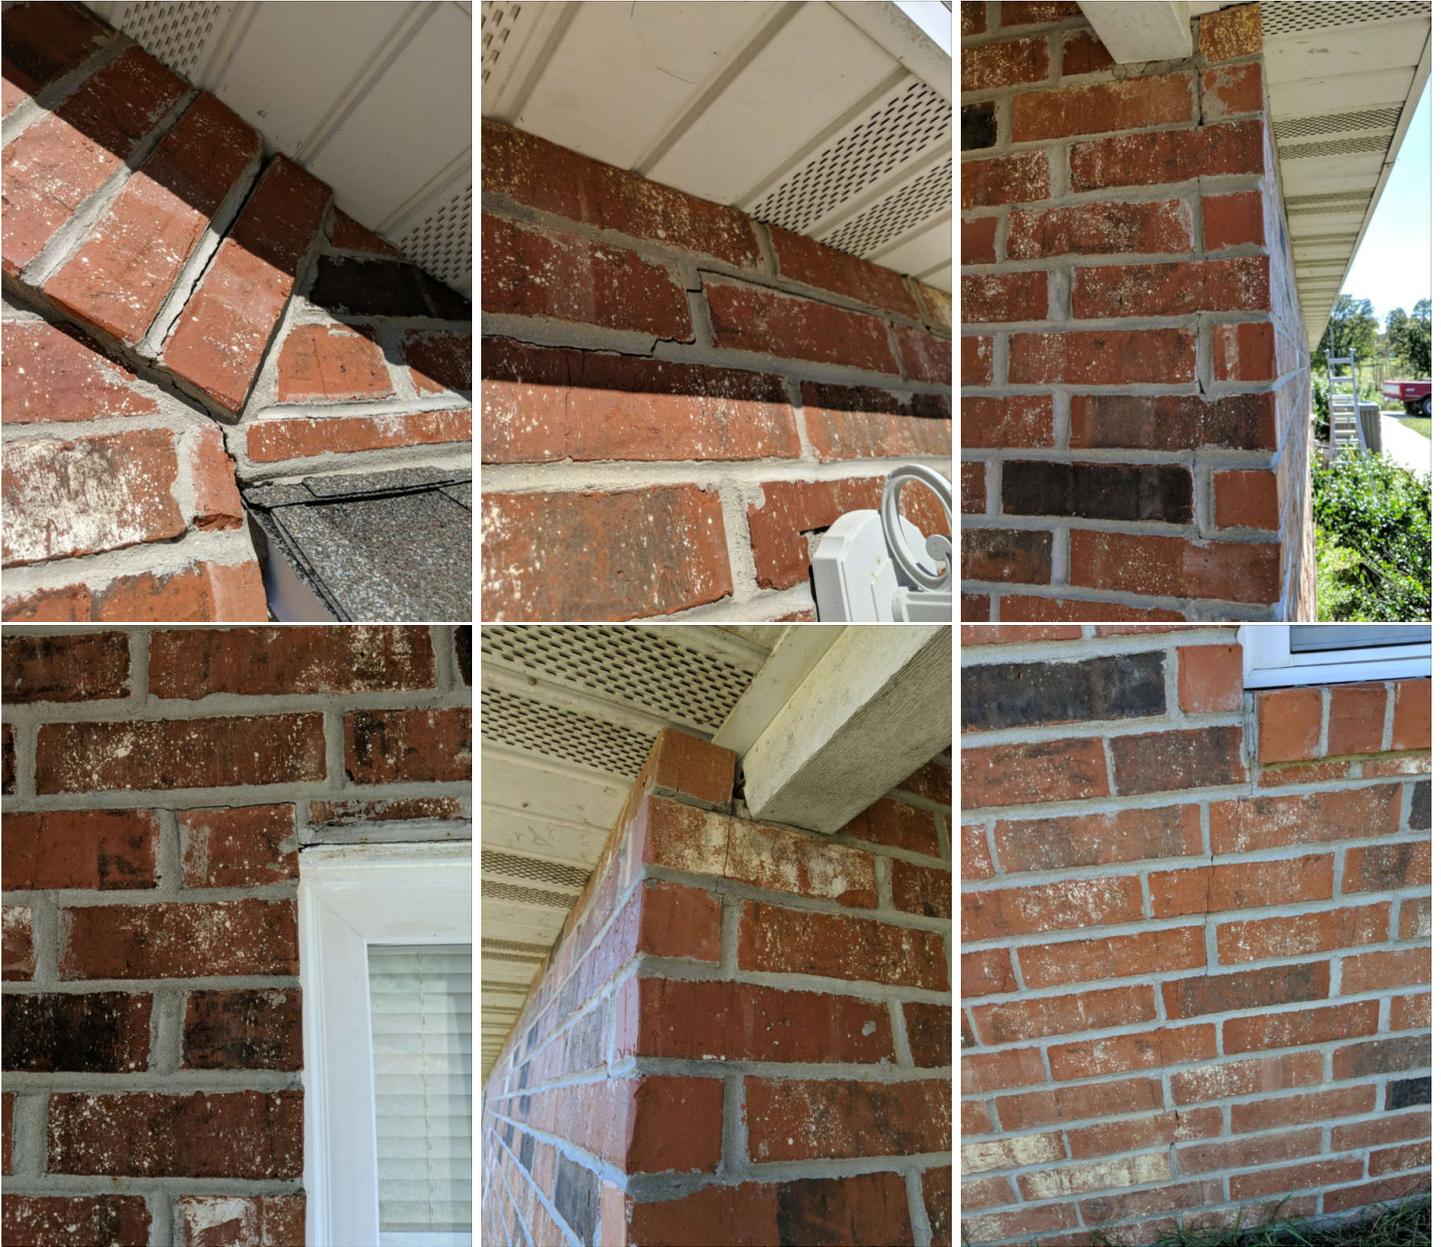
3.1.1 Siding, Flashing & Trim

CRACKING - MINOR

Siding showed cracking in one or more places. This is a result of temperature changes, and typical as homes with brick age. Recommend sealing to prevent water intrusion and further monitoring.

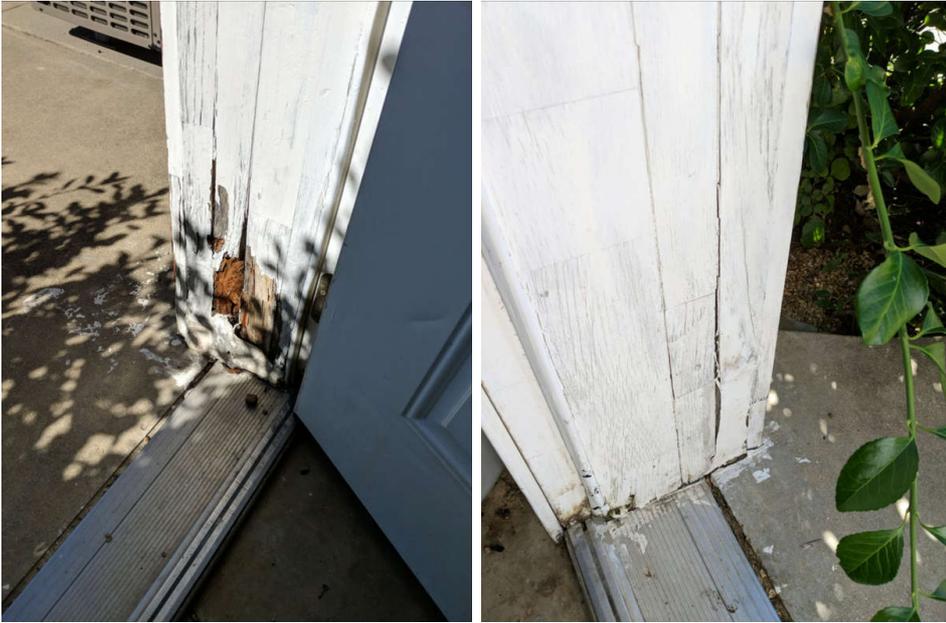
3.2.1 Exterior Doors

DOOR JAM ROTTING/DAMAGE

Exterior garage door jam was observed damaged. Recommend repair by a qualified contractor

Contact a qualified professional.

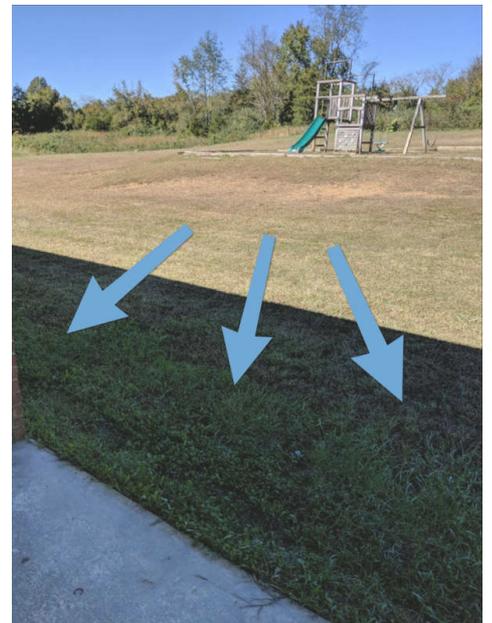
3.5.1 Vegetation, Grading, Drainage & Retaining Walls

NEGATIVE GRADING

Grading is sloping towards the home in some areas. This could lead to water intrusion and foundation issues. Recommend qualified landscaper or foundation contractor regrade so water flows away from home.

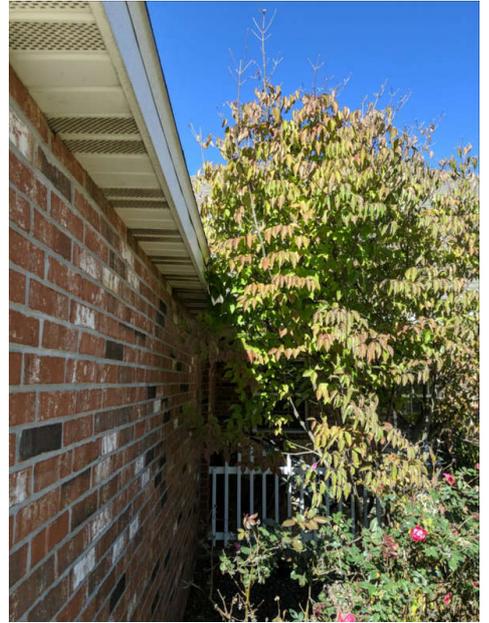
3.5.2 Vegetation, Grading, Drainage & Retaining Walls

TREE OVERHANG

Trees observed overhanging the roof. This can cause damage to the roof and prevent proper drainage. Recommend a qualified tree service trim to allow for proper drainage.

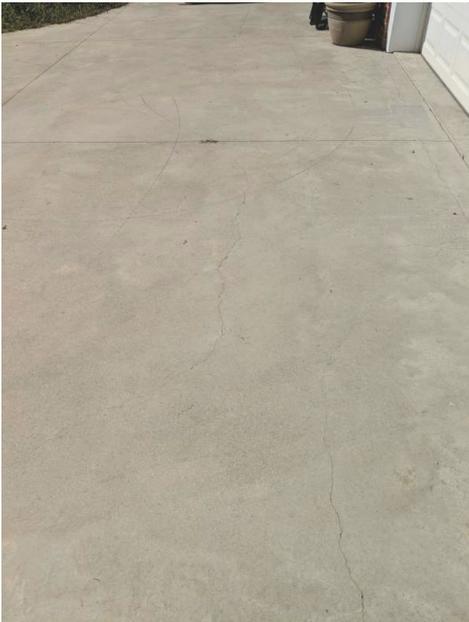
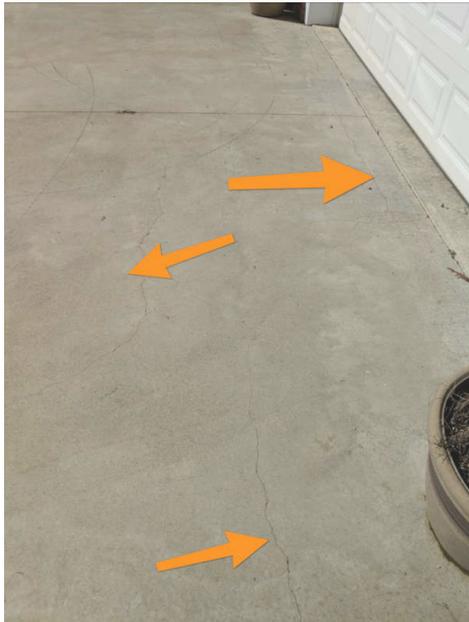
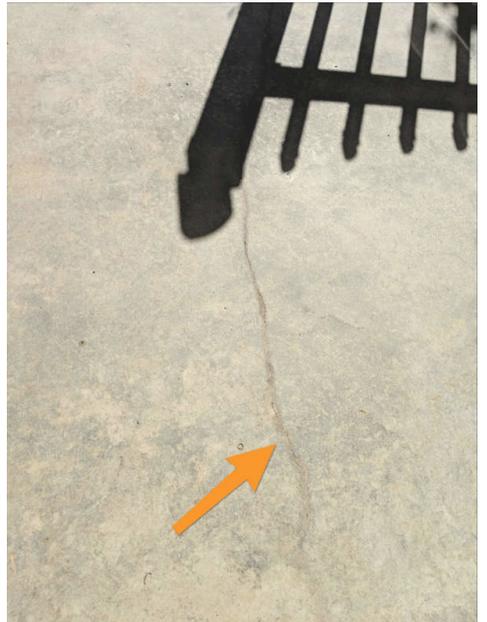
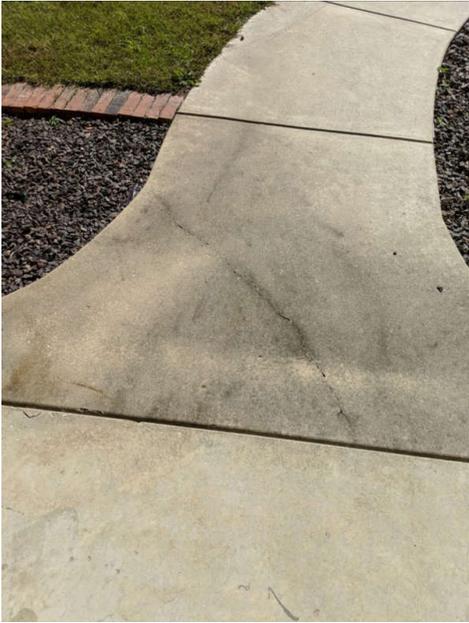
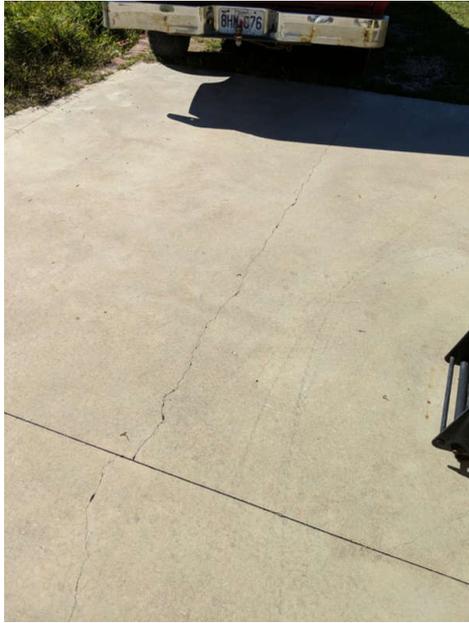
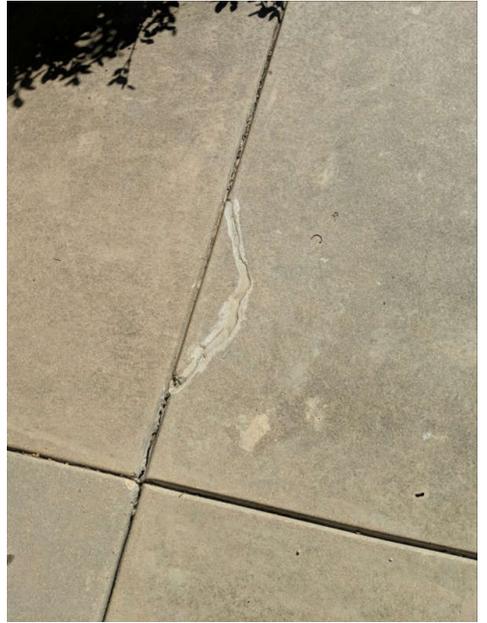
3.6.1 Walkways, Patios & Driveways

DRIVEWAY CRACKING - MINOR

Minor cosmetic cracks observed, which may indicate movement in the soil. Recommend monitor and/or have driveway contractor patch/seal.

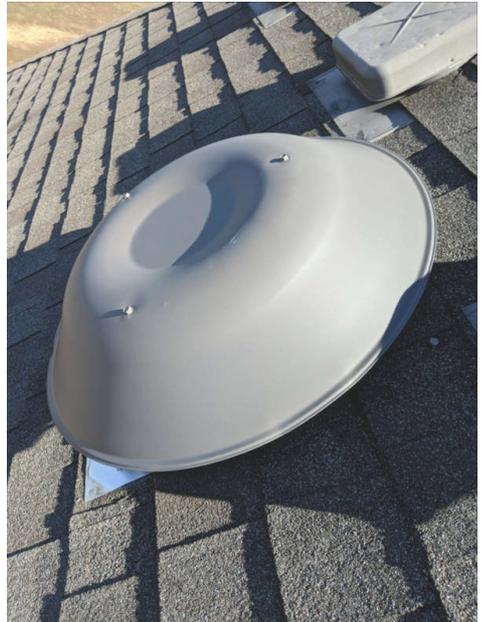
5.3.1 Ventilation

ATTIC FAN INOPERABLE

Attic fan was observed on the roof but interior portion and controls were in a part of the Attic that appears inaccessible. Recommend consulting current owner for further information

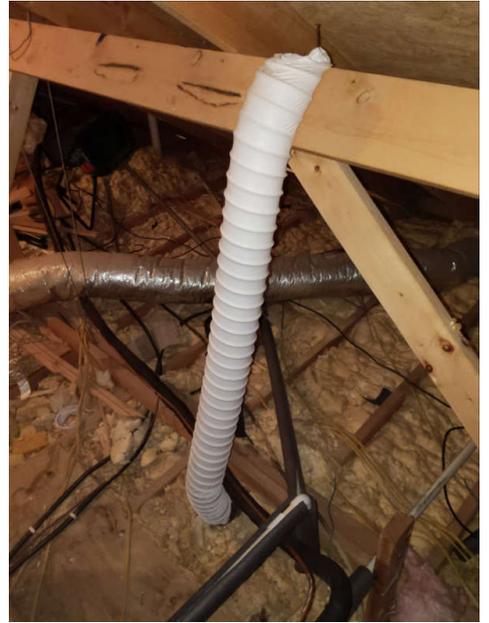
5.4.1 Exhaust Systems

BATHROOM VENTS INTO ATTIC

Bathroom fan vents into the attic, which can cause moisture and mold. Recommend a qualified attic contractor property install exhaust fan to terminate to the exterior.

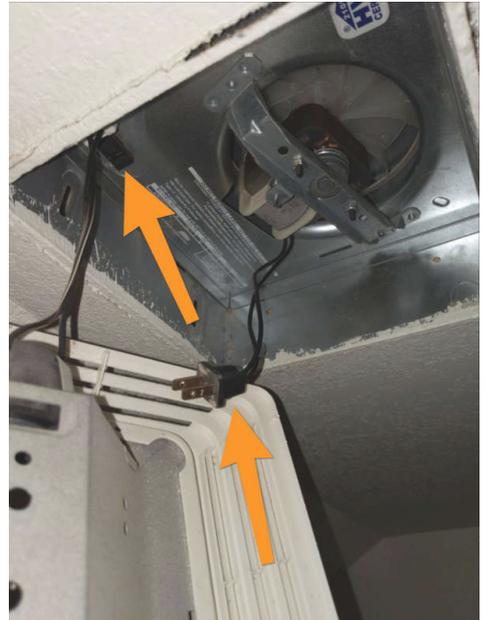
5.4.2 Exhaust Systems

UPSTAIRS BATHROOM EXHAUST VENT

The upstairs bathroom exhaust fan was disconnected at time of inspection. Recommend consulting current owner about condition.

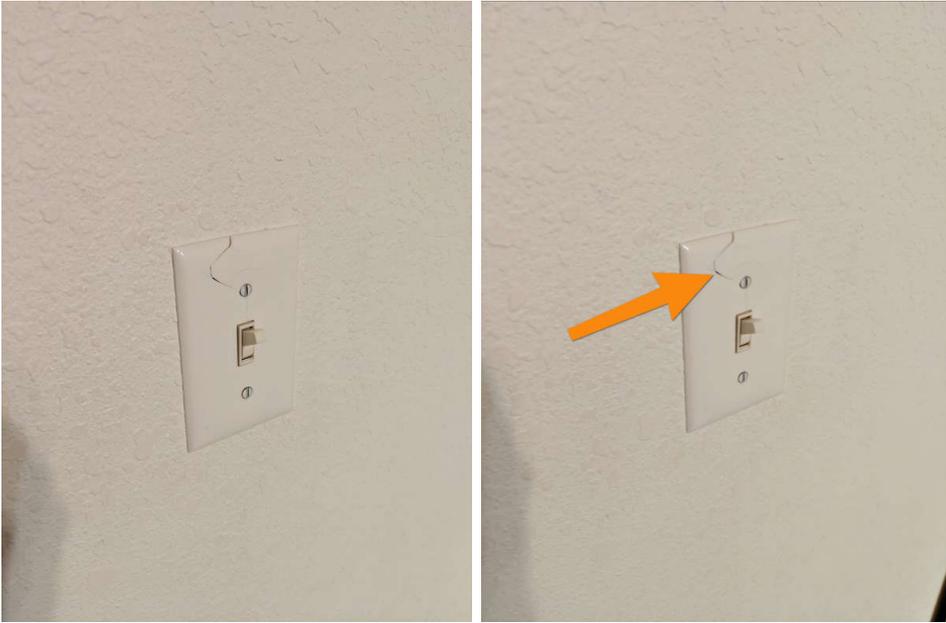
6.4.1 Connected Devices and Fixtures

COVER PLATES DAMAGED

One or more receptacles have a damaged cover plate. Recommend replacement.

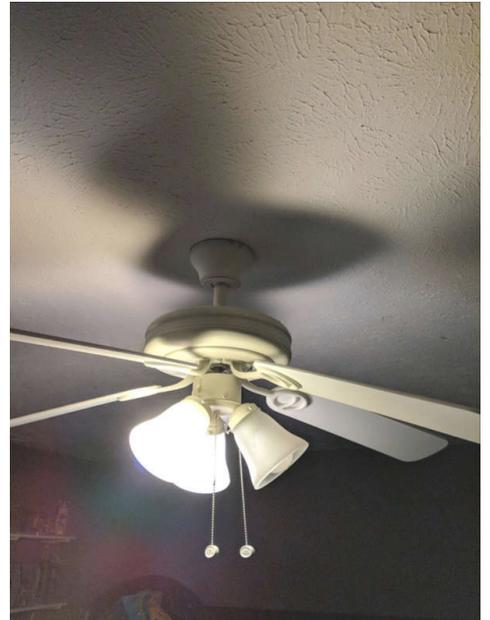
6.4.2 Connected Devices and Fixtures

CEILING FAN INOPERABLE

1ST FLOOR BEDROOM NORTHEAST

One or more ceiling fan did not operate at the time of the inspection

Contact a qualified professional.

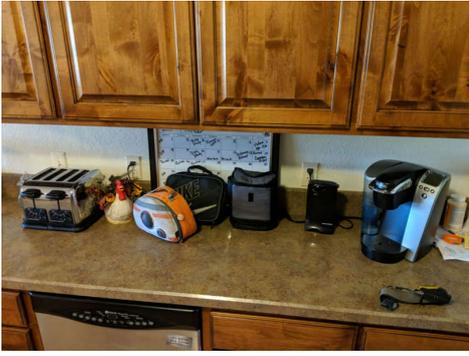
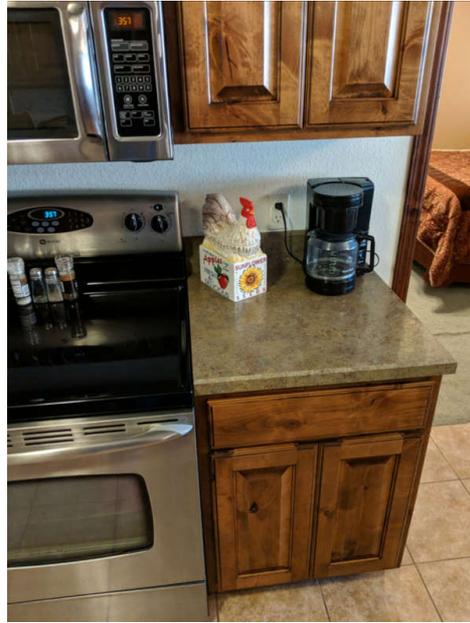
6.6.1 GFCI & AFCI

NO GFCI PROTECTION INSTALLED

KITCHEN

No GFCI protection present in one or more locations. Recommend licensed electrician upgrade by installing ground fault receptacles in all locations.

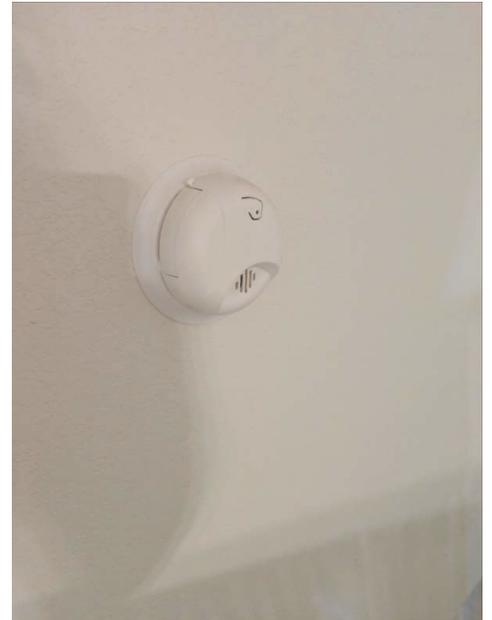
6.7.1 Smoke Detectors

DEFECTIVE

2ND FLOOR NORTHEAST

Smoke detector is connected, but not functioning properly.
Recommend replacement.

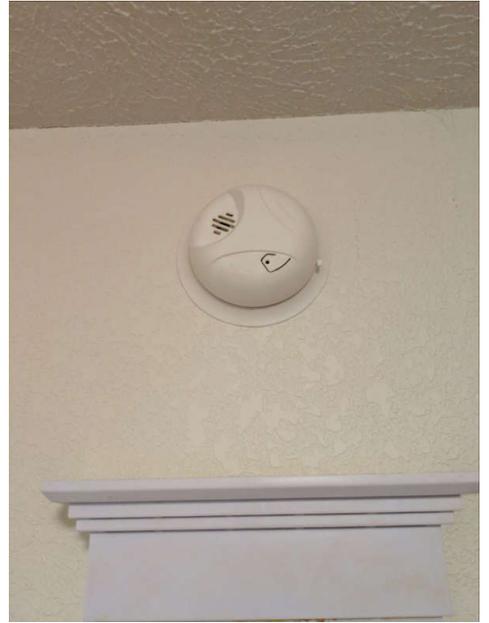
6.7.2 Smoke Detectors

LOW BATTERY

1ST FLOOR EAST

Smoke detector failed to respond when tested. Recommend battery
be replaced.

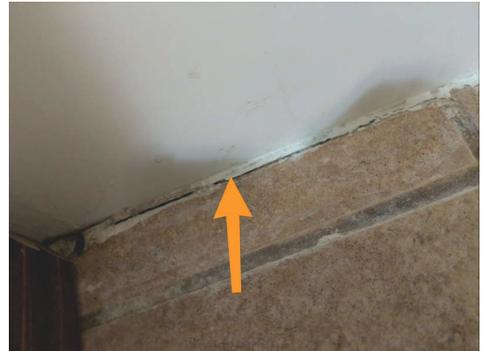
8.1.1 Fixtures / Faucets

FAILED CAULKING AROUND TUB/SHOWER

1ST FLOOR BATHROOM

One or more sections of failed caulking observed around tub/shower. Recommend repairing to keep any water intrusion from happening.

Contact a qualified professional.

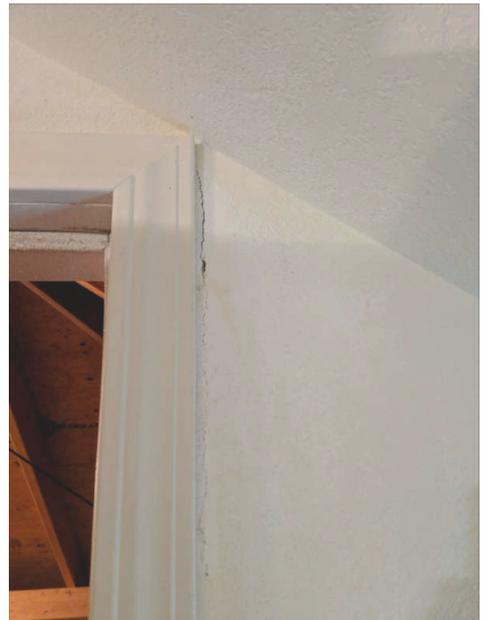
10.1.1 Walls

MINOR CORNER CRACKS

Minor cracks at the corners of doors and windows in walls. Appeared to be the result of long-term settling. Some settling is not unusual in a home of this age and these cracks are not a structural concern.

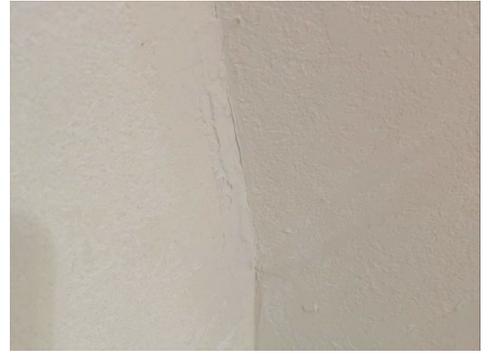
10.1.2 Walls

POOR PATCHING

2ND FLOOR NORTHWEST

Sub-standard drywall patching observed at time of inspection. Recommend re-patching.

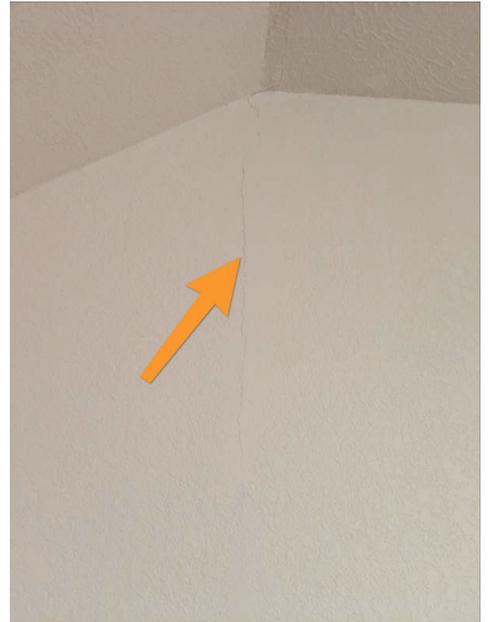
10.1.3 Walls

MINOR DRYWALL CRACKING

Cracking was observed at one or more locations on drywall. Can be a result of slight settling and normal seasonal changes. Recommend monitoring and patching but may come back in the future with temperature and humidity changes.

Contact a qualified professional.

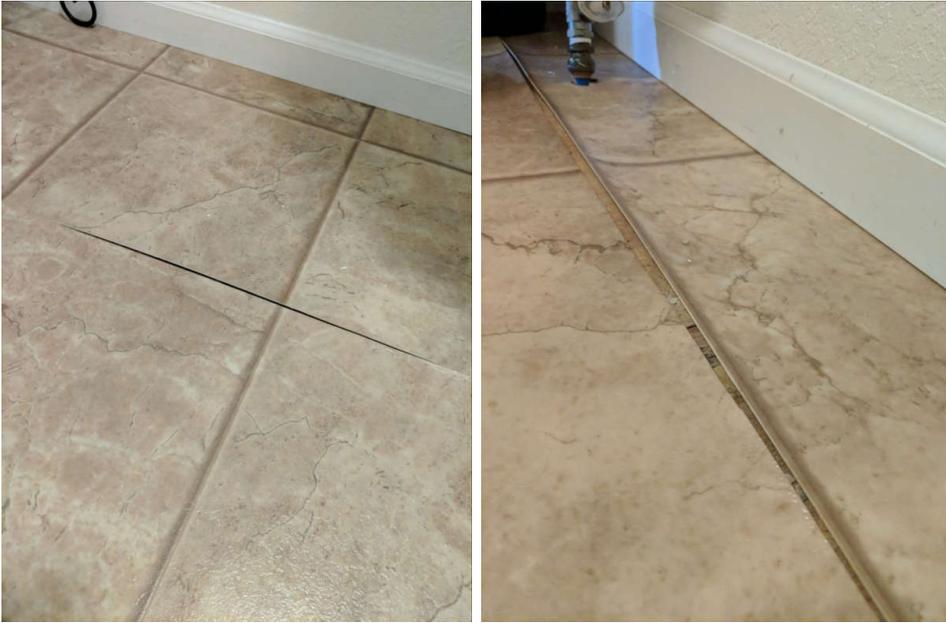
10.3.1 Floors

LINOLEUM LOOSE/PEELING

2ND FLOOR BATHROOM

One or more sections of linoleum coming loose from floor

Contact a qualified professional.

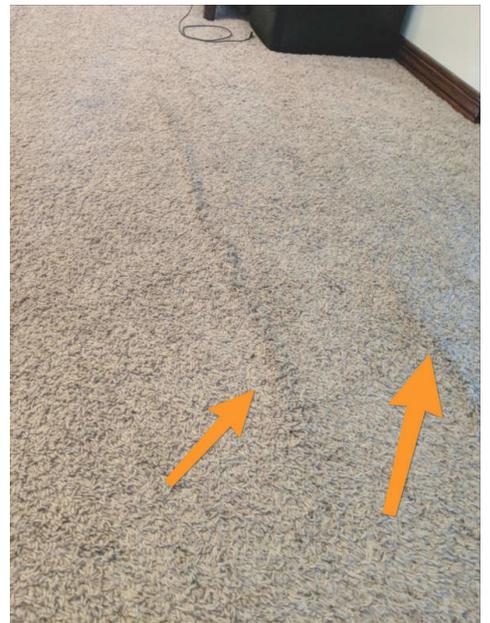
10.3.2 Floors

LOOSE CARPET

Carpet showed signs wear. Recommend flooring professional evaluate for possible restretching or replacing

Contact a qualified professional.

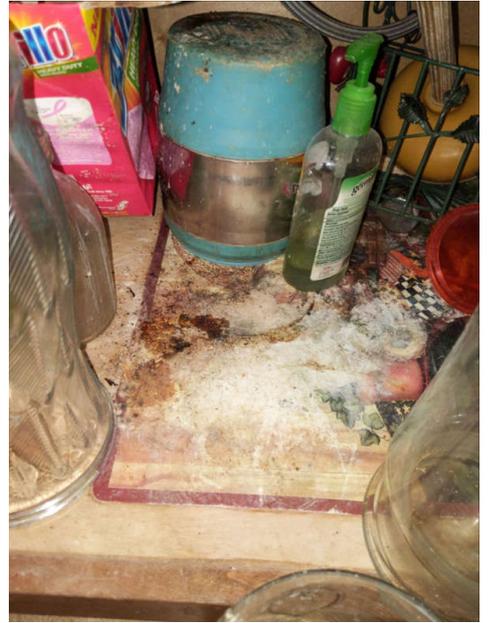
10.5.1 Countertops & Cabinets

WATER EVIDENCE

Signs of previous moisture was present inside cabinet under kitchen sink. No leaks were found during inspection. Recommend cleaning to keep from molding.

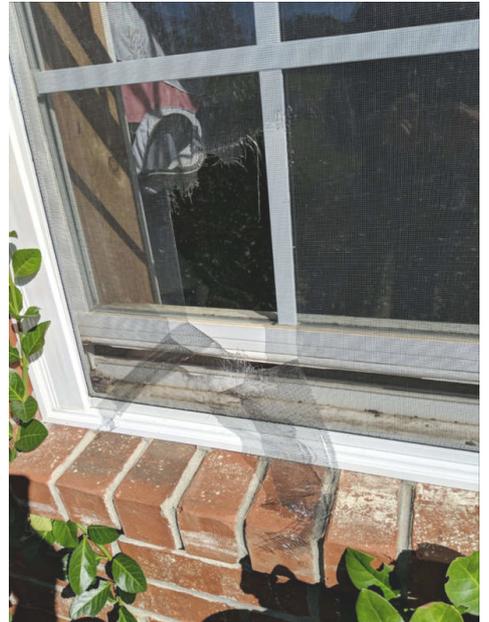
10.7.1 Windows

DAMAGED SCREEN

Found one damaged screen at garage window. Recommend replacing.

Contact a qualified professional.

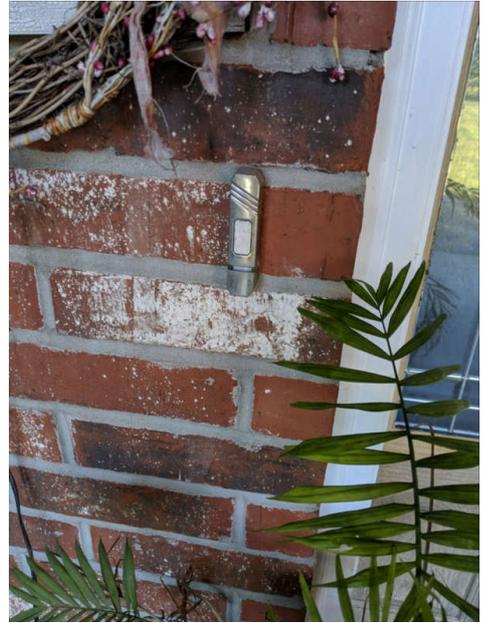
10.9.1 Doorbell

DOORBELL INOPERABLE

Doorbell did not operate at time of inspection. Recommend further evaluation by a qualified professional.

Contact a qualified professional.

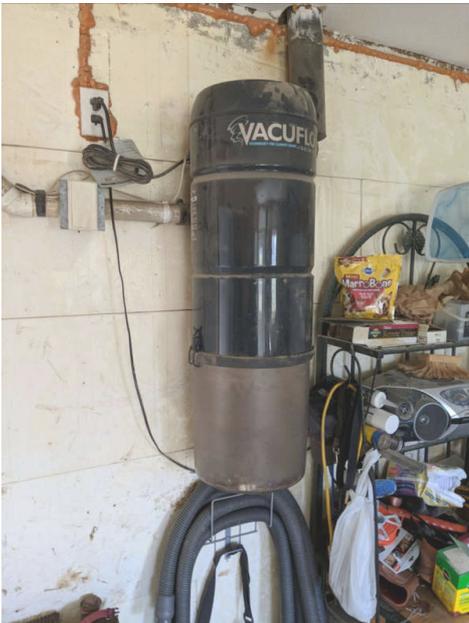
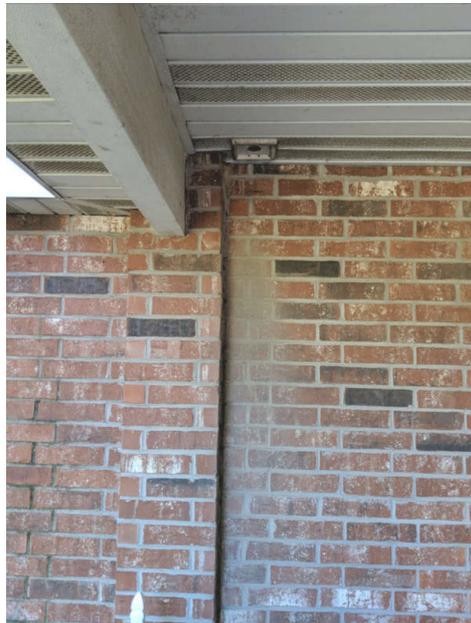
10.10.1 Whole House Vacuum
VACUUM INOPERABLE

Whole house vacuum did not operate at time of inspection. Recommend further evaluation by a qualified professional.

Recommendation
Contact a qualified professional.
