**SUMMARY**  
1234 Main St. Oklahoma City Oklahoma  
73170  
Buyer Name  
04/04/2019 9:00AM

Craig Hill, CPI  
Certified Professional...  
Hot Home Inspections  
4054569404  
[help@hothomeinspections.com](mailto:help@hothomeinspections.com)

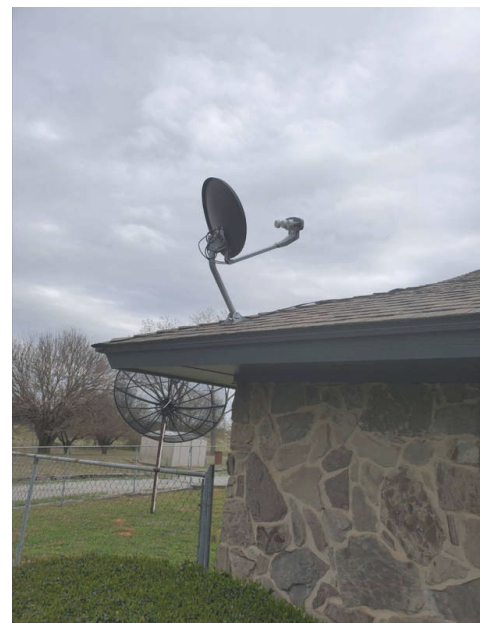
### **SATELLITE ATTACHMENTS**

There were one or more areas where a satellite has been secured to the roof surface. Repair/seal these areas as needed.

Recommendation  
Contact a qualified professional.

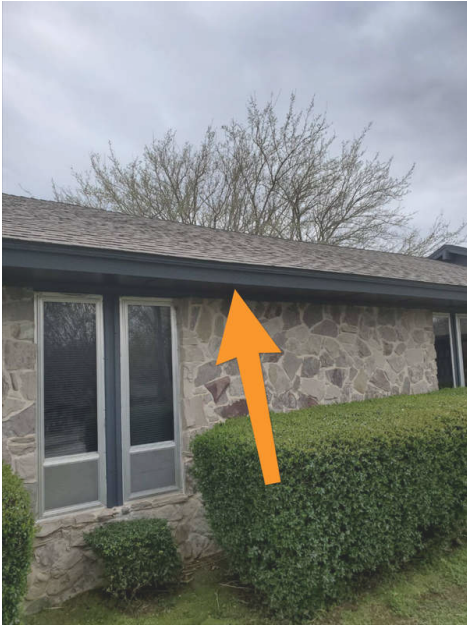
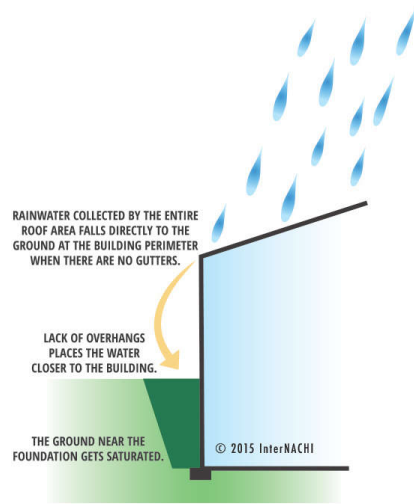
**NO OR PARTIAL GUTTERS**

There is no or partial guttering on the structure. We recommend installing guttering to all applicable areas of the structure.

Contact a qualified gutter contractor

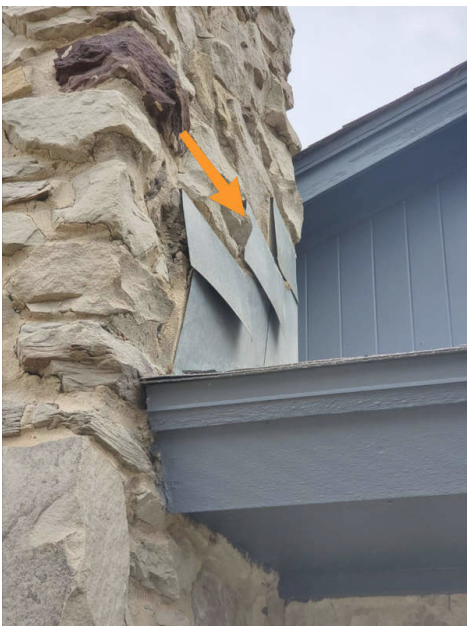
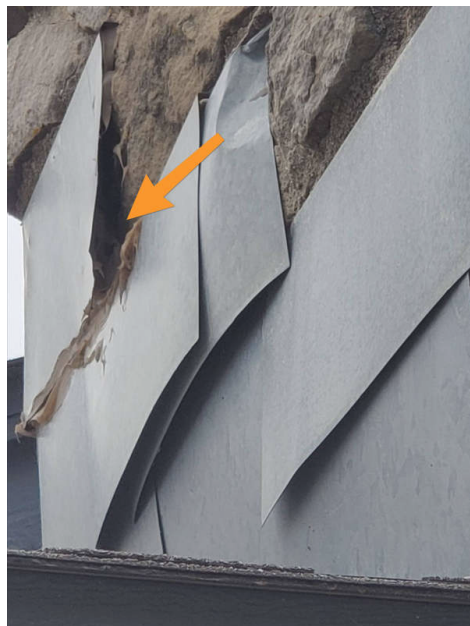
CHIMNEY

**DAMAGED FLASHING**

One or more flashings are damaged. To prevent possible moisture intrusion into the building structure we recommend having the flashing repaired and/or replaced.

Starting to loosen

Contact a qualified professional.

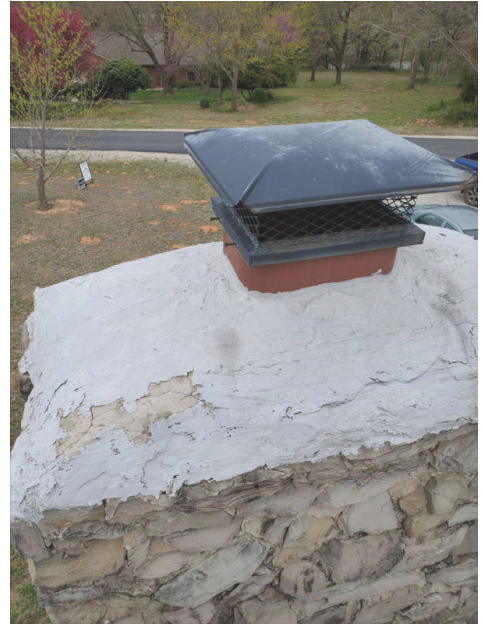
**CHIMNEY CAP- END OF USEFUL LIFE**

The chimney cap had severe deterioration and appeared to be at the end of its useful life. Failure of the cap can allow moisture intrusion of the chimney structure that can damage the structure and create unhealthy conditions.

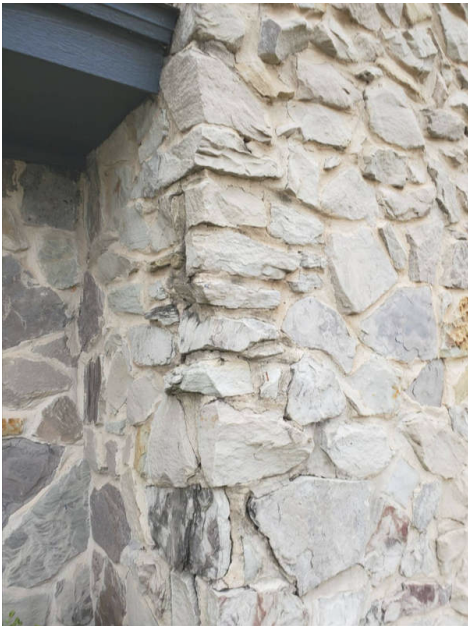
Chimney

**CRACKED BRICK AND/OR MORTAR**

Seal and monitor brick and/or mortar cracks to prevent moisture intrusion.

Contact a qualified masonry professional.

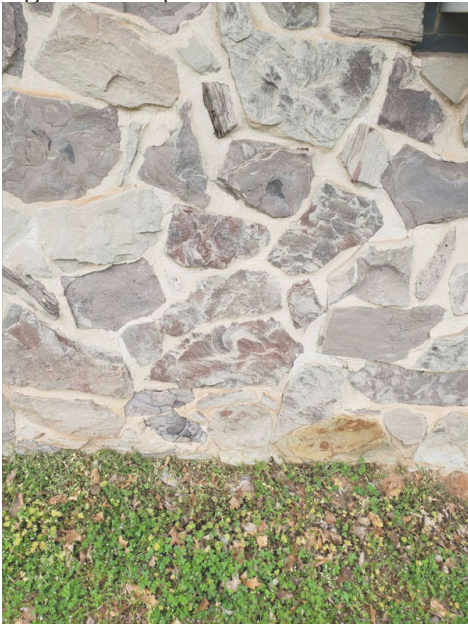
Minor spalling and cracks - typical - left side

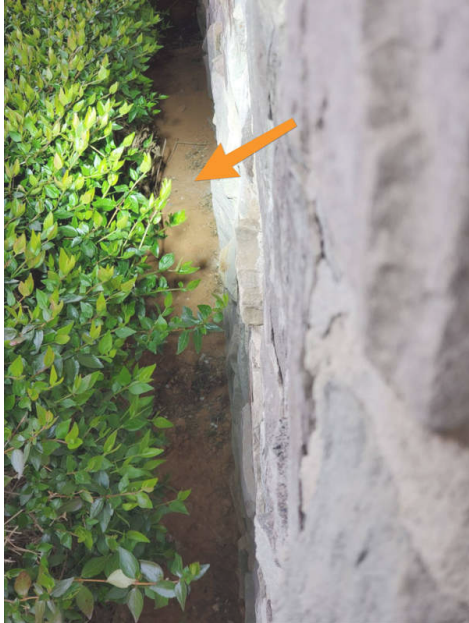
Right side behind bushes

**GROUND CLEARANCE**

Inadequate clearance between siding and ground. Recommend a minimum ground clearance between bottom of siding and ground of 4". Siding in contact with the ground or soil can provide direct access for wood destroying insects.

Contact a qualified landscaping contractor

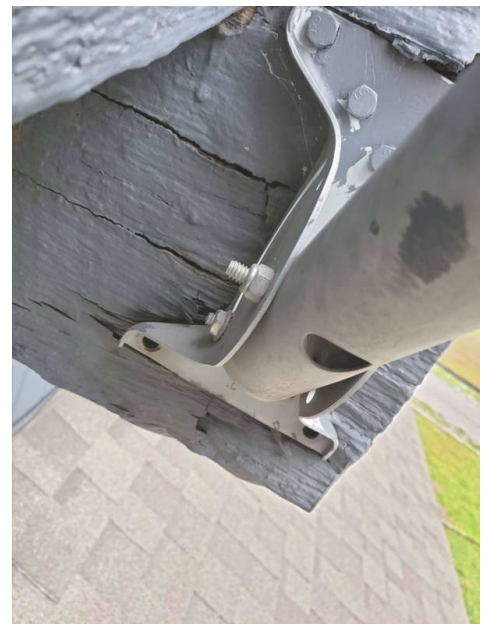
Left side roof

**WOOD ROT**

There is wood rot that should be repaired to prevent further damage and deterioration.

Contact a qualified siding specialist.

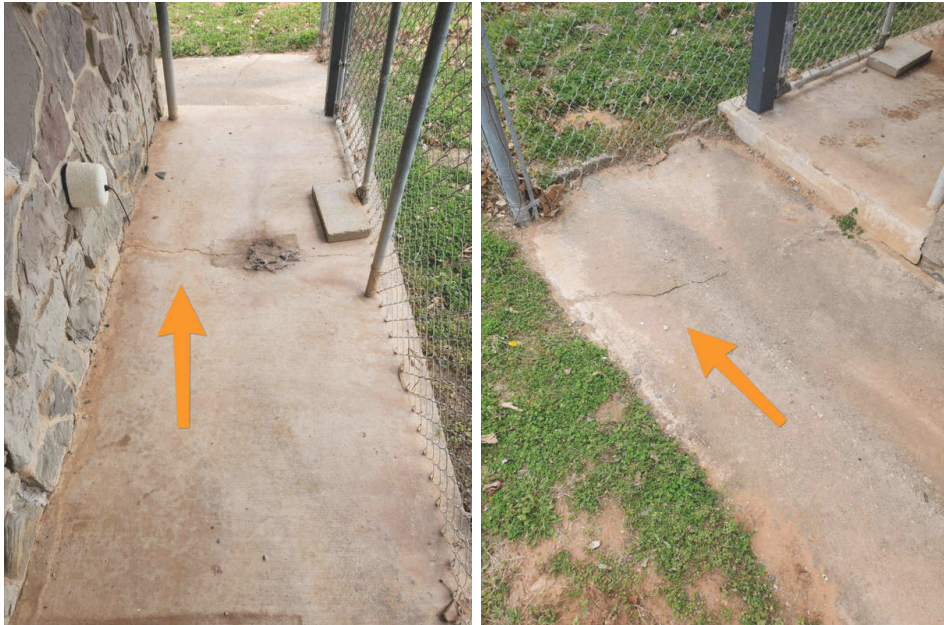
Left side

**WALKWAY CRACKS**

Cracks observed at the walkway. Seal and monitor to prevent further damage. Bigger cracks or settling could cause a tripping hazard.

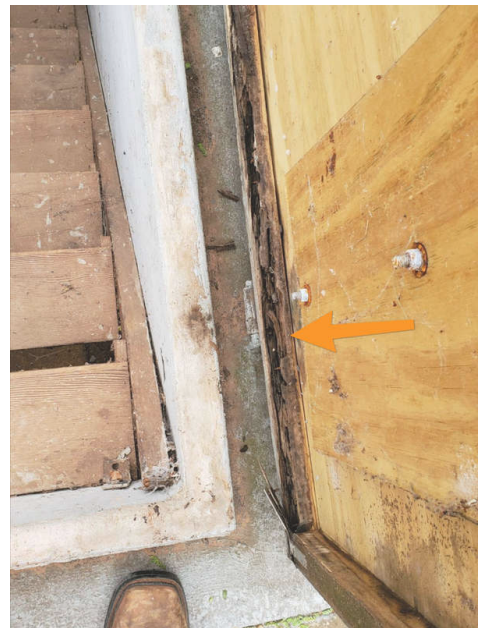
**DOOR - WOOD ROT**

Contact a qualified professional.

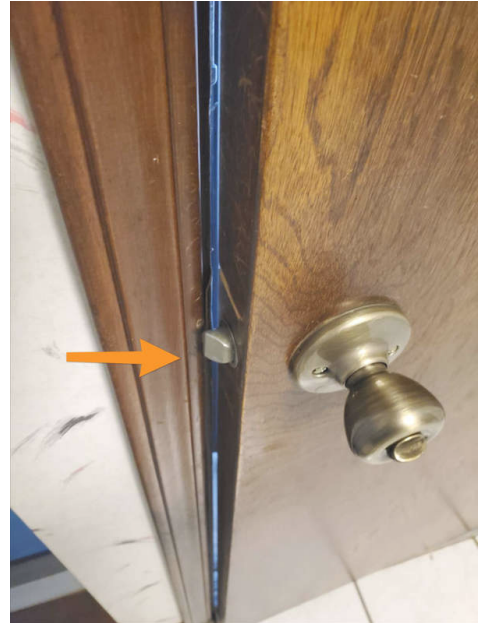
**DOOR DOESN'T LATCH**

Door doesn't latch properly.

Front Door - does not latch

Contact a handyman or DIY project

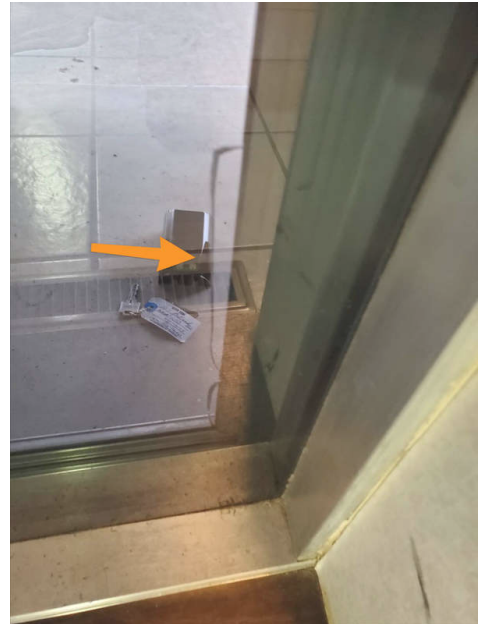
**BROKEN GLASS**

One or more windows have broken glass.

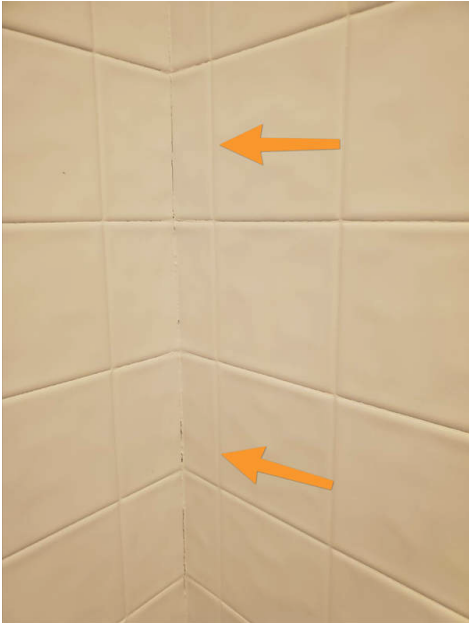
Rear left corner

**TILE/GROUT  
DAMAGE/DETERIORATION**

Tile and/or grout have damage/deterioration. This can potentially allow moisture intrusion.

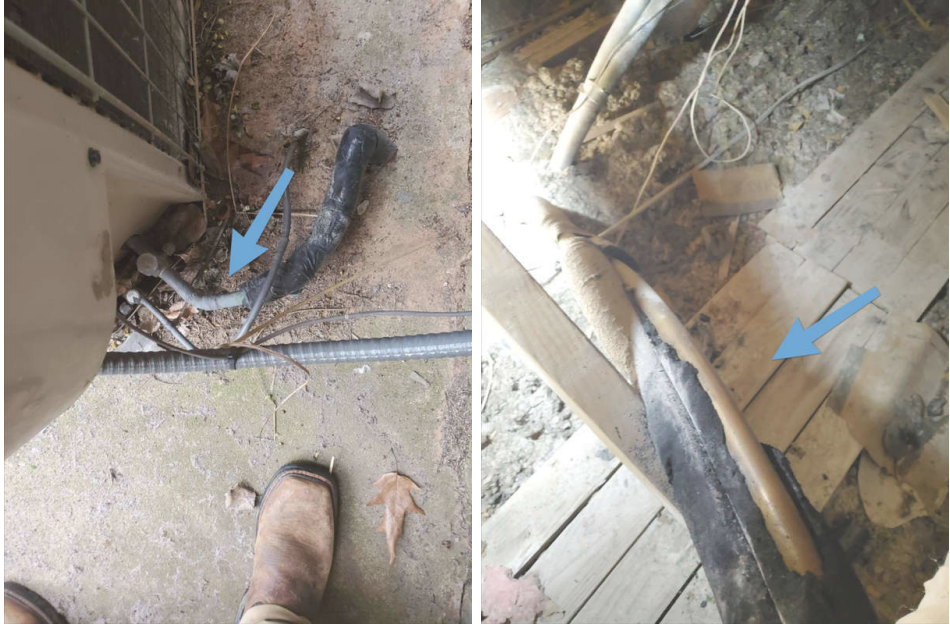
Attic

**INSULATION MISSING OR DAMAGED**

Refrigerant line insulation is missing and/or damaged. Missing or damaged insulation on refrigerant lines can cause energy loss and condensation buildup - leading to moisture intrusion. Recommend repair area of concern by owner or hvac contractor.

Recommendation  
Contact a qualified HVAC professional.

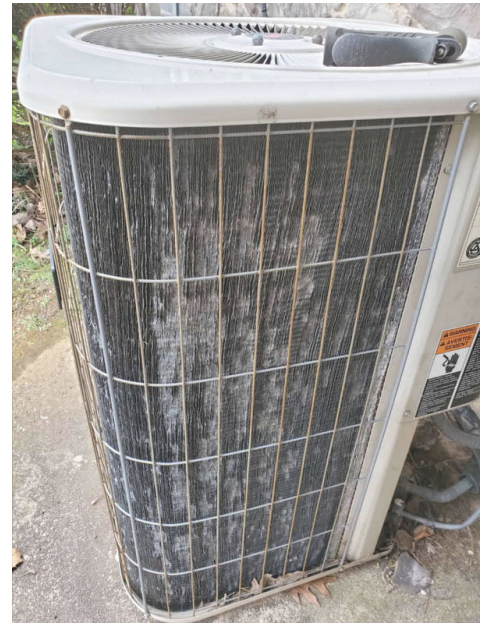
**CONDENSER COIL FINS DAMAGED AND/OR DIRTY**

Condenser coil fins are damaged and/or dirty.

Contact a qualified HVAC professional.

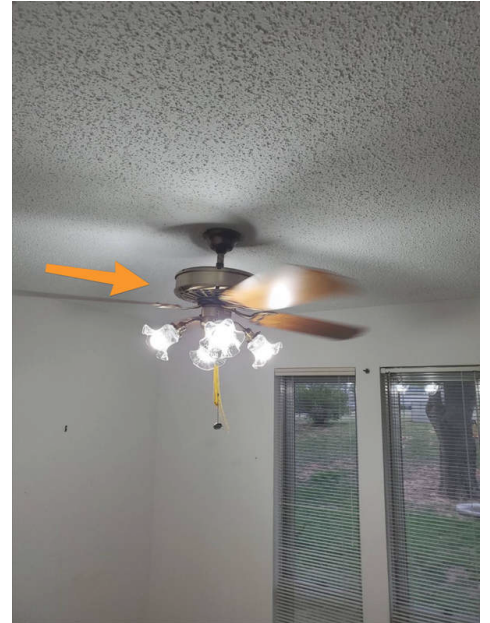
First Bedroom In Left

**WOBBLING CELING FAN**

One or more celing fans are wobbling. This could be result of warped or sagging blades, and/or incorrect installation.

Recommendation  
Contact a qualified professional.

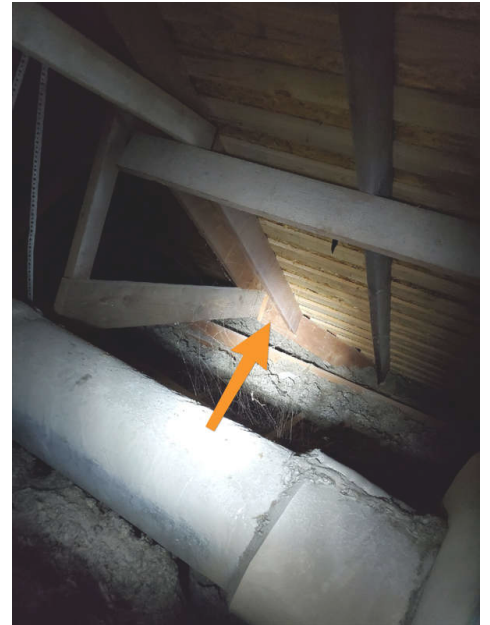
#### **BROKEN RAFTER**

Very minor

Recommend repairing to protect the integrity of the roof structure.

Contact a qualified professional.

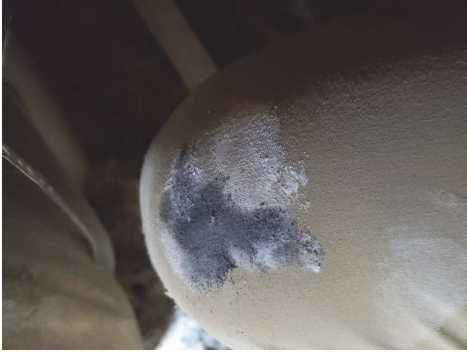
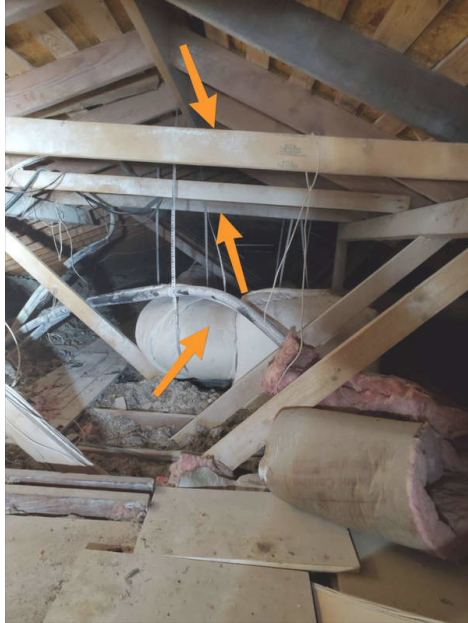
### WHITE POWDER SUBSTANCE IN ATTIC

There is an unknown white powder

substance in the attic, without laboratory testing the inspector can not 100% verify chemical makeup and any known health risks. The inspector's professional opinion is that the powder is likely insecticide and more specifically diatomaceous earth. Please visit link for more information.

Contact a qualified professional.

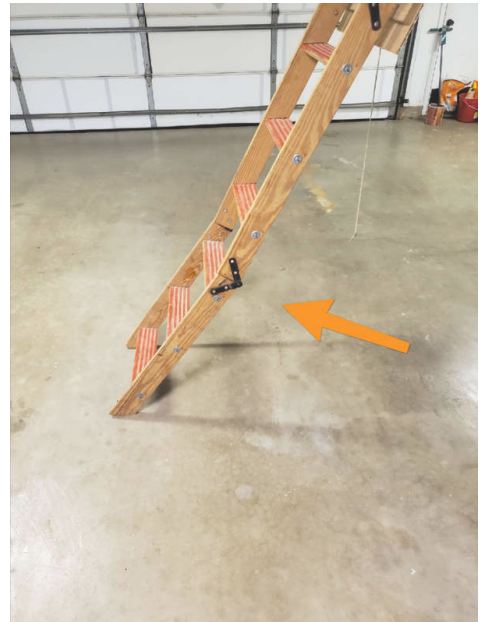
### ADJUSTMENT NEEDED

Adjustment is needed at the attic-access pull-down ladder to facilitate personal safety.

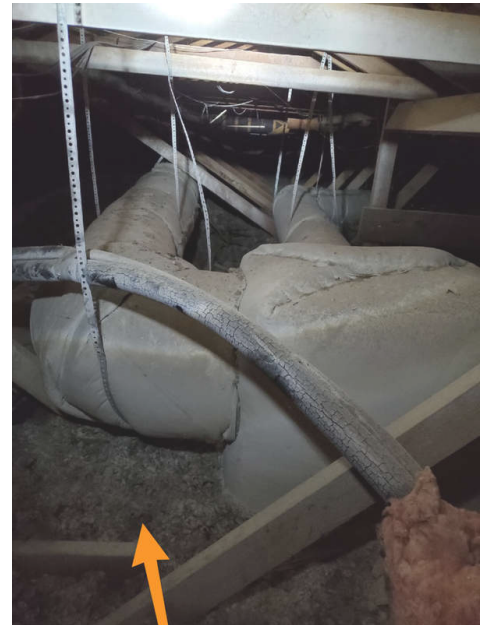
**INSUFFICIENT INSULATION**

Insulation depth was inadequate. To maximize savings on heating and cooling costs, insulation levels should comply with local energy codes. Current standard is R-40. We recommend a qualified attic insulation contractor install additional insulation.

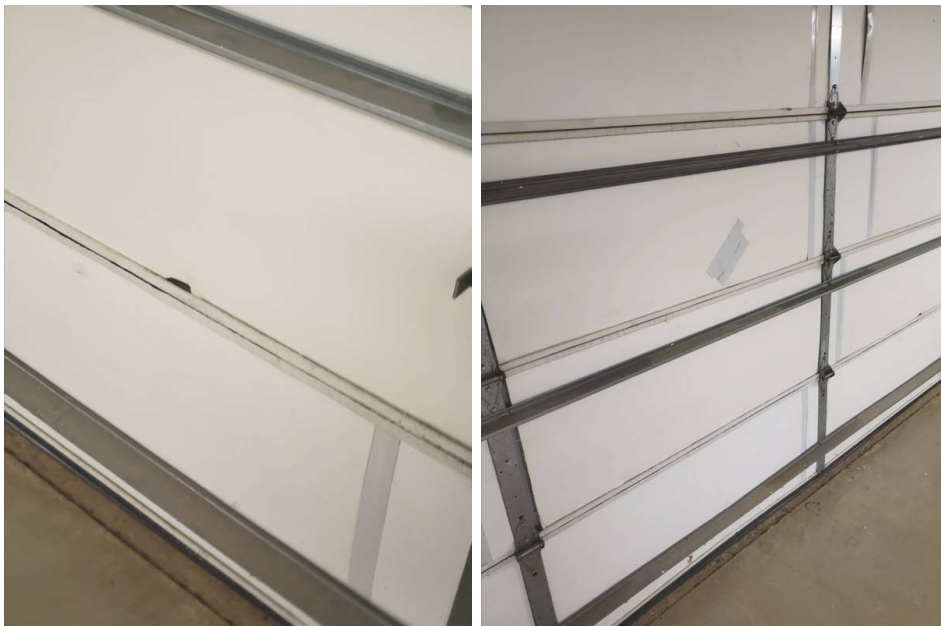
**PANEL DAMAGE**

Garage door panel is damaged.

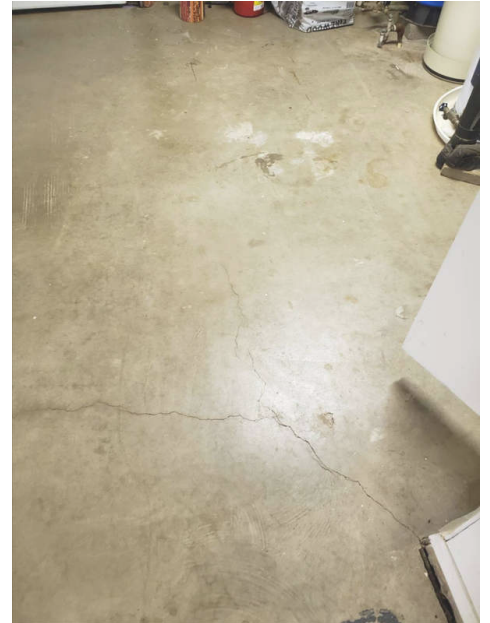
**MINOR CURING CRACKS**

We observed curing cracks at the garage floor.

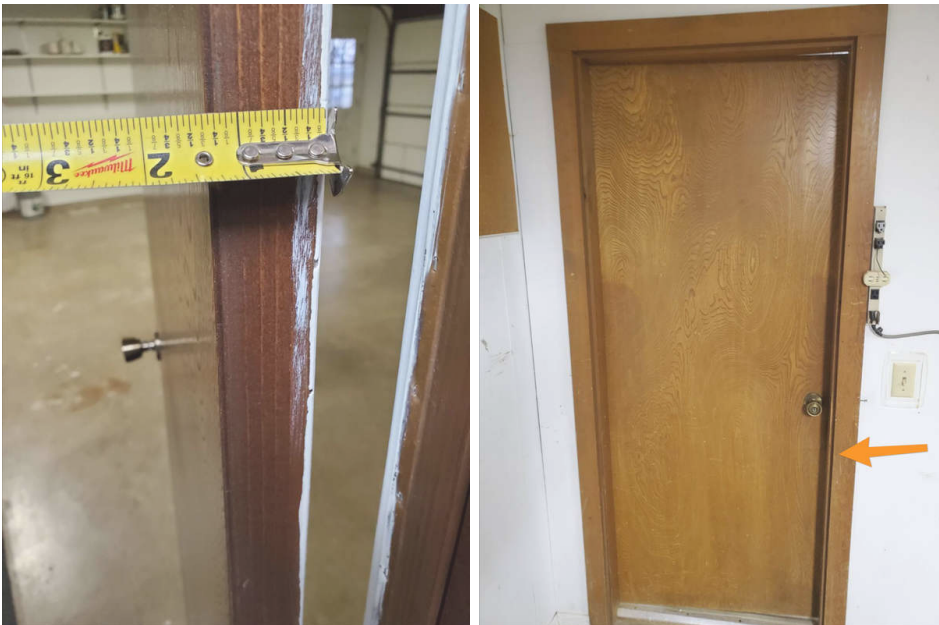
BOTH OCCUPANT DOORS

**DOOR DOES NOT MEET SEPARATION REQUIREMENTS**

Door separating garage and home does not meet safety standards. Doors in firewalls must be at least 1 3/8-inch thick, metal/steel, or a 20-minute fire-rated door.

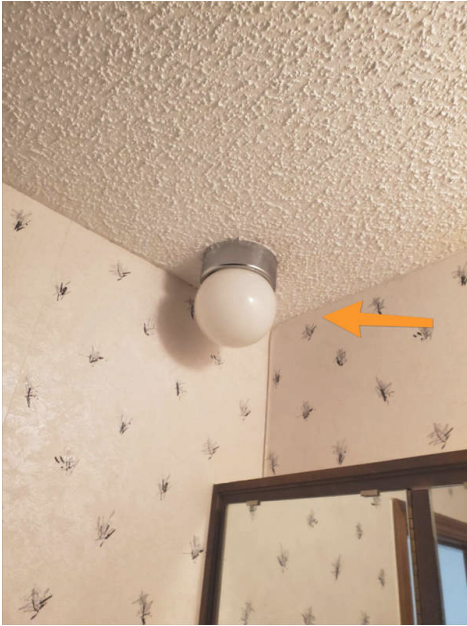
Master bathroom

**LIGHT INOPERABLE**

Light fixture did not respond to the switch. The bulb may need to be replaced or there may be a problem with the switch, wiring or light fixture.

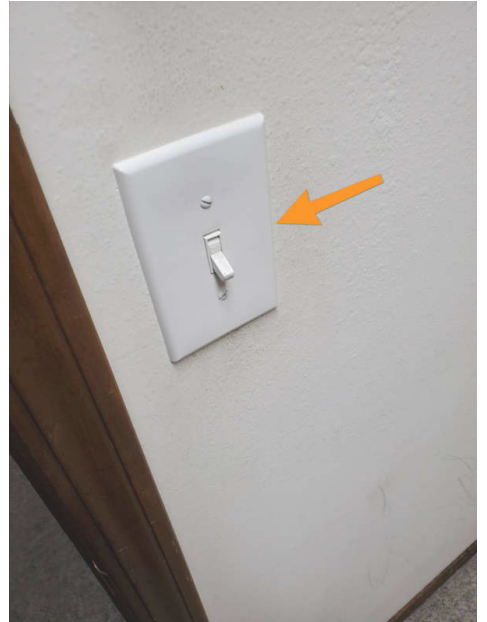
Laundry Room

**UNKNOWN SWITCH**

The inspector was unable to determine what device is controlled by a switch.

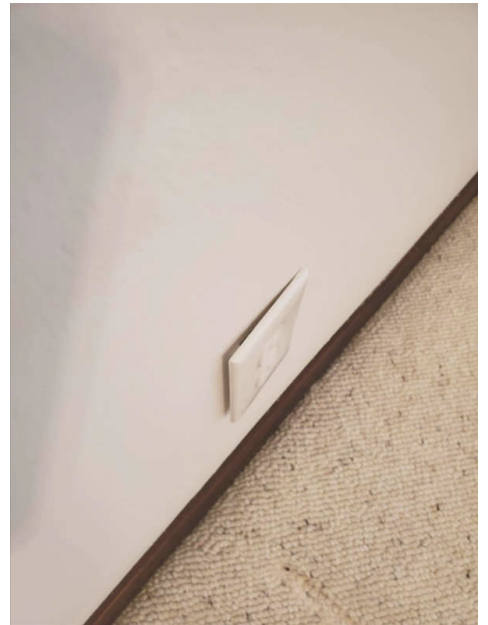
Bedroom end of the hall - left wall

**DAMAGED RECEPTACLE(S)**

An electrical receptacle is damaged.

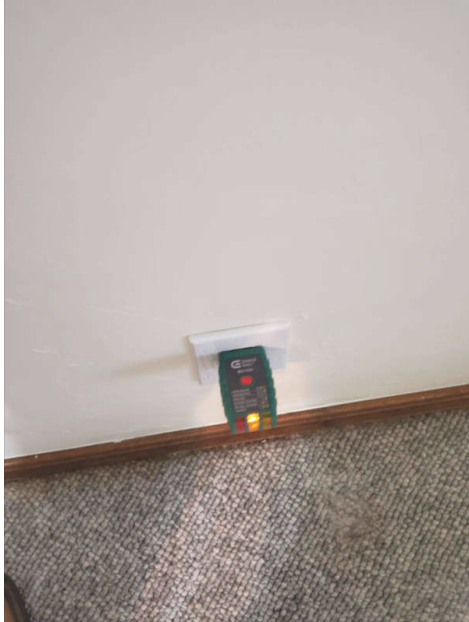
Dining - left of hallway opening

### OPEN GROUND RECEPTACLE(S)

An electrical receptacle had an open ground. Other receptacles in the home were grounded.

For GFCI's with open ground, they need a sticker that reads "no equipment ground".

Contact a qualified electrical contractor.

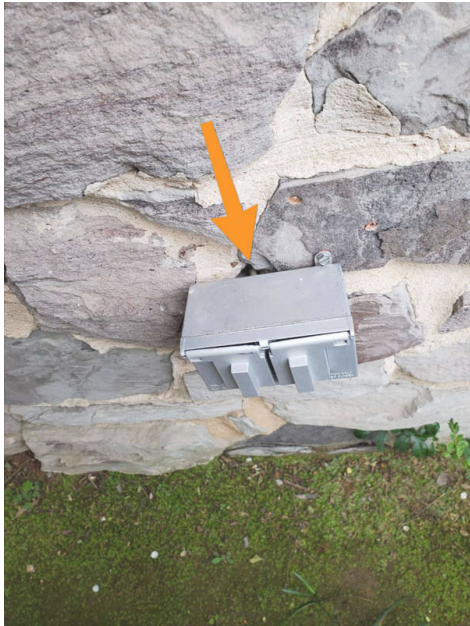
8.3.5 Lighting Fixtures, Switches & Receptacles  
**HOT-NEUTRAL REVERSED RECEPTACLE**

An electrical receptacle had hot and neutral wires reversed.

Front right side - loose and needs secured

Recommendation  
Contact a qualified electrical contractor.

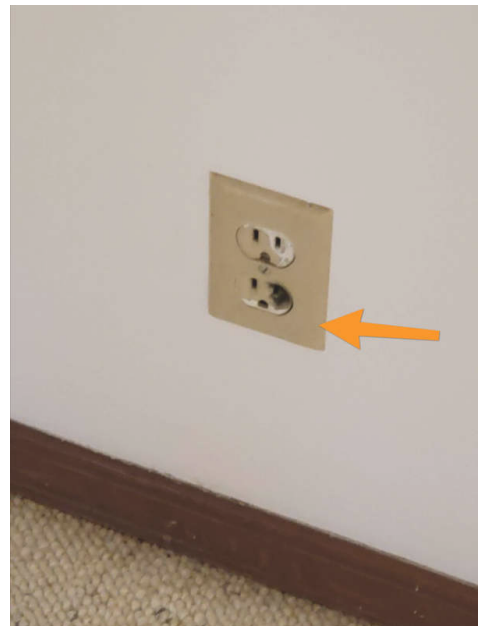
Living room on left

8.3.6 Lighting Fixtures, Switches & Receptacles  
**SCORCHING- RECEPTACLE**

An electrical receptacle exhibited visible scorching. This condition is a potential fire hazard and should be investigated and any repairs made by a licensed electrician.

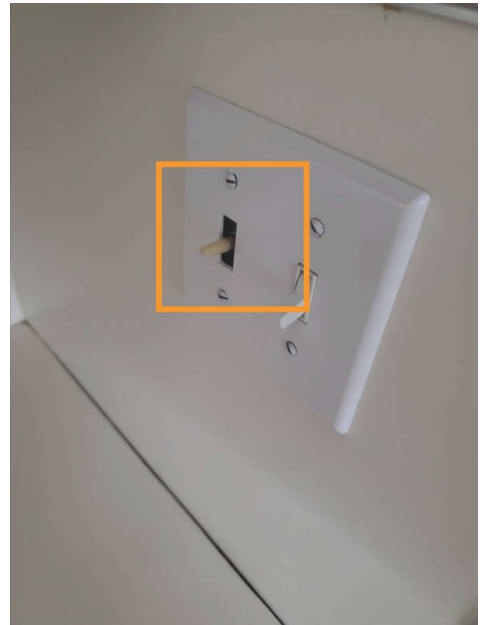
**DAMAGED SWITCH**

Control kitchen ceiling fan speed

Contact a qualified professional.

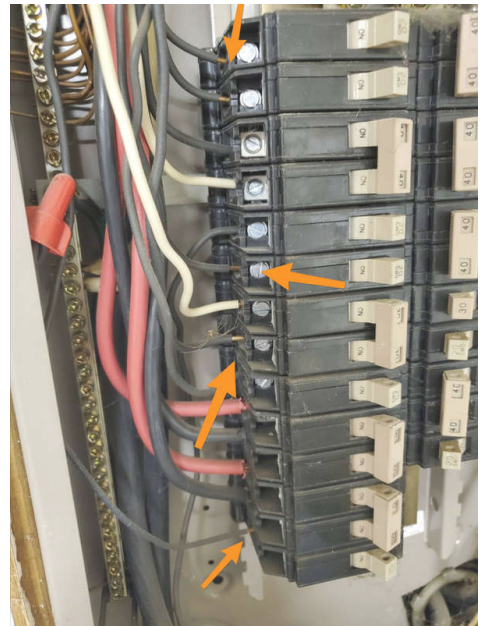
**EXCESSIVE SHEATHING REMOVED**

Excessive sheathing removed at branch wiring circuits or service entrance cables. This is a safety hazard. Recommend further evaluation by a licensed electrician.

Contact a qualified professional.

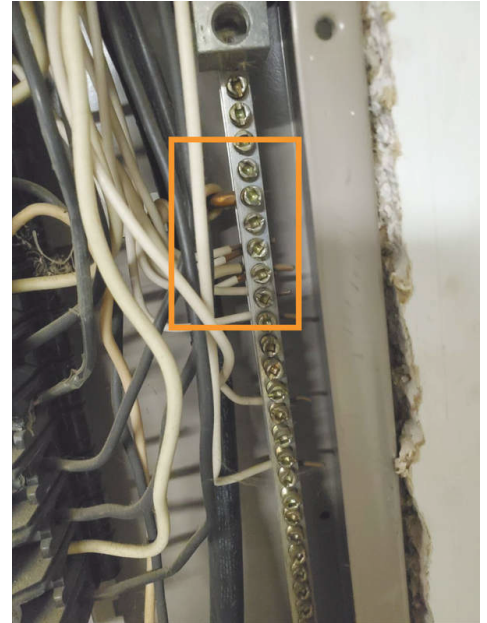
### DOUBLE TAPPED NEUTRALS

There were lug(s) on the neutral/ground bus bar that have more than one neutral wire connected to them. Each neutral wire should be attached to a separate lug to ensure a proper physical connection and to make sure that each circuit can be worked on independently. Recommend to have this corrected.

Recommendation  
Contact a qualified electrical contractor.

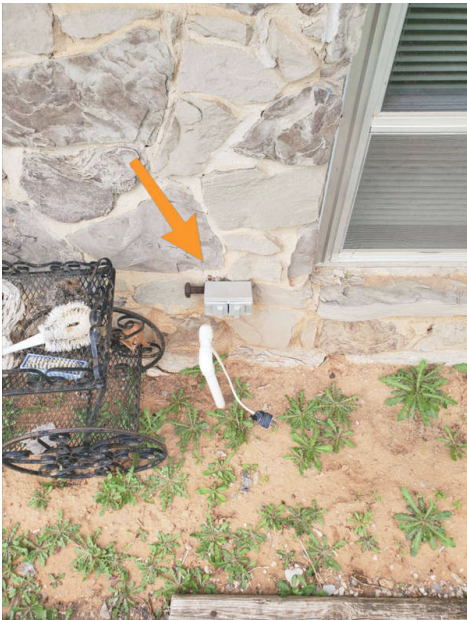
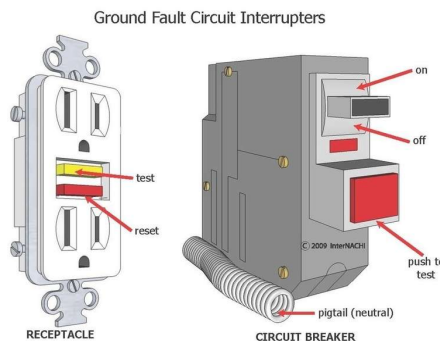
ENTIRE HOME

### NO GFCI PROTECTION INSTALLED

No ground fault circuit interrupter (GFCI) protection of home electrical receptacles was provided at one or more locations in the home at the time of inspection. Although GFCI protection may not have been required at the time the home was built, for safety reasons, the Inspector recommends that electrical receptacles located in basements, crawlspaces, garages, the home exterior, and interior receptacles located within 6 feet of a plumbing fixture be provided with ground fault circuit interrupter (GFCI) protection in good working order to avoid potential electric shock or electrocution hazards. This can be achieved relatively inexpensively by:

1. Replacing an individual standard receptacle with a GFCI receptacle.
2. Replacing the electrical circuit receptacle located closest to the overcurrent protection device (usually a breaker) with a GFCI receptacle.
3. Replacing the breaker currently protecting the electrical circuit that contains the receptacles of concern with a GFCI breaker.

Recommendation  
Contact a qualified electrical contractor.

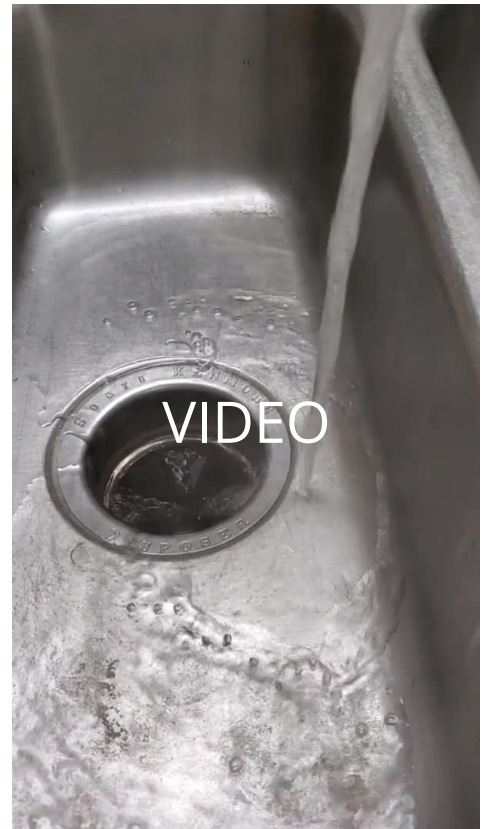
**EXCESSIVE VIBRATION**

At the time of the inspection, the garbage disposal vibrated excessively when operated.

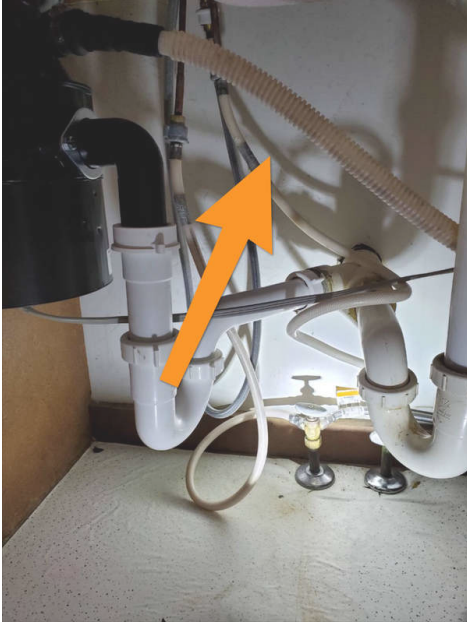
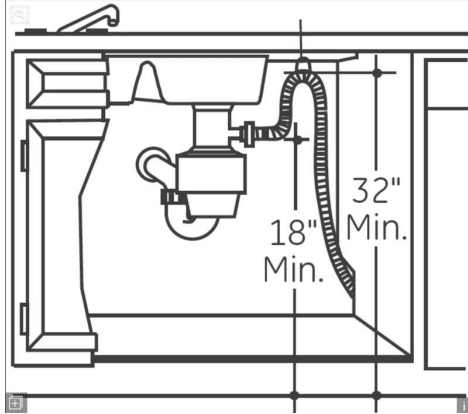
**NO AIR GAP/ANTI-SIPHON/HIGH-LOOP DEVICE PRESENT**

There is no air gap or high loop in the discharge line from the dishwasher to the garbage disposal or drain. Implication: Grey water from the sink can back up into the dishwasher and can subsequently contaminate dishes and/or flood the floor.

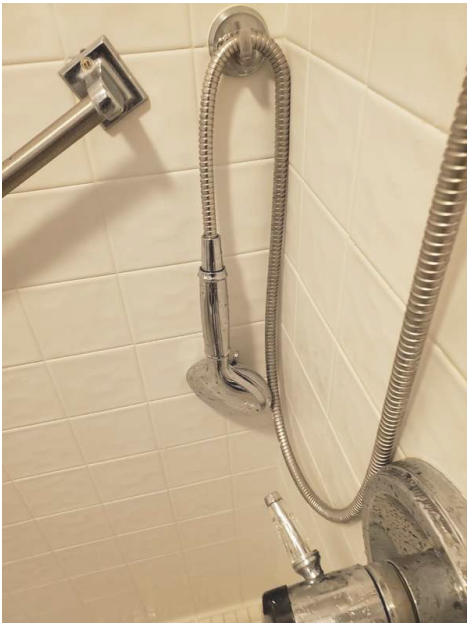
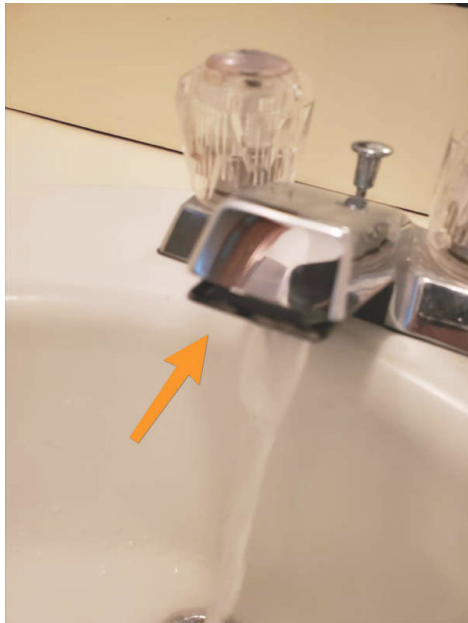
Guest Bath

**PLUMBING FIXTURE DAMAGED**

One or more plumbing fixtures were damaged. Please see individual pictures and comments for further details.

Recommendation  
Contact a qualified professional.

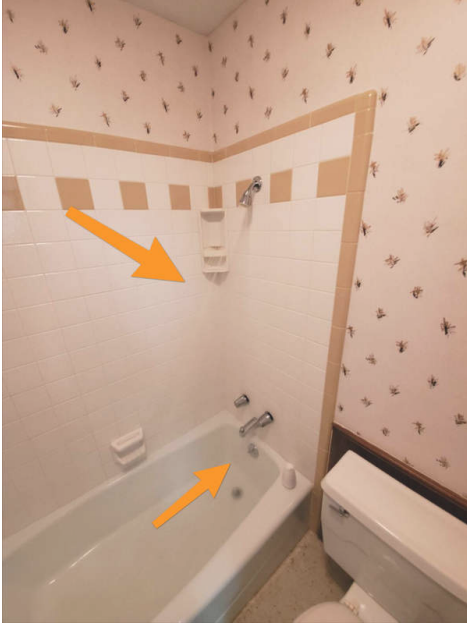
Hallway bathroom

### SHOWER DIVERTER PROBLEM

Water flow does not completely divert to the shower head.

Contact a qualified plumbing contractor.

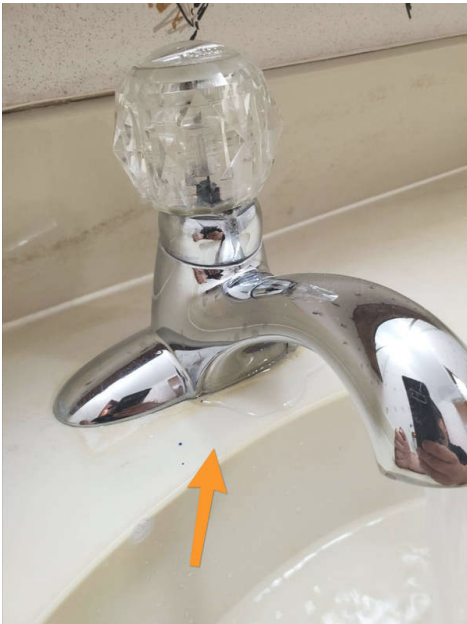
Hallway sink

### PLUMBING FIXTURE LEAKS

A plumbing fixtures leaks and should be repaired to prevent more severe conditions such as water damage.

Contact a qualified professional.

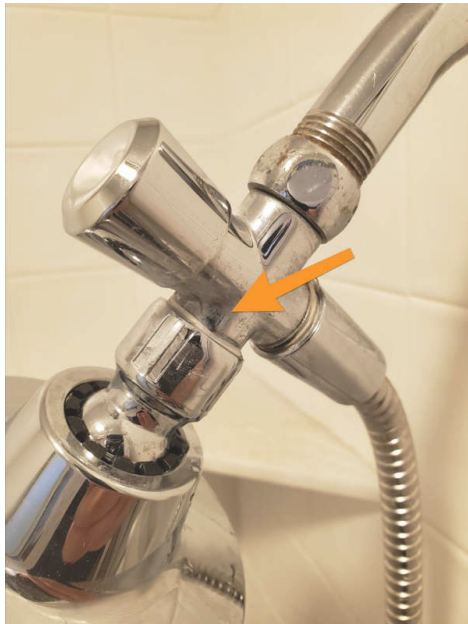
Leak at fitting - master

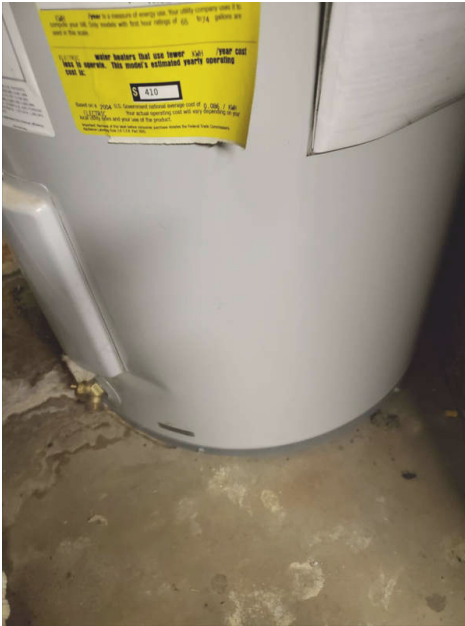
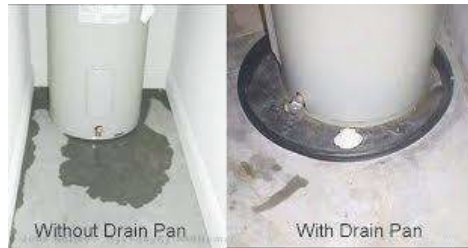
## NO DRIP PAN

No drip pan was present at the water heater.

Contact a qualified plumbing contractor.

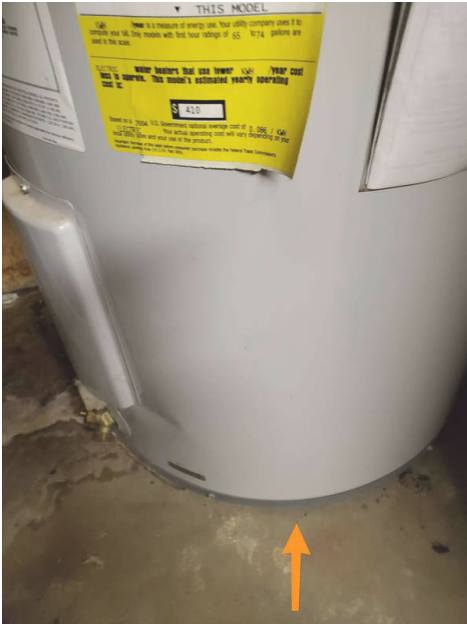
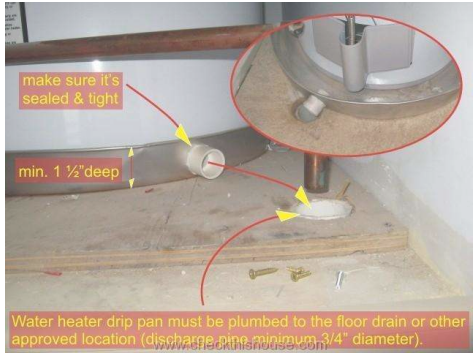
### OVERFLOW PAN NOT PLUMBED TO DRAIN

The water heater drain pan had no overflow. To reduce the potential for damage from a leaking tank or pipe fittings, the drip pan should have an overflow pipe installed that discharges to the home exterior or to a floor drain. The Inspector recommends correction by a qualified plumbing contractor.
