SUMMARY

1234 Main St.Mt. Pleasant MI 48858

Buyer Name
05/14/2019 9:00AM

Kal Cotter
InterNACHI Certified Home Inspector
Central Home Solutions, LLC.
(989) 824-0170
kalcotter@gmail.com

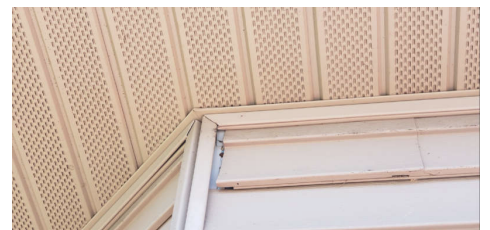
4.1.2 Walls / Cladding

VINYL SIDING CUT SHORT

Marginal Defect

Pieces of vinyl siding were cut short in areas, exposing the wall sheathing. This can allow for rainwater infiltration. Replacement of the affected siding is recommended by a qualified person.

Recommendation
Contact a qualified siding specialist.

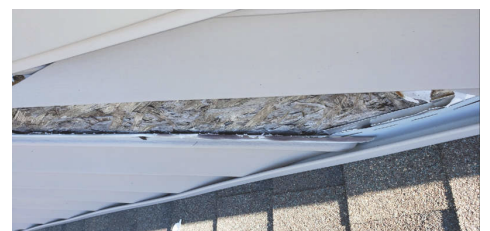
4.1.4 Walls / Cladding

SIDING MISSING

Marginal Defect

A piece of vinyl siding was missing. Replacement is recommended by a qualified person.

Recommendation
Contact a qualified professional.

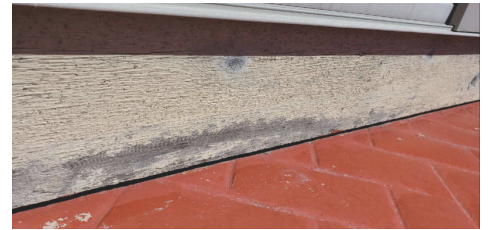
4.5.1 Sealant / Paint Overall

FLAKING PAINT - WEATHERED WOOD

Marginal Defect

Flaking paint and weathered wood was present in areas. Scraping, Sanding, and repainting is recommended as needed by a painting contractor. Any damaged wood found during this process should be repaired or replaced as needed.

Recommendation

Contact a qualified painting contractor.

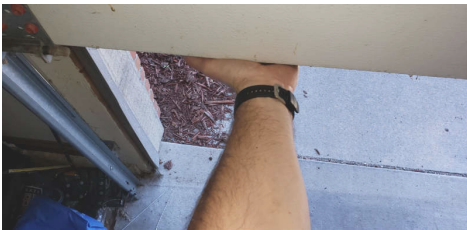
5.4.1 Garage Door Safety

RESISTANCE TEST FAILED

Marginal Defect

The garage door(s) did not auto reverse when met with resistance. DASMA testing procedures were followed, and the door did not auto-reverse when contacting a 2" X 4" laid on the ground under the door. Garage doors contain two safety mechanisms to prevent someone from being injured or pinned under a closing door; photoelectric eyes and the ability to auto reverse when met with resistance. This is typically an adjustment of the "Force Close" setting (if present) on the opener. Repairs are recommended as needed by a garage door contractor for proper operation.

Recommendation

Contact a qualified garage door contractor.

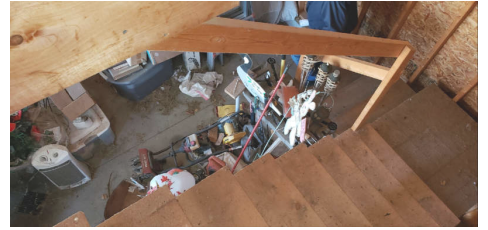
5.7.1 Stairs

− Marginal Defect

GUARDRAIL SPACING

There was spacing present on the guardrail at the top of the stairs in the garage that was greater than 4 inches. Current safety standards require that guardrails be designed as to not allow the passage of a 4 inch sphere through them. Safety upgrades should be considered here.

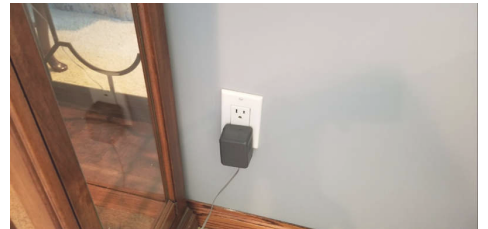
8.10.1 Receptacles

LOOSE AT WALL

There were receptacle(s) present that were loose at the wall. Proper securement is recommended as needed by a licensed electrician.

Marginal Defect

Recommendation

Contact a qualified electrical contractor.

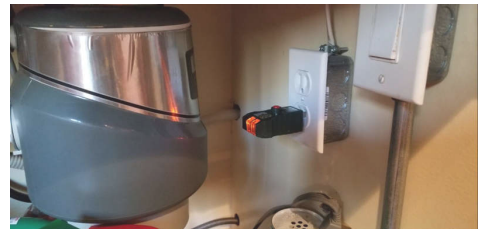
8.11.1 GFCI Protection

GFCI PROTECTION NOT PRESENT/FOUND

GFCI protection was not present/found at the areas referenced at the top of the electrical section of the report, at the time of inspection. GFCI protection is recommended for the exterior, garage, and basement receptacles for safety, as well as kitchen and bathroom receptacles within 6 feet of a water source. Installation or repairs as needed to ensure GFCI protection is present at all recommended locations for safety is recommended by a licensed electrician.

Marginal Defect

Recommendation

Contact a qualified electrical contractor.

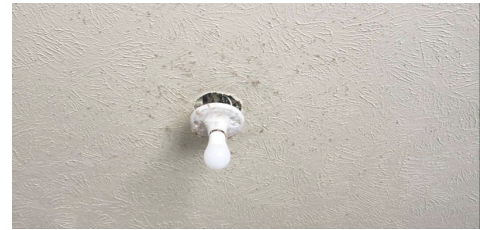
8.13.2 Switches, Lights

EXTERIOR LIGHT NOT SECURED

GARAGE

There were exterior light(s) present that were not secured properly. Repairs are recommended as needed to properly secure the fixture(s) by a licensed electrician or other qualified person.

Marginal Defect

Recommendation

Contact a qualified handyman.

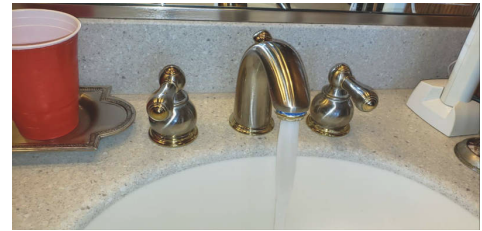
10.4.2 Sink(s)

FAUCET AND VALVES LOOSE

The faucet assembly was loose at the base. Proper securement of the assembly is recommended by a qualified person, typically this is associated with loose plastic nuts under the sink.

Marginal Defect

Recommendation

Contact a qualified handyman.

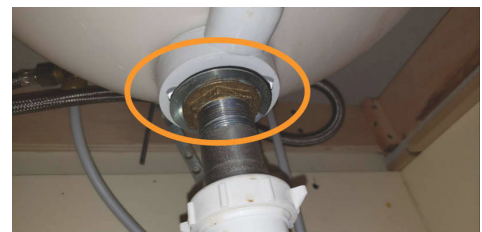
10.5.1 Undersink Plumbing - Bathroom

LEAK PRESENT

There was a leak present under the sink. Repairs are recommended as needed to rectify any leaks by a licensed plumber.

Marginal Defect

Recommendation

Contact a qualified plumbing contractor.

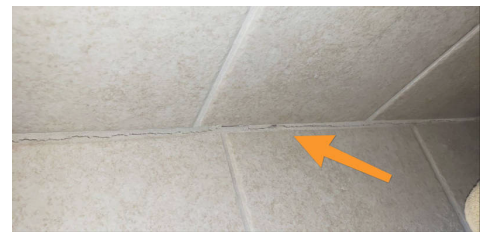
10.7.1 Shower Walls

CRACKED GROUT/SEALANT PRESENT

Areas of cracked grout/sealant were present. This can allow for water infiltration behind the tile walls. Repairs are recommended as needed to prevent any moisture infiltration by a qualified person.

Marginal Defect

Recommendation

Contact a qualified professional.

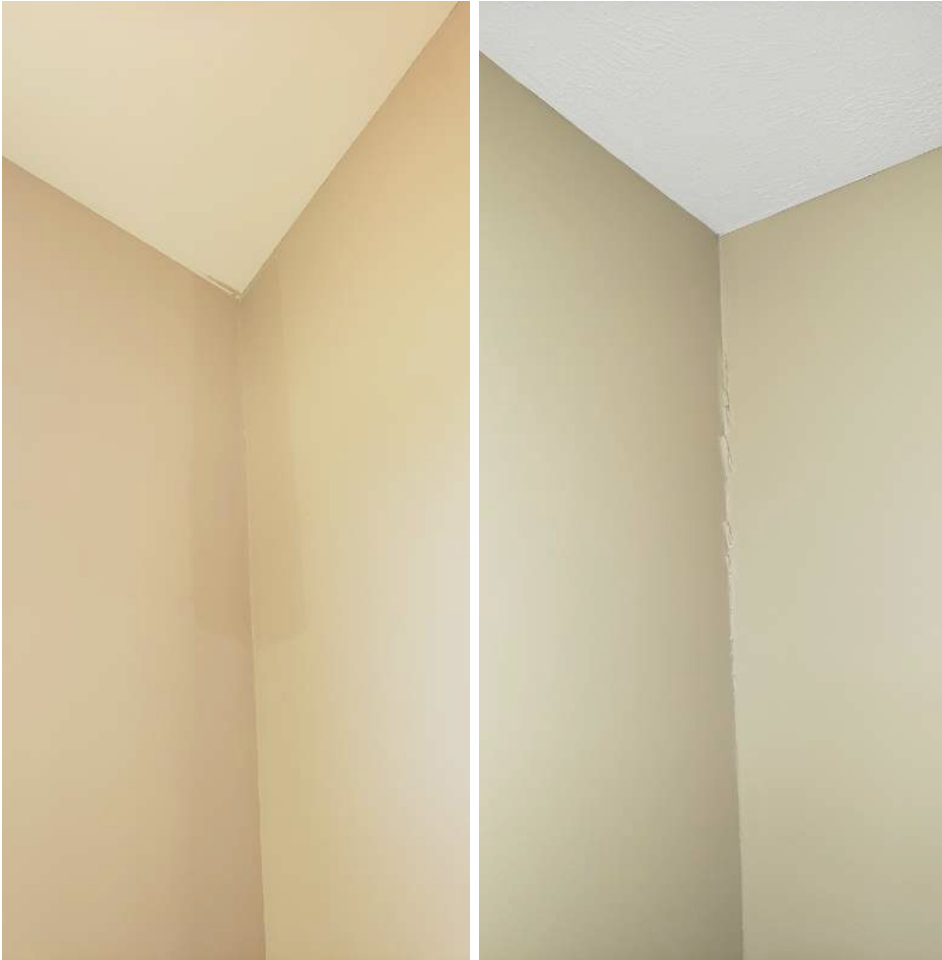
POSSIBLE MOISTURE STAINING/DAMAGE PRESENT

Marginal Defect

MASTER BEDROOM, LIVING ROOM

Moisture stain(s) and related damage was present on the ceilings in the referenced areas. Although the area(s) were not actively leaking at the time of inspection, moisture stains should be viewed as active leaks until they prove themselves otherwise. I recommend inquiring with the sellers about the stains as they would have firsthand knowledge of why the stain is present, and what repairs were carried out to address it. If they are unsure of the stains, a roofing contractor or plumbing contractor (as applicable) should evaluate and make repairs as needed. Repairs to any damage is recommended as needed by a qualified person.

Recommendation

Contact a qualified professional.
