SUMMARY

1234 Main St. St. George Utah 84770

Johnnie Shirts
InterNACHI Certified Home Inspector
Fair & Square Inspections, LLC
208-250-3181
fairandsquareinspections@gmail.com

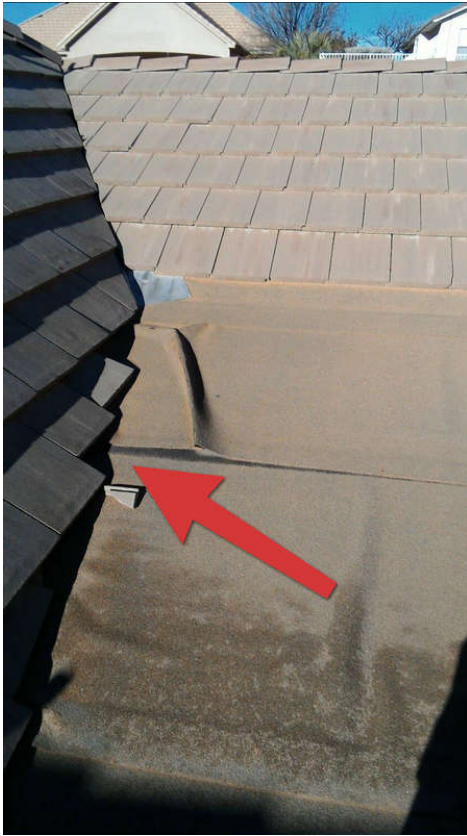
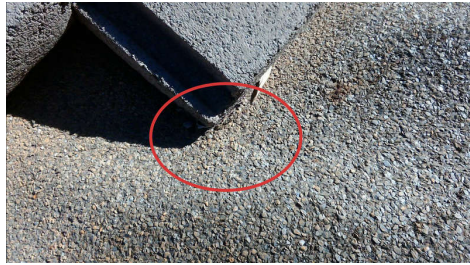
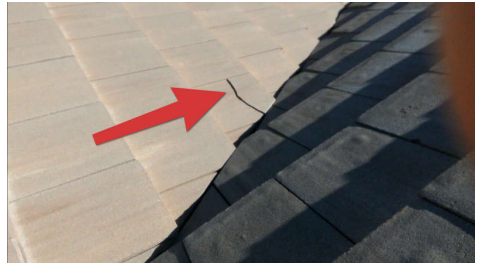
2.1.2 Coverings

BROKEN AND LOOSE TILES

NEAR CORNER OF GARAGE AND FRONT ROOM

Loose tile is rubbing against the asphalt sheeting. In some places has pushed clear through. This condition will allow moisture to enter and eventually cause damage inside the home.

Contact a qualified roofing professional.

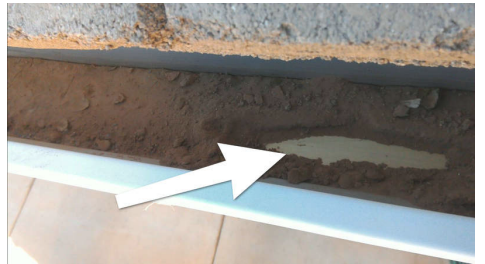
2.2.1 Roof Drainage Systems

DEBRIS

ALL GUTTERS

Debris has accumulated in the gutters. Recommend cleaning to facilitate water flow.

North Garage

Contact a qualified roofing professional.

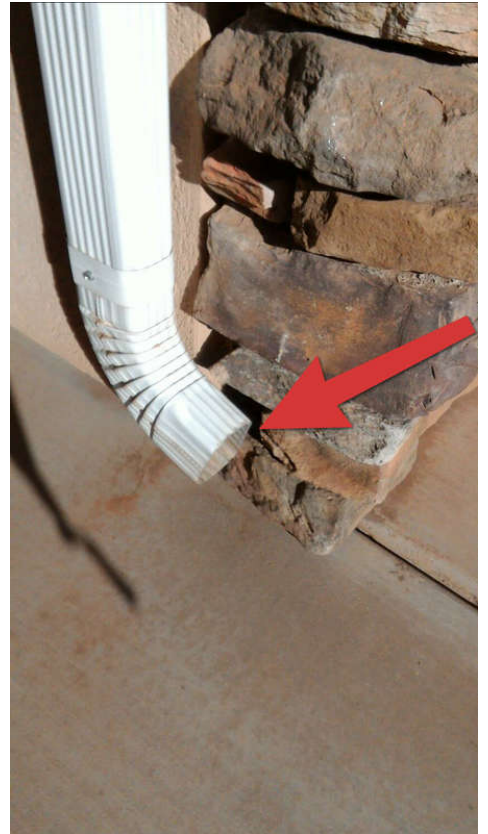
2.2.2 Roof Drainage Systems

DOWNSPOUTS DRAIN NEAR HOUSE

NEAR FRONT DOOR

One or more downspouts drain too close to the home's foundation. This can result in excessive moisture in the soil at the foundation, which can lead to foundation/structural movement. Recommend a qualified contractor adjust downspout extensions to drain at least 6 feet from the foundation.

Contact a qualified roofing professional.

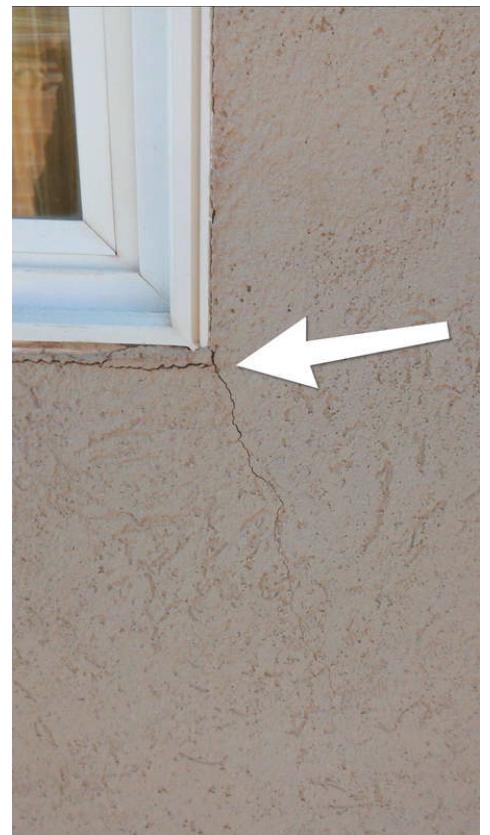
3.1.1 Siding, Flashing & Trim

CRACKING - MINOR

NORTH SIDE OF HOUSE

Siding showed cracking in one or more places. This is a result of temperature changes, and typical as homes with stucco age. Recommend monitoring.

Recommended DIY Project

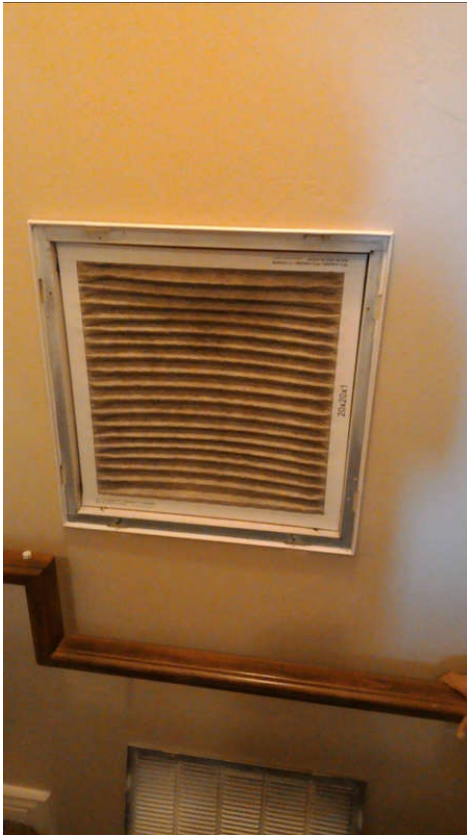
5.1.1 Equipment

FILTER DIRTY

STAIRWAY

The furnace filter is dirty and needs to be replaced every 3 months.

Contact a qualified HVAC professional.

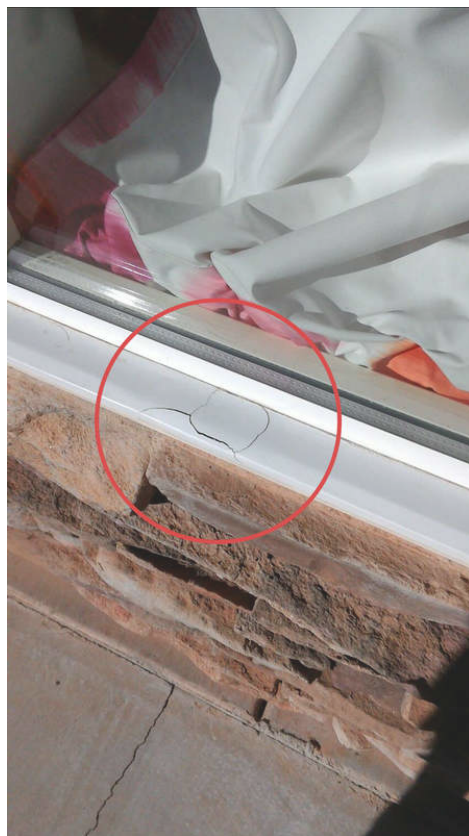
10.2.1 Windows

DAMAGED WINDOW SILL

One or more windows appears to have general damage, but are operational. Recommend a window professional clean, lubricate & adjust as necessary.

Contact a qualified window repair/installation contractor.

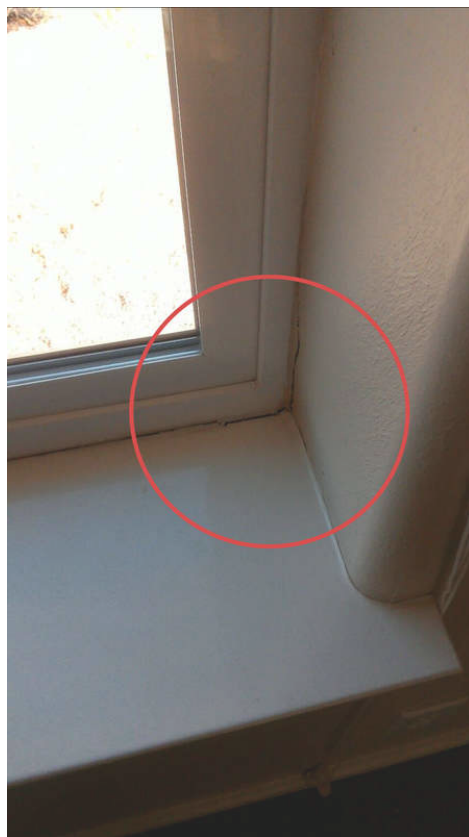
10.2.2 Windows

CAULK SEPARATING

MASTER BEDROOM ON WEST SIDE

Contact a handyman or DIY project

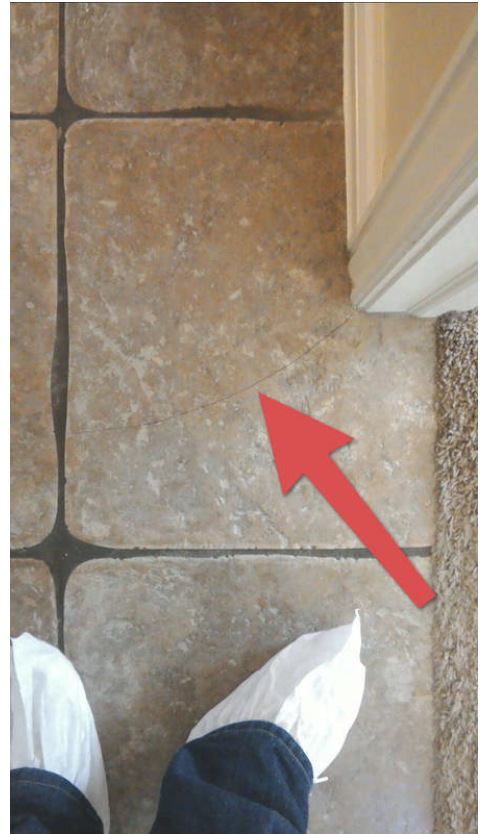
10.3.1 Floors

BROKEN TILE

OUTSIDE MASTER BEDROOM

Broken tile

Contact a qualified professional.

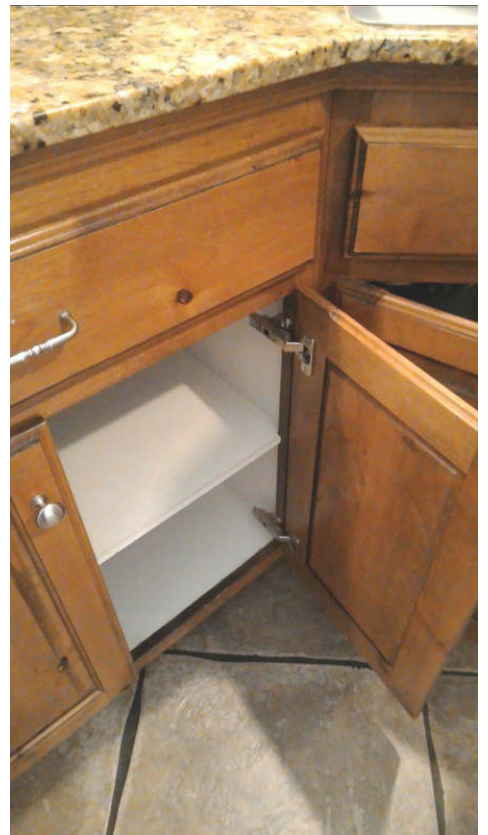
10.7.1 Countertops & Cabinets

CABINET HINGE LOOSE

One or more cabinet hinges were loose. Recommend a qualified handyman or cabinet contractor repair.

Contact a qualified cabinet contractor.
