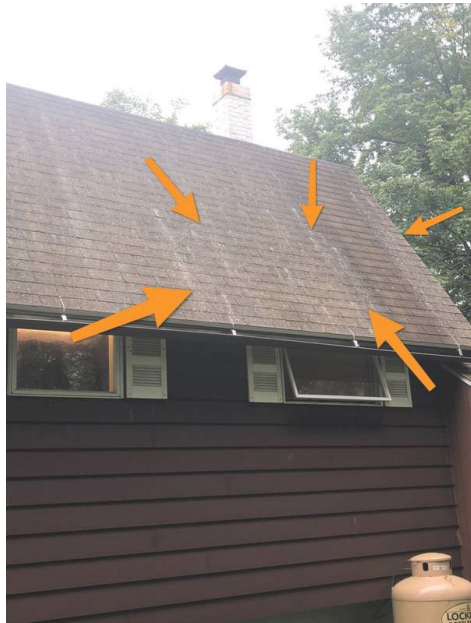
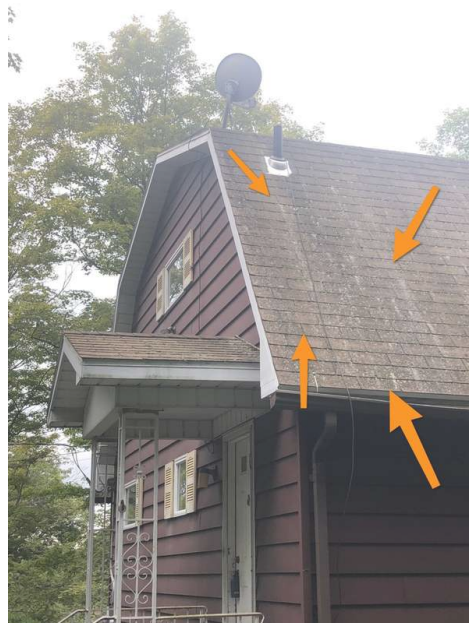
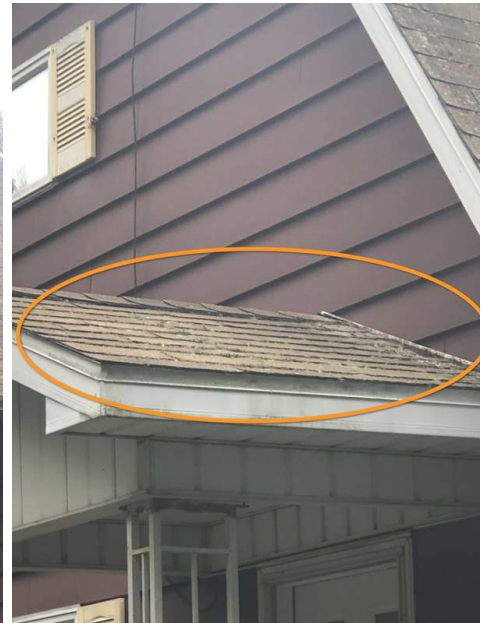
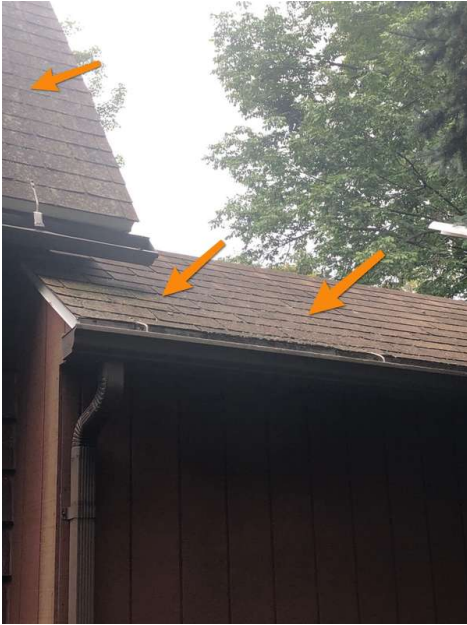
2.1.1 Coverings

ORGANIC MATERIAL

NORTH SIDE OF HOME (PRIMARILY)

By holding moisture against the roof surface, any organic material will speed up the wear of the asphalt shingle surface in freezing climates by increasing frost damage to the mineral granule coating on the shingles. Recommend cleaning of shingles by a qualified roofing contractor.

The source is an algae called *Gloeocapsa magma*. Cleaning may be the most cost-effective solution, since it's a fraction of the price of a roof replacement

Algae-caused marking isn't preventable but can be removed, though not always permanently. The algae survive through photosynthesis and by feeding on limestone filler used in asphalt shingles.

While the dark streaks are unsightly, experts tell our team that the greatest danger to the roof is from moisture retention or root damage that algae and other life forms can cause. Also, algae and fungus can grow together to form lichen, the roots of which can wrap around and feed on the granules covering the shingles. Once established, lichen is not easily removed. Even if it dries out, it can come back to life with the next rain. Scrubbing or power washing lichen will only cause more damage.

Contact a qualified roofing professional.

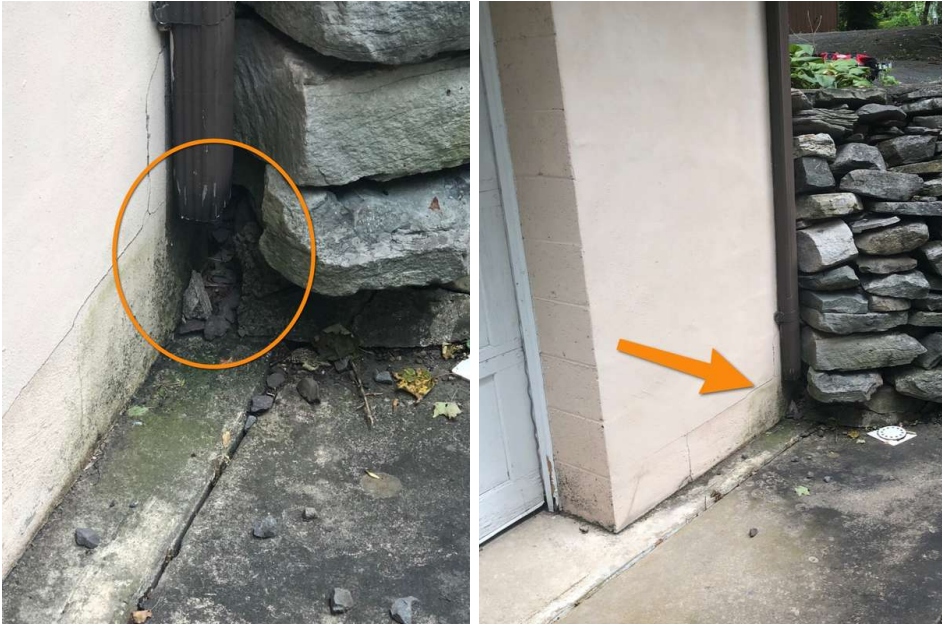
2.2.1 Roof Drainage Systems

DOWNSPOUTS DRAIN NEAR HOUSE

RIGHT OF GARAGE DOOR

One or more downspouts drain too close to the home's foundation. This can result in excessive moisture in the soil at the foundation, which can lead to foundation/structural movement. Recommend a qualified contractor adjust downspout extensions to drain at least 6 feet from the foundation.

Contact a handyman or DIY project

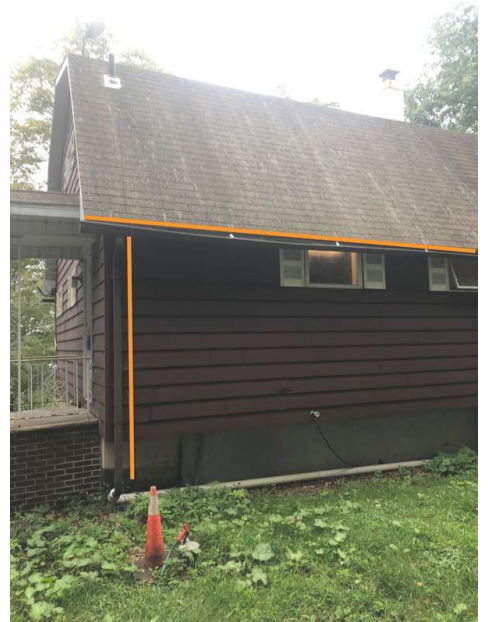
2.2.2 Roof Drainage Systems

GUTTER IMPROPERLY SLOPED

REAR OF HOME

The Gutter is improperly sloped in the rear of the home, which could result in runoff drainage around the foundation and possible structural shifting. Recommend qualified roofing or gutters contractor repair.

Contact a qualified roofing professional.

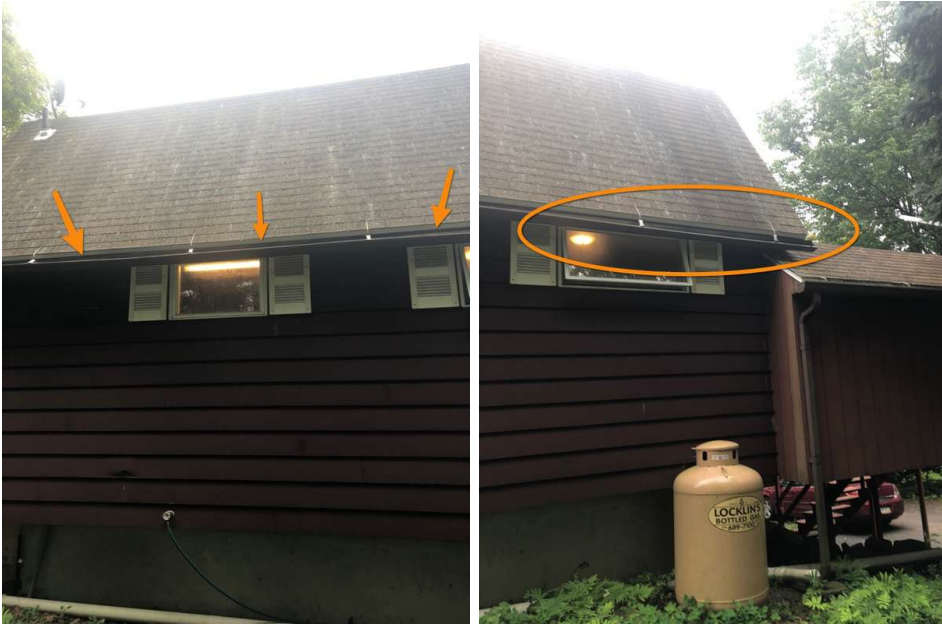
2.2.3 Roof Drainage Systems

GUTTER LOOSE

REAR OF HOME

The gutter(s) is loose and needs to be re-fastened pitched properly.

The gutter brackets may be reused. Although the gutter was observed to have twisted the brackets appeared to be intact.

Contact a qualified gutter contractor

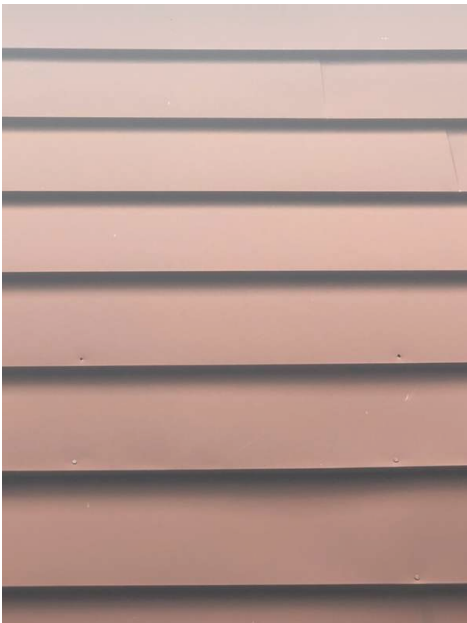
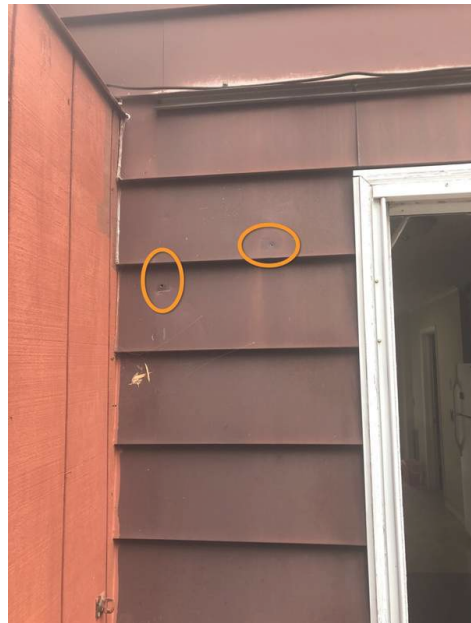
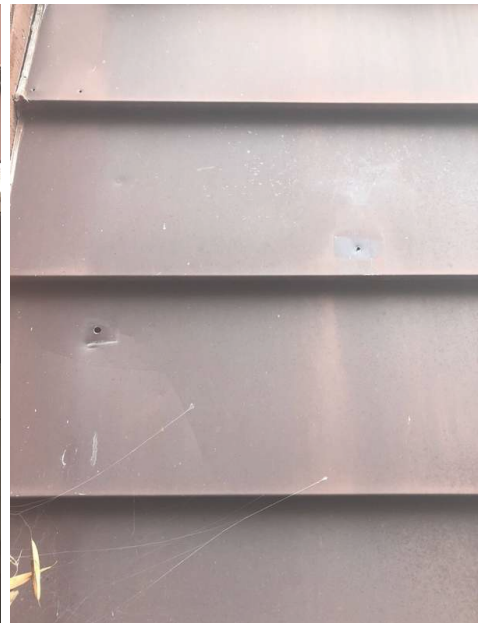
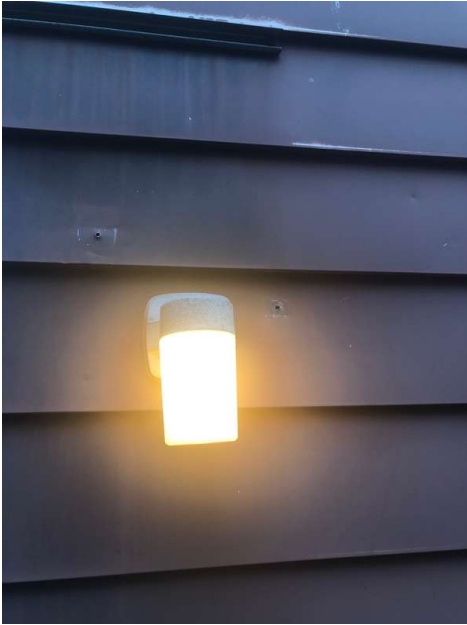
3.1.1 Siding, Flashing & Trim

MINOR NAIL HOLES

THROUGHOUT EXTERIOR (SEE PICTURE DESCRIPTIONS)

Siding showed minor holes in multiple locations. This is a result of nail pop. Recommend caulking or replacing to avoid moisture intrusion or insect infestation.

This location is to the left of the door on the deck.

This location is to the left of the door on the deck. (this is a close up)

Contact a handyman or DIY project

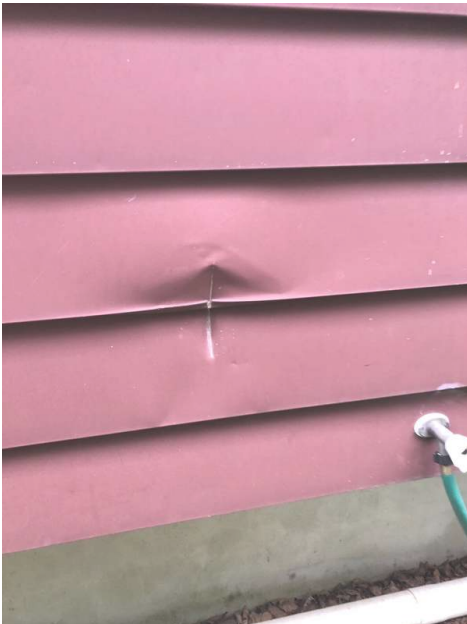
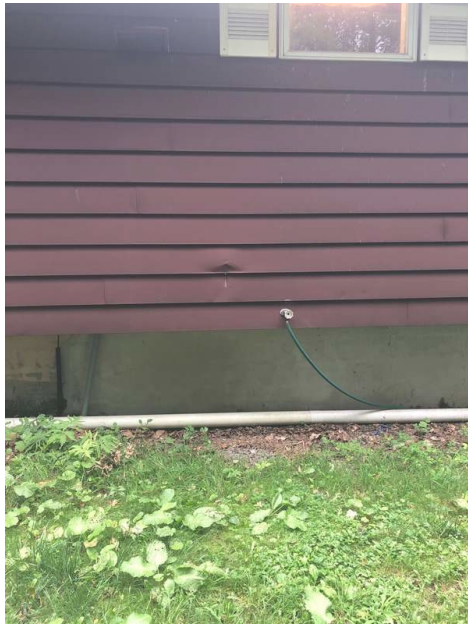
3.1.2 Siding, Flashing & Trim

GENERAL DAMAGE - MINOR

REAR OF HOME

Siding showed signs consistent with landscaping damage. Recommend monitoring for any areas that may allow moisture intrusion.

Contact a handyman or DIY project

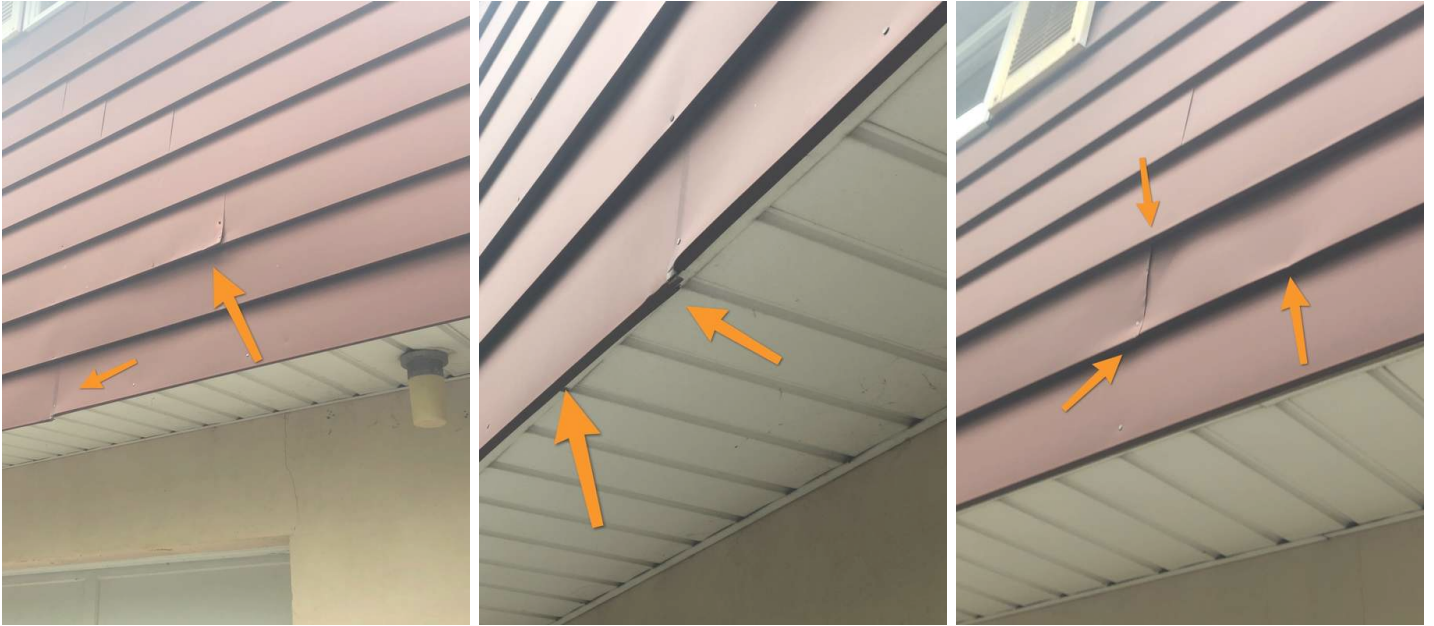
3.1.3 Siding, Flashing & Trim

WARPING/BUCKLING

ABOVE GARAGE

Siding was warping or buckling in areas. This is often as a result of nailing siding boards too tight to the home, preventing expansion/contraction. Recommend a qualified siding contractor evaluate and repair.

Recommendation
Contact a qualified siding specialist.

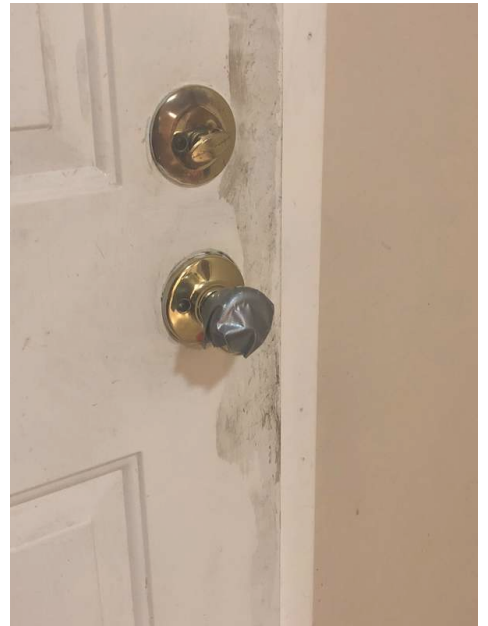
3.2.1 Exterior Doors

DOOR DOES NOT CLOSE OR LATCH

MAIN DOOR

Door does not close or latch properly. Recommend qualified handyman replace the hardware.

Contact a handyman or DIY project

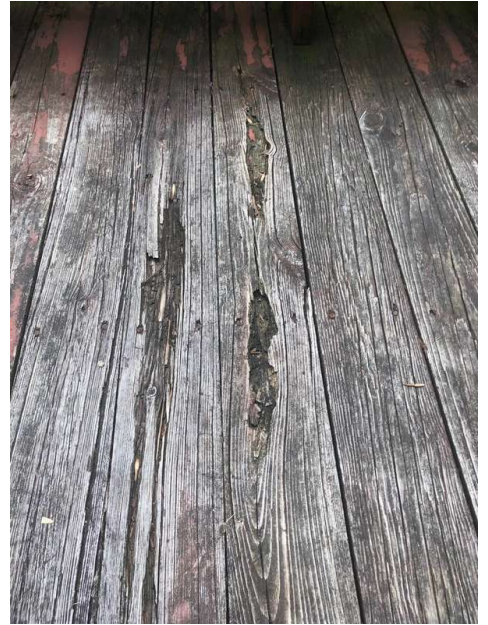
3.4.1 Decks, Balconies, Porches & Steps

DECK - ROTTED BOARDS

DECK

One or more deck boards are showing signs of rot. Recommend a qualified deck contractor replace.

Contact a qualified deck contractor.

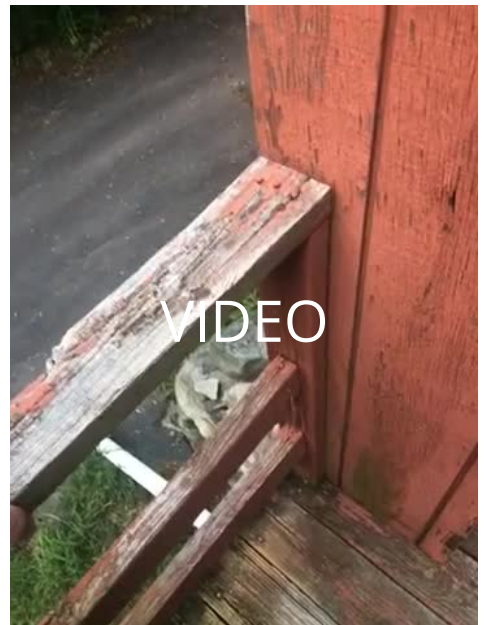
3.4.2 Decks, Balconies, Porches & Steps

DECK - UNSTABLE SUPPORT

DECK

One of more areas of the deck support appears unstable. This could cause a safety hazard and further deterioration of the deck. Recommend qualified deck contractor evaluate and repair.

Contact a qualified deck contractor.

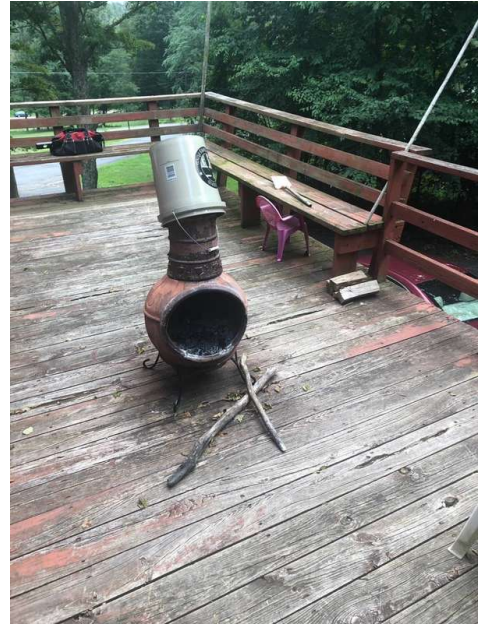
3.4.3 Decks, Balconies, Porches & Steps

DECK - WATER SEALANT REQUIRED

DECK

Deck is showing signs of weathering and/or water damage. Recommend water sealant/weatherproofing be applied.

Contact a qualified deck contractor.

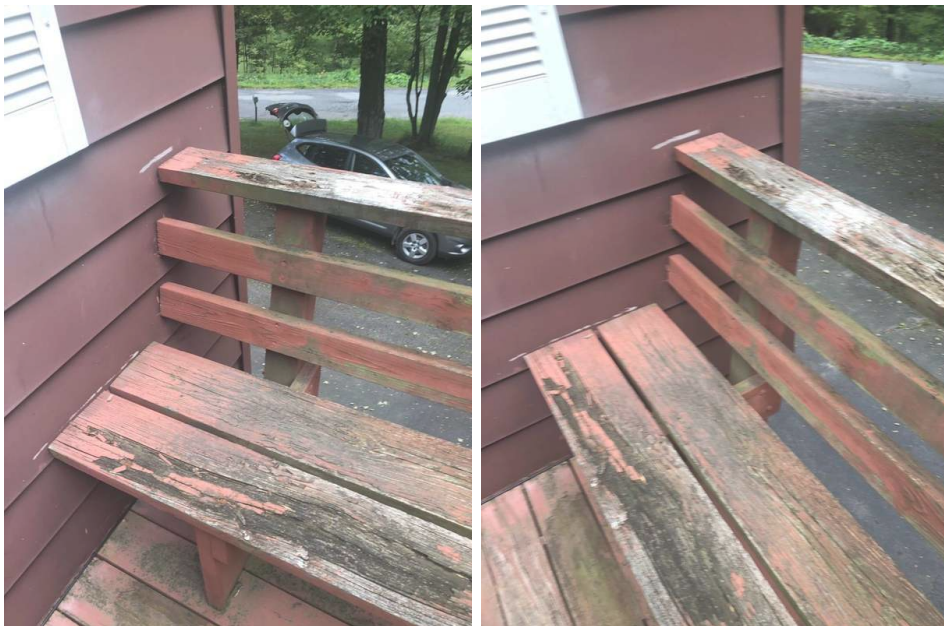
3.4.4 Decks, Balconies, Porches & Steps

IMPROPER DECK CONSTRUCTION PRACTICES

DECK
Deck was observed to have general poor construction. Recommend qualified deck contractor evaluate.
Recommendation
Contact a qualified deck contractor.

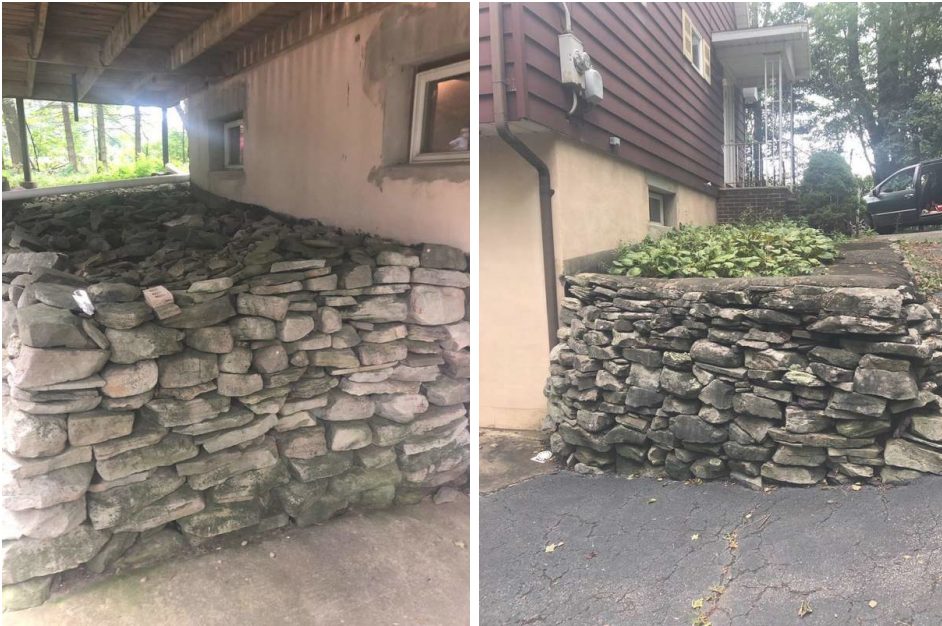
3.6.1 Vegetation, Grading, Drainage & Retaining Walls

RETAINING WALL CRACKS

BESIDE FOUNDATION

Retaining wall is showing signs of failing. Recommend qualified contractor evaluate and repair.

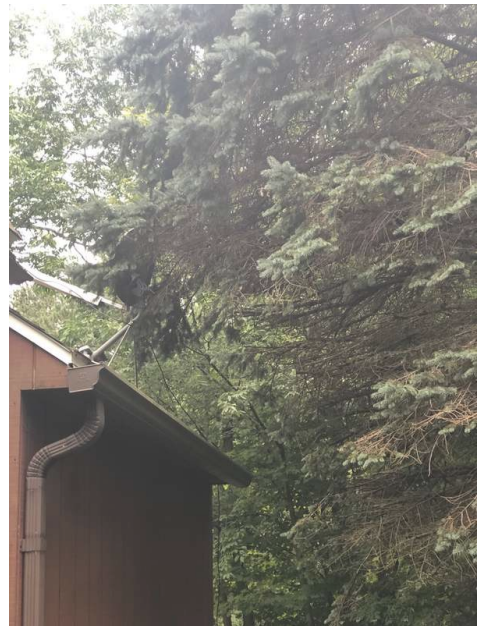
3.6.2 Vegetation, Grading, Drainage & Retaining Walls

TREE OVERHANG

Trees observed overhanging the roof. This can cause damage to the roof and prevent proper drainage. Recommend a qualified tree service trim to allow for proper drainage.

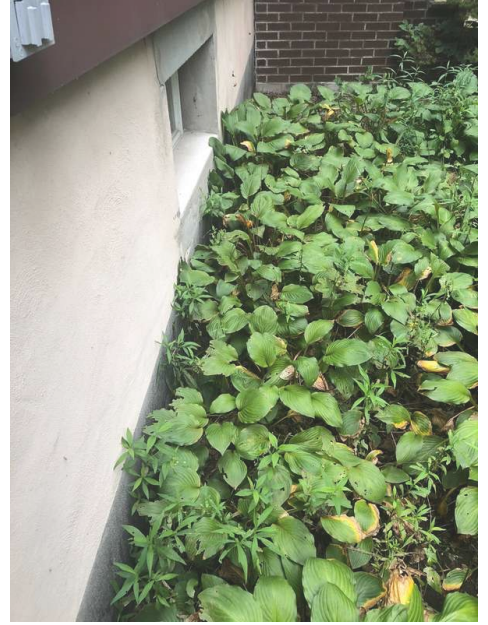
3.6.3 Vegetation, Grading, Drainage & Retaining Walls

VEGETATION TOO CLOSE/ IN CONTACT WITH HOME

RETAINING WALL AREA

Moisture held against the building by shrubs keeps the exterior wet and is more likely to allow water inside the home's foundation which can damage structural components and/or create an environment conducive for mold growth.

Additionally vegetation touching the home may allow for insects and rodents, to enter the home. Recommend cutting all vegetation back a minimum of 18".

Contact a qualified professional.

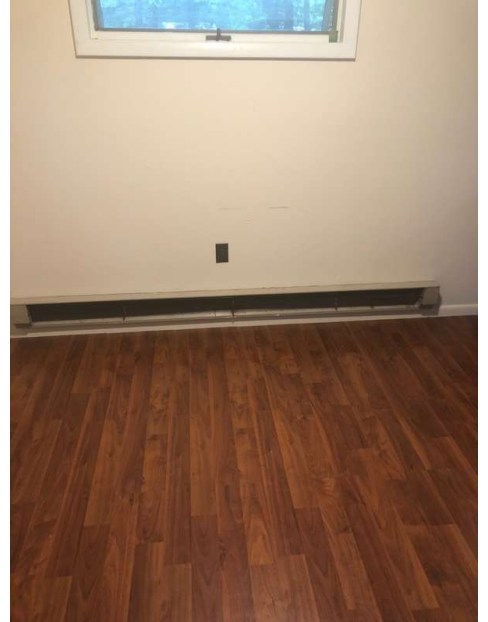
5.3.1 Distribution Systems

BASEBOARD COVER MISSING

DINING ROOM

The baseboard cover was observed to be missing at the time of inspection. Recommend installation of a new one.

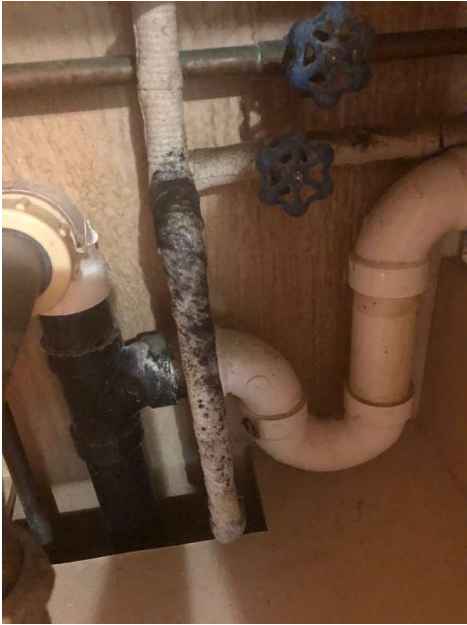
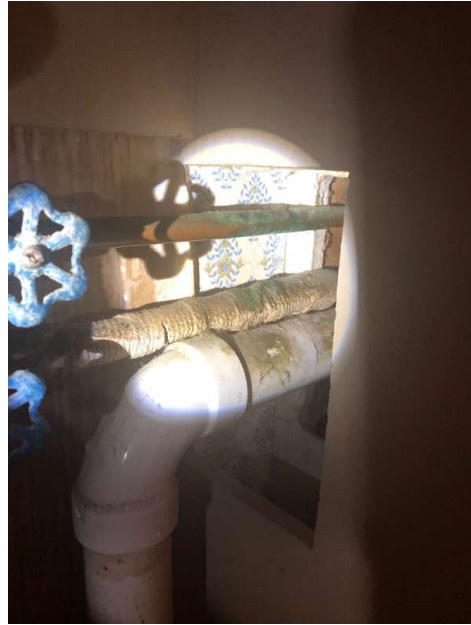
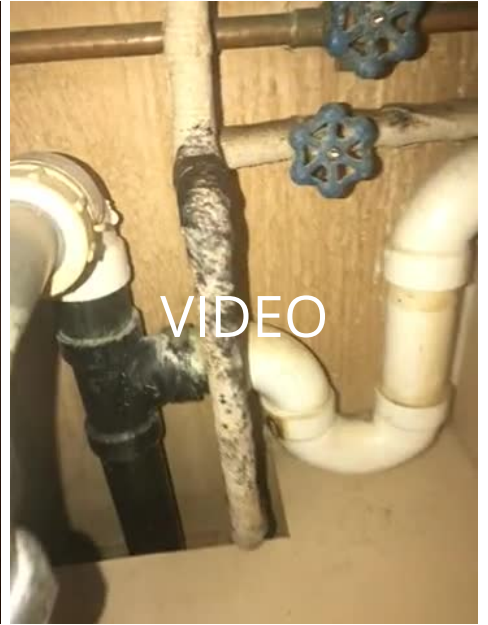
7.3.1 Water Supply, Distribution Systems & Fixtures

PRESENCE OF MOLD

UPSTAIRS BATHROOM

Distribution pipes were observed to be wrapped with a cloth-like material that has grown mold. Avoid using any organic based material in areas of the home prone to moisture as they are more likely to hold moisture. The conditions observed in this location are ideal for mold growth. Recommend removal of the material, cleaning of the area and possible testing by a qualified individual. Mold can be potentially very harmful to certain individuals so this is a safety concern.

Contact a qualified mold remediation contractor

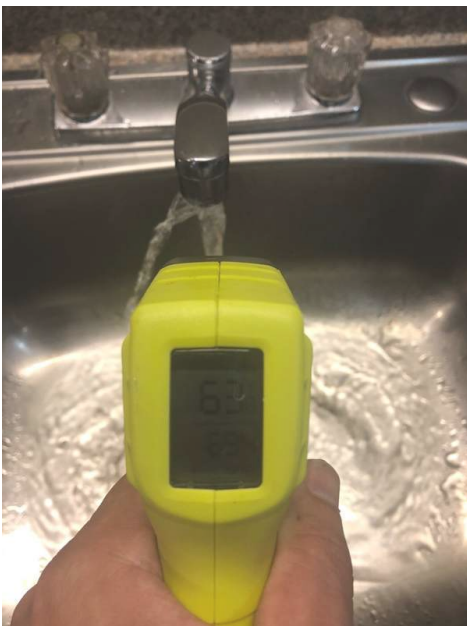
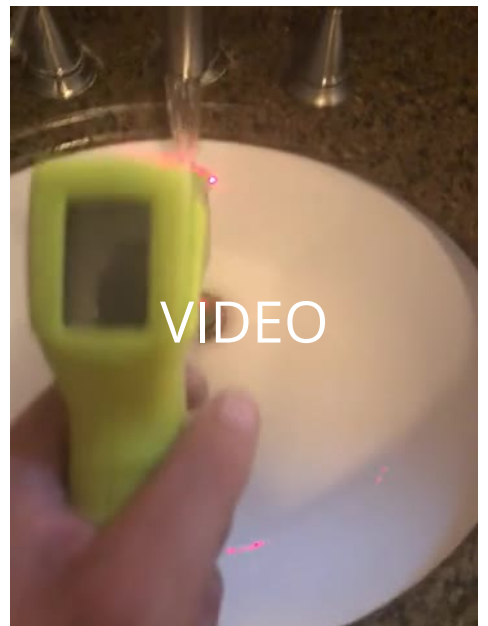
7.3.2 Water Supply, Distribution Systems & Fixtures

LOW WATER TEMPERATURE

KITCHEN SINK/BATHROOM SINK

The water temperature was observed to be too low. Water temperature in a home should be 120 degrees to ensure safety regarding various bacteria while not exceeding 130 degrees to avoid scalding.

Contact a qualified plumbing contractor.

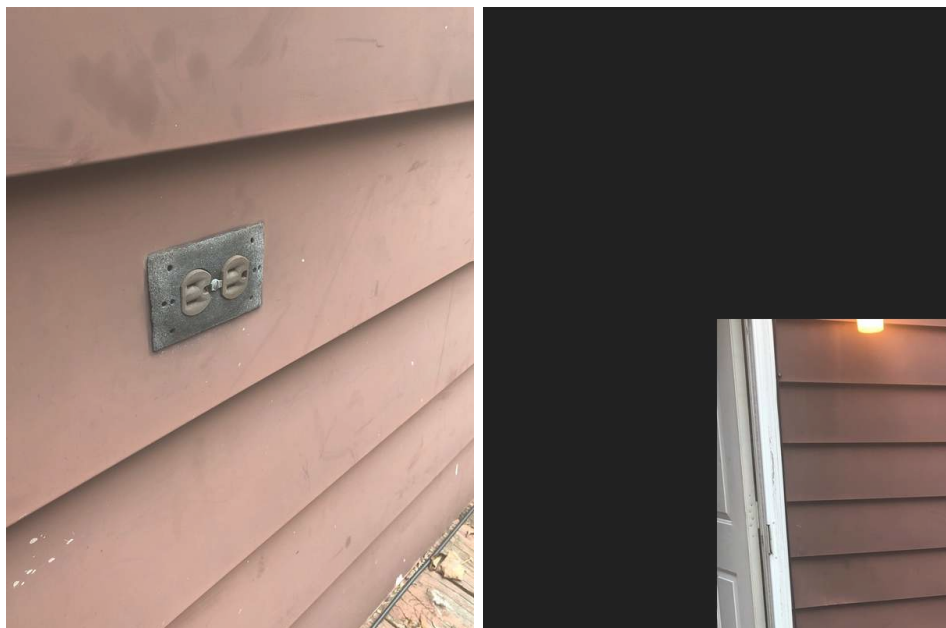
8.4.1 Lighting Fixtures, Switches & Receptacles

COVER PLATES MISSING

EXTERIOR BESIDE DECK

The exterior outlet was observed to be missing a self closing cover plate. The box should be self closing to prevent moisture intrusion in addition to preventing shock hazards.

Contact a qualified electrical contractor.

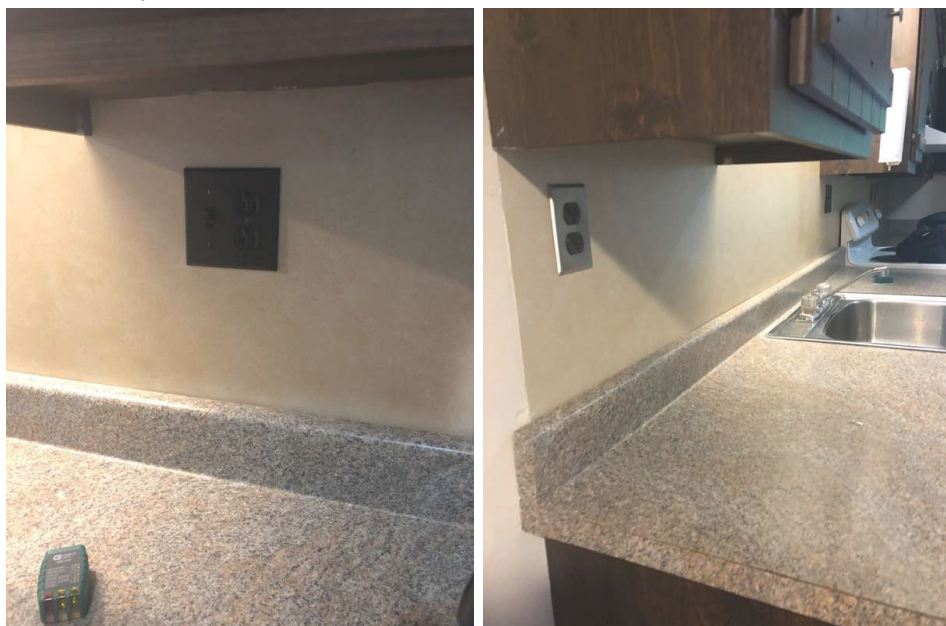
8.5.1 GFCI & AFCI

NO GFCI PROTECTION INSTALLED

6' WITHIN ALL WATER SOURCES

No GFCI protection present in all locations 6' within a water source. Recommend licensed electrician upgrade by installing ground fault receptacles in all locations.

Contact a qualified electrical contractor.

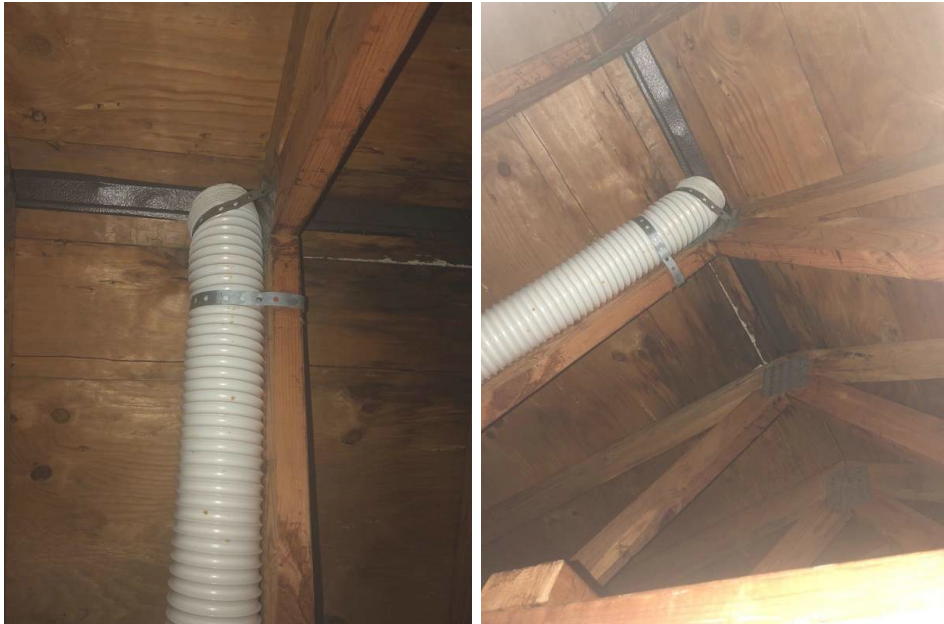
10.4.1 Exhaust Systems

BATHROOM VENTS INTO ATTIC

ATTIC

Bathroom fan vents into the attic, which can cause moisture and mold. Recommend a qualified attic contractor properly install exhaust fan to terminate to the exterior.

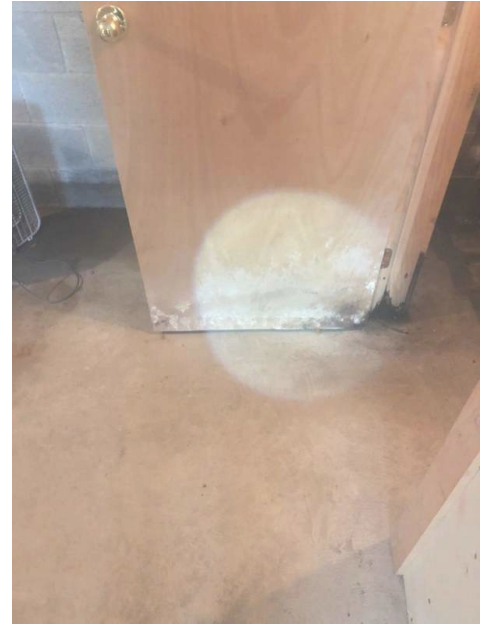
11.1.1 Doors

WATER STAINING

GARAGE

Door shows noticeable water staining, which could lead to further deterioration. Monitor for future repair or replacement.

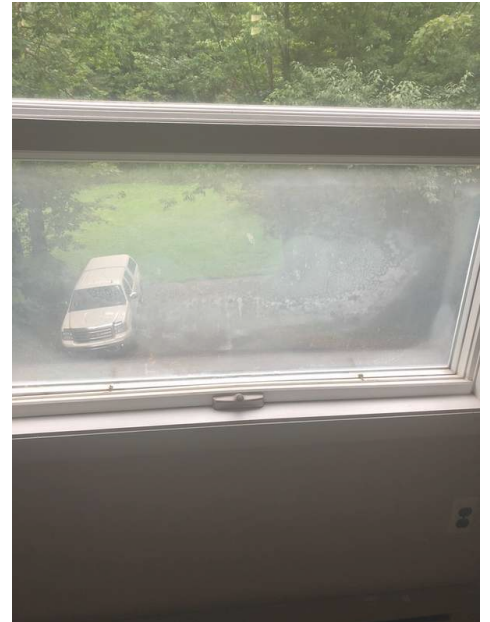
11.2.1 Windows

FAILED SEAL

Observed condensation between the window panes, which indicates a failed seal. Recommend qualified window contractor evaluate & replace.

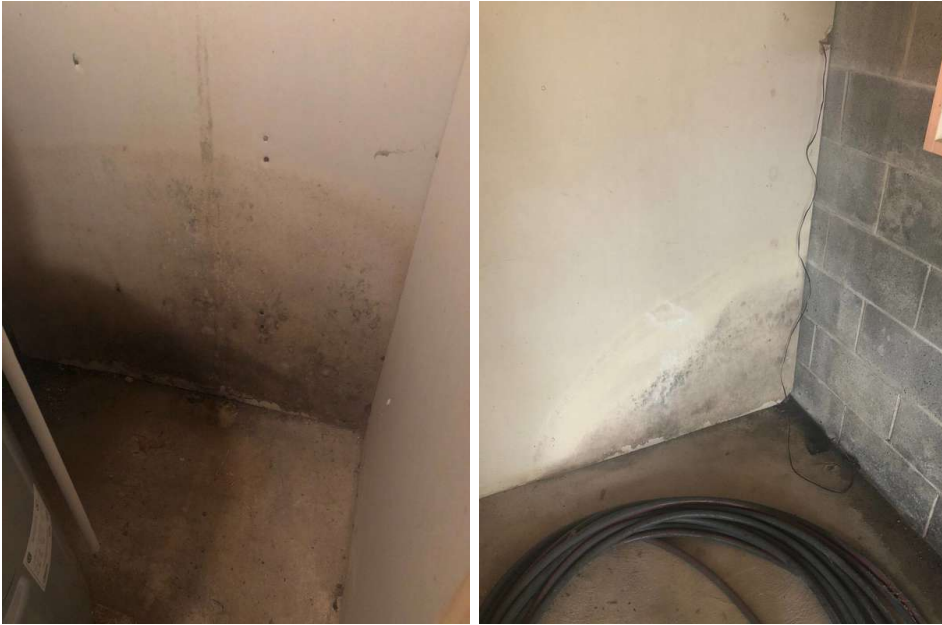
11.4.1 Walls

MOISTURE DAMAGE

GARAGE

Stains on the walls visible at the time of the inspection appeared to be the result of moisture intrusion. The source of moisture appears to be the result of the retaining wall located on the other side of the foundation. Recommend further examination by a qualified contractor to provide confirmation.

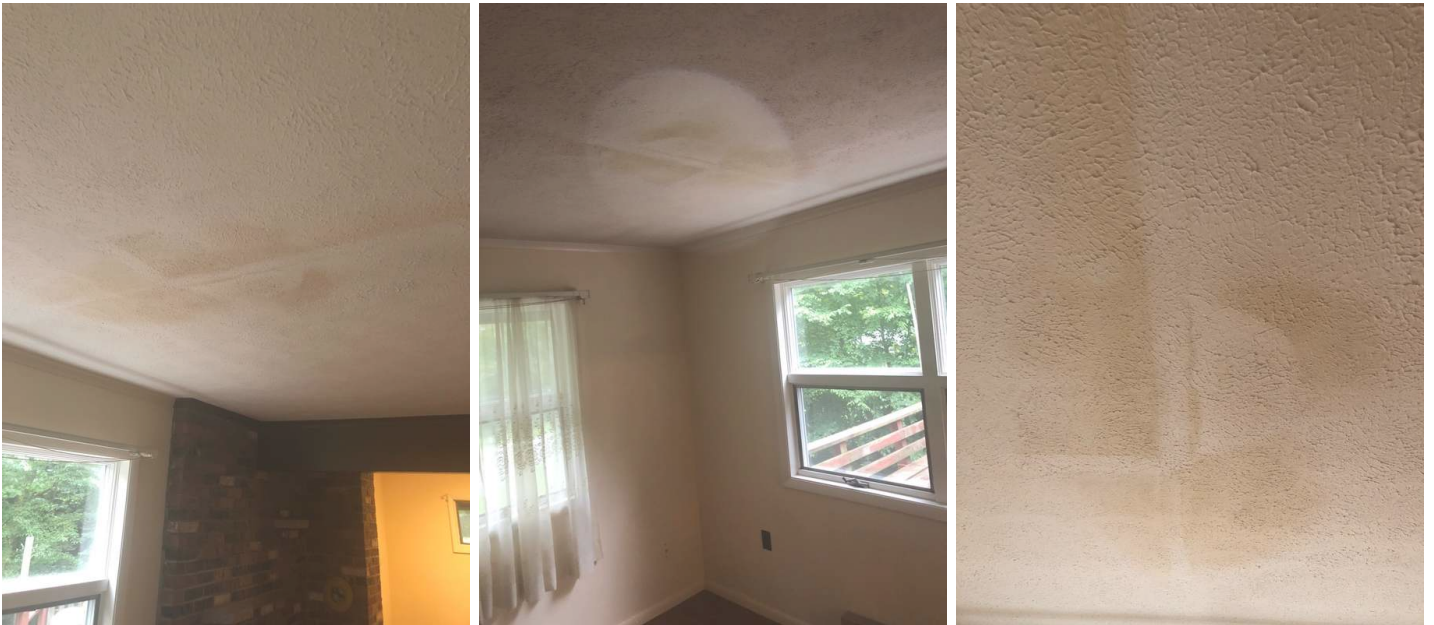
11.5.1 Ceilings

STAIN(S) ON CEILING

LIVING ROOM

There is a stain on ceiling/wall that requires repair and paint. Source of staining should be determined however it appears to have been a single occurrence and minor in nature as no structural damage has occurred to the ceiling.

Contact a handyman or DIY project

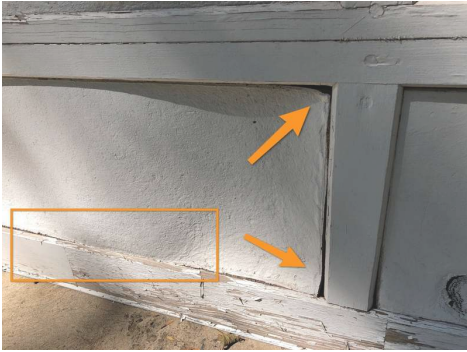
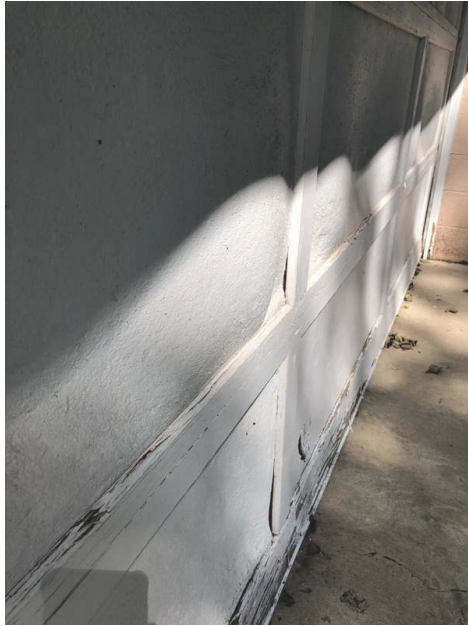
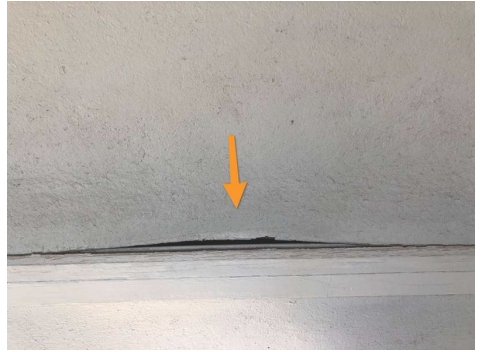
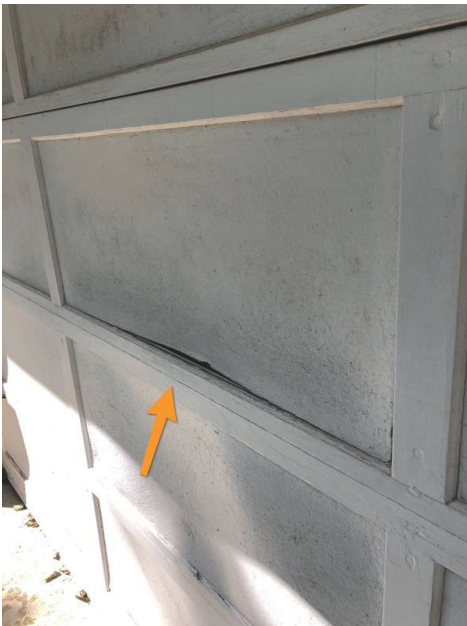
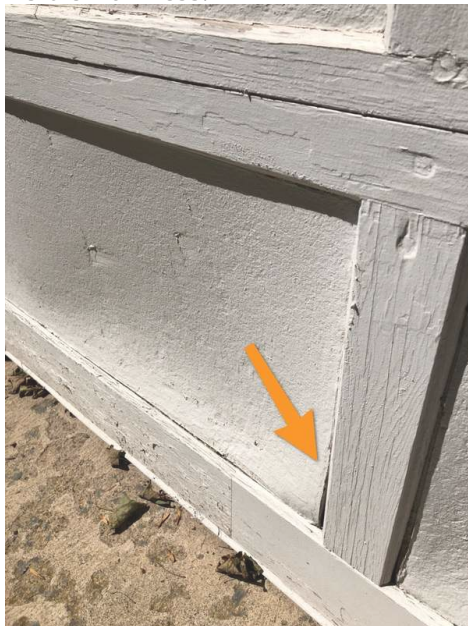
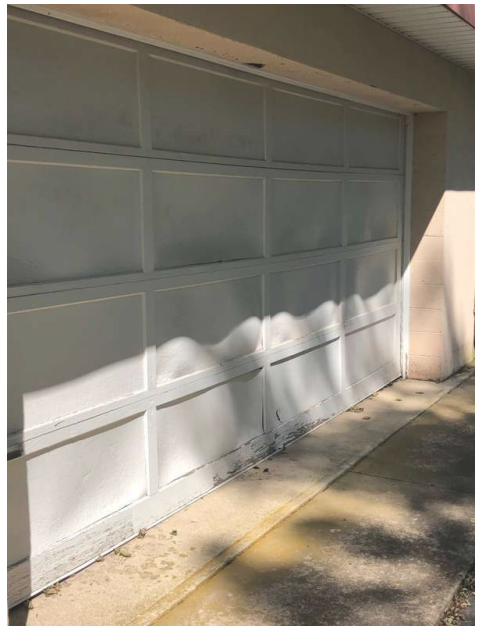
12.4.2 Garage Door
PANEL DAMAGE

Garage door panel is damaged and may need repair/replacement. Recommend a qualified garage door contractor evaluate.

The shadow line should be straight, in this photo the line is highlighting the condition of the door by the visible waviness.
