## SUMMARY

1234 Main St. San Diego CA 92154

Jerry Covarrubias  
InterNachi Certified Home Inspector  
Cova Home Inspections  
619-895-0582  
covahomeinspections@gmail.com

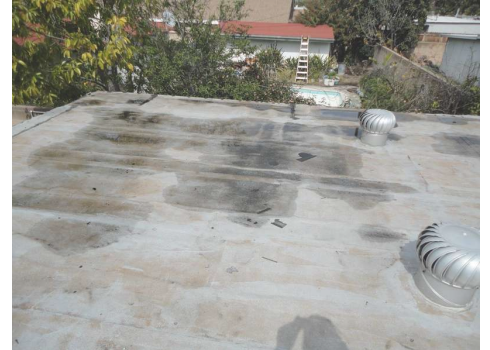
### 2.1.1 Coverings

#### PONDING

Observed ponding in one or more areas of roof. Ponding can lead to accelerated erosion and deterioration. Recommend a qualified roofing contractor evaluate and repair.

Contact a qualified roofing professional.

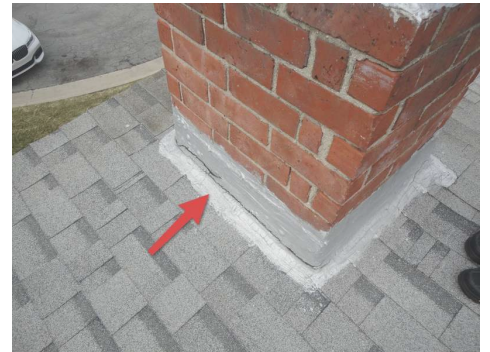
### 2.3.1 Flashings

#### CORRODED - MINOR

Roof flashing showed signs of corrosion, but are still in working condition. Flashing should be monitored to prevent severe corrosion leading to moisture intrusion.

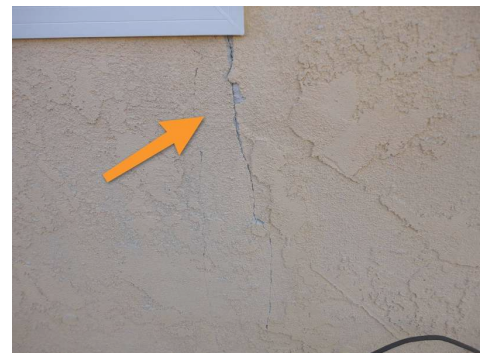
### 3.1.1 Siding, Flashing & Trim

#### CRACKING - MINOR

Siding showed cracking in one or more places. This is a result of temperature changes, and typical as homes with stucco age. Recommend monitoring.

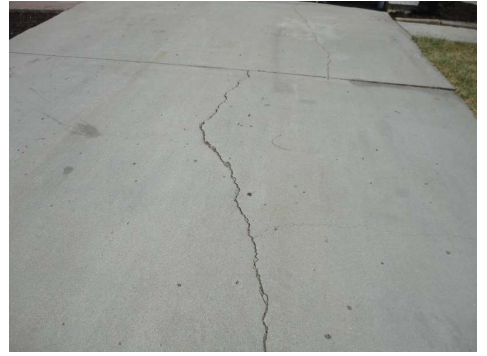
### 3.3.1 Walkways, Patios & Driveways

#### DRIVEWAY CRACKING - MINOR

Minor cosmetic cracks observed, which may indicate movement in the soil. Recommend monitor and/or have concrete contractor patch/seal.

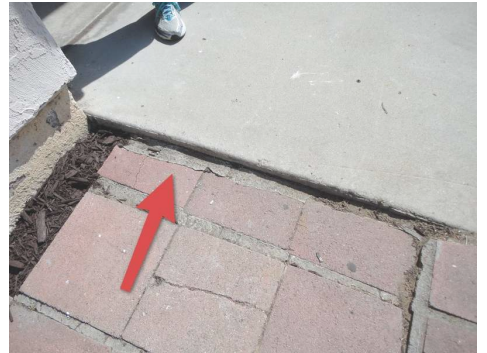
### 3.3.2 Walkways, Patios & Driveways

#### **DRIVEWAY TRIP HAZARD**

Trip hazards observed. Patch or repair recommended.

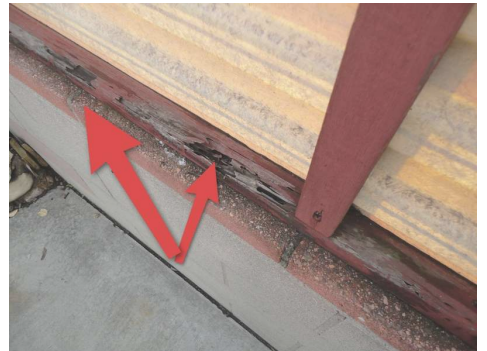
### 3.4.1 Decks, Balconies, Porches & Steps

#### **DECK - ROTTED BOARDS**

One or more deck boards are showing signs of rot. Recommend a qualified deck contractor replace.

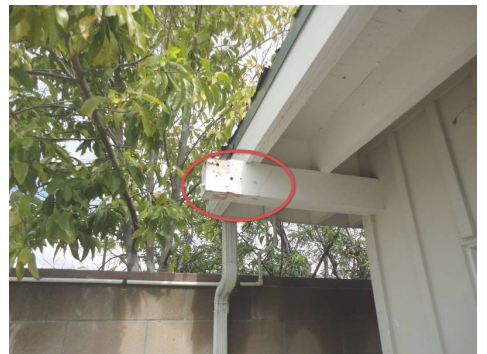
### 3.5.1 Eaves, Soffits & Fascia

#### **FASCIA - DAMAGED**

One or more sections of the fascia are damaged. Recommend qualified roofer evaluate & repair.

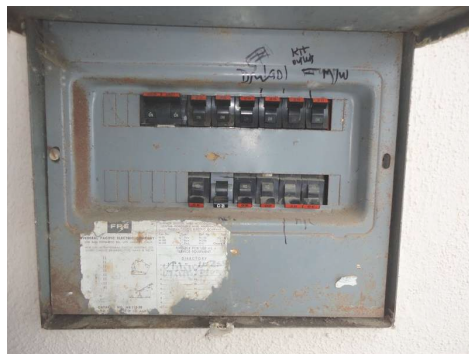
### 8.2.1 Main & Subpanels, Service & Grounding, Main Overcurrent Device

#### **MISSING LABELS ON PANEL**

At the time of inspection, panel was missing labeling. Recommend a qualified electrician or person identify and map out locations.

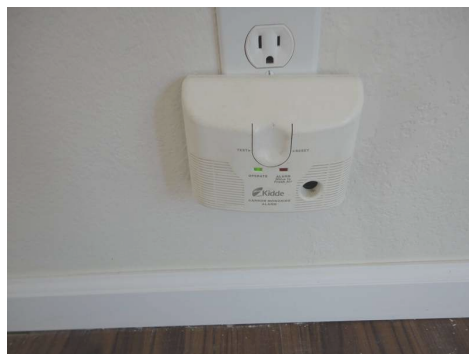
#### 8.7.1 Carbon Monoxide Detectors

### DEFECTIVE

Carbon monoxide detector is connected, but not functioning properly. Recommend replacement.

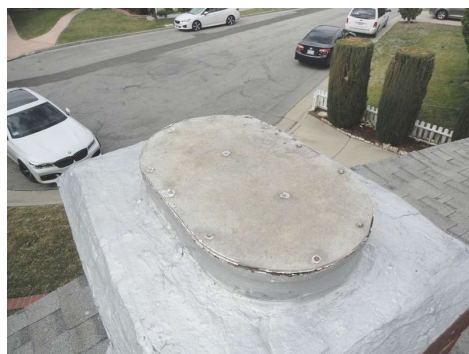
#### 9.1.1 Vents, Flues & Chimneys

### FIREPLACE

Blocked off flue for unknown reason unable to test fireplace.

Contact a qualified professional.

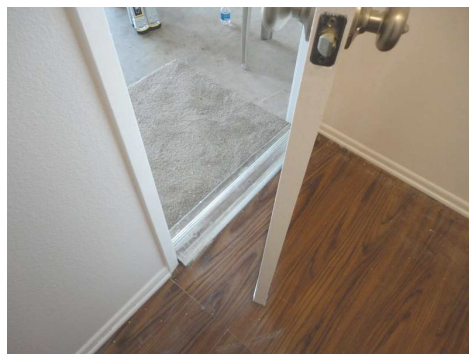
#### 11.1.1 Doors

### DOOR DOESN'T LATCH

Door doesn't latch properly. Recommend handyman repair latch and/or strike plate.

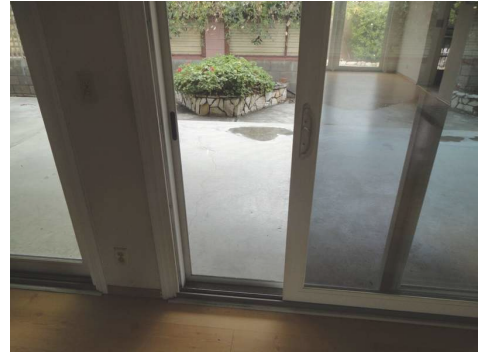
#### 11.2.1 Windows

### MISSING SCREEN

Window missing screen. Recommend replacement.

missing screen Dining Room

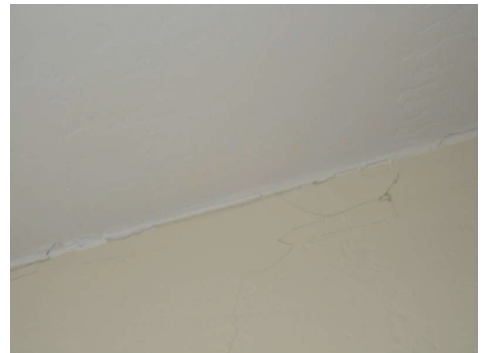
#### 11.4.1 Walls

### MINOR CORNER CRACKS

Minor cracks at the corners of doors and windows in walls. Appeared to be the result of long-term settling. Some settling is not unusual in a home of this age and these cracks are not a structural concern.

Contact a qualified handyman.

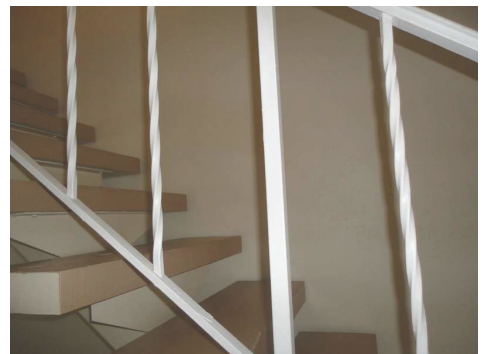
#### 11.6.1 Steps, Stairways & Railings

### BALUSTER SPACES TOO WIDE

The baluster space is not up to modern safety standards. The space between balusters should not allow passage of a 4 3/8-inch sphere for child safety. Recommend a qualified handyman or original installer repair and bring up to code.

Contact a qualified handyman.

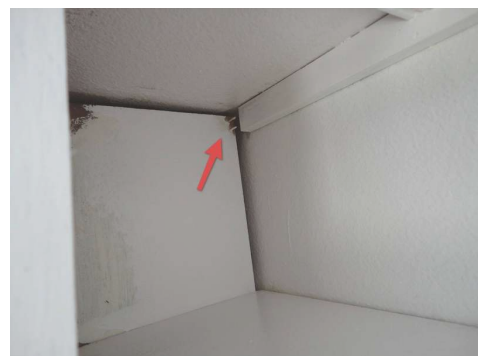
#### 11.7.1 Countertops & Cabinets

### CABINET SEPARATING FROM WALL

Cabinets are separating from ceiling or wall. Recommend a qualified cabinet contractor re-fasten cabinets securely.

Contact a qualified cabinet contractor.
