## DEFICIENCIES SUMMARY

1234 Main St. Everett WA 98201

Pierre Arcos  
WA License #691  
JAKE Home Inspections  
425-231-8983

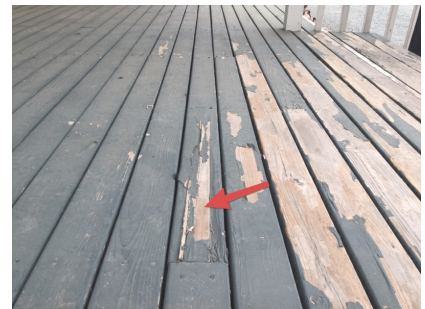
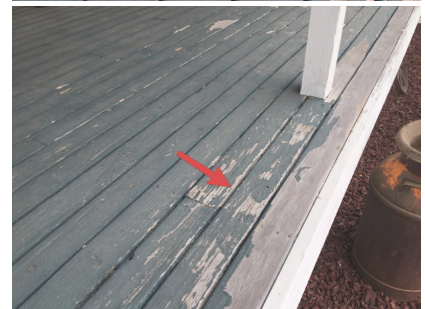
### 2.5.1 Front Steps

## DECK - ROTTED BOARDS

One or more deck boards are showing signs of rot. Recommend a qualified contractor replace.

Recommendation  
Contact a quality handyman.

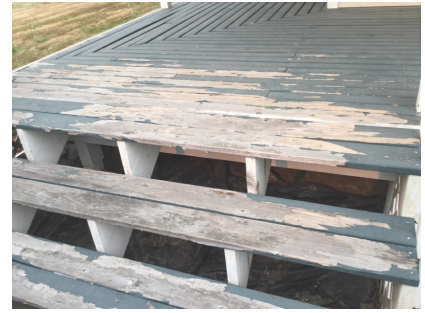
2.5.2 Front Steps

## DECK STEPS -PAINT

The finish is peeling off the deck steps. Have a licensed contractor scrape off the loose paint and then repaint to protect the wood from deterioration.

Recommendation  
Contact a qualified painter.

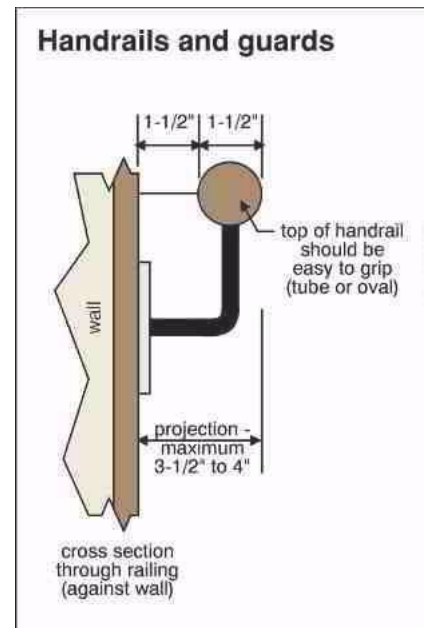
2.5.3 Front Steps

## MISSING HANDRAILS

Missing graspable handrails at steps. Have a licensed contractor install a graspable handrail at steps. Handrail should be continuous and uninterrupted.

Recommendation  
Contact a qualified deck contractor.

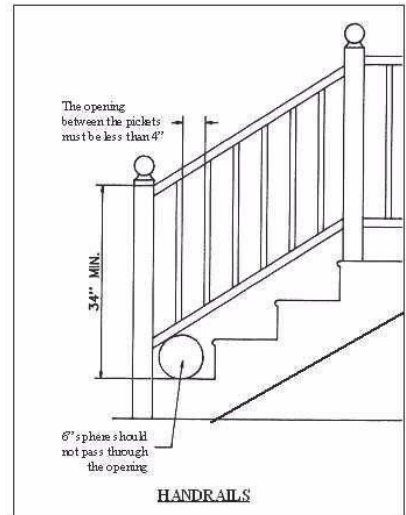
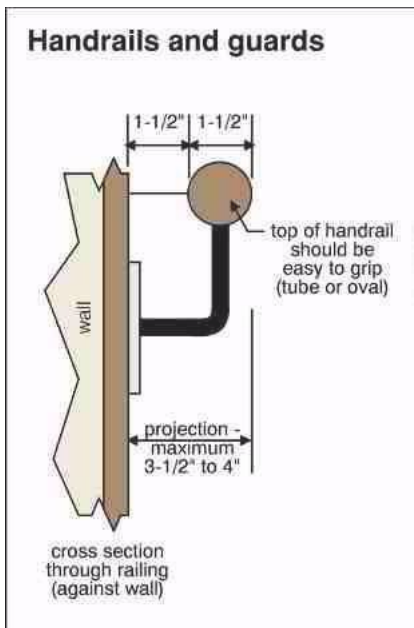
2.14.2 Back Steps

# MISSING HANDRAILS

Missing graspable handrails at steps. Have a licensed contractor install a graspable handrail at steps. Handrail should be continuous and uninterrupted.

Contact a qualified deck contractor.

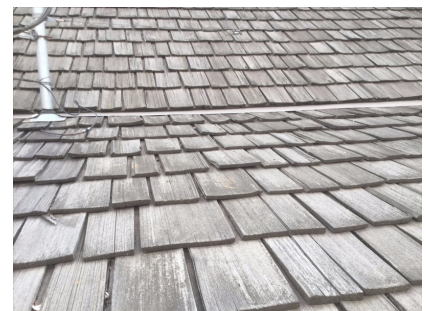
3.1.1 Coverings

# AGE

The shingles displayed overall wear. Recommend having a licensed contractor clean and seal the shingles to help them last longer.

Contact a qualified roofing professional.

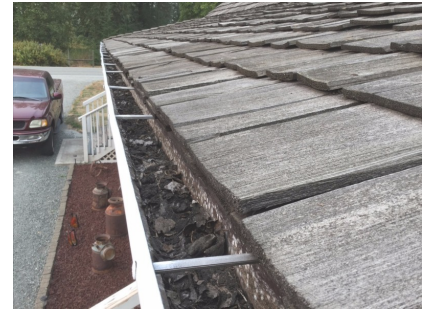
### 3.2.1 Roof Drainage Systems

## DEBRIS IN GUTTER

Debris has accumulated in the gutters. Recommend cleaning to facilitate water flow. Install basket strainers in the downspout openings in the gutters to help prevent debris from clogging the footing drains.

Recommendation  
Contact a quality handyman.

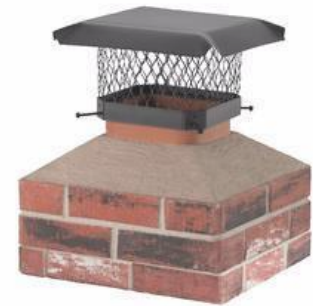
### 3.4.1 Chimneys

## CHIMNEY CAP MISSING

No chimney cap was observed. This is important to protect from moisture intrusion and protect the chimney. Recommend installing a cap over the flue opening.

Recommendation  
Contact a quality handyman.

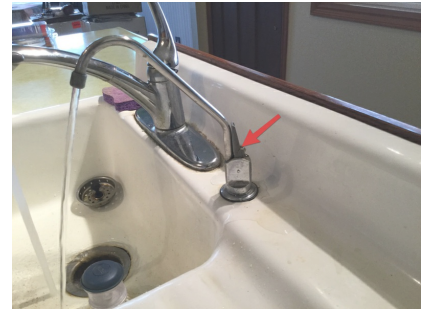
#### 4.3.1 Plumbing Fixtures

## FAUCET LEAK

Leaking faucet. The insta-hot faucet is leaking at the handle. Have a licensed contractor repair or replace the faucet.

Recommendation  
Contact a quality handyman.

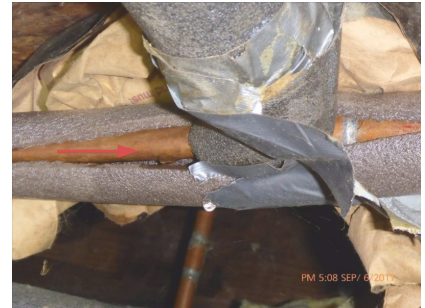
#### 4.3.2 Plumbing Fixtures

## LEAKING WATER SUPPLY PIPE

There are water leaks in the water supply lines. It cannot be determined where or how many leaks there are. Have a licensed plumber repair all of the water supply leaks.

Recommendation  
Contact a qualified plumber.

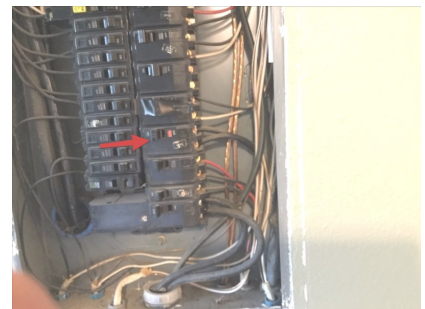
#### 5.2.1 Electric Panel

## BREAKER TRIPPING

The range circuit breaker trips when all burners and the oven are turned on. It is unknown if the issue is with the range or with the electric circuit. Have the proper licensed contractor evaluate the issue and make required repairs/replacement.

Recommendation  
Contact a qualified electrician.

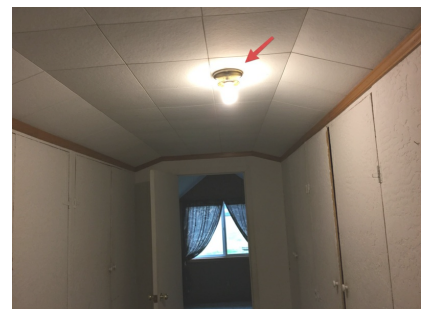
#### 5.4.1 Light Fixtures

## MISSING LIGHT SHADE

Install a new light shade to protect the light bulb from breakage.

Recommendation  
Recommended DIY Project

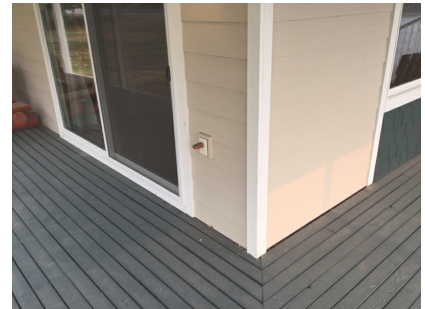
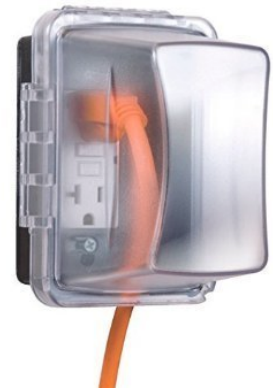
5.7.1 GFCI & AFCI

## MISSING GFCI RECEPTACLES AT EXTERIOR

Exterior electrical receptacles should be GFCI protected and be inside weatherproof boxes

GFCI receptacle inside weatherproof box

Contact a qualified electrician.

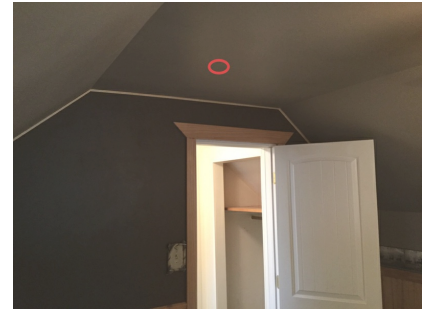
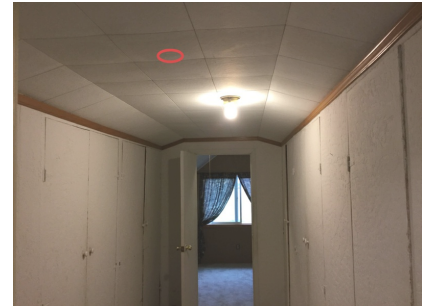
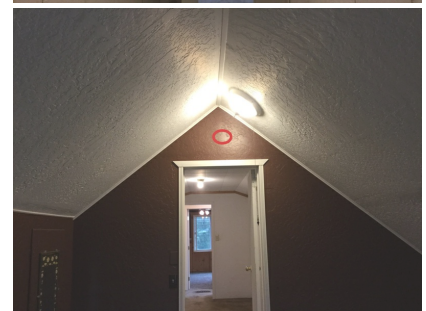
5.8.1 Smoke Alarms

# MISSING SMOKE ALARMS

A smoke alarm should be located in the hall adjacent to bedrooms and in each bedroom within three feet of the bedroom door. Install a new photoelectric smoke alarm in the hallway and bedrooms.

Contact a quality handyman.

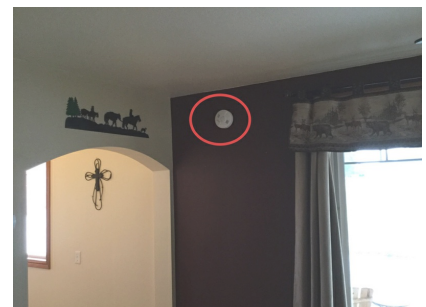
5.9.1 Carbon Monoxide Alarms

# DEFECTIVE

Carbon monoxide alarm is connected, but not functioning properly. Recommend replacement.

Recommended DIY Project

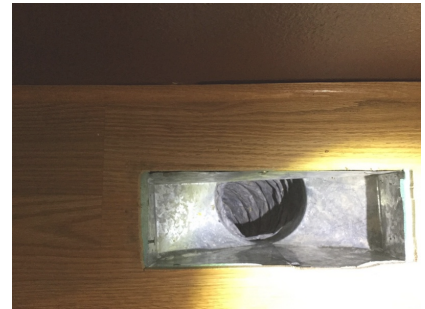
### 6.2.1 Distribution Systems

## DIRTY DUCTS

Ducts are dirty. Have a licensed contractor clean out the duct work.

Contact a qualified professional.

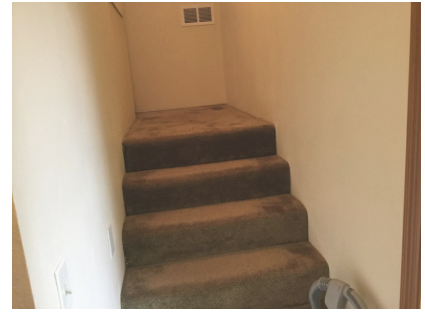
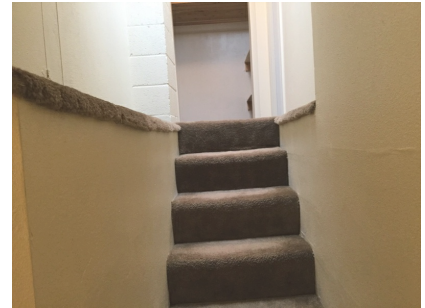
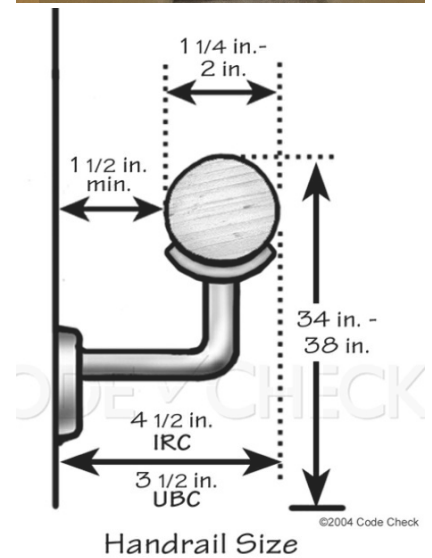
7.4.1 Railings

# NO GRASPABLE HANDRAIL

Staircase had no handrails. This is a safety hazard. Recommend a qualified handyman install a graspable handrail.

Recommendation  
Contact a quality handyman.

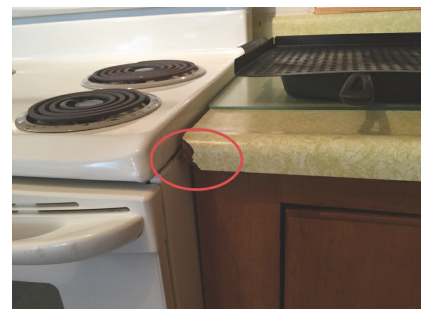
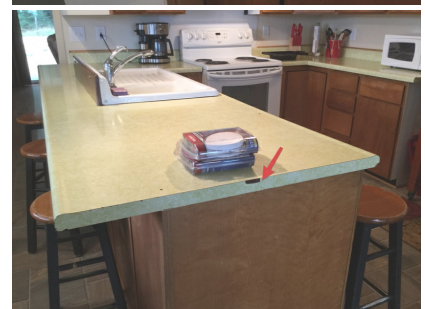
7.6.1 Countertops & Cabinets

# COUNTERTOP CRACKED/CHIPPED

Countertop had one or more cracks or chips. Recommend qualified countertop contractor evaluate and repair.

Recommendation  
Contact a qualified countertop contractor.

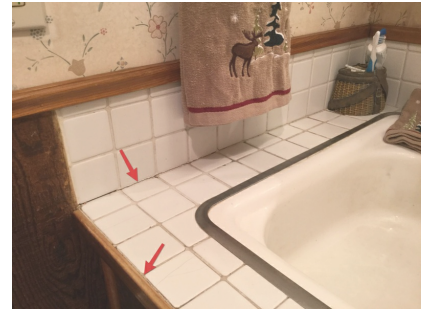
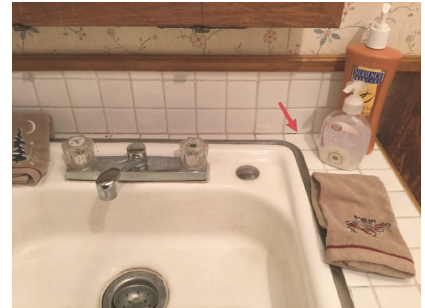
7.6.2 Countertops & Cabinets

# GROUT DETERIORATING

Grout lines were cracked or deteriorated. Recommend a qualified contractor repair or replace grout.

Contact a qualified countertop contractor.

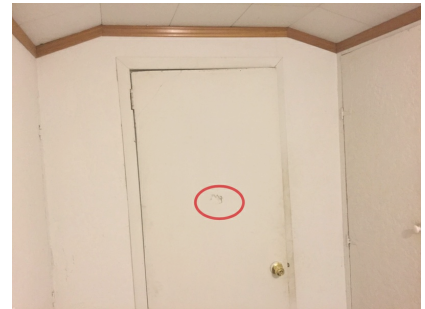
7.7.1 Doors

# DAMAGED DOOR

Repair or replace the damaged door.

Contact a quality handyman.

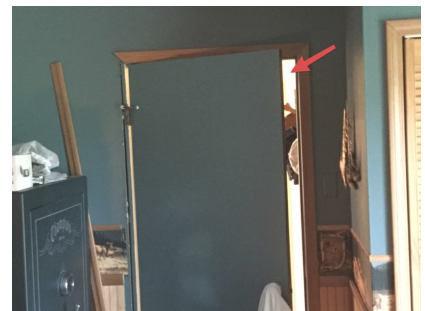
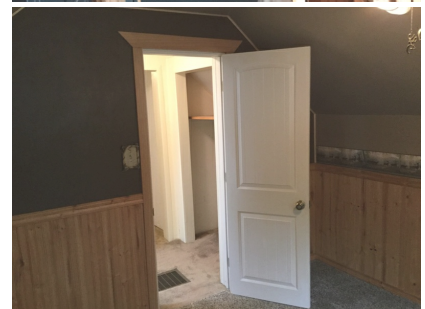
7.7.2 Doors

# DOOR IS BINDING

Door sticks and does not open smoothly. Recommend having a licensed contractor adjust the door.

Contact a quality handyman.

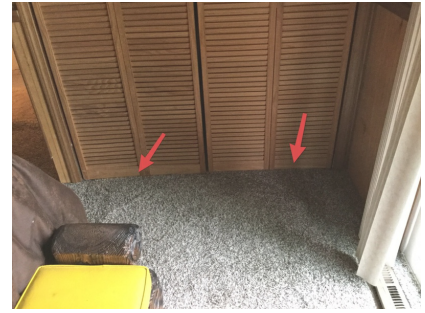
### 7.7.3 Doors

## DOOR RUBBING CARPET

Interior door is rubbing against the carpet. Have a licensed contractor trim about 1 to 2 inches off the bottom of the door so that there is a gap between the bottom of the door and the carpet.

Contact a quality handyman.

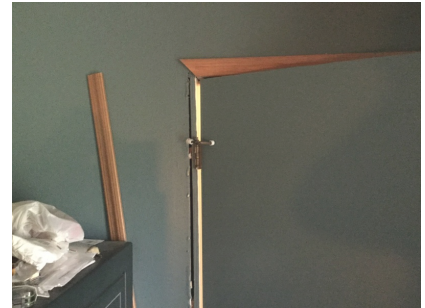
### 7.12.1 Trim

## MISSING TRIM

Trim boards are missing throughout the house. Have a licensed contractor install trim at door frames, window frames, floor base and ceiling.

Contact a qualified carpenter.

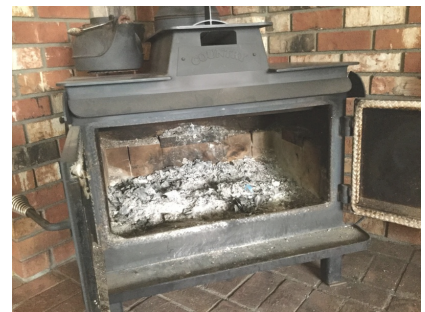
### 8.1.1 Fireplaces, Stoves & Inserts

## FIREBOX DIRTY

Clean out the fire box. Have a licensed contractor check the flue for creosote. Clean as needed.

Contact a qualified chimney contractor.

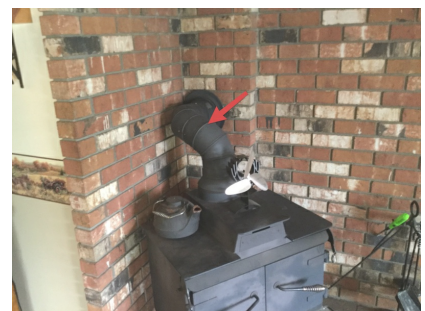
### 8.3.1 Chimney & Vent Systems

## CONDITION OF FLUE UNKNOWN

The chimney flue was not visible for inspection. Have a licensed contractor clean the flue before using the pellet stove.

Contact a qualified chimney contractor.

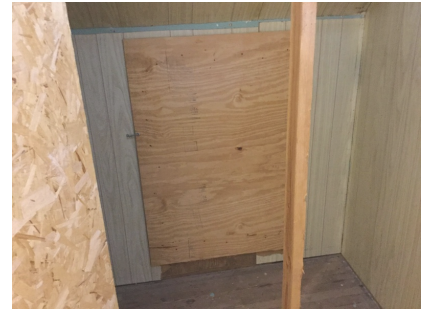
9.1.1 Attic Insulation

## ATTIC HATCH

Attic hatch does not fit properly. Attic air is escaping into the living area. Replace the hatch cover with a new one or install weatherstripping around the door opening to make it air-tight.

Recommendation  
Recommended DIY Project

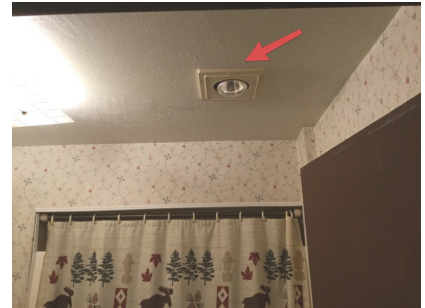
9.4.1 Exhaust Systems

## DIRTY EXHAUST FANS

Have a licensed contractor clean all bathroom, laundry and kitchen exhaust fans to ensure they are working effectively at removing excess moisture from the house. Excess moisture in the house can lead to mildew and mold.

Recommendation  
Contact a qualified professional.

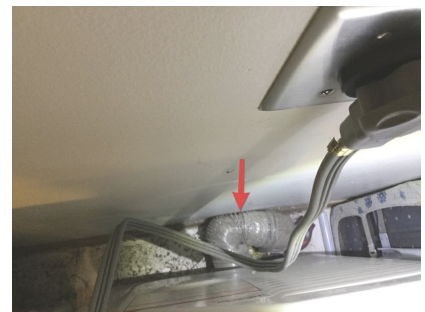
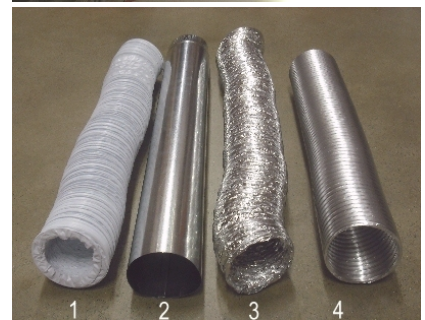
9.4.2 Exhaust Systems

## VINYL DRYER DUCT

Vinyl dryer duct is susceptible to melting when lint is allowed to build up inside. Recommend replacing the vinyl duct with a rigid metal duct to reduce the chance of lint build up and potentially catching fire.

#2 or #4 best ducts for dryers

Recommendation  
Contact a quality handyman.

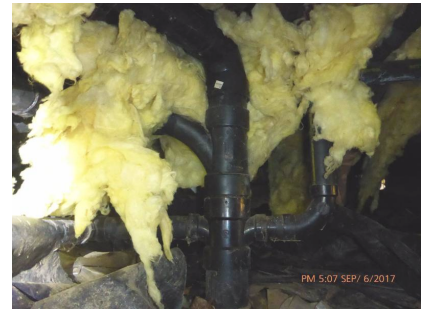
9.5.2 Crawlspace / Basement Insulation

## MISSING INSULATION

Insulation is missing from between the floor joists. Install new insulation where missing.

Recommended DIY Project
