SUMMARY
1234 Main St. Apopka Florida 32712
Buyer Name
03/06/2019 9:00AM

Jim Reynolds
License HI11043
Full Circle Home Inspectors
352-459-6173
jim@fullcirclehomeinspectors.com

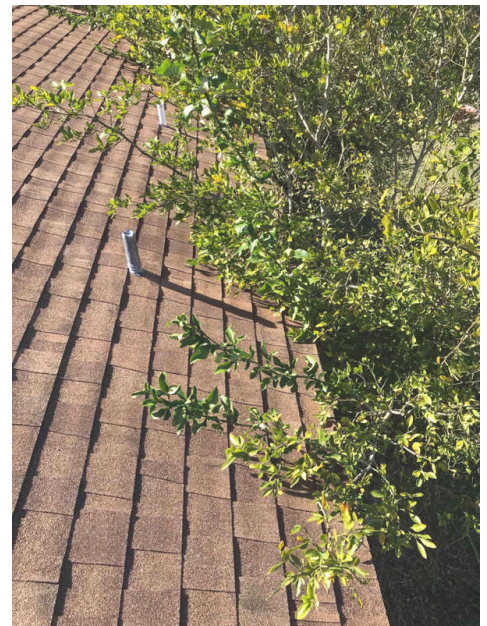
2.1.1 General

VEGETATION IN CONTACT OR OVERHANGS

Vegetation such as trees, shrubs, and/or vines overhung the roof surface or were in contact with the roof edge. Organic debris such as leaves or needles are likely to accumulate in gutters and on the roof surface. Gutters can overflow and cause water to come in contact with the building exterior or water can accumulate around the foundation. This is a conducive condition for wood-destroying organisms. Vegetation in contact with the roof can damage the roof surface and/or the roof drainage system. Recommend pruning vegetation so as to not be in contact with the roof and to not overhang the roof surface. If vegetation is too tall then it should be pruned at least 10 feet above the roof surface.

Recommendation
Contact a qualified tree service company.

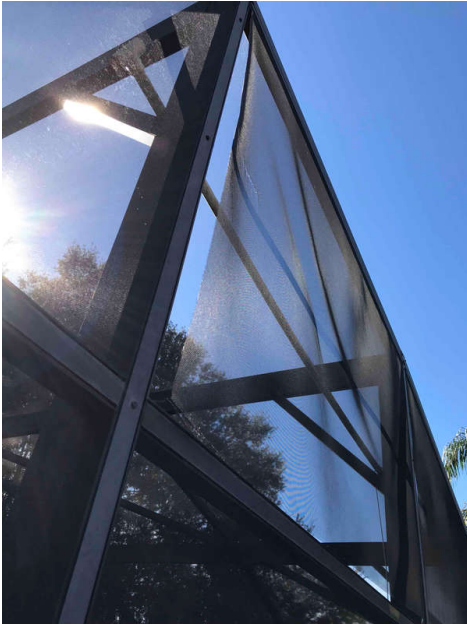
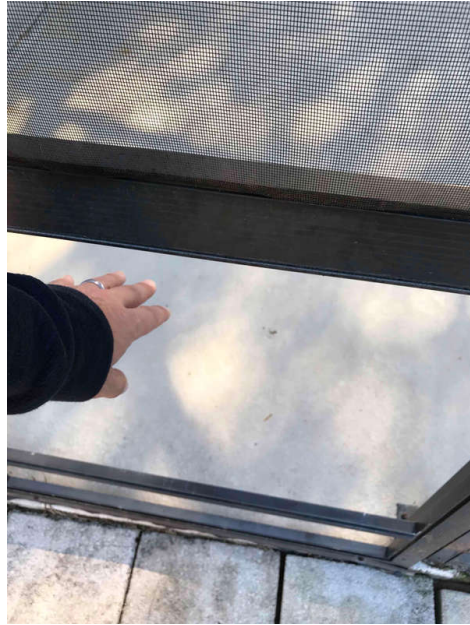
3.2.1 Driveway, Walkway, Patio

SCREEN ENCLOSURE-SCREENS TORN

One or more screens are torn or missing in the frame(s) of the screen patio. A certified contractor should make the necessary repairs.

Recommendation
Contact a qualified handyman.

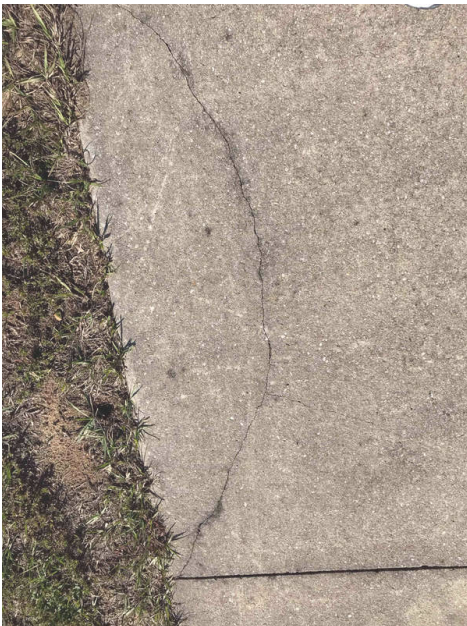
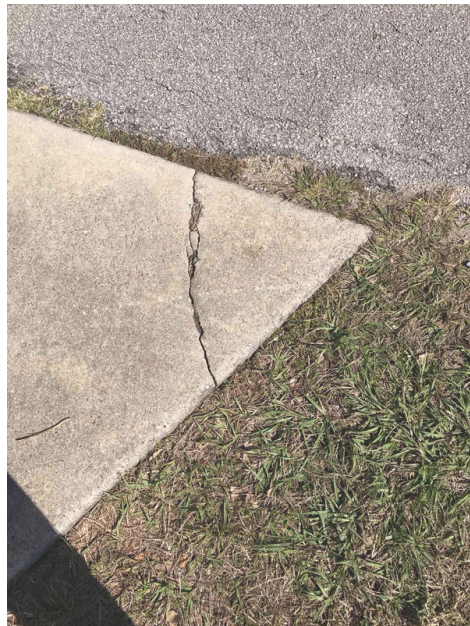
3.2.2 Driveway, Walkway, Patio
MINOR DRIVEWAY CRACK

Observed one or more hairline cracks in driveway. Should monitor for settlement.

Recommendation
Contact a qualified professional.

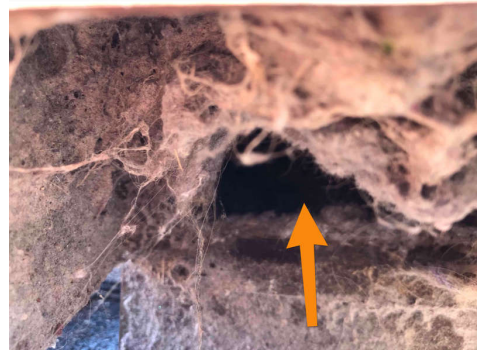
3.3.1 Exterior issues
DRYER VENT CLOGGED
ROOF

The dryer vent is clogged and needs to be cleaned. A clogged dryer vent can lead to dryer failure and extended dry times.

Recommendation
Contact a qualified professional.

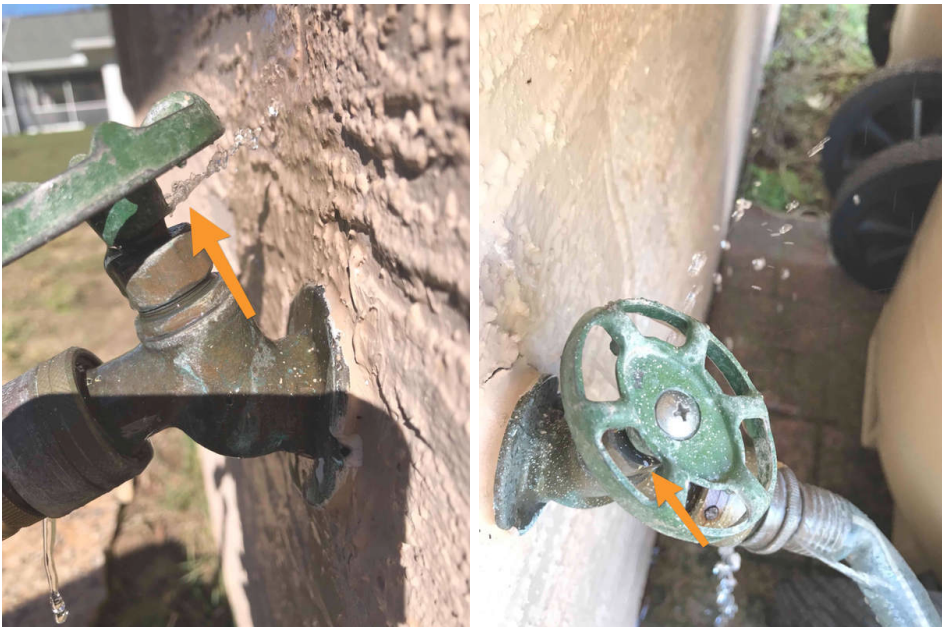
3.3.2 Exterior issues

HOSE BIBB LEAK

One or more hose bibbs was observed to leak when in the on position. This is usually from corrosion around the packing nut, recommend repair or tightening upon evaluation from a qualified person.

Recommendation
Contact a qualified professional.

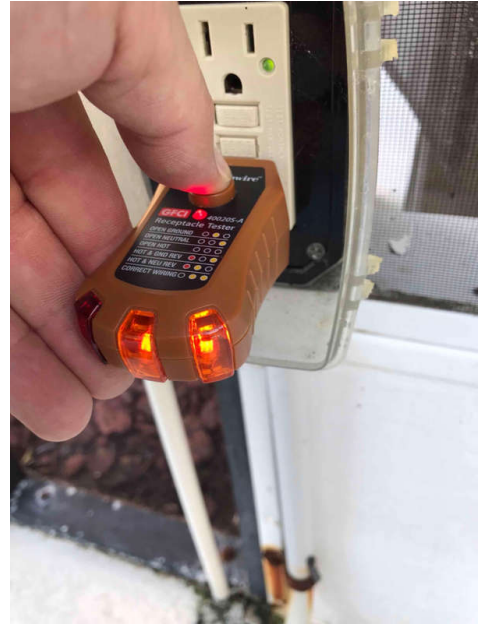
3.4.1 Electrical

GFCI ISSUE

POOL AREA

One or more ground fault circuit interrupter (GFCI) receptacles (outlets) were not functioning properly (would not trip/would not reset). Recommend a licensed electrical contractor replace with new GFCI outlet.

Recommendation
Contact a qualified electrical contractor.

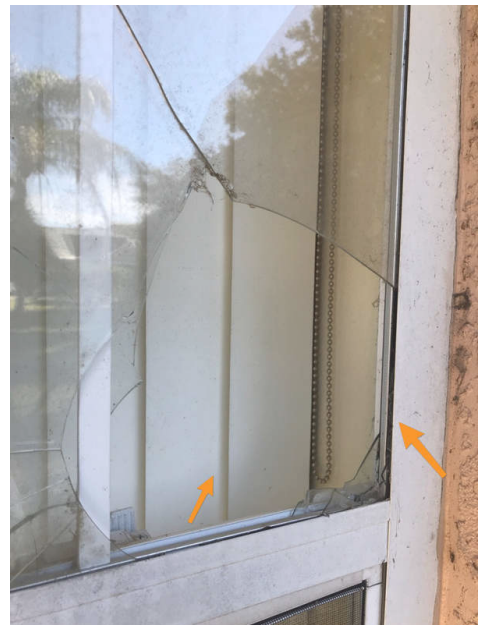
3.5.1 Windows and Door

BROKEN WINDOW

There is a broken window for one of the windows. A licensed window repair contractor should replace the glass as needed.

Contact a qualified window repair/installation contractor.

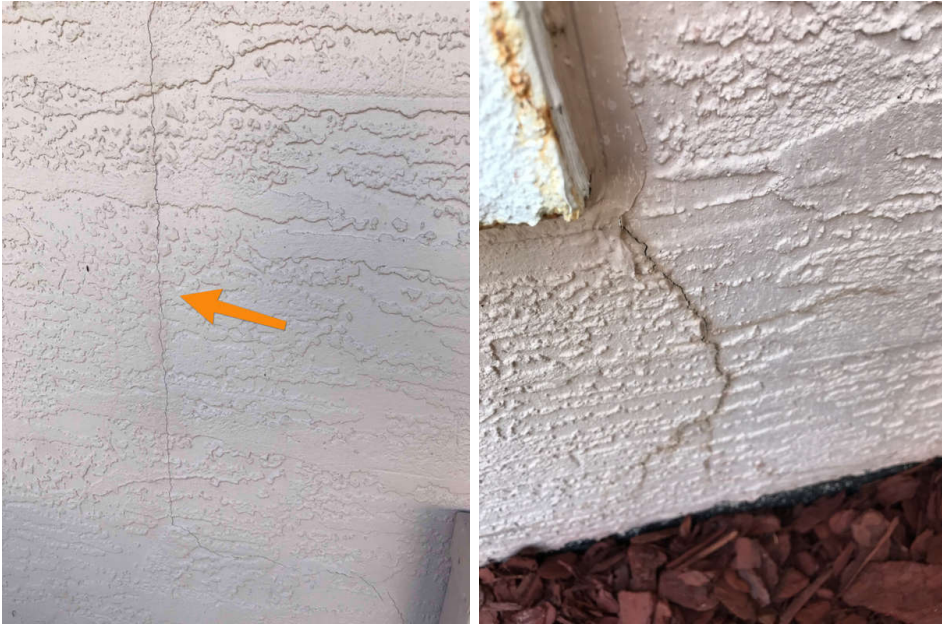
3.8.1 Stucco Walls

HAIRLINE STUCCO CRACKING

One or more minor hairline cracks were found in the stucco or wall areas. It is unknown the age of these cracks. At the time of inspection nothing out of the ordinary of normalized cracking was noticed. Recommend caulking and painting these areas, along with monitoring for future movement/widening. Stucco cracks over framing can allow moisture penetration behind wall areas and can potentially damage sheathing/framing. Note that areas concealed behind walls are not able to be evaluated without invasive testing and cannot be evaluated.

Recommended DIY Project

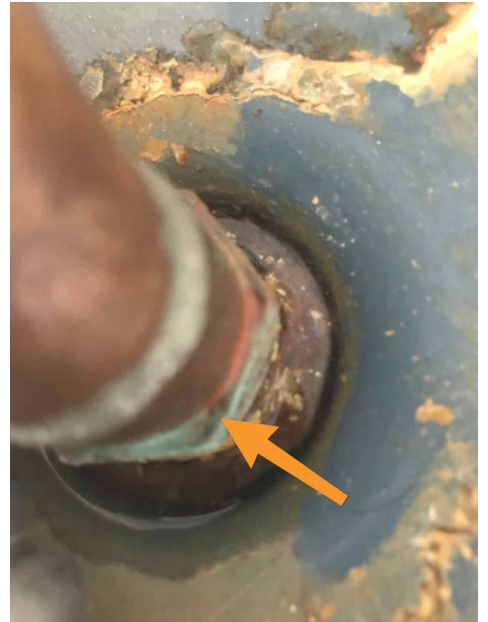
5.1.1 Water Heater

CORROSION ON FITTING/LINES

Corrosion was found on fittings and/or water supply lines for the water heater. Leaks may exist. A qualified plumbing contractor should evaluate and repair as necessary.

Contact a qualified plumbing contractor.

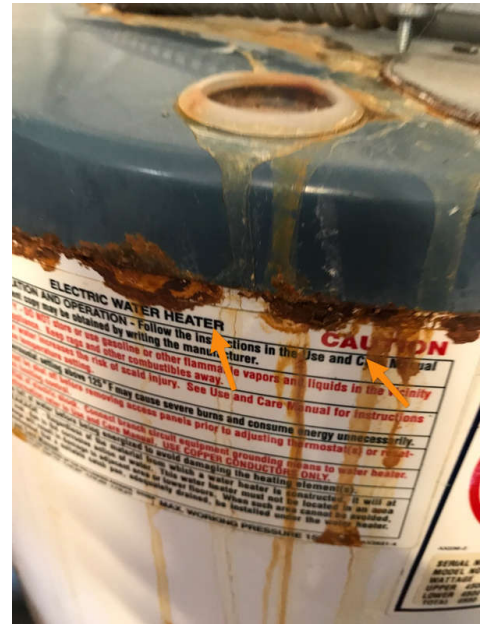
5.1.2 Water Heater

CORROSION ON TANK

Corrosion was found in one or more areas on the water heater. The water heater may be failing. A qualified plumbing contractor should evaluate and replace or repair water heater if necessary.

Contact a qualified plumbing contractor.

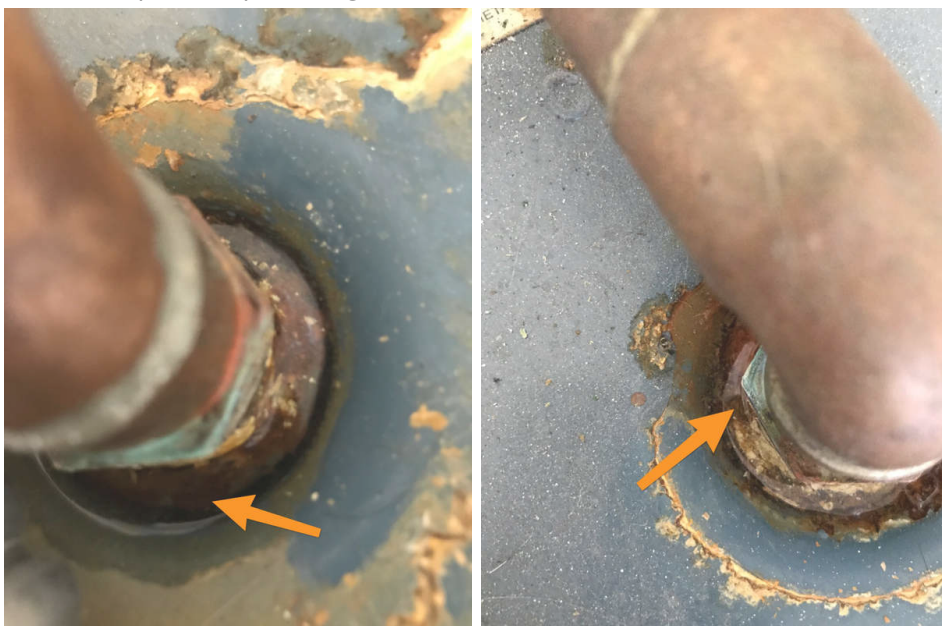
5.1.4 Water Heater

LEAK SUPPLY PIPE/FITTING

One or more active leaks were found at the water heater's supply pipes, valves, or fittings. A qualified plumber should evaluate and repair as necessary.

Contact a qualified plumbing contractor.

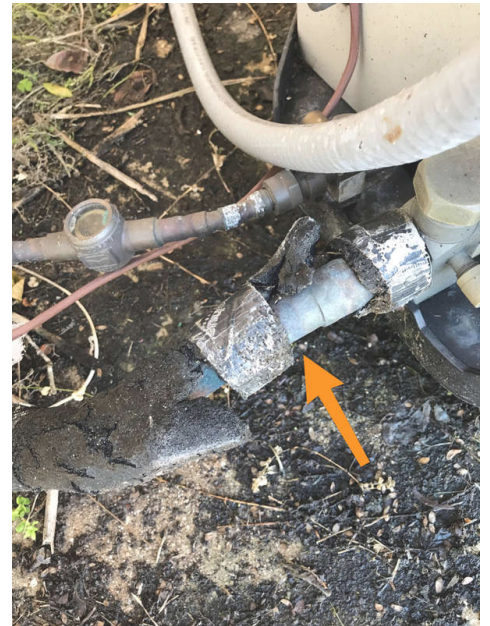
7.2.1 Condensing Unit

LINE INSULATION

Insulation for the outside condensing unit's refrigerant lines is damaged, deteriorated and/or missing in one or more areas. This may result in reduced efficiency and increased energy costs. A qualified heating and cooling contractor should replace insulation as necessary.

Contact a qualified HVAC professional.

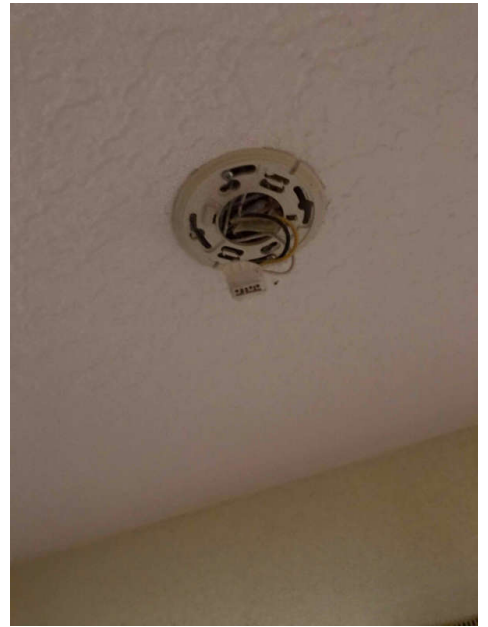
9.3.1 Smoke and CO alarms

SMOKE ALARM MISSING/DAMAGE

One or more smoke alarms were damaged, or missing components. Smoke alarms should be replaced as necessary.

Contact a qualified electrical contractor.

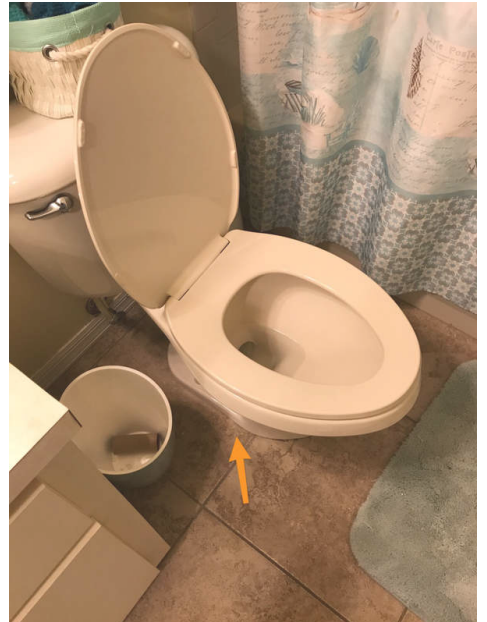
10.8.1 Toilets

LOOSE

One or more toilets are loose. A qualified contractor should remove the toilet(s) for further evaluation and repairs if necessary. A new wax ring should be installed and toilet(s) should be securely anchored to the floor to prevent movement and leaking.

Contact a qualified plumbing contractor.

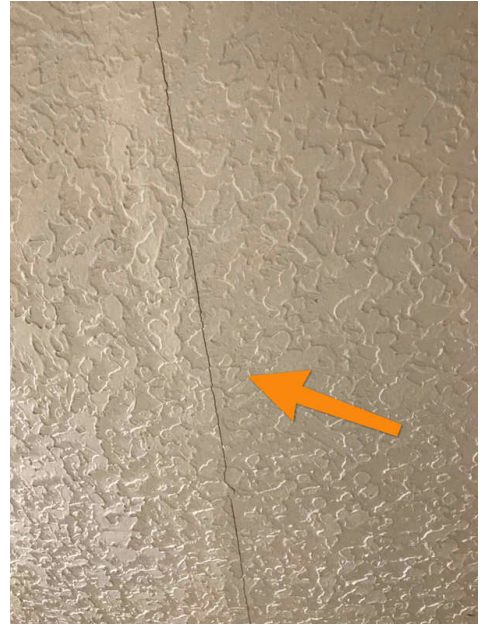
11.3.1 Floors, walls, Ceiling

MINOR CRACKS CEILING

Minor cracks were found in ceilings in one or more areas. They do not appear to be a structural concern, but the client(s) may wish to repair these for aesthetic reasons.

Contact a qualified professional.

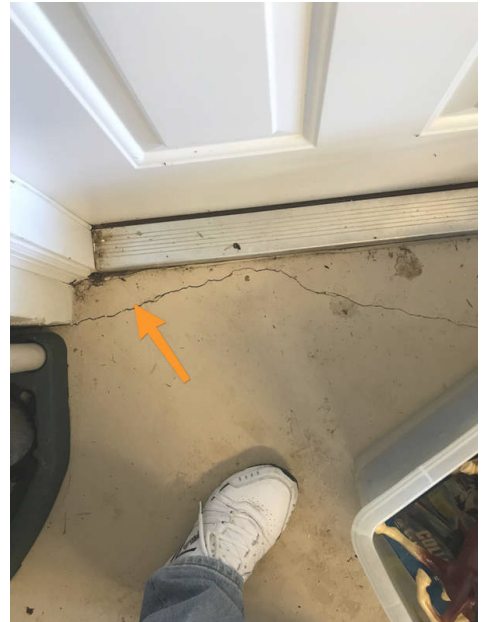
11.3.2 Floors, walls, Ceiling

MINOR FLOOR CRACKS

The concrete floor of the garage has some minor cracking. These cracks do not appear to be of structural concerns. The client should monitor these cracks.

Contact a qualified professional.

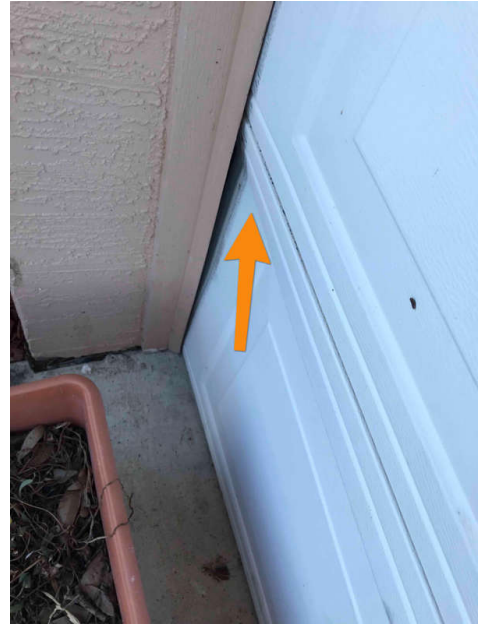
11.4.1 Vehicle door

REPAIR/REPLACE

The garage vehicle door is damaged or deteriorated. A qualified contractor should evaluate and repair or replace the door if necessary.

Contact a qualified garage door contractor.

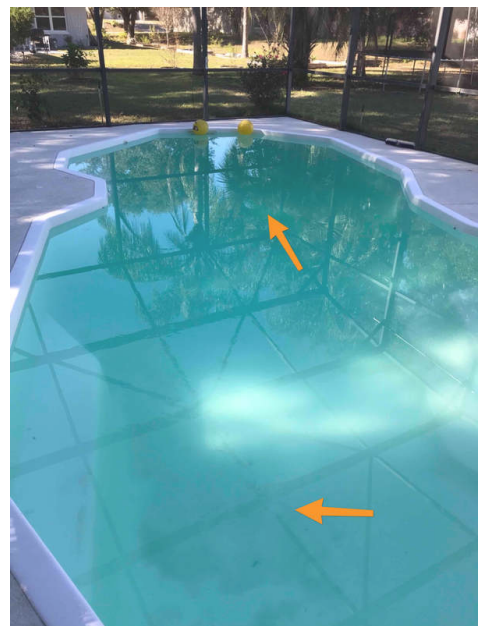
12.3.1 Water
CLOUDY

The pool water was cloudy, dull or hazy. This is a potential safety hazard because it can interfere with rescuing swimmers in trouble and reduce divers' depth perception. Cloudy water may be caused by poor filtration and/or sanitation. Recommend consulting with a pool specialist.

Recommendation
Contact a qualified Swimming Pool Contractor

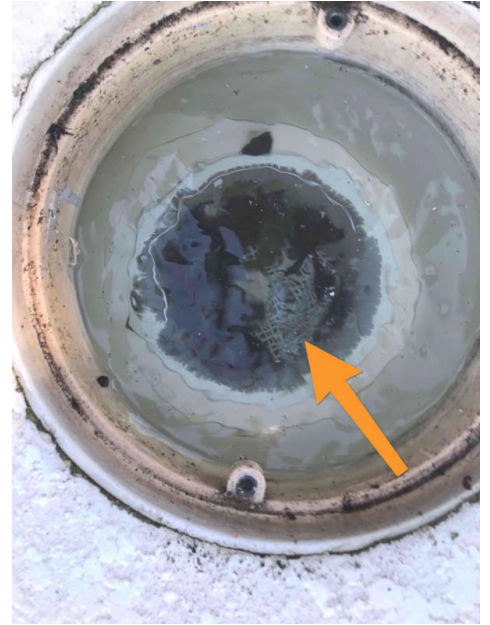
12.4.1 Pool and decking
CLEAN SKIMMER

The pool skimmer has debris in the basket. The debris needs to be removed to allow the skimmer to function properly.

Recommended DIY Project

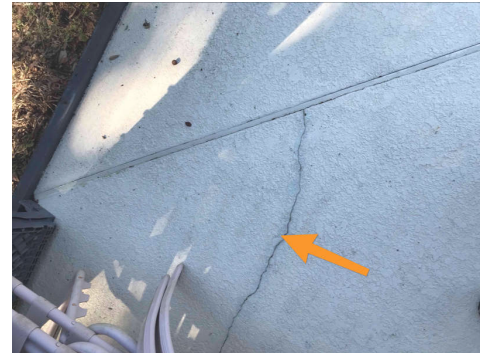
12.4.2 Pool and decking

DECK CRACKING

The pool deck has some deck cracking. It does not appear to be structural at this time, but it is recommended to monitor the area(s) in concern in the future.

Contact a qualified concrete contractor.
