**SUMMARY**  
1234 Main St.Appomattox VA 24522  
Buyer Name  
03/27/2018 9:00AM

Mike Green  
Virginia License # 3380000956  
Evergreen Home Inspections LLC  
434-808-2171  
ehillc2209@gmail.com

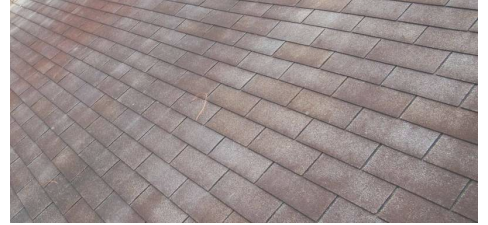
### 2.1.1 Coverings

#### **DISCOLORATION**

Roof shingles were discolored, which can be caused by moisture, algae, rust or soot. Recommend a qualified roofing contractor evaluate and remedy with a roof cleaning or repair.

Contact a qualified roofing professional.

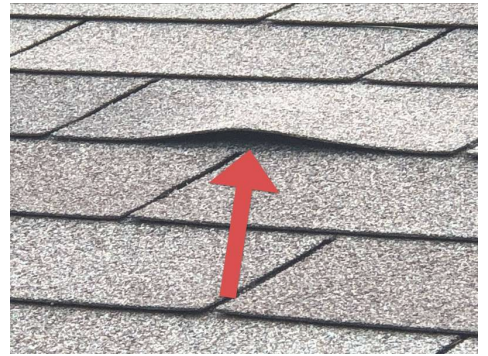
### 2.1.2 Coverings

#### **NAIL POPPING**

Nails have popped up in one or more areas. These areas will eventually allow moisture intrusion which will eventually cause structural damage. Recommend having repaired by a qualified roofer.

Contact a qualified roofing professional.

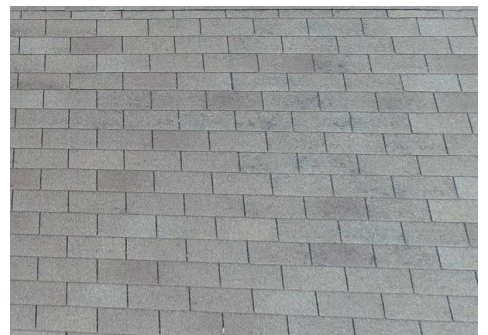
### 2.1.3 Coverings

#### **GRANULES MISSING**

Asphalt shingles had suffered noticeable uniform granule loss across the roof. Uniform granule loss is not considered by insurance companies or manufacturers to be a defective condition, but a natural result of the aging process. The bond between asphalt and granules deteriorates over time as asphalt loses volatile compounds, dries and shrinks. It does not affect the ability of the shingles to shed water.

Recommend monitoring.

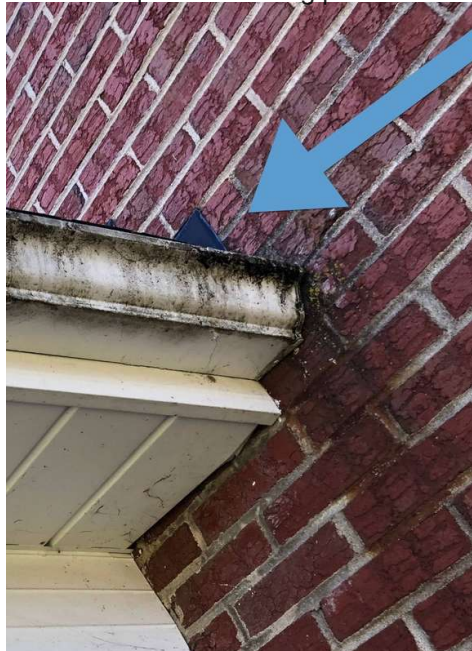
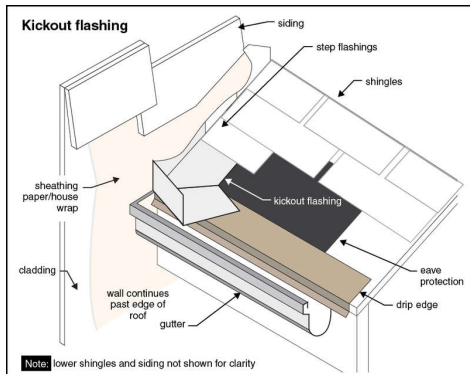
### 2.2.1 Flashings

#### **NO KICK OUT FLASHING**

The home had no kick-out flashing installed where walls extended past roof edges. Kick-out flashing is designed and installed to divert water from behind the exterior wall covering at areas of the home where a sidewall extends out past a connecting roof eave. This condition may allow moisture intrusion of the exterior wall covering. Moisture intrusion of the wall structure can damage home materials and encourage the growth of mold. Long term moisture intrusion can cause structural damage from wood decay. The Inspector recommends that before the expiration of your Inspection Objection Deadline, you consult with a qualified roofing contractor to discuss options and costs for replacement.

Contact a qualified roofing professional.

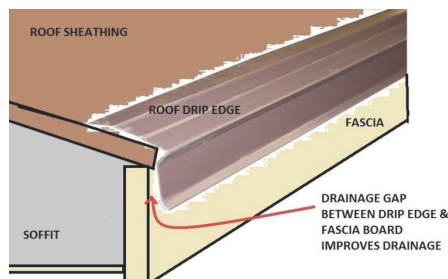
2.3.1 Drip Edge Flashing

**MISSING**

Flashings were missing at time of inspection. Flashings provide protection against moisture intrusion. Drip edge flashing prevents rain runoff from destroying fascia board and roof sheathing. Recommend a qualified contractor evaluate and remedy.

Drip Edge Flashing

Contact a qualified roofing professional.

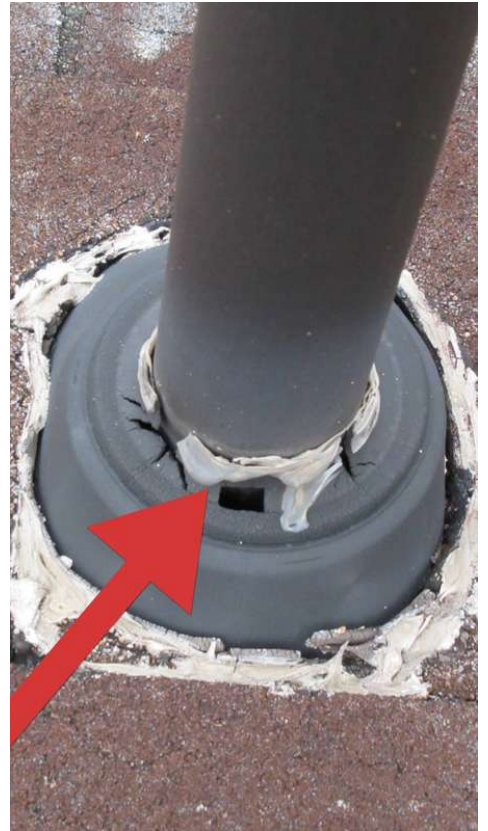
2.5.1 Plumbing vents and other roof penetrations

**VENT PIPE BOOTS DETERIORATED**

One or more vent pipe boots have deteriorated allowing moisture to enter attic area. I recommend repair/replacement.

Contact a qualified roofing professional.

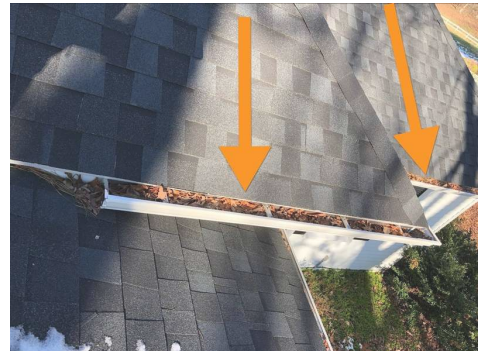
### 2.6.1 Roof Drainage Systems

#### **DEBRIS**

Debris has accumulated in the gutters. Recommend cleaning to facilitate water flow.

Contact a handyman or DIY project

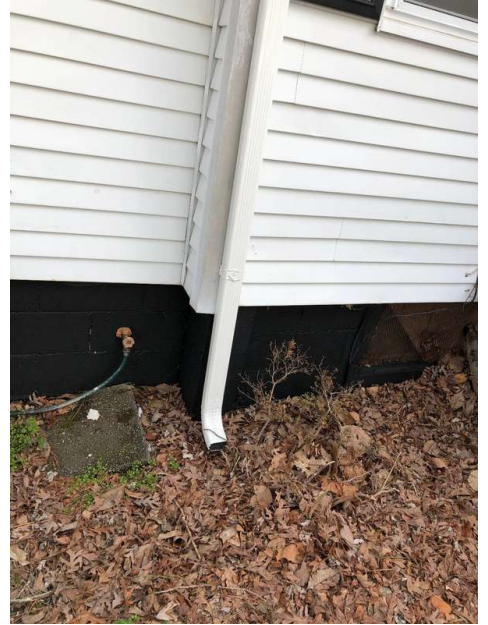
### 2.6.2 Roof Drainage Systems

#### **DOWNSPOUTS DRAIN NEAR HOUSE**

##### BACK OF HOUSE

One or more downspouts drain too close to the home's foundation. This can result in excessive moisture in the soil at the foundation, which can lead to foundation/structural movement and a wet basement/crawlspace. Recommend adjusting downspout extensions to drain at least 6 feet from the foundation.

Contact a handyman or DIY project

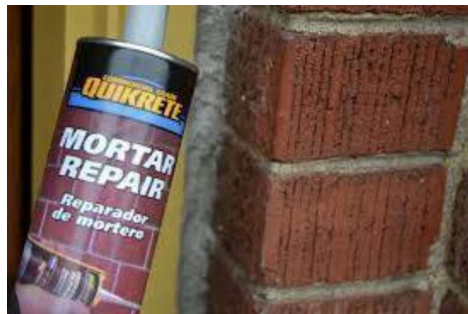
### 3.1.1 Siding, Flashing & Trim

## BRICK MORTAR CRACKING-MINOR

SEVERAL LOCATIONS AROUND HOUSE

Recommend filling brick mortar cracks with mortar (repointing) or a mortar sealant to prevent further damage from moisture intrusion.

Contact a handyman or DIY project

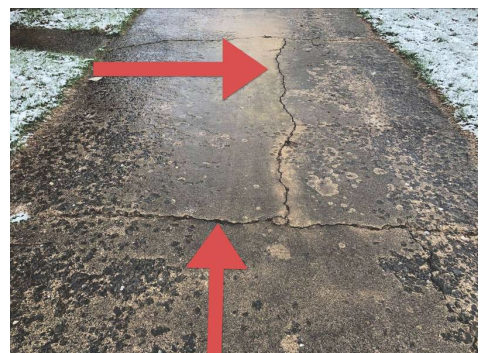
### 3.2.1 Walkways, Patios & Driveways

## CONCRETE DRIVEWAY CRACKING - MAJOR

Major cracks observed. Recommend concrete contractor evaluate and repair.

Contact a qualified concrete contractor.

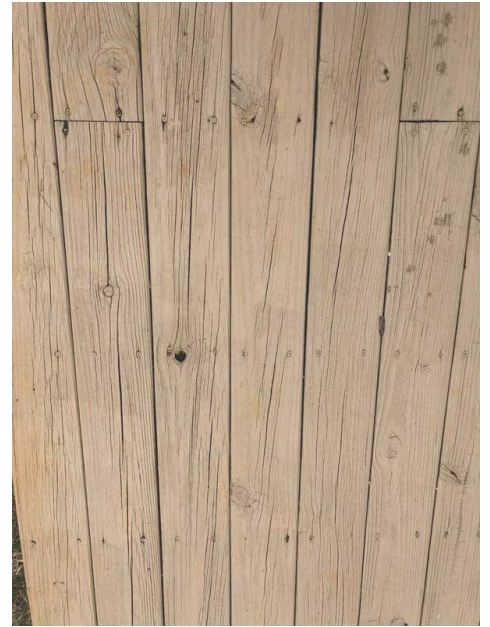
3.3.1 Decks, Balconies, Porches & Steps

**DECK - WATER SEALANT REQUIRED**

BACK DECK

Deck is showing signs of weathering and/or water damage. Recommend water sealant/weatherproofing be applied.

Contact a handyman or DIY project

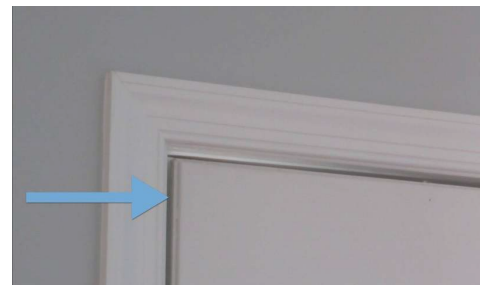
4.1.1 Interior Doors

**DOOR STICKS**

2ND FLOOR BEDROOM

Door sticks and is tough to open or close. Recommend repair.

Contact a handyman or DIY project

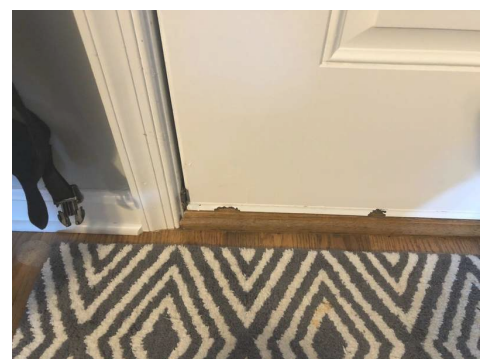
4.2.1 Exterior Doors

**WEATHERSTRIPPING DAMAGED OR NOT PRESENT**

FRONT

Door is missing standard weatherstripping or it is damaged. This can result in significant energy loss and moisture intrusion. Recommend installation of standard weatherstripping.

Contact a handyman or DIY project

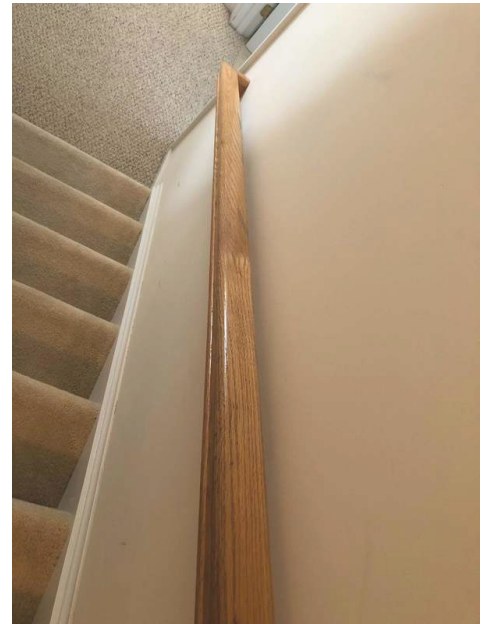
#### 4.8.1 Steps, Stairways & Railings

### **LOOSE BALUSTERS**

IN STAIRWAY LEADING TO 2ND FLOOR

Handrail balusters were loose. This could pose a safety hazard. Recommend a qualified handyman evaluate and fasten.

Contact a qualified handyman.

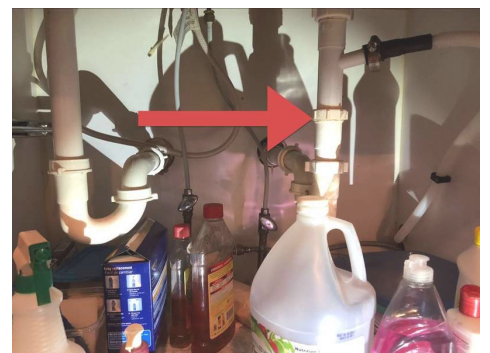
#### 5.4.1 Sink

### **DRAIN PIPE LEAK**

KITCHEN

Drain pipe under the sink is leaking. Recommend repair by a qualified professional.

Contact a qualified professional.

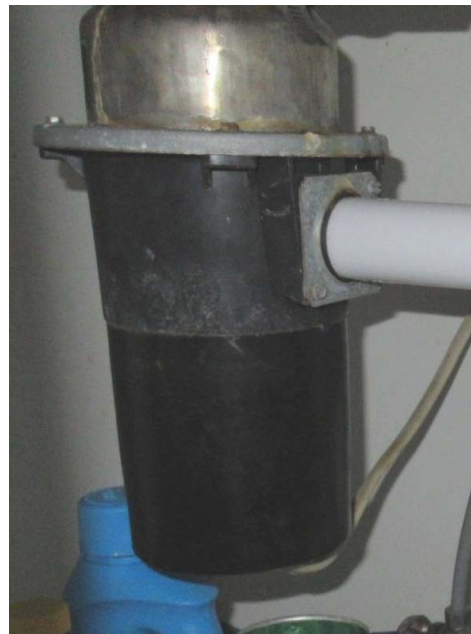
#### 5.8.1 Garbage Disposal

### **EXCESSIVE NOISE**

Garbage disposal was excessively noisy. Recommend a qualified handyman or plumber evaluate and repair.

Recommendation  
Contact a qualified handyman.

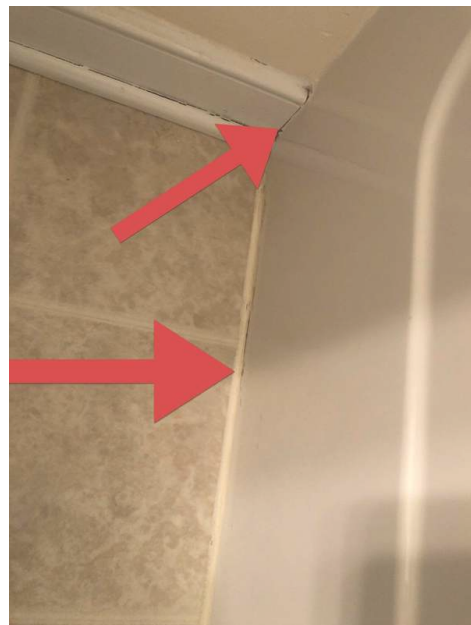
6.3.1 Shower/Bath tub

### **MISSING OR DETERIORATED CAULK/GROUT**

MASTER BATHROOM

Recommend caulking or glazing where needed to prevent water damage to underlying wood materials.

Recommendation  
Contact a handyman or DIY project

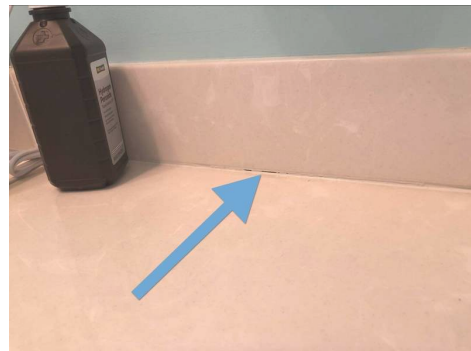
6.5.1 Sink And Vanity

### **POOR/MISSING CAULK**

MASTER BATH

Bathroom countertop was missing sufficient caulk/sealant at the wall. This can lead to water damage. Recommend adding sealant at sides and corners where counters touch walls.

Recommendation  
Contact a handyman or DIY project

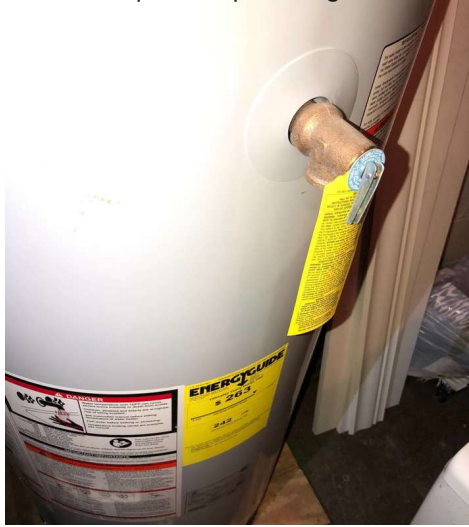
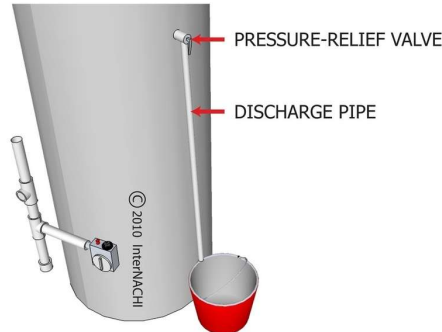
### 7.4.1 Hot Water Systems, Controls, Flues & Vents

## TPR VALVE EXTENSION IMPROPER/MISSING

Temperature pressure relief valve extension should extend to 4 to 6 inches off the floor. This is a safety concern.

DISCHARGE PIPE ON TPR VALVE

Contact a qualified plumbing contractor.

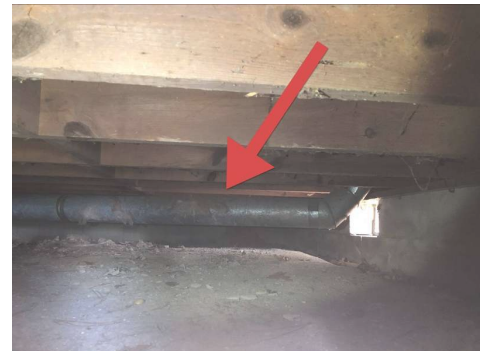
### 9.3.1 Distribution System

## DUCTS UNINSULATED

Ducts are not insulated, resulting in significant energy loss. Recommend licensed HVAC contractor insulate ducts.

Contact a qualified HVAC professional.

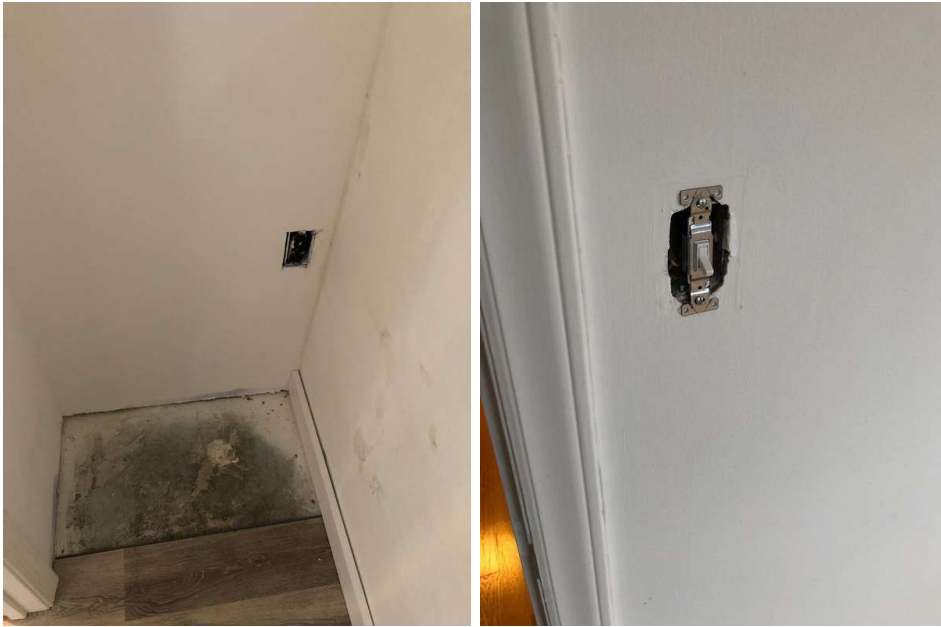
### 11.4.1 Lighting Fixtures, Switches & Receptacles

## COVER PLATES MISSING

One or more receptacles are missing cover plates. This causes a short and shock risk. Recommend installation of plates.

Contact a qualified electrical contractor.

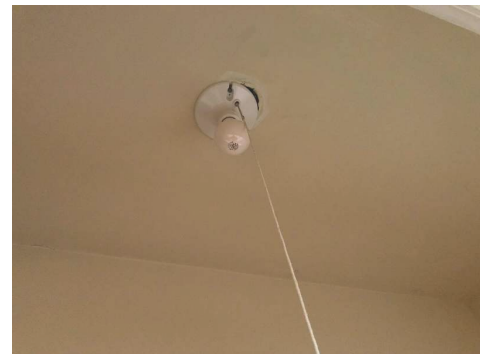
11.4.2 Lighting Fixtures, Switches & Receptacles

**LIGHTS IN CLOSETS**

Modern standards require that lights in closets have a globe over them. Incandescent lights can become hot, creating a fire hazard. I recommend installing globes or at the least to use cooler bulbs.

Recommendation  
Contact a handyman or DIY project

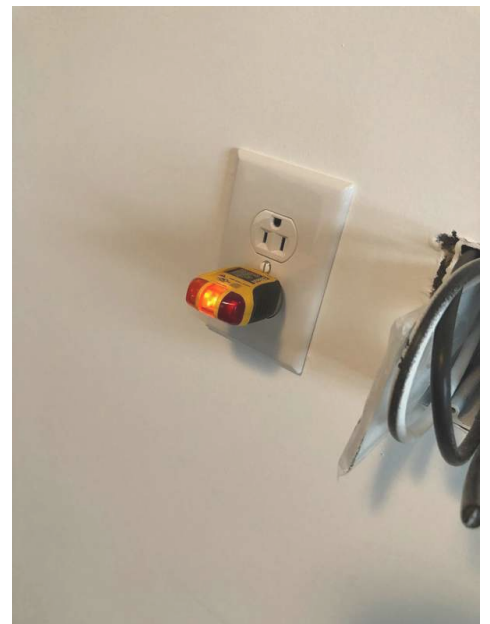
11.4.3 Lighting Fixtures, Switches & Receptacles

**UNGROUND RECEPTACLE**

1ST FLOOR BEDROOM

One or more receptacles are ungrounded. To eliminate safety hazards, all receptacles in kitchen, bathrooms, garage & exterior should be grounded.

Recommendation  
Contact a qualified electrical contractor.
