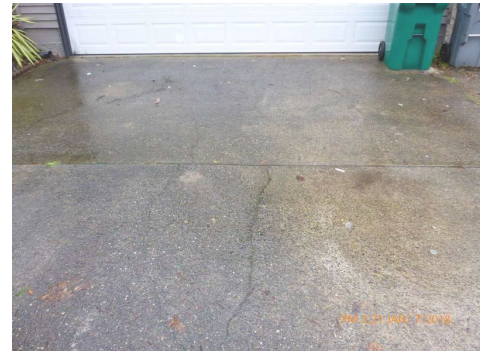
2.1.1 Driveways

DRIVEWAY CRACK

Water can penetrate the crack and erode the substrate below the concrete. The freeze-thaw cycle during the winters could also further deteriorate the concrete at the crack. Recommend filling the crack with a high-quality caulk or cement filler.

Contact a handyman or DIY project

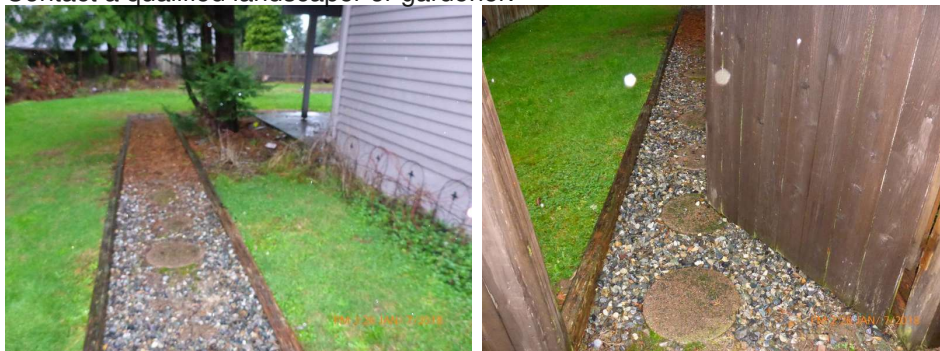
2.2.1 Walkways

TRIP HAZARD - PERIMETER WALKWAY

WEST SIDE

Uneven surfaces at perimeter walkway could pose a trip hazard. Homeowner could be liable for injuries caused by the trip hazards. Have a licensed contractor repair or replace uneven walking surfaces to eliminate trip hazards.

Contact a qualified landscaper or gardener.

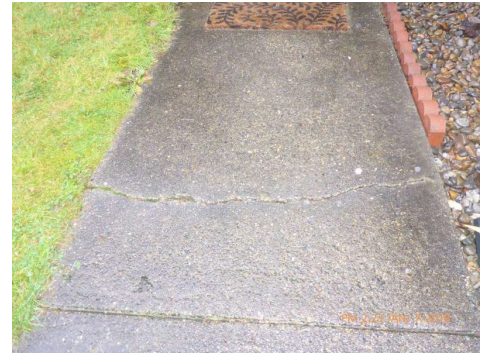
2.2.2 Walkways

WALKWAY CRACKING - MINOR

FRONT WALK

Minor cosmetic cracks observed. Recommend monitor and/or patch/seal.

Contact a handyman or DIY project

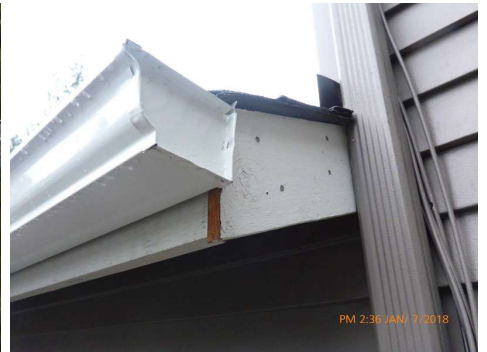
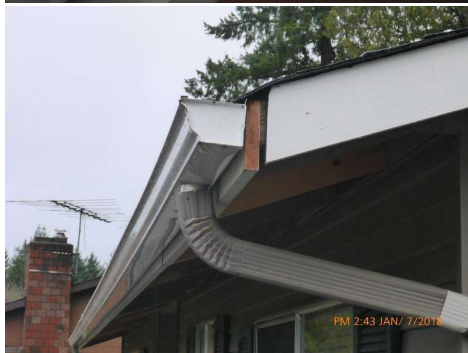
2.7.1 Fascia

NEW FASCIA NOT PAINTED

SEVERAL LOCATIONS

New fascia board has not been painted. Paint the fascia board to protect the wood from the weather and premature deterioration.

Contact a qualified painter.

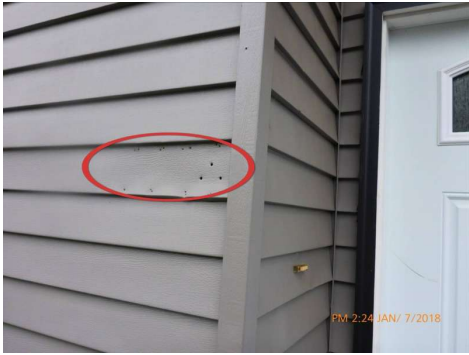
2.10.1 Siding

DAMAGED METAL SIDING

SOUTH SIDE

There are several locations where the siding is damaged from hanging items. Fill the holes with a paintable caulk and then paint the patches.

Contact a handyman or DIY project

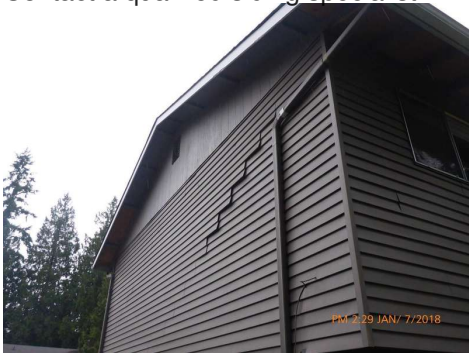
2.10.2 Siding

METAL SIDING WORKING LOOSE

EAST SIDE

Several panels of siding are working loose. This type of siding is susceptible to working loose during high winds. Have a licensed contractor secure loose slats of siding where needed. The new homeowner should inspect the siding for loose or missing pieces after high wind events.

Contact a qualified siding specialist.

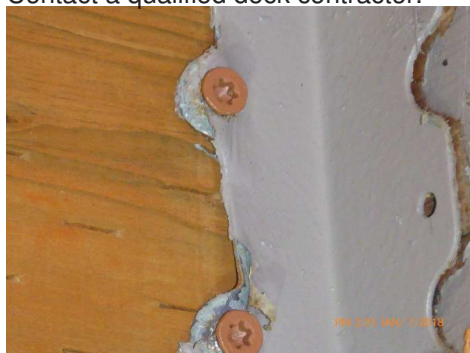
2.13.2 Back Deck

IMPROPER FASTENERS

The deck joists, stair stringers and beam-to-joist brackets are secured with improper fasteners. The existing fasteners are designed for deck boards only and not structural metal brackets, they do not have the same shear strength as dedicated bracket fasteners. Have a licensed contractor replace the existing fasteners with new, proper fasteners as prescribed by the bracket manufacturer.

Joist-to-ledger

Beam-to-joist

Contact a qualified deck contractor.

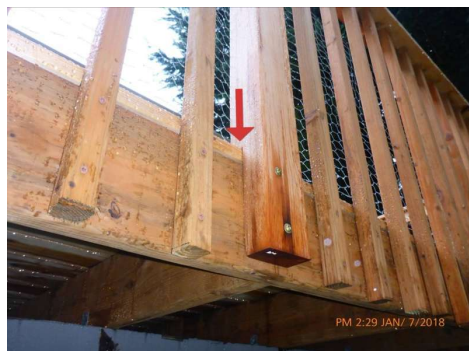
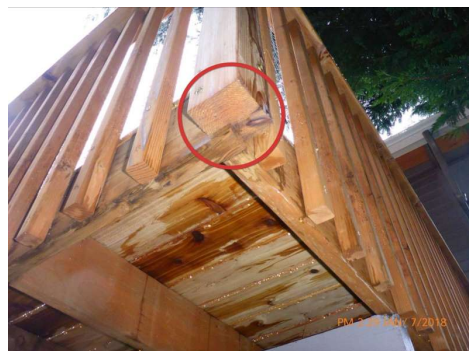
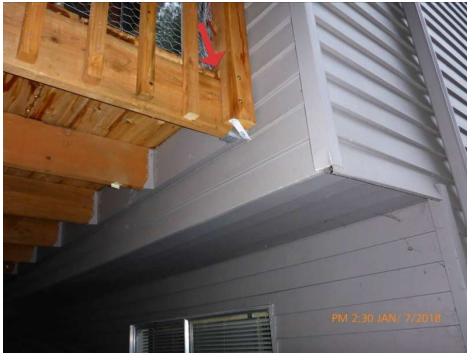
The deck 4x4 guardrail posts have been notched making them weak and in danger of breaking if put under a heavy load such as an adult falling into the guardrail. The posts should be replaced with new posts that are not notched. Have a licensed contractor replace the notched posts with new posts.

Contact a qualified deck contractor.

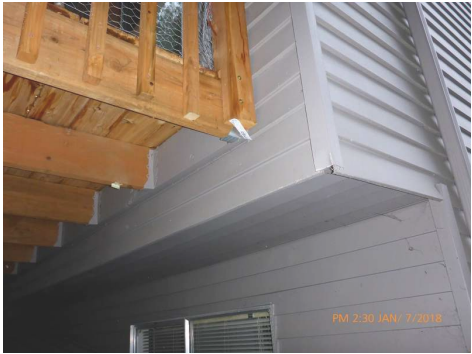
2.13.4 Back Deck

DECK ATTACHED TO HOUSE CANTILEVER

The new deck is attached to the house at a cantilever. This is not recommended deck-building practice. Although the house is almost 40 years old and previous decks may have been built this way, the deck could potentially pull away from the house and cantilever. Recommend installing new vertical deck supports and new beam under the deck near the cantilever to remove the dead weight of the deck off of the house structure.

Existing condition of deck-to-house connection

Recommendation
Contact a qualified deck contractor.

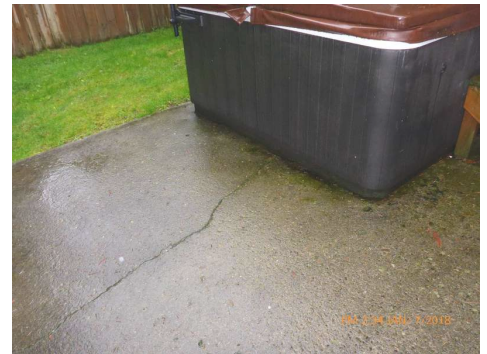
2.15.1 Patios

HOT TUB ON PATIO

A hot tub sits on top of the patio. If the patio was not designed to support the hot tub, concrete could settle and crack under the weight of the hot tub. Recommend asking seller if special thought was put into the design of the patio where the hot tub sits.

Contact a foundation contractor.

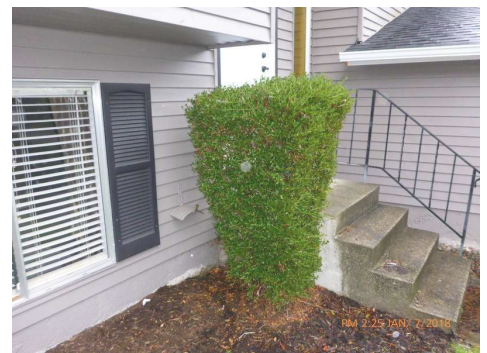
2.20.1 Vegetation

SHRUBS - CONDITIONS CONDUCTIVE FOR WOOD DESTROYING ORGANISMS

SOUTH SIDE

Vegetation growing against the house provides food and shelter for potential WDO activity. Recommend cutting back or removing (and relocating if possible) all vegetation growing against the house. Clearing a 2' or wider path between the house and vegetation will allow the homeowner to monitor the perimeter of the house, promote drying of siding components and discourage WDO and rodent activity around the house.

Contact a qualified handyman.

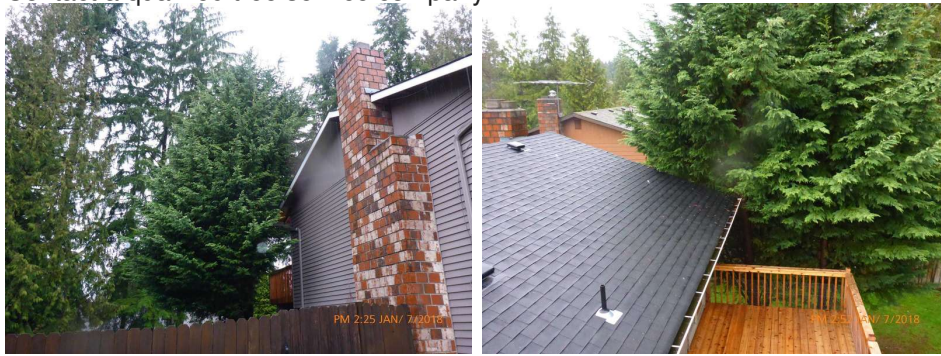
2.20.2 Vegetation

TREES- CONDITIONS CONDUCTIVE FOR WOOD DESTROYING ORGANISMS

NW CORNER

Tree(s) growing close to the house and/or over the roofline provide food and shelter and a means for entry into the structure for potential WDO activity. Recommend cutting back trees.

Recommendation
Contact a qualified tree service company.

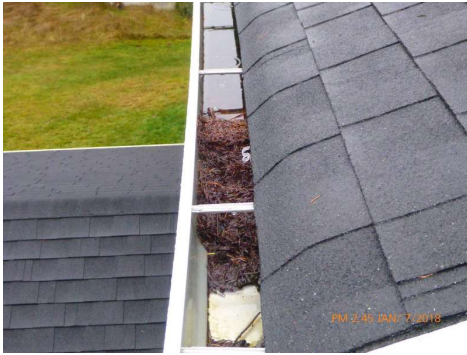
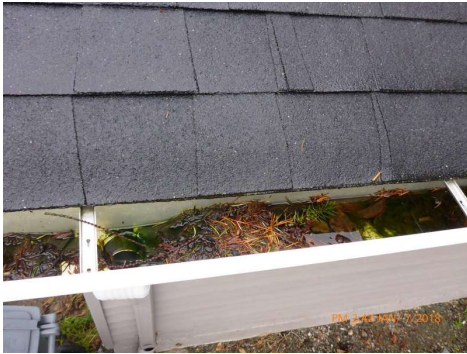
3.2.1 Roof Drainage Systems

DEBRIS IN GUTTER

Debris has accumulated in the gutters. Recommend cleaning to facilitate water flow. Install basket strainers in the downspout openings in the gutters to help prevent debris from clogging the footing drains.

Recommendation
Contact a qualified handyman.

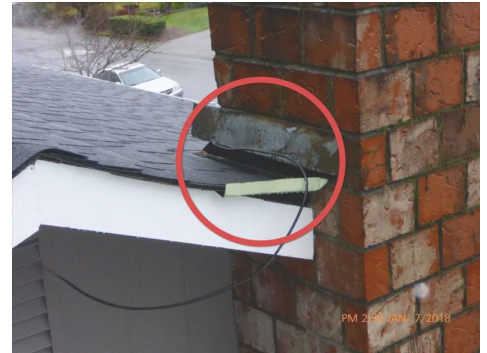
The flashing at the chimney is improperly installed. It is making a dam and holding water. That water may be seeping below the shingles and reaching the wood decking. Have a licensed contractor replace the flashing so that water can drain off the roof.

Contact a qualified roofing professional.

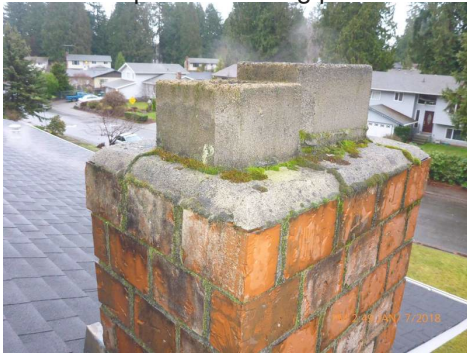
3.4.1 Chimneys

CHIMNEY CAP MISSING

No chimney cap was observed. This is important to protect from moisture intrusion and protect the chimney. Recommend installing a cap over the flue opening.

Contact a qualified roofing professional.

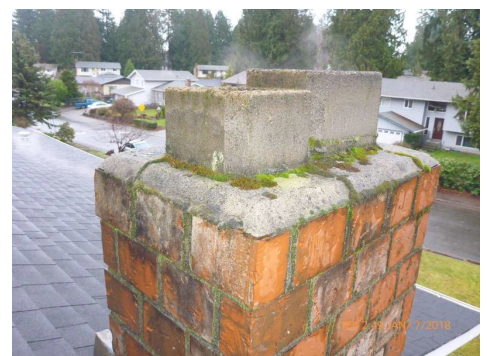
3.4.2 Chimneys

HEAVY MOSS GROWTH

Clean moss off chimney. The moss retains moisture that can deteriorate the mortar joints and crown. Have a licensed contractor power wash the chimney. Cracks in the crown should be caulked with a high-quality caulk.

Contact a qualified professional.

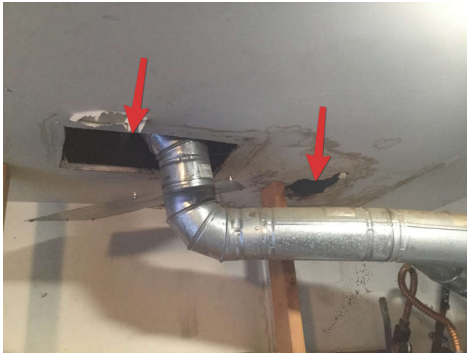
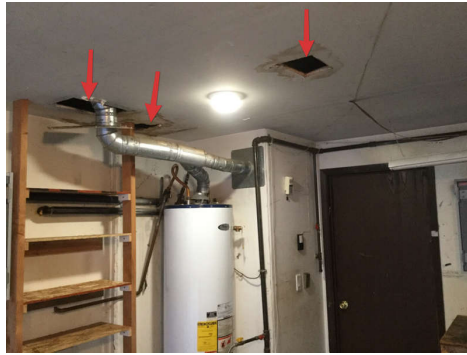
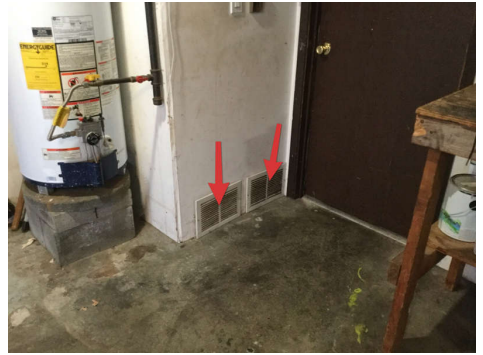
4.2.1 Garage Structure

DAMAGED DRYWALL

Damaged drywall at walls and/or ceiling in garage adjacent to the living space is a safety hazard. Smoke, fire and toxic fumes could enter the house through the damaged drywall harming the occupants. Have a licensed contractor fill cracks in the drywall and repair damaged drywall.

Contact a qualified drywall contractor.

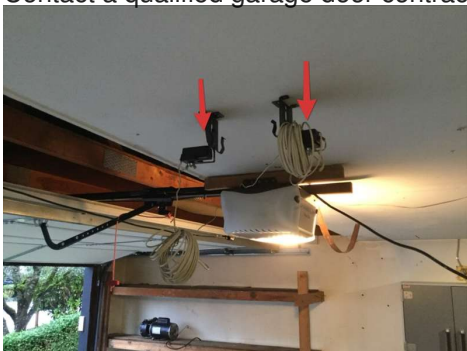
The overhead garage door is missing photoelectric edge sensors. The sensors work by reversing the door if an obstacle is in the path of the door. People could be injured or property can be damaged without operable sensors. Have a licensed contractor install new photoelectric edge sensors to help prevent personal injuries or property damage.

Photo-electric sensors are at ceiling. They should be at the door rail near the

Recommendation
Contact a qualified garage door contractor.

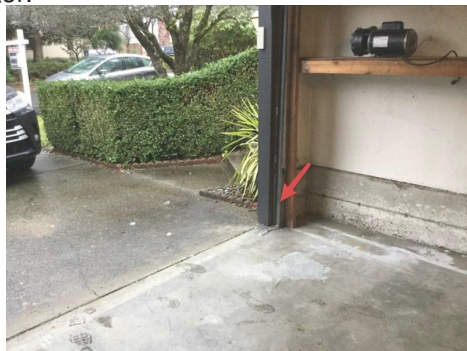
photo-electric sensor should be here.

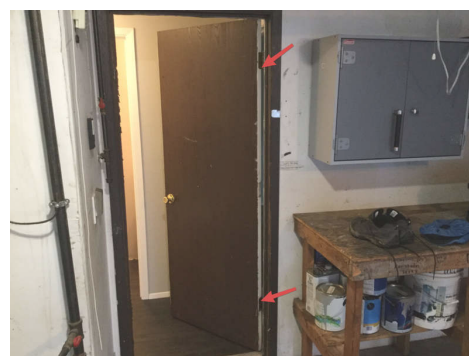
MISSING AUTO-CLOSING HINGES

The pedestrian door is missing auto-closing hinges. Garage sourced gases and fire could spread quickly into the dwelling if the pedestrian door was left open. Have a licensed contractor install new auto-closing hinges on pedestrian door.

Recommendation
Contact a qualified handyman.

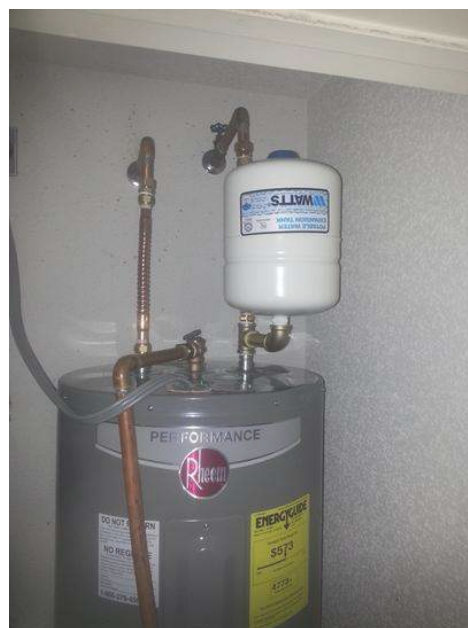
5.1.1 Water Heater

MISSING EXPANSION TANK

Missing an expansion tank at the water heater. A safety device known as a **water heater expansion tank** (sometimes called a thermal **expansion tank**) **can** help minimize the risk of pressure damage to the plumbing system. ... Since **water** expands when it is heated due to thermal **expansion**, the **water heater** creates extra **water** volume every time it heats **water**. Have a licensed contractor install a new expansion tank.

Example of an Expansion Tank at Water Heater

Recommendation
Contact a qualified plumbing contractor.

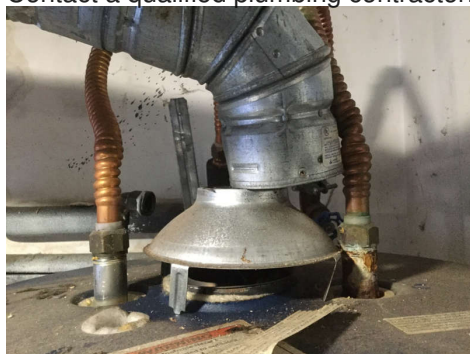
5.1.7 Water Heater

EXHAUST FLUE IMPROPERLY INSTALLED

The exhaust flue is loose and falling out of place. Exhaust gases are escaping into the garage and potentially into the living space above the garage. Have a licensed contractor repair the exhaust flue so that gases travel through the flue and diverted to the exterior of the house.

Contact a qualified plumbing contractor.

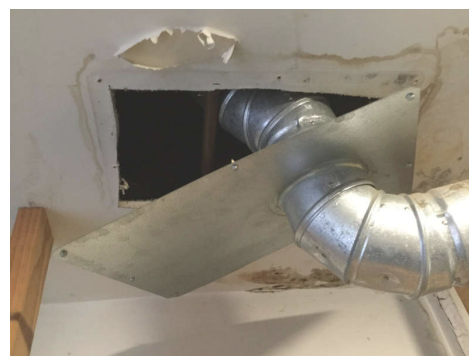
5.1.8 Water Heater

PLATE IS LOOSE

Plate loose. The plate should be reinstalled and fire-caulked to make it smoke and gas tight.

Contact a qualified HVAC professional.

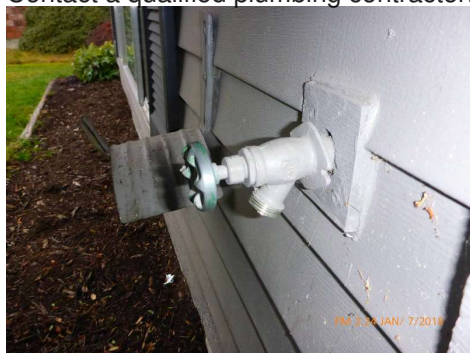
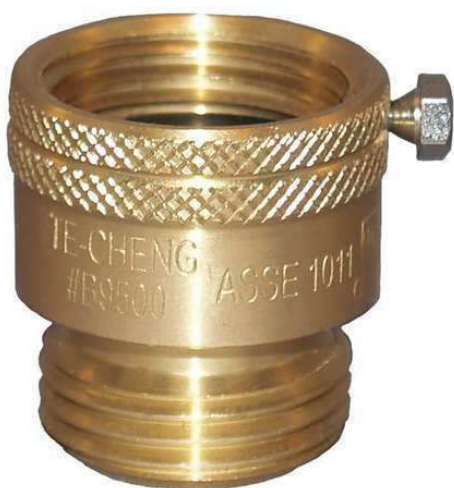
5.2.1 Plumbing Fixtures

HOSE BIBS - ANTI SIPHON

Existing hose bib does not have anti siphon valve. The anti siphon valve prevents potentially contaminated water from being sucked back into the house's potable water supply in the event the municipal water system should lose water pressure. Install a new anti siphon hose bib or install an anti siphon valve at the existing hose bib. They can be found at any home improvement store.

Example of Anti-Siphon Valve added to Existing Hose Bib

Recommendation
Contact a qualified plumbing contractor.

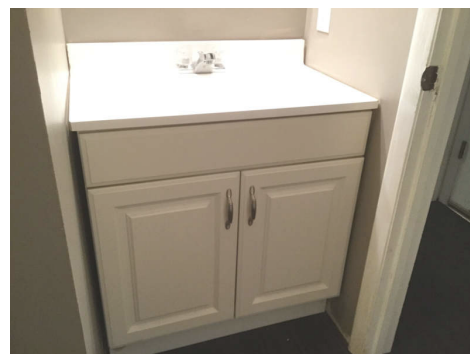
SINK VANITY LOOSE

The vanity is loose. Have a licensed contractor secure it to the wall. A secured cabinet will prevent the plumbing drain and water supply lines from being damaged.

Recommendation
Contact a qualified handyman.

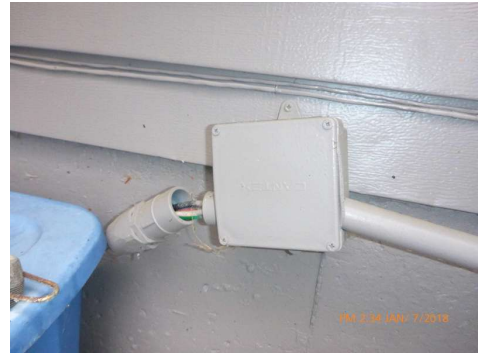
6.1.1 Electric Panel

The conduit and fittings leading up to the hot tub sub panel or falling apart leaving the wires exposed. Have a licensed contractor reconnect the fittings and conduit so that the electrical wires are protected.

Recommendation
Contact a qualified electrical contractor.

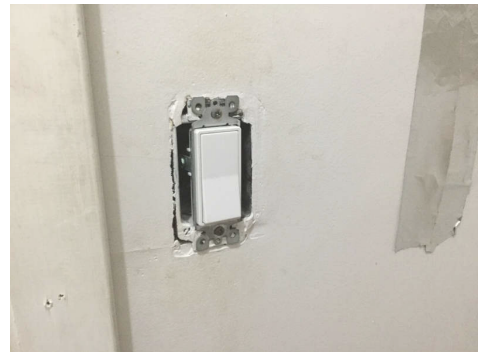
6.5.1 Light Switches

COVER PLATES MISSING

One or more receptacles are missing a cover plate. This causes short and shock risk. Recommend installation of plates.

Contact a qualified handyman.

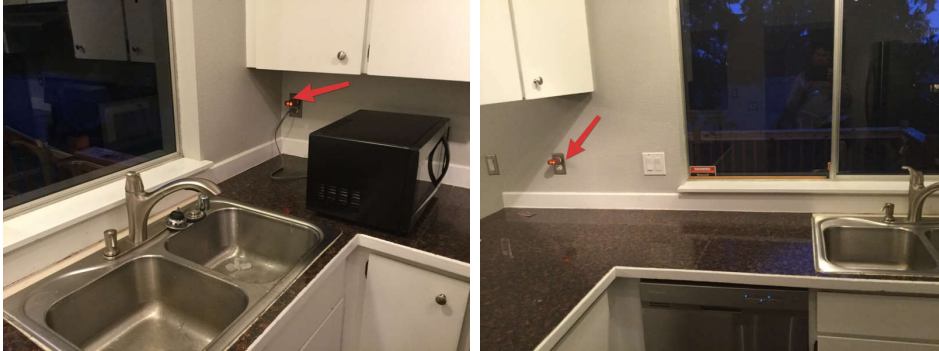
6.7.1 GFCI & AFCI

MISSING GFCI RECEPTACLES IN KITCHEN / BATH

Electric receptacles within 6 feet of a water source should be GFCI protected. Recommend having a licensed electrician install new GFCI outlets in wet locations of the house.

Contact a qualified electrical contractor.

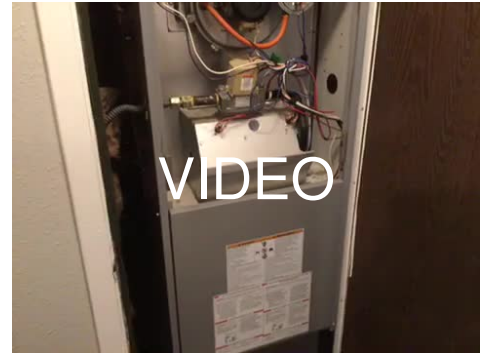
Furnace blower was excessively noisy during operation. Recommend a qualified HVAC technician evaluate and repair.

Contact a qualified HVAC professional.

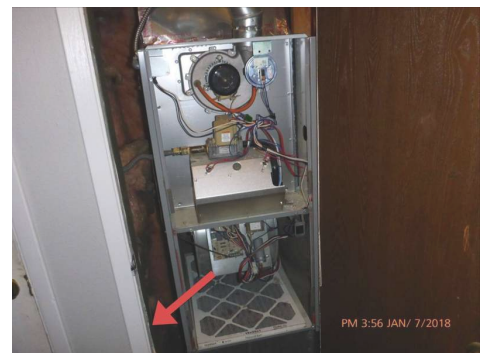
7.1.5 Heating Equipment

MAKEUP AIR MAY BE CONTAMINATED

The furnace closet has 2 vents in the garage that provide air supply for the combustion of natural gas. Toxic fumes originating from the garage could be sucked into the furnace. It is recommended that make up air is taken from the exterior of the house such as a side wall or roof. Have a licensed HVAC professional further evaluate the furnace and alternate make up air supply sources.

Make up air vents on left side of furnace. Direct line to garage.

Contact a qualified HVAC professional.

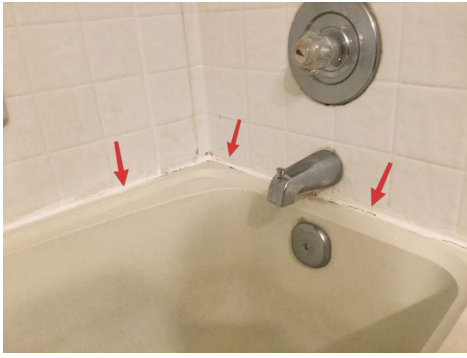
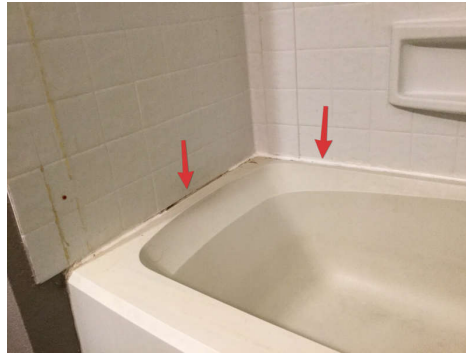
8.1.1 Walls

CAULK IN POOR CONDITION

Have a licensed contractor remove the deteriorating caulk and install new caulk.

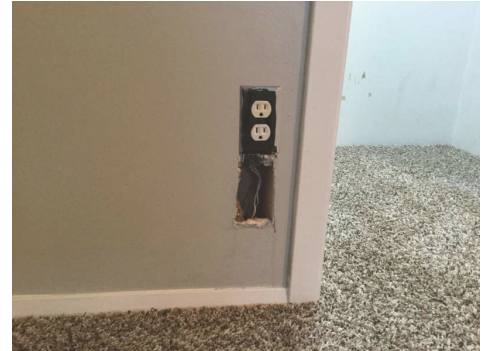
8.1.2 Walls

MINOR WALL DAMAGES

Throughout the house, there are minor wall damages due to child gates and every day living. Have a licensed contractor patch all of the wall dings throughout the house. Paint the repairs to match the surrounding color.

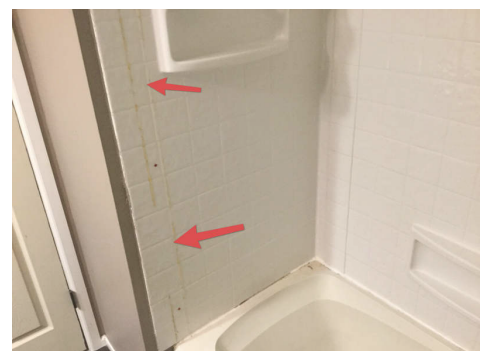
SHOWER SURROUND DAMAGED

The old shower door and frame have been removed. The result are screw holes and adhesive left on the walls. Have a licensed contractor repair or replace the damaged shower surround.

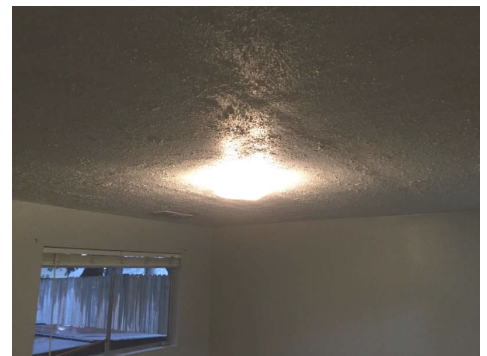
8.2.1 Ceilings

ACOUSTIC TEXTURE

The acoustic texture may potentially contain asbestos; a material that can be hazardous to people. If disturbed, the asbestos fibers could be inhaled and cause damage to the lungs. If the ceiling texture is to be removed, recommend having a licensed contractor safely remove it. Otherwise, the texture if left undisturbed can be harmless.

Contact a qualified professional.

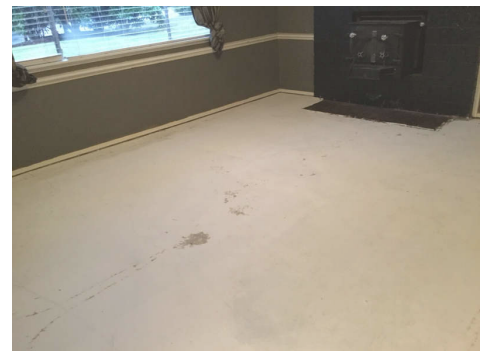
8.3.1 Floors

UNFINISHED FLOORS

It is unknown why flooring is missing in a portion of the basement. Was there a water issue? Mold? Mildew? Recommend asking the seller if any event occurred that required them to remove the flooring. Finish floors in basement if there are no underlying issues.

Contact a qualified flooring contractor

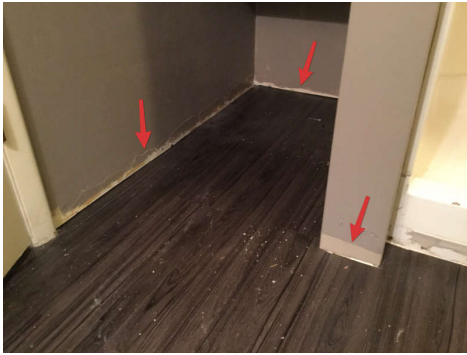
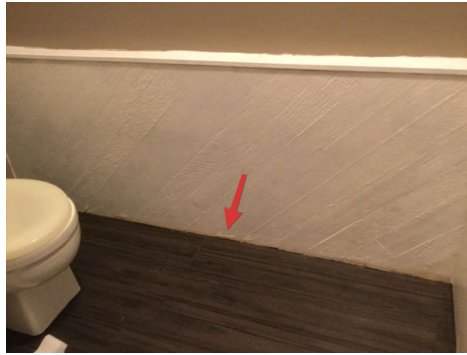
8.4.1 Trim

MISSING TRIM

Trim boards are missing throughout the house. Have a licensed contractor install trim at door frames, window frames, floor base and ceiling.

Contact a qualified carpenter.

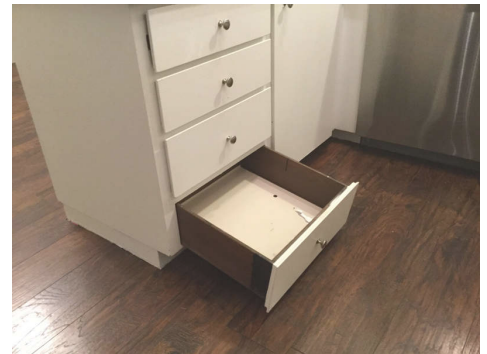
8.7.1 Countertops & Cabinets

CABINET DRAWER SLIDER

Sliding shelf bracket off track. Repair or replace.

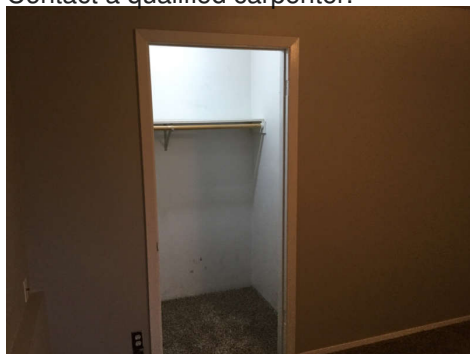
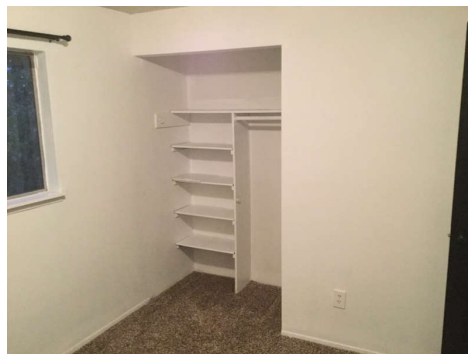
8.12.1 Closets

CLOSET DOORS MISSING

Closet doors missing. Have a licensed contractor install new doors or reinstall existing doors at all closets. Replace damaged door hardware if needed.

Contact a qualified carpenter.

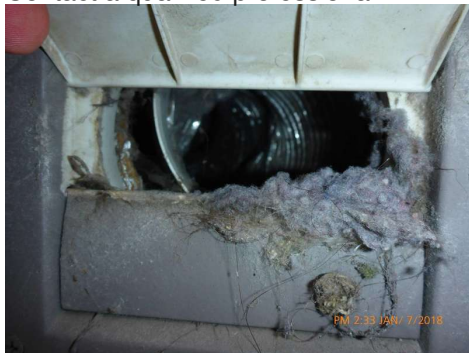
The dryer duct has built-up dryer lint in it. The lint could potentially clog up the duct and cause the dryer to perform poorly or even catch fire. Recommend having a licensed air-duct cleaning company clean out the dryer duct.

Contact a qualified professional.

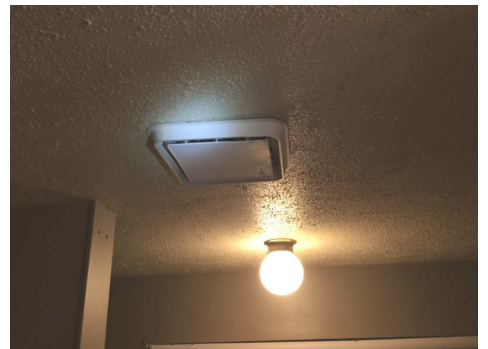
10.3.2 Exhaust Systems

DIRTY EXHAUST FAN

Clean the exhaust fan to ensure it is removing excess moisture from the house. Recommend replacing the old, inefficient exhaust fan with a new, more efficient fan.

Recommended DIY Project
