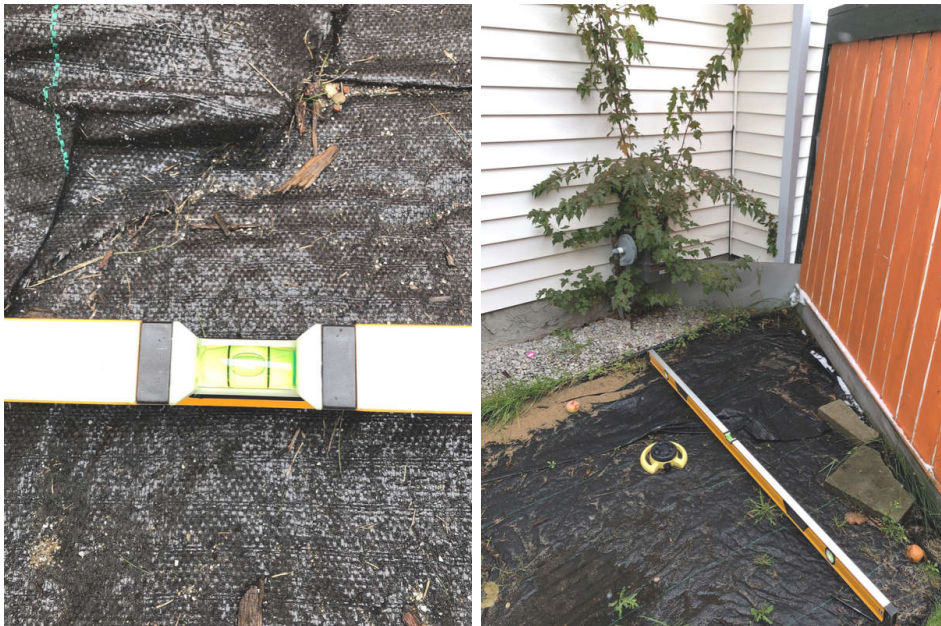
2.2.1 Grading & Lot Drainage

NEGATIVE GRADING

Grading was flat or sloping towards the home in some areas. This could lead to water accumulation. Accumulated water may cause the foundation to settle over time. Recommend qualified landscaper or foundation contractor regrade so water flows away from home.

Recommendation

Contact a qualified landscaping contractor

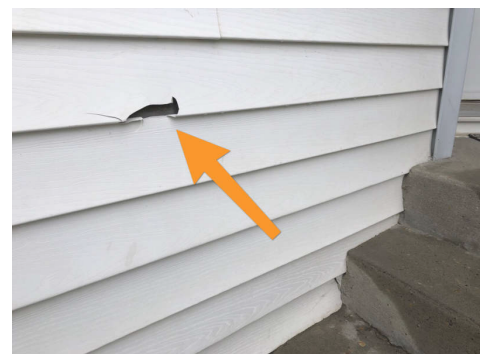
2.6.1 Siding, Flashing & Trim

HOLES/GAPS

NORTH

One or more holes or gaps were found in siding or trim, possibly allowing vermin or water to enter. Recommend that a qualified person repair as necessary.

Recommendation

Contact a qualified professional.

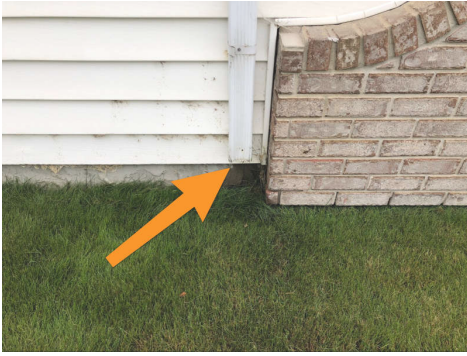
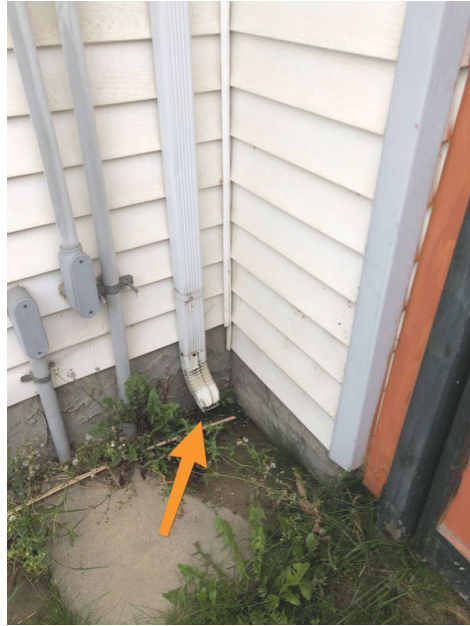
2.8.1 Downspouts

DOWNSPOUT EXTENSIONS MISSING

Home was missing downspouts in one or more areas. This can cause soil erosion and water to accumulate around the home's foundation. Excessive water around the foundation lead settling/structural movement. Recommend a qualified contractor install downspout(s) and extension(s) that drains at least 6 feet from the foundation.

East

Recommendation
Contact a qualified gutter contractor

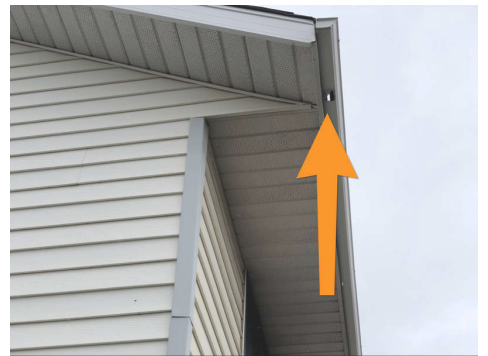
2.8.2 Downspouts
DOWNSPOUTS MISSING
SOUTHWEST

Home was missing downspouts in one or more areas. This can cause soil erosion and water to accumulate around the home's foundation. Excessive water around the foundation can lead to structural movement. Recommend a qualified contractor install downspout(s) and extension(s) that drain at least 6 feet from the foundation.

Recommendation
Contact a qualified gutter contractor

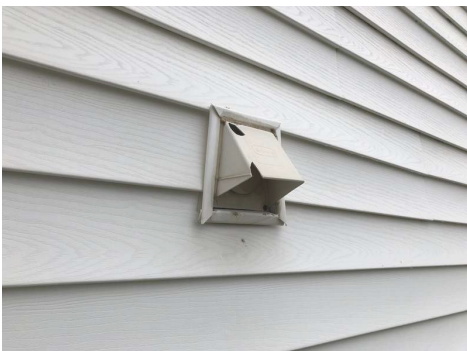
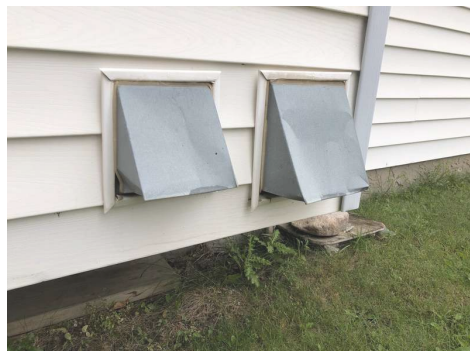
2.9.1 Penetrations
EXHAUST VENT DAMAGED

One or more exhaust duct end caps were missing, loose, damaged, or deteriorated. Their purpose is to prevent unconditioned air from entering the building, and keep out birds, rodents and bugs. Blocked ducts can cause fan motors and/or clothes dryers to overheat and can pose a fire hazard. Recommend that a qualified person repair or replace caps as necessary.

West

Recommendation
Contact a qualified HVAC professional.

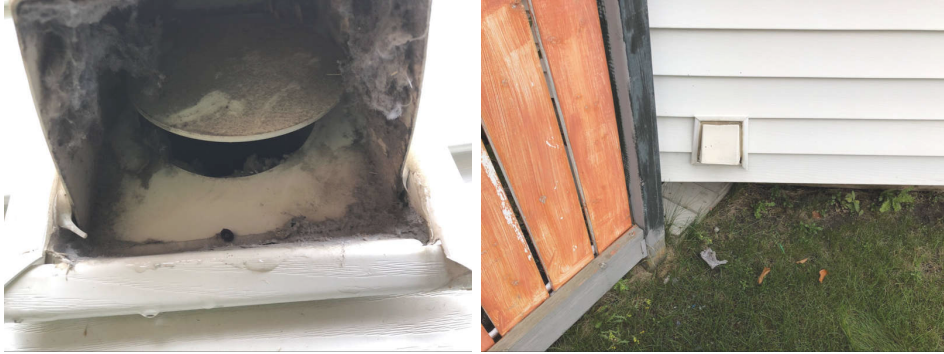
2.9.2 Penetrations

DRYER VENT CLOGGED

WEST

The dryer vent is clogged and needs to be cleaned. A clogged dryer vent can lead to dryer failure an extended dry times.

There is a screen installed at the dryer vent which is causing lint to accumulate. Screened vents are designed for intake air and exhaust/dryer vents should be the flap type.

Recommend dryer duct be cleaned and have a qualified professional replace the dryer vent with the proper type.

Contact a qualified professional.

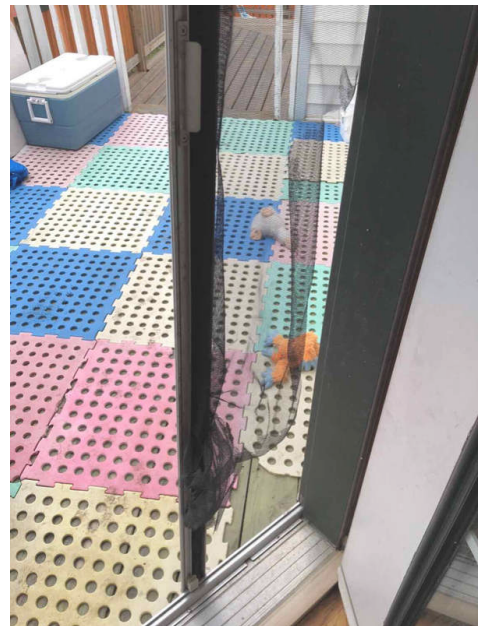
2.10.2 Exterior Doors

SLIDING SCREEN DOOR DETERIORATED

One or more sliding screen doors are damaged and/or deteriorated. Screen doors should be replaced where necessary.

Contact a qualified door repair/installation contractor.

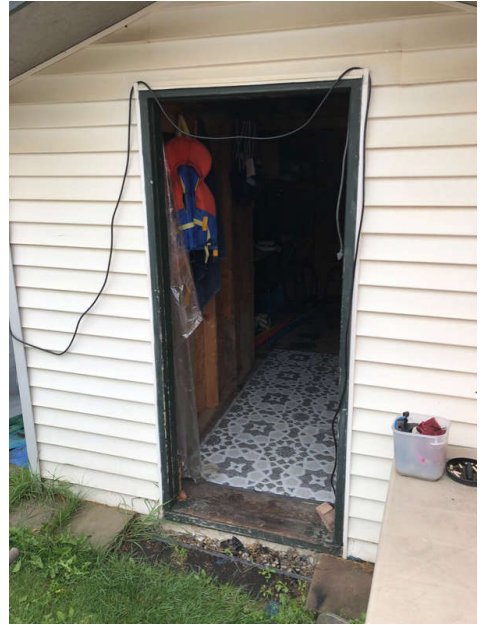
2.10.3 Exterior Doors

SHED DOOR MISSING

The shed door is not on its hinges and should be reinstalled. Location of door unknown.

Contact a qualified professional.

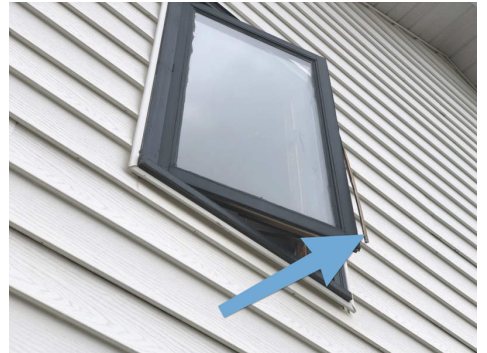
2.11.1 Exterior Windows

WINDOW BEADS/SEALS

The seal/bead is missing or deteriorated at one or more windows. It is recommended to have a contractor evaluate and make the necessary repairs.

Contact a qualified window repair/installation contractor.

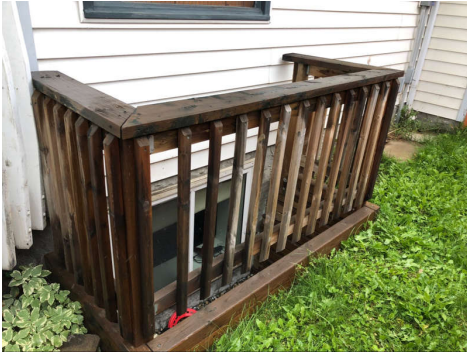
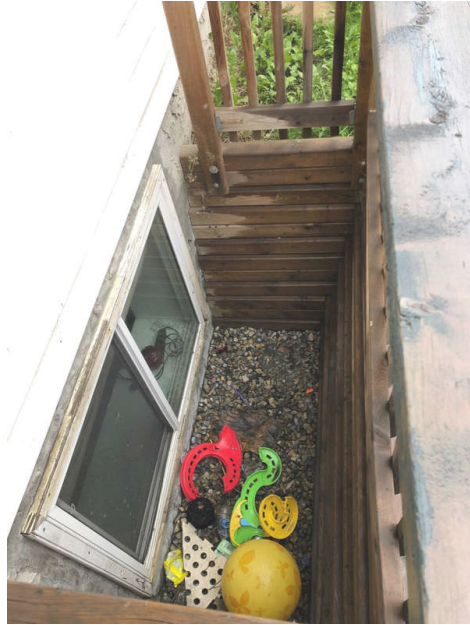
2.11.2 Exterior Windows

WINDOW EGRESS

The window well had no means of easy egress in case of an emergency. The railing around the window well provides good safety from falling into the well; however prevents easy exit in case of emergency. Recommend installing means of egress.

East

Contact a qualified professional.

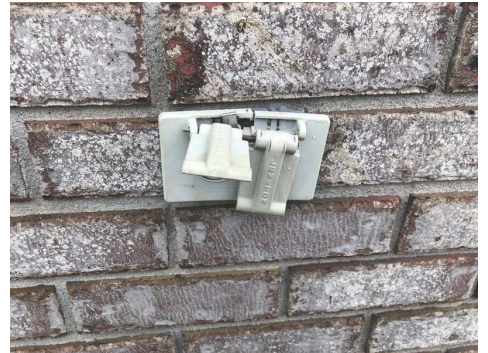
2.12.2 Exterior Electrical (Other Than Service)

COVER PLATES DAMAGED

NORTH

One or more receptacles had a damaged cover plate. Recommend replacement.

Recommendation
Contact a qualified electrical contractor.

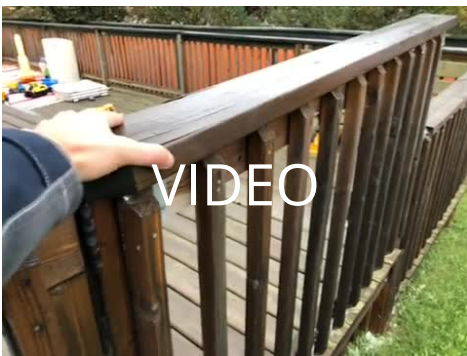
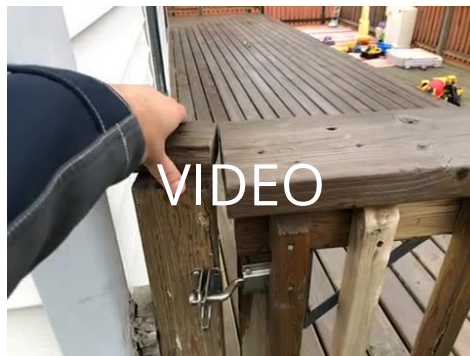
2.13.1 Decks, Balconies & Porches

GUARDRAIL LOOSE

Guardrails at one or more locations with drop-offs higher than 30 inches were loose, damaged, and/or deteriorated and pose a fall hazard. Recommend that a qualified person repair guardrails as necessary.

Recommendation
Contact a qualified deck contractor.

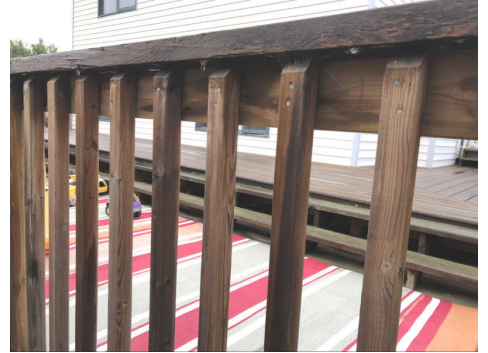
2.13.3 Decks, Balconies & Porches

PROTECTION MISSING

Wooden deck or porch components appeared to have had no paint, stain, or penetrating oil applied. Recommend that a qualified person clean and preserve as necessary.

Contact a qualified professional.

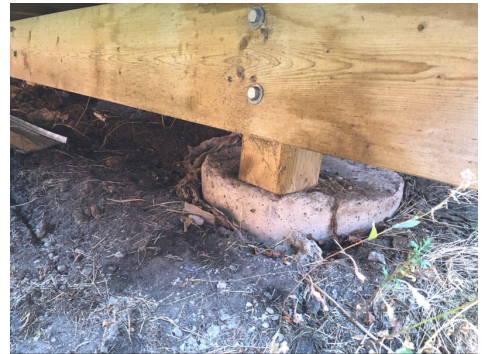
2.13.4 Decks, Balconies & Porches

WOOD ON CONCRETE

Wooden support posts for the deck or porch were resting directly on concrete piers or footings below. Water may wick up into the support post ends and result in elevated levels of moisture in the wooden support post ends. This is a conducive condition for rot. Support posts should rest in metal brackets above concrete piers or footings, or should be separated from the concrete below by impervious membranes such as composition shingle scraps. Even if posts are made of treated wood the cut ends may not have been field-treated, leaving little or no preservative at the post center. Recommend that a qualified contractor repair per standard building practices. For example, by installing an isolation barrier between the posts and the concrete below.

Contact a qualified professional.

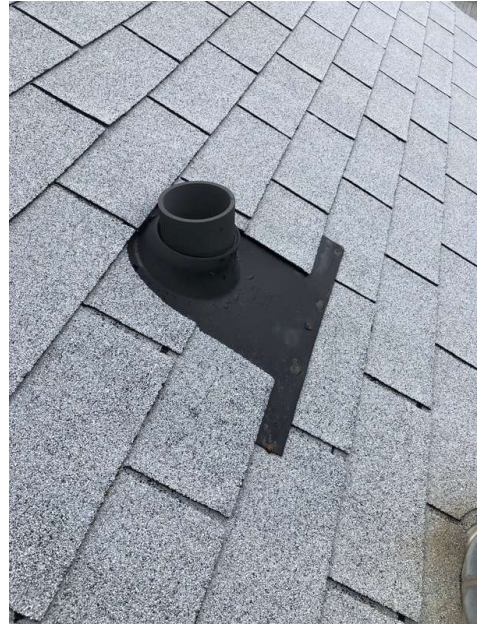
3.2.1 Flashing/Vents

PLUMBING VENT TOO LOW

One or more plumbing vent pipes terminated less than 6 inches above the roof surface below. Debris can block vent pipe openings with such short pipes. Blocked vent pipes can cause sewer gases to enter living spaces. Recommend that a qualified person repair per standard building practices. For example, by extending pipe(s) to terminate at least 6 inches above the roof surface.

North facing roof on south side of house

Contact a qualified roofing professional.

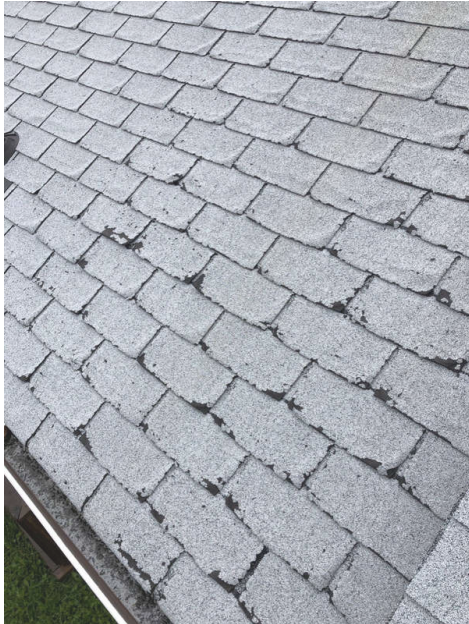
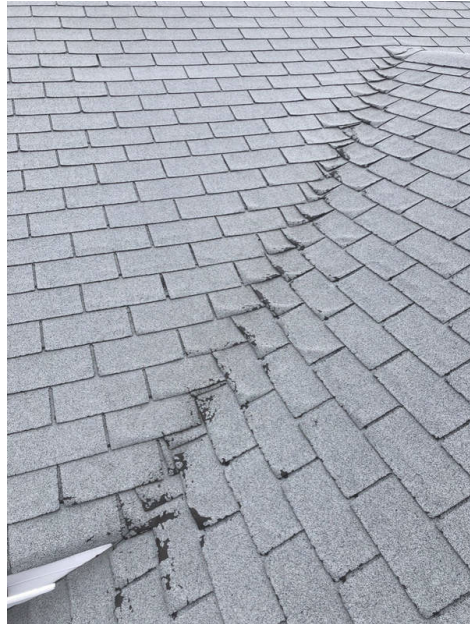
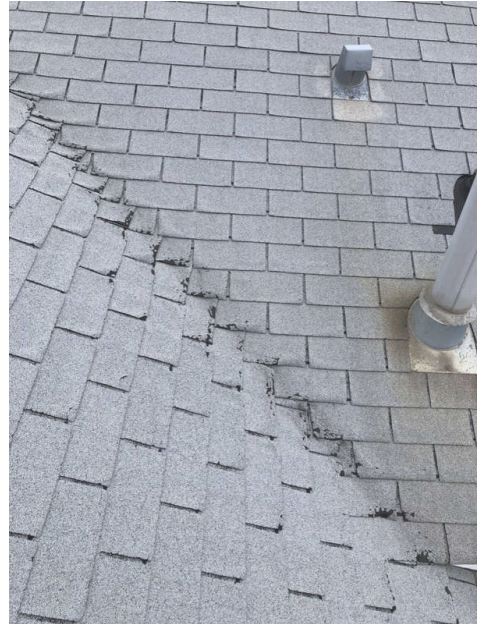
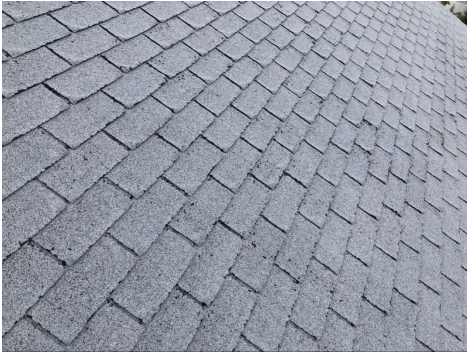
3.3.1 Shingles

SHINGLE DETERIORATION

One in three of the roofing shingles are deteriorated (i.e. Missing or deteriorated granules). A qualified roofing contractor should evaluate and make the necessary repairs.

East

West

South

Contact a qualified roofing professional.

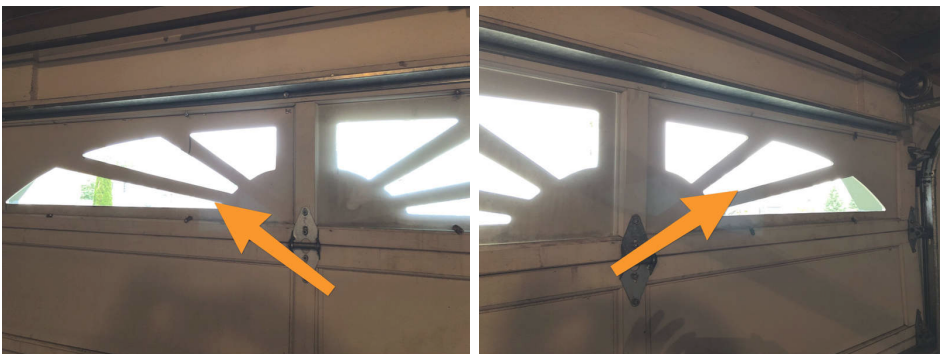
4.2.2 Vehicle door

GARAGE DOOR WINDOW MISSING

One or more panels from the overhead garage door were missing. Recommend having windows replaced.

Contact a qualified professional.

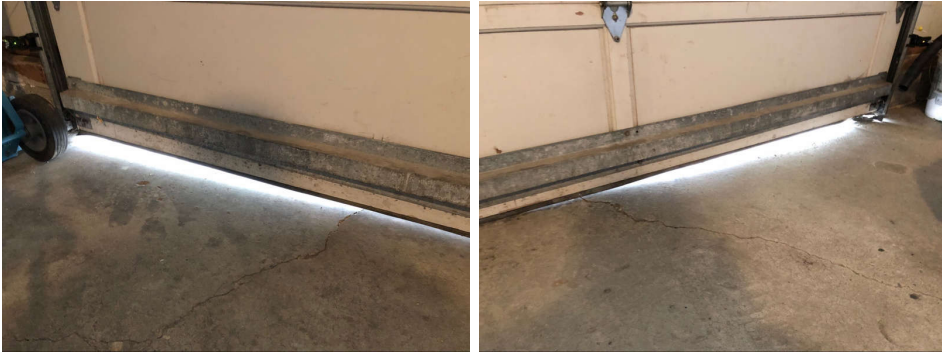
4.3.1 Floors

SETTLING

Garage floor shows signs of settling in the soil beneath the slab. Recommend a qualified professional evaluate for potential repairs.

Contact a qualified professional.

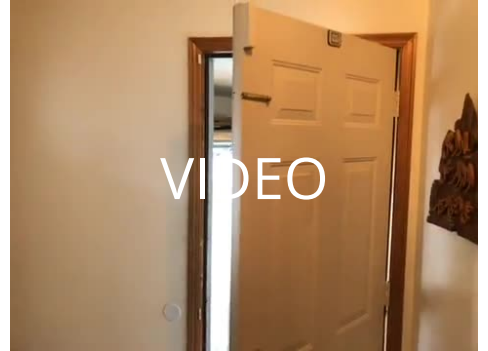
4.7.1 Doors

SELF-CLOSE FUNCTION

The self-closing device on the door between the garage and the house didn't close and latch the door. These devices are installed to keep the door closed to prevent possible fire and fumes from the garage from spreading to the house. Recommend that a qualified person repair as necessary.

Contact a qualified door repair/installation contractor.

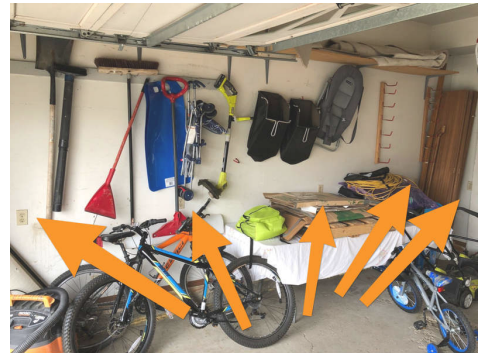
4.8.1 Lighting Fixtures, Switches & Receptacles

NO POWER AT RECEPTACLE

SOUTHEAST

One or more electric receptacles appeared to have no power. Recommend asking the property owner about this. Switches may need to be operated or GFCI/AFCI protection may need to be reset to make some receptacles energized. If necessary, recommend that a qualified electrician evaluate and repair.

Five receptacles inoperable

Contact a qualified electrical contractor.

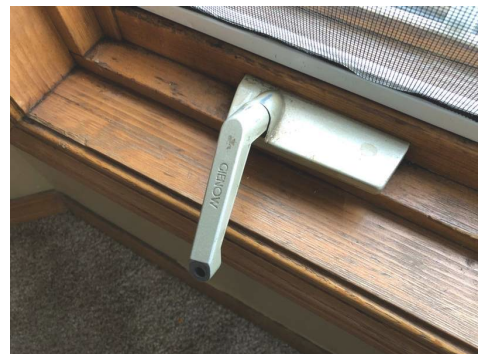
5.6.2 Windows

HARDWARE MISSING

Opening and/or locking hardware was missing. Recommend having installed by qualified window contractor.

Contact a qualified professional.

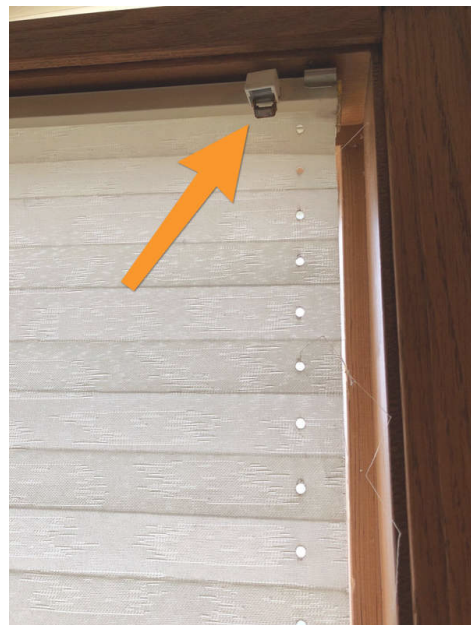
5.6.3 Windows

BLINDS DAMAGED

The window blinds were damaged in sections or had missing components. Opening and closing is difficult or impossible. Recommend replacing blinds.

Contact a qualified professional.

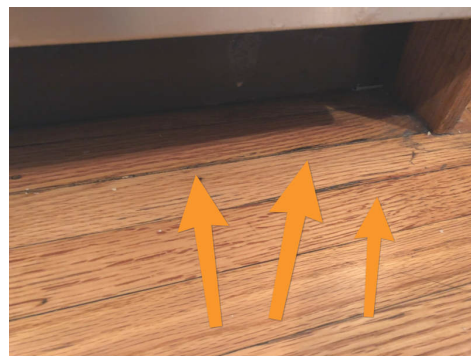
6.2.1 Dishwasher

DISHWASHER WATER DAMAGE BELOW

Water damage was found beneath the dishwasher, indicating a possible active leak. A qualified plumber or appliance technician should evaluate and repair as necessary.

Contact a qualified appliance repair professional.

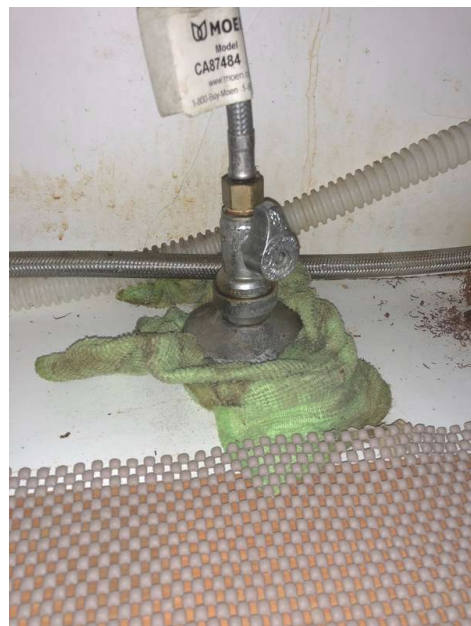
6.6.1 Sink

EVIDENCE OF LEAKING WATER LINE

The waterline has a towel wrapped around the base and was damp. Recommend having water line repaired by a qualified plumbing contractor.

Contact a qualified plumbing contractor.

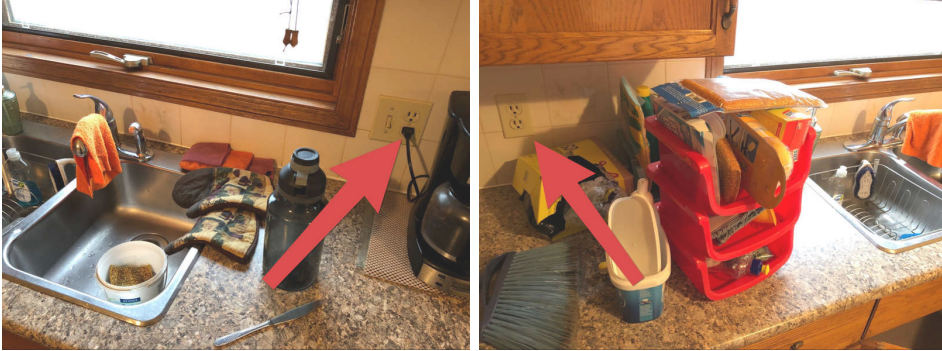
6.14.1 Lighting Fixtures, Switches & Receptacles

NO GFCI PROTECTION INSTALLED

One or more locations were noted as not having ground-fault circuit interrupter (GFCI) protection. Modern building standards require GFCI protection for any receptacles within 1.5 metres of a sink, tub, or shower stall.

Adoption of GFCI protection was generally phased in over numerous years/decades. Recommend client consult with qualified electrical contractor to evaluate upgrading these areas with GFCI protection.

Contact a qualified electrical contractor.

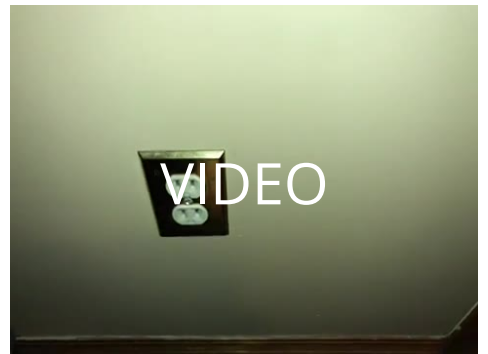
8.7.1 Lighting Fixtures, Switches & Receptacles

RECEPTACLE LOOSE

One or more electric receptacles and/or the boxes in which they were installed were loose and/or not securely anchored. Wire conductors can be damaged due to repeated movement and/or tension on wires, or insulation can be damaged. This can become a shock and fire hazard. Recommend that a qualified electrical contractor repair as necessary.

Contact a qualified electrical contractor.

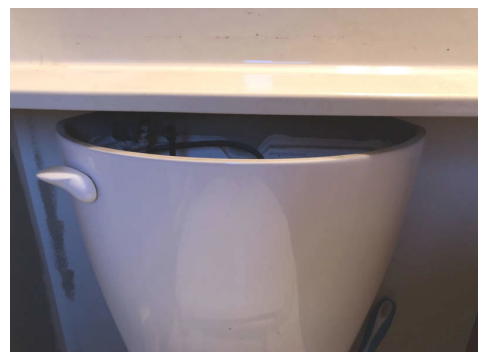
11.2.1 Toilets

MISSING TANK LID

The toilet tank lid was missing. Lid(s) should be replaced as necessary.

Contact a qualified plumbing contractor.

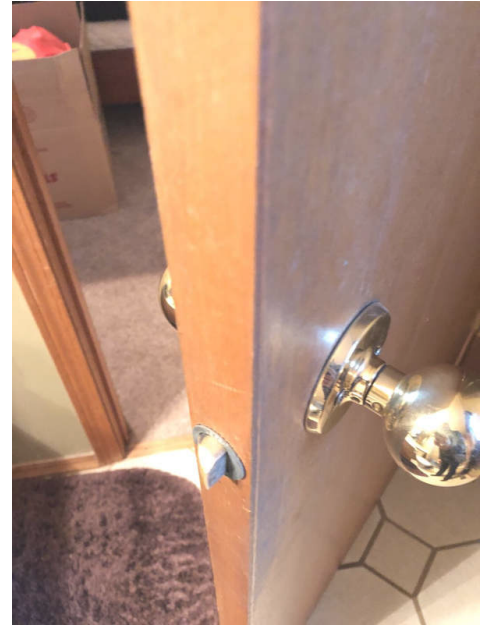
11.10.2 Doors

DOOR DOES NOT LOCK

The bathroom door lockset was not lockable. Recommend having lock set replaced with one that locks for bathroom privacy.

Recommendation
Contact a qualified professional.

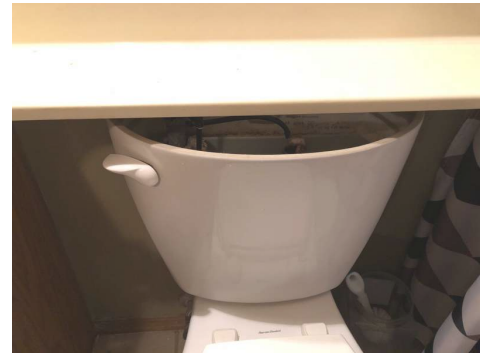
12.2.1 Toilets

MISSING TANK LID

The toilet tank lid was missing. Lid(s) should be replaced as necessary.

Recommendation
Contact a qualified plumbing contractor.

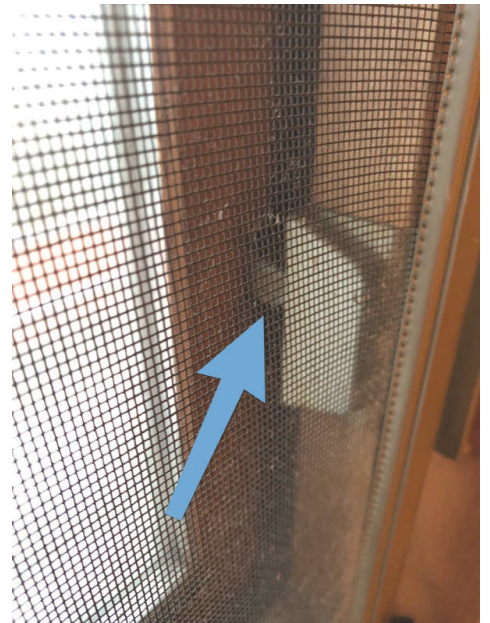
13.6.1 Windows

LOCK INOPERABLE

Lock mechanisms on one or more windows were missing and/or damaged so that they were inoperable. Repairs should be made by a qualified contractor or service technician so that windows lock and unlock easily.

Recommendation
Contact a qualified window repair/installation contractor.

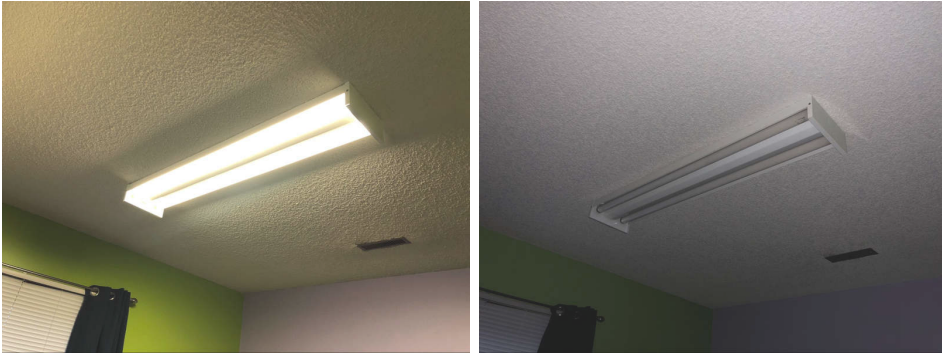
15.7.1 Lighting Fixtures, Switches & Receptacles
FLUORESCENT TUBING NOT COVERED

Deficiency

Recommendation
Contact a qualified electrical contractor.

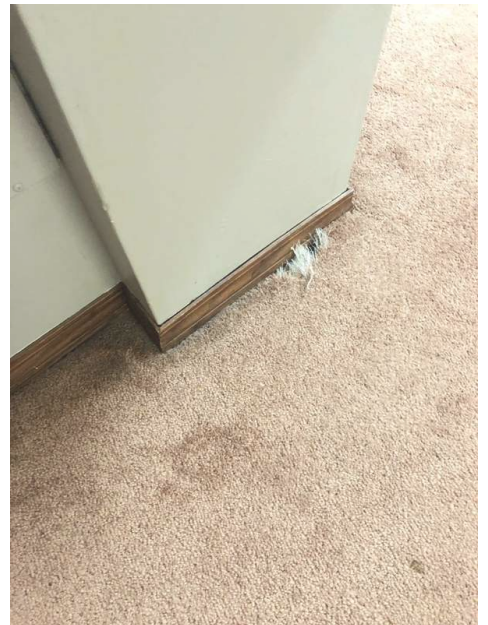
16.2.1 Floors
CARPET DETERIORATED

Carpeting in one or more rooms was damaged and/or significantly deteriorated. Recommend replacing carpeting where necessary.

Recommendation
Contact a qualified flooring contractor

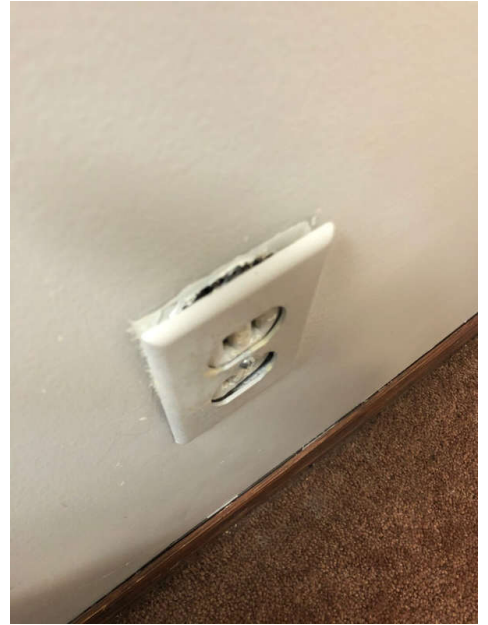
16.7.1 Lighting Fixtures, Switches & Receptacles
RECEPTACLE LOOSE

One or more electric receptacles and/or the boxes in which they were installed were loose and/or not securely anchored. Wire conductors can be damaged due to repeated movement and/or tension on wires, or insulation can be damaged. This can become a shock and fire hazard. Recommend that a qualified electrical contractor repair as necessary.

Recommendation
Contact a qualified electrical contractor.

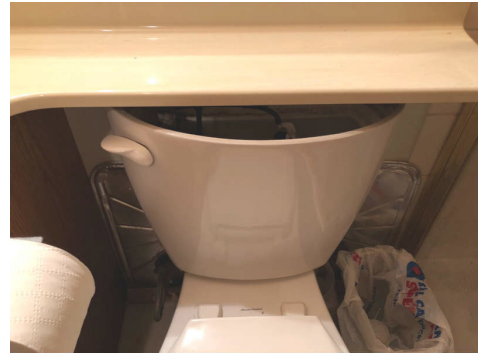
17.2.1 Toilets

MISSING TANK LID

The toilet tank lid was missing. Lid(s) should be replaced as necessary.

Contact a qualified plumbing contractor.

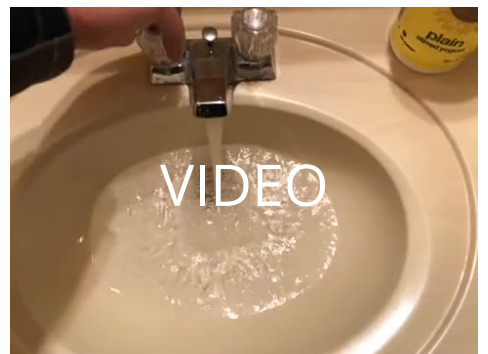
17.6.1 Sink/countertop

SINK DRAINS SLOW

One or more sinks are clogged or drain slowly. Drain(s) should be cleared as necessary, and by a qualified plumber if necessary.

Contact a qualified plumbing contractor.

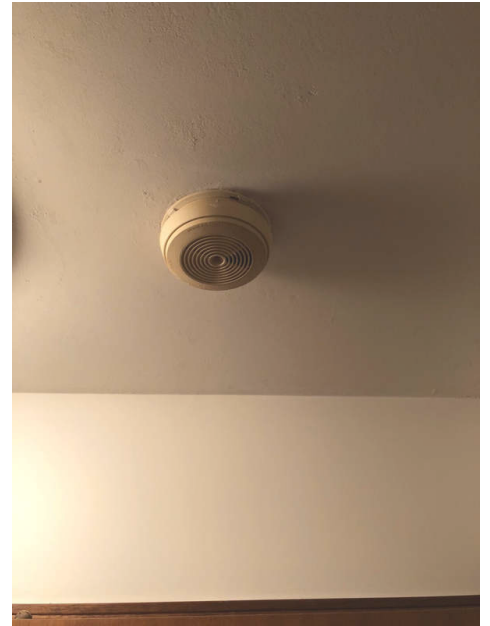
18.3.2 Smoke Detectors

SMOKE ALARM >10 YRS

Based on the age of this structure and the appearance of existing smoke alarms, the alarms may have been installed more than 10 years ago. According to National Fire Protection Association, aging smoke alarms don't operate as efficiently and often are the source for nuisance alarms. Older smoke alarms are estimated to have a 30% probability of failure within the first 10 years. Newer smoke alarms do better, but should be replaced after 10 years. Unless you know that the smoke alarms are new, replacing them when moving into a new residence is also recommended by NFPA.

Lower level

Recommendation
Contact a qualified electrical contractor.

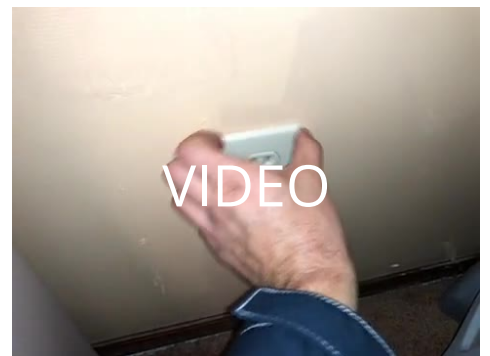
18.10.1 Lighting Fixtures, Switches & Receptacles

RECEPTACLE LOOSE

BASEMENT

One or more electric receptacles and/or the boxes in which they were installed were loose and/or not securely anchored. Wire conductors can be damaged due to repeated movement and/or tension on wires, or insulation can be damaged. This can become a shock and fire hazard. Recommend that a qualified electrical contractor repair as necessary.

Recommendation
Contact a qualified electrical contractor.

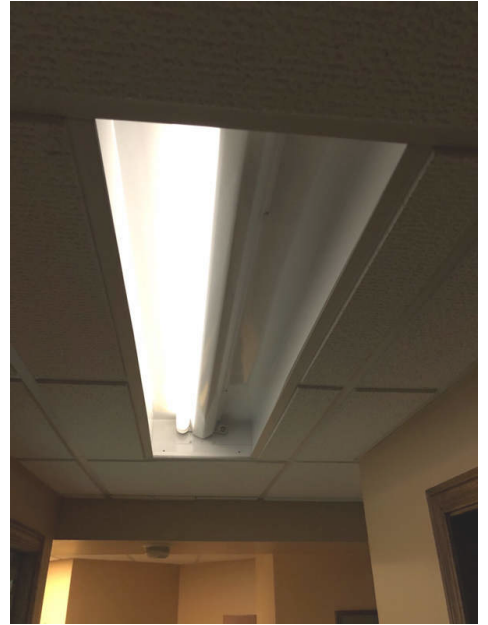
18.10.3 Lighting Fixtures, Switches & Receptacles

FLUORESCENT TUBING NOT COVERED

Recommendation
Contact a qualified electrical contractor.

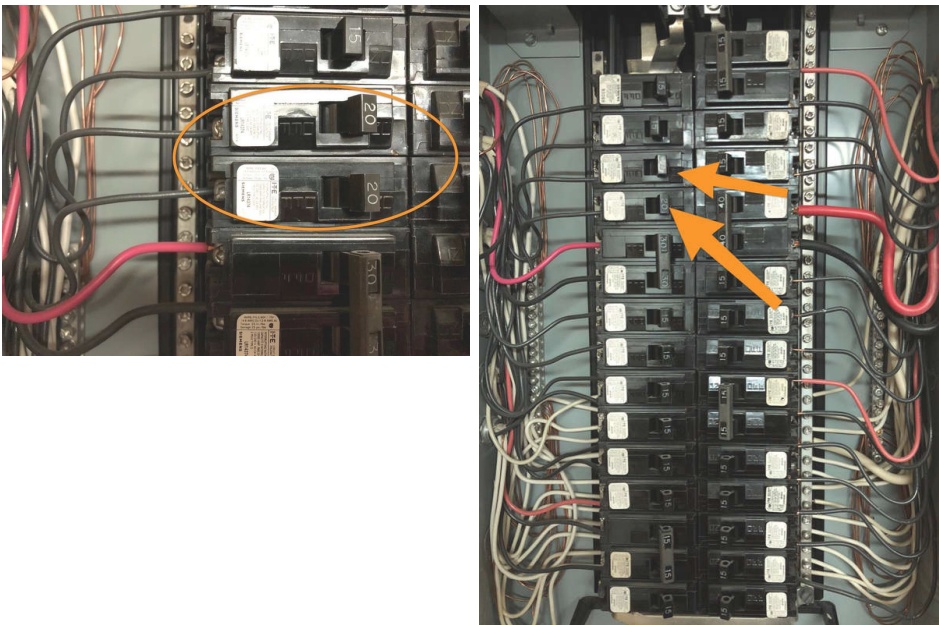
21.4.1 Branch Wiring Circuits, Breakers & Fuses

INCORRECT SIZING

Overcurrent protection device (breaker/fuse) rating was insufficient for the size of wire terminated. This can cause the wire to overload, and overheat, without tripping the breaker.

The breakers indicated were 20 amp breakers servicing 14 gauge wire. These should be 15 amp breakers.

Recommend qualified electrical contractor to repair as necessary.

Recommendation
Contact a qualified electrical contractor.

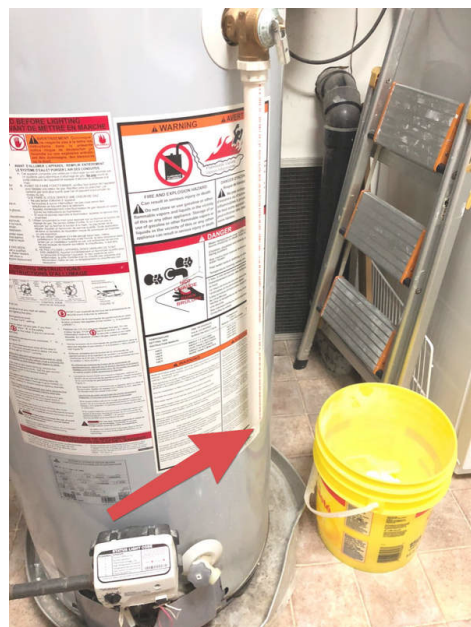
23.6.1 Water Heater

TPR EXTENSION TOO SHORT

TPR extension for the water heater is too short. This is a potential safety hazard due to the risk of scalding if someone is standing next to the water heater when the valve opens. A qualified plumber should install an extension line as per standard building practices. For example, extending to 6 inches from the floor, or routed so as to drain outside.

Contact a qualified plumbing contractor.

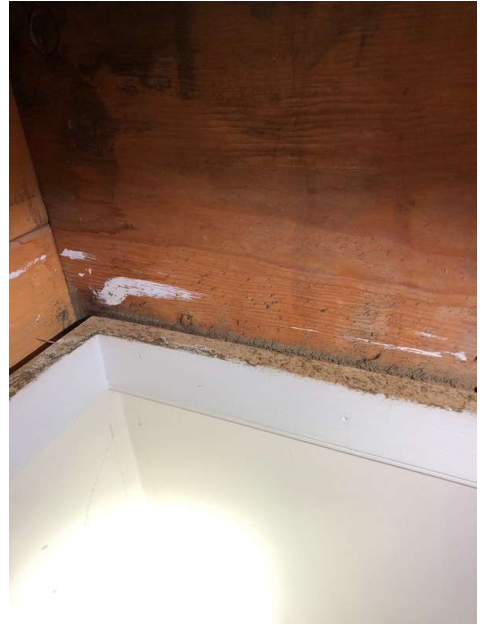
25.2.1 Attic Hatch

NO WEATHERSTRIP-LIVING SPACE

No weatherstrip is installed around the attic access hatch. Weatherstrip should be installed around the hatch to prevent conditioned interior air from entering attic.

Contact a qualified handyman.

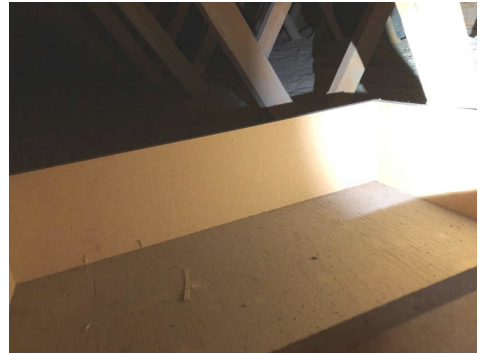
25.2.2 Attic Hatch

NO INSULATION OVER

No insulation is installed over the attic access hatch. Recommend installing insulation above hatch for better energy efficiency.

Contact a qualified insulation contractor.
