SUMMARY

1234 Main St. Medina OH 44256

Kurt Hoes
CPI, ASHI, NACHI
North Ohio Property Inspection
330-604-0544

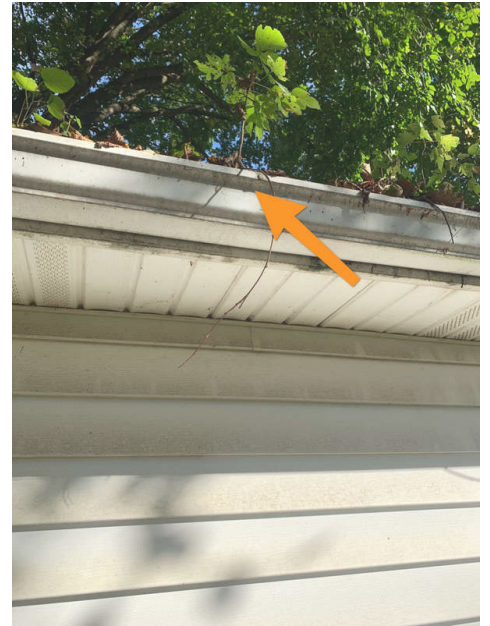
3.2.1 Roof Drainage Systems

DEBRIS IN GUTTERS

GARAGE GUTTERS

Debris has accumulated in the gutters. Gutters are an important part of keeping the foundation dry. I recommend cleaning gutters on a regular basis to facilitate water flow.

Contact a handyman or DIY project

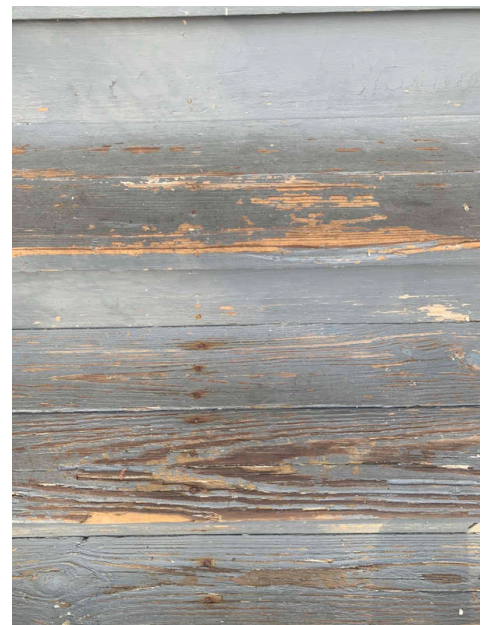
4.1.1 Siding, Flashing & Trim

PAINT DEFICIENT- EXTERIOR

PORCH

Areas of the exterior are in need of scraping/repainting. Deficient paint could lead to rot and possible water intrusion. I recommend replacing any rotted wood/materials and repainting all affected areas to prevent future damage.

Contact a qualified painter.

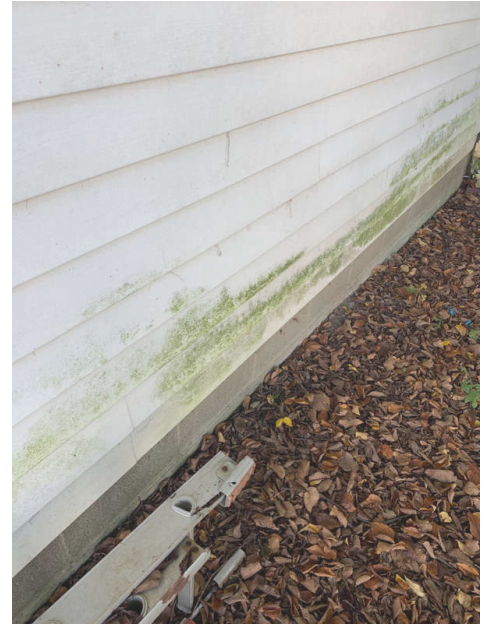
4.1.2 Siding, Flashing & Trim

MILDEW/ALGAE

GARAGE

There are signs of algae and/or mildew on the siding. This is a cosmetic issue and is not uncommon especially on shaded portions of the home. Recommend that affected areas be washed or cleaned on a regular basis.

Contact a handyman or DIY project

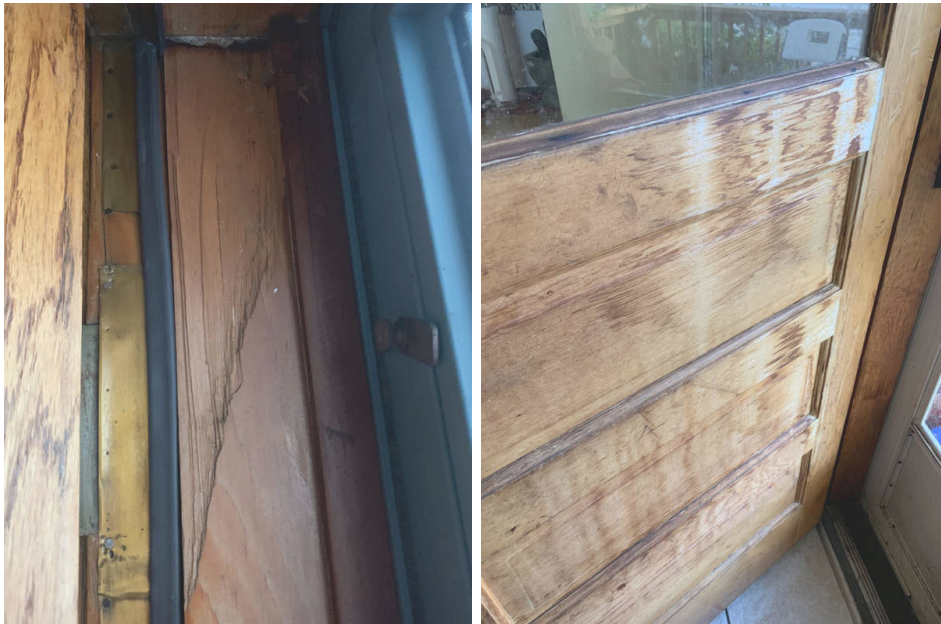
4.2.1 Exterior Doors

EXTERIOR DOOR DAMAGE- GENERAL

DAMAGE TO FRONT DOOR FRAME, BACK DOOR NEEDS REFINISHING

There is general damage to one or more doors. I recommend making proper repair or replacing the affected doors.

Contact a qualified handyman.

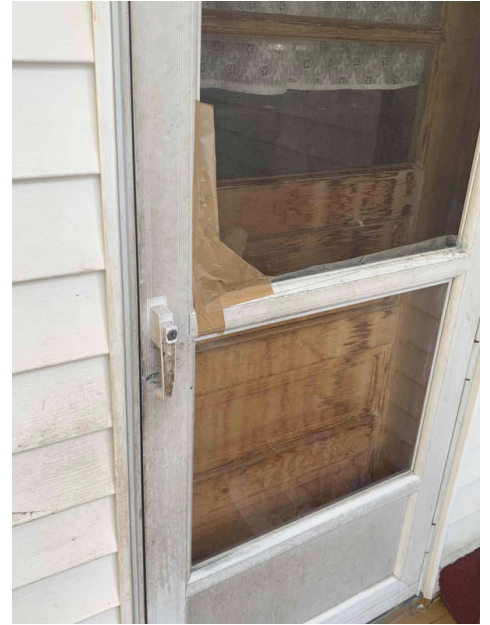
4.2.2 Exterior Doors

SCREEN DOOR- DAMAGE TO SCREEN

BACK SCREEN DOOR

There is damage to the screen on one of the screen doors. I recommend repairing or replacing the screen.

Recommendation
Contact a handyman or DIY project

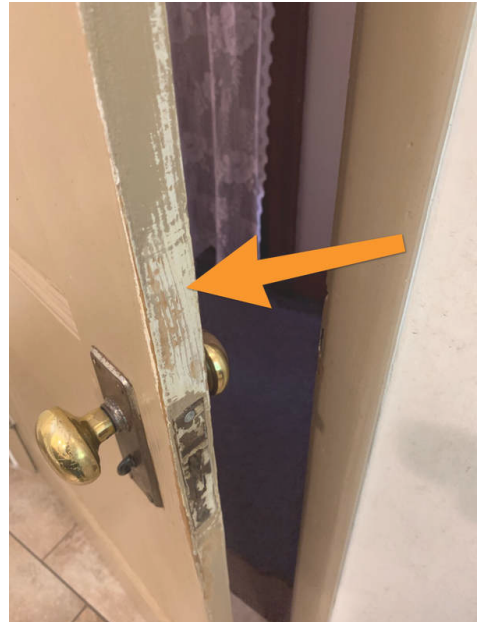
6.1.1 Doors

DOOR STICKS

2ND FLOOR BATHROOM

Door sticks and is tough to open/close. Recommend sanding down offending sides.

Area where door rubs

Contact a handyman or DIY project

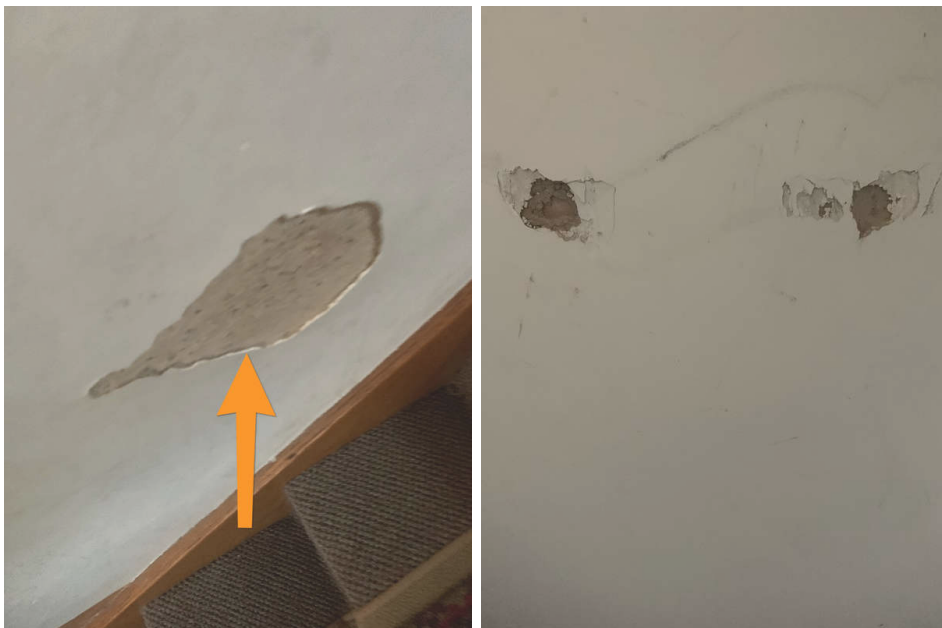
6.4.1 Walls

DAMAGED DRYWALL/PLASTER

There was physical damage to drywall or plaster. I recommend repairing and repainting the affected areas.

Contact a qualified drywall contractor.

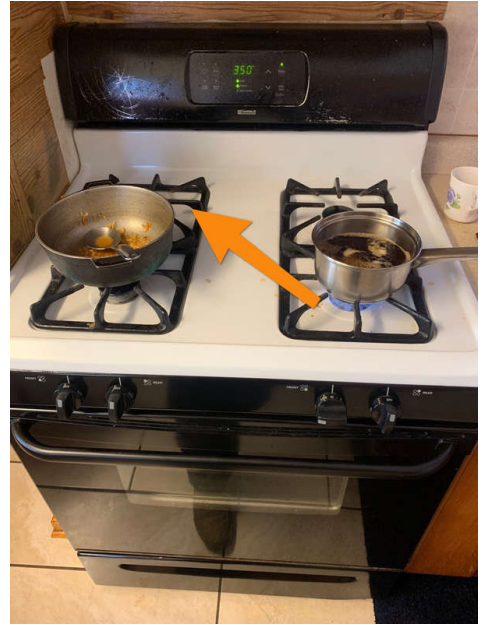
7.2.1 Range/Oven/Cooktop

BURNER WOULDNT IGNITE

LEFT REAR BURNER

A burner on the gas stove wouldnt ignite at the time of inspection. This can be frequently repaired by cleaning the burner and igniter. I recommend evaluation/repair.

Contact a qualified appliance repair professional.

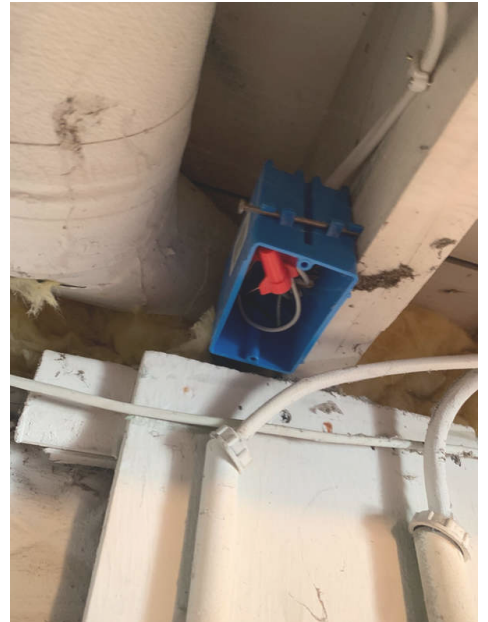
8.4.1 Lighting Fixtures, Switches & Receptacles

COVER PLATES MISSING

BASEMENT ABOVE GAS METER

One or more receptacles are missing a cover plate. This exposes the hot terminals on the side of the receptacle and causes short and shock risk. This may also create an issue during the appraisal process. Recommend installation of cover plates on all outlets in the home that are missing them.

Contact a handyman or DIY project

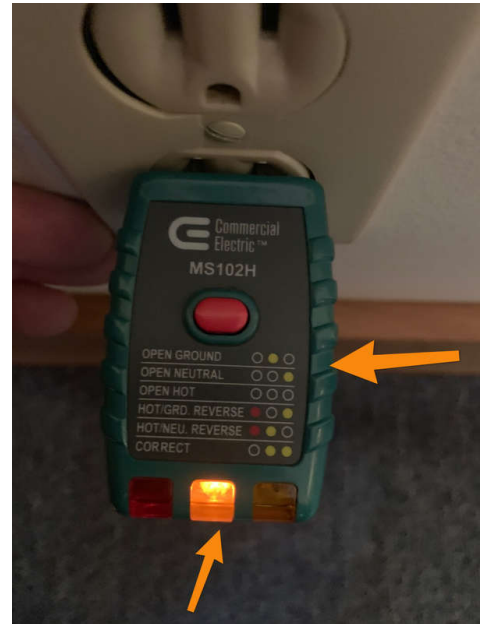
8.4.2 Lighting Fixtures, Switches & Receptacles

UNGROUND RECEPTACLES

VARIOUS LOCATIONS THROUGHOUT HOME

One or more receptacles are ungrounded. To eliminate safety hazards, all receptacles in kitchen, bathrooms, garage & exterior should be grounded. Replacing 3 prong ungrounded outlets with GFCI outlets or reverting to 2 prong is considered to be a suitable replacement.

Contact a qualified electrical contractor.

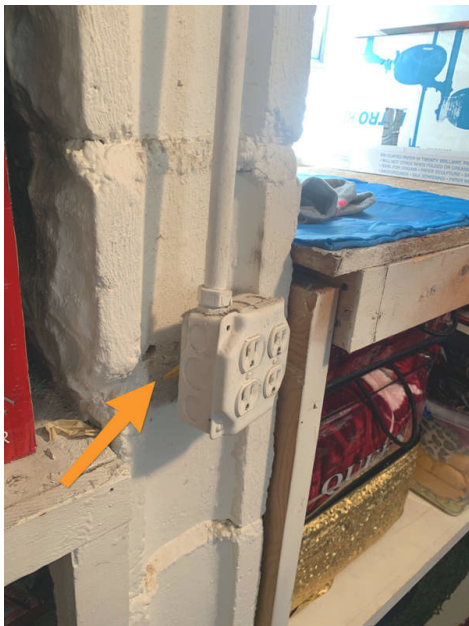
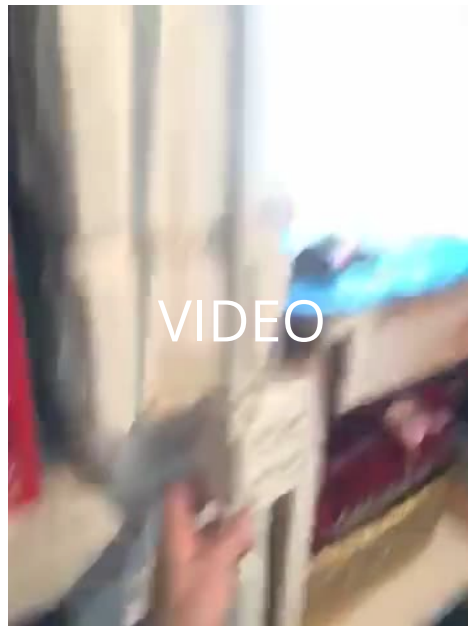
8.4.3 Lighting Fixtures, Switches & Receptacles

LOOSE FIXTURE

BASEMENT

A fixture is loose. I recommend securing the fixture properly.

Contact a handyman or DIY project

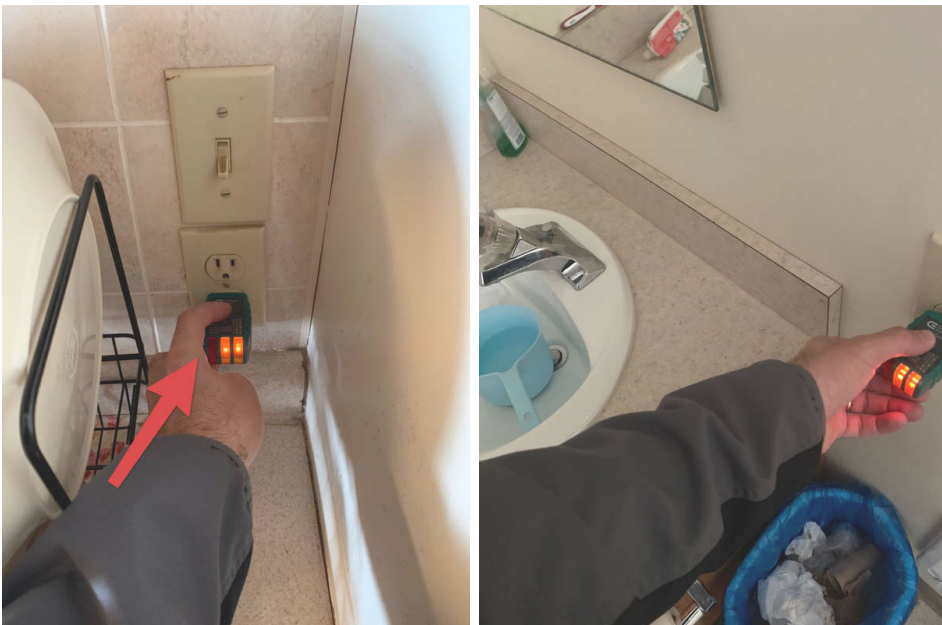
8.5.1 GFCI & AFCI

NO GFCI PROTECTION INSTALLED

KITCHEN, BASEMENT BATHROOM

One or more outlets in a required area did not have GFCI protection. Although GFCI protection may not have been required at the time the home was built, for safety reasons, it is recommended that electrical receptacles located in basements, crawlspaces, garages, the home exterior, and interior receptacles located within 6 feet of a plumbing fixture be provided with ground fault circuit interrupter (GFCI) protection in good working order to avoid potential electric shock or electrocution hazards. I recommend installing GFCI protection.

Recommendation
Contact a qualified electrical contractor.

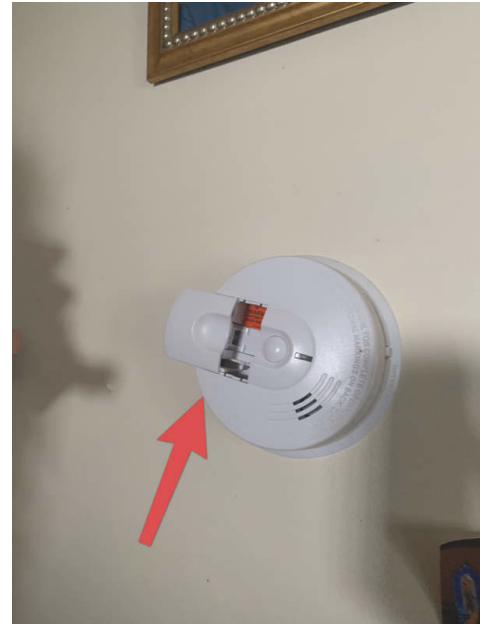
8.6.2 Smoke Detectors

SMOKE DETECTOR- NO BATTERY

LIVING/DINING ROOM OFF KITCHEN

There was a smoke detector that had its battery removed. I recommend replacing the battery and testing for proper operation.

Recommended DIY Project

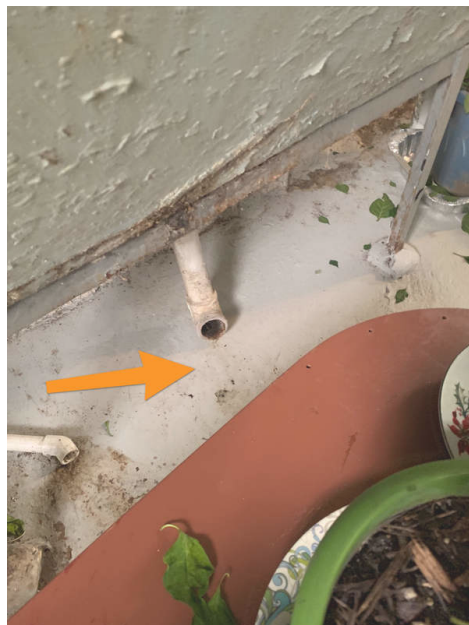
9.2.1 Drain, Waste, & Vent Systems

DRAIN NOT CONNECTED

The utility tub in the basement drains into the floor. I recommend connecting the drain to the plumbing system. I could not test for leaks/proper operation due to items stored in the tub.

Contact a qualified plumbing contractor.

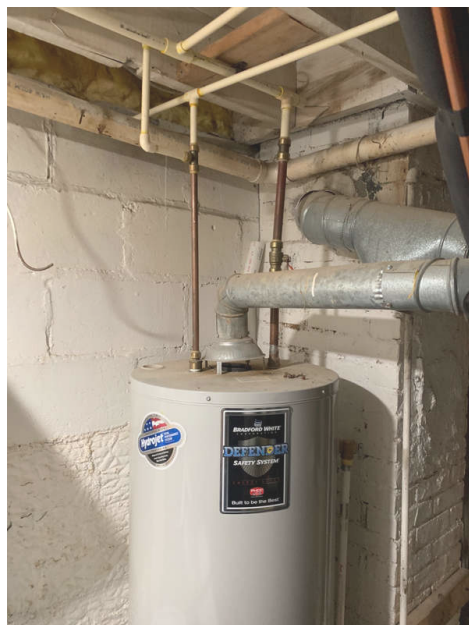
9.4.1 Hot Water Systems

NO EXPANSION TANK

No expansion tank was present. Expansion tanks allow for the thermal expansion of water in the pipes. These are required in certain areas for new installs. Recommend a qualified plumber evaluate and install.

Contact a qualified plumbing contractor.

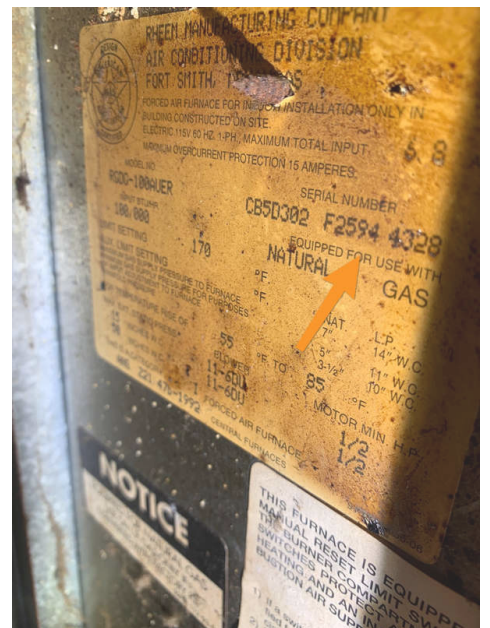
11.1.1 Equipment

FURNACE AGE

Furnace is nearing the end of its expected life. While it is common for this type of furnace to run for an extended period of time, I recommend budgeting for a replacement in the future.

Built in 1994

Recommendation
Recommend monitoring.

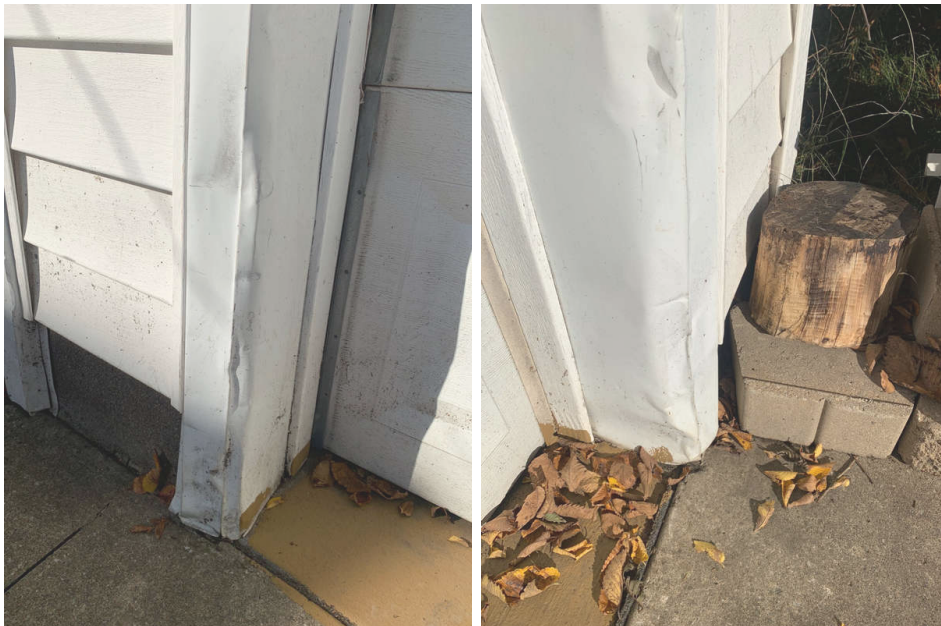
13.4.2 Garage Door

DAMAGE AROUND OUTSIDE FRAME OF GARAGE DOOR

There is damage to the outside frame of the garage door. I recommend repairing or replacing the trim.

Contact a qualified general contractor.
