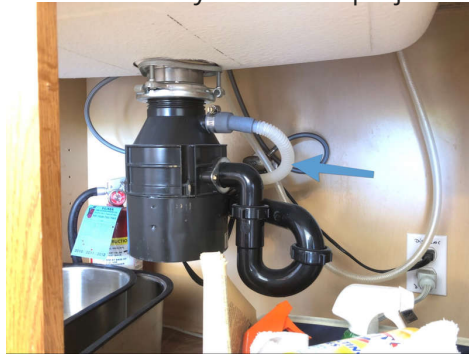
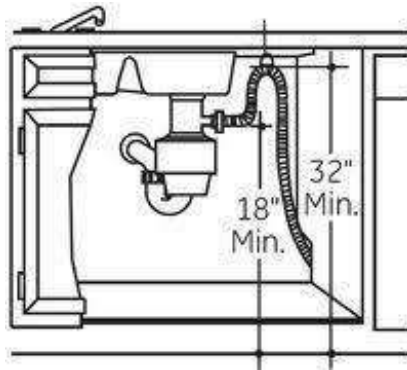
3.3.1 Dishwasher

NO HIGH LOOP

Dishwasher drain pipe was installed without a "high loop" to prevent cross-contamination. Recommend a handyman or DIY to repair. This will also prevent smells from accumulating from a low spot.

Contact a handyman or DIY project

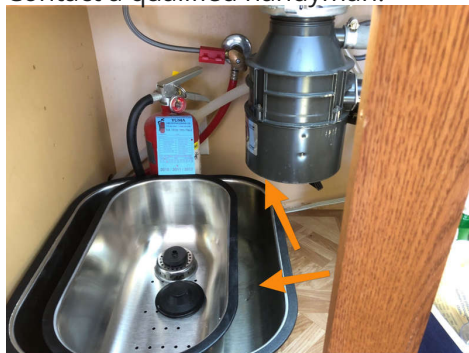
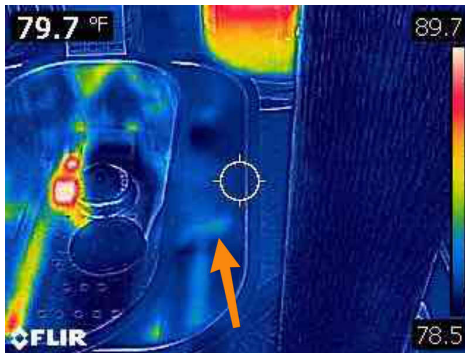
3.4.1 Garbage Disposal

LEAKING GARBAGE DISPOSAL

The garbage disposal is leaking or has been in the past and requires repair or replacement as necessary from a qualified technician.

Contact a qualified handyman.

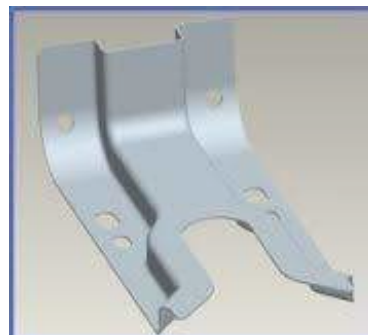
3.5.1 Range

NO ANTI TIP DEVICE

The Anti Tip Device is missing from the range and one should be installed for safety.

Anti Tip Device

Recommendation
Contact a qualified handyman.

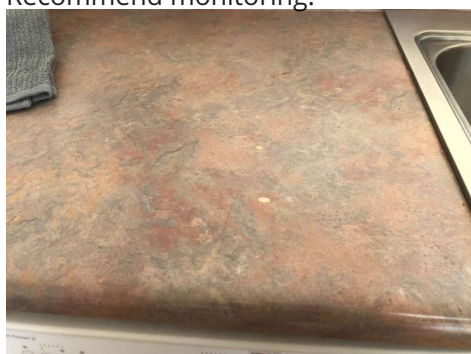
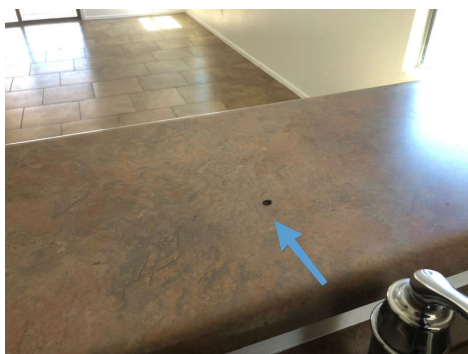
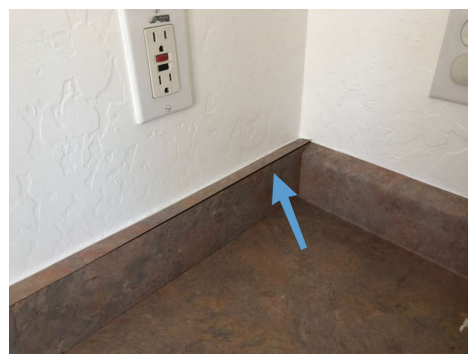
4.2.1 Countertop

TYPICAL WEAR AND TEAR

The kitchen countertop showed typical wear and tear, or cosmetic damage that you should view for yourself.

Recommendation
Recommend monitoring.

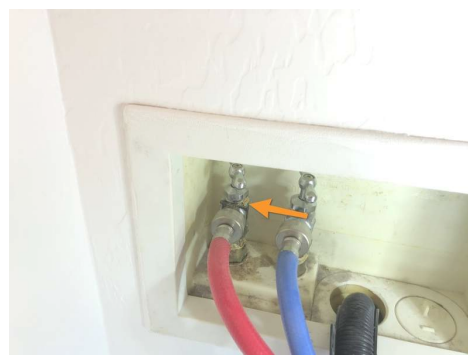
5.11.1 Valves & Connectors

CORROSION LEFT SHUT-OFF VALVE

Corrosion and/or mineral build-up was observed on the left shut-off valve . This corrosion or build-up may prevent the shut-off valve from working properly, especially if emergency shut-off is needed. I recommend a qualified, licensed plumber should evaluate and repair or replace this valve or connection as necessary.

Recommendation
Recommend monitoring.

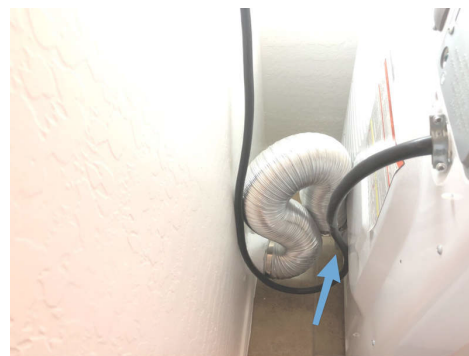
5.15.1 Dryer Vent

SEPARATED BEHIND THE DRYER

The dryer vent is separated behind the dryer and should be hooked up before use.

Contact a qualified handyman.

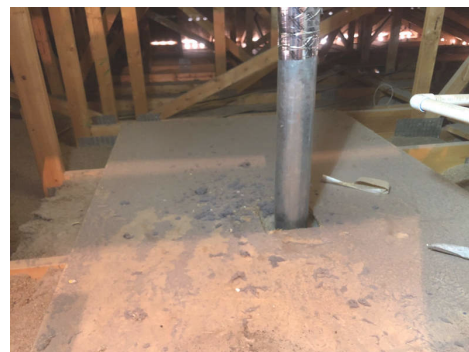
5.15.2 Dryer Vent

DRYER LINT IN THE ATTIC

There is a lot of dryer lint in the attic which can indicate a clogged or damaged dryer vent. I recommend further evaluation or service as necessary from a qualified technician.

Contact a qualified handyman.

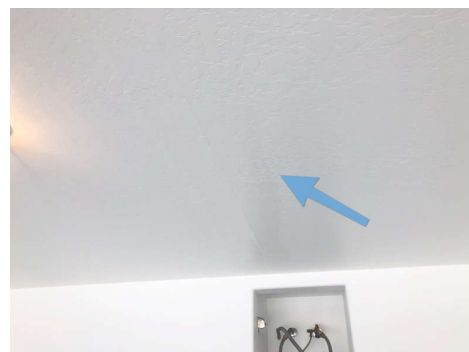
6.6.1 Walls and Ceiling

TYPICAL SETTLEMENT CRACKING ON WALLS AND CEILINGS

Observed typical settlement type cracking on walls and ceilings.

Recommend monitoring.

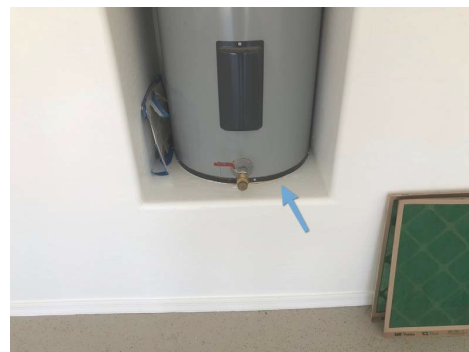
7.1.1 Hot Water System 1

NO DRAIN PAN OR PIPE

The water heater is not equipped with a drain pan and a discharge pipe, which is designed to prevent water damage from a leak. Nevertheless, the water heater should be periodically monitored for any signs of a leak we recommend having one installed if feasible when the water heater is replaced.

Contact a qualified professional.

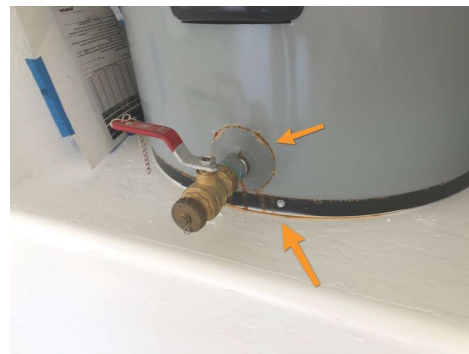
7.1.2 Hot Water System 1

WATER STAINS, RUST-LEAKAGE

Water stains, or rust were observed beneath water heater, indicating a past or present leak. Recommend further evaluation and repair or replacement by a qualified plumber.

Contact a qualified plumbing contractor.

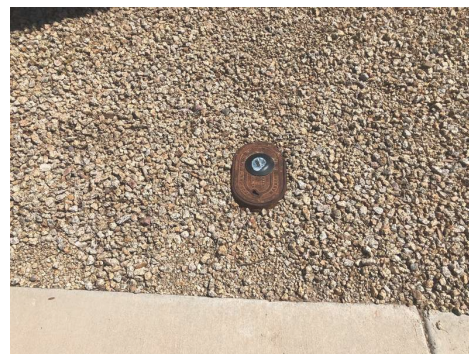
7.3.1 Main Water Shut-Off, Distribution & Supply

WATER METER BOX LOCKED

The water meter box appears locked and we were unable to view the water meter. Recommend the water meter be inspected when access is available.

Contact a qualified professional.

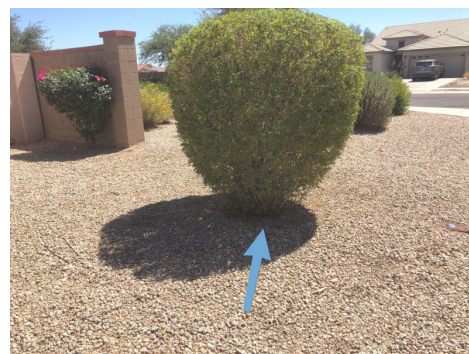
7.5.1 Irrigation

MISSING DRIP HEADS

There are missing drip heads or cracked drip lines on the irrigation system that need service or replacement. They are currently spraying uncontrolled in the yard when the system is turned on.

Contact a handyman or DIY project

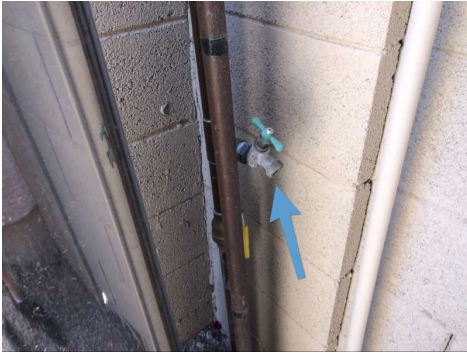
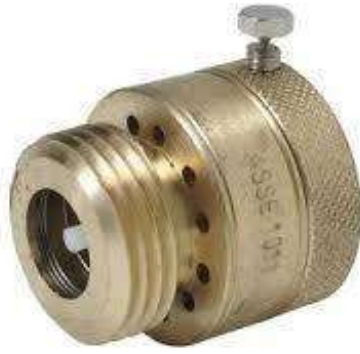
7.6.1 Hose Bibs

NO ANTI-SIPHON VALVES

The hose bibs do not include anti-siphon valves. These valves are relatively inexpensive and are required by current standards. However, I may not have located and tested every hose bib on the property.

Anti Siphon

Contact a qualified handyman.

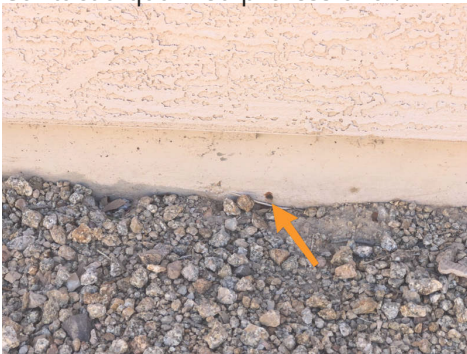
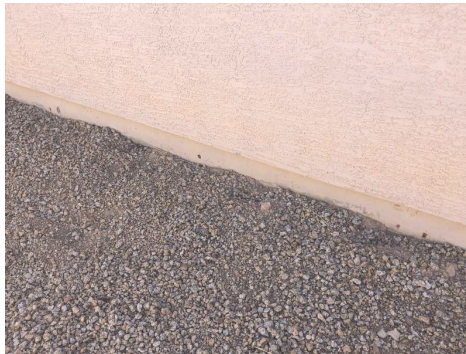
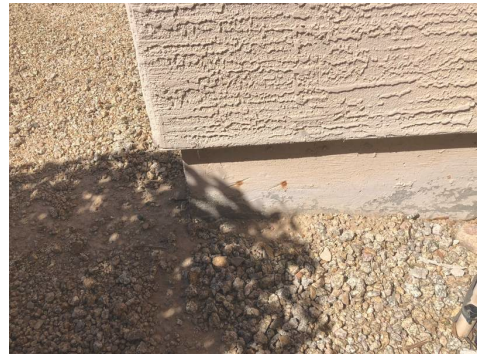
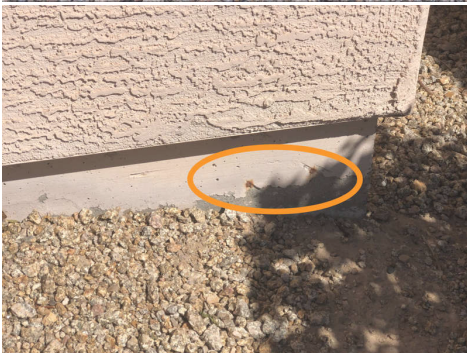
8.2.1 Foundation / Stem walls

EXPOSED METAL

The exposed metal at one or more location(s) around the stemwall should be covered/sealed to prevent corrosion and deterioration.

Contact a qualified professional.

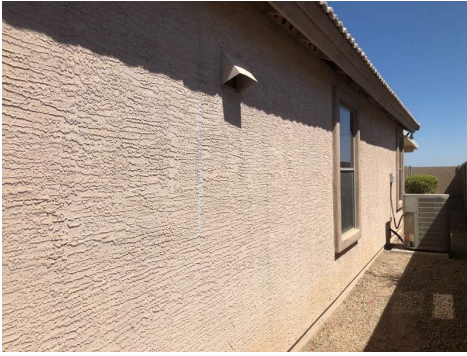
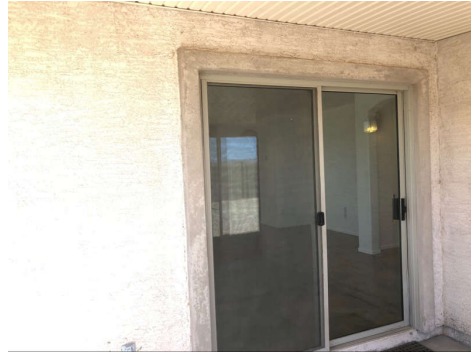
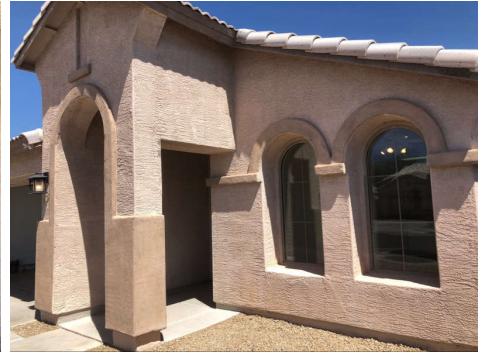
10.2.1 House Wall Finish

PAINT IS DISCOLORED

The exterior paint is discolored at some areas around the residence. A likely result of normal wearing and its age. Most homes need a new exterior coat of paint every 10-12 years. I recommend further evaluation from a painter.

Contact a qualified painter.

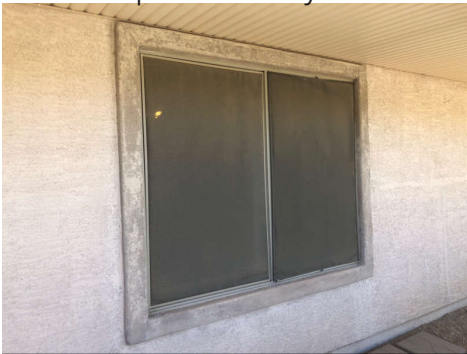
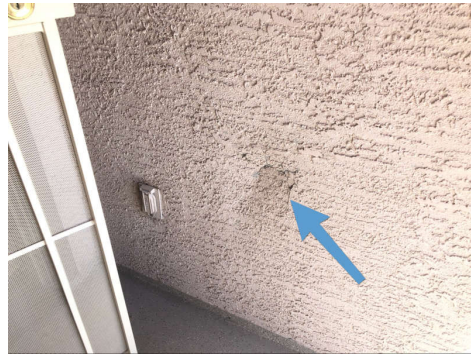
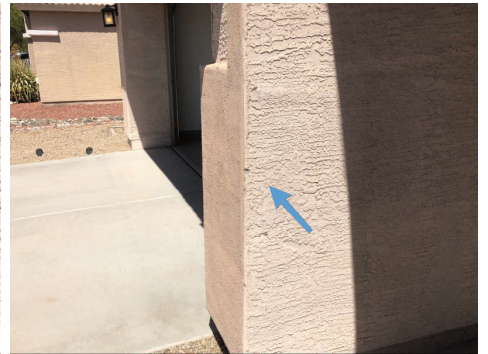
10.2.2 House Wall Finish

DAMAGED SIDING OR STUCCO

Observed areas of damaged siding or stucco around the residence that should be further evaluated and repaired to help prevent moisture intrusion issues. These damaged areas can allow moisture to penetrate the walls if not properly repaired.

Recommendation
Contact a qualified handyman.

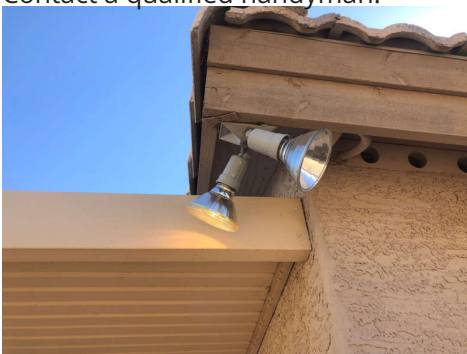
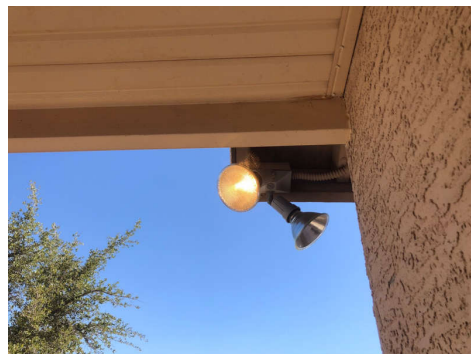
10.6.1 Lights

SOME EXTERIOR LIGHTS DID NOT WORK.

Observed exterior lights that did not work on demand and should be serviced as necessary or demonstrated. Maybe just bad bulbs?

Recommendation
Contact a qualified handyman.

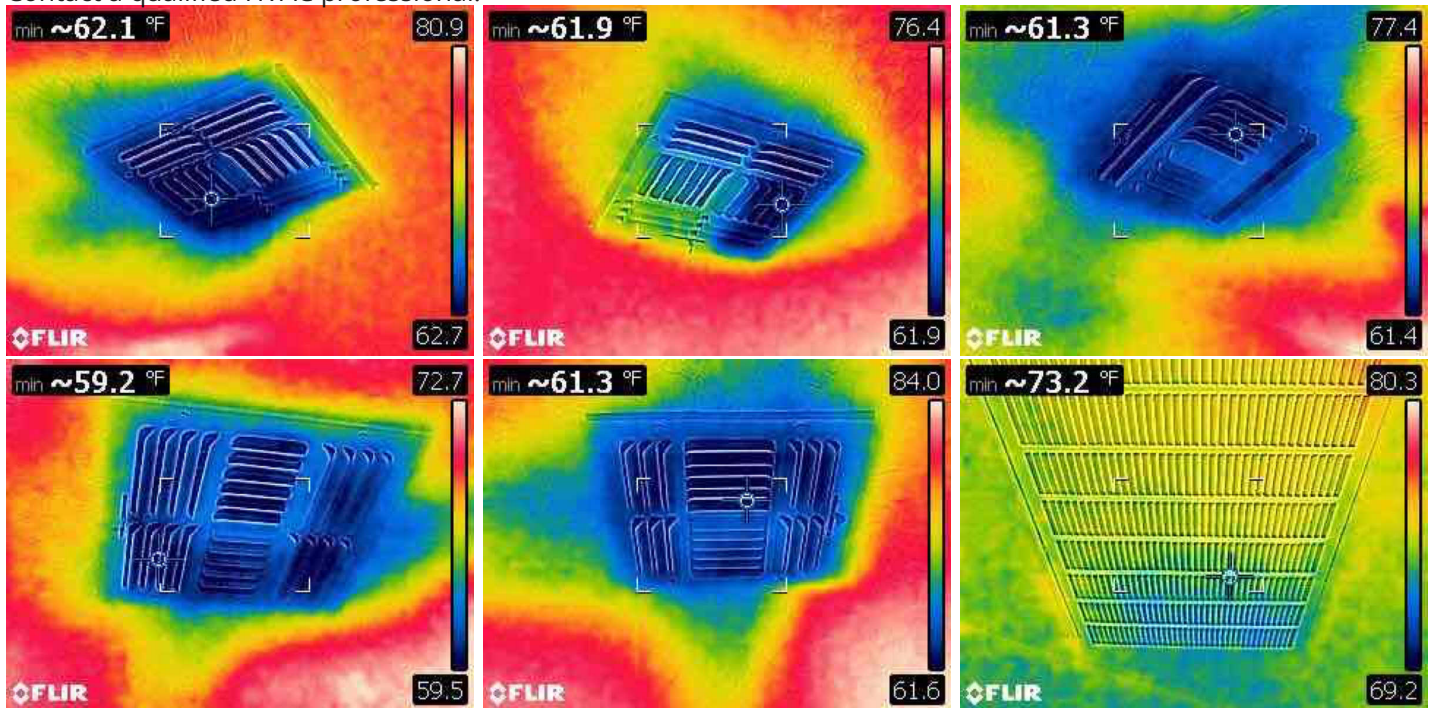
11.2.1 Differential Temperature Readings

AC LOW DIFFERENTIAL TEMPERATURE SPLIT

The air-conditioning responded, but only achieved a low differential temperature split between the air entering the system and that coming out. This could indicate that the system is low on refrigerant, or that other service is necessary, and should be serviced by a qualified, licensed HVAC professional within the inspection period or before the close of escrow.

Contact a qualified HVAC professional.

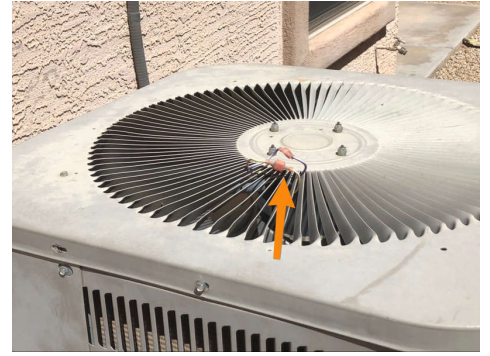
11.5.2 Condensing Coil (outside)

EXPOSED WIRING

The exposed wiring should be relocated for safety reasons.

Contact a qualified professional.

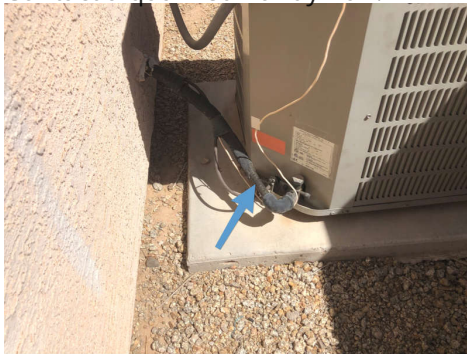
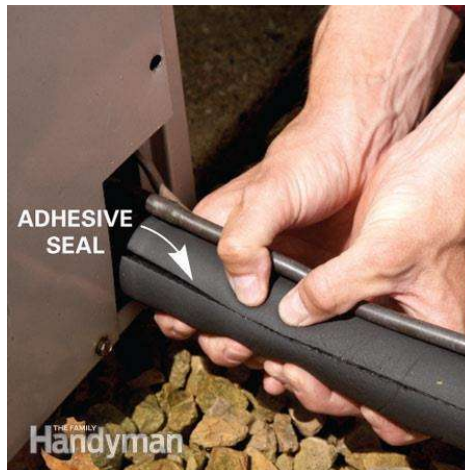
11.6.1 Refrigerant Lines

INSULATION MISSING

Insulation is missing from the refrigerant lines at the condensing coil, which could help inhibit condensation to form and drip within the wall, hvac foam should be installed for that reason and for increased efficiency. These are easily found at the hardware store.

Add insulation to refrigerant lines

Contact a qualified handyman.

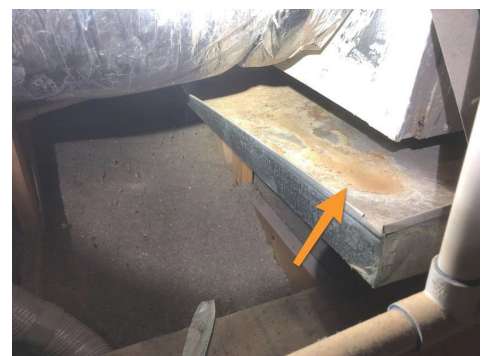
11.9.1 Drip Pan

RUST STAINING IN PAN

The rust colored staining in the drain pan indicates a previous leak issue that may or may not have been corrected; most likely a clogged or blocked primary condensation drain line. I recommend further review from a qualified HVAC service to determine if this needs repair or not.

Contact a qualified HVAC professional.

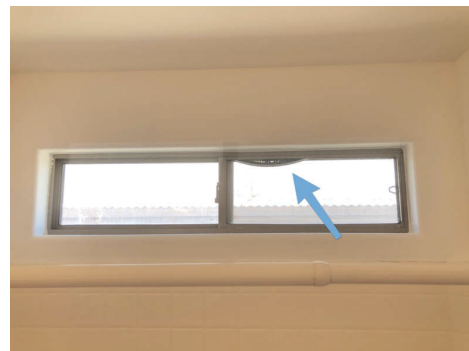
17.4.1 Windows

THE SEALS ARE DROOPING

A window(s) seals are drooping this is mostly cosmetic however we recommend that you have a professional check out all the window seals in the residence if you are concerned.

Recommendation
Contact a qualified window repair/installation contractor.

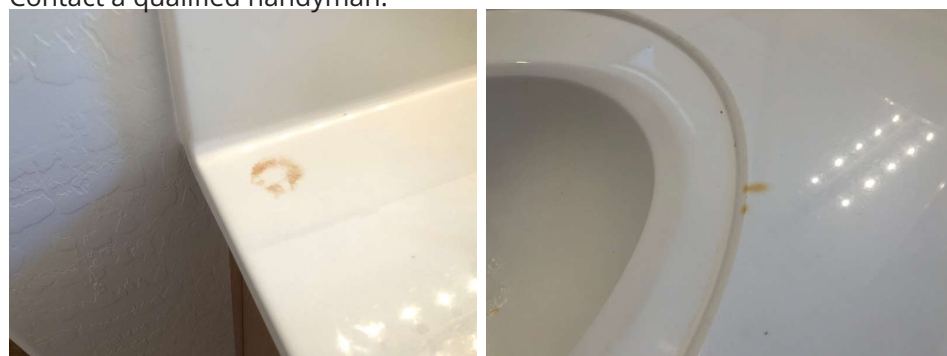
17.7.1 Countertop

TYPICAL WEAR AND TEAR

The countertop showed typical wear and tear that you should view for yourself

Recommendation
Contact a qualified handyman.

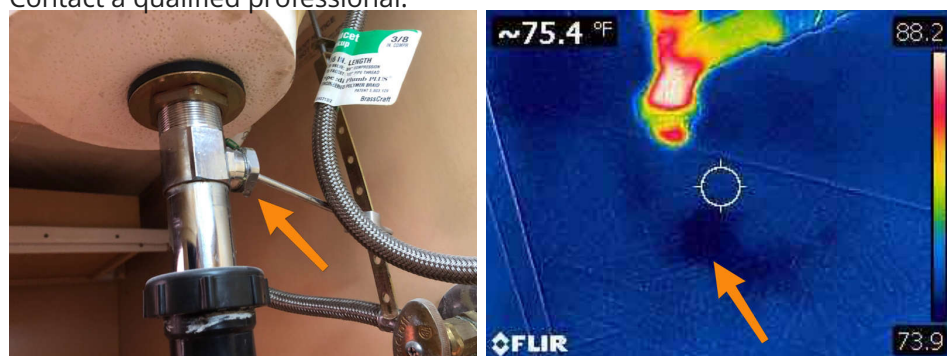
17.8.1 Trap and Drain

LEAK AT DRAIN LINE BELOW THE SINK

There is a leak at the drain line below the sink which should be repaired as necessary.

Recommendation
Contact a qualified professional.

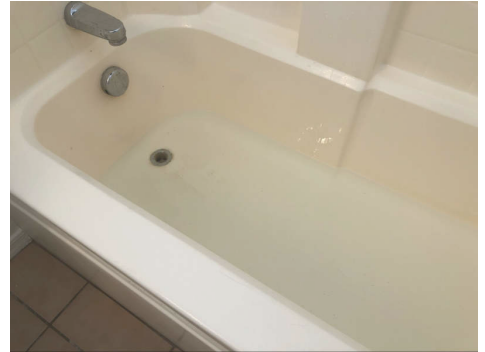
SLOW DRAIN

The tub/shower drains too slowly and should be serviced as necessary, because such blockages can progress beyond the drain trap and involve the main waste line. Maybe a build up of hair and soap or stopper?

Contact a qualified plumbing contractor.

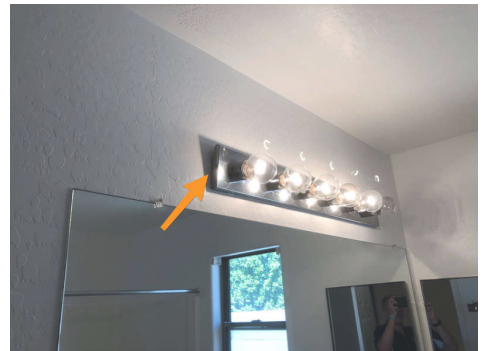
LIGHT FIXTURE IS LOOSE

A light fixture is loose at the wall/ceiling and should be serviced.

Contact a qualified handyman.

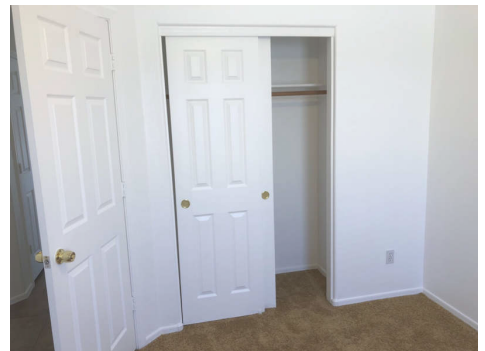
DOORS DO NOT OPEN AND CLOSE EASILY

The closet doors do not open and close easily, and should be serviced.

Contact a qualified handyman.

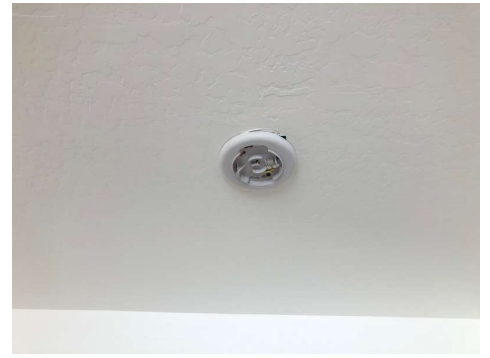
THE SMOKE DETECTORS MISSING

The smoke detector is missing and should be replaced as a fire safety feature.

Contact a qualified handyman.
