This Summary outlines potentially significant issues from a cost, safety or urgency standpoint. This section is provided as a courtesy and cannot be considered a substitute for reading the entire report. Please read the complete document.

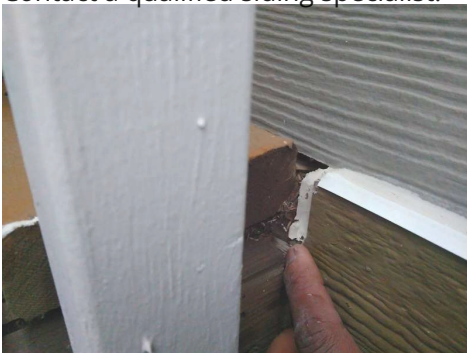
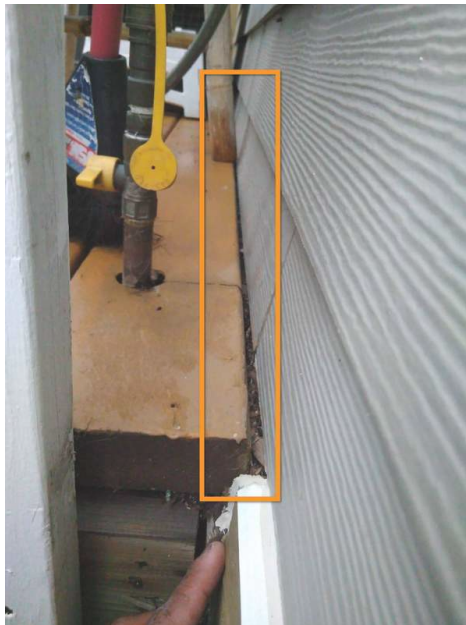
## 2.6.2 Decks, Balconies and Steps

### MISSING FLASHING

The house is missing Z- flashing at the junction of the siding and the deck. Recommend installing to help prevent (further) moisture and rot damage.

Contact a qualified siding specialist.

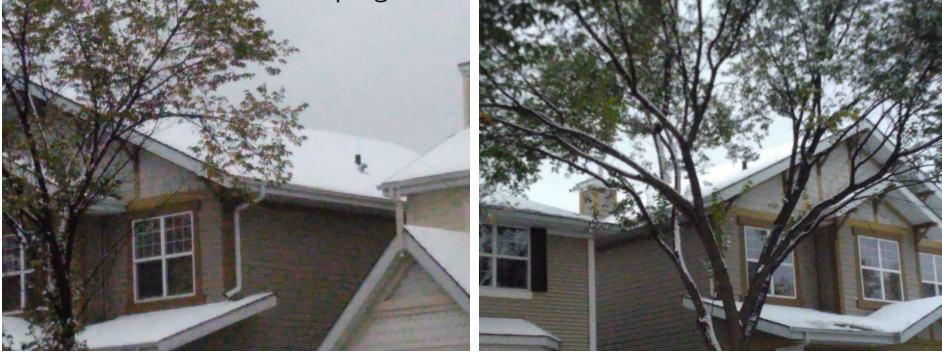
## 2.7.1 Vegetation, Lot Drainage & Retaining Walls

### TREE TO HOME CONTACT

The tree/bush is in contact with the home. This can cause damage to the siding and roofing materials, improper drainage to gutters and downspouts. Recommend trimming the tree back or removing to help prevent further damage and rodent access to the siding, roof and eaves.

Recommendation  
Contact a qualified landscaping contractor

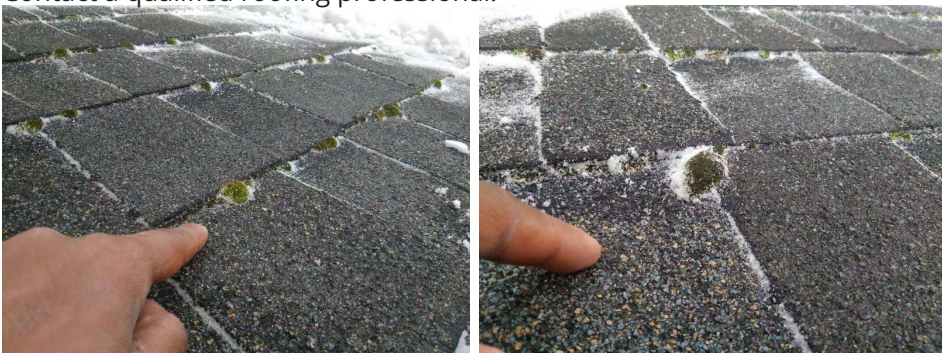
3.1.1 Roof Coverings

### MOSS/DEBRIS ON ROOF

There was excessive moss and/or debris on the roof. Recommend cleaning to help prolong the life of the roof covering and prevent damage and leaks. Observed missing vent on porch area this could be another reasoning for high moisture around front porch roof.

Recommendation  
Contact a qualified roofing professional.

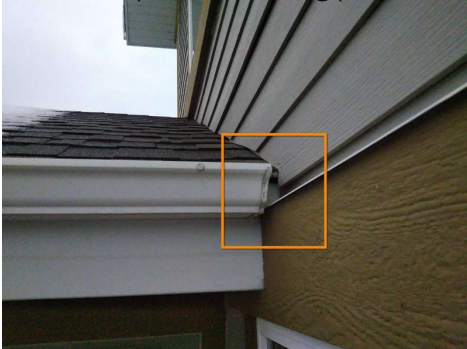
3.3.1 Side Wall Flashings

**MISSING KICK-OUT FLASHING**

The roof was missing kick-out flashing at the bottom edge of the roof against the side-wall. Recommend installing to help prevent water intrusion behind the siding.

Contact a qualified roofing professional.

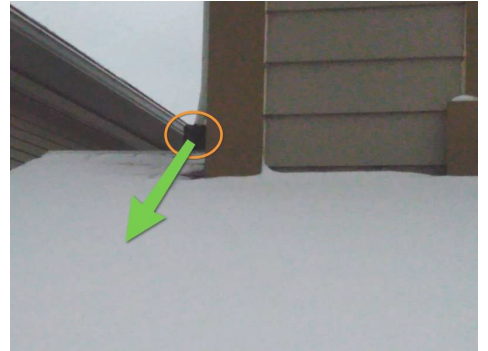
3.4.1 Gutter, Downspouts, Extensions

**DOWNSPOUTS/GUTTER DISCHARGES ON ROOF**

The downspout or gutter discharges onto the roof below. This can cause premature wear of the shingles below. Recommend repair to help prolong the life of the shingles.

Contact a qualified handyman.

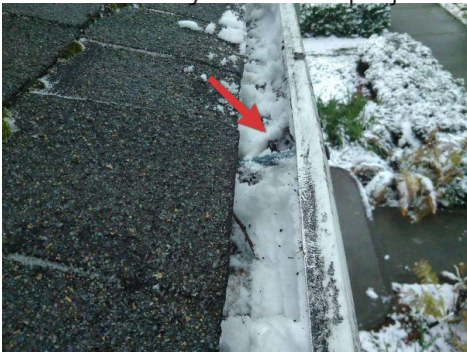
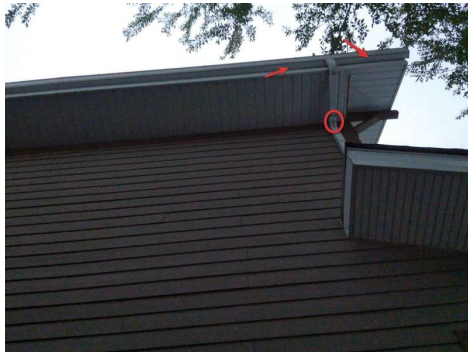
3.4.2 Gutter, Downspouts, Extensions

**GUTTERS FULL OF DEBRIS**

Debris has accumulated in the gutters. Recommend cleaning to facilitate water flow and void further damage to the soffit and other component.

signs of over flow

Contact a handyman or DIY project

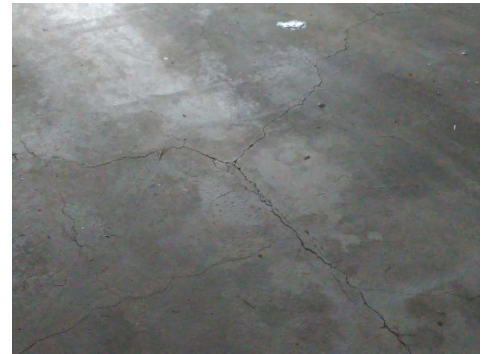
11.3.1 Floor Structure

**SETTLING CONCRETE FLOOR**

The concrete floor has settled. Recommend monitoring for proper slope, cracks and trip hazards and making repairs as necessary.

Recommendation  
Contact a qualified concrete contractor.

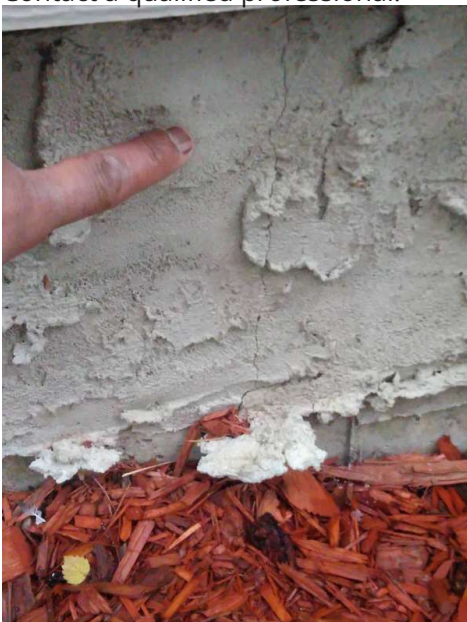
11.4.1 Crawlspace/Basement

**MINOR FOUNDATION CRACKS**

Observed Minor Foundation cracks, recommend sealing the crack and monitoring.

left side of the house

Garage

Recommendation  
Contact a qualified professional.
