SUMMARY

1234 Main St. Fargo ND 58102

Troy Swenson
InterNachi Certified
Guardian Home Inspections
701 238-7092
inspectorswen@gmail.com

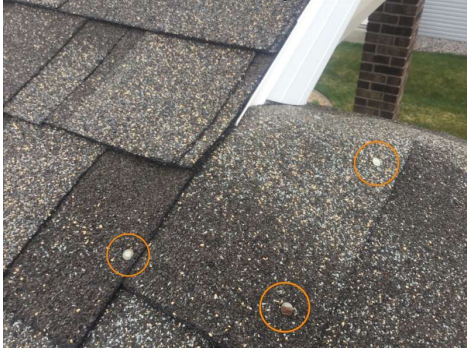
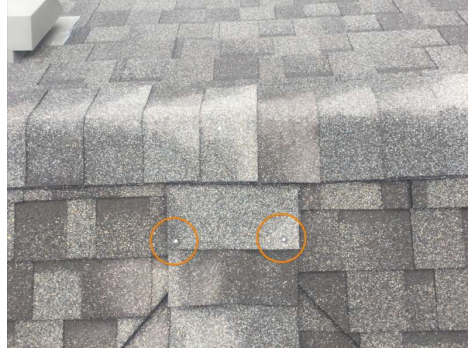
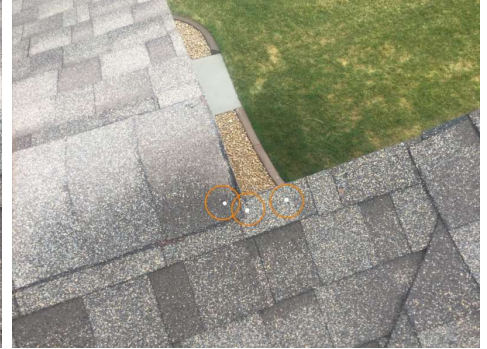
2.1.1 Coverings

EXPOSED NAILS

One or more exposed nails were observed. Recommend applying appropriate roofing sealant over nail heads.

Recommendation
Recommended DIY Project

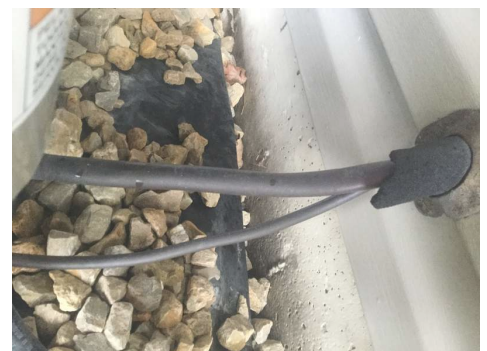
6.1.1 Cooling Equipment

INSULATION MISSING OR DAMAGED

Missing or damaged insulation on refrigerant line can cause energy loss and condensation.

Recommendation
Recommended DIY Project

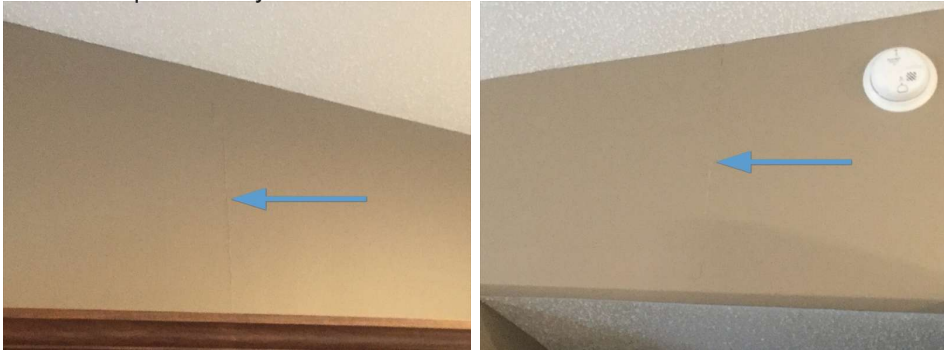
10.4.1 Walls

SETTLING CRACKS

Settling cracks are generally associated with the settling of the house. They may be caused by slight movement/settling in the foundation due to the expansion and contraction of the clay soil commonly found in this area. They may also be caused from the downward pressure put on a roof from a (snow load). The cracks can be repaired by sanding smooth, cleaning out the crack, re-taping & mudding. Or, sanding smooth, cleaning out the crack and applying flexible (elastomeric) paintable caulking. In either case, chances are that over time they will probably reappear at some point. Most common places to find this type of crack is at the top corner of a doorway or window, or on vaulted ceilings at the peak or were it meets the outside walls. Most materials used in building a house are somewhat flexible, including drywall, unfortunately it's the tape joints in the drywall that are the most susceptible to cracking (Paper or fiberglass mesh tape with an 1/8" of drywall compound over the top).

Contact a qualified drywall contractor.

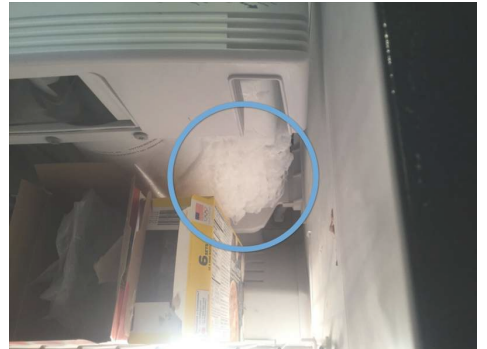
11.2.1 Refrigerator

FROST BUILD-UP

excessive frost buildup on underside of ice maker. Probably due to food storage in too close proximity. Recommend defrosting and monitoring. (Ice maker worked at time of inspection).

Recommended DIY Project
