SUMMARY
1234 Main St. Beaumont TX 77706
Buyer Name
08/29/2018 9:00AM

Gregory Clark, Jr
TREC #:23283
Legendary Inspection Group, LLC
4092735909
gregory@legendaryinspections.com

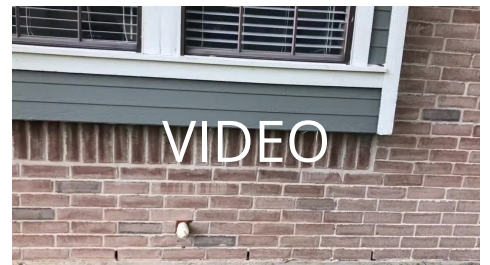
2.5.1 E. Walls (Interior and Exterior)

SIDING

Siding appears to be damaged on the right side

Of the home, underneath the kitchen window. Could cause water or rodent intrusion.

Contact a qualified professional.

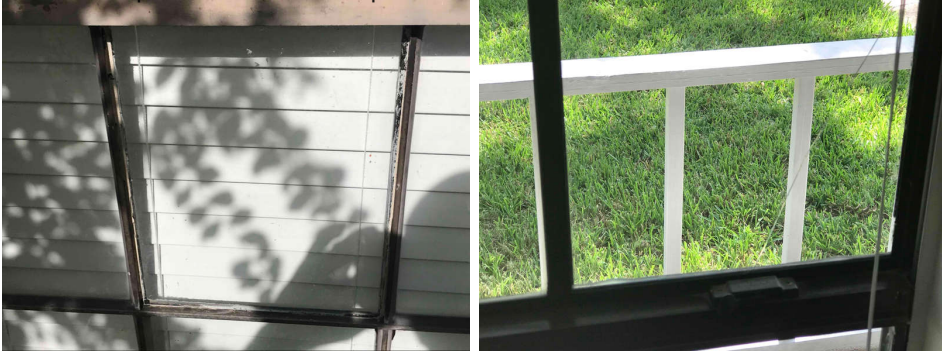
2.8.1 H. Windows

DAMAGED

One or more windows appears to have general damage, but are operational. Recommend a window professional clean, lubricate & adjust as necessary.

Contact a qualified window repair/installation contractor.

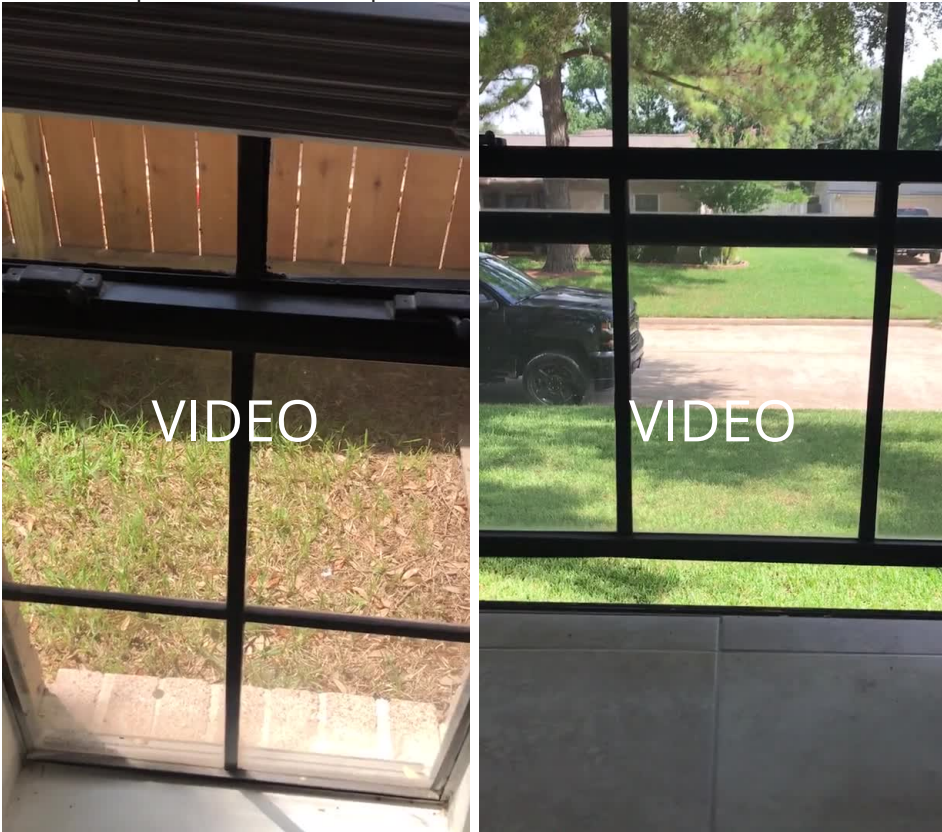
2.8.2 H. Windows

IMPROPER INSTALLATION

Windows in the kitchen appear to not be operating properly due to substandard installation. Recommend window specialist evaluate.

Contact a qualified window repair/installation contractor.

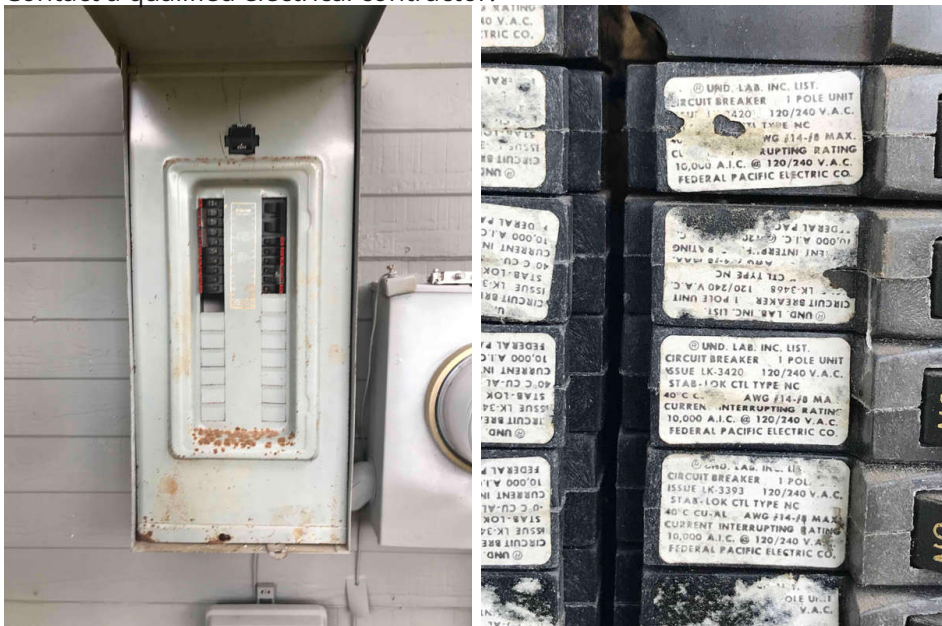
3.1.2 A. Service Entrance and Panels **PANEL MISSING LABELS**

Electrical panel does not have labels. Recommend a qualified electrician test and properly label all switches.

Recommendation
Contact a qualified electrical contractor.

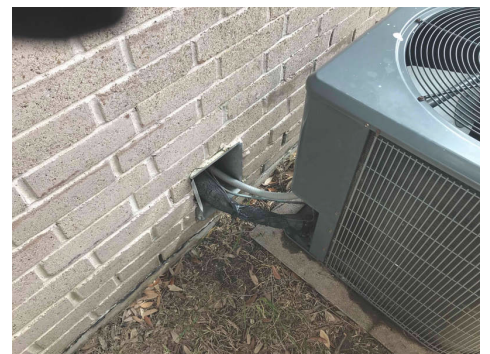
4.2.1 B. Cooling Equipment

INSULATION MISSING OR DAMAGED

Missing or damaged insulation on refrigerant line can cause energy loss and condensation.

Contact a qualified HVAC professional.

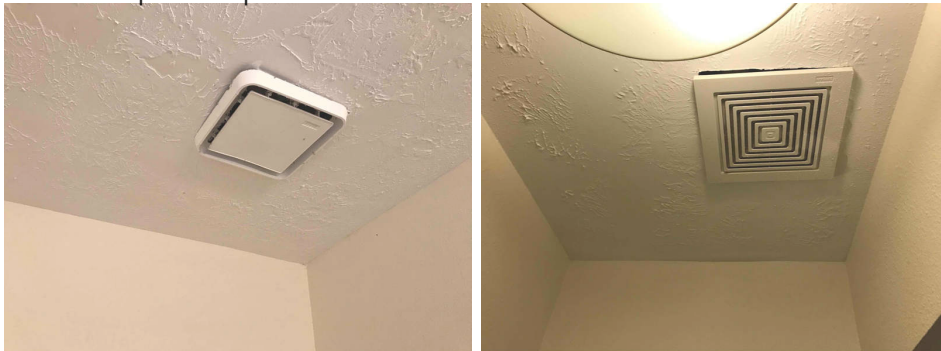
6.6.1 F. Mechanical Exhaust Vents and Bathroom Heaters

BATHROOM VENTS

Recommend that Bathroom vents be cleaned.

Recommendation
Contact a qualified professional.
