## SUMMARY

1234 Main St. Beaverton OR 97006

Grant Waller  
OCHI 1950, CCB 213007  
PacWest Home Inspections  
503-217-2000  
grant@pw-hi.com

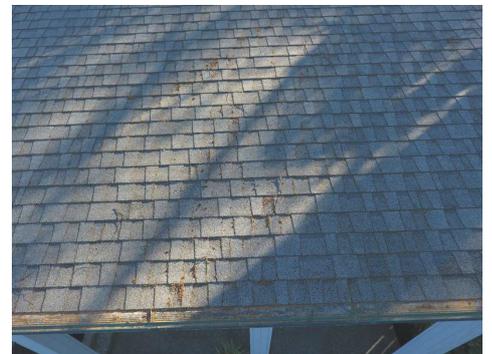
### 2.1.1 Coverings

#### DEBRIS

Minor/Maintenance Issues

Recommend cleaning any debris off of the roof to prevent water from pooling. For safety, recommend a licensed professional for steeper or high roofs.

Contact a handyman or DIY project

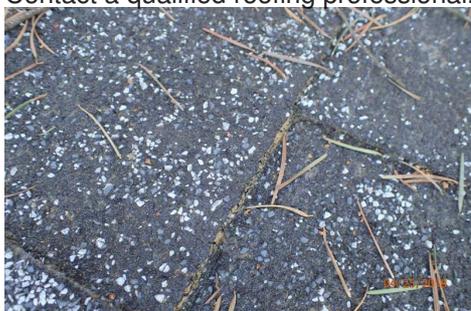
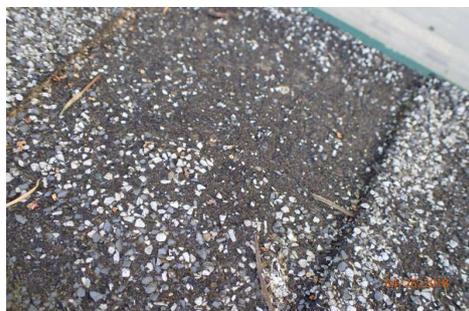
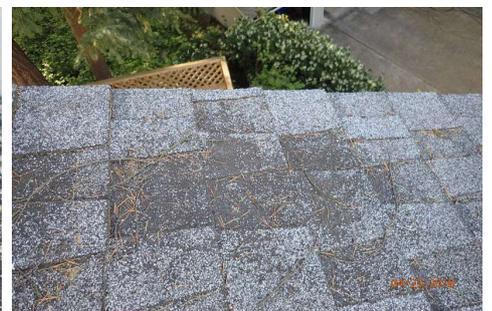
### 2.1.2 Coverings

#### GRANULE LOSS

Granule loss is a common occurrence and naturally happens over time. As the shingles are walked on, age, or expose to extreme elements, the granule loss can increase. As the granule loss occurs the likely hood of a leak increases. Recommend monitoring and consulting with a licensed roofer as the loss continues.

Contact a qualified roofing professional.

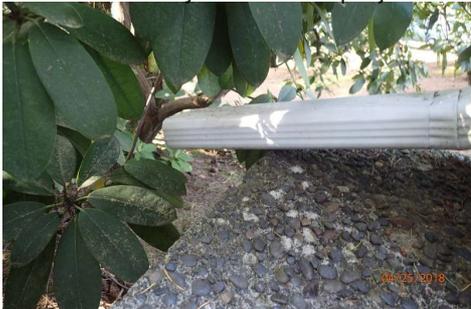
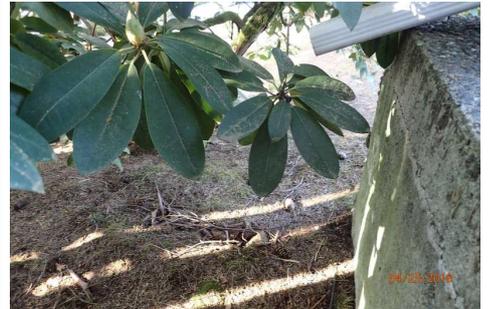
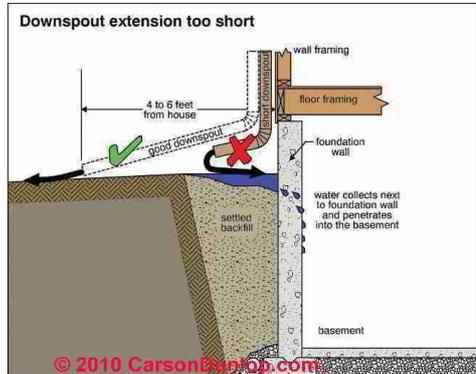
## 2.2.1 Roof Drainage Systems

### DOWNSPOUT - DISCHARGE NEAR HOUSE

SOUTH

One or more downspouts drain too close to the home's foundation. This can result in excessive moisture in the soil at the foundation, which can lead to foundation/structural movement. Recommend a qualified contractor adjust downspout extensions to drain at least 6 feet from the foundation.

Contact a handyman or DIY project

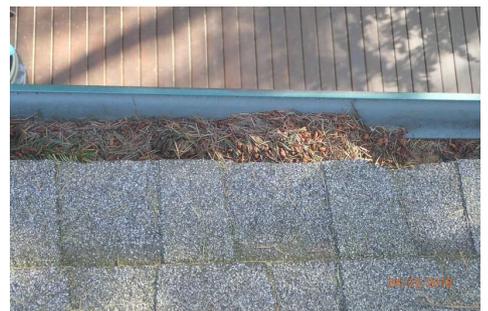
## 2.2.2 Roof Drainage Systems

### GUTTER - DEBRIS

NORTH

Debris has accumulated in the gutters. Recommend cleaning to facilitate water flow.

Contact a handyman or DIY project

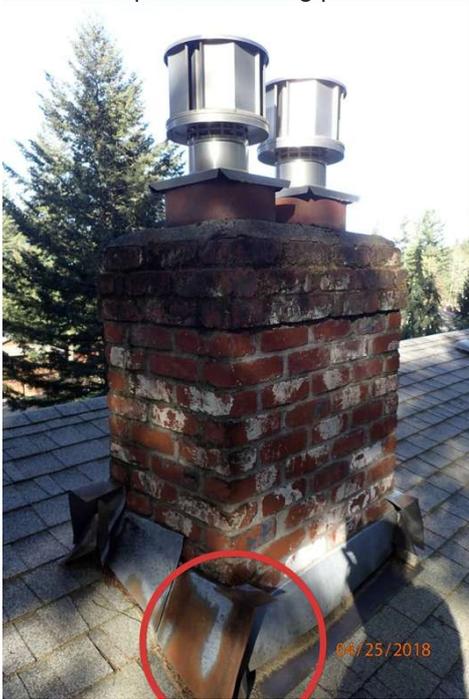
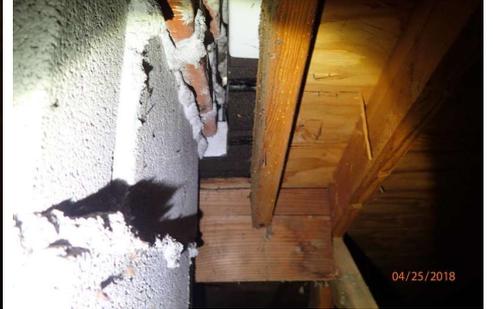
### 2.3.1 Flashings

## RECOMMEND ADDITIONAL FLASHING

### CHIMNEY

Flashing around the chimney was found to be inadequate. There are currently no signs of any leaks but daylight can be seen into the attic around the chimney.

Contact a qualified roofing professional.

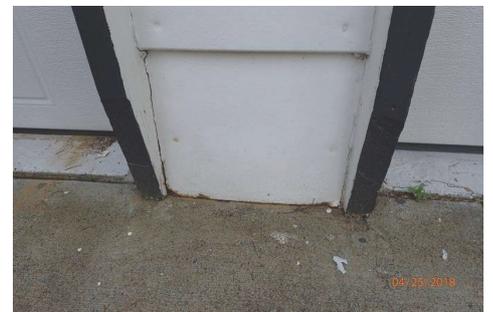
### 3.1.1 Siding

## SIDING - GROUND CLEARANCE

### WEST

Inadequate clearance between siding and ground. Recommend a minimum ground clearance between bottom of siding and ground of 4". Siding in contact with the ground or soil is a serious concern because that condition can provide direct access for wood destroying insects and consistent contact with moisture.

Contact a qualified siding specialist.

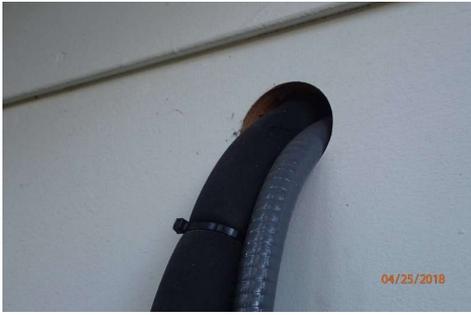
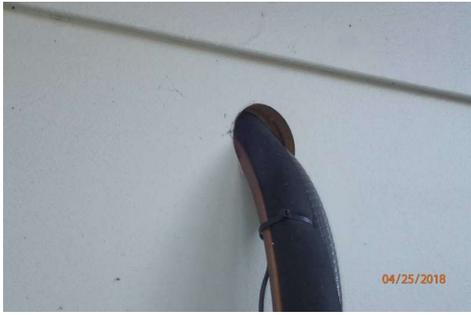
### 3.1.2 Siding

## SIDING - HOLE

### AC

There is a small hole in the siding that can allow moisture to penetrate and eventually lead to rot behind the siding. Recommend sealing with new siding, flashing, or caulking depending on the size.

Contact a qualified siding specialist.

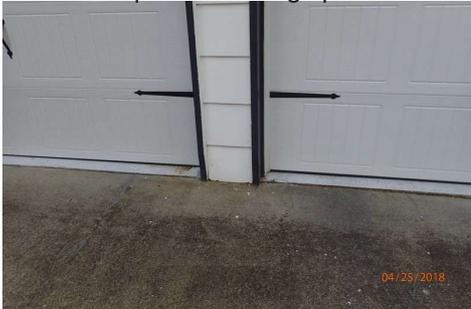
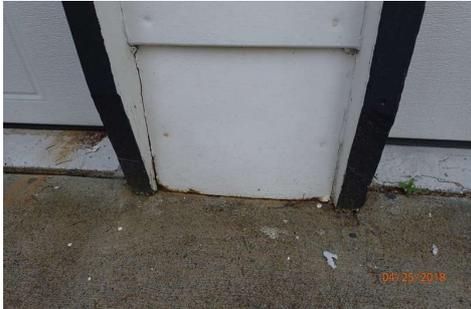
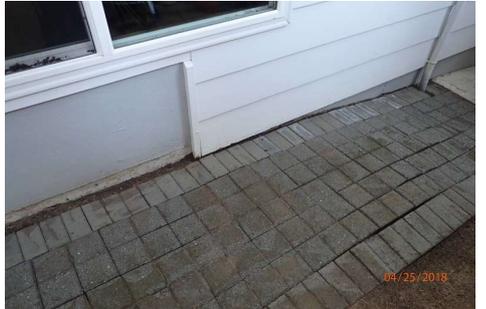
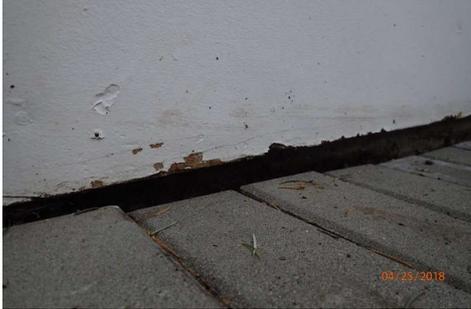
3.1.3 Siding

**SIDING - MINIMAL DETERIORATION**

EAST PATH, GARAGE DOORS

Siding in some locations is showing signs of age and minimal deterioration. These areas will likely need additional maintenance and potentially replacement in the future.

Contact a qualified siding specialist.

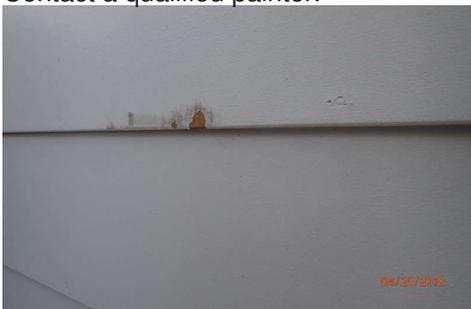
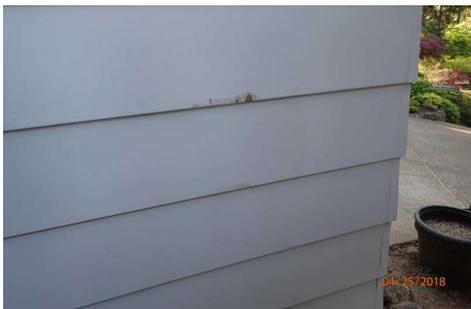
3.1.4 Siding

**SIDING - PAINT DETERIORATING**

WEST GATE

Recommend cleaning and painting siding as needed.

Contact a qualified painter.

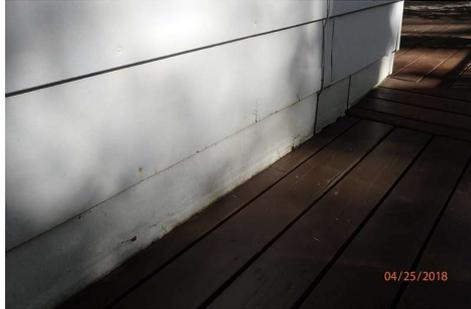
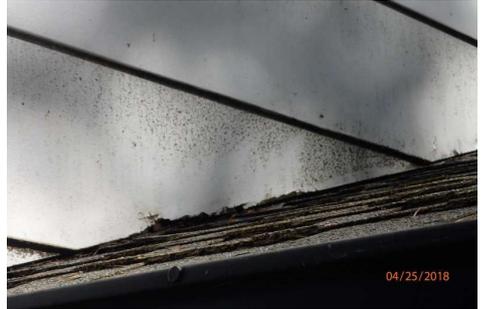
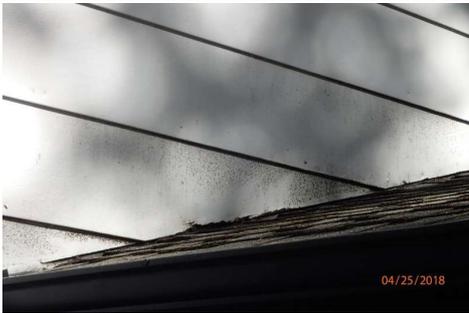
3.1.5 Siding

**SIDING - ROT-**

EAST WALL, EAST ROOF LINE

One or more locations of siding is rotten. Recommend a licensed siding contractor or qualified handyman to repair or replace as needed.

Contact a qualified siding specialist.

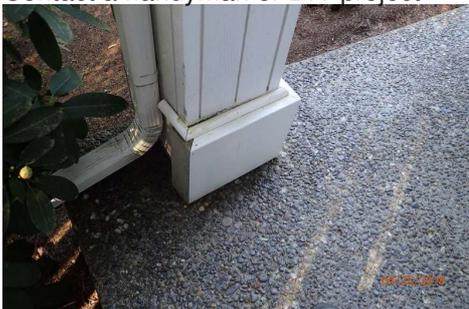
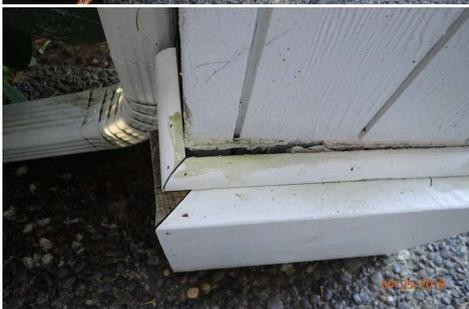
**CAULKING**

The caulking has failed and/or is needed in several areas. Recommend trimming, cleaning, and re-applying an exterior based product such as Vulkem. If desired recommend hiring a licensed siding or painting contractor.

Contact a handyman or DIY project

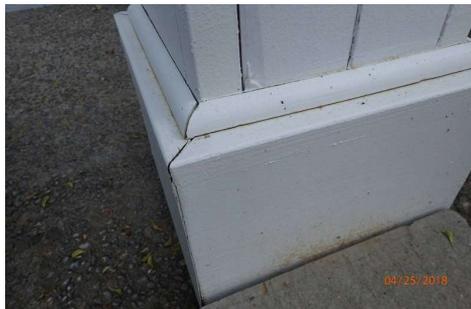
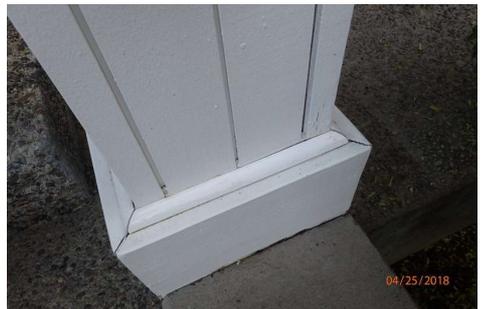
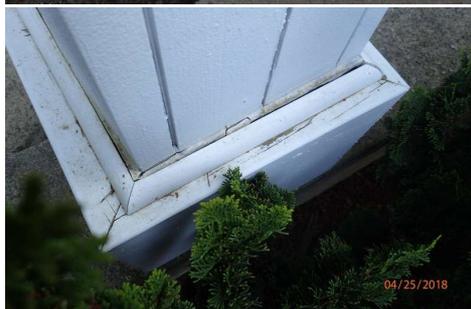
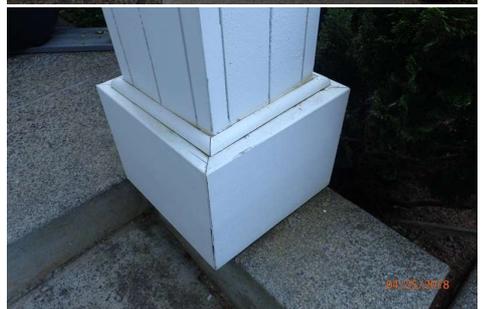
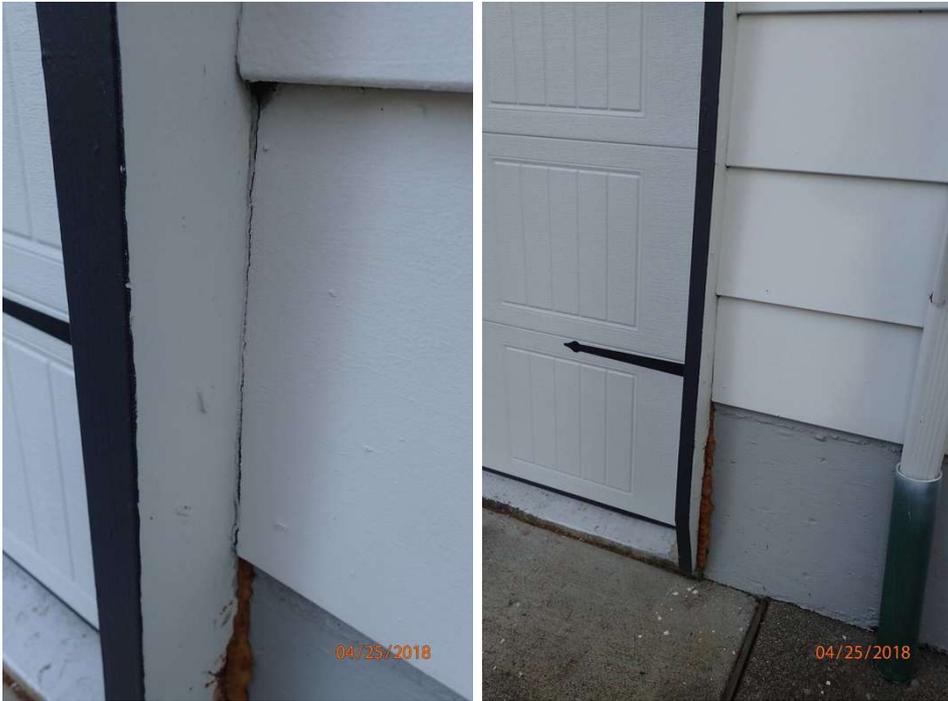
3.2.1 Trim & Flashing

FRONT COLUMNS, EXTERIOR SIDING/TRIM

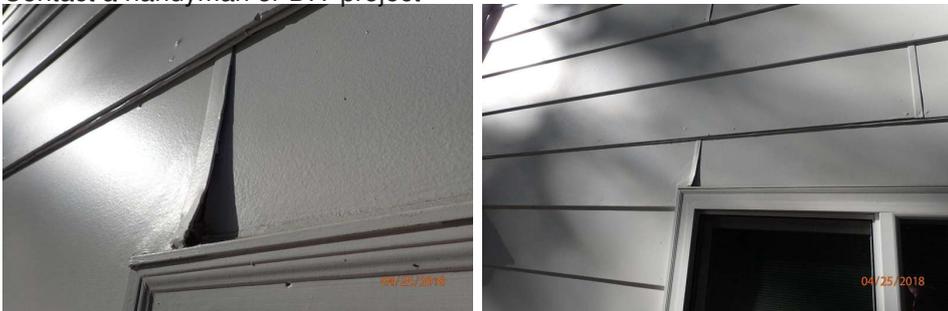
### 3.2.2 Trim & Flashing

#### **FLASHING - LOOSE**

EXTERIOR NORTH

Chance of moisture entering the building. Recommend properly securing and sealing.

Contact a handyman or DIY project

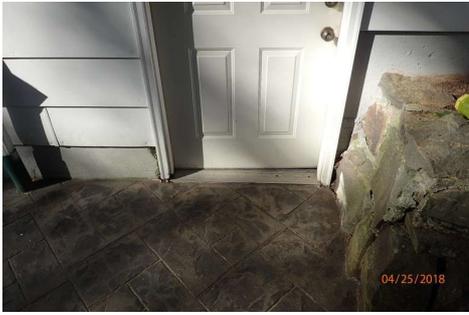
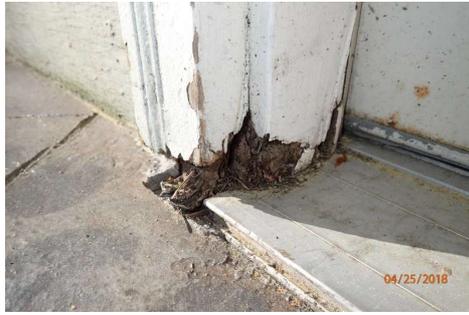
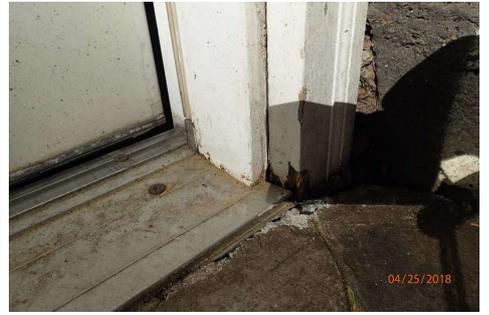
### 3.3.1 Exterior Doors

#### **DOOR SILL/TRIM**

NORTH GARAGE ENTRY

Door sill and/or trim is loose, deteriorated or worn and repair or replacement should be considered.

Contact a qualified door repair/installation contractor.

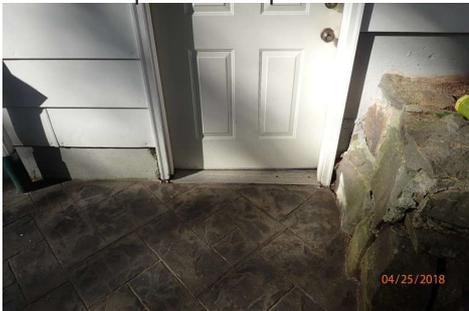
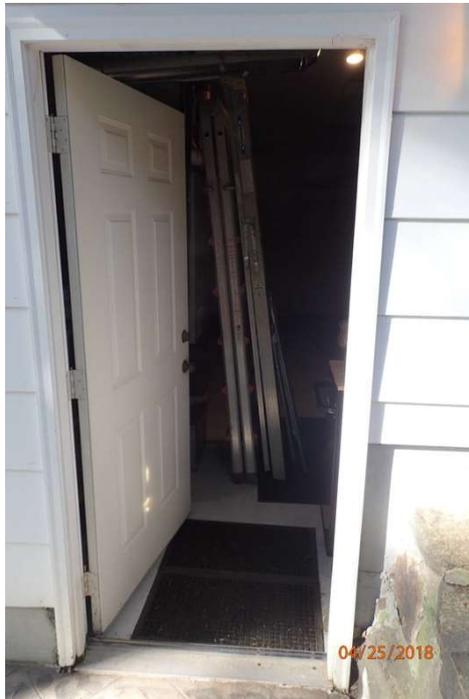
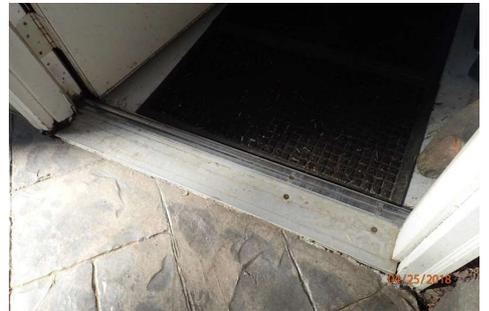
### 3.3.2 Exterior Doors

#### **DOOR - STIFF**

##### NORTH GARAGE ENTRY

One or more of the exterior doors is stiff and difficult to use. Recommend a licensed carpenter or door installer to further evaluate and repair.

Recommendation  
Contact a qualified carpenter.

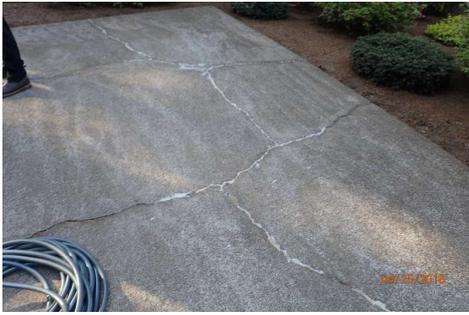
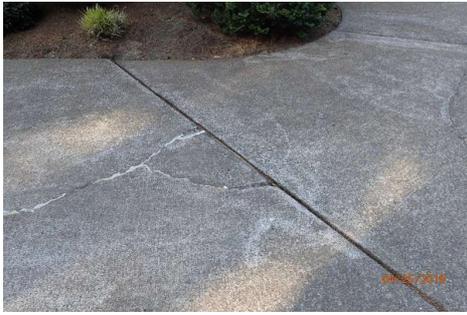
### 3.5.1 Driveways, Walkways, & Front Porches

#### **DRIVEWAY CRACKING-**

##### FRONT DRIVEWAY

Minor cosmetic cracks observed, which may indicate movement in the soil. Recommend monitor and/or have concrete contractor patch/seal.

Recommendation  
Contact a qualified concrete contractor.

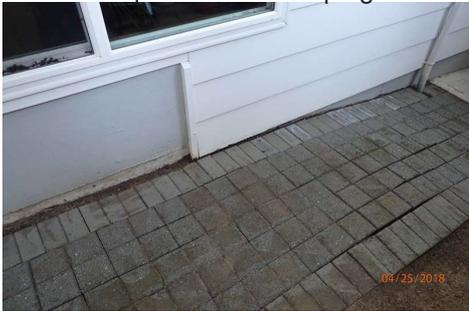
### 3.5.2 Driveways, Walkways, & Front Porches

#### **WALKWAY - HEAVING, TREE ROOTS**

Tree roots have begun to uplift the walkway. Recommend an arborist to further evaluate and repair as need. If the roots can not be address, the walkway may need to be adjusted.

Contact a qualified landscaping contractor

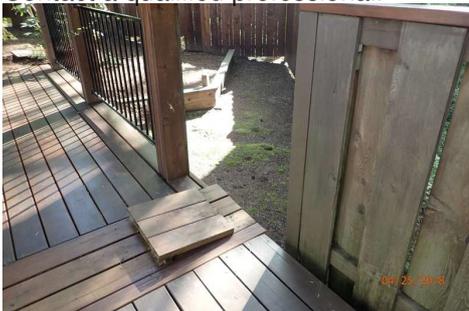
### 3.6.1 Decks, Balconies, & Patios

#### **RAILING - MISSING**

An area or section of railing is missing, recommend a licensed carpenter or decking contractor to install/complete railing.

Contact a qualified professional.

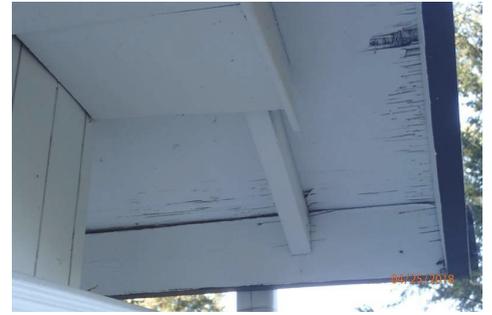
### 3.7.1 Eaves, Soffits & Fascia

#### **EVES - PAINT DETERIORATING**

#### SOUTHEAST CORNER

The eaves are showing signs of deteriorating paint. This can lead to rot, buckling, and delamination of plywood type products. Recommend a licensed painter to further evaluate and repair.

Recommendation  
Contact a qualified painter.

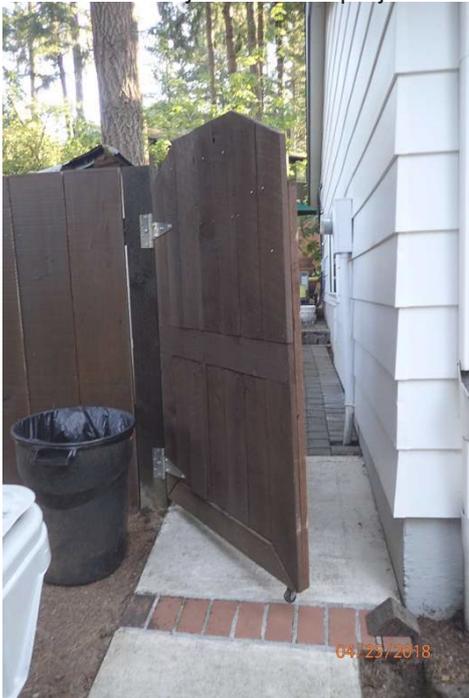
### 3.9.1 Fence

## GATE - ADJUSTMENT NEEDED

WEST

One or more of the gates need an adjustment to allow for proper use. Over time certain gates based on size and design will begin to sag. Depending on the designs there are many ways to easily adjust. Recommend contacting a handyman or fencing contractor if desired.

Recommendation  
Contact a handyman or DIY project

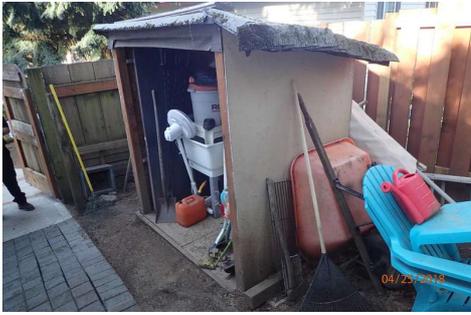
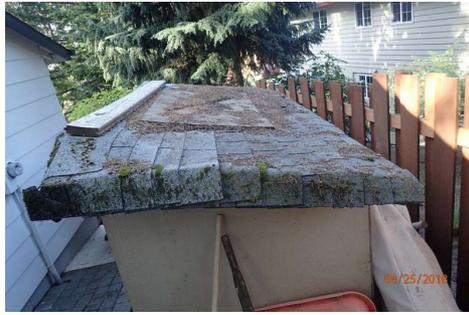
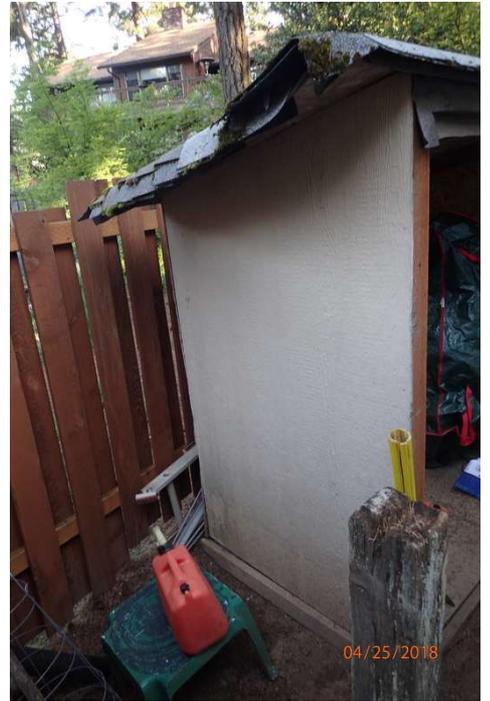
### 3.11.1 Shed/Out Building

## GENERAL DISREPAIR

The outbuilding is in general disrepair. Recommend a complete evaluation to determine its structural safety and list of repairs.

Recommendation  
Contact a qualified general contractor.

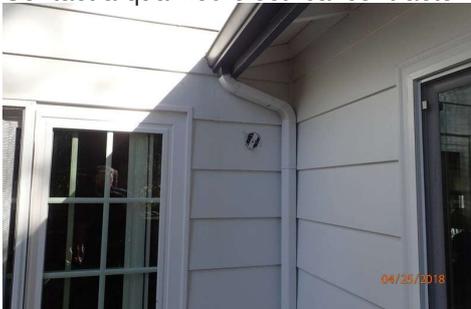
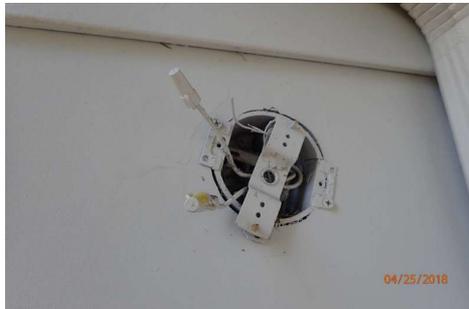
### **JUNCTION BOX - MISSING COVER**

One or more junction boxes is missing its cover. This can allow debris, flammable material, and/or body extremities such as finger inside. Recommend covering for safety.

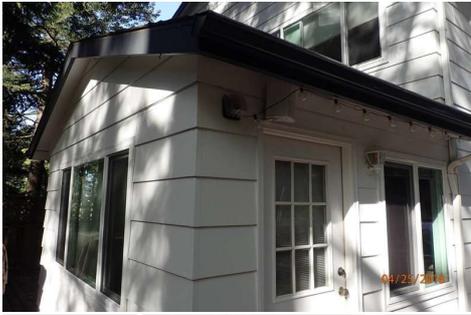
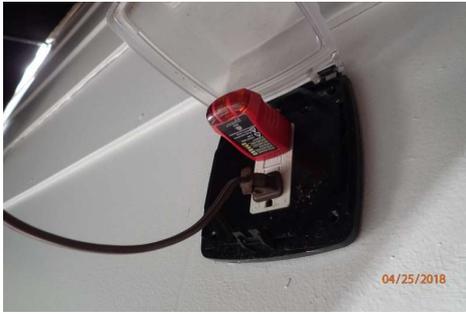
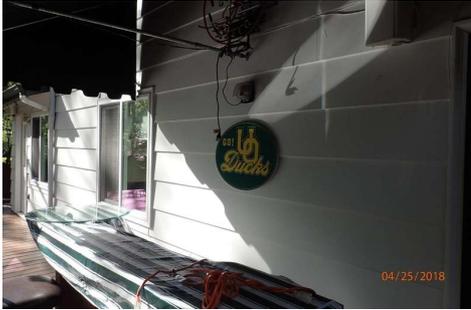
### **FAULTY GFCI**

GFCI is faulty. Recommend licensed electrical contractor to further inspect and make repairs / replace.

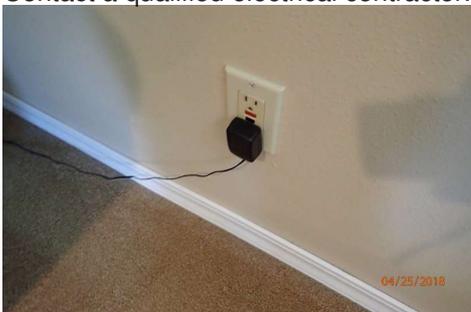
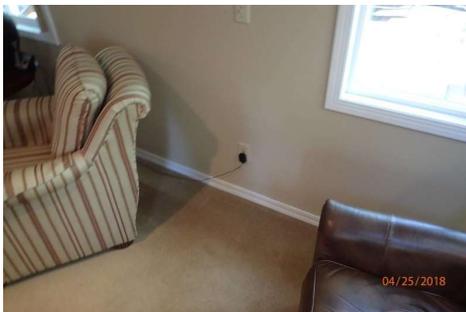
### 5.5.2 GFCI & AFCI **MULTIPLE GFCI'S**

NORTH LIVING ROOM, KITCHEN

Multiple GFCI's have been found on the same circuit. This does not reduce the safety of the system but can become a nuisance as both or many GFCI's may have to be reset in a specific series in order to restore power to the protected outlets. There are ways to wire GFCI's on the same circuit without interfering with each other. Recommend a licensed electrical contractor to further evaluate and repair at your convenience.

Contact a qualified electrical contractor.

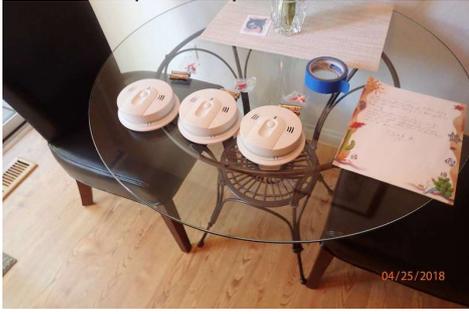
### 5.7.1 Carbon Monoxide Detectors

#### **ADDITIONAL CO MONITORS REQUIRED**

A law went into effect requiring carbon monoxide detectors be installed upon transfer of ownership. These CO detectors are required within 15 feet of all bedrooms and is recommended to have one on each level for additional safety. [Additional Information](#)

Recommendation  
Contact a qualified professional.

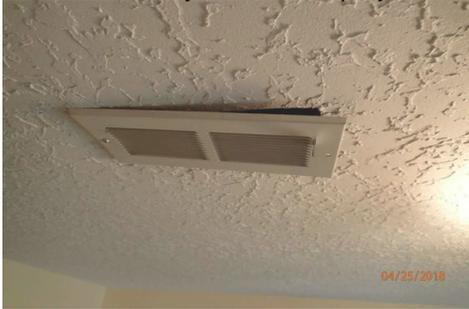
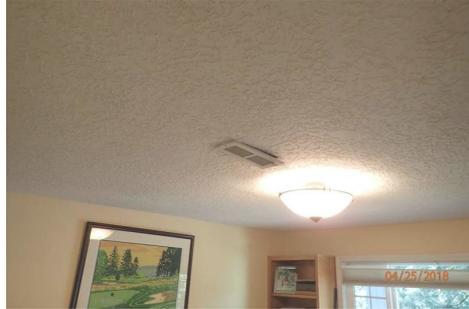
Recommend properly securing the ceiling register to prevent damage or injury in the case of it falling.

Recommendation  
Contact a handyman or DIY project

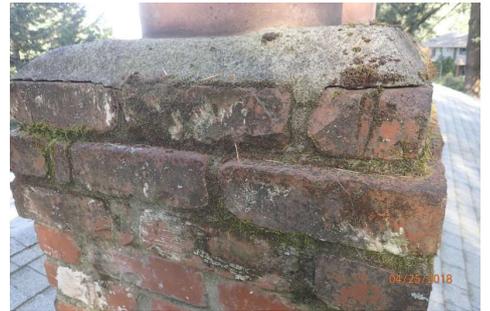
### 6.6.1 Chimney, Vents and Flues

## DETERIORATING MORTAR-

Some of the mortar on the chimney is beginning to deteriorate. The type of deterioration found is minimal and from common wear and tear. Recommend repairing at your earliest convenience and as needed.

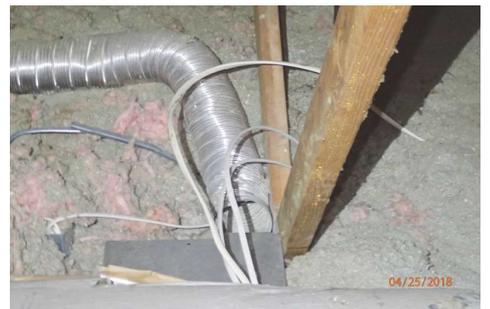
### 8.6.1 Exhaust Systems

## BATHROOM EXHAUST - VENTS INTO ATTIC

MASTER BATHROOM

Bathroom fan vents into the attic, which can cause moisture and mold. Recommend a qualified attic contractor properly install exhaust fan to terminate to the exterior.

Recommendation  
Contact a qualified professional.

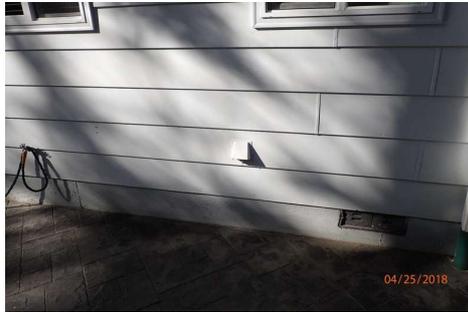
## 8.6.2 Exhaust Systems

### DRYER VENT - EXTERIOR OBSTRUCTED

The dryer venting to the exterior has noticeable lint clogging the pipe. This can reduce the effectiveness of the dryer, increase the chance of a fire, and allow pests to enter the venting if the end cap is propped open from lint. Recommend cleaning on a regular basis.

Contact a handyman or DIY project

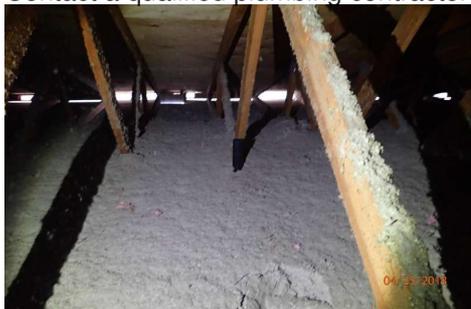
## 9.2.1 Drain, Waste, & Vent Systems

### PIPE VENTING - DISCONNECTED

There is pipe venting in the attic that is disconnected. Recommend a licensed plumber to verify it is still in use and properly vent to the exterior.

Contact a qualified plumbing contractor.

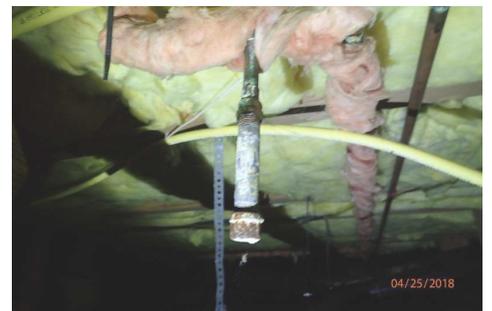
## 9.3.1 Water Supply, Distribution Systems

### DIELECTRIC UNION

#### CRAWL SPACE

Corrosion between copper and steel has been found during the inspection. These joints required a dielectric union to prevent premature failure of the plumbing. Recommend a licensed plumbing contractor to further evaluate and repair as needed.

When copper and steel pipes are connected, which happens often at the fittings near a water heater, an electrolytic reaction begins. Water is the electrolyte, and the combination of two metals and water essentially becomes a battery. It happens slowly over many months. A small amount of electric current starts flowing nowhere near enough to shock you and atoms from one metal begin to break off and cling to the other metal. The result is a crumbling, white powder buildup on the galvanized steel pipe, which is called galvanic corrosion.

Contact a qualified plumbing contractor.

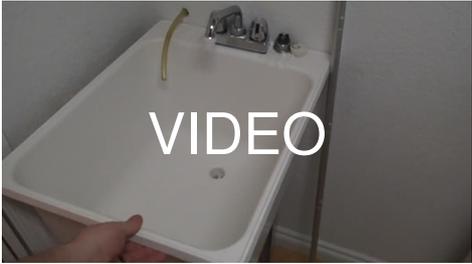
LAUNDRY ROOM

**SINK - NOT SECURED**

Recommend properly securing the cabinet and/or sink to prevent movement and potential leak in the drain line.

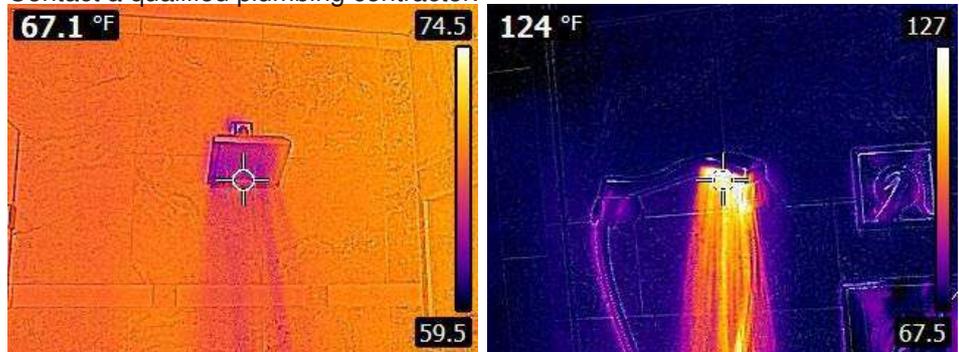
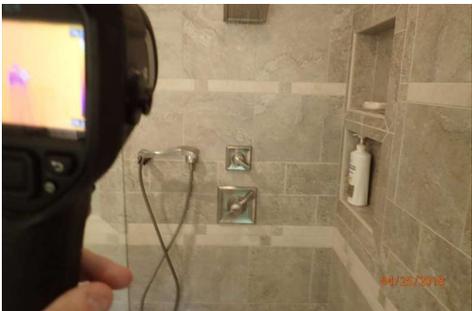
9.6.1 Tub / Shower

**HOT / COLD REVERSED**

MASTER BATHROOM

The hot and cold in one or more of the shower is reversed. For safety recommend adjusting these to allow for proper and habitual use.

Contact a qualified plumbing contractor.

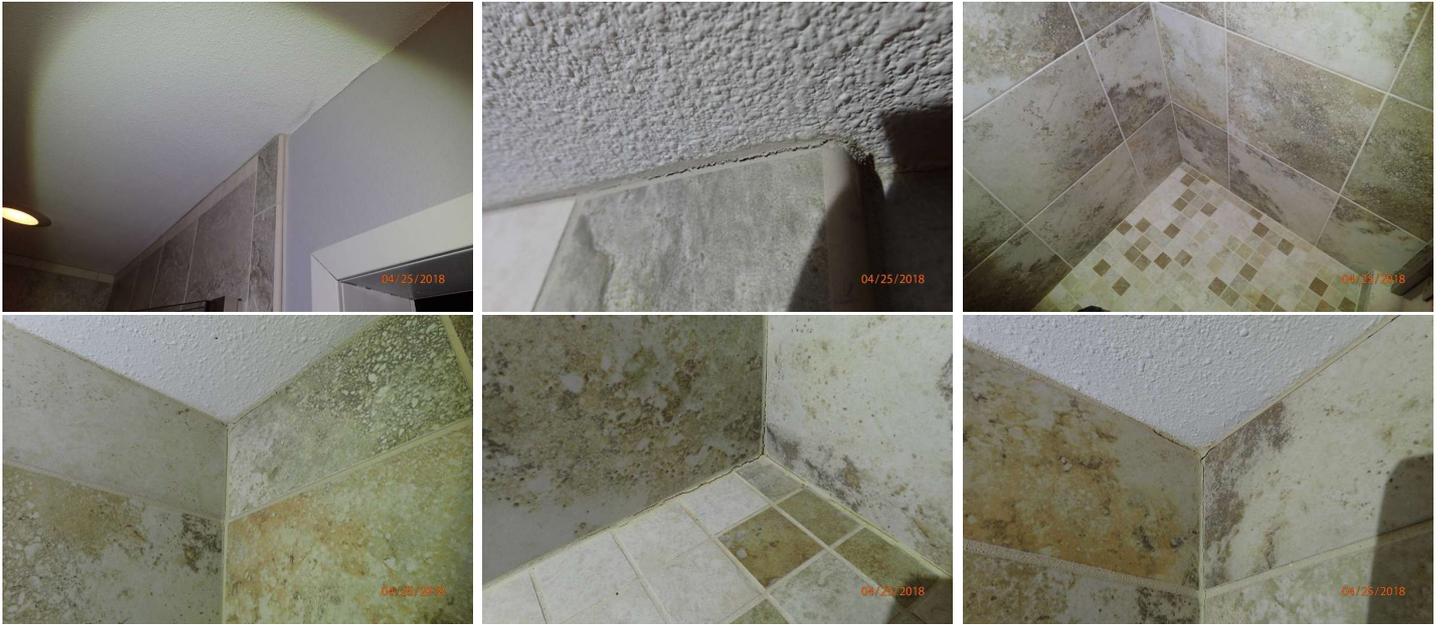
9.6.2 Tub / Shower

**SHOWER/BATHTUB - CAULKING/GROUT FAILING**

2ND FLOOR HALL BATHROOM, MASTER BATHROOM

Some of the caulking or grout in the bath and or shower area is failing. Caulking/grout is one of the most common items to fail in the bathroom. Because of its common failure rate it is also one of the largest contributors moisture damage in the bathroom. Recommend removing, cleaning, caulking/grouting, and inspecting on a regular basis to control the moisture in the bathroom.

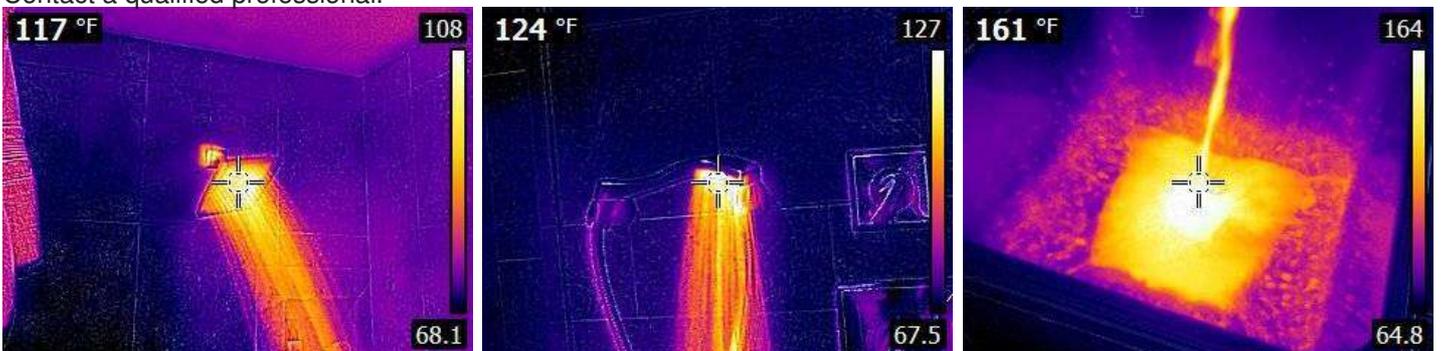
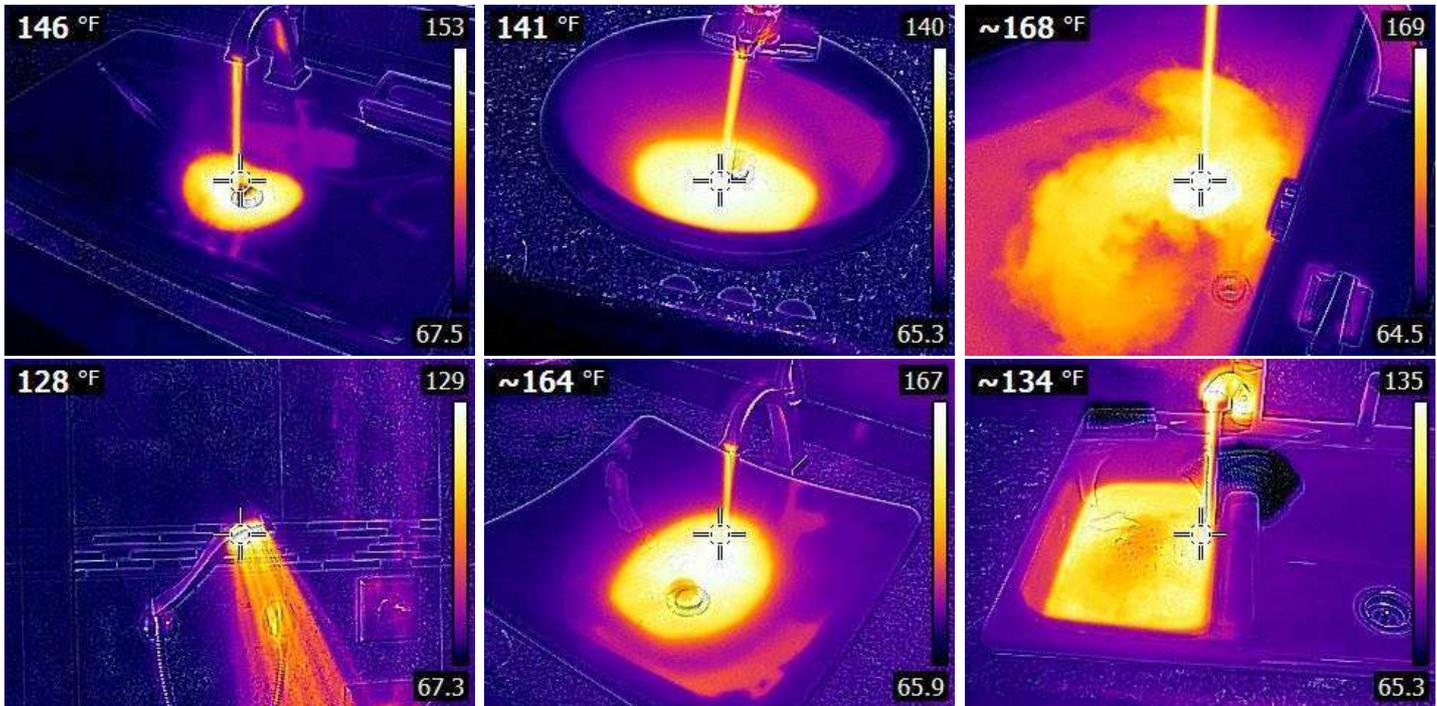
9.7.1 Water Heater

**WATER TEMP UNSAFE**

The water heater is turned up to produce water hotter than 120 degrees at the fixtures. This can generally be fixed by adjusting the thermostat at the water heater. Some styles such as electric water heaters may require the removal of panels which can leave you exposed to active electrical. Recommend contacting a licensed plumbing contractor if you are not comfortable in safely lowering the temperature.

Recommendation  
Contact a qualified professional.

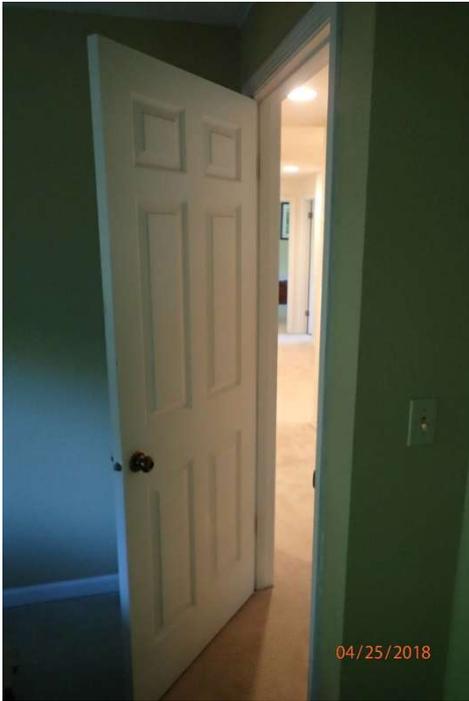
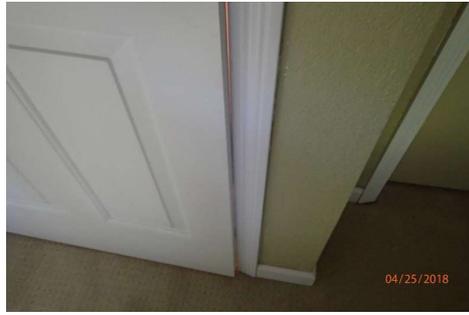
10.1.1 Doors

**DOOR - STICKS**

NORTHWEST BEDROOM

Door sticks and is tough to open. Recommend sanding down offending sides.

Contact a handyman or DIY project

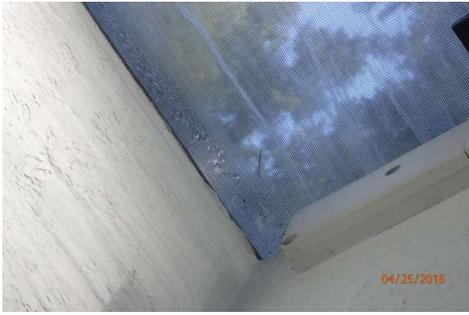
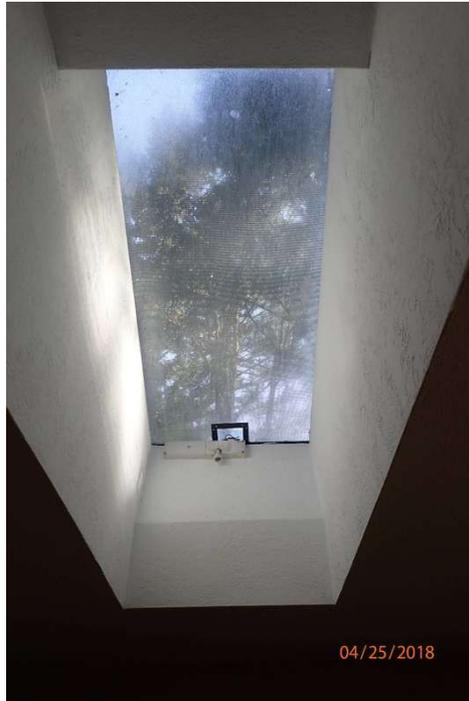
#### 10.2.1 Windows

### GLASS - BROKEN SEAL

LIVING ROOM SKYLIGHT

Observed condensation between the window panes, which indicates a failed seal. Recommend qualified window contractor evaluate & replace.

Contact a qualified window repair/installation contractor.

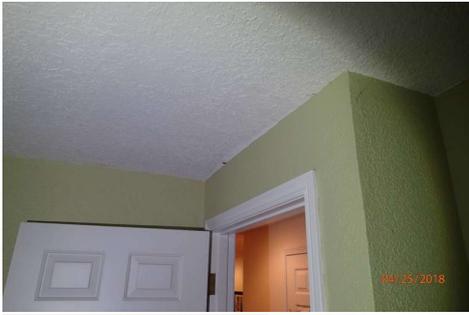
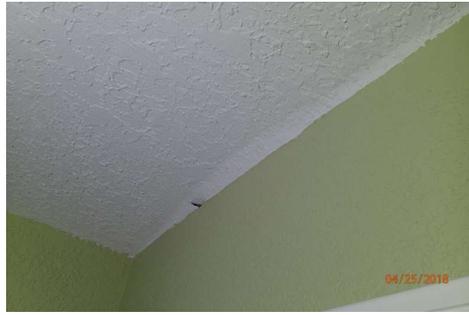
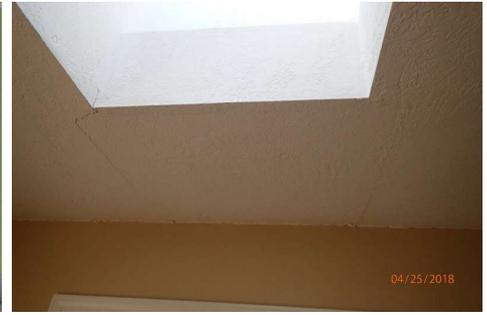
### 10.5.2 Ceilings

## **MINOR DAMAGE**

### NORTHWEST BEDROOM, LIVING ROOM SKYLIGHTS

Minor damage or deterioration to the ceiling was visible at the time of the inspection.

Contact a qualified drywall contractor.

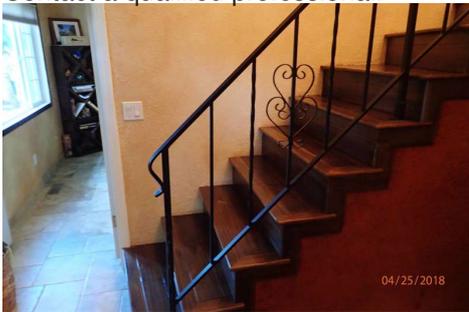
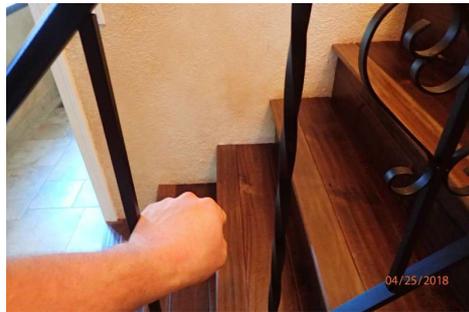
### 10.6.1 Steps, Stairways & Railings

#### **SPINDLE SPACES TOO WIDE**

The baluster space is not up to modern safety standards. The space between spindles should not allow passage of a 4 inch sphere for child safety.

Recommendation  
Contact a qualified professional.

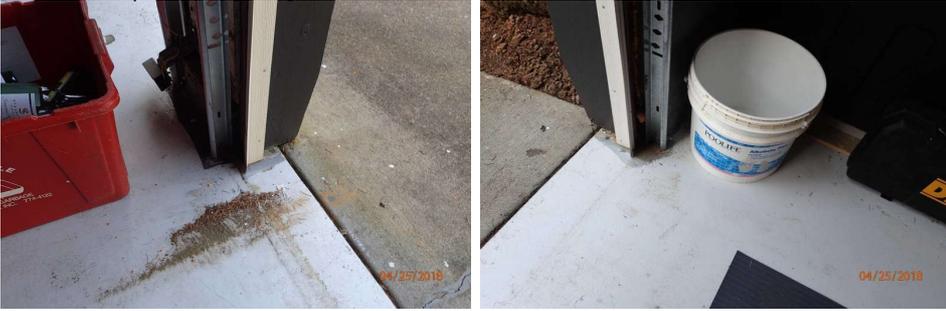
### 11.2.1 Garage Door Opener

#### **GARAGE DOOR SENSORS MISSING**

WEST DOOR

The garage door sensors are missing. Prior to the 90's it was uncommon to see the sensors installed with the opener. The sensors are there not only to protect the door and objects underneath but also any person or child that may walk under its path. Recommend a licensed garage door contractor to further evaluate and install sensors.

Recommendation  
Contact a qualified garage door contractor.

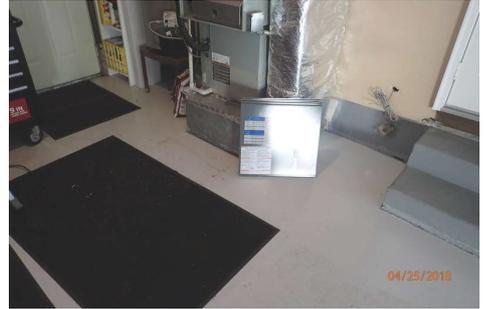
11.3.1 Bollard  
**NOT PRESENT**

It is recommend a "bollard" is installed in front of any appliances located in the garage that a vehicle could strike. In general this device is at least 36" tall, composed of metal and strong enough to stop a moving vehicle. Specific federal, state, county, and city codes will differ, these recommendations are set a minimum and based on general safety. Multiple bollards may be required for appliances that are further apart.

Recommendation  
Contact a qualified professional.

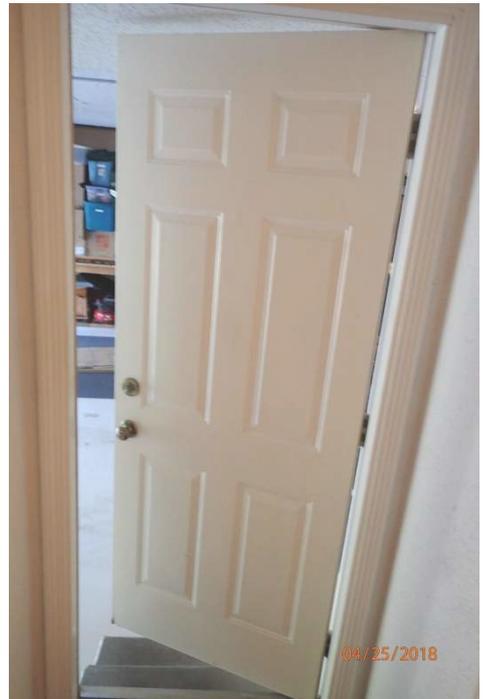
11.4.1 Occupant Door (From garage to inside of home)  
**NOT SELF-CLOSING**

Door from garage to home should have self-closing hinges to help prevent spread of a fire to living space. Recommend a qualified contractor install self-closing hinges.

Recommendation  
Contact a handyman or DIY project

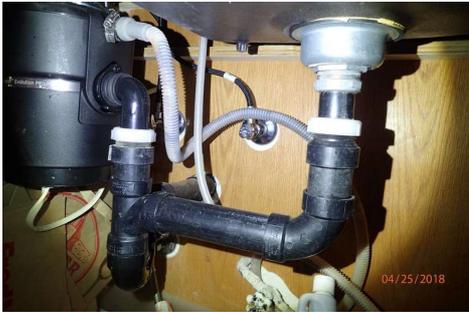
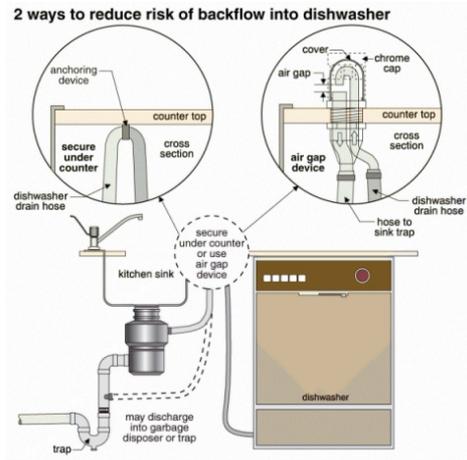
12.3.1 Dishwasher  
**IMPROPERLY INSTALLED DRAIN PIPE**

## Back-flow Prevention Missing.

It is recommended for your dishwasher to have a back flow prevention device. Such a device or "system" prevents water that could back flow from a clogged sink into a dishwasher and flood the dishwasher. Many dishwashers today have a system built in but they are typically impossible to view with the dishwasher installed. Because your inspector is not able to verify the presence and functionality of a back flow device, it is recommended to install one. There are several methods but we recommend a simple "Drain Loop" or "Air Gap".

Back-flow problems often depend on the siphon effect to pull water backward through the line. An air-gap back-flow preventer stops siphoning with a break between pipe sections. Water from the upper drainpipe falls into a wide funnel at the mouth of a lower drain. The gap eliminates siphoning, and any water flowing back simply overflows the lower drain. Air gaps approved for dishwashers mount to the back of the sink deck; if drain water backs up into the sink, the backup can't overflow through the air gap. A sanitary cover hides the dishwasher drain outlet and funnel.

Many dishwashers use an even simpler system to stop most backups from reaching the dishwasher. Dishwashers include enough drain hose to form a higher inverted U underneath the sink. Strapping the hose to the cabinet at the highest possible point beneath the sink places the bend above all but the worst sink backups. The sink must fill completely to pour water back through the hose. This can be the easiest method of back-flow prevention but because the bend lacks a true air gap, it does not prevent siphoning if water overflows the bend.
