SUMMARY

1234 Main St. Alliance OH 44601

Todd Hoffmeyer
Board Certified Master Inspector...
Top Choice Home Inspections, LLC
330-614-0054
todd@topchoice-homeinspections.com

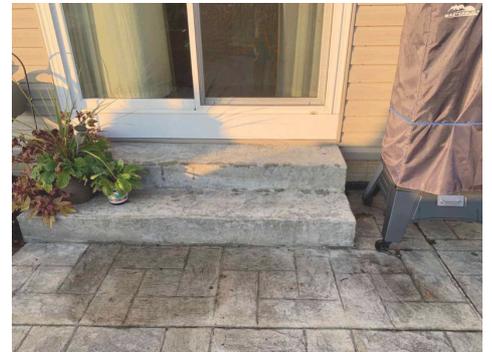
NO HAND-RAILING - EXTERIOR STEPS

REAR SIDE

Exterior steps vary in height and had no handrail installed. Safe building practices dictate that stairs with 3 or more risers should have a handrail. **A fall or injury could occur if not corrected.**

Recommendation
Contact a qualified carpenter.

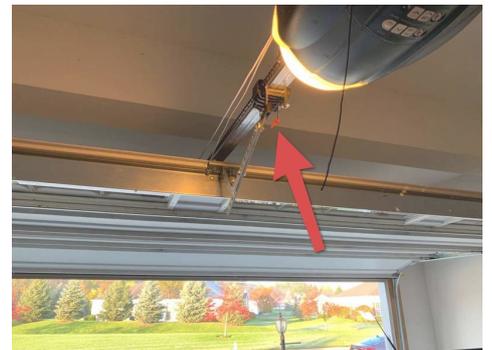
DOOR EMERGENCY RELEASE ROPE - MISSING

GARAGE

The emergency release rope was missing. This condition may prevent children or those lacking in physical stature from using the manual disconnect to exit the garage during an emergency.

Recommendation
Contact a handyman or DIY project

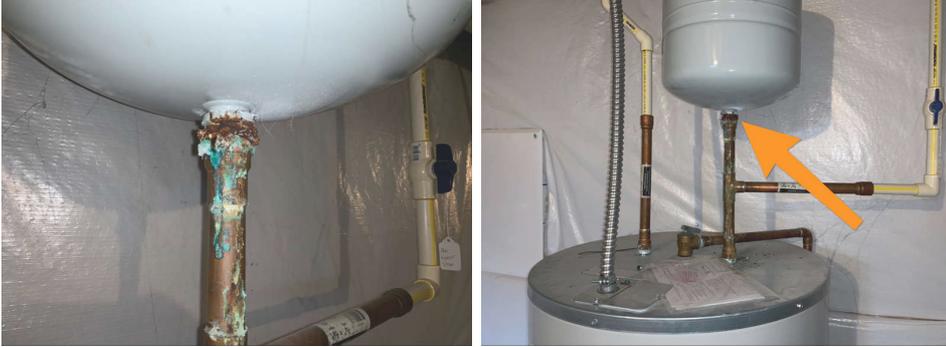
CORROSION

WATER HEATER

Corrosion was visible at the copper water supply pipe and expansion tank above water heater. Implications: Chance of water damage to contents, finishes and/or structure. **A licensed plumbing contractor should evaluate and replace water supply components as necessary.**

Recommendation
Contact a qualified plumbing contractor.

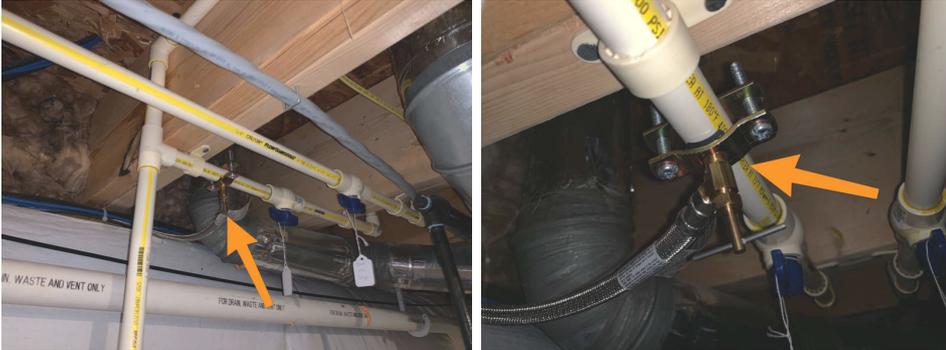
SADDLE VALVE

ABOVE FURNACE

A saddle (piercing needle) shut-off valve was installed on water supply line. **These types of valves can leak without warning and should be replaced with a quarter turn type valve.**

Recommendation
Contact a qualified plumbing contractor.

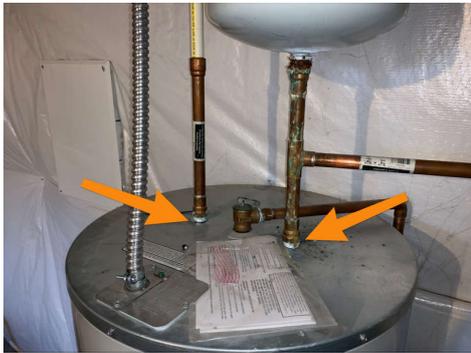
DIELECTRIC UNIONS - MISSING

WATER HEATER

No dielectric unions were installed on water supply lines. Implications: Galvanic corrosion or electrolytic action, chance of water damage to contents, finishes and/or structure.

Recommendation
Contact a qualified plumbing contractor.

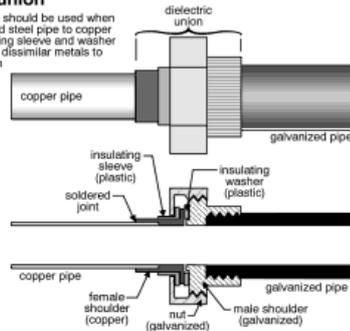
Dielectric union

a dielectric union should be used when joining galvanized steel pipe to copper pipe - the insulating sleeve and washer separate the two dissimilar metals to prevent corrosion

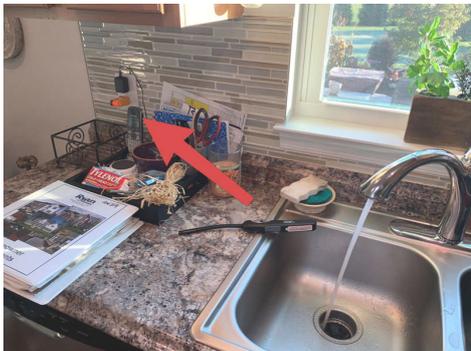
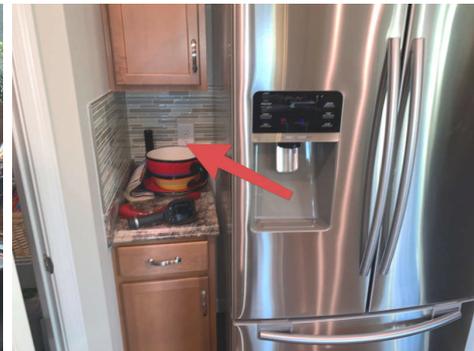
LOOSE OUTLET

KITCHEN (LEFT OF SINK AND REFRIGERATOR)

Two outlets were loose from the wall box. Implications: electrical shock. **Recommend correction by a licensed electrician.**

Contact a qualified electrical contractor.

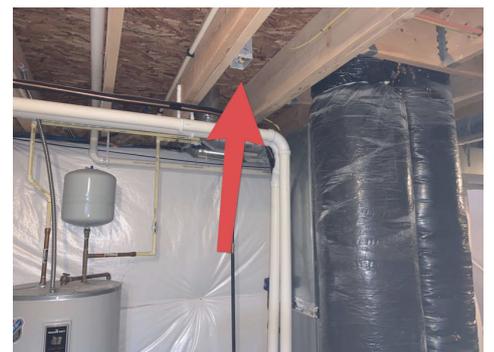
MISSING COVER PLATE

BASEMENT (ABOVE FURNACE)

Implications: Electric shock. **Install cover plate.**

Contact a qualified electrical contractor.

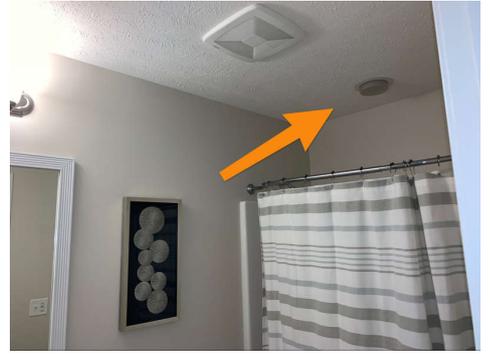
LIGHT INOPERABLE

HALLWAY BATHROOM

One or more lights are not operating. Try replacing light bulb first.

Contact a qualified electrical contractor.

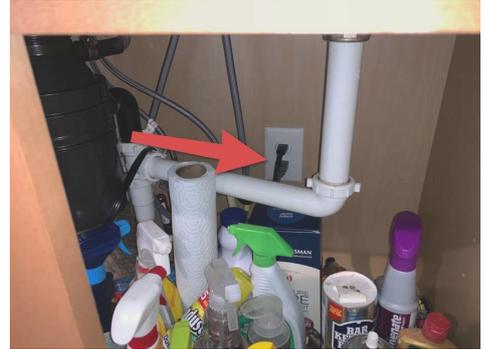
NO GFCI PROTECTION INSTALLED

BENEATH KITCHEN SINK, LAUNDRY AREA

Ground Fault Circuit Interrupter (GFCI) protection of electrical outlets was not provided at all wet locations of the home. For safety reasons, GFCI protection should be provided at all of the following outlet locations: Within 6 feet of all plumbing fixtures, Garages, Bathrooms, Outside, Unfinished basement, Kitchens (at counter-tops, including islands & beneath sinks) and Laundry area.

Contact a qualified electrical contractor.

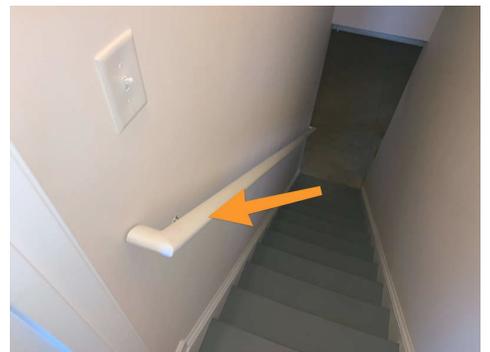
HANDRAIL LOOSE

BASEMENT

Handrail for stairway was loose. Implications: Fall Hazard. **Handrail needs properly secured.**

Contact a handyman or DIY project
