SUMMARY

1234 Main St. Jefferson GA 30549

Kurt Puterbaugh
ASHI #260782

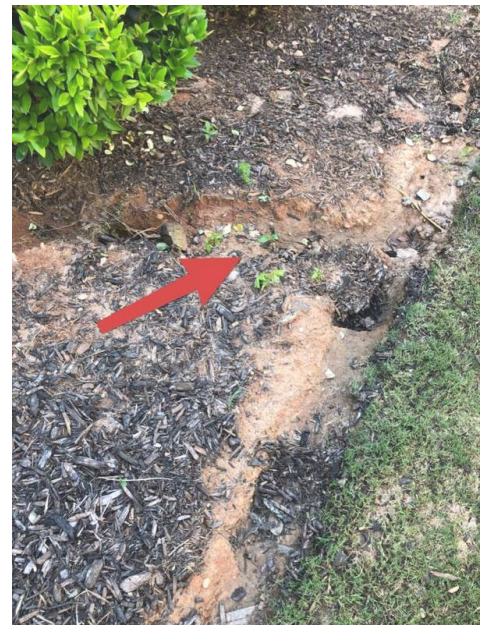
Right

EROSION

SERVICE / REPAIR: Erosion noted at time of inspection. Have ground area restored and make efforts to control rain water runoff to prevent reoccurrence. Some local and state municipalities can invoke fines on property owners for storm water silt runoff responsible for filling streams.

Recommendation
Contact a qualified landscaping contractor

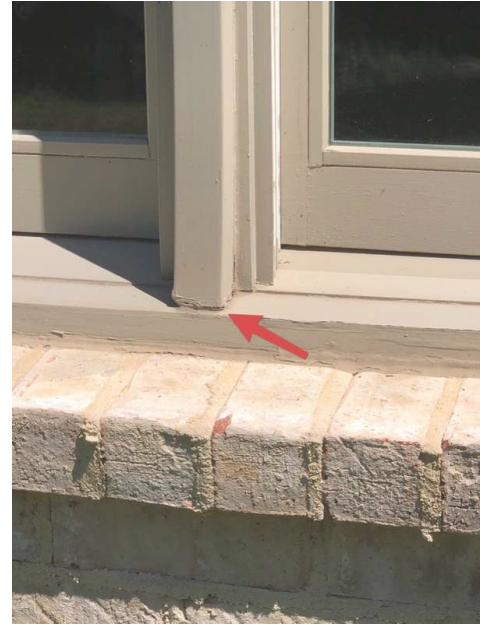
Rear

DAMAGED - TRIM

SERVICE / REPAIR: The trim was observed to be damaged. Have qualified contractor repair or replace as needed.

Recommendation
Contact a qualified carpenter.

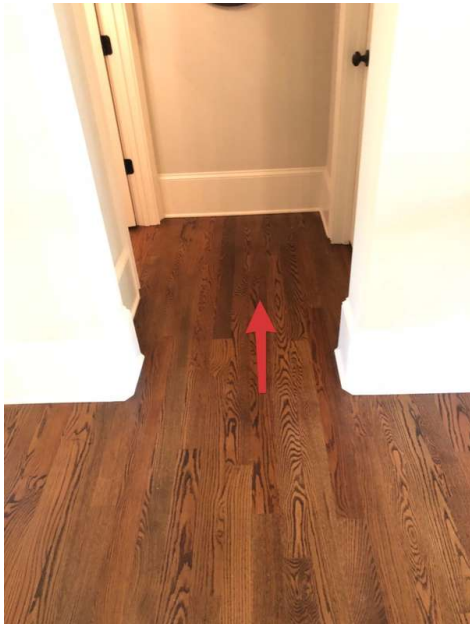
Foyer

FLOOR UNEVEN

SERVICE / REPAIR: Observed uneven floor slope. Have qualified contractor evaluate and repair as necessary.

Recommendation
Contact a qualified flooring contractor

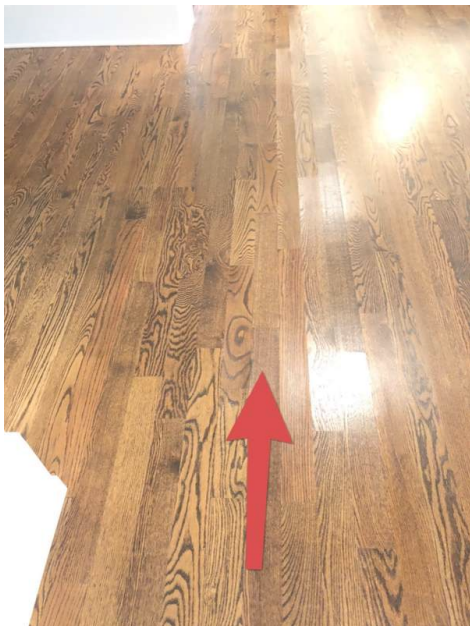
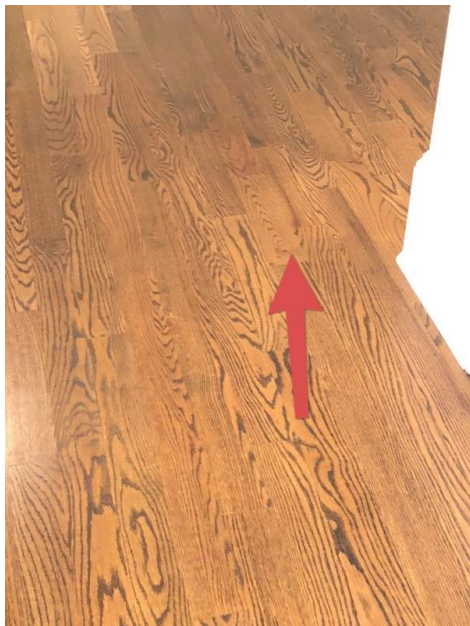
Family Room

DAMAGED

SERVICE / REPAIR: Damaged areas of flooring observed. Have a professional flooring contractor evaluate and repair or replace the flooring as needed.

Contact a qualified flooring contractor

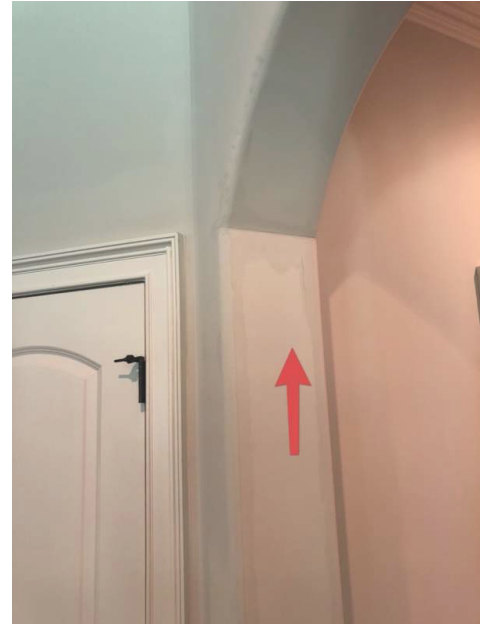
Basement

IR - DRY

GENERAL NOTE: The ceiling/wall is water damaged. Infrared scan indicated no moisture above the ceiling and moisture meter indicates low moisture content(dry) at the time of this inspection. Have qualified contractor repair as needed.

Recommendation
Contact a qualified painter.

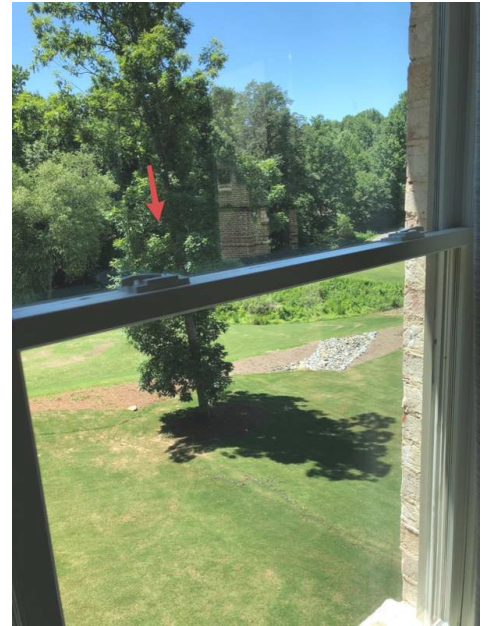
Master Bedroom

6.5.1 Windows
WINDOWS STUCK

SERVICE / REPAIR: A number of windows are painted shut. Have contractor repair as needed to ensure proper egress.

Recommendation
Contact a qualified window repair/installation contractor.

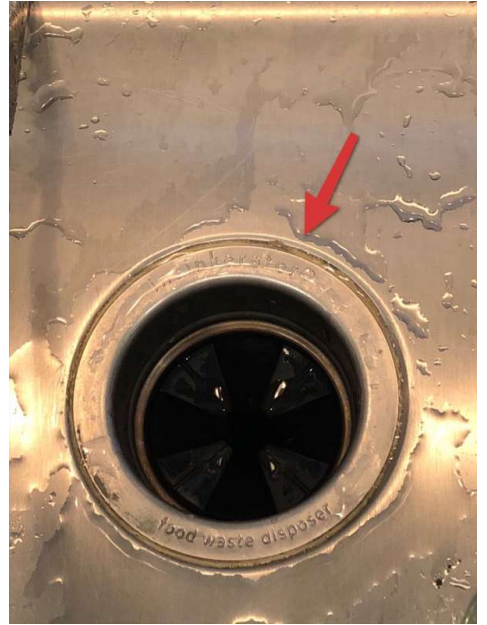
Bar

8.3.1 Food Waste Disposer
JAMMED

SERVICE / REPAIR: Disposal jammed at time of inspection with debris found inside unit. Have cleared and freed up to run correctly.

Recommendation
Contact a qualified plumbing contractor.

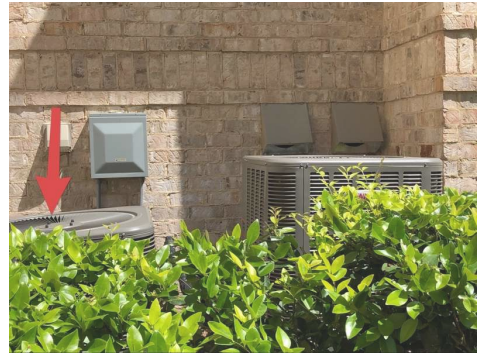
Rear

12.2.1 Air Conditioner **CONDENSER - TIPPING**

GENERAL NOTE: Tipping the compressors more than 10 degrees can damage the unit and voids the manufacturer's warranty. Unit(s) should be leveled.

Recommendation
Contact a qualified HVAC professional.

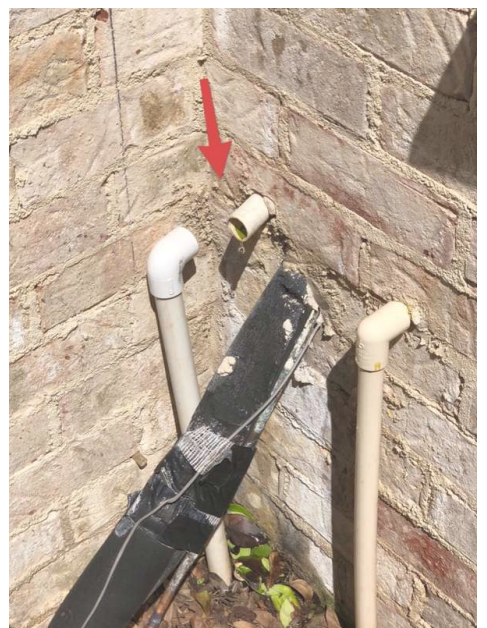
Rear

12.2.2 Air Conditioner **CONDENSATE DRAIN**

SERVICE / REPAIR: The drain line is disconnected. Have a qualified contractor repair as needed.

Recommendation
Contact a qualified HVAC professional.
