SUMMARY

1234 Main St. Garland TX 75043

Greg Cheptene
Professional Inspector TREC#110678
Ally Certified Home Inspector
972-900-1088
gcheptene@gmail.com

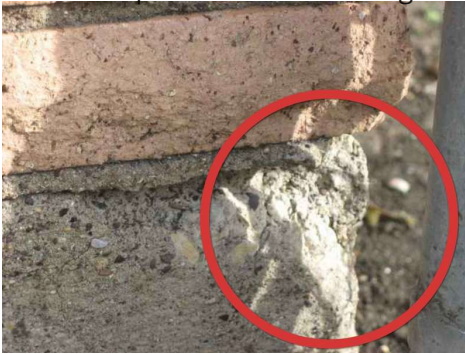
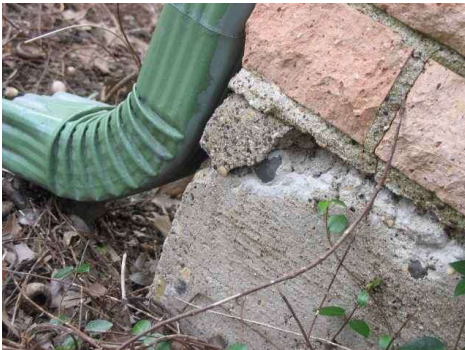
2.1.1 A. Foundations

FOUNDATION CRACKS - MINOR

I inspected the foundation slab from the outside and inside of the house. I have observed Minor defects, conner pop-up at south east and south west conners of the house and exposed metal component was also noted at the exterior of the foundation on the west side. Conner pops are common as concrete ages.

Recommend monitoring for more serious shifting/displacement.

I also recommend patching the exposed metal component to prevent corrosion. The implications of rust are loss of strength. When steel rusts, it expands to 6-7 times its original volume. This can cause even more cracking in the concrete and eventually weakening of the slab. Recommend correcting by a qualified professional and further monitoring .

Contact a qualified structural engineer.

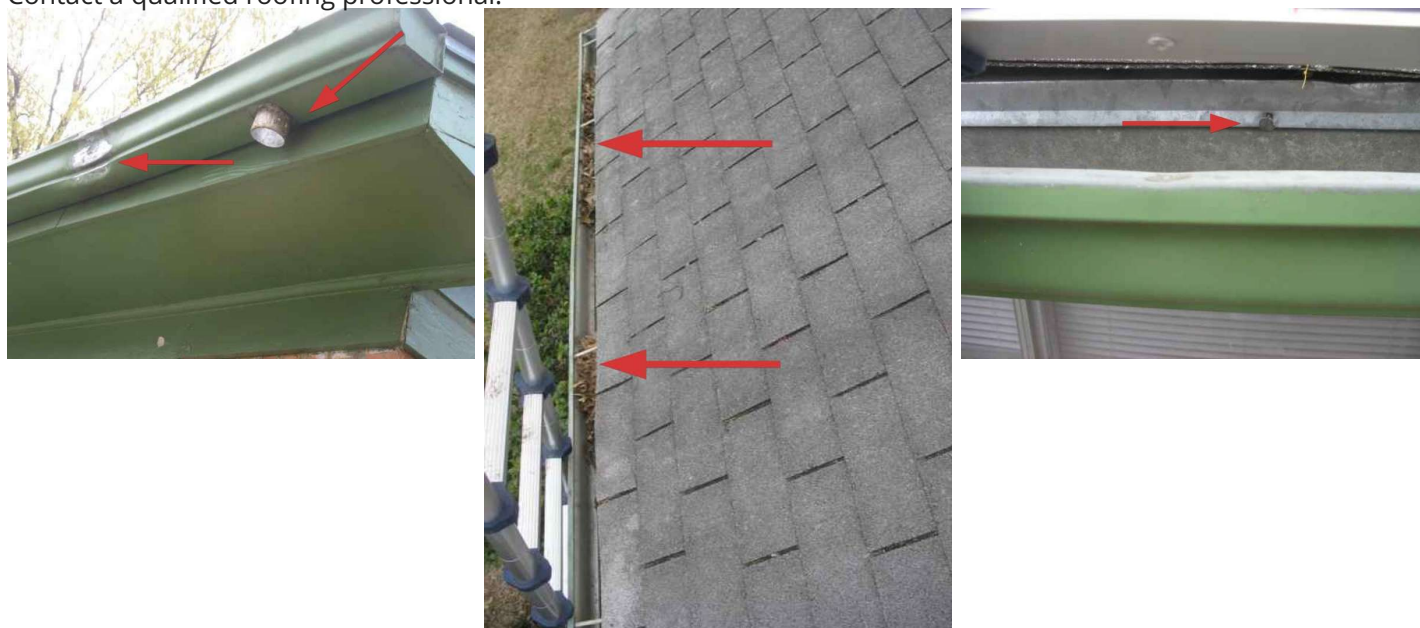
MISSING GUTTERS AND DOWNSPOUTS

I observed mechanical damage to gutters, clogged gutters, nails popping out and missing downspouts at the front and missing gutters in the back of the house.

I did not observe any indication of negative draining or standing water on a dry day, though on a rainy day, the amount of water washed down from the roof may adversely affect the finish to the siding, fascia and soffits of the house when downspouts were missing.

Recommend correcting by a qualified roofing / gutter company.

Recommendation
Contact a qualified roofing professional.

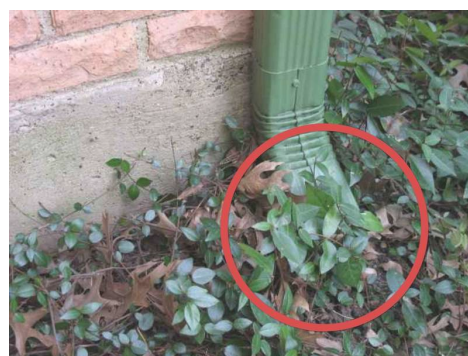
MISSING SPLASH BLOCKS

During the inspection of the exterior and drainage slopes, I also noticed missing splash blocks below the downspouts, intended to deflect the water running down the downspout away from the foundation. Recommend installing splash blocks or downspout extensions to improve the drainage and keep water away from the foundation.

Recommendation
Recommended DIY Project

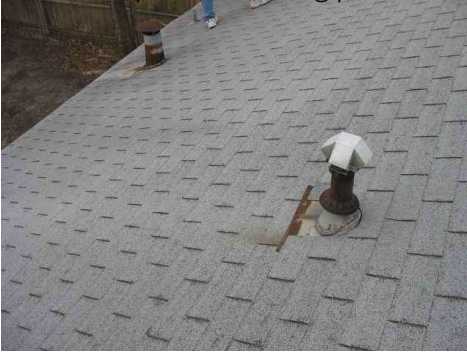
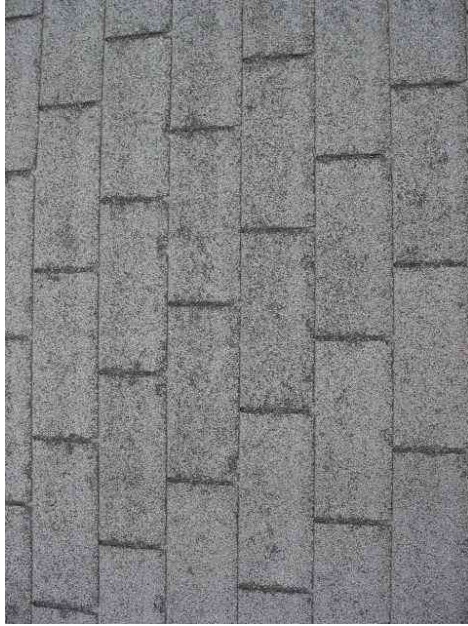
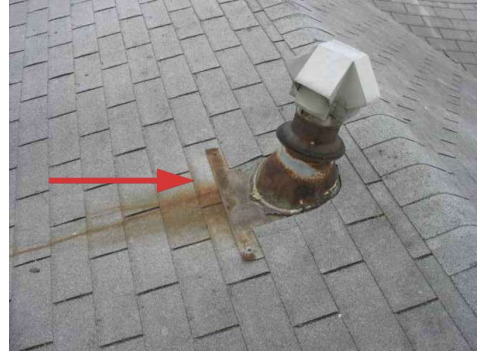
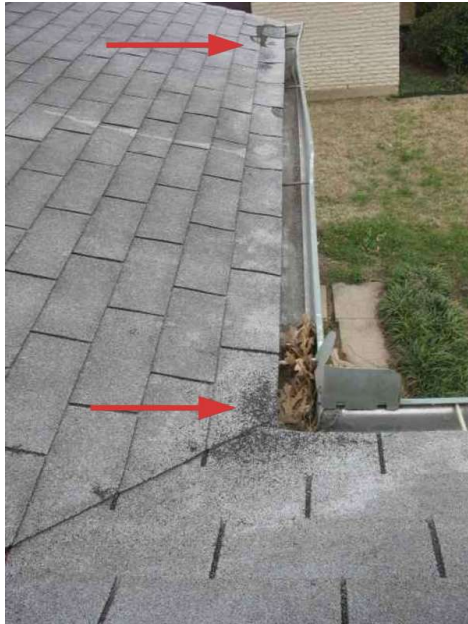
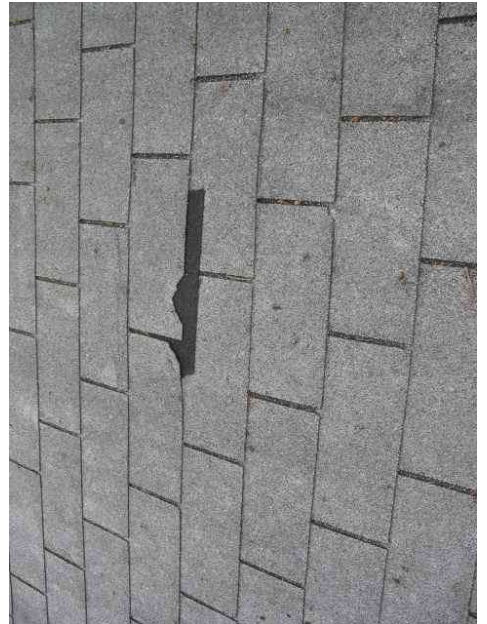
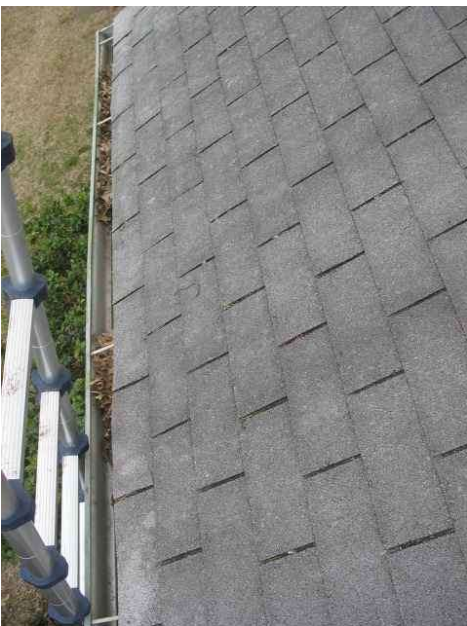
DAMAGED COVERINGS

Roof coverings exhibited general damage that could affect performance. The asphalt shingles granules were worn out, parts of shingles torn especially on the perimeter of the roof in the back of the house. I observed indications of hail damage and mechanical damage to shingles, eaves and gutters. I inspected the flashings and weather boots to exhaust vents and plumbing stacks. The flashings showed signs of rust, nails exposed and not sealed properly, thus lost its sealing capacity. The roof covering is near the end of its service life. Implications of failing flashings and damaged shingles are water leakage. I recommend a qualified roofer evaluate and repair / replace.

Recommendation
Contact a qualified roofing professional.

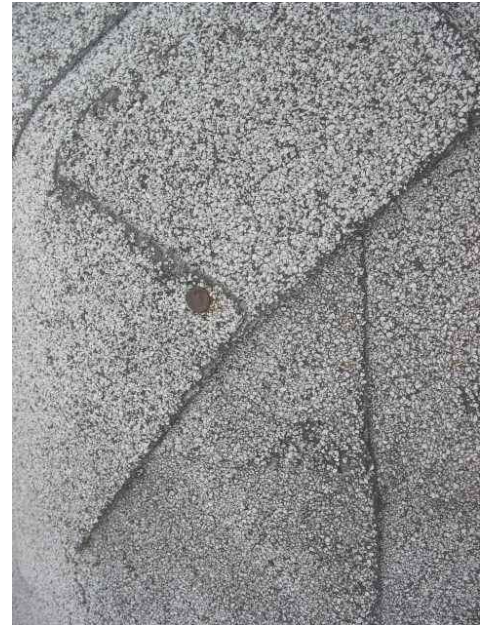
EXPOSED NAILS

Under-driven or exposed nails were found in one or more roof coverings. Recommend a qualified roofer evaluate and correct.

Contact a qualified roofing professional.

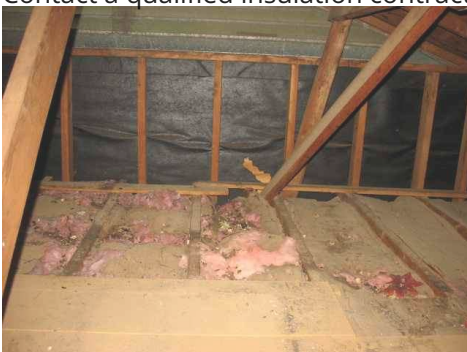
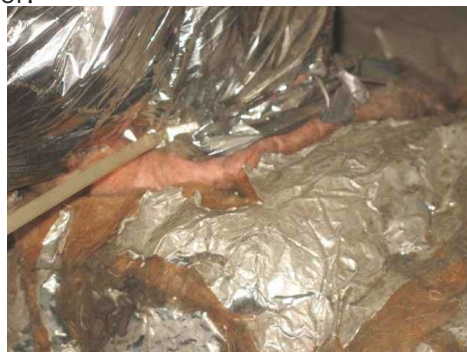
DAMAGED INSULATION

Insulation appears to have been pulled out / disturbed by pests. I observed a combination of wool type and fiberglass insulation. The depth of the insulation was approximately 5 inches deep. Recommend a qualified insulation contractor evaluate and increase the R-value of insulation. This is not a safety hazard. The proper R-value of the insulation will increase the comfort of the home and reduce heating / cooling costs.

NOTE: I observed evidence of pest or other living creatures intrusion into the attic due to damaged soffits and fascia.

Contact a qualified insulation contractor.

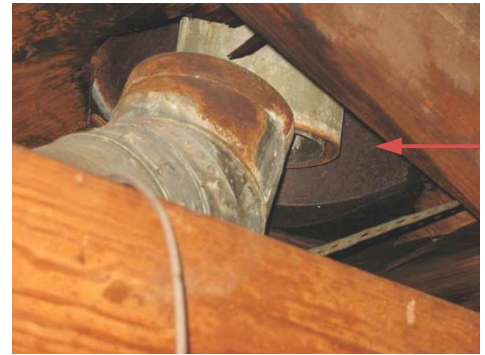
IMPROPER INSTALLATION

I observed the exhaust pipe offset at the roof penetration in the Attic. The roof sheathing and rafters appear to show indication of overheating and fire. If not corrected, the implications may create a safety hazard for occupants and fire damage to the house.

Recommend a qualified contractor evaluate and correct.

Contact a qualified HVAC professional.

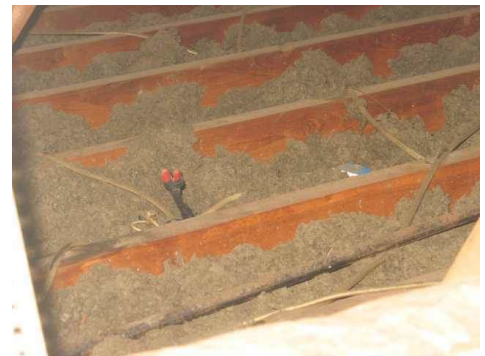
INSUFFICIENT INSULATION

Insulation depth was inadequate. Recommend a qualified attic insulation contractor install additional insulation.

Contact a qualified insulation contractor.

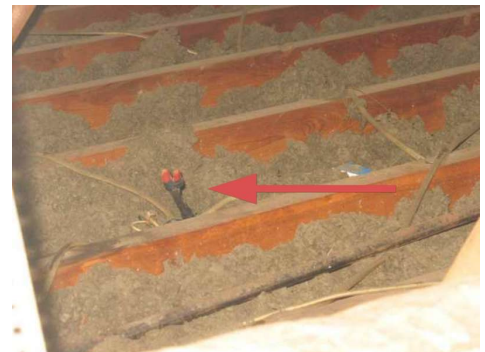
FIRE HAZARD / ARCING AND SPARKING

I observed unprotected electrical splices in the attic close to attic insulation.

All electrical splices need to be executed inside electrical box and have a cover box. Implications of unprotected splices are overheating of connections, arcing, sparking and fire hazard to the house.

Recommend further evaluation and correction by a licensed electrician.

Contact a qualified electrical contractor.

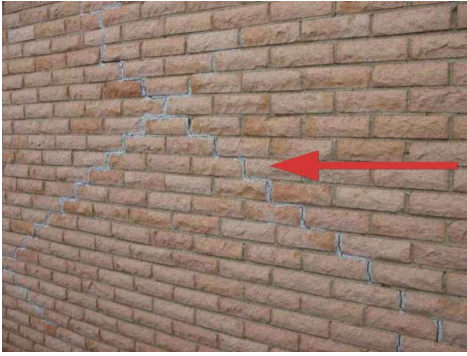
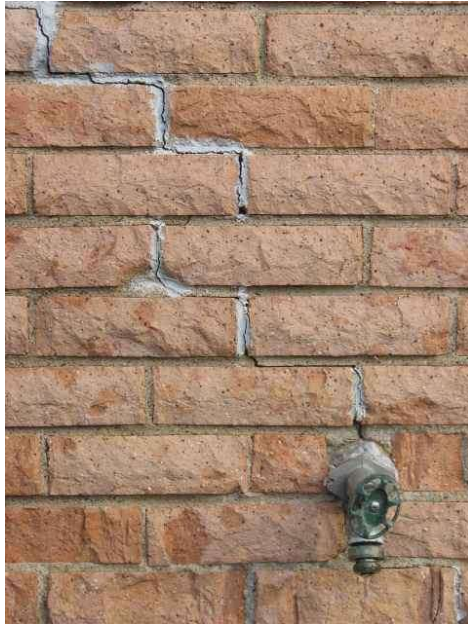
CRACKS - MAJOR

Major cracking observed on the west side of the house in wall structure. Repairs had been performed, though cracking progressed. The brick siding is moving significantly at the moderate press of the hand. I inspected the eaves, soffits and fascia. I observed mechanical damage to to fascia, shingles and gutters on the front and west side of the house. Implications of cracking in the exterior of the house is possible water damage to the wall structures and inside finishes. Recommend a qualified structural engineer evaluate and advise on course of action.

Contact a qualified structural engineer.

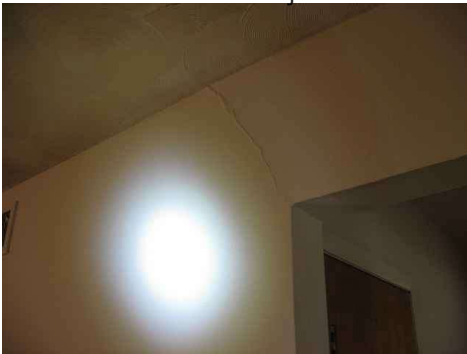
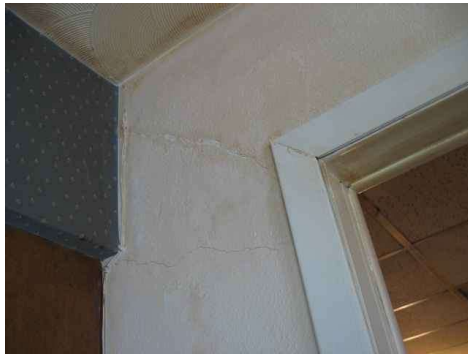
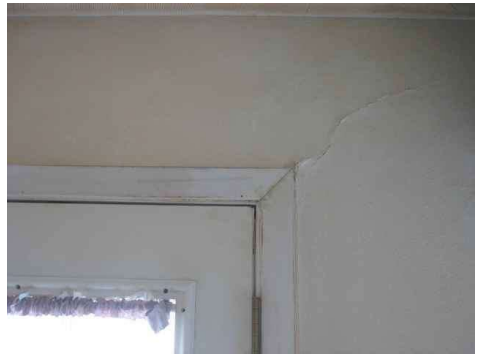
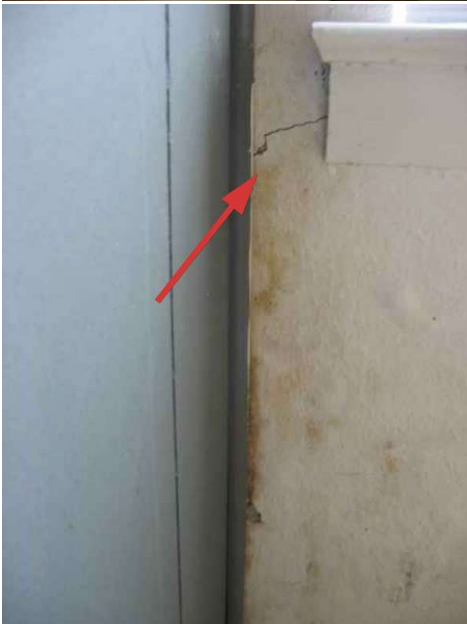
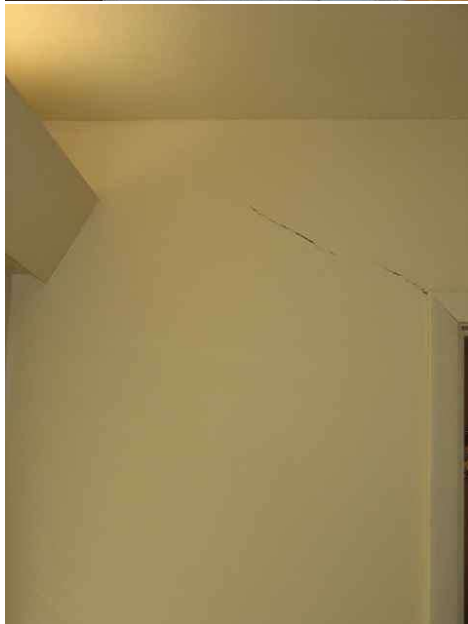
CRACKS - MINOR

Void cracking was observed on the interior wall structure leading to the window and door openings. This is common in homes this age. Recommend correcting and further monitoring.

Recommended DIY Project

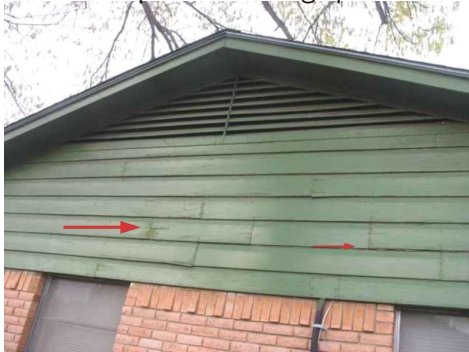
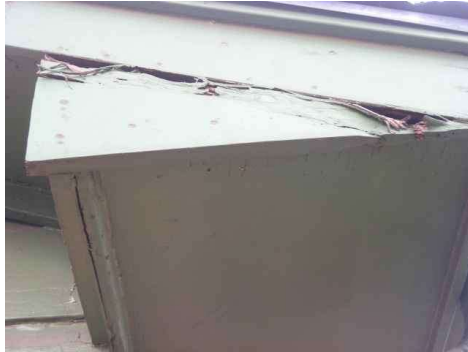
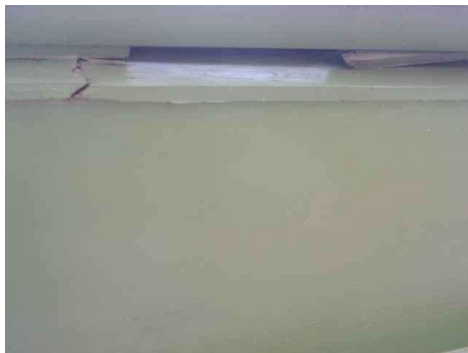
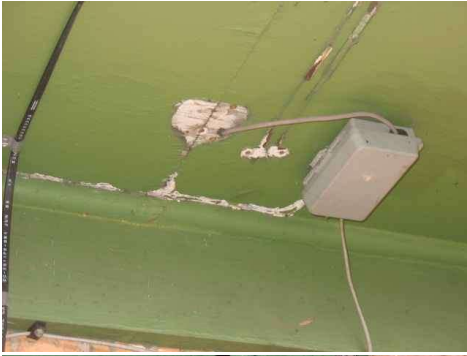
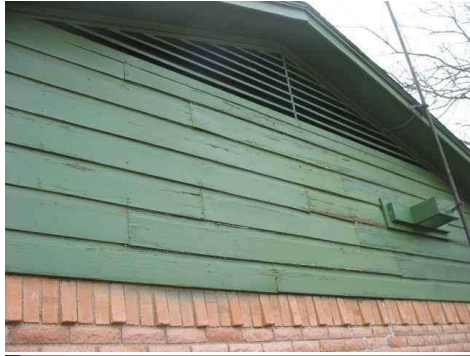
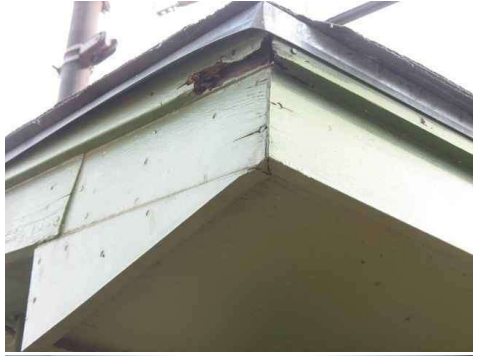
EVIDENCE OF STRUCTURAL DAMAGE

Evidence of structural damage caused by rot was found in the wall exterior siding on the east and west side of the house. Recommend a general contractor evaluate and advise on how to repair / replace siding material.

I also observed unfinished wall, improper installation and mechanical damage to the interior finishes in laundry room, closets, wet bar area.

Recommend correcting / patching or further evaluation by a drywall specialist.

Contact a qualified siding specialist.

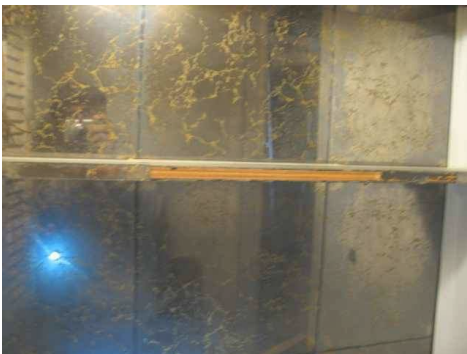
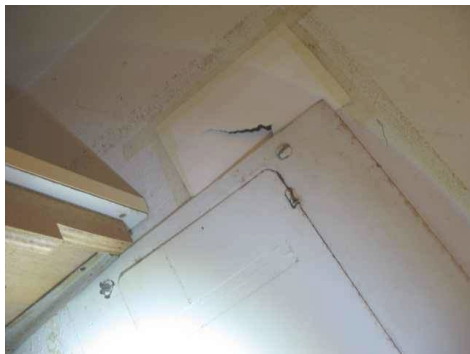
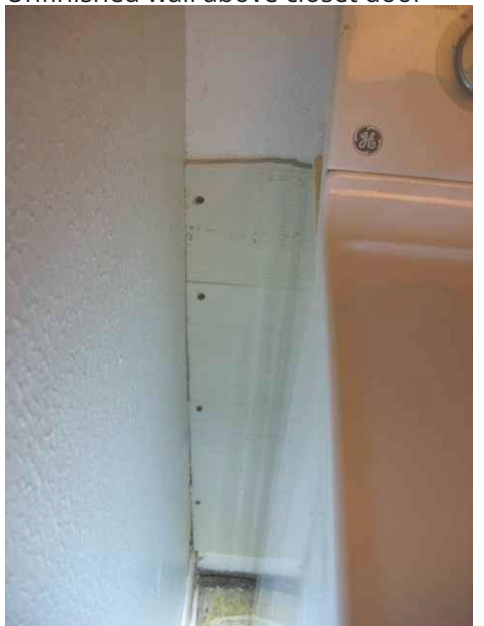
Unfinished wall above closet door

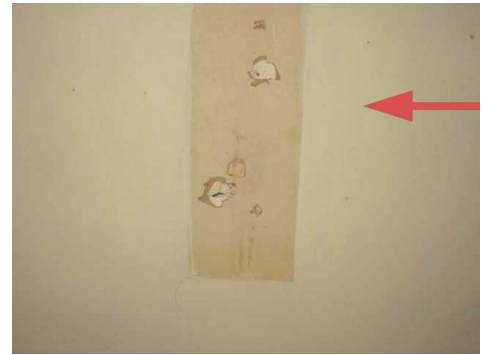
2.5.4 E. Walls (Interior and Exterior)
DEFECTIVE CLOSET SHELVING
CLOTHES CLOSET

I observed mechanical damage to the shelving and interior walls in the clothes closets. The implications are both cosmetic and functional. The closet shelves may sag under the weight of the storage and cause bodily injury by collapsing on the tenants head or feet. Recommend further evaluation by a handyman or carpenter.

missing bracket under a shelf in the bedroom. Clothes closet

Recommendation
Contact a qualified carpenter.

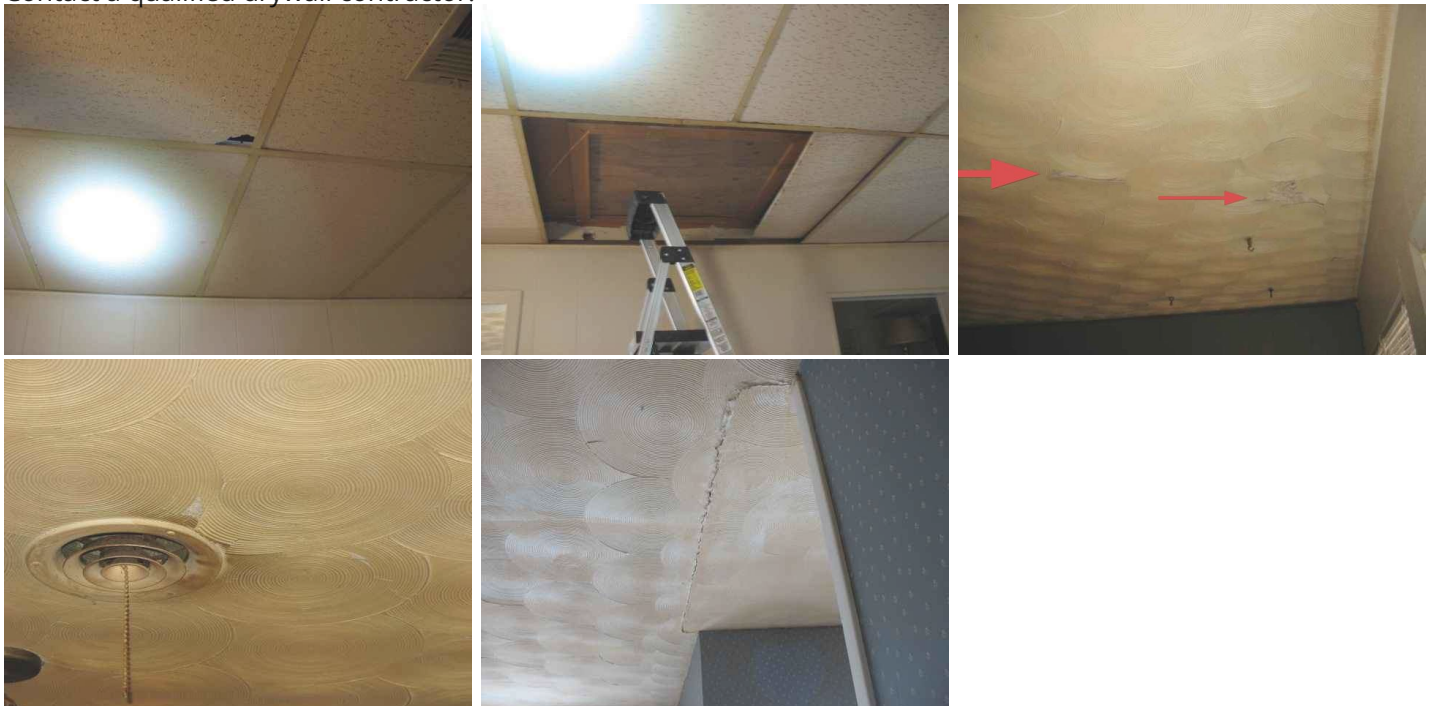
CEILING - MINOR DAMAGE

Minor damage or deterioration to the ceiling was visible at the time of the inspection. This was a cosmetic defect, though comfort of the house and thermal envelope of the house had been compromised. Recommend correcting / replacing with like material.

Recommendation
Contact a qualified drywall contractor.

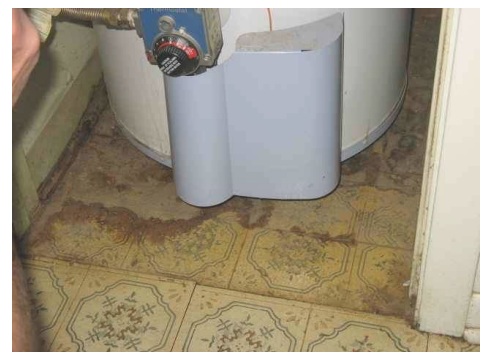
FLOORING - DAMAGED

The home flooring had general moderate wear and tear visible at the time of the inspection. Evidence of prior water damage was observed by the water heater. It could have been caused by the original water heater prior to replacement. Recommend evaluation by a qualified flooring contractor.

Recommendation
Contact a qualified professional.

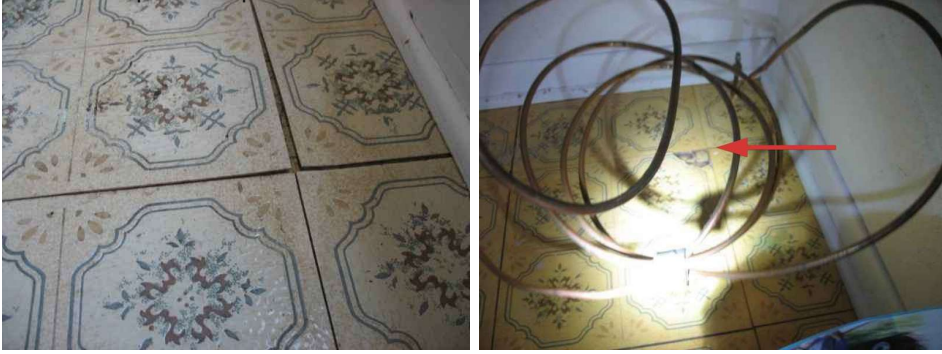
FLOORING - TILES LOOSE

Loose vinyl tiles were present in the dining/ nook area. Recommend re-attach and seal with flooring adhesive according to manufacturer instructions. Broken corners to the vinyl tiles observed in the kitchen area. Implications: may create a trip hazard and / or water damage to the subfloor.

Contact a qualified professional.

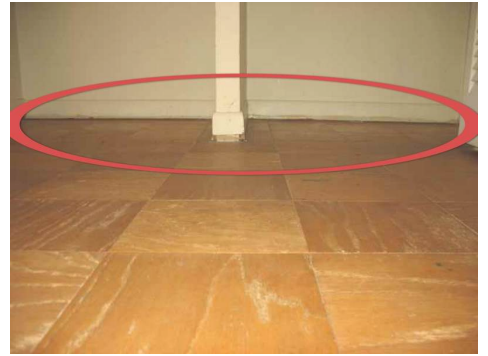
FLOORING IMPROPER INSTALLATION

I inspected the flooring in the clothes closets. I observed excessive gaps on the floor/ wall connection. Implications: pest intrusion into the house, thermal envelope of the house was compromised, which may cause excessive heating/ cooling costs. Recommend further evaluation and correction by a flooring contractor .

Contact a qualified flooring contractor

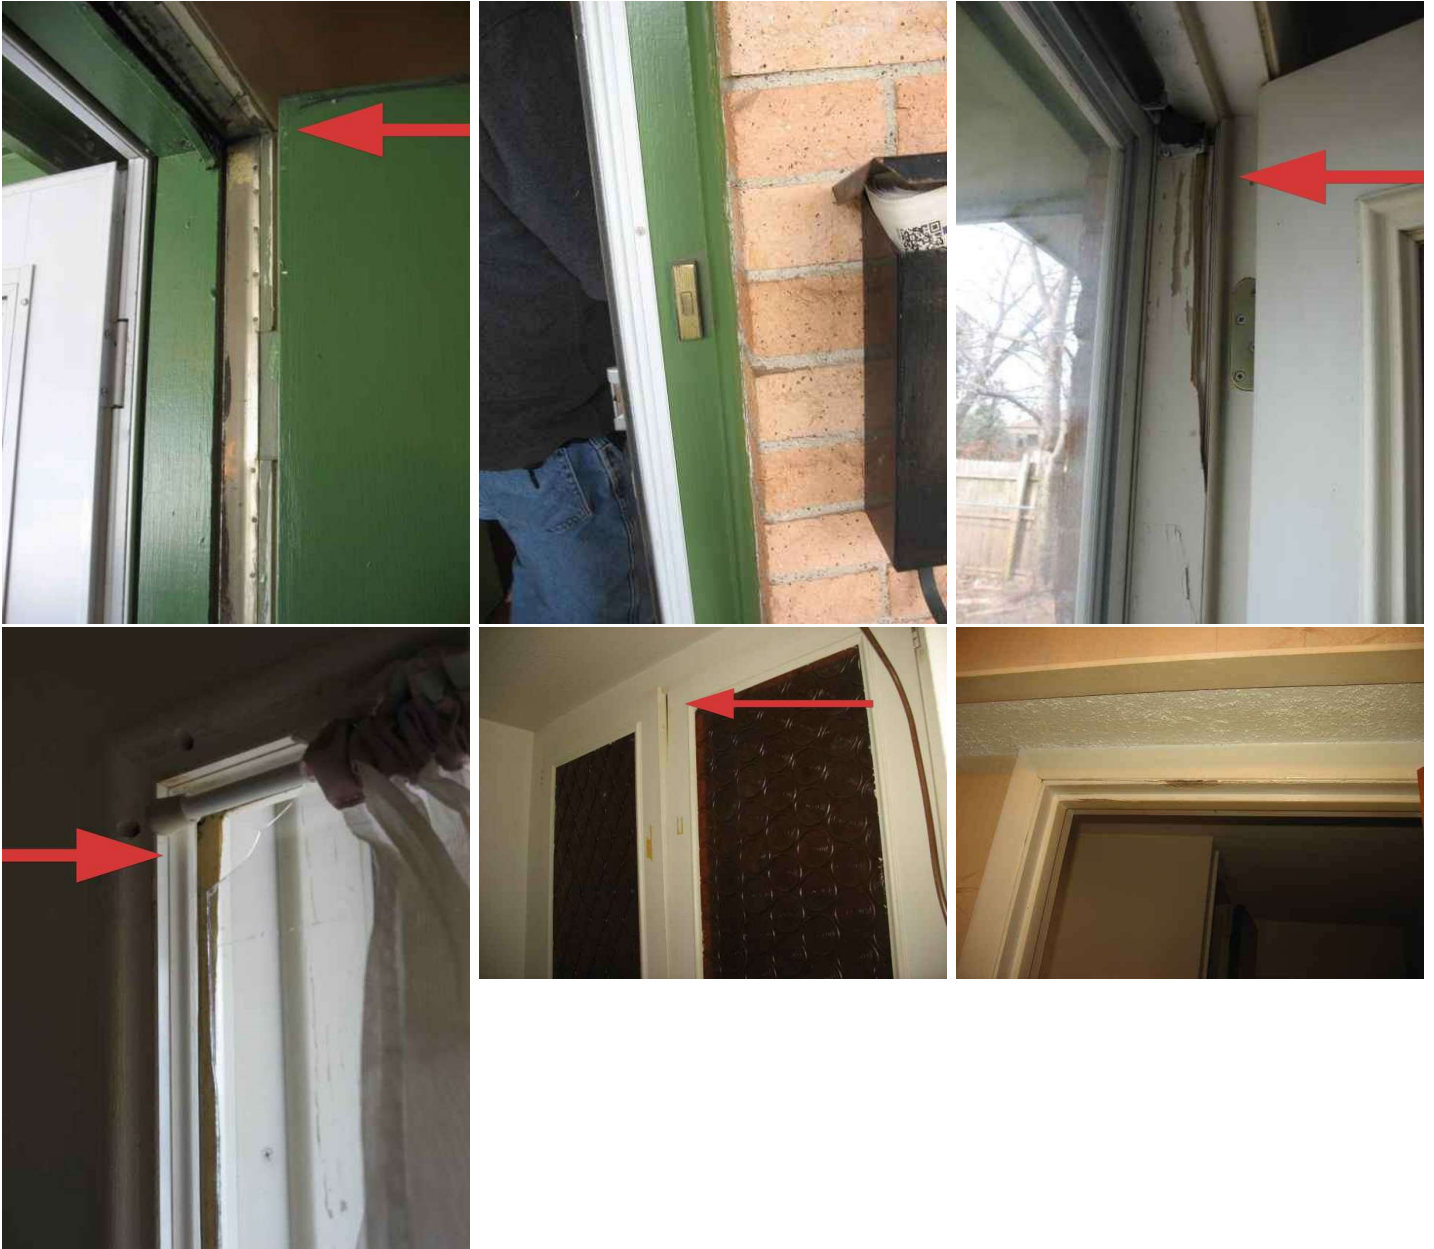
WEATHERSTRIPPING INSUFFICIENT

The front Door had partially missing / deteriorated standard weatherstripping. This can result in significant energy loss and moisture intrusion. When operating the door bell, it failed to perform its function. Defective doorbell . Recommend installation of standard weatherstripping and repair/ replace doorbell components / system.

I observed mechanical damage to the jams of the back door leading to the back patio area. The glass on the back door of the house was broken and unprofessionally secured in its place. I also observed cosmetic / functional defects to interior doors to bedrooms and closets. Recommend further evaluation by a door repair and installation contractor.

Contact a qualified carpenter.

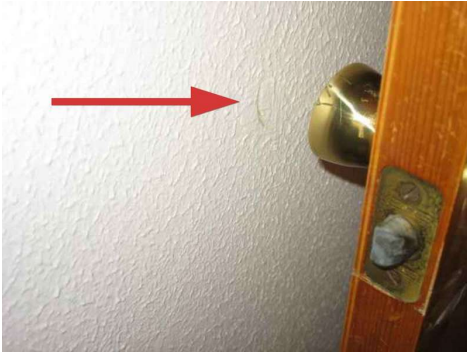
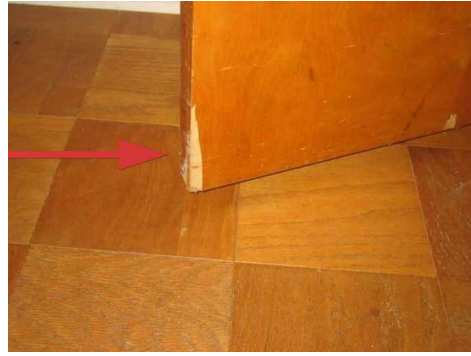
MISSING DOOR STOPPERS

Master Bedroom door missing door stopper. Implications are both cosmetic and material: mechanical damage to the finish of the wall and breaking the thermal envelope of the house (air leakage) resulting in increased heating / cooling cost. I recommend correcting the issue by a handyman or the buyer.

Contact a handyman or DIY project

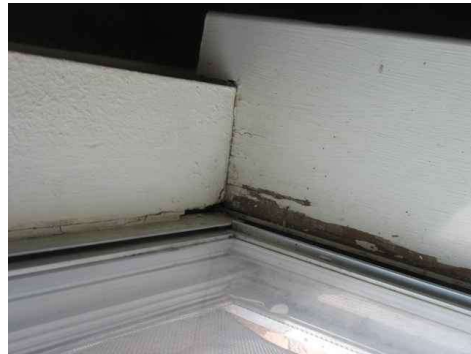
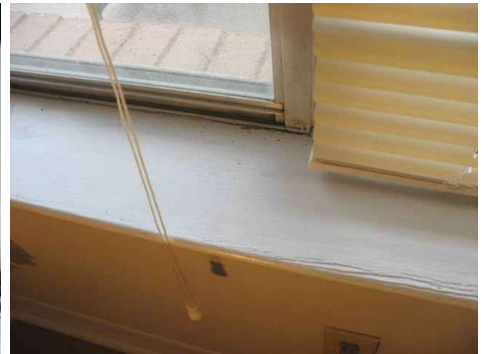
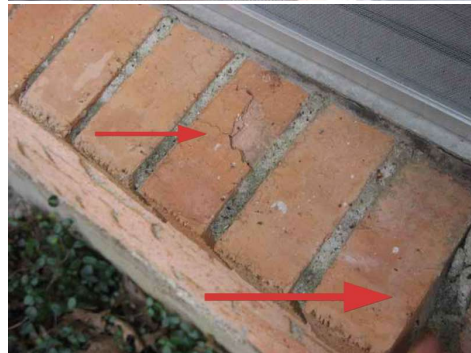
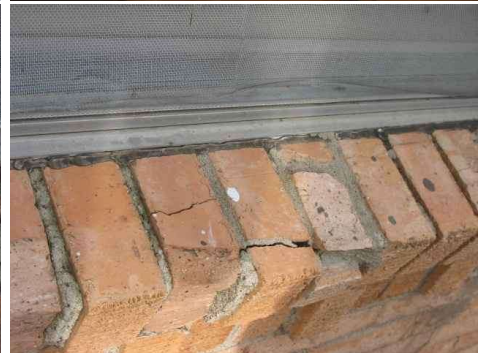
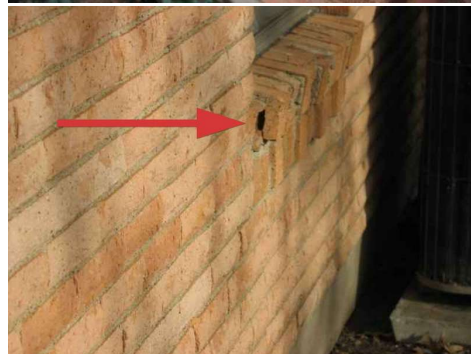
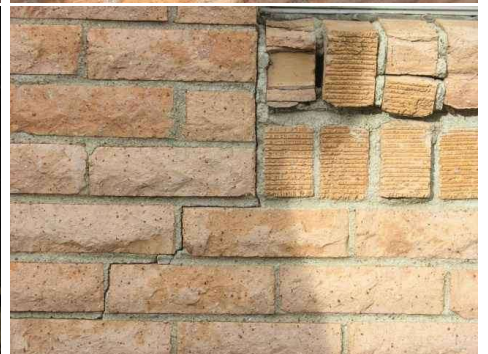
DAMAGED

I inspected a representative number of windows in the house. One or more windows appeared to have general damage, but are operational. I also observed defective window sills, cracks and masonry spalling on the exterior window sill, air leakage as a result of old and failed sealant, broken / missing window screens. Implications of such defects are critical to the window and wall structures, as they may lead to concealed damages to the wall below the window as a result of water intrusion.

Recommend a window professional further evaluate, clean, lubricate & adjust as necessary.

Contact a qualified window repair/installation contractor.

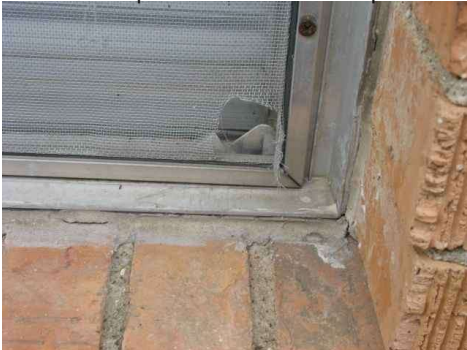
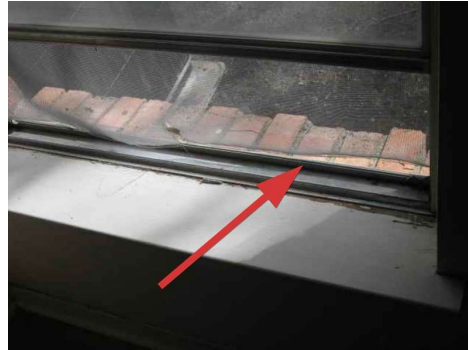
MISSING SCREEN(S)

Contact a qualified window repair/installation contractor.

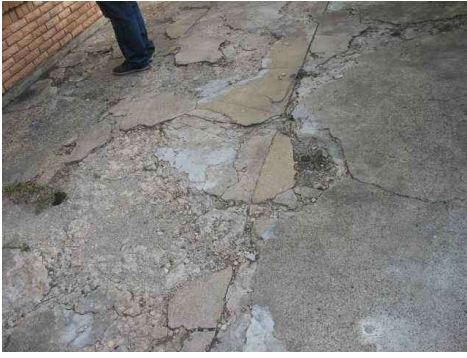
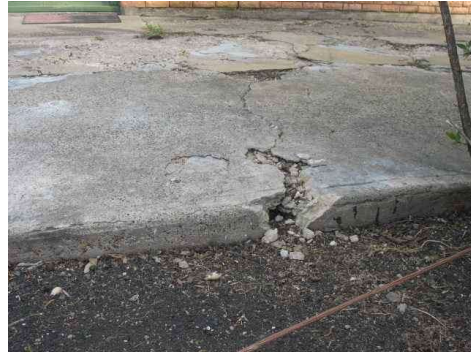
2.11.1 K. Porches, Balconies, Decks, and Carports

CRACKED EXTERIOR FLOOR

Contact a qualified concrete contractor.

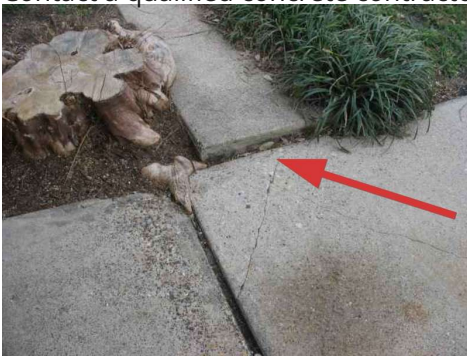
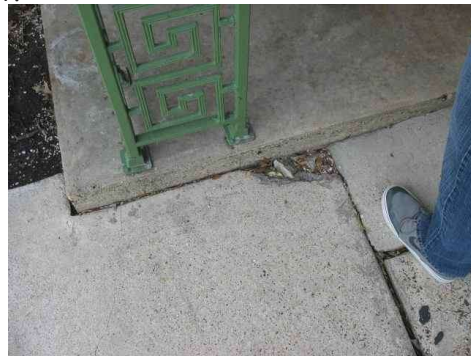
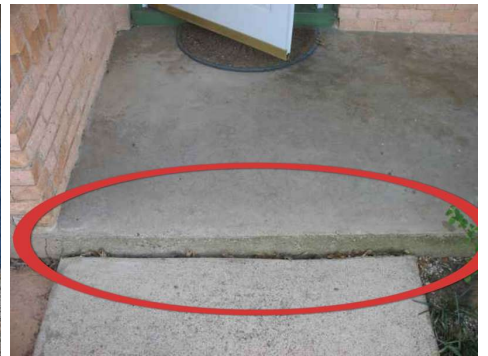
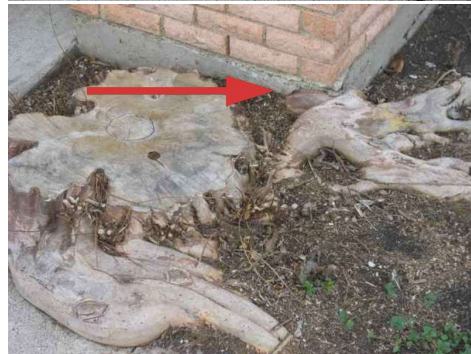
UN-LEVEL PAVEMENT

Front of the house exterior walks and driveways showed signs of movement. I observed Un-even, un-level walk pavement to the front and north west corner of the house. Implications of such conditions: trip hazard.

I also observed excessive gap between front porch and walk way which may contribute to excessive collection of water next to the foundation wall.

Tree stump too close / touching the foundation. Recommend monitoring the condition of the foundation.

Recommend further evaluation by a concrete contractor.

Contact a qualified concrete contractor.

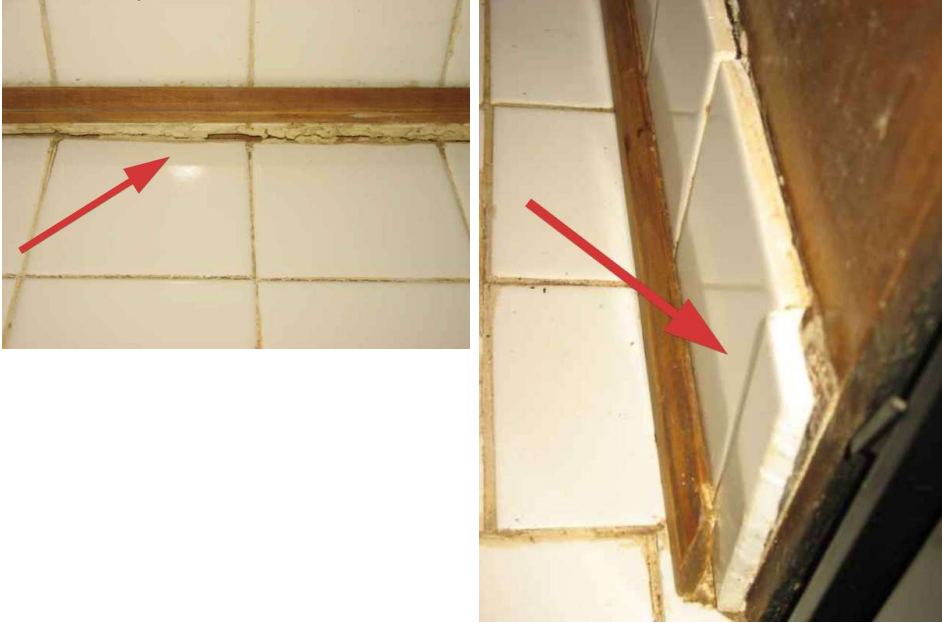
IMPROPER INSTALLATION

I inspected the kitchen countertops and a representative number of cabinet doors. Cabinets appeared to be functional. Improper installation of wood trim - quarter round to the tile countertops, broken seal and loose pieces. Implications: water damage to the trim and wall structure, rot, poor hygiene.

Recommend further evaluation and replacement by a cabinet contractor.

Contact a qualified cabinet contractor.

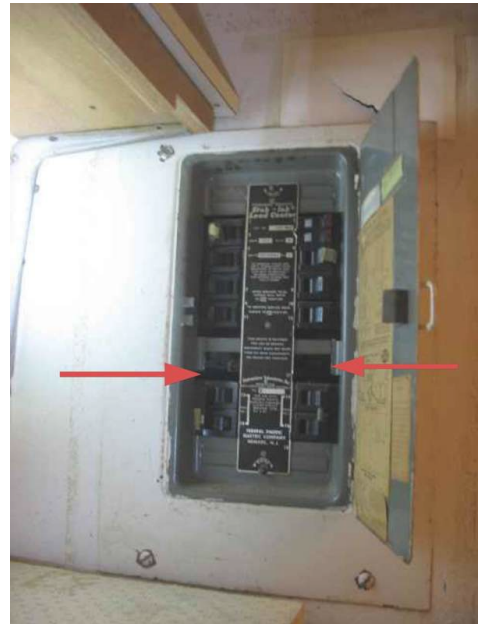
PANEL UPGRADE NEEDED

I also observed missing knock outs. The implication of missing knock out is exposed live connection inside the panel and electrical shock hazard.

I highly recommend immediate remedy or replacement by a licensed electrician.

Recommend a qualified electrician evaluate and upgrade.

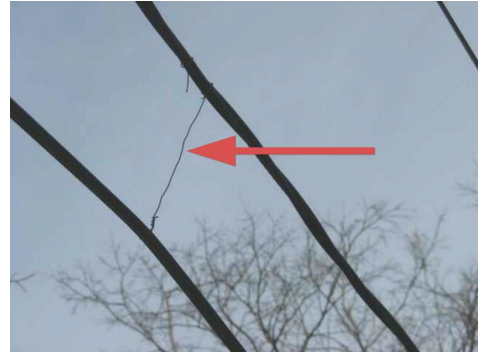
ILLEGAL SUPPORT

I have observed an illegal support. Utility service drop may never be obstructed or used as a support for other wires below. The implication may be an electrical shock. This is a safety hazard.

Recommend immediate correction of the issue.

Recommendation
Contact a qualified electrical contractor.

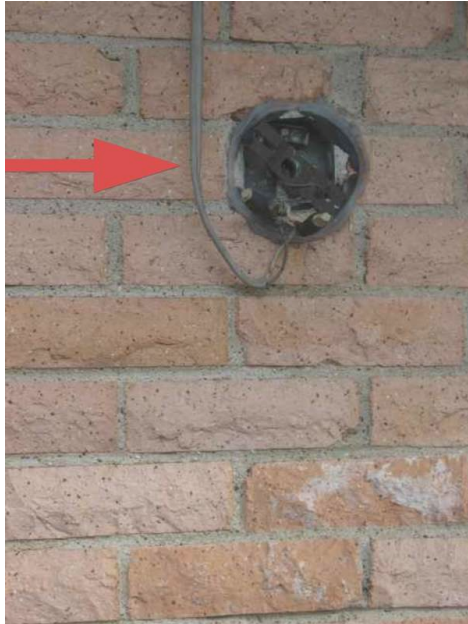
IMPROPER INSTALLATION

I identified the following defect: an underground feeder cable (UF) was used in open air to provide electrical connection to the barn in the back yard. I also identified an electrical box missing the cover on the back patio.

Recommend proper installation and further evaluation by a licensed electrician.

Recommendation
Contact a qualified electrical contractor.

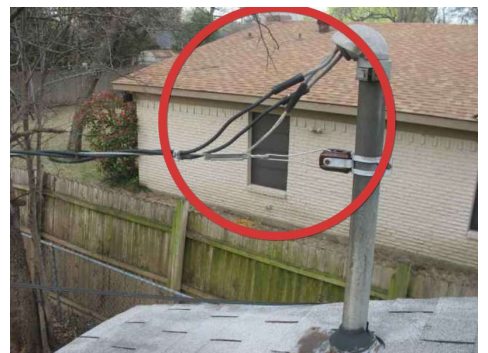
SERVICE ENTRANCE (SE)

While inspecting the roof covering I have identified the following defect: service entrance to the house was missing the drip loop. Implication of a missing drip loop on electrical entrance is potential water access to the electrical panel through the mast. Water in the electrical panel may promote corrosion to the panel housing and other components. Water is a good electrical conductor and should NOT be found anywhere close to electrical wires.

Recommend correction by a licensed electrician.

Recommendation
Contact a qualified electrical contractor.

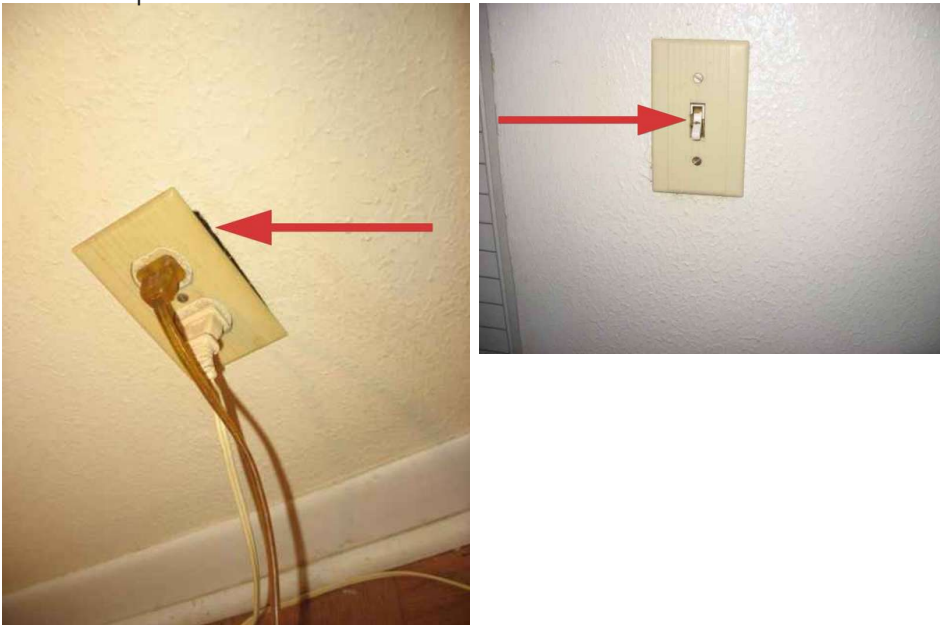
COVER PLATES DAMAGED

One or more receptacles showed signs of inappropriate installation of cover plate or drywall opening for electrical box was cut too large. Implication of such installation is potential access to the electrical box and live wires some other way, than intended. It may pose electrical shock hazard to children and adults alike. Recommend correcting the defect / replacement to a larger plate.

I identified one broken light switch, still operable , but may pose electrical shock to children and adults alike. Recommend replacement.

Recommendation
Contact a qualified electrical contractor.

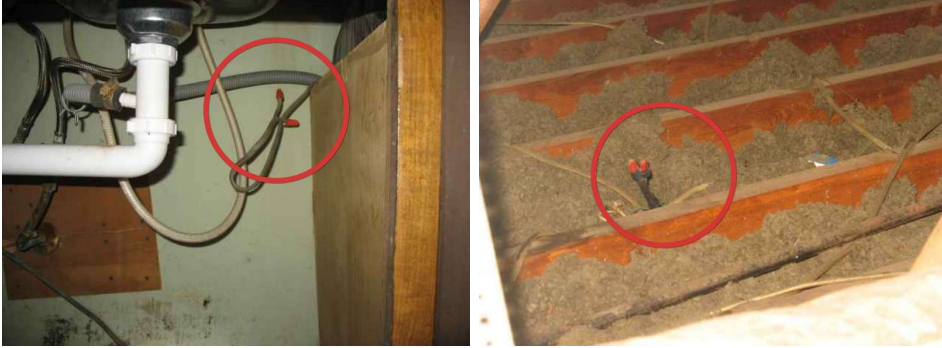
IMPROPER WIRING

Improper wiring was observed at the time of inspection. All wire connections & charged wires with exposed ends and splices should be covered in junction boxes for safety. Recommend a licensed electrician evaluate and repair.

Electrical splice outside the box under the kitchen sink. Needs to be addressed by an electrician.

Contact a qualified electrical contractor.

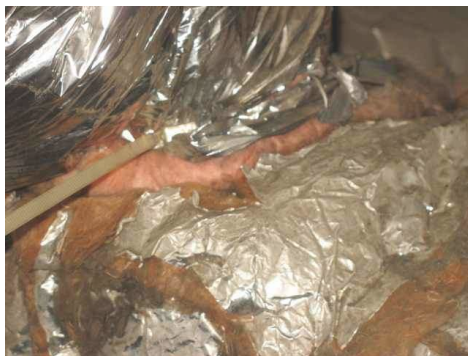
DUCTS NOT PROPERLY SEALED

Air supply ducts were not properly sealed. Recommend a qualified HVAC contractor seal supply and return ducts for maximum efficiency.

Recommendation
Contact a qualified HVAC professional.

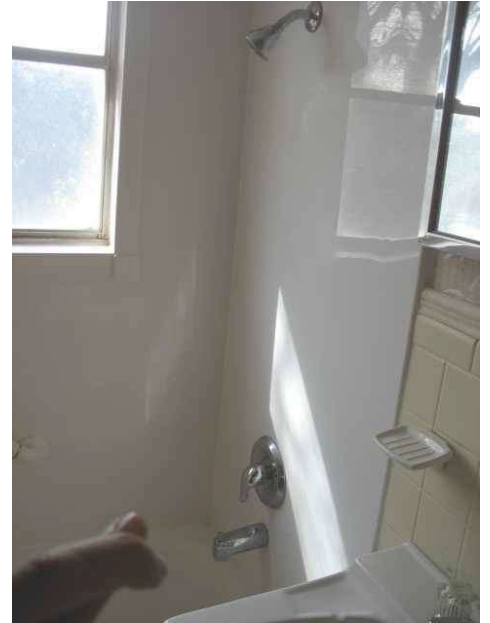
INOPERATIVE

I inspected the operation of all plumbing fixtures. The Shower and tub enclosure failed to operate. Needs further evaluation by a plumbing contractor.

Contact a qualified plumbing contractor.

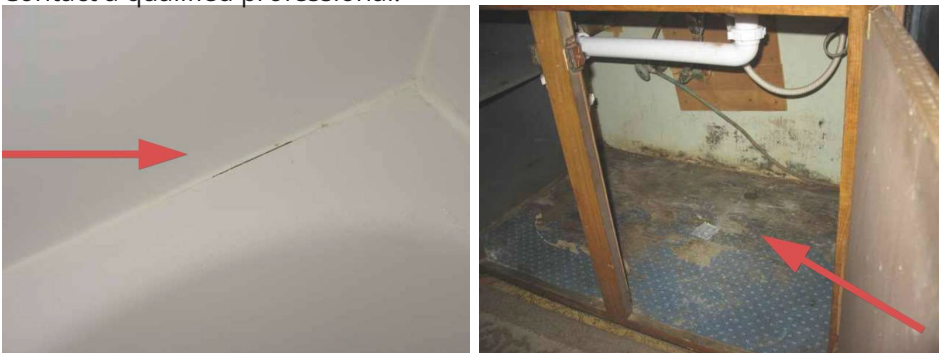
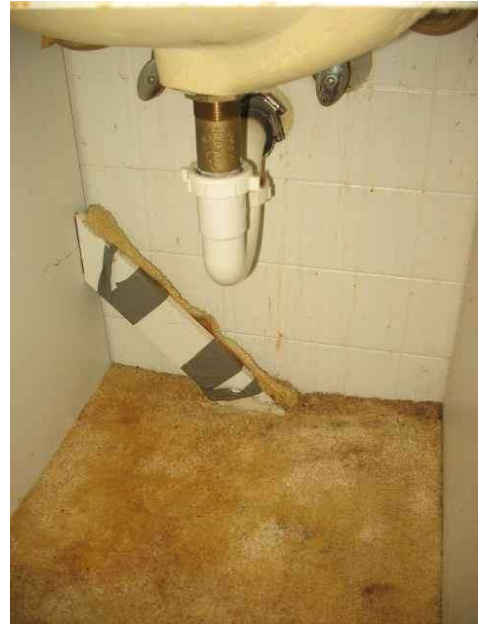
SURFACE DEFECTS AND FAILED SEALANT

Observed failed sealant and other surface defects to bathtub and shower panels.

Observed indication of prior leaks under kitchen sink. No active leaks were detected, though damage to the kitchen cabinets had been done.

Carpet piece inside the bathroom cabinet under the lavatory. May be an indication of concealed damage caused by previous leaks to the cabinet. Needs further evaluation and correction.

Contact a qualified professional.

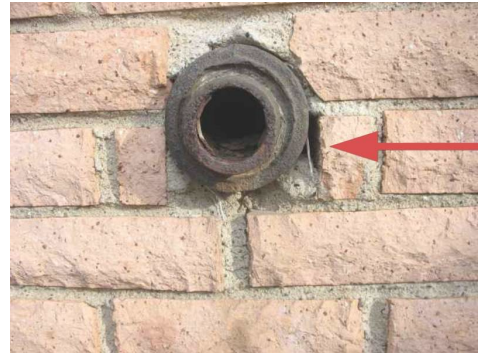
5.2.1 B. Drains, Wastes, & Vents
CLEAN OUT MISSING CAP
SOUTH BACK YARD

Observed clean out to the kitchen sink missing cap. This is not a safety hazard, but I recommend using a cap and sealing around the pipe to prevent excessive water intrusion into the wall structure and keep creatures away.

Recommendation
Contact a qualified plumbing contractor.

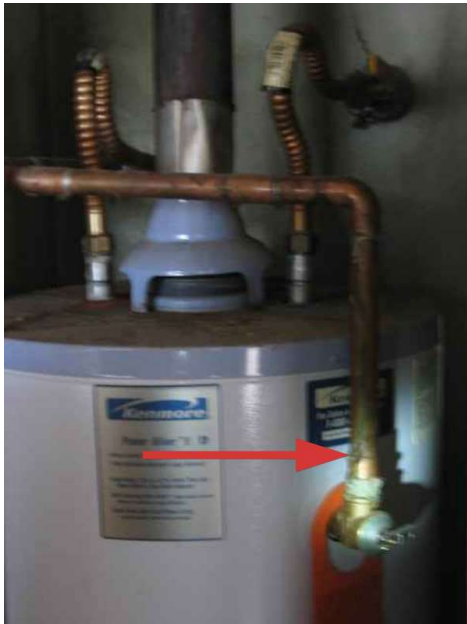
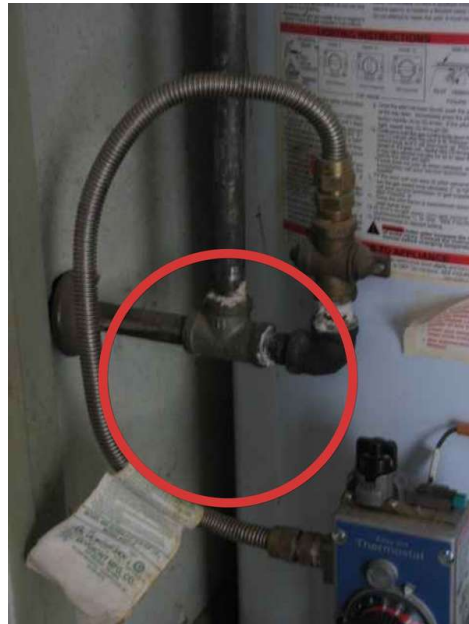
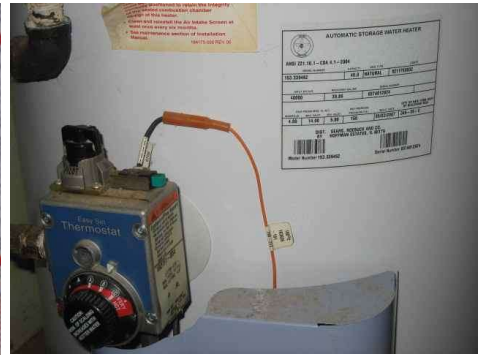
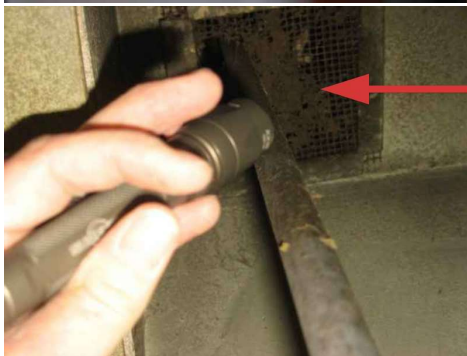
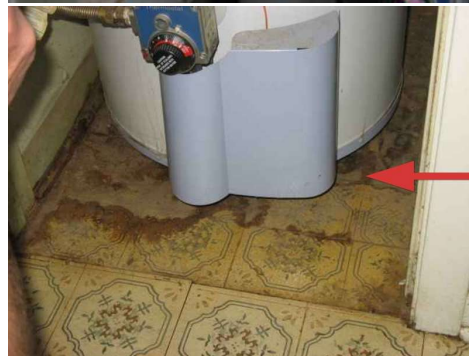
5.3.1 C. Water Heating Equipment
IMPROPER INSTALLATION

Observed the presence of temperature and pressure relief valve, though the discharge line is improperly installed. Should discharge down to the outside of the house or into a pan within 6 inches from the floor or grade level. Recommend qualified plumber evaluate & repair.

Gas line leading to the water heater was missing drip leg. This is a defect in installation. Needs further evaluation and correction by a qualified professional.

Draft air vent appeared to be clogged by dust and debris. Needs cleaned for improved draft air.

Drip pan was missing at the water heating unit. A 1 1/2" deep drip pan with overflow hose plumbed to discharge to the exterior of the home is required.

Recommendation
Contact a qualified plumbing contractor.

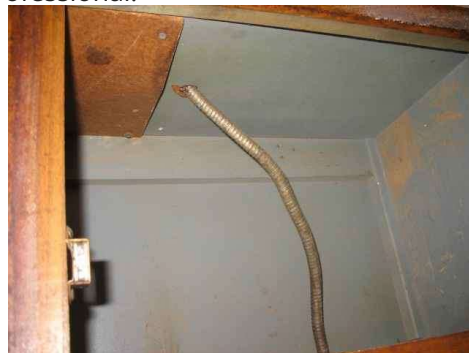
EXHAUST LIGHTS INOPERABLE

Exhaust did not respond to light controls. Failed to operate.

Exhaust had significant oil grease, rust and debris build-up and failed to engage when tested. The exhaust appeared to be near the end of its service life. Recommend repair or replacement by a qualified service technician.

Contact a qualified appliance repair professional.
