SUMMARY

1234 Main St. Garland TX 75043

Greg Cheptene
Professional Inspector TREC#110678
Ally Certified Home Inspector
972-900-1088
gcheptene@gmail.com

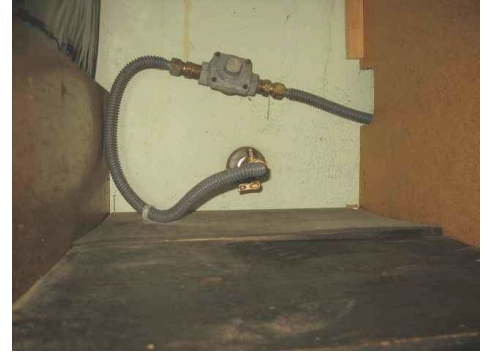
OVEN NOT HEATING UP

Gas oven wasn't heating up at time of inspection. Recommend a qualified appliance contractor evaluate and repair.

Contact a qualified professional.

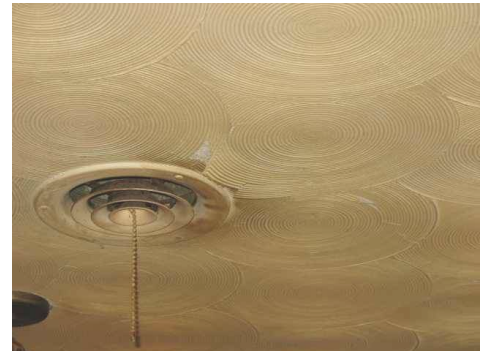
INOPERABLE VENTING

I observed inoperable vents in kitchen and bathrooms. The pull chain vents did not respond when tested. Recommend further evaluation and replacement by a licensed electrician.

Contact a qualified electrical contractor.

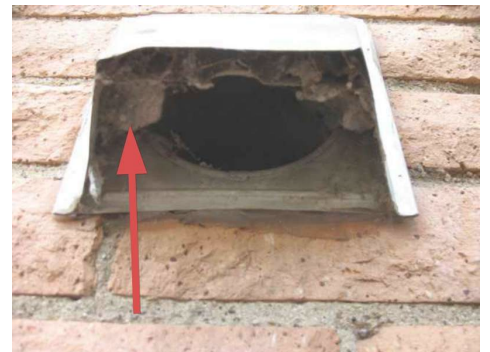
IMPROPER VENTING

Dryer vent was obstructed by lint, vent damper not operable and stuck open. Recommend a qualified HVAC contractor or handyman further evaluate the venting system.

Contact a qualified HVAC professional.
