SUMMARY

1234 Main St.Salem OR 97301

Jordan Prince
InterNACHI Certified Home Inspector &
AHIT Certified
Royal Inspections LLC
9712407710
jordanprince@royal-inspections.com

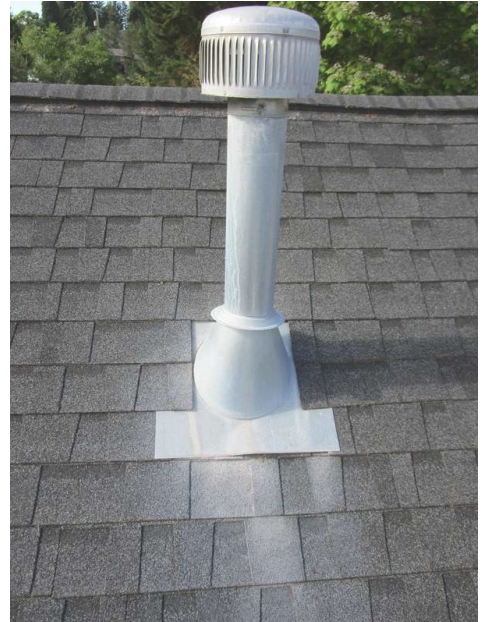
2.3.1 Skylights, Chimneys & Other Roof Penetrations

WHITE ROOF STAIN UNDER EXHAUST VENT

White deposits on combustion vents, or on the roof below them, are evidence that excessive condensation has been forming. The roof stain does not appear to have damaged the roofing material. I recommend monitoring the stain below the vent, and if it gets much bigger calling an HVAC professional for an evaluation.

Contact a qualified professional.

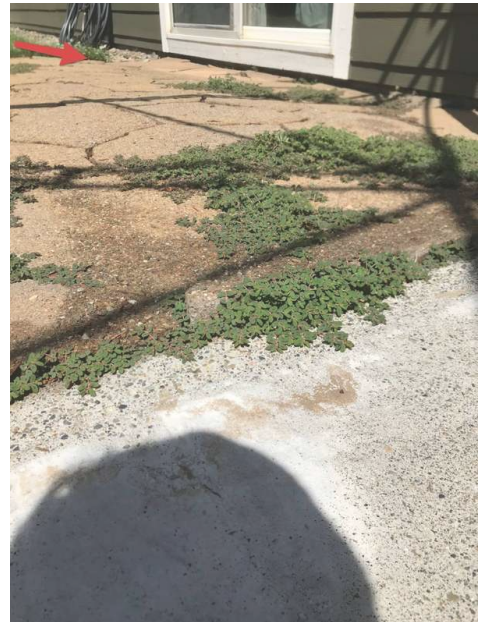
3.1.1 Walkways, Patios & Driveways

WALKWAY PITCHED TOWARD HOME

The walkway has a negative slope and drains towards the structure. Recommend repair.

Contact a qualified professional.

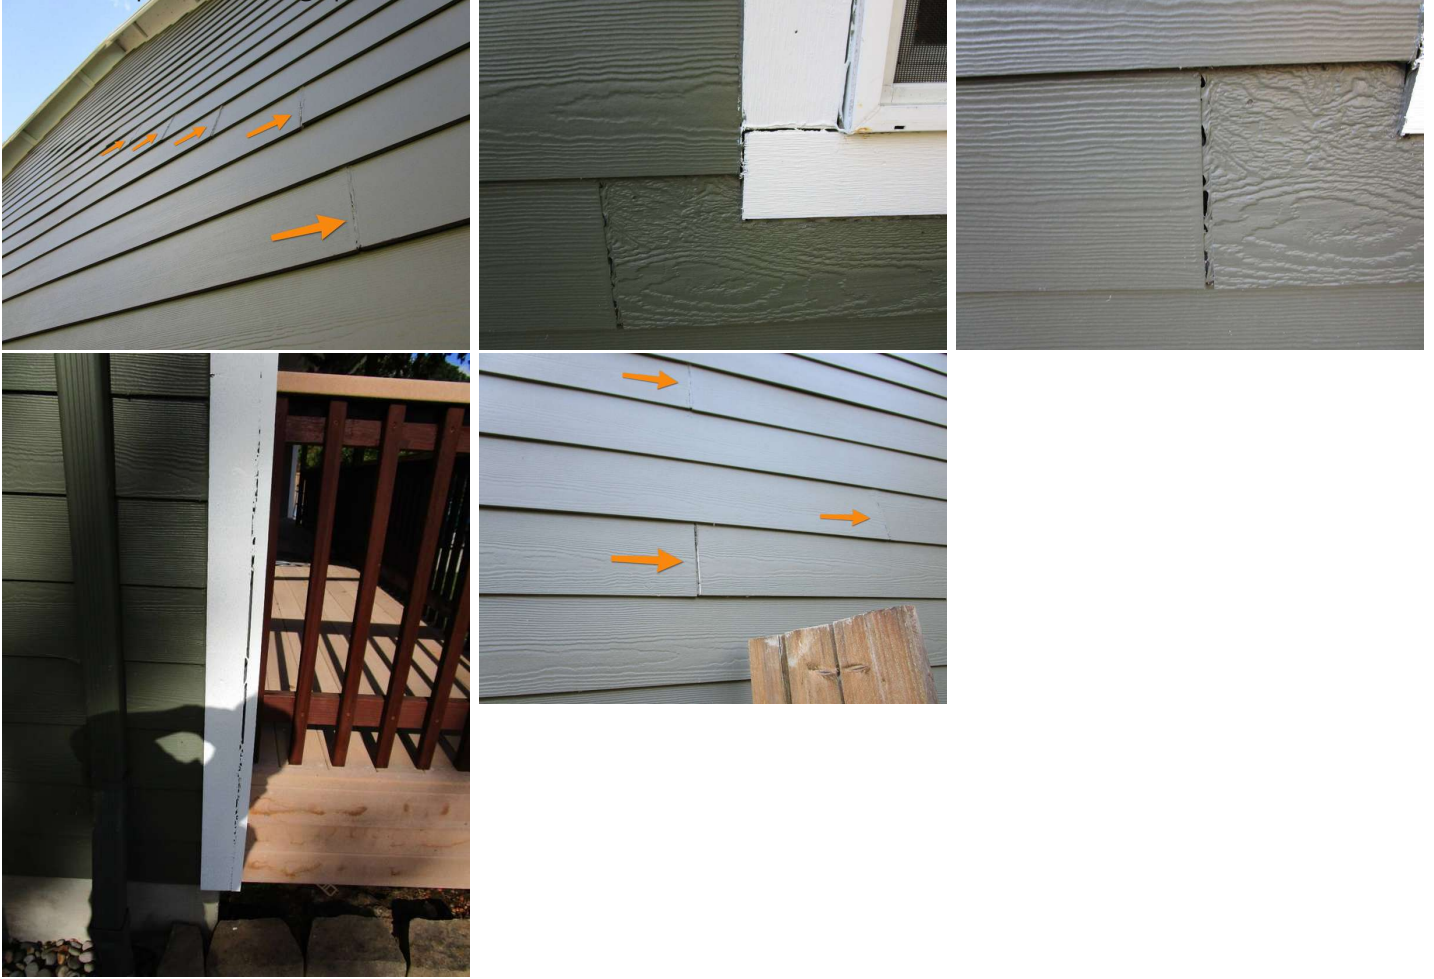
4.1.1 Siding, Flashing & Trim

CAULKING FAILURE

Caulking around windows and doors and / or siding joints was failing in some areas. This is common, but is an entry point for water which can deteriorate wood and potentially create structural insufficiencies. It is recommended that the failing caulking be cut out and new caulking reapplied and painted.

Recommendation
Contact a qualified siding specialist.

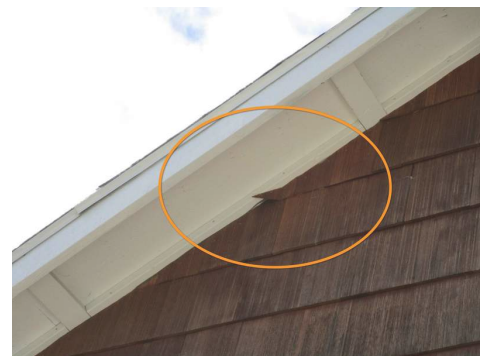
4.1.2 Siding, Flashing & Trim
LOOSE BOARDS

One or more siding boards were loose, which could result in moisture intrusion. Recommend repair.

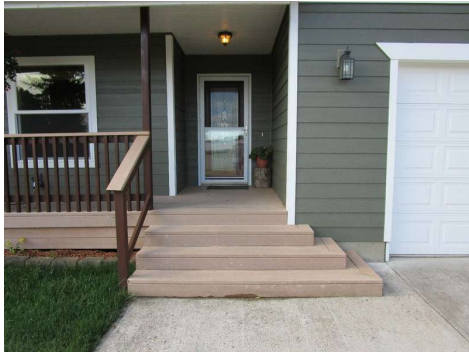
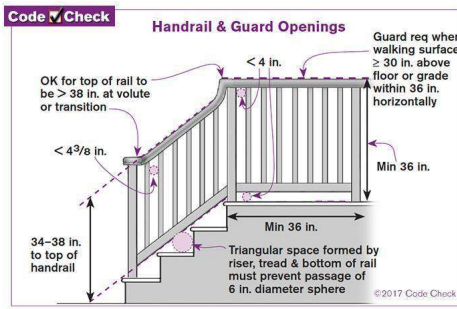
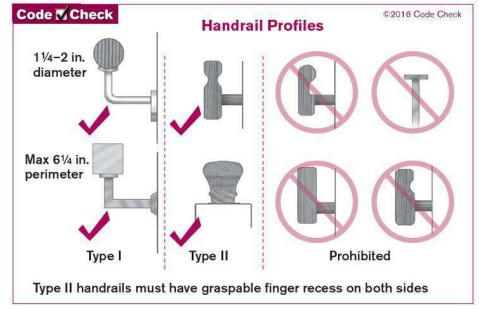
4.4.1 Decks, Balconies, Porches & Steps
RAILING UNSAFE

There is an unsafe opening in the railing. The spacing on the rail should not exceed 4". An opening greater than 4" is a safety hazard especially for children as their head or other body part can become trapped or fall through. The stair hand rail also needs to be graspable. Recommend Repairs to the front porch hand rail.

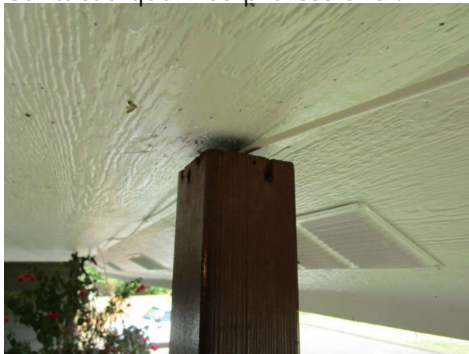
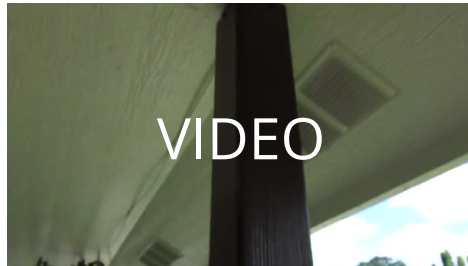
4.4.2 Decks, Balconies, Porches & Steps

TOP OF POSTS UNSECURED

The tops of the 4x4 posts on the front porch are not attached / secured to the ceiling structure.

Recommendation
Contact a qualified professional.

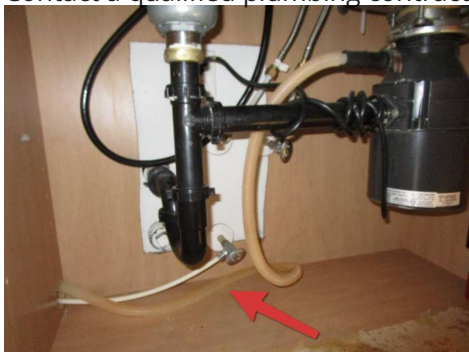
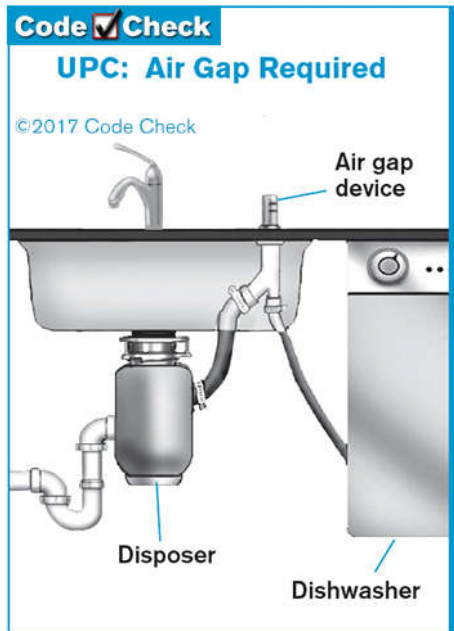
5.1.2 Kitchen Overview

IMPROPER AIR GAP

Recommend adding / repair of air gap between kitchen sink and dishwasher. This is to prevent dirty water from the dishwasher from backing up into the sink.

Recommendation
Contact a qualified plumbing contractor.

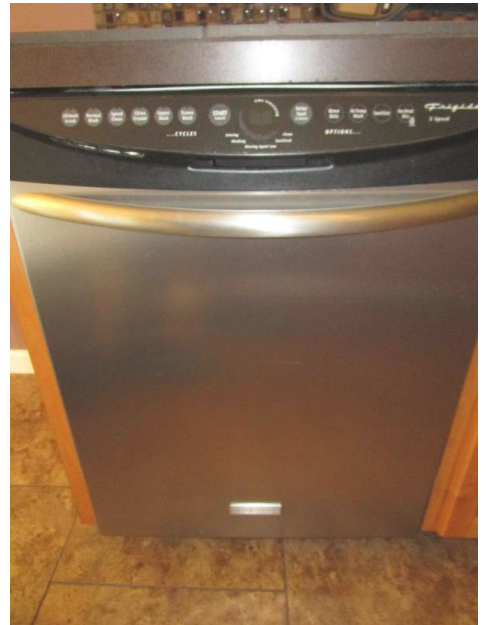
5.3.1 Dishwasher

INOPERABLE

Dishwasher was inoperable using standard controls. The unit would only display a CL code and would not begin it's wash cycle. Upon further research the CL code stands for door ajar. I recommend asking the home owners if they had any problems with the dishwasher not operating correctly and recommend a qualified person to repair as needed.

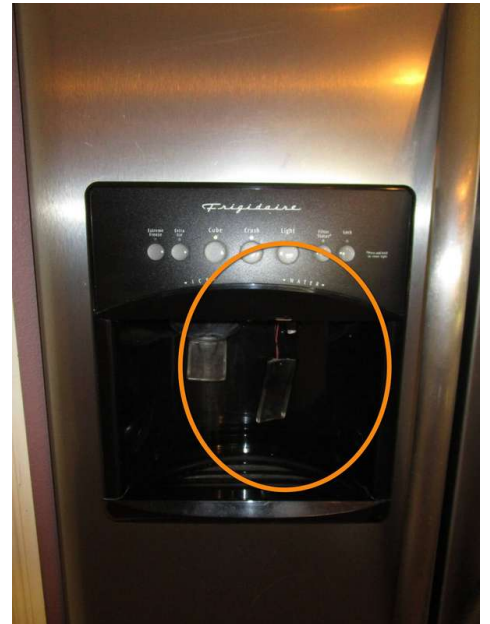
5.5.1 Refrigerator

WATER DISPENSER BROKEN

The water dispenser was clearly broken and dangling by it's electrical wires. Recommend a qualified person repair.

Contact a qualified professional.

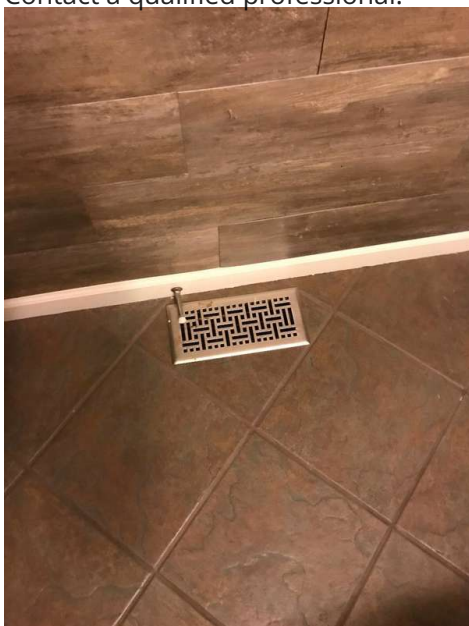
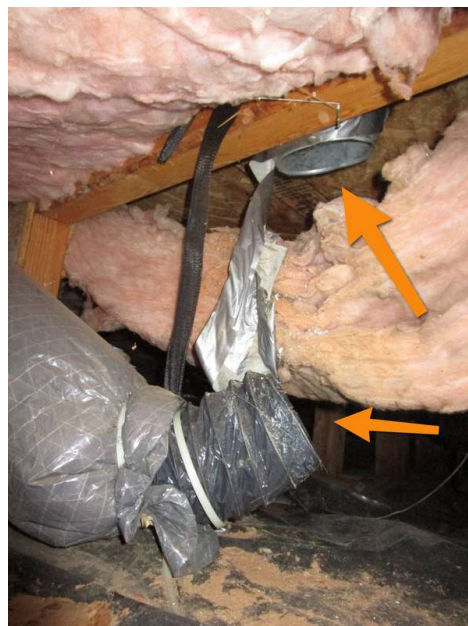
6.1.1 General
HEAT SOURCE
CRAWLSPACE

The ducting under the house to the hall bath had fallen off the heat register and was blowing cold / hot air under the house. Recommend Repair.

Recommendation
Contact a qualified professional.

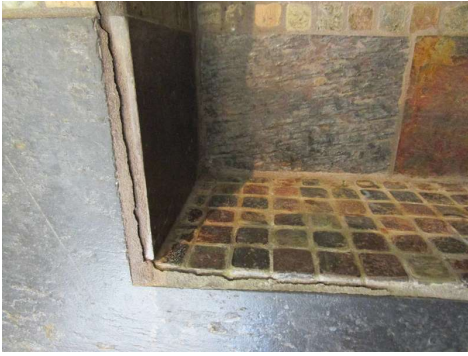
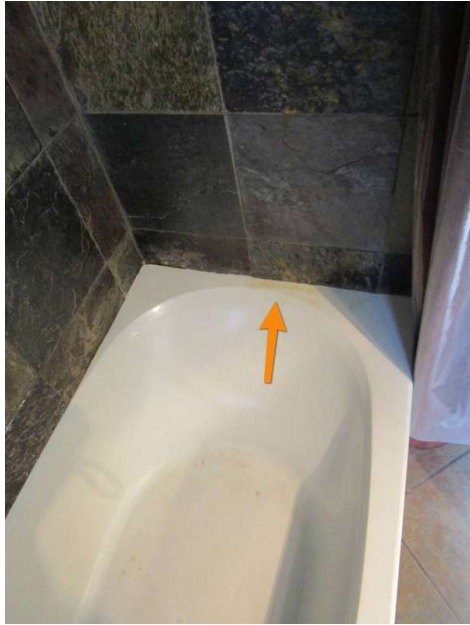
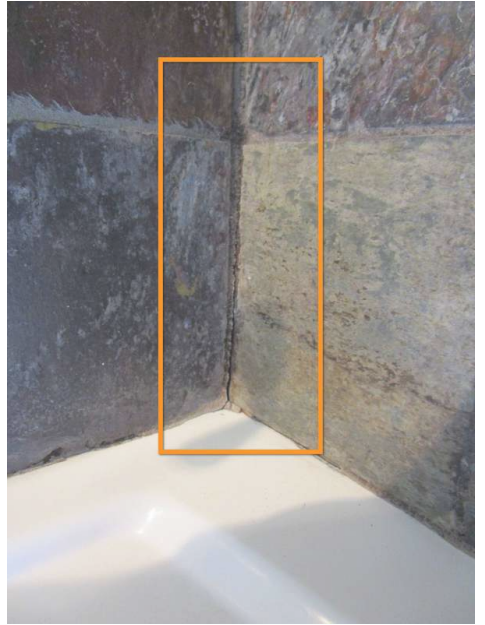
6.7.1 Shower(s)
MASTER BATH TILE
MASTER BATHROOM

Cracks in grout in some areas of tiled shower in master bath. Recommend sealing these areas so water does not penetrate into the wall causing further damage.

Some staining on master tub surface.

Recommendation
Contact a qualified professional.

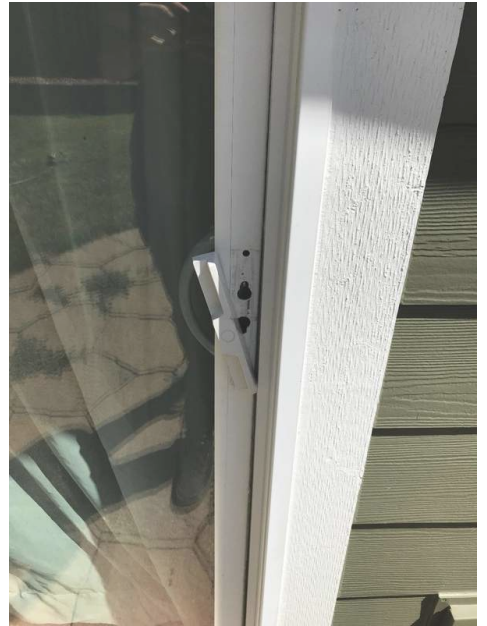
7.1.1 Doors

DOOR HANDLE

Door handle is loose on top side. Recommend handyman repair handle, latch and/or strike plate.

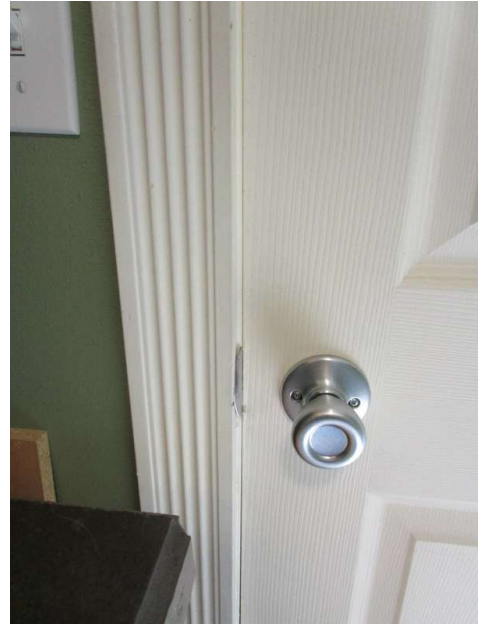
7.1.2 Doors

DOOR STICKS

Door sticks and is tough to open. Recommend sanding down offending sides.

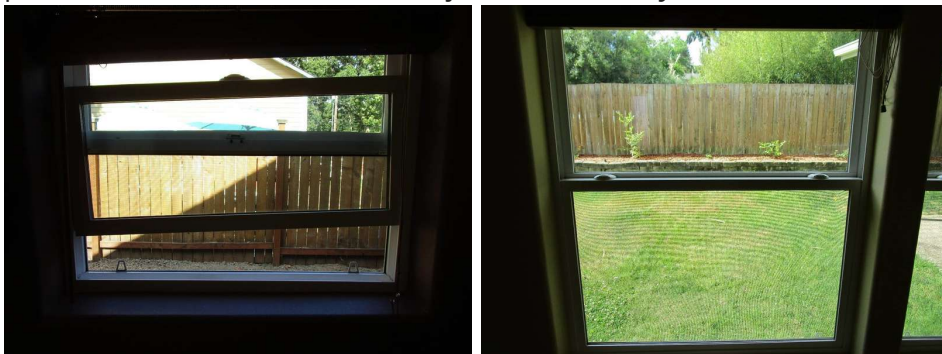
7.2.1 Windows

DAMAGED

One or more windows appears to have general damage, but are operational. Recommend a window professional clean, lubricate & adjust as necessary.

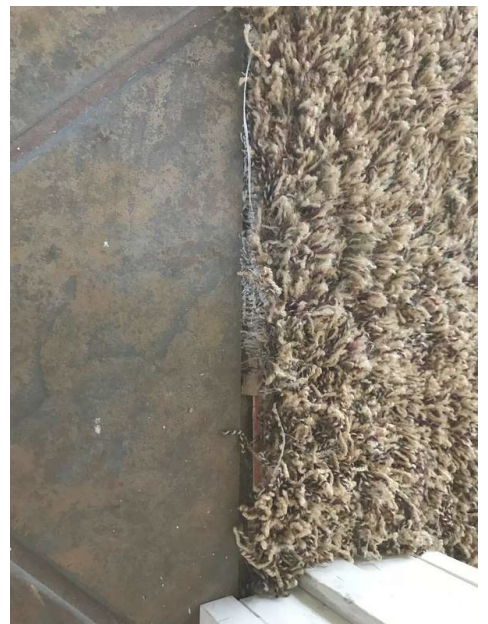
7.3.1 Floors

DAMAGED (GENERAL)

The carpet had pulled off the tack strip in one or more areas. Recommend service by a qualified contractor.

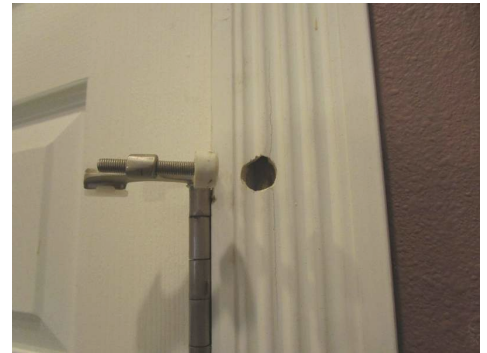
7.7.1 Walls

DOORSTOP HOLE

Wall had damage from doorstop. Recommend a qualified handyman or drywall contractor repair.

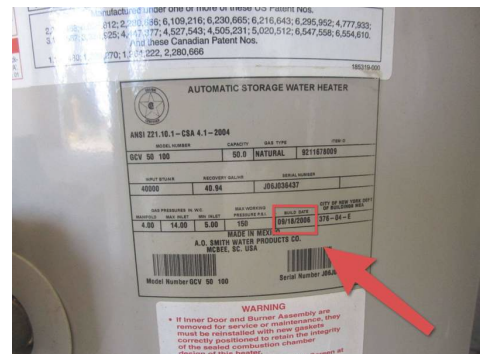
9.1.1 Hot Water Systems, Controls, Flues & Vents

NEAR END OF LIFE

The typical life span for a water heater is 10 to 15 years. This water heater is 12 years old. Recommend monitoring it's effectiveness and budgeting for its replacement in the near future.

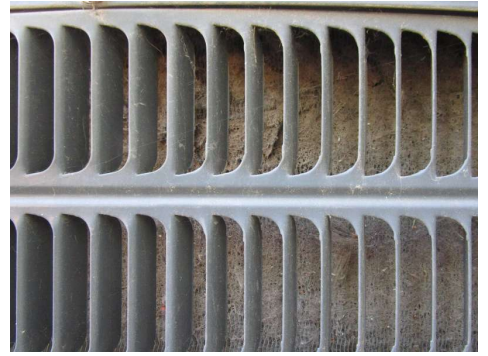
11.1.1 Cooling Equipment

AIR FLOW RESTRICTED

Air flow to the air conditioner condenser was restricted. This may result in inefficient operation. Recommend cleaning dirt and/or debris from unit.

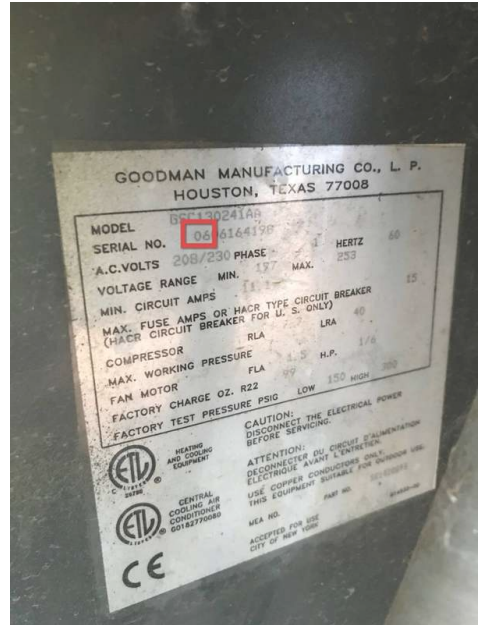
11.1.2 Cooling Equipment

AC NEAR END OF EXPECTED LIFE

This AC works as it should but appears to be near the end of its typical life expectancy. Recommend budgeting for a new AC unit for the near future.

This unit's manufacture date is 2006

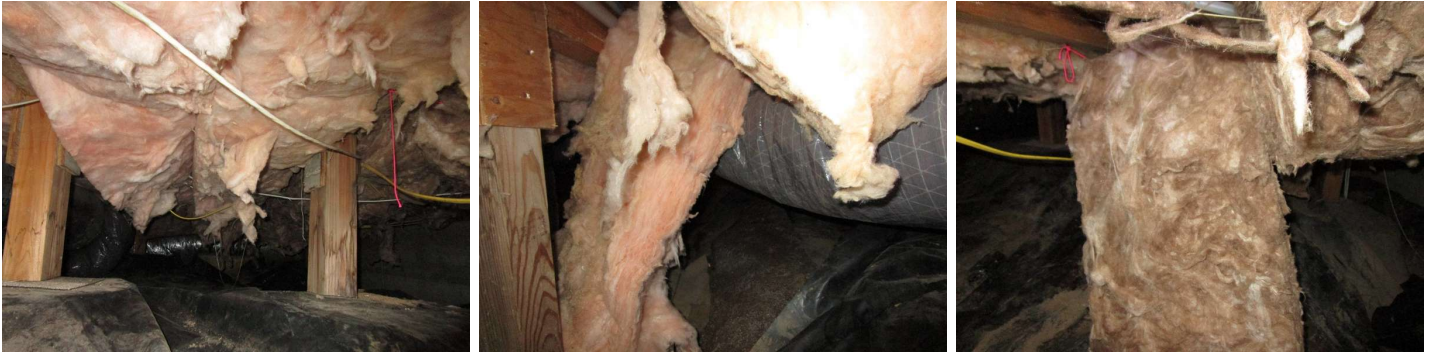
15.4.1 Floor Structure

FALLING INSULATION

One or more areas in the floor structure had insulation falling from the floor. It appears that there may have been previous water damage in some areas, soaking the insulation and making it fall from between the joists. Recommend re-installing / replacing insulation as needed.
