General Information: Overview

A home inspection is a non-invasive, visual examination of the accessible areas of the property, designed to identify areas of concern within specific systems or components defined by the City Of Edmonton Standards of Practice, that are both observed and deemed material by the inspector at the exact date and time of inspection. Any and all recommendations for repair, replacement, evaluation, and maintenance issues found, should be evaluated by the appropriate trades contractors within the clients inspection contingency window or prior to closing, which is contract applicable, in order to obtain proper dollar amount estimates on the cost of said repairs and also because these evaluations could uncover more potential issues than able to be noted from a purely visual inspection of the property. This inspection will not reveal every concern or issue that exists, but only those material defects that were observable on the day of the inspection. This inspection is intended to assist an evaluation of the overall condition of the dwelling only. This inspection is not a prediction of future conditions and conditions with the property are subject to change the

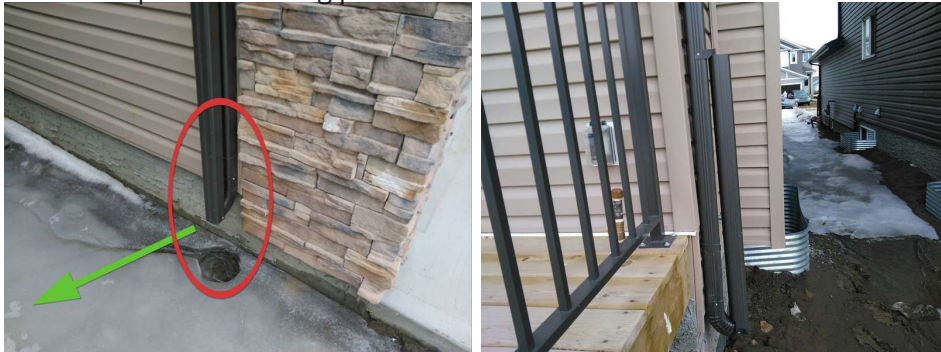
2.2.1 Roof Drainage Systems

DOWNSPOUTS DRAIN NEAR HOUSE

One or more downspouts drain too close to the home's foundation. This can result in excessive moisture in the soil at the foundation, which can lead to foundation/structural movement. Recommend Homeowner to adjust downspout extensions to drain at least 6 feet from the foundation.

Contact a qualified roofing professional.

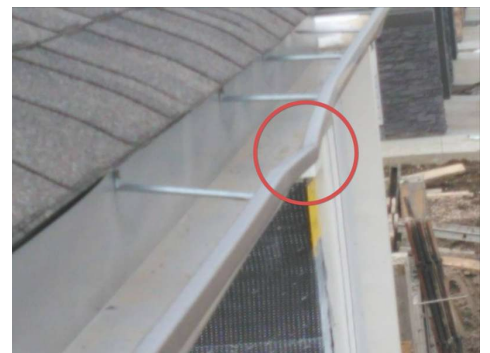
2.2.2 Roof Drainage Systems

MINOR GUTTER DAMAGE

Observed minor dent on the Gutter above Garage, recommend repair seal to avoid immature deterioration.

Contact a qualified professional.

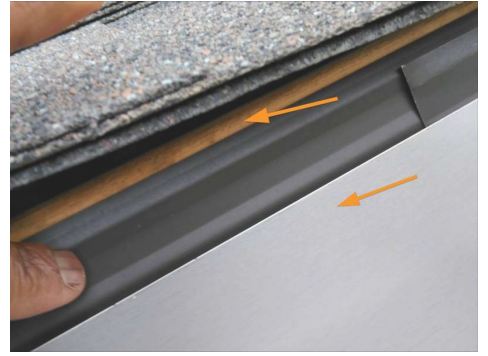
2.3.1 Flashings

MISSING

Overlay/Drip edge flashings were missing at time of inspection. Flashings provide protection against moisture intrusion and to avoid premature deterioration of roof board and Eavestrough corrosion, Recommend a qualified roofing contractor evaluate and remedy.

Recommendation
Contact a qualified roofing professional.

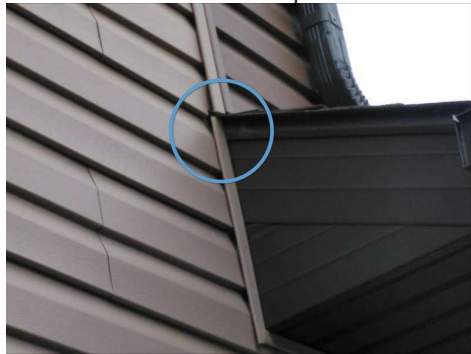
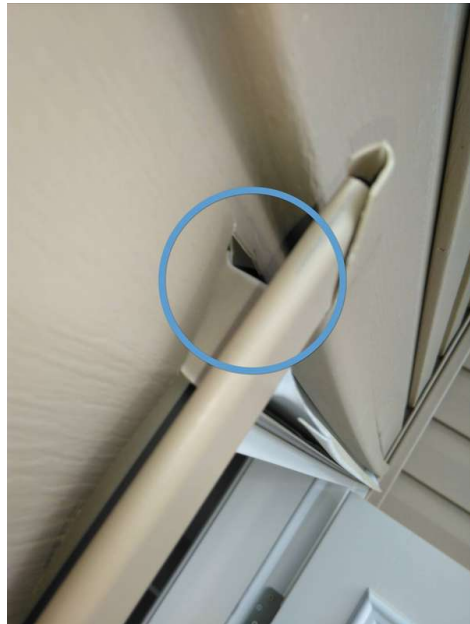
3.1.1 Siding, Flashing & Trim

EXTERIOR PENETRATION

Observed missing exterior sealant , recommend sealing all opening to void moisture intrusion.

Recommendation
Recommended DIY Project

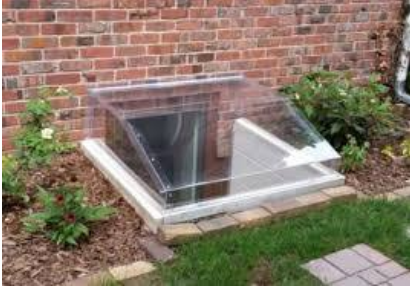
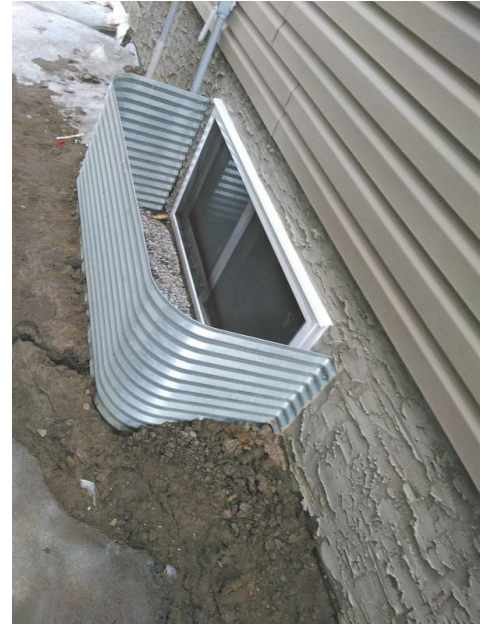
3.2.1 Exterior Doors

EGRESS WINDOW

Observed Egress windows functional, recommend upgrading with window well covering to avoid too much moisture accumulating and trip hazards.

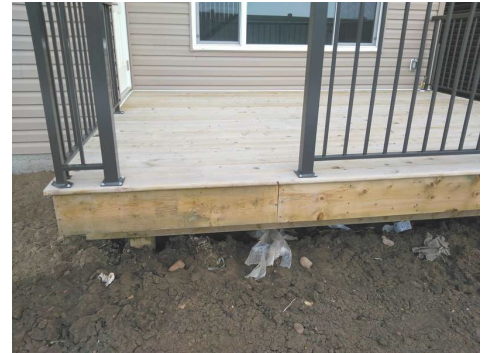
3.4.1 Decks, Balconies, Porches & Steps

MISSING STEPS

Missing Steps near deck, steps required if deck heights more than 9" and handrail must be provided with 3 or more steps, Recommend installing.

Also some of the nails were pushed into the plank, which damage the wood and creates penetration area for moisture intrusion & premature deterioration. Recommend sealing all over hammered nails.

Contact a qualified deck contractor.

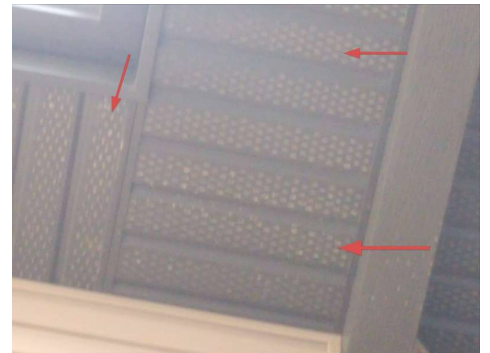
3.5.1 Eaves, Soffits & Fascia

CLOSED SOFFITS

Observed some of soffits above front door were covered with insulations, soffits provide ventilation to the roof, recommend further investigation and corrections.

Contact a qualified professional.

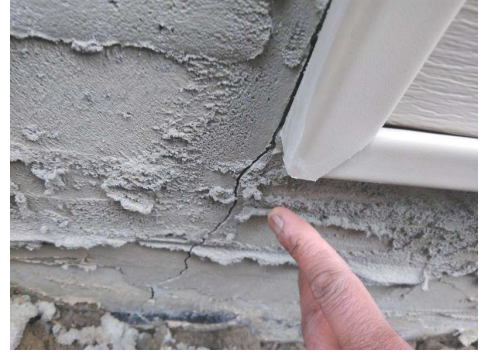
4.1.1 Foundation

FOUNDATION CRACKS - MINOR

Minor cracking was noted at the foundation. This is common as concrete ages and shrinkage surface cracks are normal. Recommend monitoring for more serious shifting/displacement.

Recommendation
Recommend monitoring.

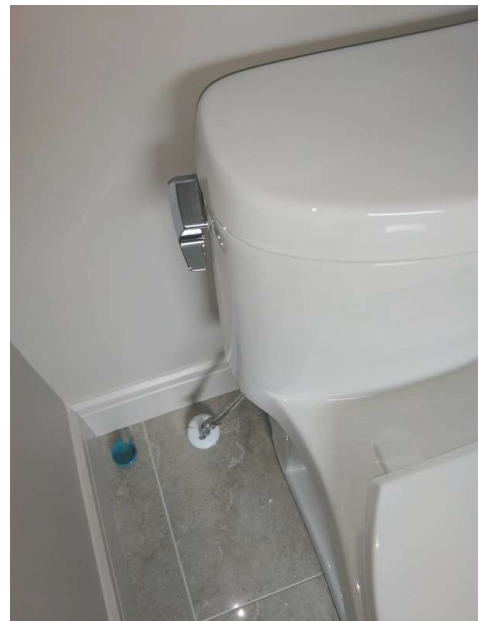
6.3.1 Water Supply, Distribution Systems & Fixtures

TOILET KNOB DAMAGE

Observed Toilet Knob Damage/not operational recommend correction.

Recommendation
Contact a qualified professional.

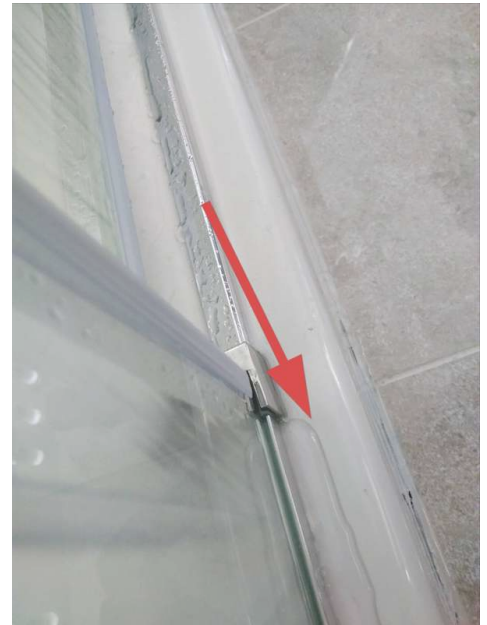
6.3.2 Water Supply, Distribution Systems & Fixtures

SHOWER GLASS DOOR

Observed shower glass door not properly align, recommend correction.

Contact a qualified professional.

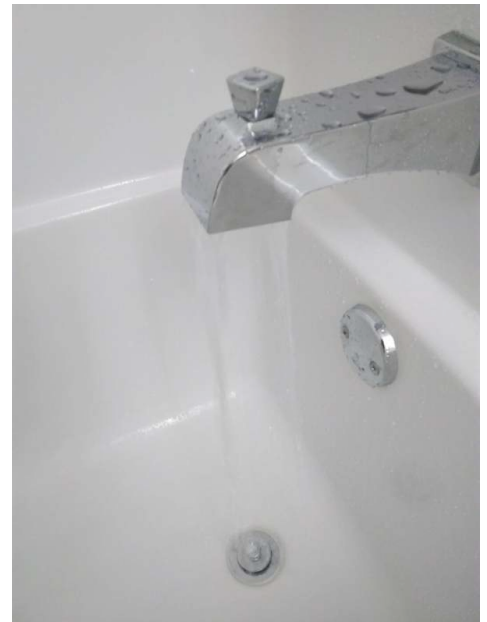
6.3.3 Water Supply, Distribution Systems & Fixtures

LOW WATER PRESSURE

Observed low water pressure on bathtub faucet, recommend finding the source and remedy.

Contact a qualified plumbing contractor.

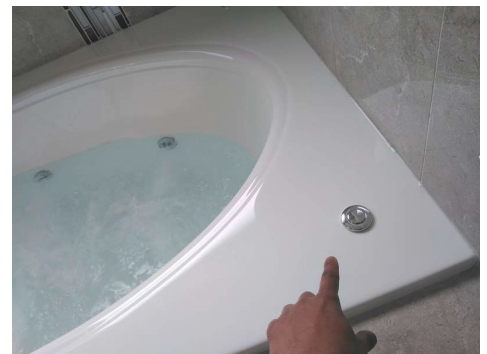
6.3.4 Water Supply, Distribution Systems & Fixtures

SAFETY SWITCH

Inspector unable to locate safety switch for jacuzzi or missing, it's a serious safety hazard as it will be easily accessible to the kids.

Recommend installing another master switch far from the jacuzzi.

Contact a qualified electrical contractor.

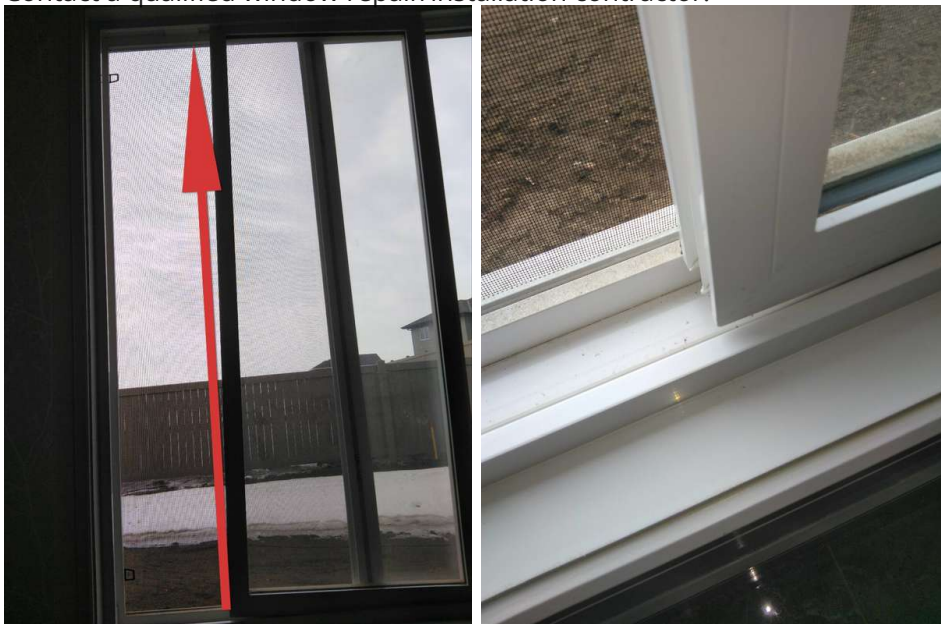
9.2.1 Windows

IMPROPER INSTALLATION

Windows appear to not be operating properly due to substandard installation or missing channel, Recommend window specialist evaluate.

Recommendation
Contact a qualified window repair/installation contractor.

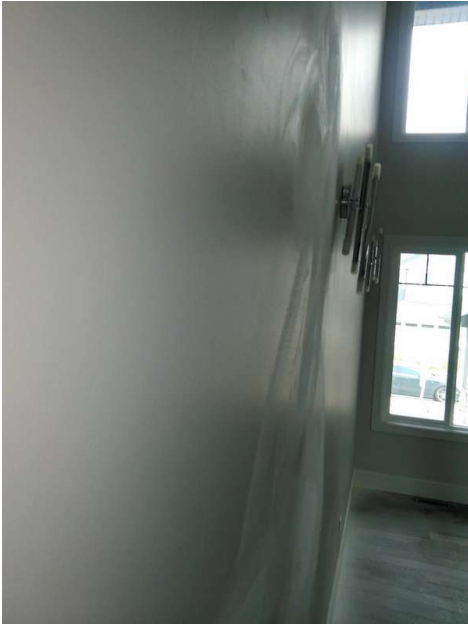
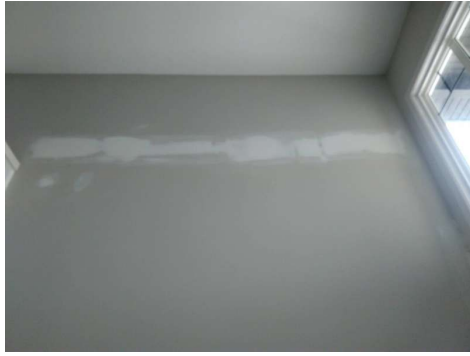
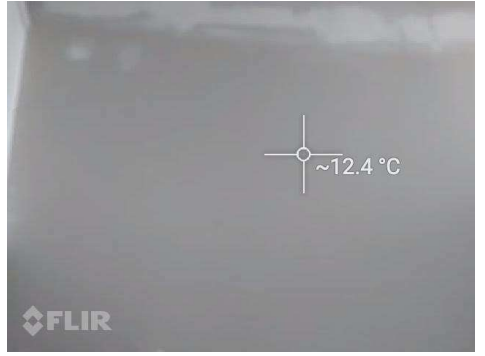
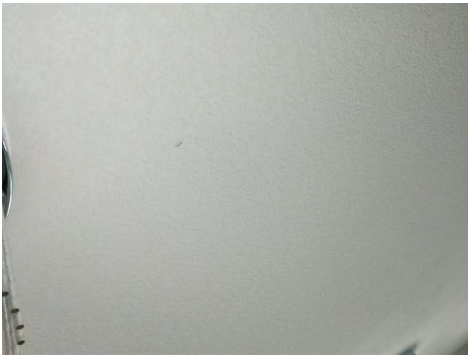
9.4.1 Walls

POOR PATCHING

unfinished drywall patching observed at time of inspection. Recommend professional finishing.

Recommendation
Contact a qualified drywall contractor.

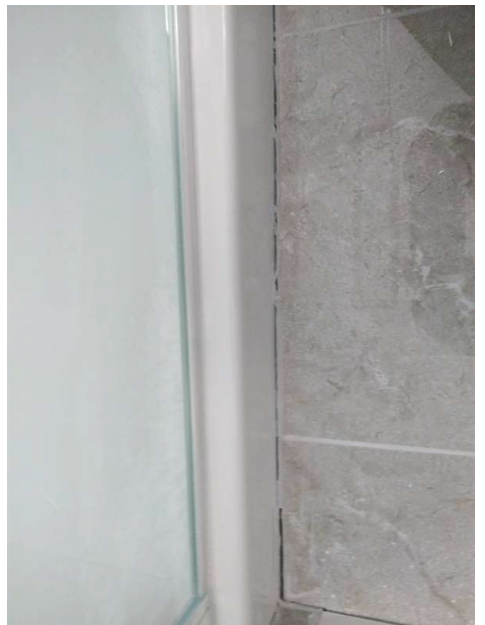
9.7.1 Countertops & Cabinets **POOR/MISSING CAULK**

Bathroom tiles was missing sufficient caulk/sealant, This can lead to water damage. Recommend adding sealant at sides and corners where counters touch walls.

Recommendation
Recommended DIY Project

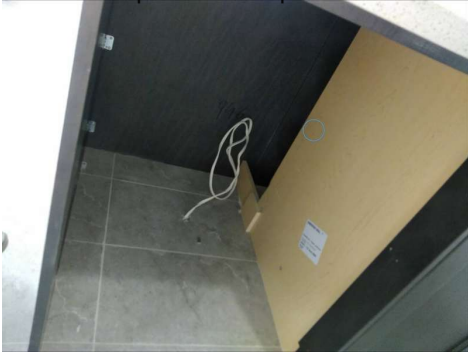
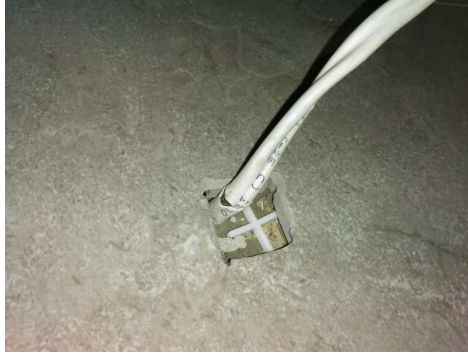
10.1.1 Dishwasher **DISHWASHER** MAIN FLOOR KITCHEN

Observed unfinished wire connection/receptacle for the dishwasher connection.

Also observed missing access whole for drainage line of the dishwasher.

Recommend correction.

Contact a qualified carpenter.
