SUMMARY
1234 Main St. Apopka Florida 32712
Buyer Name
05/22/2018 9:00AM

Jim Reynolds
License HI11043
Full Circle Home Inspectors
352-459-6173
jim@fullcirclehomeinspectors.com

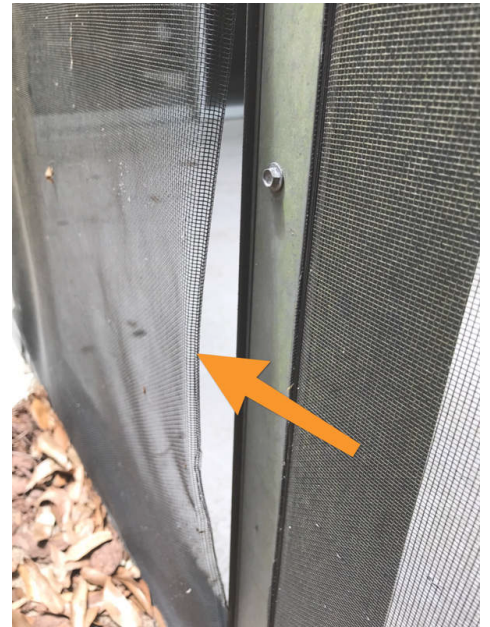
3.2.1 Driveway, Walkway, Patio

SCREEN ENCLOSURE-SPLINE ISSUE

The spline is coming loose or missing at one or more sections of the screen patio. The spline is what secures the screen in the frame. It is recommended to have a qualified contractor make the necessary repairs.

Contact a qualified handyman.

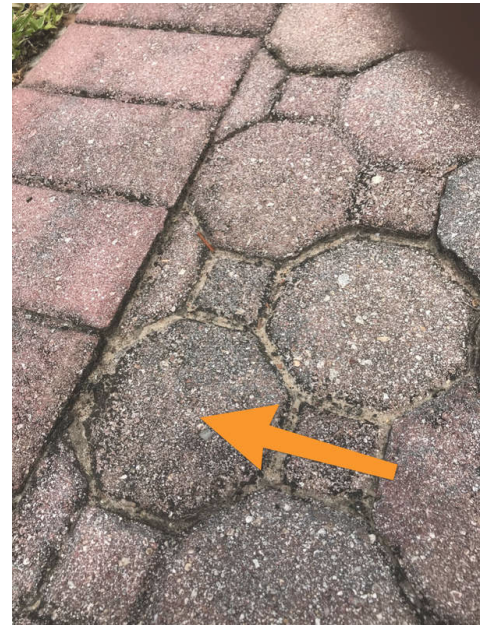
3.2.2 Driveway, Walkway, Patio

NEED REPAIR-SIDEWALK

Cracks, holes, settlement, heaving and/or deterioration were found in sidewalks and/or patios. Recommend that qualified contractor repair as necessary.

Contact a qualified professional.

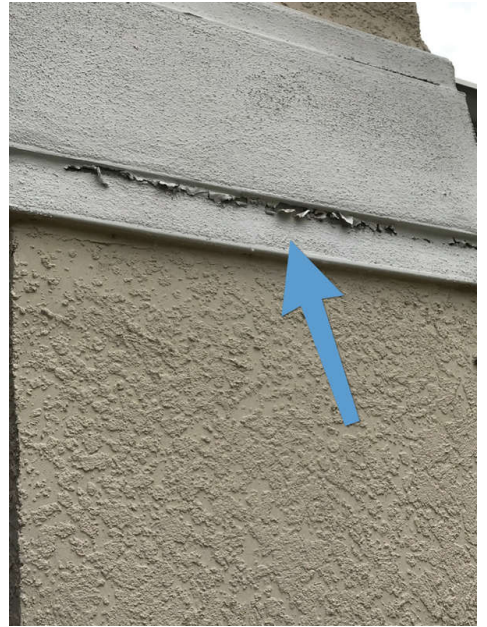
3.3.1 Exterior issues

PAINT FAILING

The paint or stain finish in some areas was failing (e.g. peeling, faded, worn, thinning). Siding and trim with a failing finish can be damaged by moisture. Recommend that a qualified contractor prep (e.g. clean, scrape, sand, prime, caulk) and repaint or restain the building exterior where necessary and per standard building practices. Any repairs needed to the siding or trim should be made prior to this..

Contact a qualified painter.

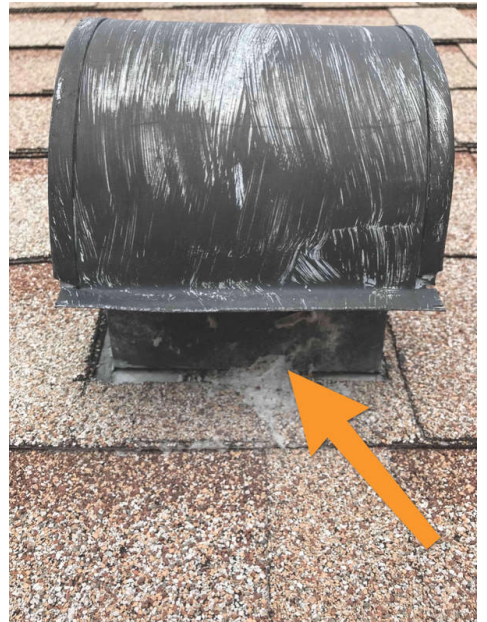
3.3.2 Exterior issues

DRYER VENT CLOGGED

The dryer vent is clogged and needs to be cleaned. A clogged dryer vent can lead to dryer failure and extended dry times.

Contact a qualified professional.

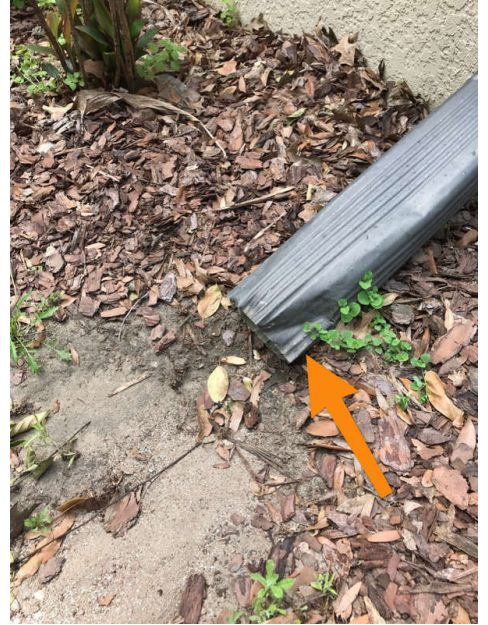
3.7.1 Gutters and Flashing

DOWNSPOUT EXTENSIONS

Extensions such as splash blocks or drain pipes for one or more downspouts were *missing / poorly sloped / misaligned / clogged / substandard / damaged*. Water can accumulate around the building foundation or inside crawl spaces or basements as a result. Recommend that a qualified person install, replace or repair extensions as necessary so rainwater drains away from the structure.

Contact a qualified professional.

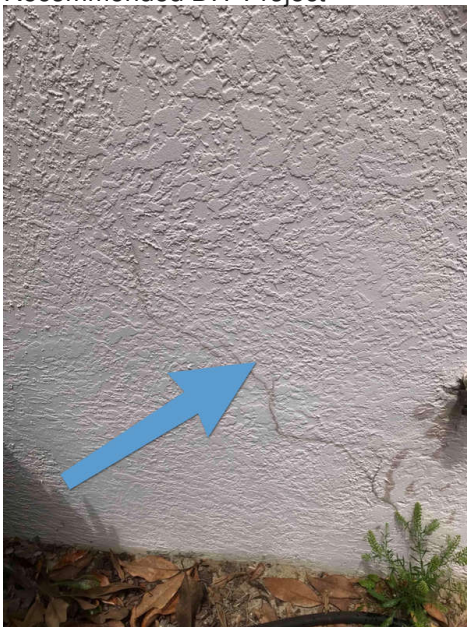
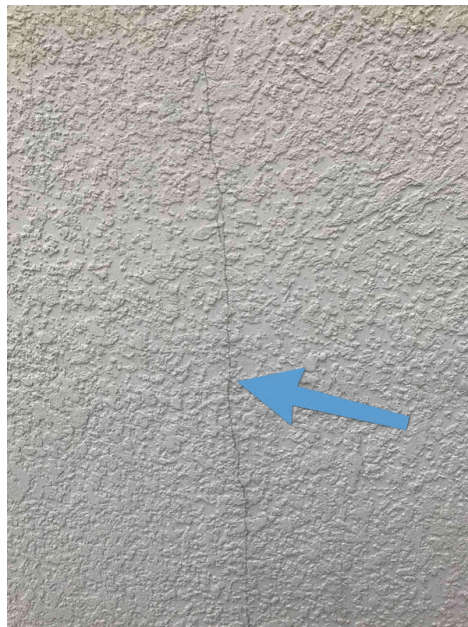
3.8.1 Stucco Walls

HAIRLINE STUCCO CRACKING

One or more minor hairline cracks were found in the stucco or wall areas. It is unknown the age of these cracks. At the time of inspection nothing out of the ordinary of normalized cracking was noticed. Recommend caulking and painting these areas, along with monitoring for future movement/widening. Stucco cracks over framing can allow moisture penetration behind wall areas and can potentially damage sheathing/framing. Note that areas concealed behind walls are not able to be evaluated without invasive testing and cannot be evaluated.

Recommended DIY Project

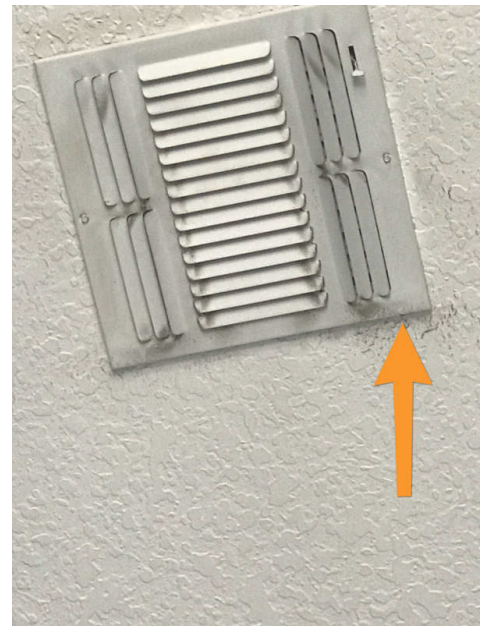
7.4.1 Duct Work

DIRTY

Significant amounts of debris, dirt and/or dust are visible in one or more sections of supply and/or return air ducts. This can be a health hazard, especially for those with allergies or respiratory problems. The Environmental Protection Association (EPA) recommends considering having ducts professionally cleaned when "ducts are clogged with excessive amounts of dust and debris and/or particles are actually released into the home from your supply registers". At a minimum, the visible debris should be thoroughly cleaned. Recommend having a qualified contractor clean the ducts if concerned.

Contact a qualified HVAC professional.

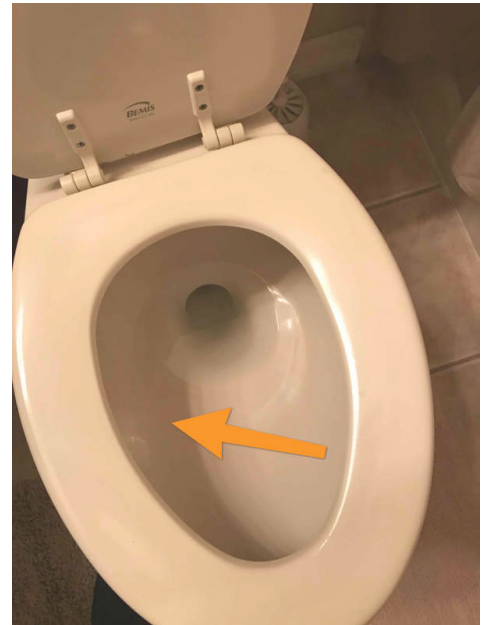
10.8.1 Toilets

FLAPPER DID NOT RESEAT

The "flapper valve" in one or more toilets did not reseat after flushing. Significant amounts of water can be lost through such leaks. A qualified plumber should evaluate and repair or replace components as necessary.

Contact a qualified plumbing contractor.

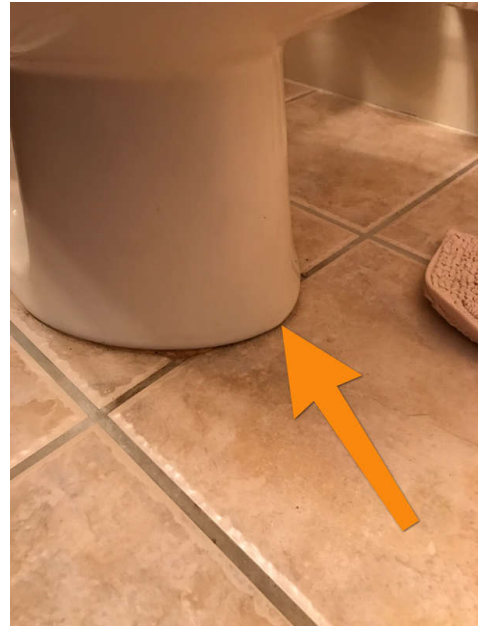
10.8.2 Toilets

NO OR BAD CAULK BASE

Caulk around the base of the toilet was missing, substandard and/or deteriorated. Modern standards require caulk to be installed around the entire toilet base where it meets the floor for sanitary reasons. Without it, soiled water can soak into flooring and sub-floor materials if the toilet overflows. Condensation from the toilet can also soak into the flooring. Recommend that a qualified person caulk around toilet bases per standard building practices.

Recommended DIY Project

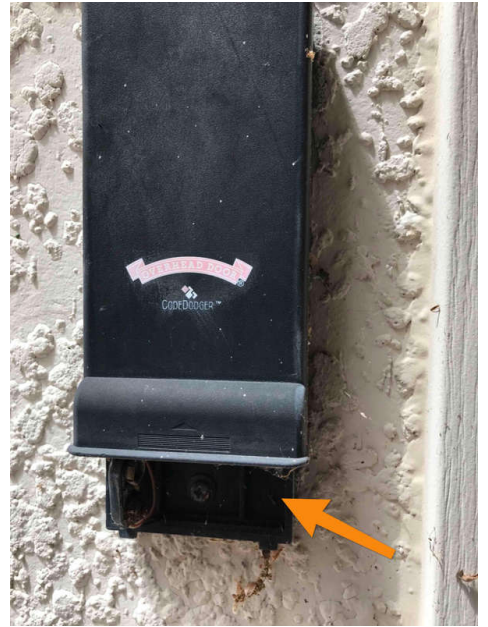
11.4.3 Vehicle door

OUTSIDE KEYPAD

Outside keypad does not operate

Contact a qualified garage door contractor.

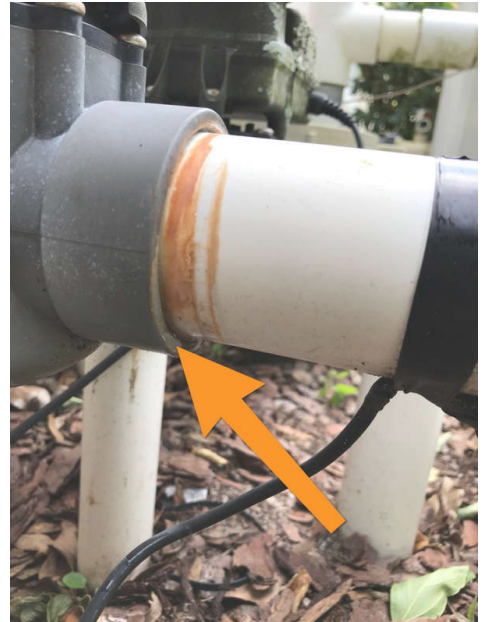
12.1.1 Pool Equipment

LEAK

There is a leak at the pool equipment. This will cause water loss. The equipment should be evaluated and any leaks repaired to help prevent unwanted water loss.

Contact a qualified Swimming Pool Contractor
