**SUMMARY**  
 1234 Main St. Laurelton NJ 08723  
 Buyer Name  
 06/11/2019 9:00AM

1.1.1 Essential Information  
**VITAL INFORMATION**

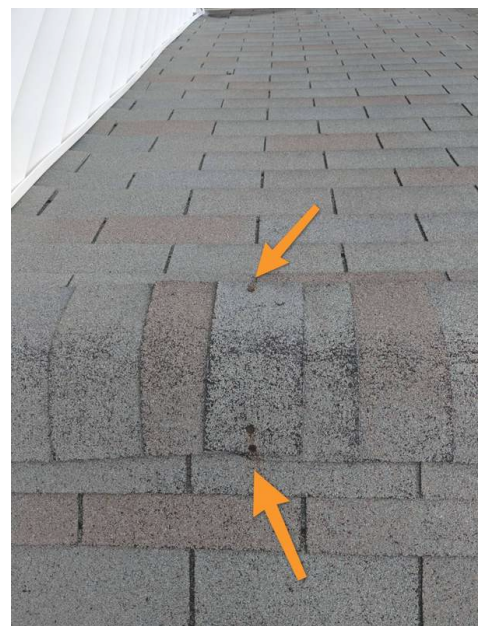
3.1.2 Coverings  
**EXPOSED NAILS**

Under-driven or exposed nails were found in one or more roof coverings. This can let water to enter the roof structure and cause damage.

Recommend a qualified person caulk all exposed nails with roofing mastic.

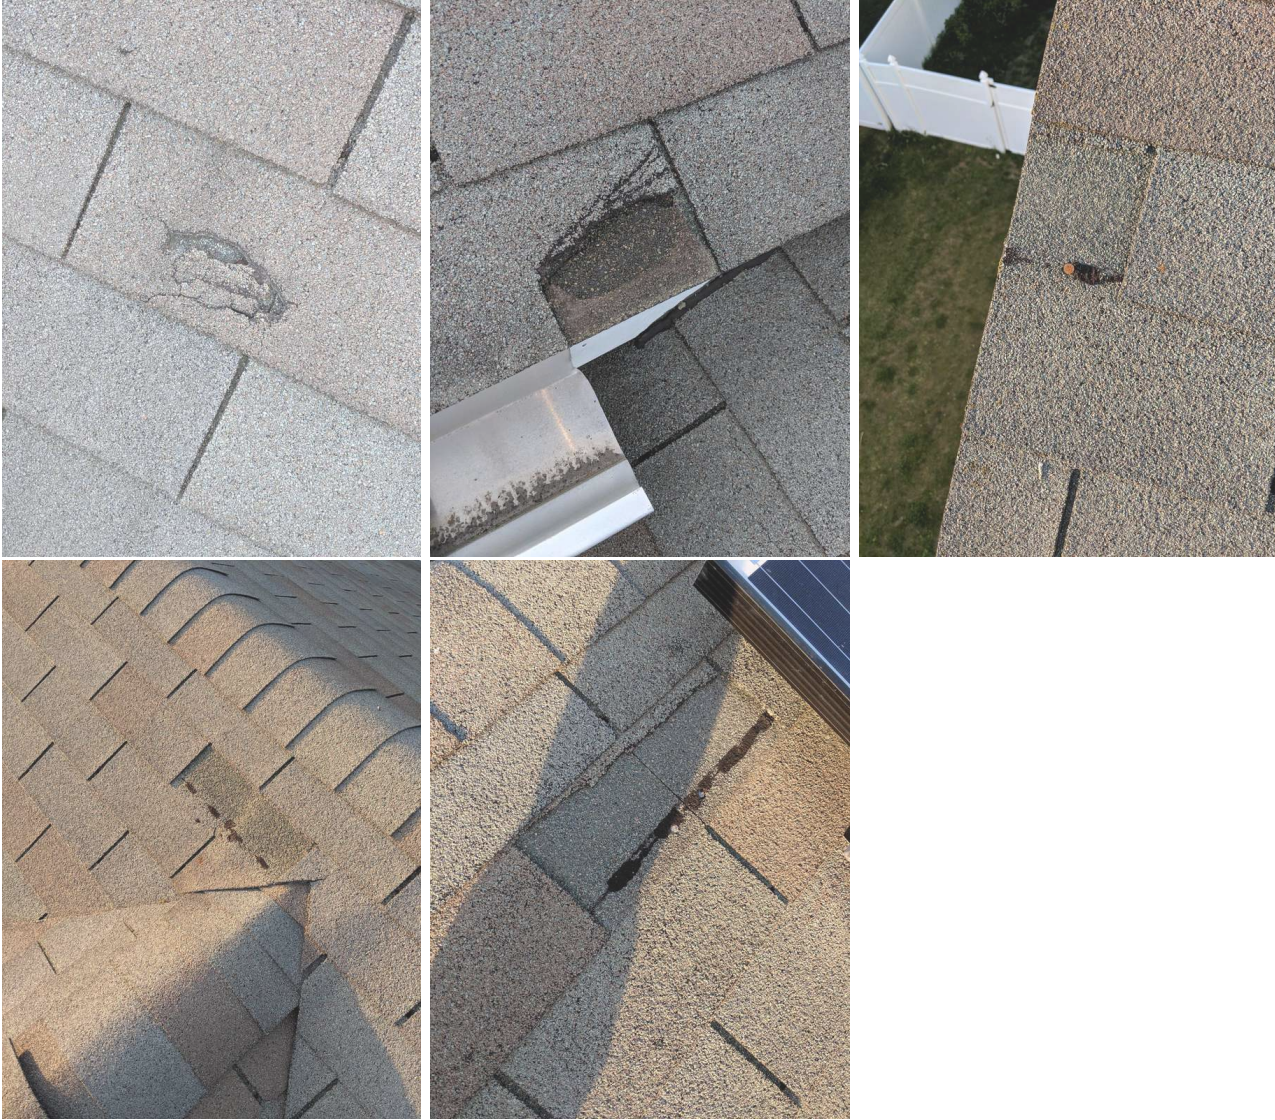
#### **CRACKED SHINGLES/TABS MISSING**

A few shingles were cracked others were missing tabs and need to be replaced or repaired.

These can eventually cause a leak.

Recommend a qualified roofer inspect the entire roof for such shingles and repair or replace as needed.

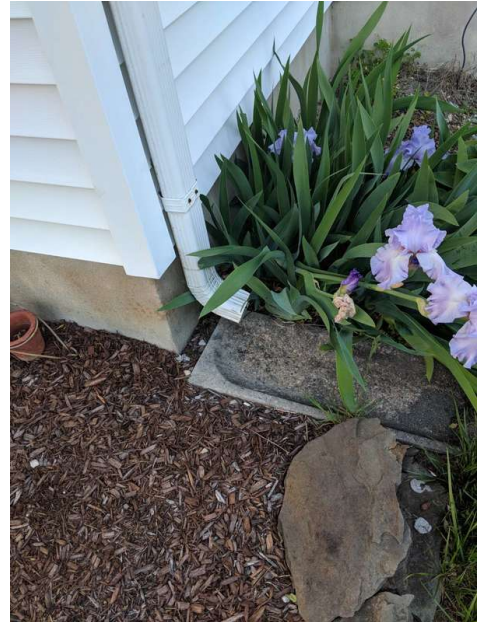
#### **DOWNSPOUTS DISCHARGES TO FOUNDATION**

One or more downspouts drain too close to the home's foundation.

This can result in excessive moisture in the soil at the foundation.

Recommend a qualified contractor adjust downspout extensions to drain at least 6 feet from the foundation.

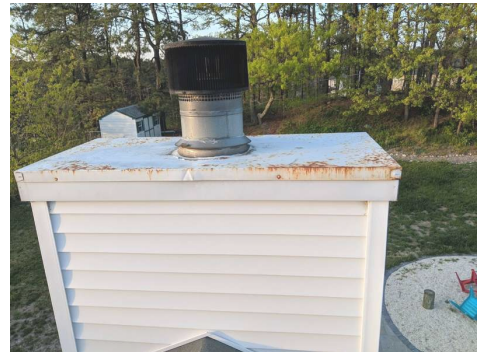
### CAP/COVER NEEDS PAINT

The chimney cover was in need of fresh paint, this protects the cover from corrosion and eventual leaks.

Recommend a qualified contractor paint the cover.

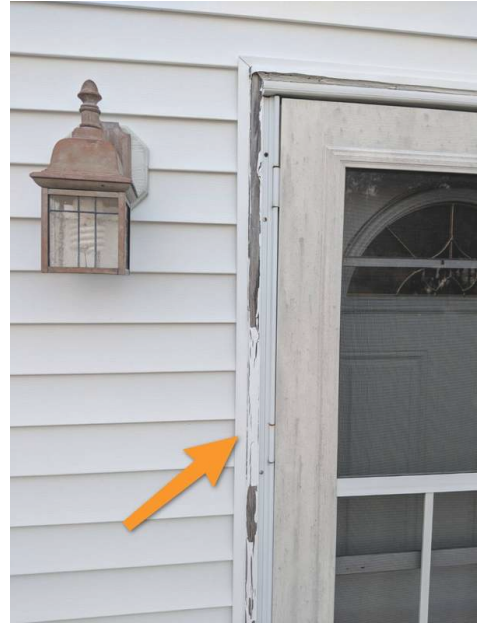
### NEEDS PAINT AND CAULKING

The garage door trim needs to be painted and some caulking is needed.

Recommend a qualified painter paint and caulk.

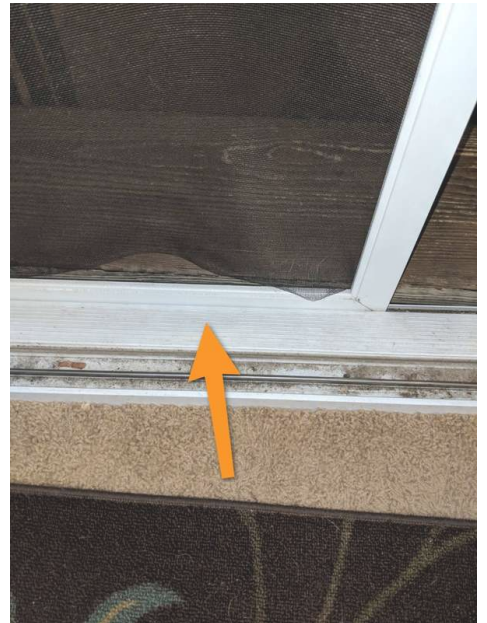
**RIPPED SCREEN**

The screen door to the sunroom had a ripped screen and needs to be replaced.

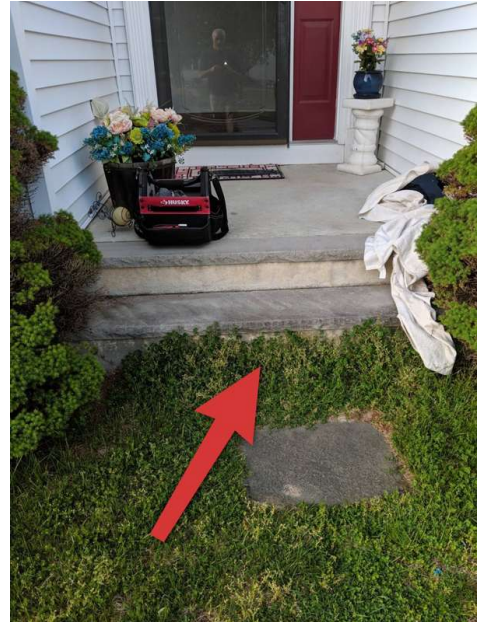
**NEEDS LANDING**

The front porch had stairs that terminated in the grass lawn, this is a trip hazard and normally there should be a stable platform to land on at the bottom of the stairs.

Recommend a qualified contractor install a landing platform.

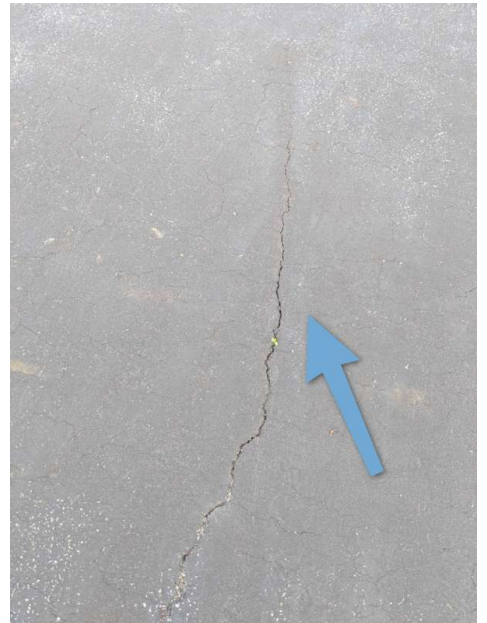
### WALKWAY/DRIVEWAY CRACKING - COMMON

Common cracks (1/4-inch or less) were visible in the Walkway and driveway. Cracks should be filled with an appropriate material to avoid continued damage to the surface from freezing moisture.

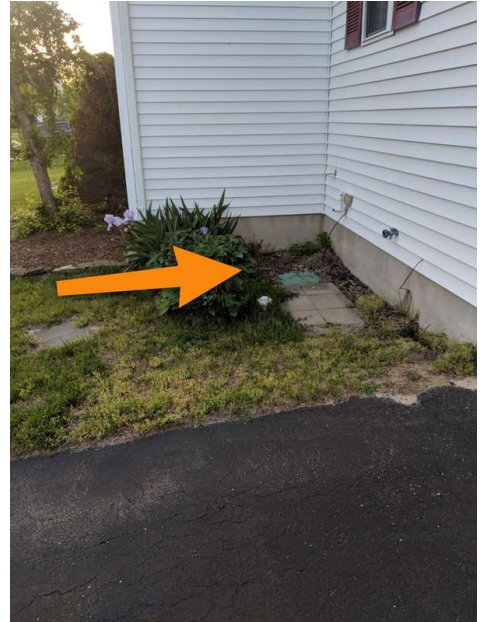
### NEGATIVE OR NEUTRAL GRADING

Grading is sloping towards the home or not sloped at all in one area. This could lead to water intrusion and foundation issues. Recommend qualified landscaper or foundation contractor regrade, so water flows away from home.

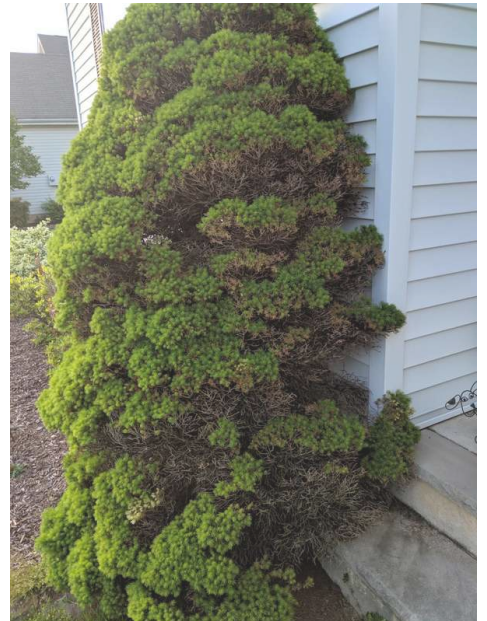
### SHRUBS AGAINST STRUCTURE

Shrubs should not be in contact with the home.

Cutting back the shrubs will prevent premature wear and tear of the siding.

Recommend a qualified person cut back the shrubs so there is no contact with the structure.

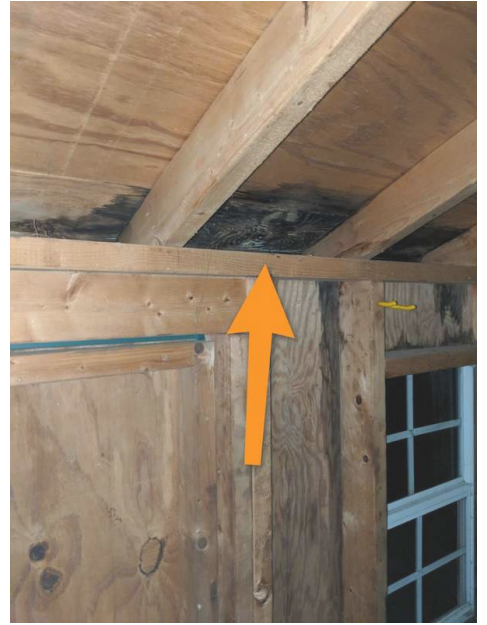
### ROOF LEAKING

The Shed roof had a leak and the roofing material was nearing the end of its life cycle and needs to be replaced.

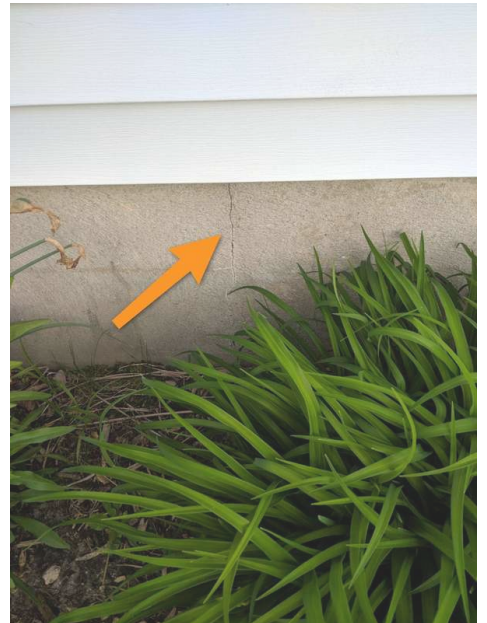
### FOUNDATION CRACKS - MINOR

Minor uniform cracking less than 1/8 inch wide was noted on the outside of the block walls, likely caused by settlement and usually not of any significance to structural integrity.

Cracks can let moisture traverse the foundation wall and should be sealed with appropriate caulking by a qualified person.

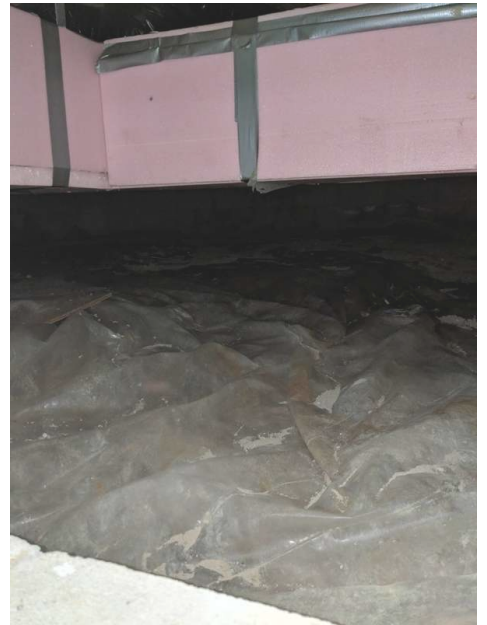
#### **NO SOIL COVER**

No soil cover was installed at the time of the inspection. Soil covers help reduce humidity levels in crawlspaces by limiting moisture evaporation into the air from the soil. Reducing humidity levels can help maintain a healthy environment in the crawl space. Recommend installation by a qualified person

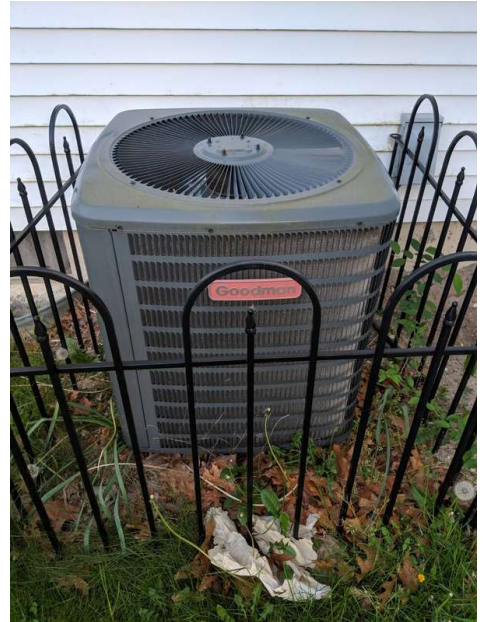
#### **CONDENSER UNIT NOT ELEVATED**

The pad supporting the outdoor condensing unit was not elevated enough above the ground level.

This will cause accelerated deterioration of the component.

Recommend a competent person elevate, or excavate around the pad, so the unit is not in contact with dirt, leaves, or debris.

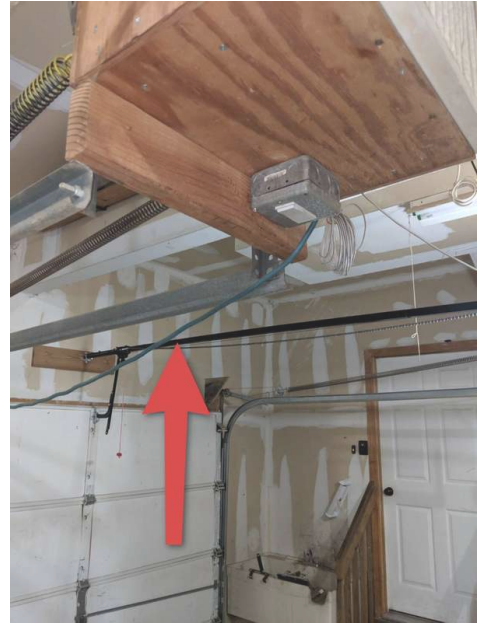
### 9.4.1 Branch Circuit Conductors **EXTENSION CORDS FOR PERMANENT WIRING**

Extension cords over 3 feet used as permanent wiring are not authorized and are a safety issue.

The Fan in the garage was using one.

The inspector recommends evaluation and correction by a qualified electrician

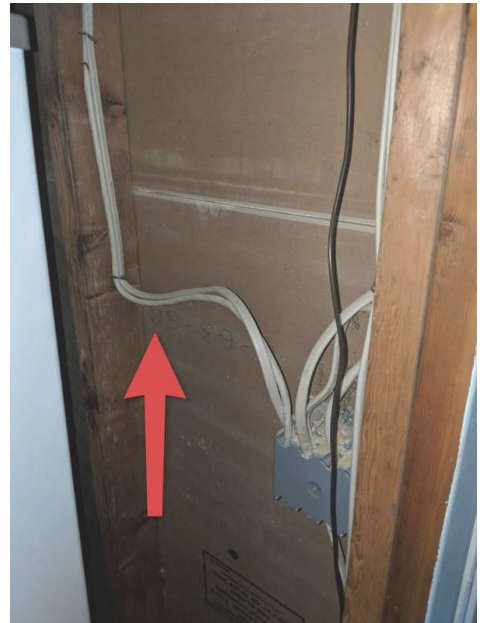
### IMPROPER SUPPORT NOT PROTECTED

A few electrical wires in the basement closet were not supported/attached/protected correctly. Anyone leaning or pulling on such wires or boxes could accidentally dislodge it, and this could lead to electrical shock. Highly recommend an electrician inspect the home for any such conditions and add supports/attachments/protect when needed

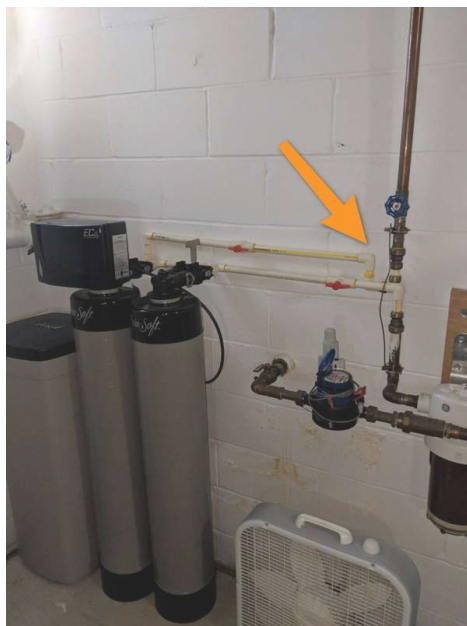
**LOW WATER PRESSURE**

The water pressure seemed insufficient if more than one fixture was being used.

The inspector noticed that the main service came in at 1" pipe then reduced to 3/4" pipe and back to 1" pipe.

This could be a cause of low water pressure.

Recommend a qualified plumber evaluate the situation and make necessary corrections.

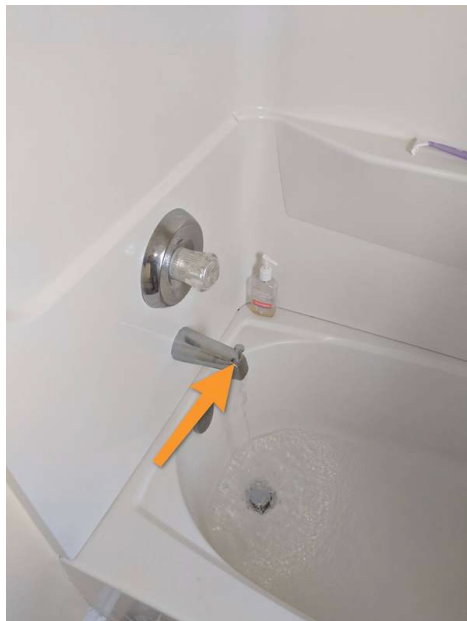
**SHOWER DIVERTER NOT FUNCTIONING PROPERLY**

The shower diverter was not functioning properly.

Recommend repair by a qualified contractor.

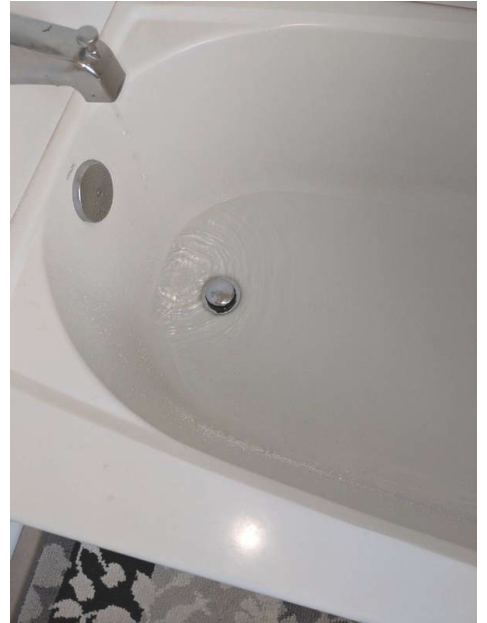
## BATHTUB DRAIN CLOGGED

The bathtub drain slowly probably clogged with hair. Recommend plunging to dislocate the clog. If the clog persists recommend evaluation and correction by a qualified plumber.

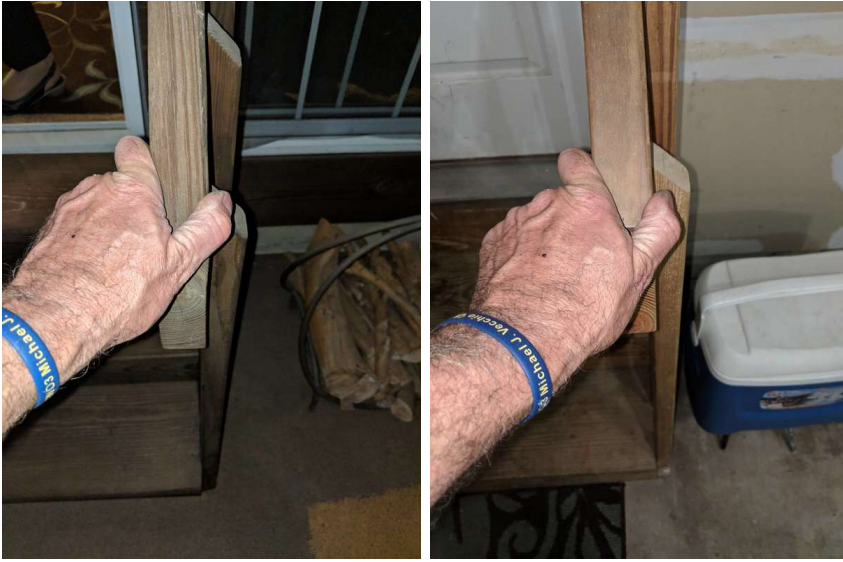
## LOOSE POST

Staircases one in the garage and one in the sunroom had post/railings that were becoming loose. This could eventually pose a safety hazard.

Recommend a qualified handyman evaluate and repair.

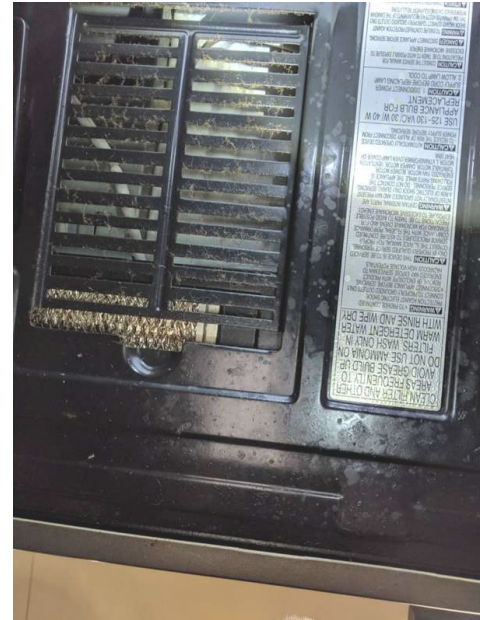
#### **FILTERS MISSING**

The recirculated exhaust hood normally has filters that collect grease.

These filters were missing at the time of inspection recommend a qualified person install filters.
